Monitoring of Streambank Stabilization and River Restoration Structures on Ice-Affected Rivers in Northern Vermont

Andrew M. Tuthill

July 2009

Final report

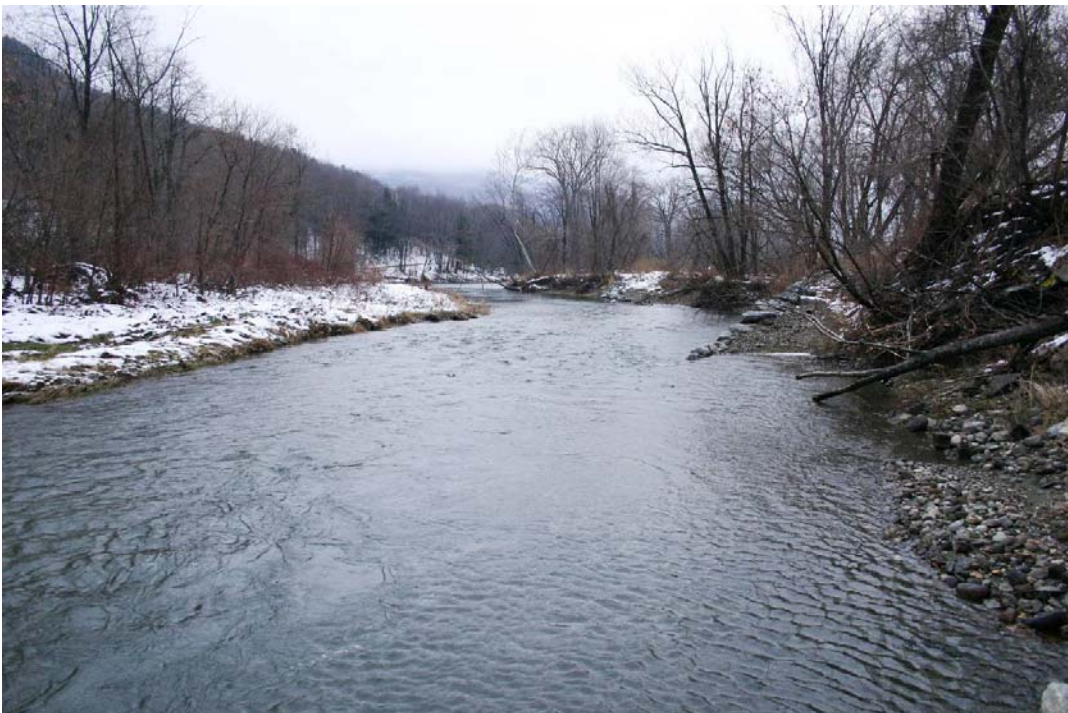
Figure 14. Rock vanes on the Winooski River, Fuller Farm, Bolton, VT viewed from upstream on 11/2/05.

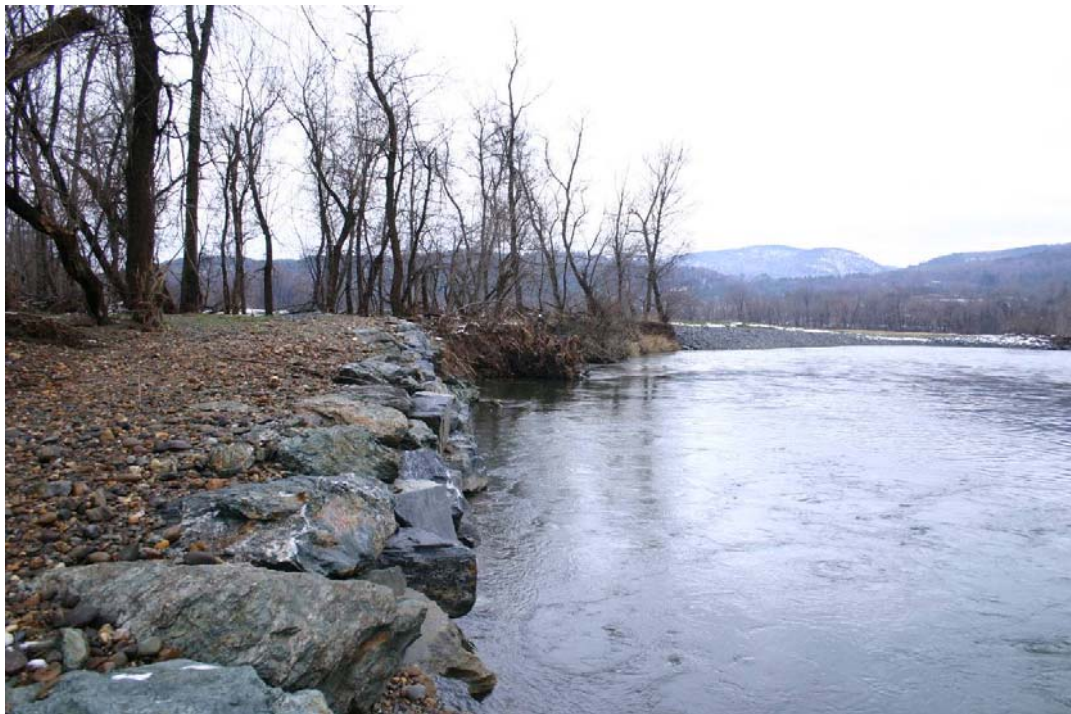
A large rock vane and stone revetment stabilize the banks at the Snowflake Farm property, about 1 mile downstream of Richmond Village (Figure 16). This NRCS vane, shown in Figures 17 and 18, is similar to but larger than the Bolton Farm vanes. Constructed of 4'×3'×2' quarried stone, the 30-ft-long structure is keyed 20 ft. into the top of the wooded bank and ramps gradually into the river forming a 15° angle with the upstream bank. The structure is built at the entrance to a flood chute where, during high flow events, water escapes the main channel to shortcut the wide bend downstream. Downstream of the vane, the edge of a field has been

Figure 17. Vane and revetment at Snowflake Farm viewed from upstream on 11/28/05.

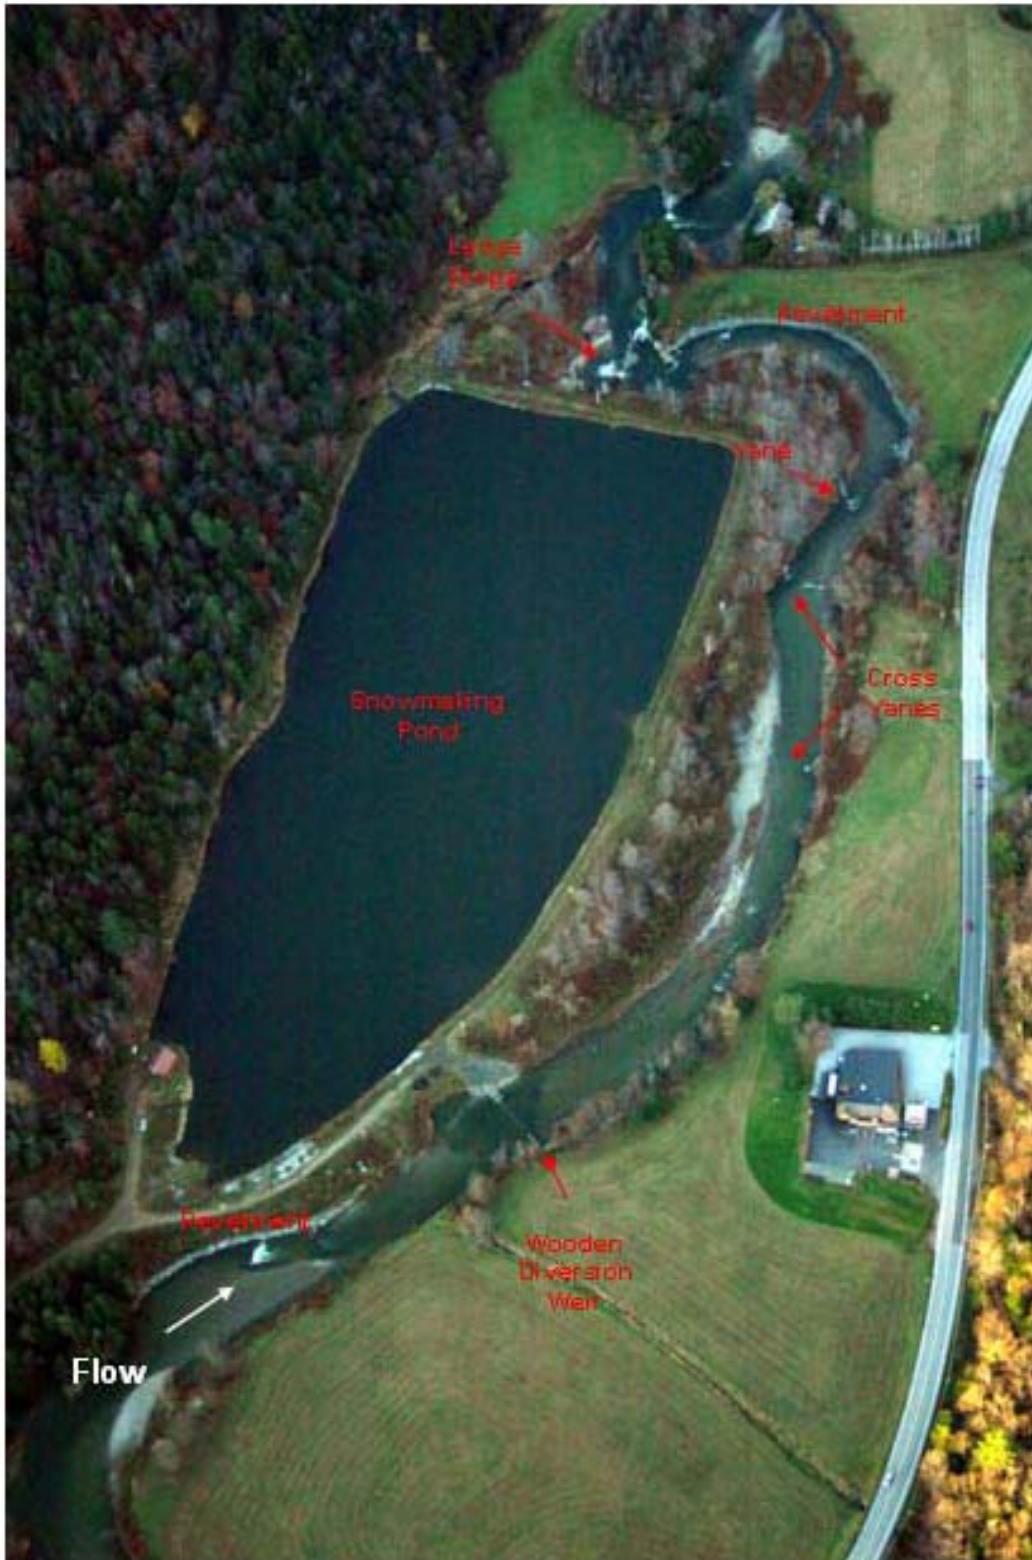
This project on the Mad River, two miles below Warren, includes two cross vanes, a vane and two revetments that stabilize banks and improve conveyance around a man-made snowmaking water storage pond (Figures 22-24). At the head of the reach, a stone revetment armors the bank along the pond. Below the revetment, a gated wooden weir serves the dual purposes of grade control and pond filling. Downstream, two cross vanes and a single vane encourage sediment deposition along the left side of the channel and concentrate flow towards the channel center.

Figure 22. Channel restoration structures on the upper Mad River at the Warren snowmaking ponds. 11/2/05

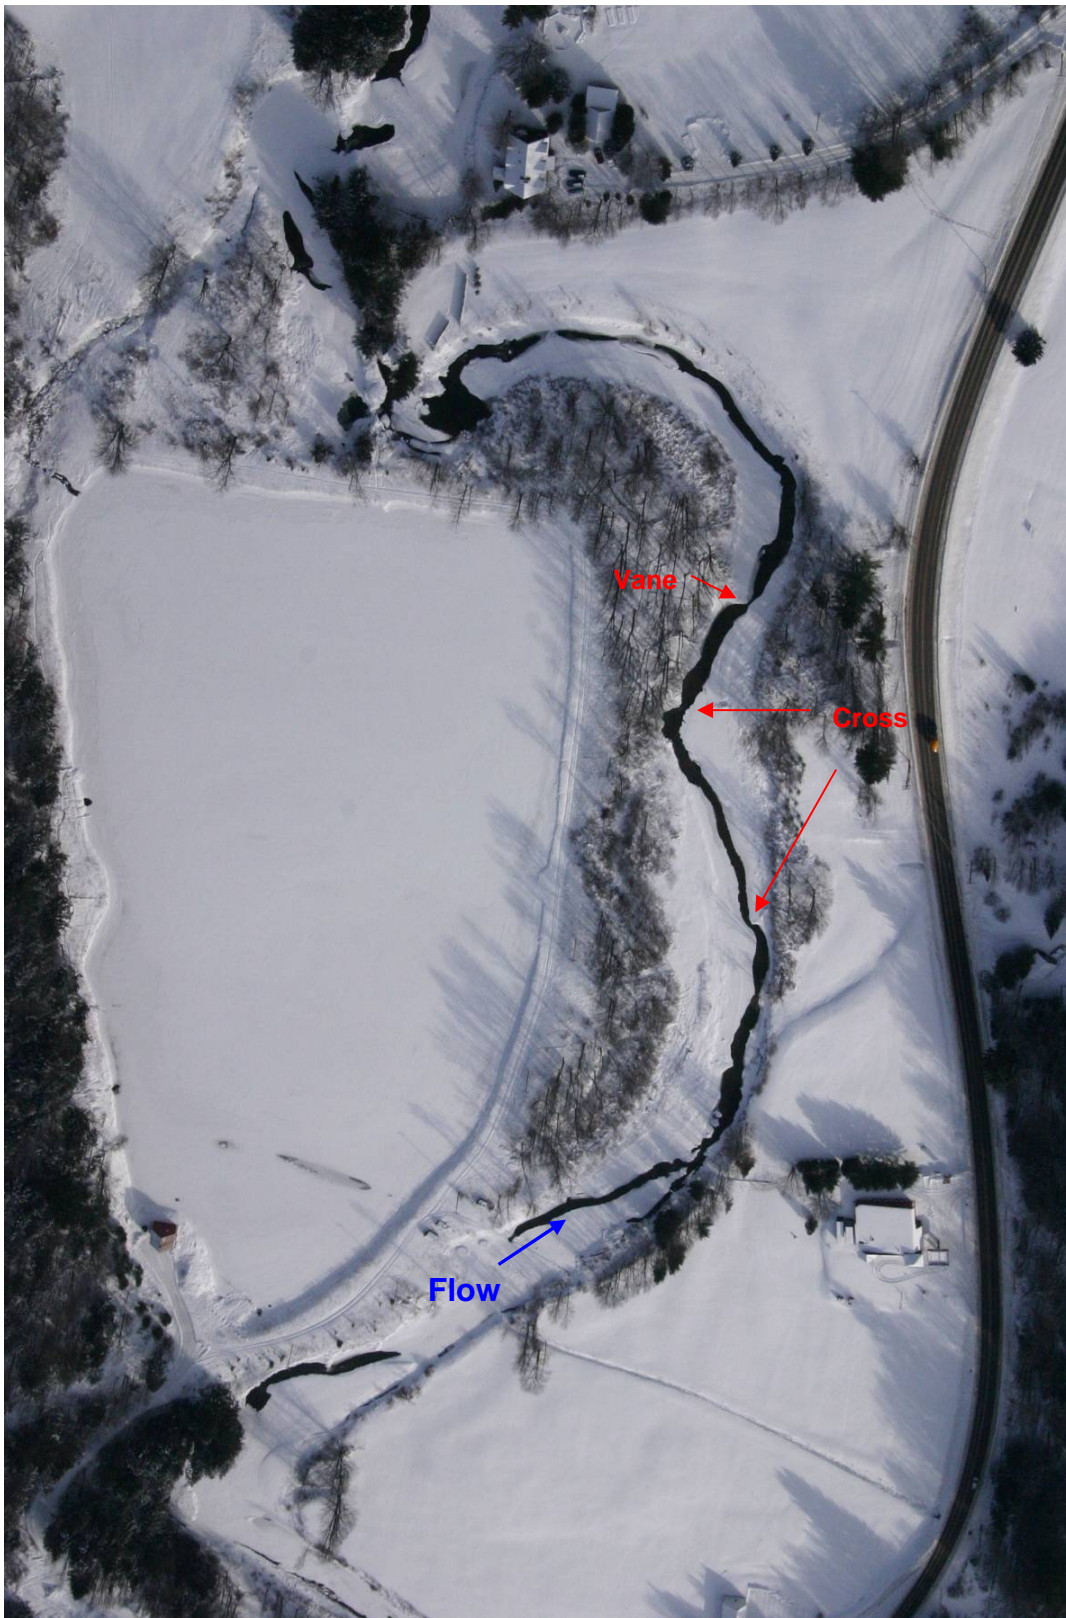
Figure 23. Partial ice cover on the upper Mad River at the Warren snowmaking ponds. 12/21/05.

An aerial view on 10 January 2006 shows a continuous open lead along the path of fastest current. The lead narrows at the structures where border ice has formed around the vanes (Figure 23). It appears that the river is still aggrading in the vicinity of the upstream cross vane, as the rocks forming the left hand vane (facing downstream) are now nearly buried in gravel (Figure 24).

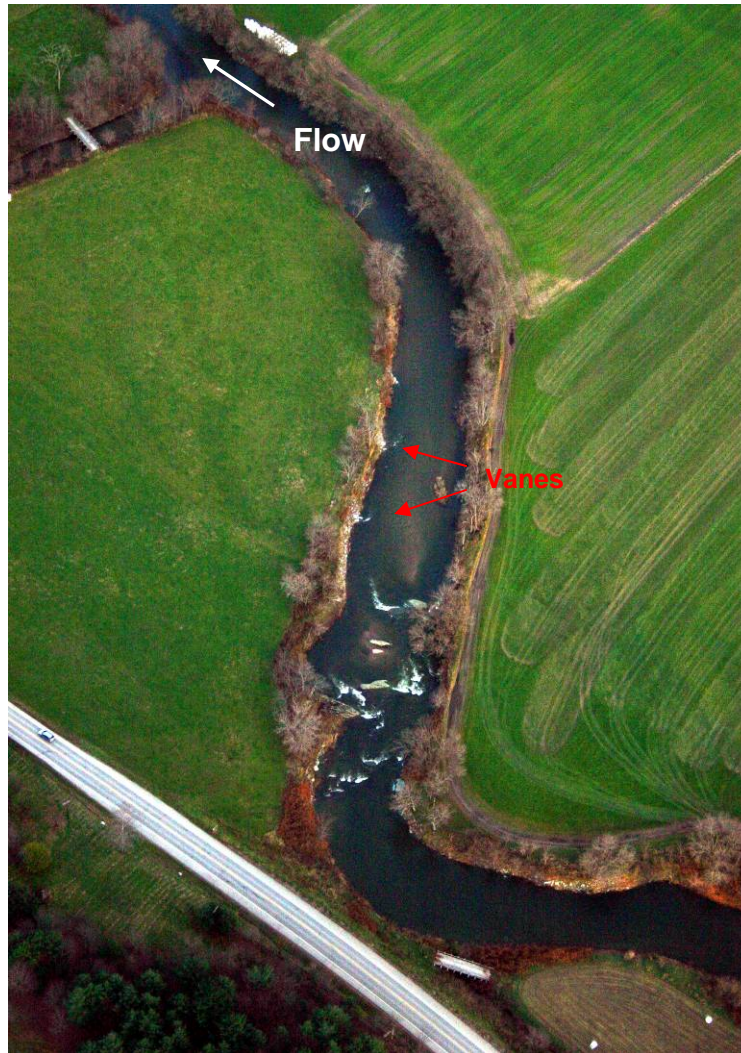
Three rock vanes or spur dikes were built along the left bank of the Mad River upstream of the Turner Farm near a location where, on past occasions including a 1998 flood, the river has gone out of bank to erode a large portion of an adjacent field (Figure 27). The designer's intention may have been to stabilize the bank in response to the 1998 flood, but because the vanes do not extend far enough out into the channel, or because they have been extensively damaged by ice or erosion, they did not appear to have much effect on flow patterns during an 2 November 2005 visit to the site (Figure 14). Tree scars in the vicinity of the project suggest that dynamic ice breakups occur at this site. It is unknown whether any of the overbank flow events and field erosion was ice jam related.

Figure 27. Mad River. Turner Farm vanes 11/2/05

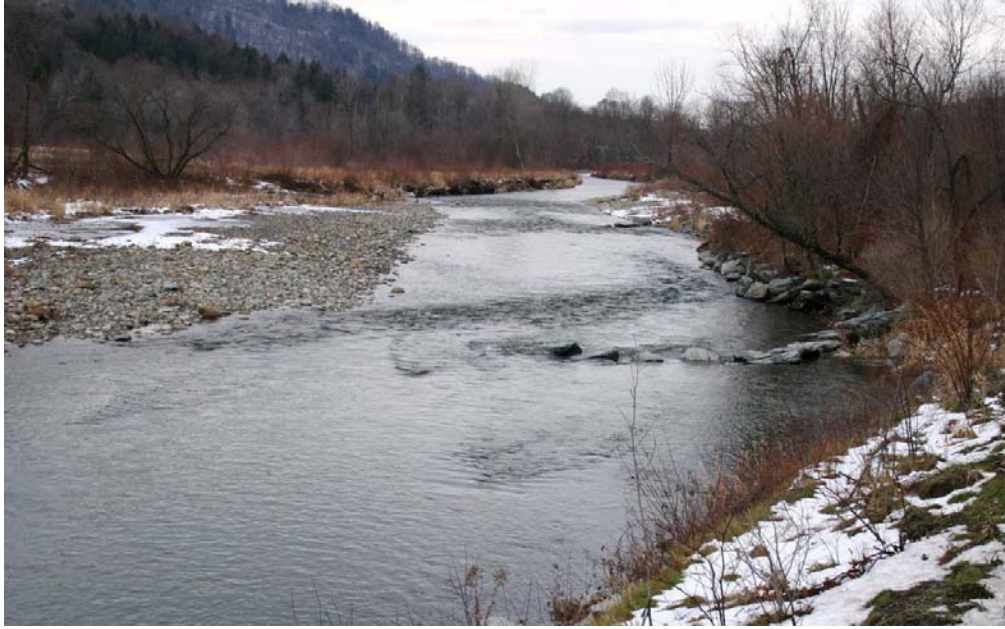
The project performed successfully for its first five years until an extreme flow event, on 17 October 2005, deposited a large volume of coarse bed material in the meander, causing a major avulsion into the blocked-off former channels to the right (Figures 30-34).

Figure 30. Cross vanes stabilize banks of channel diverging from Rt. 118 on the Trout River
11/28/05

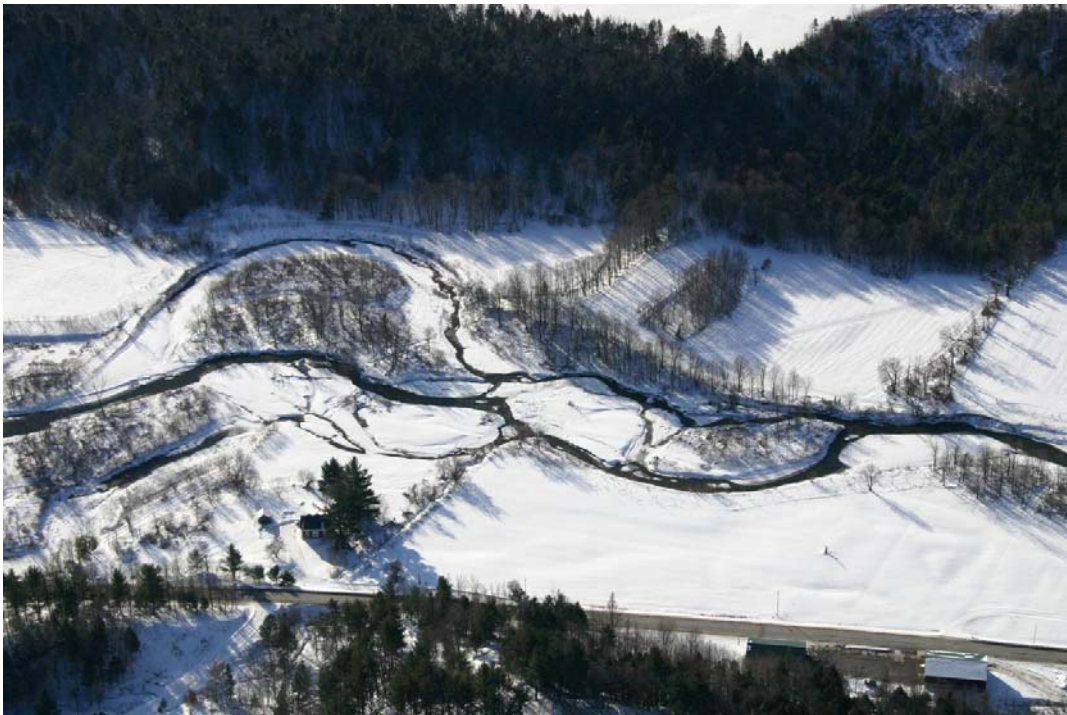
Being fairly far upstream in the watershed, it is not clear what role breakup ice events play in this section of the Trout River. Figure 35 shows a partial ice cover on the project reach on January 4, 2006. No evidence of

Figure 35. Ice forming on the Trout River restoration project below Montgomery Center on 1/4/06.

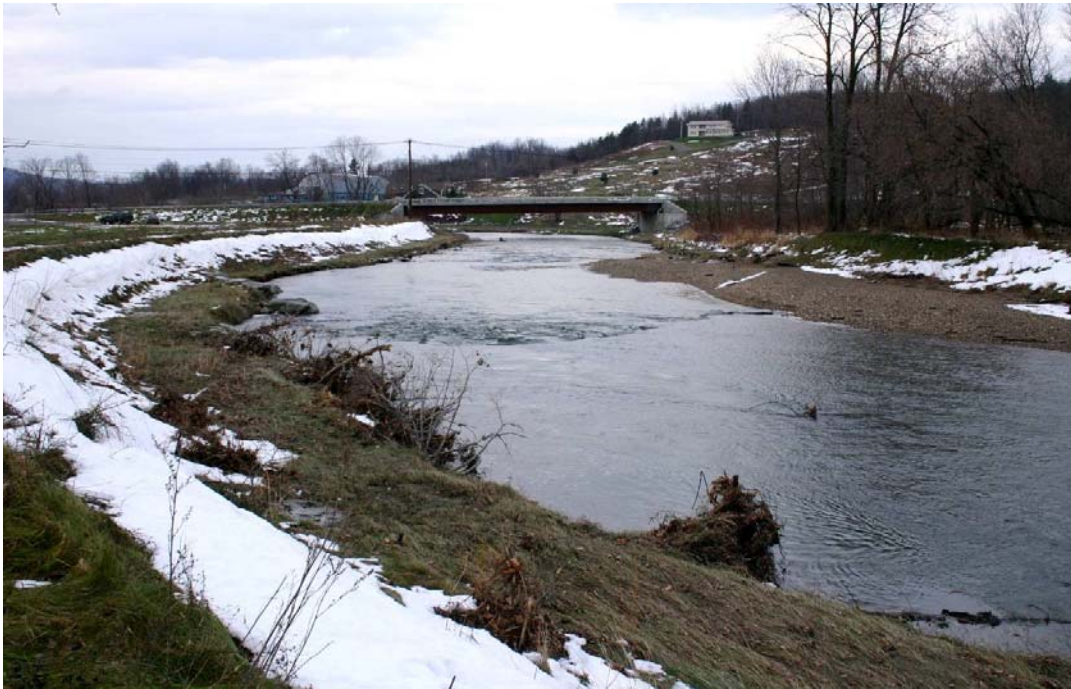
This river restoration project, completed in 2004, consists of a series of vanes, cross vanes, U-drops and rock riffles to control grade and direct the lower Trout River through a new bridge opening on VT Route 118 (Figures 36 and 37). Design and construction were overseen by the Vermont Department of Transportation (V-Trans). Root wads protrude from reshaped banks near the rock structures, and tree revetments were also installed at a few locations. Two rock riffles are located 300 and 1000ft. upstream of the bridge, consisting of four rows of large rocks. These help control grade, along with a series of U-drops and rock weirs. To the right of the restored channel, several channel blocks cut off a former flood chute.

Figure 36. Trout River looking downstream at a U-drop and rock riffles at the East Berkshire Bridge restoration project on 11/28/05.

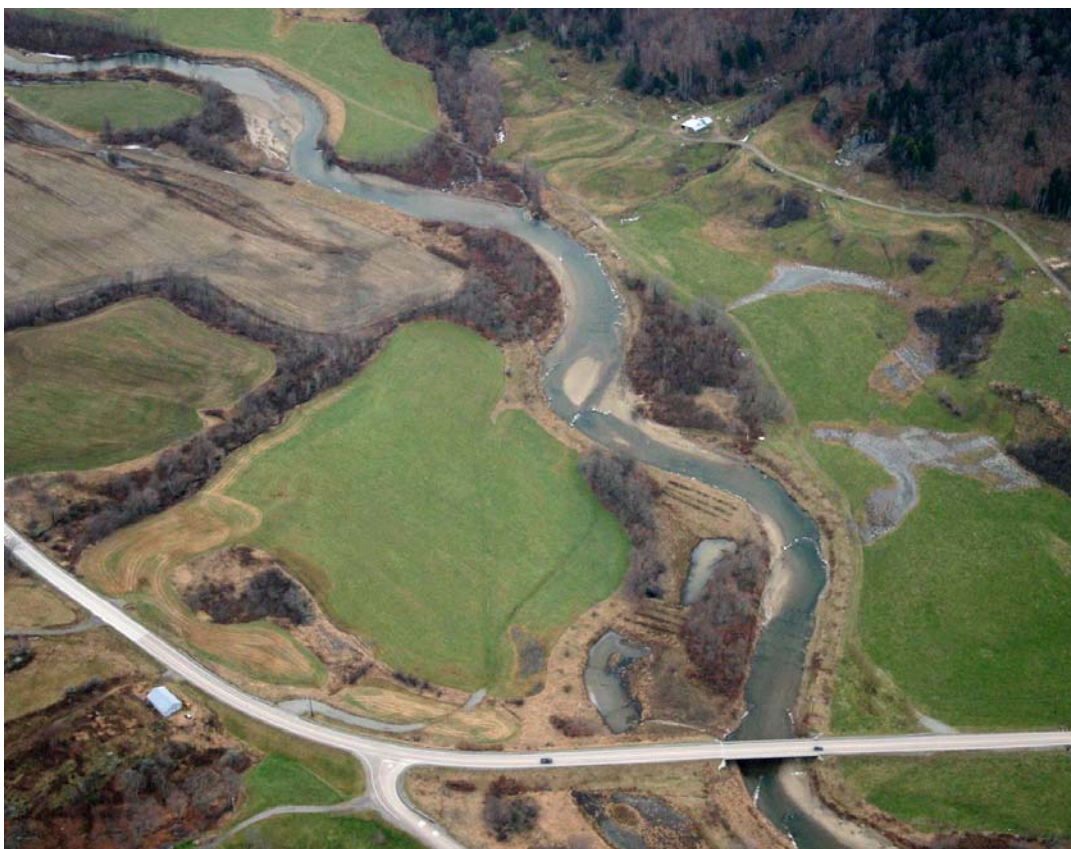
Figure 37. Trout River looking upstream at the East Berkshire Bridge restoration project on 12/3/08.

The structures were overtopped and the flood chute was accessed during the same high flow event that damaged the upstream Montgomery Center project in October 2005. However, no significant damage or deposition appears to have resulted. It may be that the East Berkshire Bridge project is better suited to withstand high flow events due to lower channel sinuosity and more equilibrium conditions in terms of bedload transport and deposition. Extensive grading and planting have been done on the left bank upstream of the bridge.

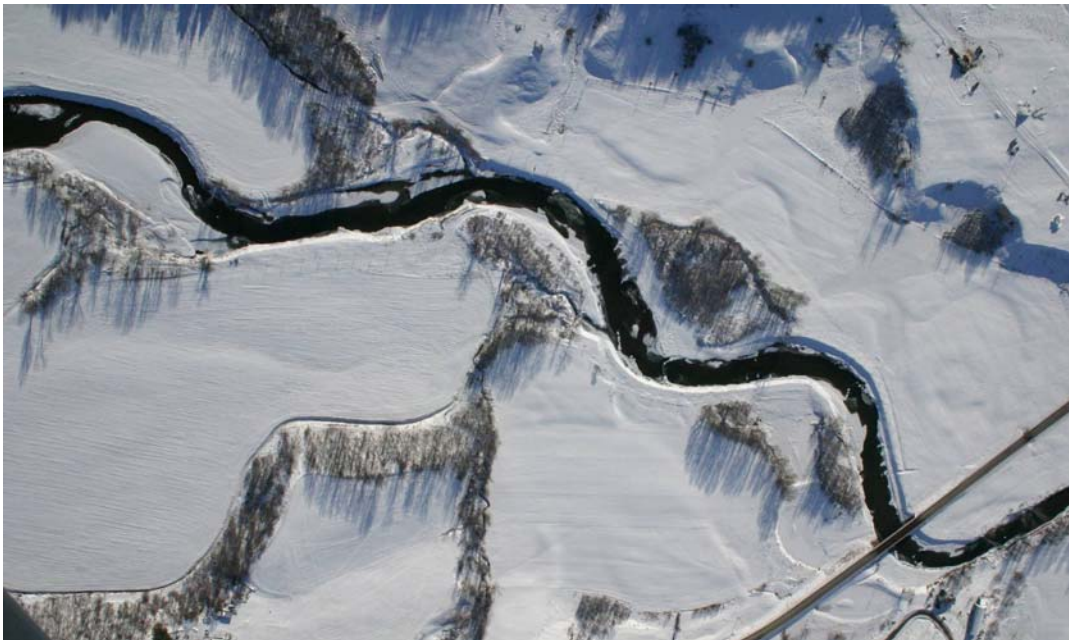
Other than enhancing the growth of border ice in the immediate vicinity of the structures, ice formation in the project reach appears to be very similar to ice growth in unaltered natural sections of the Trout River. Figure 38 shows ice starting to form on the limbs of the in-stream structures on January 4, 2006 and Figure 39 shows a more complete ice cover on the project reach on January 31, 2008.

Figure 38. Trout River looking at the East Berkshire Bridge restoration project on 1/4/06.

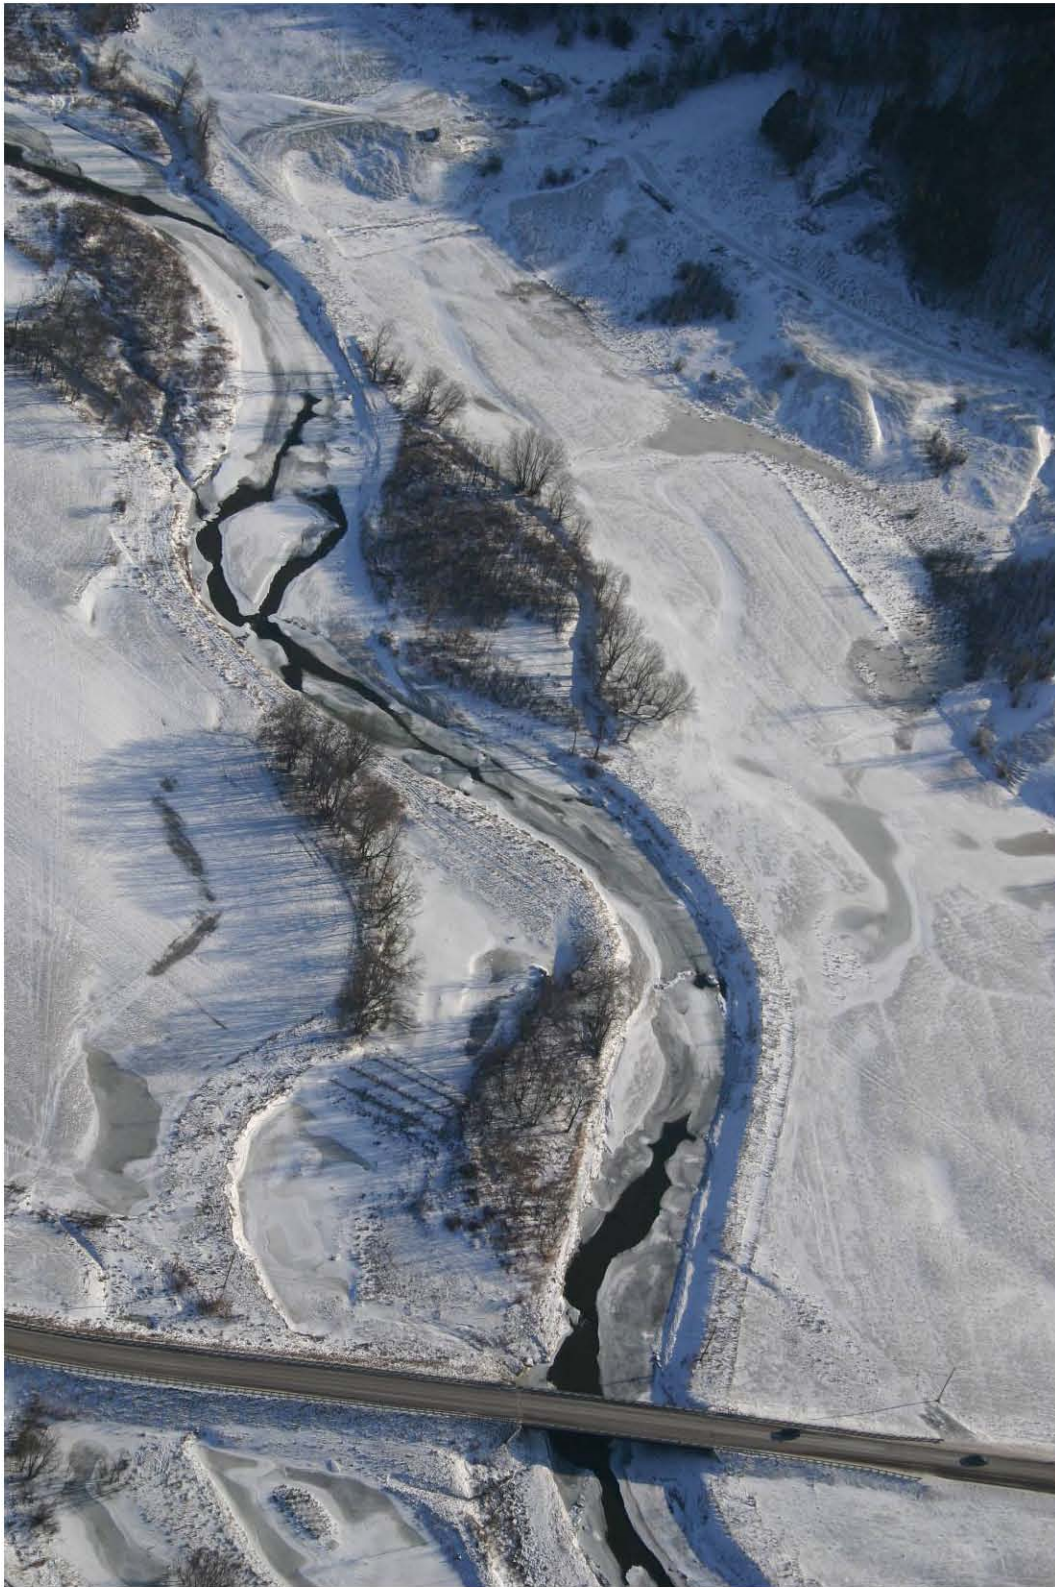
Figure 39. Trout River East Berkshire Bridge restoration project on 1/31/08.

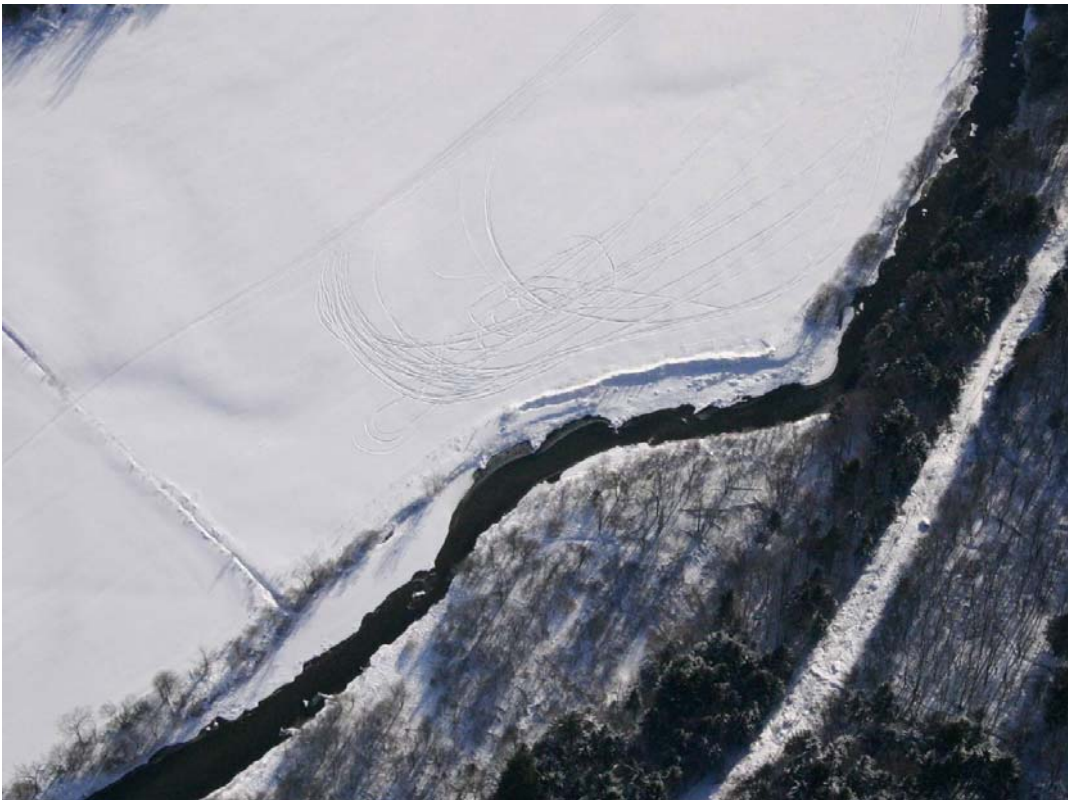
The downstream project, located above the village of Rochester, is similar, with vanes and cross vanes stabilizing the bank along the edge of a field (Figures 41 and 42). An earthen berm and a row of wooden posts have been constructed along the edge of the field with the likely purpose of preventing breakup ice from going out of bank during ice runs. The bank opposite the structures follows the edge of the valley and the structures appear to be resisting the natural tendency for the stream channel to cut the left bank and migrate into the field.

Figure 42. Ice forming around rock vanes in the White River above Rochester, VT, 12/21/05.
