## **Evaluation of Ultra High Molecular Weight (UHMW) Polyethylene Panels for Aircraft Arresting Systems**

E. Ray Brown

August 2009

Final report

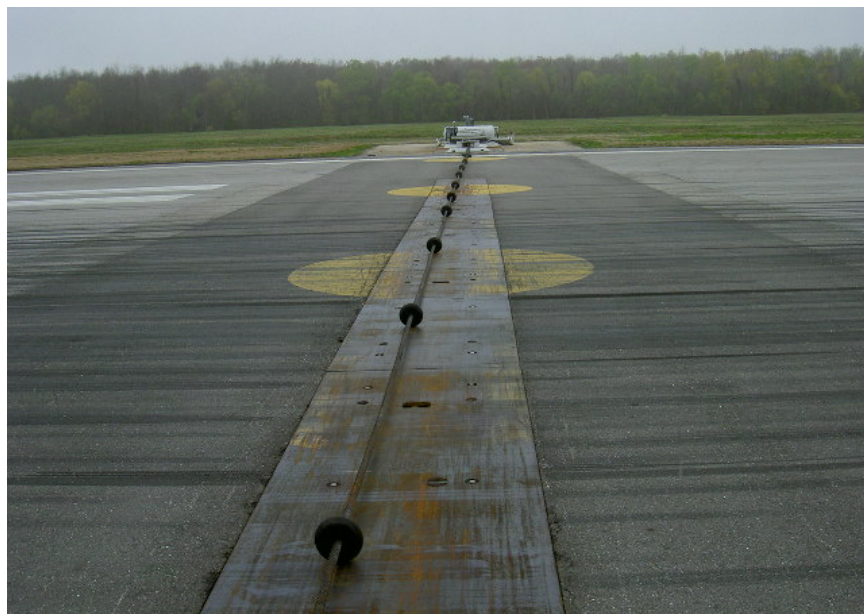
Figure 3. Use of steel plate at a Naval Base to protect pavement damage from cable.

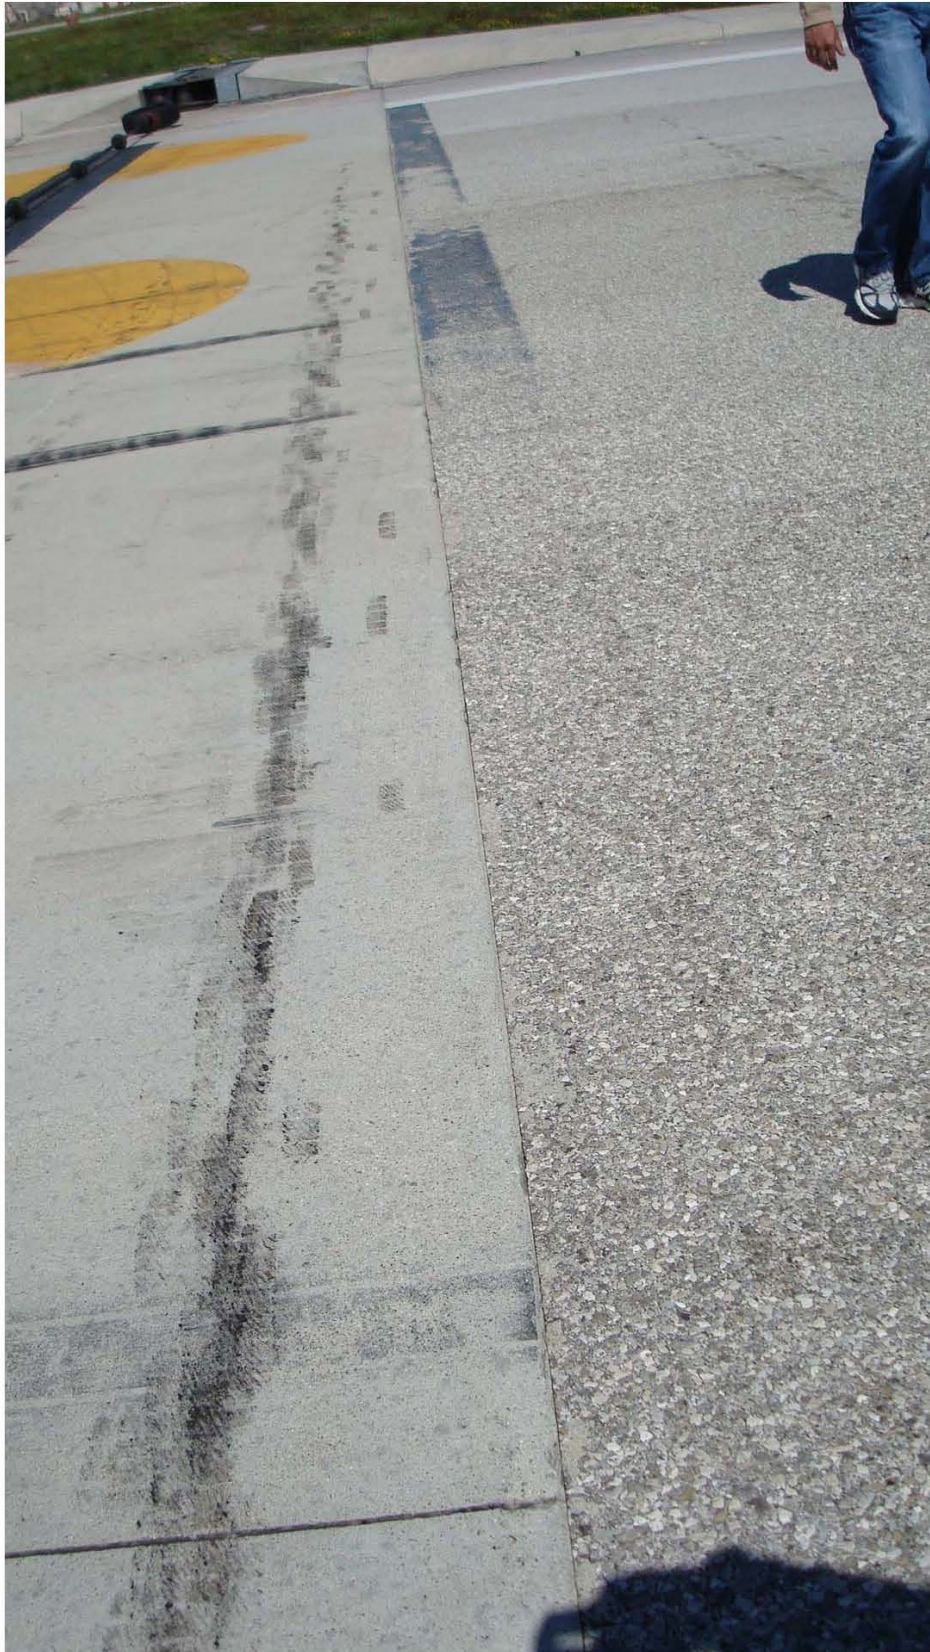
Figure 5. SMA mixture placed adjacent to concrete foundation for barrier panels at Aviano AB.

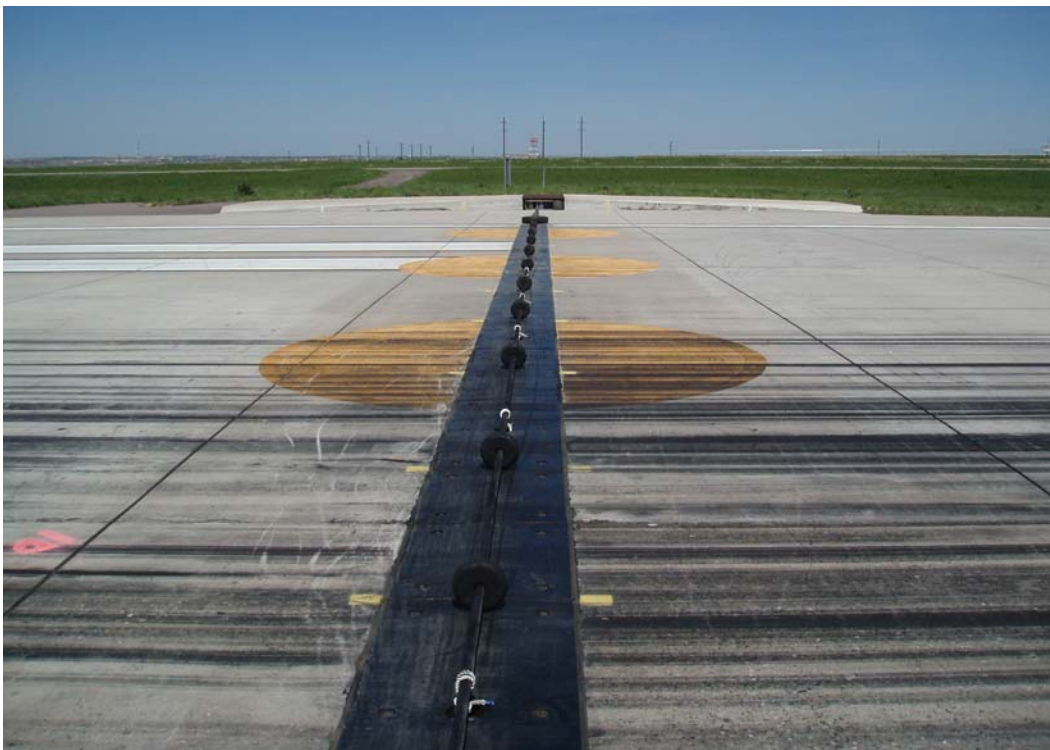
Buckley AFB was not visited as a part of this study, but some pictures (taken on May 8, 2007) were supplied showing the UHMW polyethylene panels (Figure 11) on this runway. While there was not much information about the panels as far as time placed, etc., there has been a significant amount of traffic using this runway. The panels appeared to be in good shape and vary in size from 2 ft wide by 2.5 ft long up to 2 ft wide by 5 ft long. The top of the panels appeared to be slightly lower than the adjacent pavement, as recommended.

Figure 11. Overview of UHMW polyethylene panels at Buckley AFB.

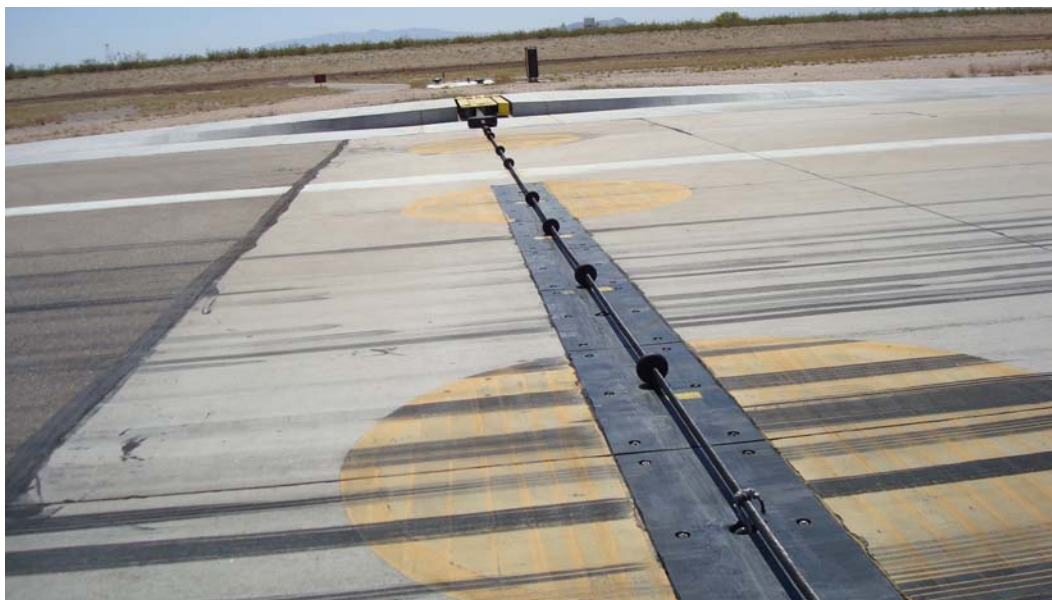
The panels at Davis-Monthan AFB were inspected on April 16, 2008. The barrier, which was constructed approximately 9 to 10 years prior to the inspection, consisted of panels placed in concrete with the concrete extending approximately 10 ft on one side of the panel and then changing to asphalt mixture (Figure 14). The concrete continued out past the recommended 200 ft on the opposite side of the barrier.

Figure 14. UHMW polyethylene panels at Davis-Monthan AFB within approximately 10 ft of change in pavement type.

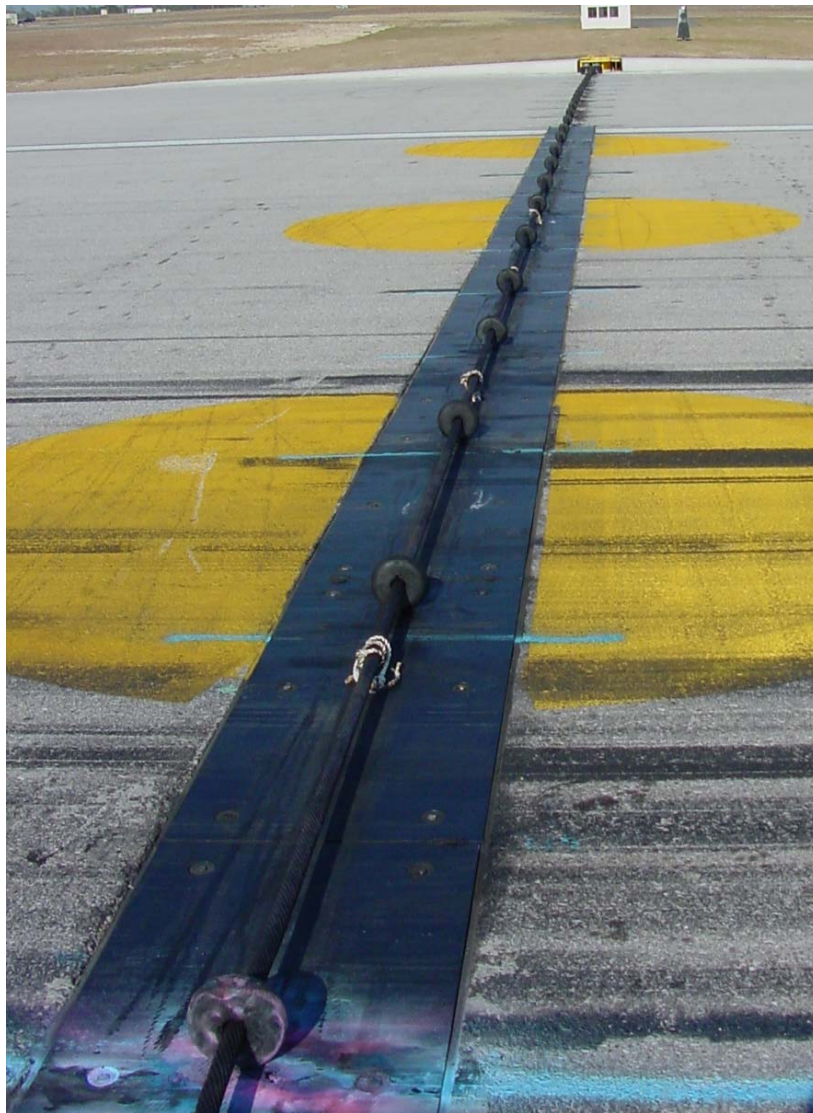
The panels at Eglin AFB are shown in Figure 18. The adjacent pavement is asphalt. The photo shown as Figure 18 was taken in January 2005 and was provided to ERDC for inclusion in this study. Based on the photo, there appears to be no particular problem with the adjacent pavement. There did appear to be some loss of asphalt mixture adjacent to the panels, but this appeared to be a minor issue at the time the photo was taken.

For the most part, the joint sealant appears to be in acceptable shape in this photo, but it is not known what type of sealant was used or how long it had been in place.

The size of the panels appears to be approximately 2 by 5 ft.

Figure 18. Overview of UHMW polyethylene panels at Eglin AFB.

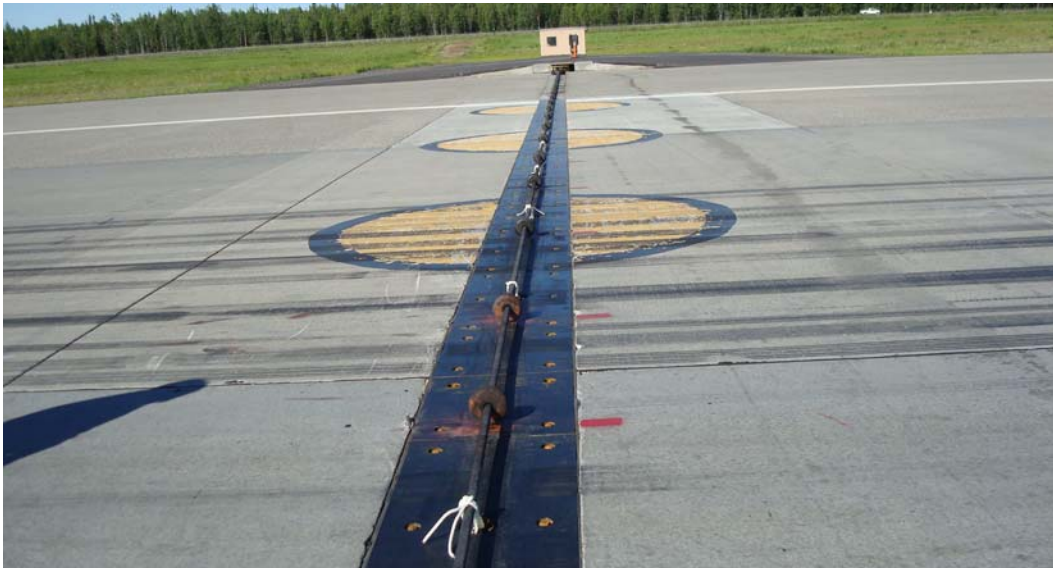
The panels at Eielson AFB were inspected on June 25, 2008. Each of the two arresting systems inspected consisted of panels placed in concrete with the concrete extending out over 200 ft in both directions (Figure 19). The panels on the south end of the runway were constructed in 2001, and the panels on the north end of the runway were constructed in 1995.

Figure 19. Overview of UHMW polyethylene panels at Eielson AFB showing concrete on both sides of the panels (south end of runway).

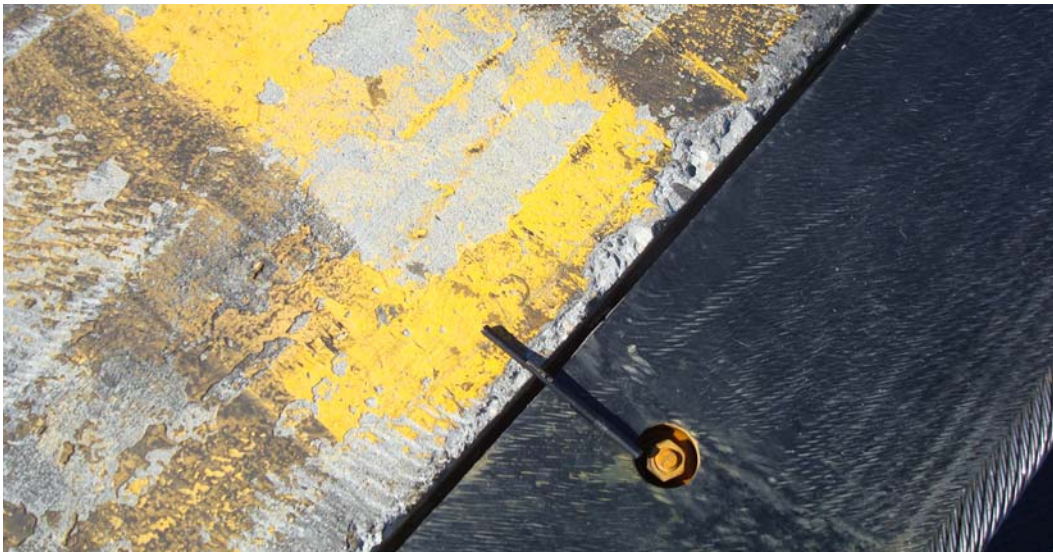
The joints had been sealed, but in many spots the sealant had been completely removed (Figure 20). Figure 20 shows some spalling in the concrete adjacent to the panels. This spalling was likely caused by snow removal equipment but could have been caused by incompressibles in the joints or by the cable beating against the concrete. In the best locations,

Figure 20. Loss of joint sealer between panels and concrete pavement (south end of runway) at Eielson AFB.

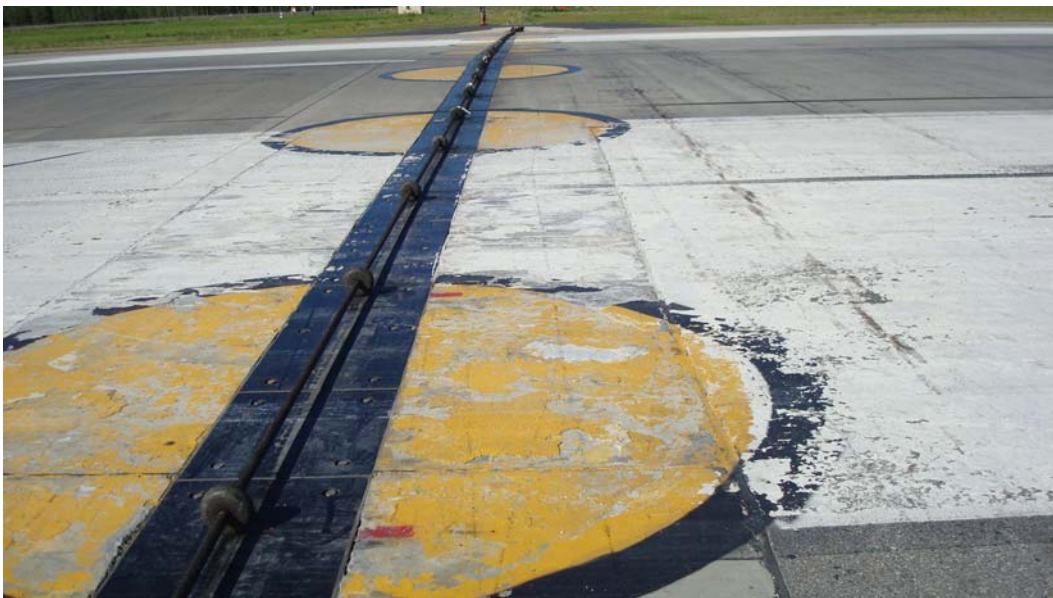
An overview of the panels on the north end of the runway is provided in Figure 22. Typical spalling of the concrete is shown in Figure 23.

Figure 22. Overview of UHMW polyethylene panels at Eielson AFB showing concrete on both sides of the panels (north end of runway).

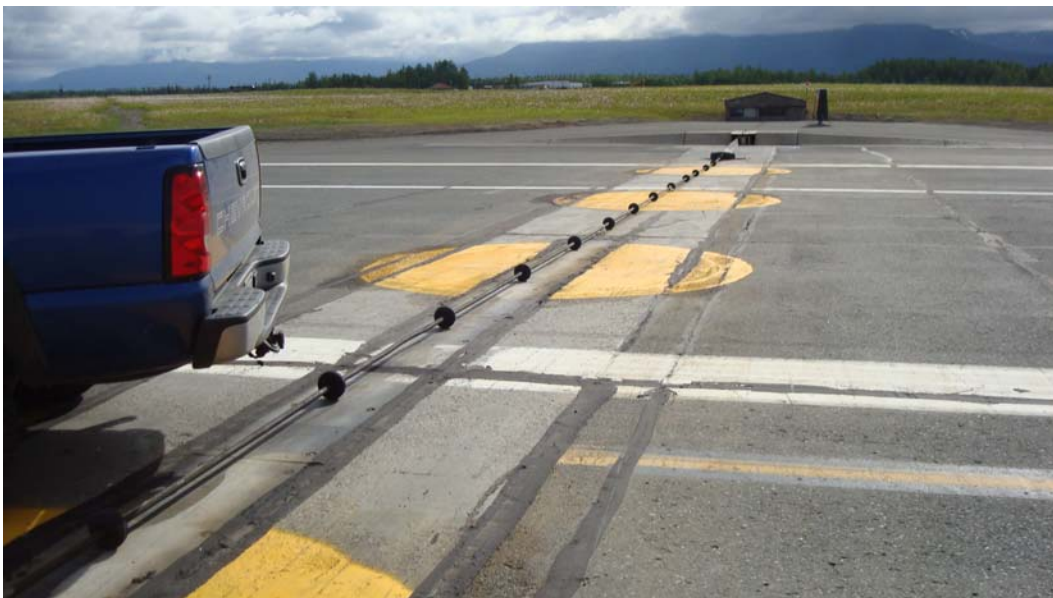
The pavement on Runway 34, which was 6 to 8 years old at the time of inspection, was in reasonably good shape (Figure 24). There was a strip of

Figure 24. Overview of UHMW polyethylene panels on Runway 34 at Elmendorf AFB.

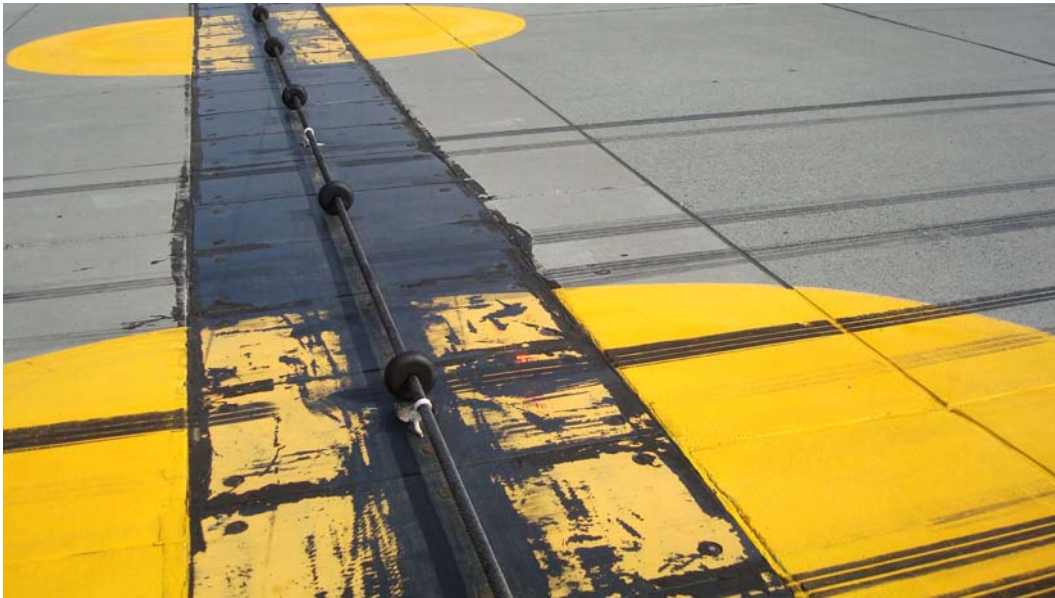
The barrier on Runway 06 had concrete pavement on both sides of the panels. The concrete was 3 to 4 years old. The panels were placed with the long dimension in the longitudinal direction (Figure 29). This is not the procedure recommended by the AFI. There did not seem to be any particular problem due to this orientation, but it does use much more of the expensive panels. In warmer climates, this will also likely cause much more expansion and warping problems.

Figure 29. Overview of panels on Runway 06 at Elmendorf AFB.

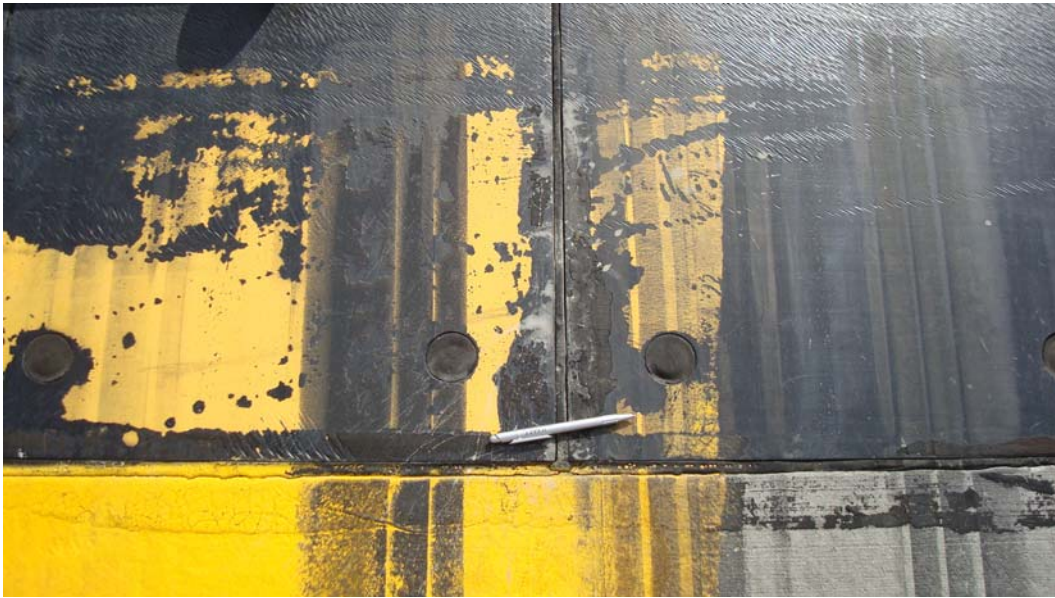
The condition of the adjacent pavement was very good, with only very minor spalling and some minor scarring of the surface due to action of the cable under traffic (Figure 30). The condition of the panels was good, with no particular problems. The sealant appeared to be intact for most of the joints (Figure 31), but there was some loss in bond between the sealant and the panels (Figure 32).

Figure 31. Sealant in reasonably good condition on Runway 06 at Elmendorf AFB.

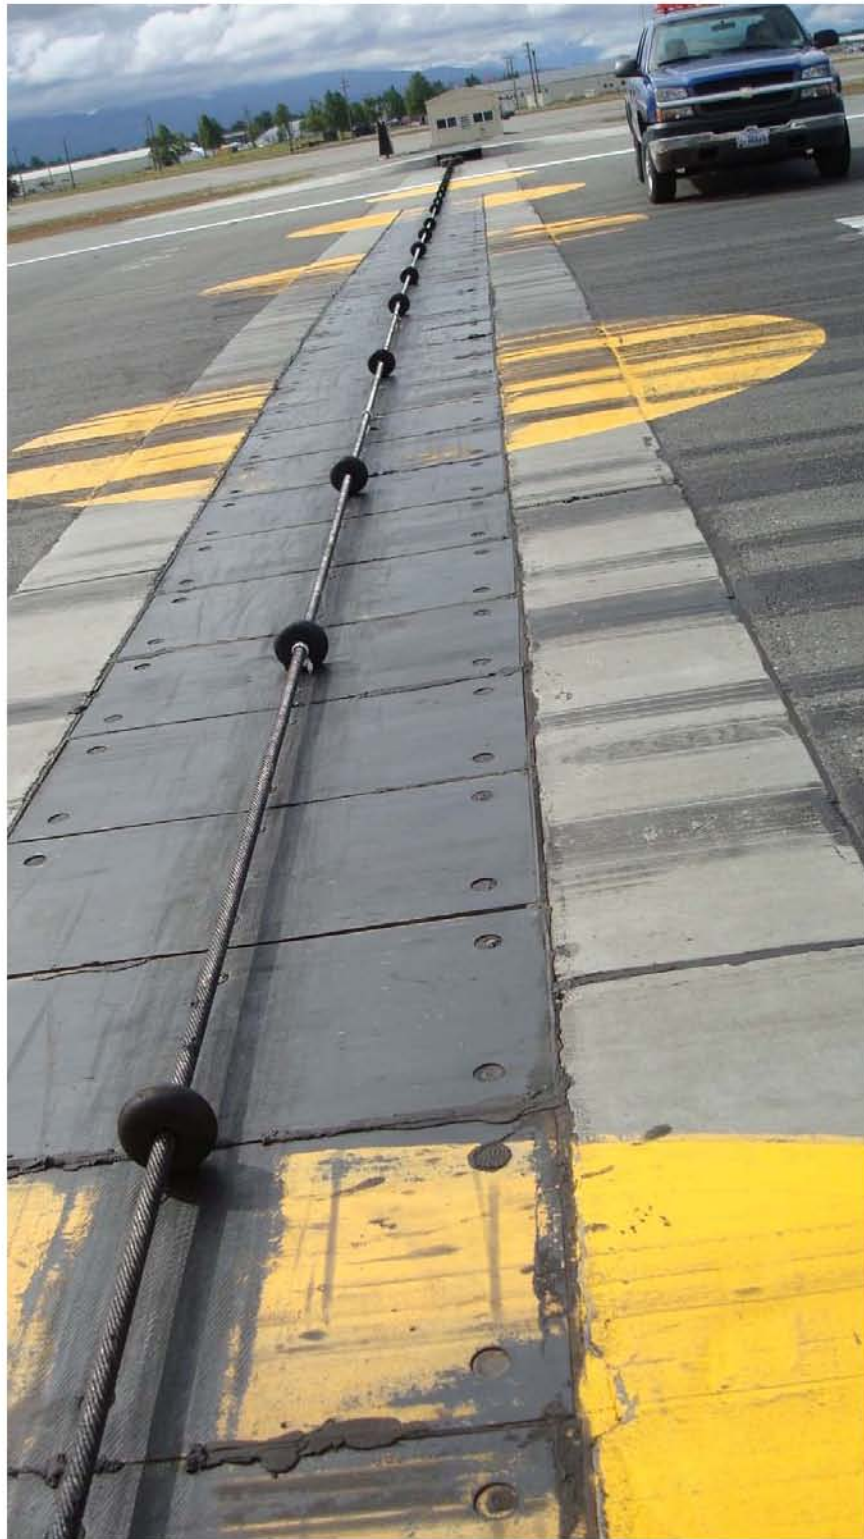
The 24 end of the runway had asphalt pavement adjacent to the barrier panels (Figure 33). There was a concrete strip on the surface on both sides of the panels. The width of the concrete strips appeared to be approximately 2 ft. There was some minor scarring of the concrete surface due to the action of the cable under traffic. There was some loss of aggregate in the asphalt mixture but no significant cracking.

Figure 33. Overview of panels on Runway 24 at Elmendorf AFB.

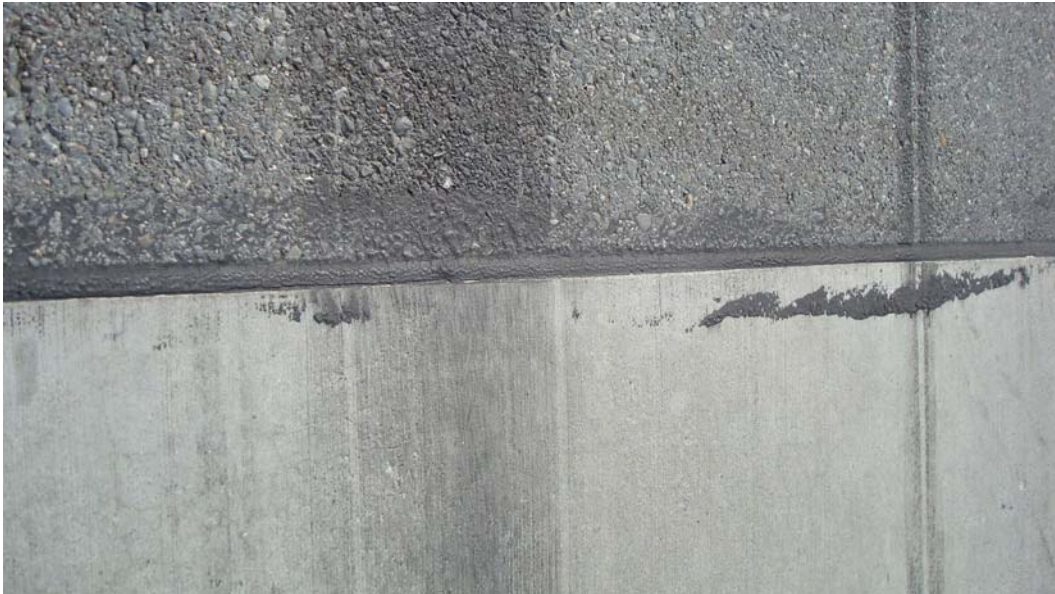
The panels appeared to be in good shape with no significant damage. The sealant between the concrete strip and the asphalt pavement appeared to be performing satisfactorily in much of the area but not well in others. The sealant between the panel and the concrete strip was not performing satisfactorily (Figures 35 and 36). The anchors had been sealed and could not be inspected. There was no evidence that there were any problems with the anchors.

Figure 35. Condition of sealant between the concrete and asphalt pavements was generally good on Runway 24 at Elmendorf AFB.

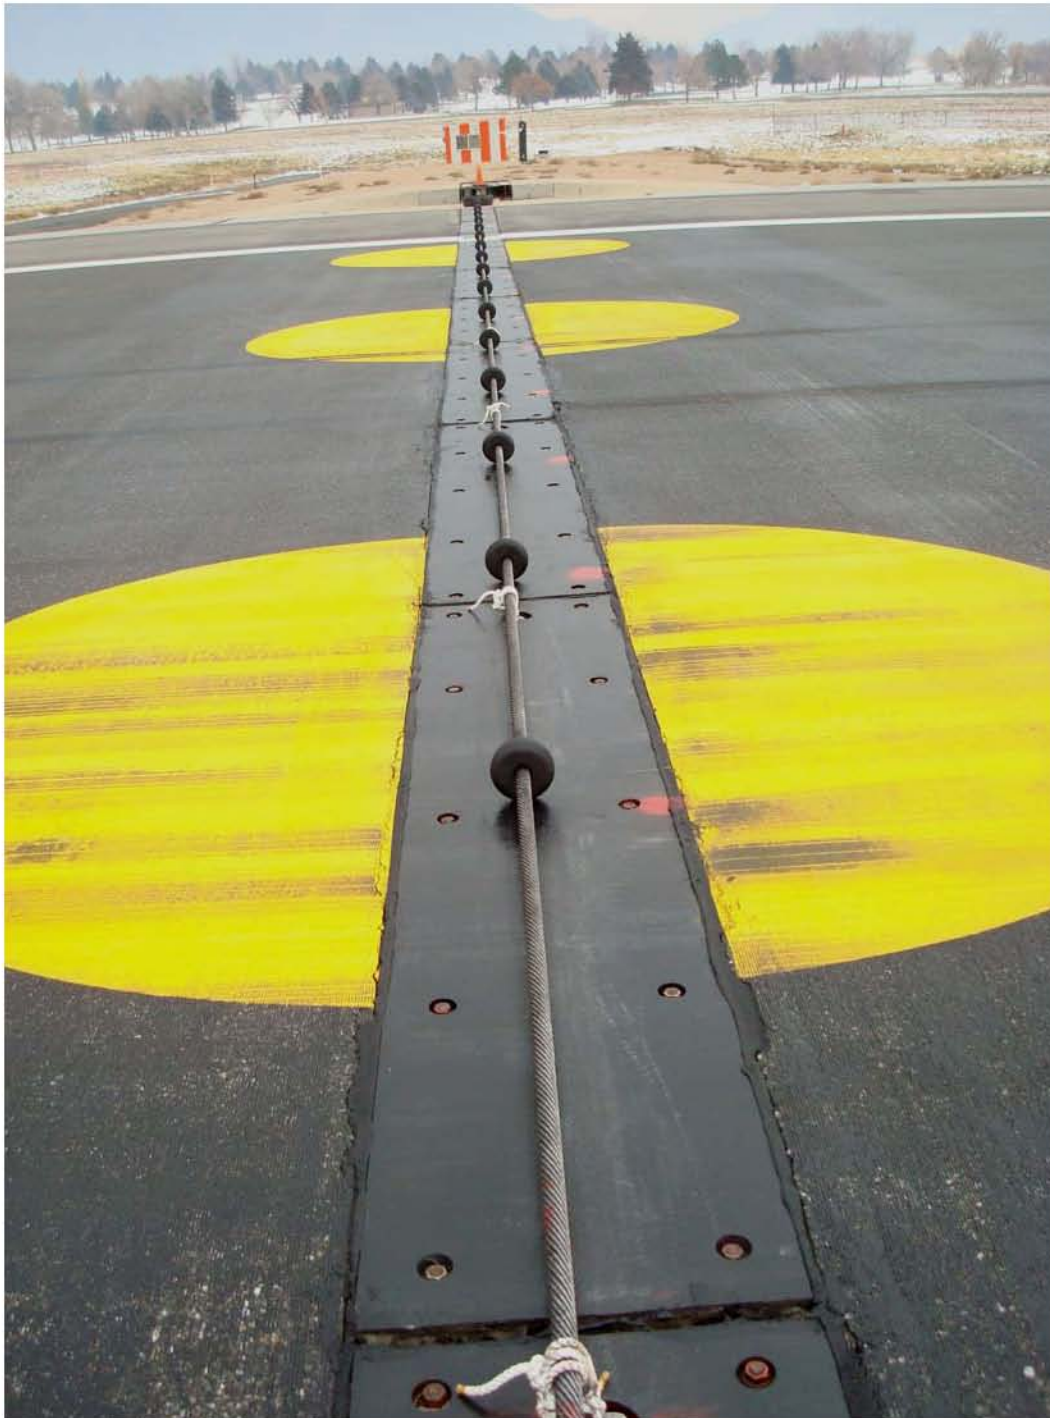
then replaced. The overall condition of the panels, sealant, and adjacent asphalt is shown in Figure 37.

The asphalt surface, which was only 2 years old at the time of inspection, was in good shape. Some grinding of the asphalt surface had been done adjacent to the panels to provide a smooth surface over the asphalt mix

and across the panels. The panels at this location were 2 by 10 ft, and the tie-downs were 10 ft apart. This length of panels exceeds that recommended by the AFI on cable systems.

Figure 37. Overview of panels on Runway 32 at Hill AFB.

The manual recommends that the length of each panel be 4 ft, but not to exceed 5 ft. The primary reason for this is that the longer panels will result in more warping, resulting in significant problems. Significant movement with temperature changes had occurred at the time of inspection, leaving a gap of over 1 in. between panels. The sealant did not bond very well to the panel edges. This has been a problem since these types of panels began to be used in the United States over 15 years prior to the preparation of this report and would be expected to be even a bigger problem with these long panels. The surface of the panels appeared to be slightly below the surface of the asphalt as recommended.

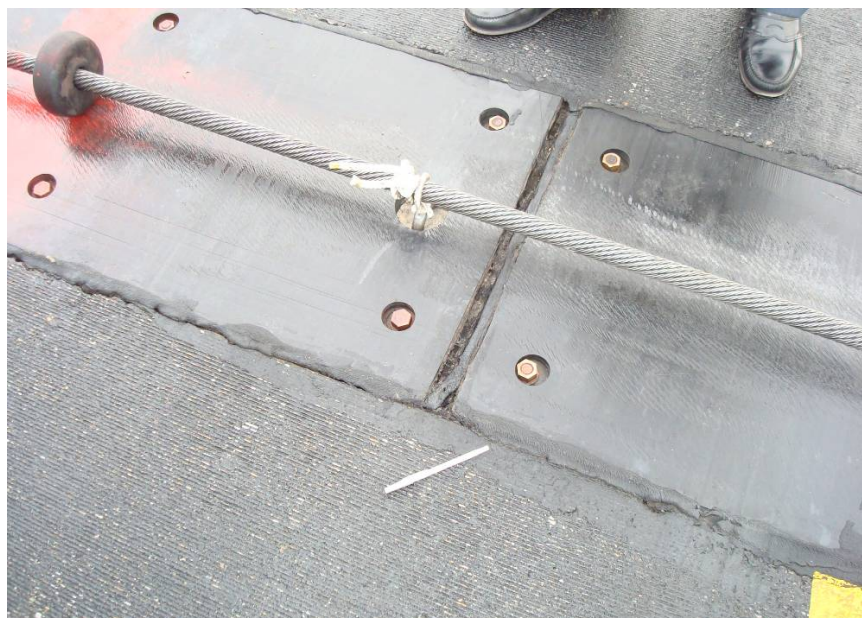
As shown in Figure 38, the condition of the asphalt was reasonably good adjacent to the panels. There was some breaking over of the asphalt, but at the time the panels were inspected, this was not a problem. The tie-downs are recommended to be placed no closer than 2 ft from the end of the panels, and it can be seen that it is much closer. There was no damage to the asphalt from the cable or hooks on the end of the runway in which the cable was being used.

Figure 38. Condition of panels, sealant, and adjacent asphalt at Hill AFB, Runway 32.

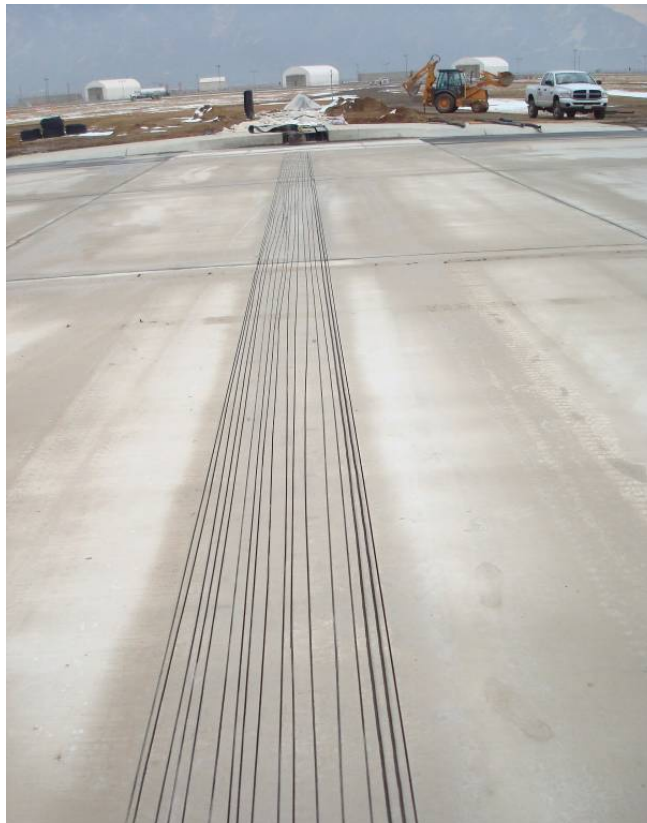
not been replaced. A trench was being cut in the concrete in the area in which the panels were going to be placed, as shown in Figure 39.

Figure 39. Saw cuts prior to removal of concrete for replacement of polyethylene panels on Runway 14 at Hill AFB.

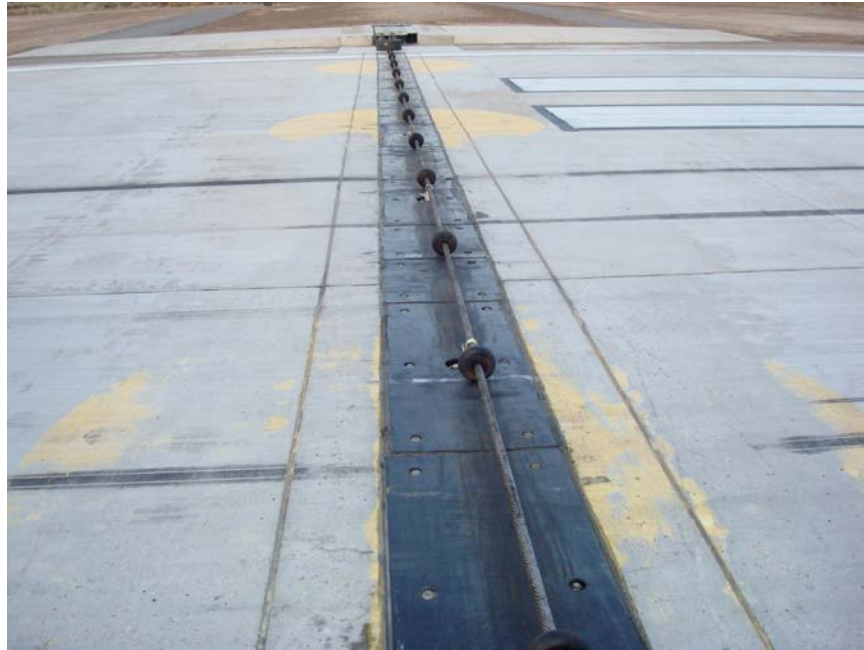
Photos of the panels on Runway 34 are provided as Figures 40 and 41. The concrete on this runway end was placed in 2005. The panels were also replaced in 2005. On this runway, the concrete adjacent to the panels was an extension of the concrete ends. This extension required that

Figure 40. Overview of barrier cable on Runway 34 at Holloman AFB.

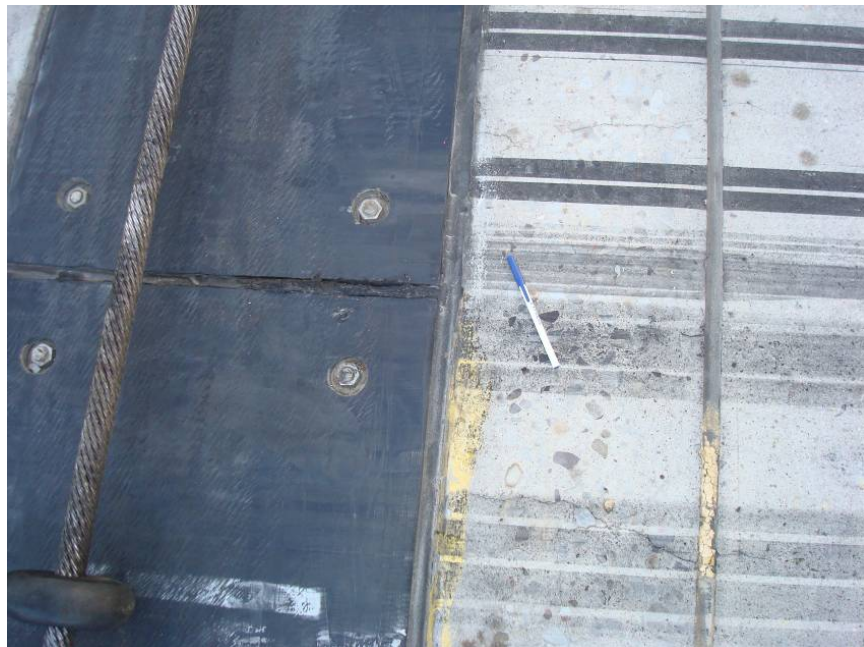
Figure 41. Condition of panels, sealant, and concrete on Runway 34 at Holloman AFB.

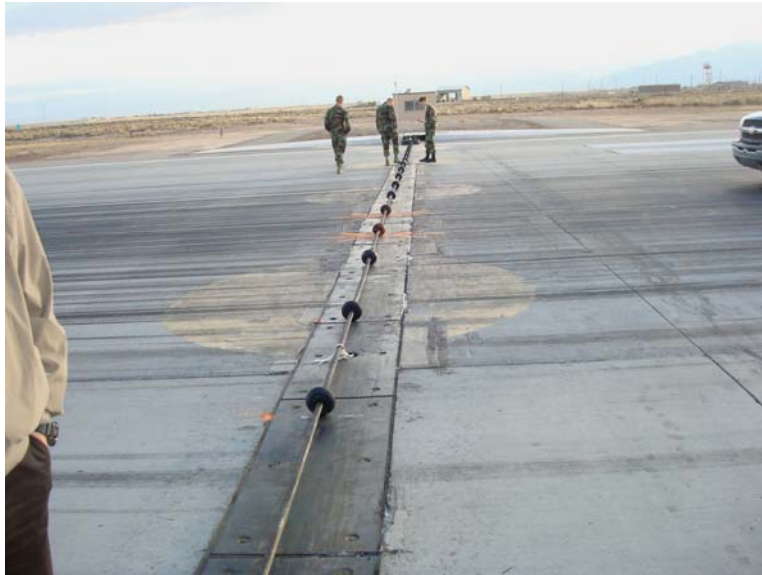
Figure 42. Overview of barrier cable on Runway 16 at Holloman AFB.

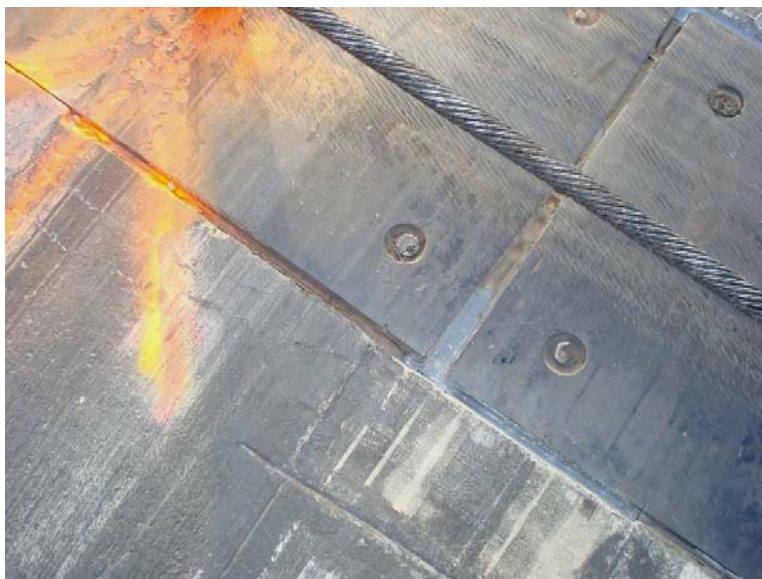
Figure 43. Condition of pavement, sealant, and panels at Runway 16 at Holloman AFB.

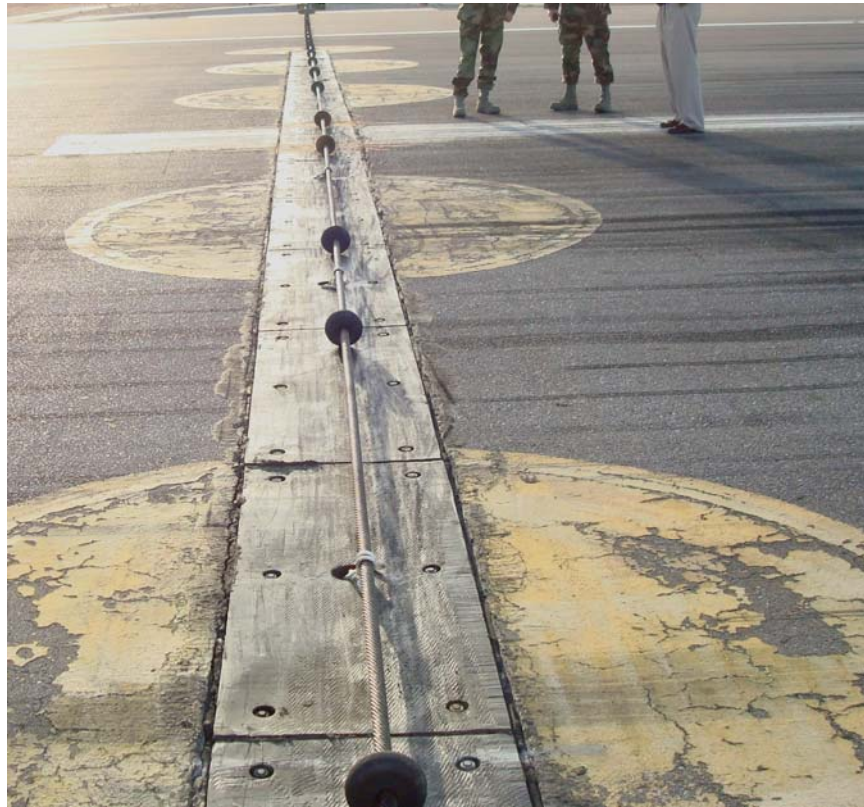
The asphalt and panels on runway end 22 were 12 years old (Figures 44 and 45). The sealant used on this project was a hot pour sealant (ASTM D3406 material). This sealant material was very stiff and was no longer effective in providing the resilience needed to perform as a sealant. Also, some silicone sealant had been used. This sealant was still flexible and able to tolerate the movement caused by temperature changes. There was some breaking off of the asphalt adjacent to the panels. The sealant had lost bond with the polyethylene panels and with the asphalt in some places.

Figure 44. Overview of barrier cable on Runway 22 at Holloman AFB.

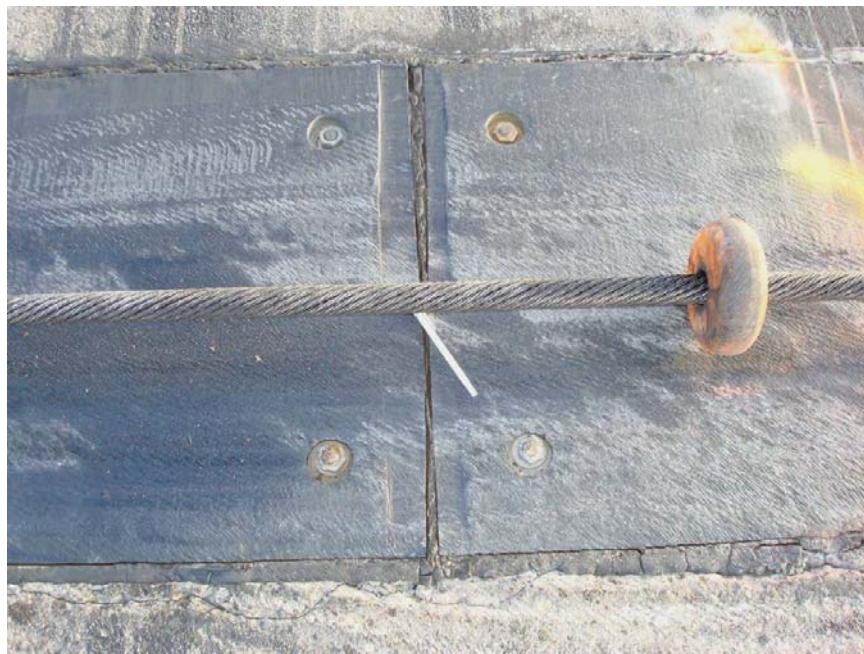
There were some pieces of asphalt in the sealant as a result of the asphalt edge being damaged. It is not clear if this damage occurred as a result of traffic or if it occurred as a result of being pulled apart by the sealant during cold weather as the joints opened. Certainly, some of the breaking

Figure 45. Condition of asphalt, sealant, and panels on Runway 22 at Holloman AFB.

of the asphalt edge was caused by traffic, since more breakage could be observed in the traffic areas than in other areas.

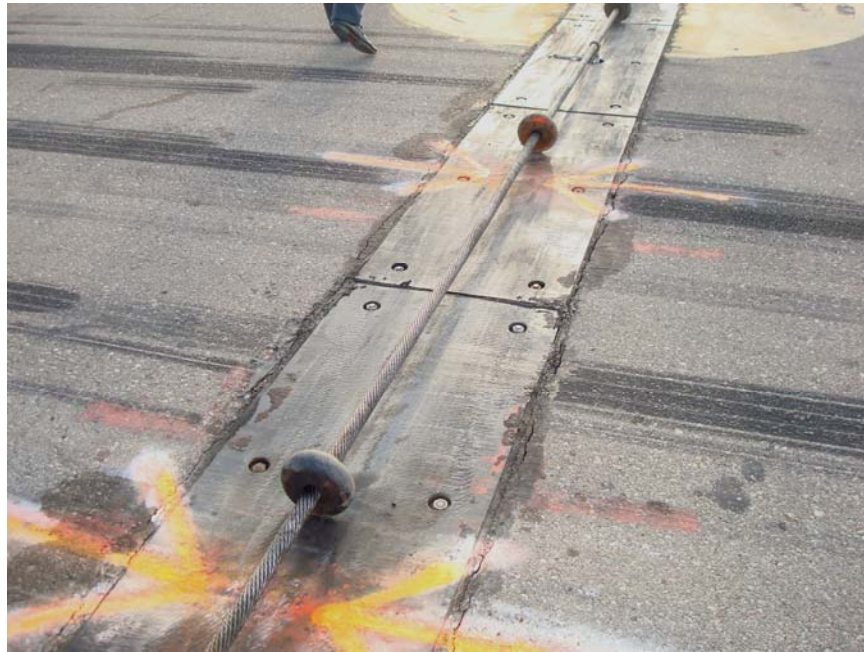
The age of the pavement and panels and the condition of the sealant, pavement, and panels on the 04 end was very similar to that on the 22 end (Figures 46 and 47). There was some warping of the panels, sometimes causing the edges of the panels to be higher than the adjacent pavement surface. The civil engineering staff at Holloman AFB made an effort to maintain the surface of the panels slightly below that of the adjacent pavement.

Figure 46. Overview of barrier cable on Runway 04 at Holloman AFB.

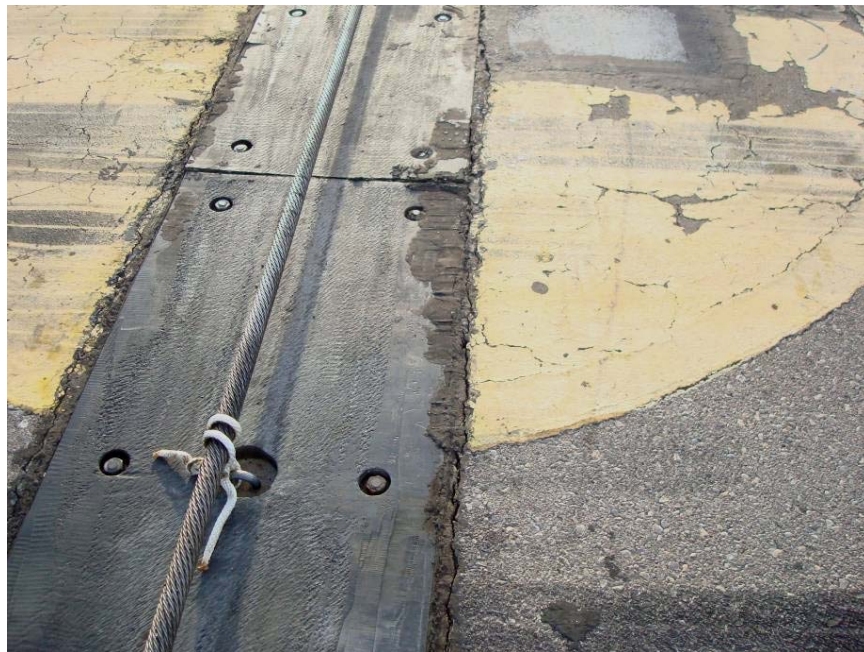
Figure 47. Condition of pavement, sealant, and panels on Runway 04 at Holloman AFB.

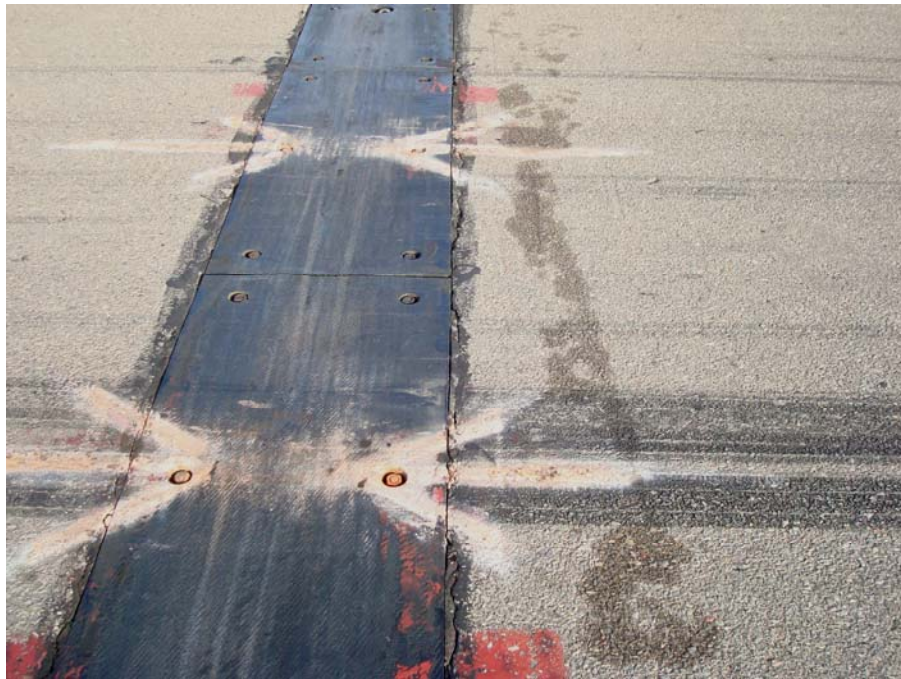
Figure 48. Overview of barrier cable on Runway 25 at Holloman AFB.

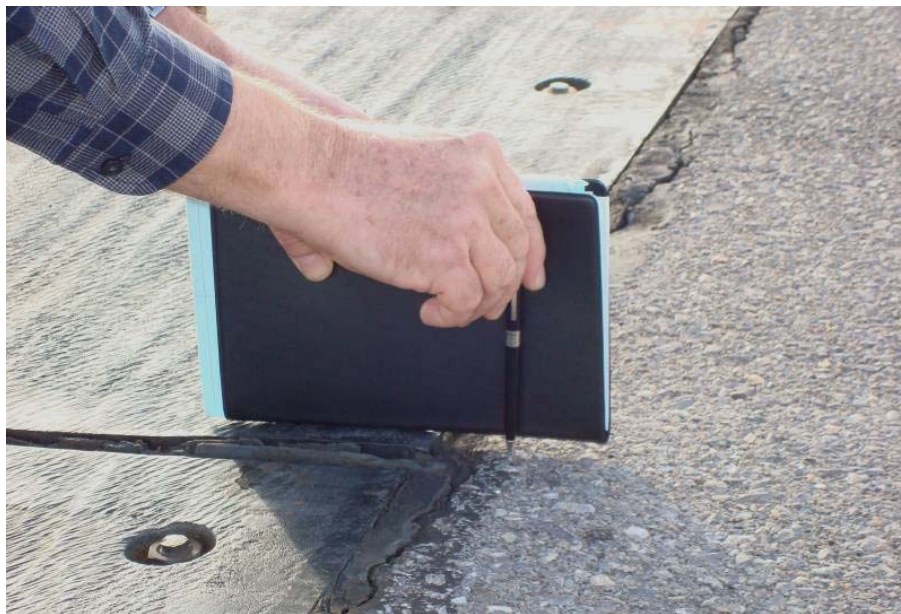
The condition of the asphalt that was placed on Runway 25 in 1996 was very good, except adjacent to the panels where some breakage of the edge had occurred. There was very little cracking and very little raveling, and the longitudinal joints were in very good shape as indicated by the fact that they were very difficult to see. The condition of the panels and adjacent sealant and pavement was very similar to that on Runway 22 (Figures 48 and 49). There was some significant warping of the panels, as shown in Figure 49. The joint sealant had lost bond in many cases, and there was some breakage of the asphalt adjacent to the joint.

Figure 49. Condition of pavement, panels, and sealant on Runway 25 at Holloman AFB.

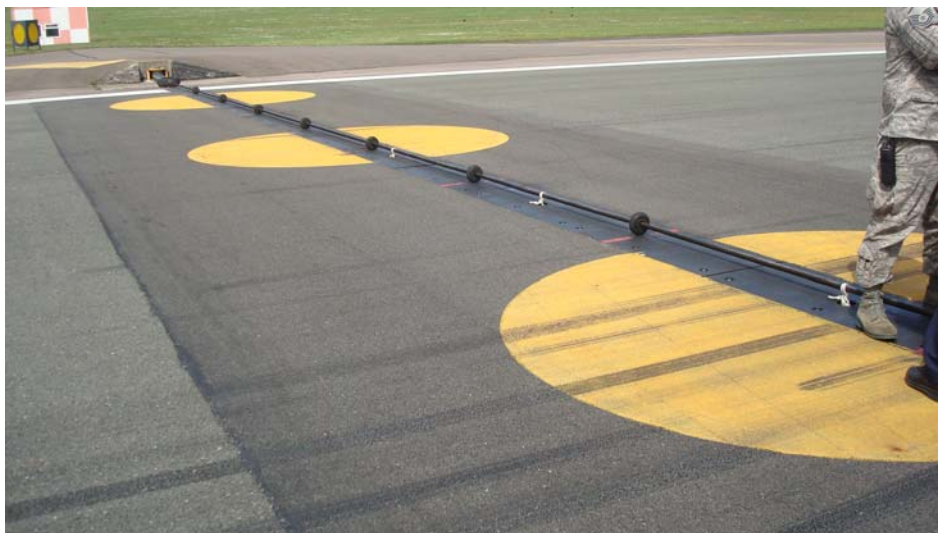
The pavement and panels at RAF Lakenheath were inspected on May 5, 2008. The pavement surface course was a porous friction course (PFC) that was about 15 years old. The panels were placed in 2007, so they were about 1 year old at the time of inspection (Figure 50). It appears that the

Figure 50. Overview of panels at RAF Lakenheath.

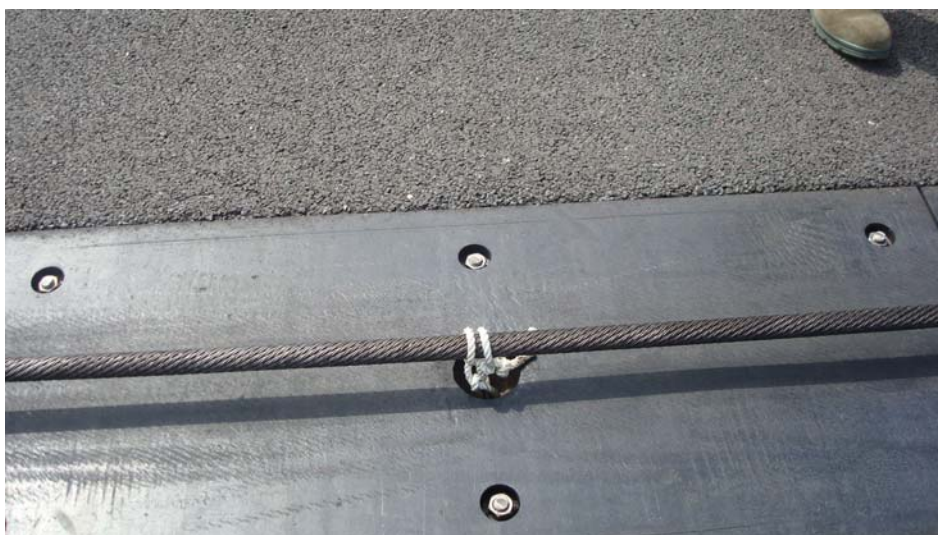
friction course was milled transversely for about 10 ft on each side of the panels. This was done to allow a transverse lane to be placed adjacent to the panels. The PFC immediately adjacent to the panels was placed when the panels were placed in 2007. The adjacent pavement was in very good shape (Figures 50 and 51), and the pavement outside this transverse strip of PFC was also in good shape especially considering that it was about 15 years old (Figure 52).

Figure 51. Condition of pavement adjacent to panels at RAF Lakenheath.
