## **Evaluation of Ultra High Molecular Weight (UHMW) Polyethylene Panels for Aircraft Arresting Systems**

E. Ray Brown

August 2009

Final report

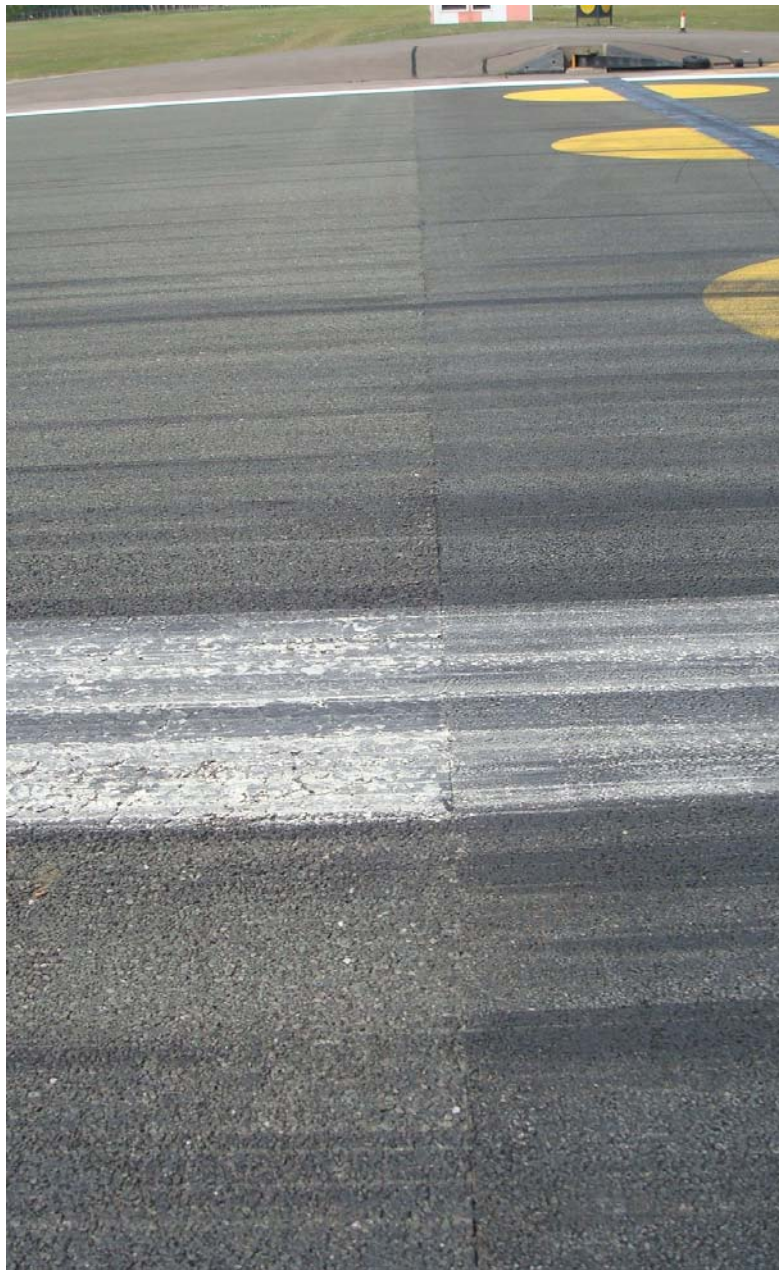
Figure 52. Condition of 1-year-old PFC and 15-year-old PFC at RAF Lakenheath.

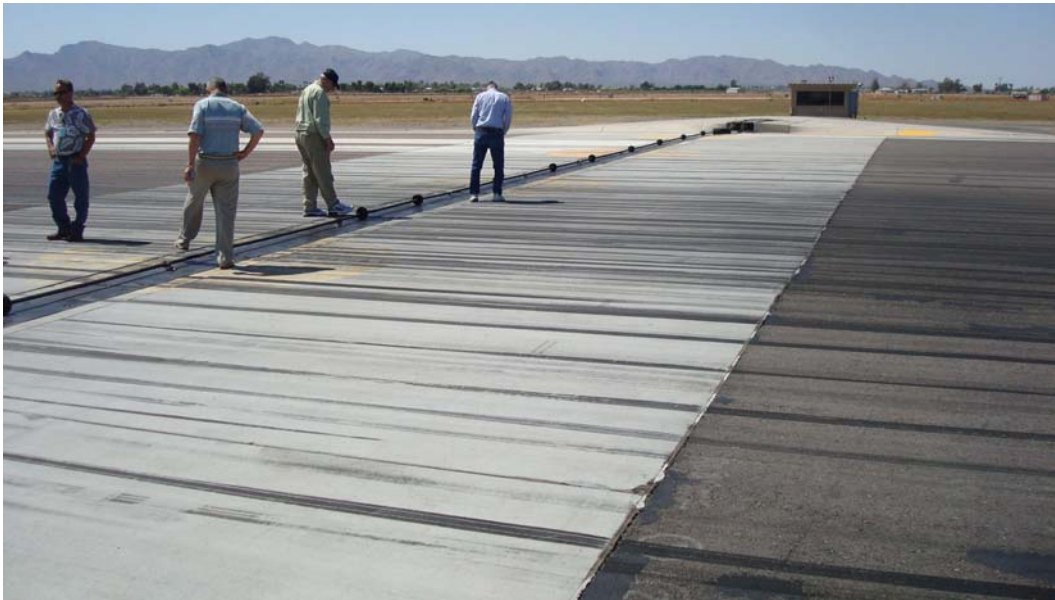
The pavement at Luke AFB, which was inspected on April 21, 2008, was in reasonably good shape (Figure 54). The pavement and panels were approximately 5 years old at the time of inspection. The two sets of barrier panels investigated were installed at the same time and had very similar characteristics. A concrete strip was constructed on either side of the barrier cable and extended out for approximately 20 ft. This is contrary to guidance specified in the AFI, which says that no change in pavement type should be made within 200 ft of the cables.

Figure 54. Overview of panels at Luke AFB.

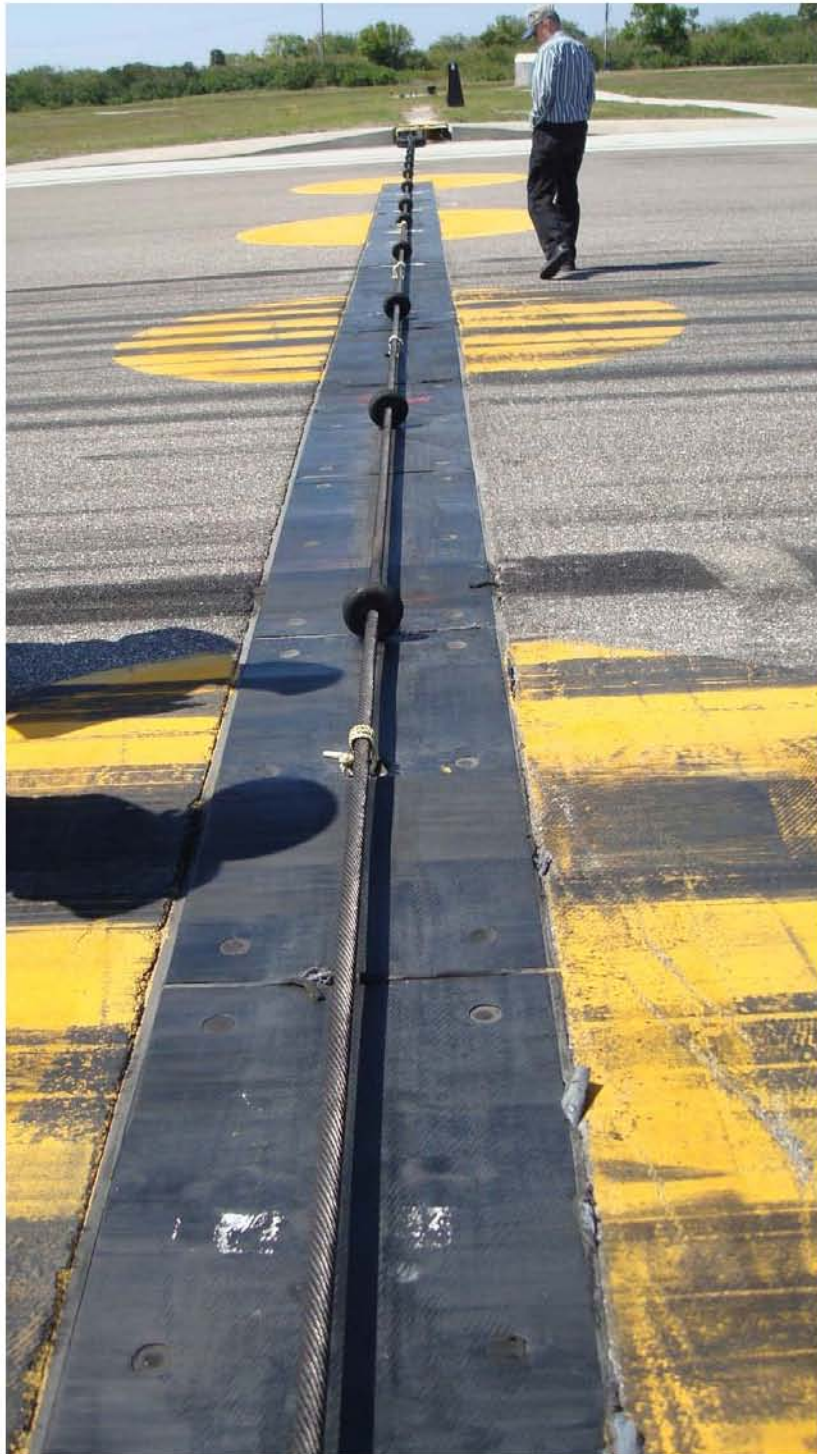
Figure 58. Overview of panels at MacDill AFB.

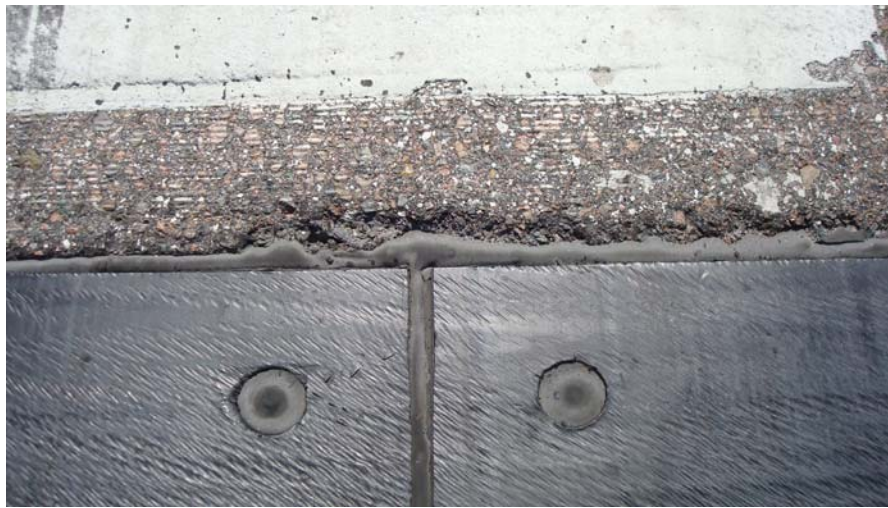
The condition of the pavement adjacent to the panels was satisfactory. However, the texture was open, and it appeared that some of the fines were lost with time. There was some loss of mix immediately adjacent to the panels, much of which was likely due to loss of aggregate during traffic. There was some grinding of the asphalt surface to make it more level with the panels (Figure 60). It appears that, here, the panels expanded in hot weather, pushing the asphalt mixture upward slightly, requiring that grinding be done to make it level.

Figure 60. Loss of mix adjacent to the panels at MacDill AFB.

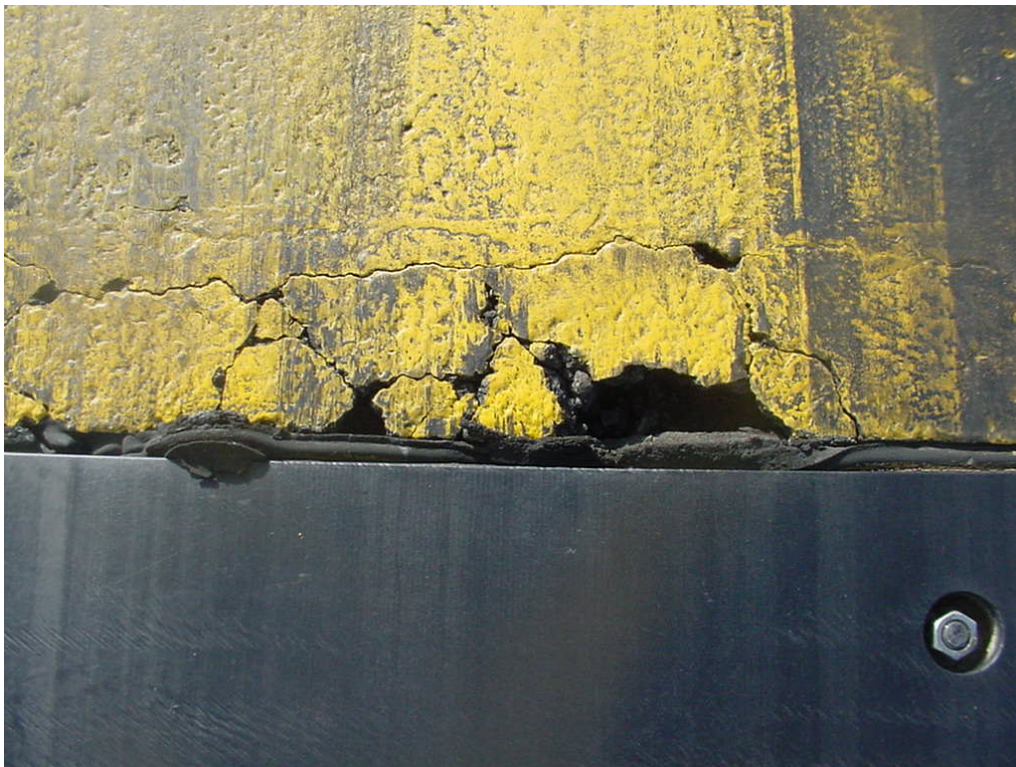
There was some loss of asphalt mixture adjacent to the panels (Figure 62). It appears that this material broke near the edge under traffic, resulting in the damage and loss of material.

Figure 62. Loss of asphalt mixture immediately adjacent to the panels at McChord AFB.

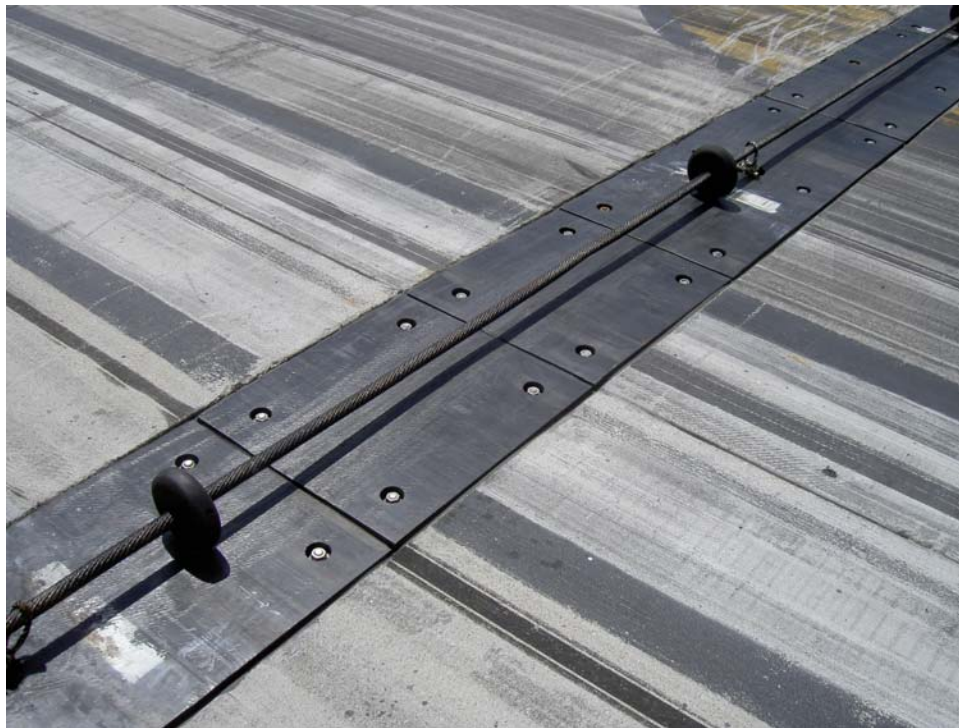
Selfridge ANGB was not visited as a part of this study, but photos of the panels at Selfridge were provided. An overview of the panels is provided in Figure 63. The panels appeared to be in good shape with some very minor spalling of the concrete edge. Generally, the bond between the sealant and the concrete and panels appeared to be good. The recesses in which the ends of the anchor bolts were located were not sealed. The ends of the anchor bolts appeared to be in good shape, with no significant corrosion or other problem. The panels generally appeared to be 2 ft wide by 2 to 4 ft long.

Figure 63. Overview of panels at Selfridge ANGB.

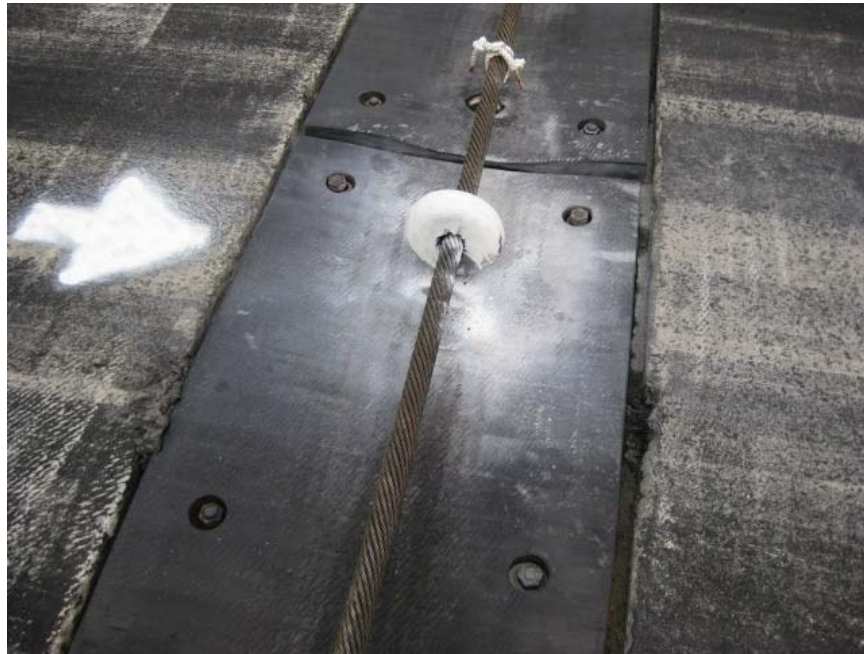
Seymour Johnson AFB was not visited as a part of this project, but photos of one barrier system there were provided. These photos were taken in January 2008. The panels were installed in a concrete pavement. The setting bed deteriorated over a period of time, resulting in the panels deforming near the middle of the panels (Figure 64). There are several reasons that the setting bed may have deteriorated, but one likely cause is water getting underneath the panels and exerting pressure on the setting

Figure 64. Deformed panels at Seymour Johnson AFB.

bed material under traffic. Another likely cause is that the quality of the setting bed may have been deficient. The recommended solution here is to remove the panels, remove and replace the setting bed, and then reinstall the panels. Some of the panels have been damaged and may need to be replaced before reinstalling. It also appears that there might be some wear near the middle of the panels, such as that observed on other projects.

It also appears from Figure 64 that the tie-downs were not located correctly in the panels. The guidance indicates that the tie-downs should be placed in the middle of the panels, but here it can be seen that the tie-down is within 1 ft of the edge and very near the anchors.

As shown in Figures 64 and 65, it is clear that the sealant has not performed satisfactorily. There was no sealant in the recesses around the anchors.

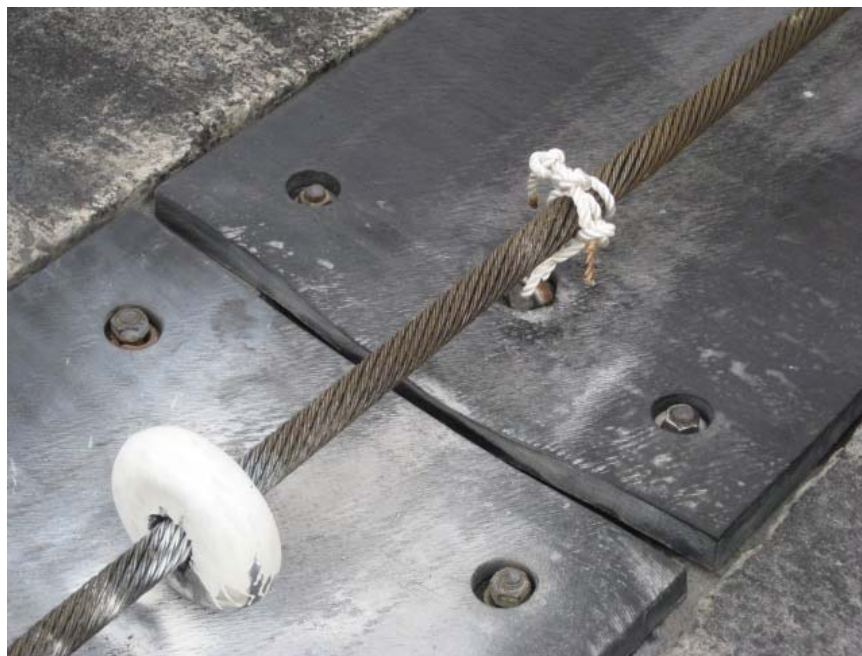
Figure 65 appears to show one or two anchors sticking up above the top of the panels. This may have been caused by the panels deforming as a result of deterioration of the setting material or may be caused by some other reason. If the anchors do stick up above the panels, they should be ground down sufficiently to keep them below the panel surface.

Figure 65. End of anchor sticking up near top of panels at Seymour Johnson AFB.

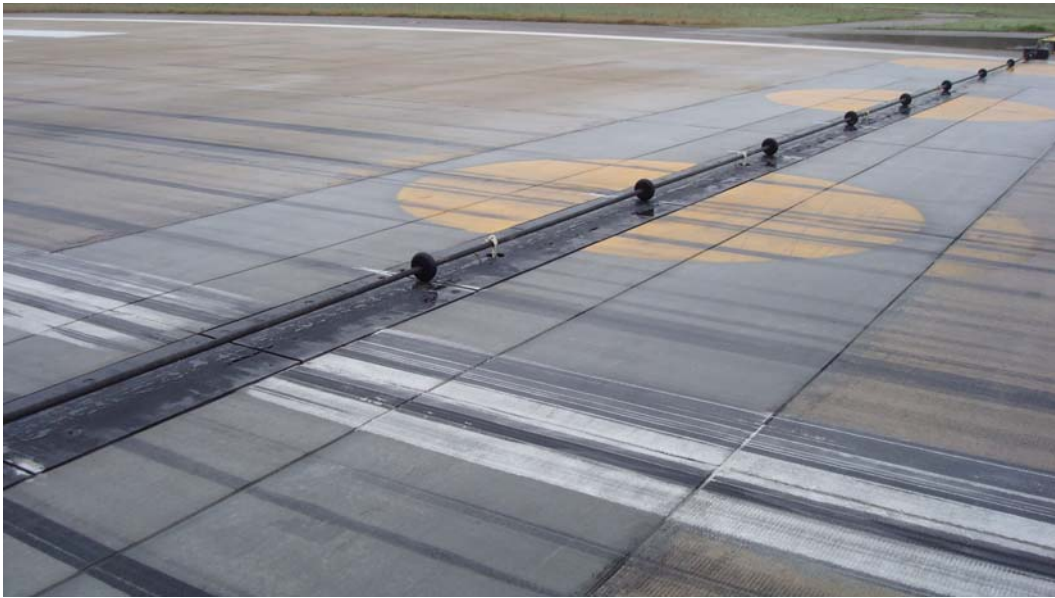
At Shaw AFB, four areas having arresting cables were inspected on April 4, 2008. An overview of the panels at the 22 end of Runway 22 R (right) is provided in Figure 66. The adjacent pavement is concrete. It appears that a section of concrete approximately 15 ft wide was removed and new concrete placed in which to construct the barrier system. The top portion of the concrete in the middle of the new concrete slab was then removed approximately 2 ft wide and deep enough to allow for the setting bed and the panels to be placed. The panels were generally 2 by 4 ft.

Figure 66. Overview of panels on Runway 22 R at Shaw AFB.

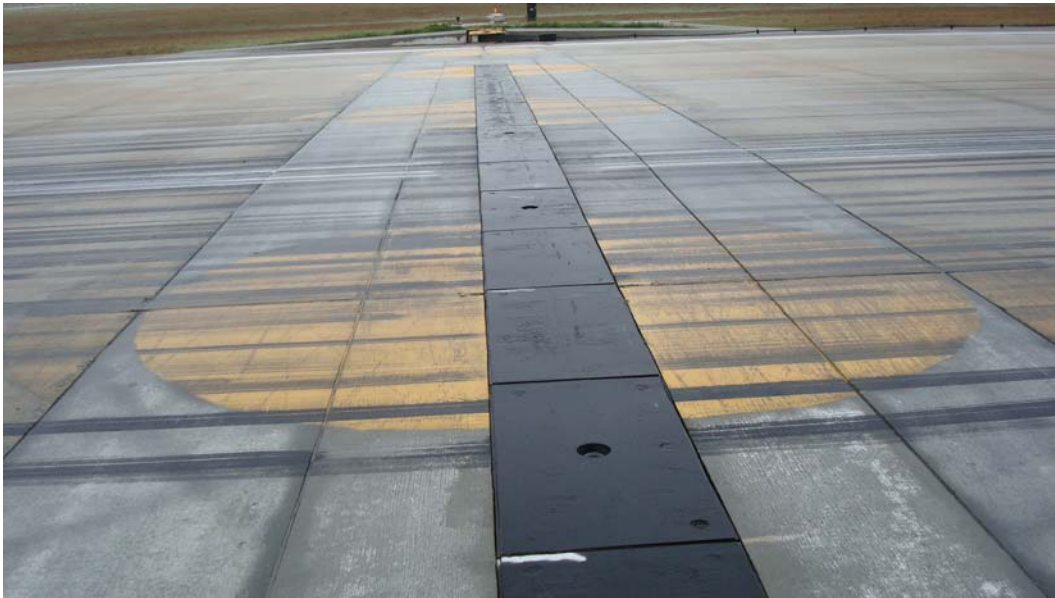
The panel system at the 4 end of Runway 22-4 R was approximately 15 months old at the time of inspection. The adjacent pavement was concrete. An overview of the cable system is shown in Figure 69. At the time of inspection, the cable had been moved off the runway.

Figure 69. Overview of panels at Runway 4 R at Shaw AFB.

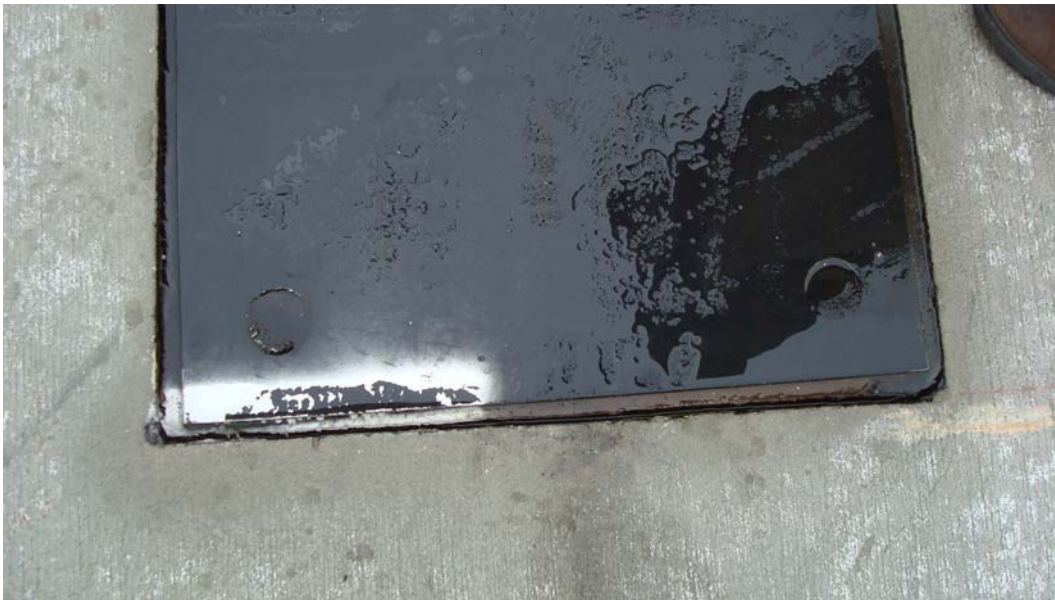
The sealant had pulled away from the concrete but still appeared to be intact as a result of the keyway in the panels (Figure 70). The joints in the panels did not always match the joints in the concrete (Figure 71).

Figure 70. Sealant pulled away from concrete at Runway 4 R at Shaw AFB.

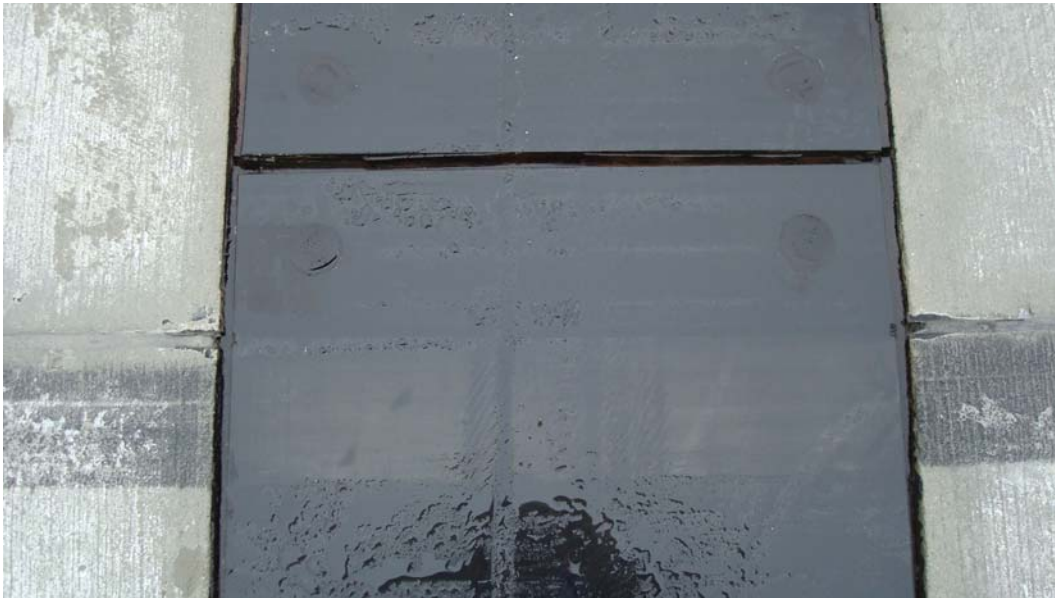
Figure 71. Joint in panels does not match joint in concrete at Runway 4 R at Shaw AFB.

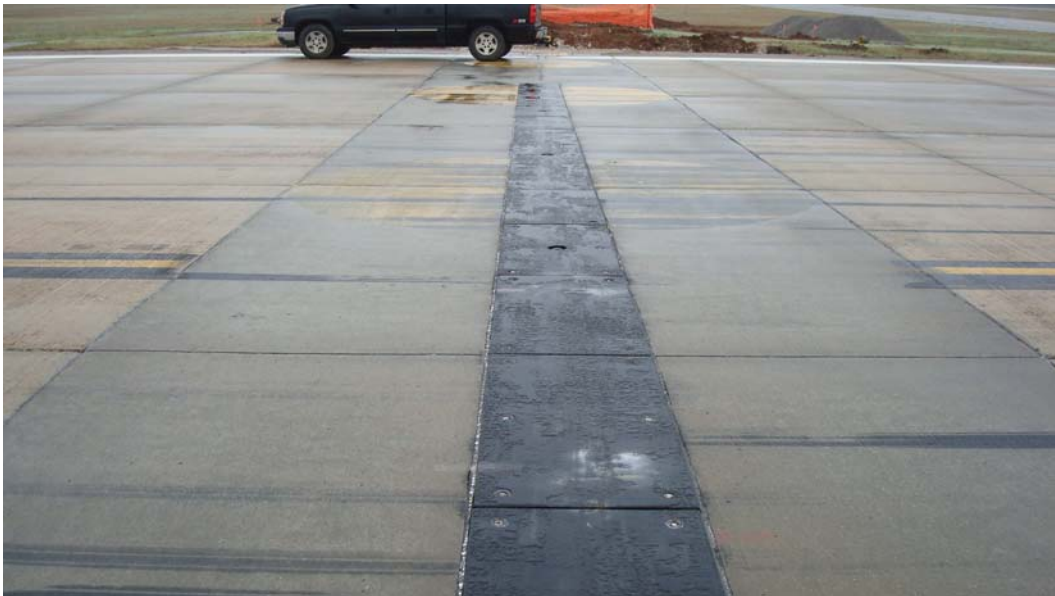
The panel system at the 22 end of Runway 22-4 L (left) (shown in Figure 72) was constructed in 1997. The adjacent pavement is concrete. It appears that a width of 12 to 15 ft of the existing concrete pavement was removed and replaced when the panels were installed.

Figure 72. Overview of panels on Runway 22 L at Shaw AFB.

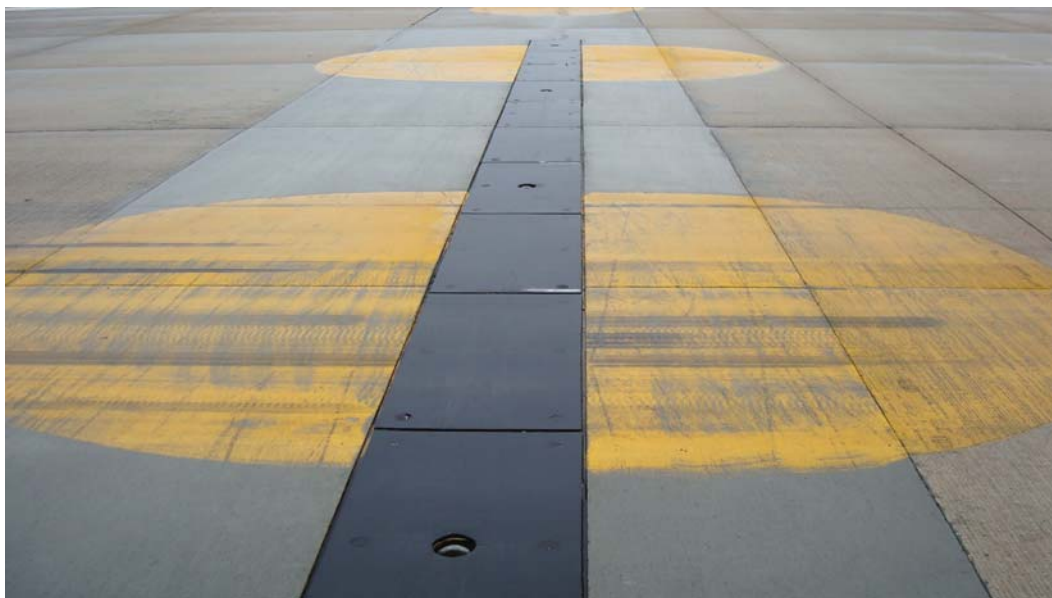
Figure 75. Overview of panels at Runway 4 L at Shaw AFB.

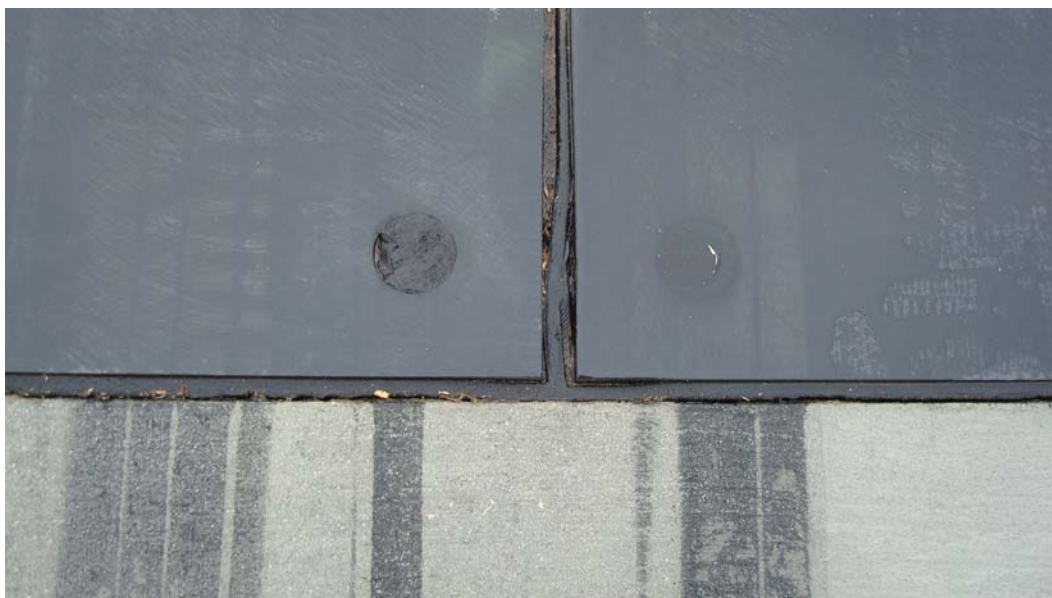
The joint sealant for location 4 had pulled away from the concrete and also had problems between two adjacent panels (Figure 76). The keyways were used in the panels, and it can be seen that the sealant in between the

Figure 76. Performance of joint sealants at Runway 4 L at Shaw AFB.

panels had not performed very well. However, it had not been dislodged from the pavement due to the extra width of sealant required as a result of the keyways. The recess at the end of each anchor had been sealed, and the sealant was performing very well in each recess.

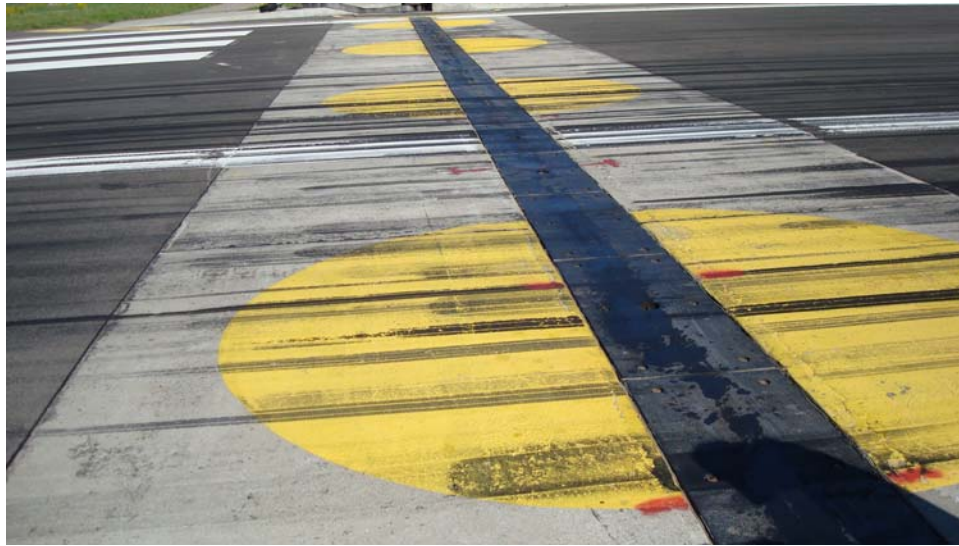
The panels at Spangdahlem AFB were inspected on May 8, 2008. The barrier consisted of panels placed in concrete with the concrete extending approximately 10 ft on either side of the panels (Figure 78).

A SMA mixture that was placed in 2007 was the surface used on the remainder of the pavement (Figure 79). This placement of the panels does not meet the guidelines documented in AFI 32-1043, Appendix A8, but the performance had been good according to the local staff. The guidelines say that the mix type should not change within 200 ft of the barrier panels. In this case, the mix type changed at approximately 10 ft from the panels.

Figure 78. Overview of panels at Spangdahlem AFB.

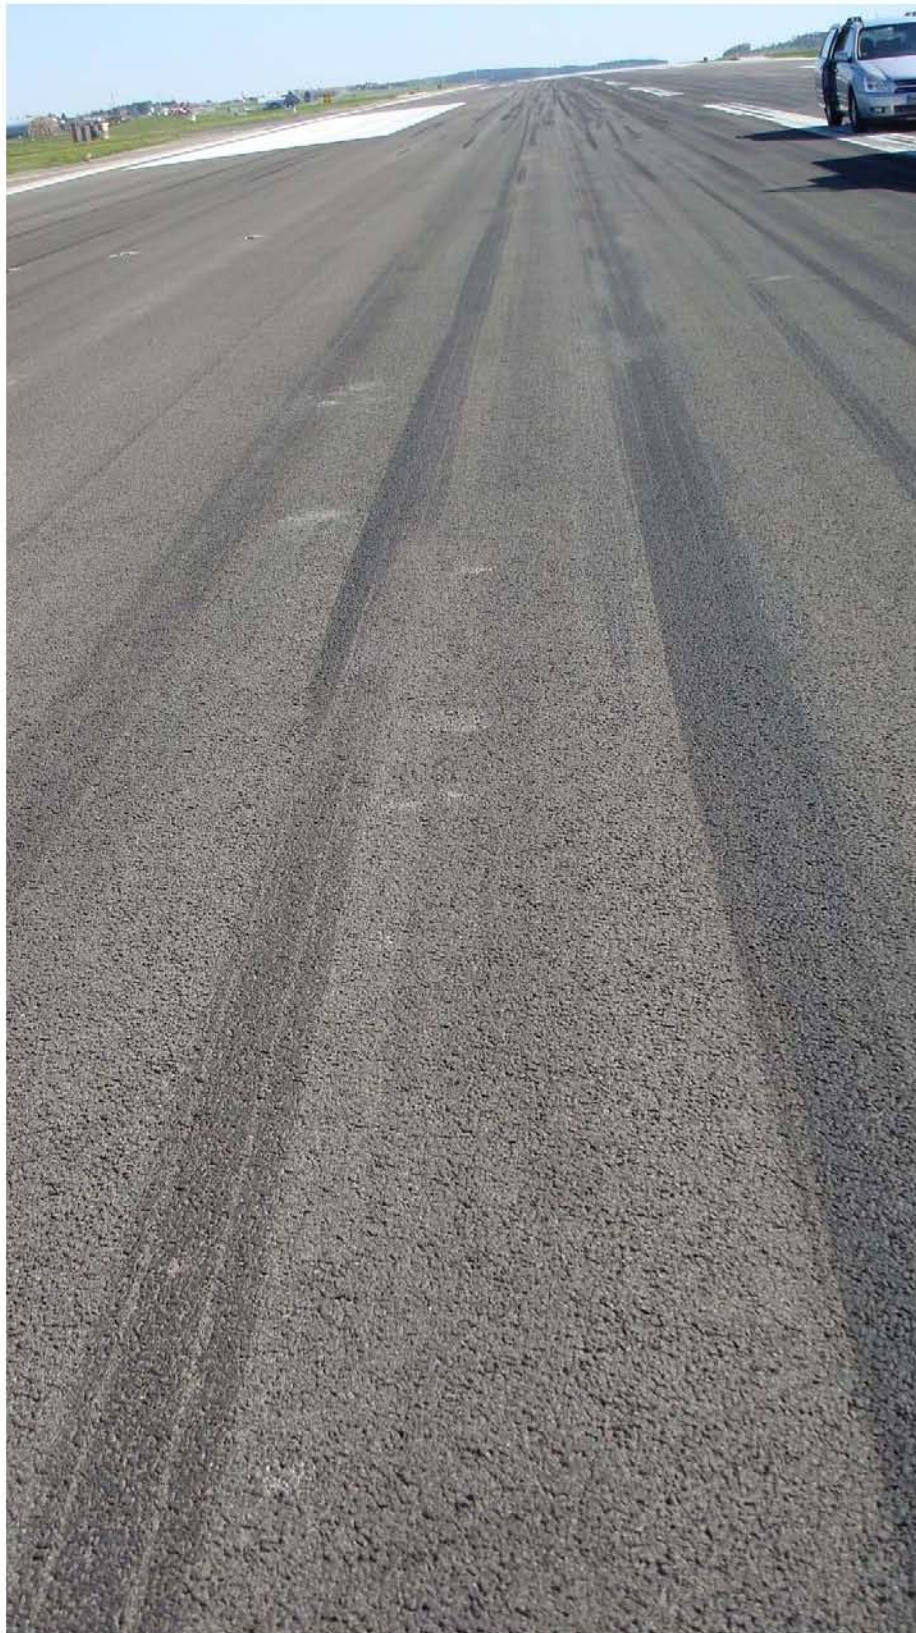
Figure 79. Surface of SMA pavement at Spangdahlem AFB.

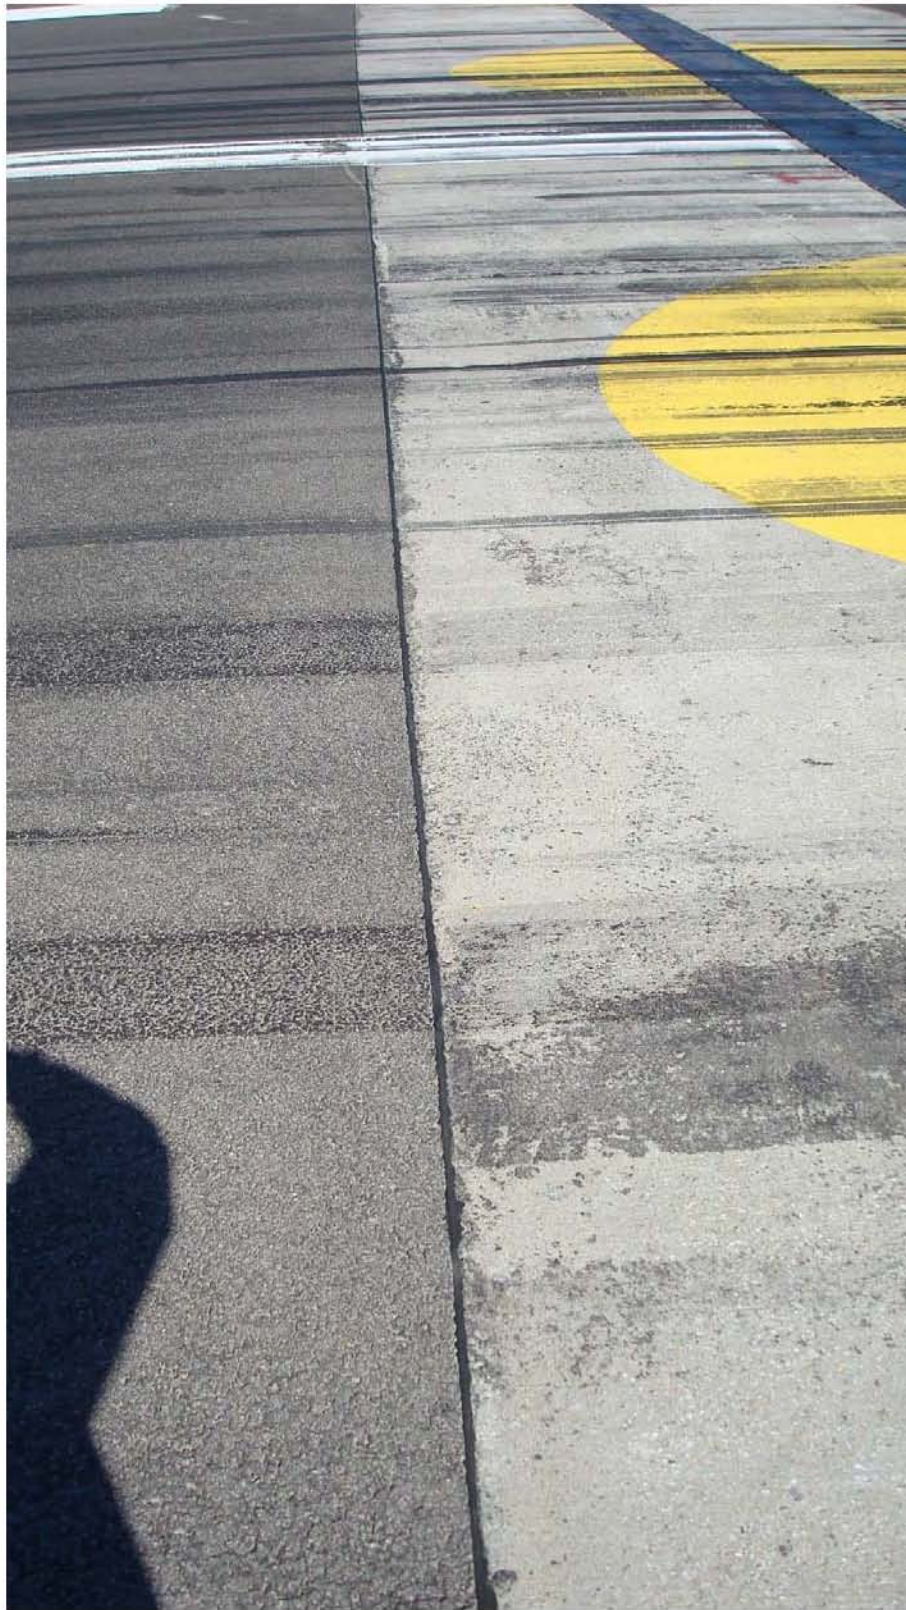
The panels were placed in 1998 and did not have to be removed during construction since the SMA mixture was not immediately adjacent to the panels. The size of the panel appears to be 2 by 5 ft. There is no damage of the SMA next to the concrete slab, but the SMA was only 1 year old at the time of inspection. Sealant was used between and around the panels, but the sealer was in poor shape at the time of inspection. The sealant used around the panels appeared to be silicone type sealant. There was no sealer in the recess around the anchor bolts. The sealer between the SMA and concrete was only 1 year old and was in good shape at the time of inspection (Figure 80).

Figure 80. Sealant between SMA and concrete adjacent to panels at Spangdahlem AFB.

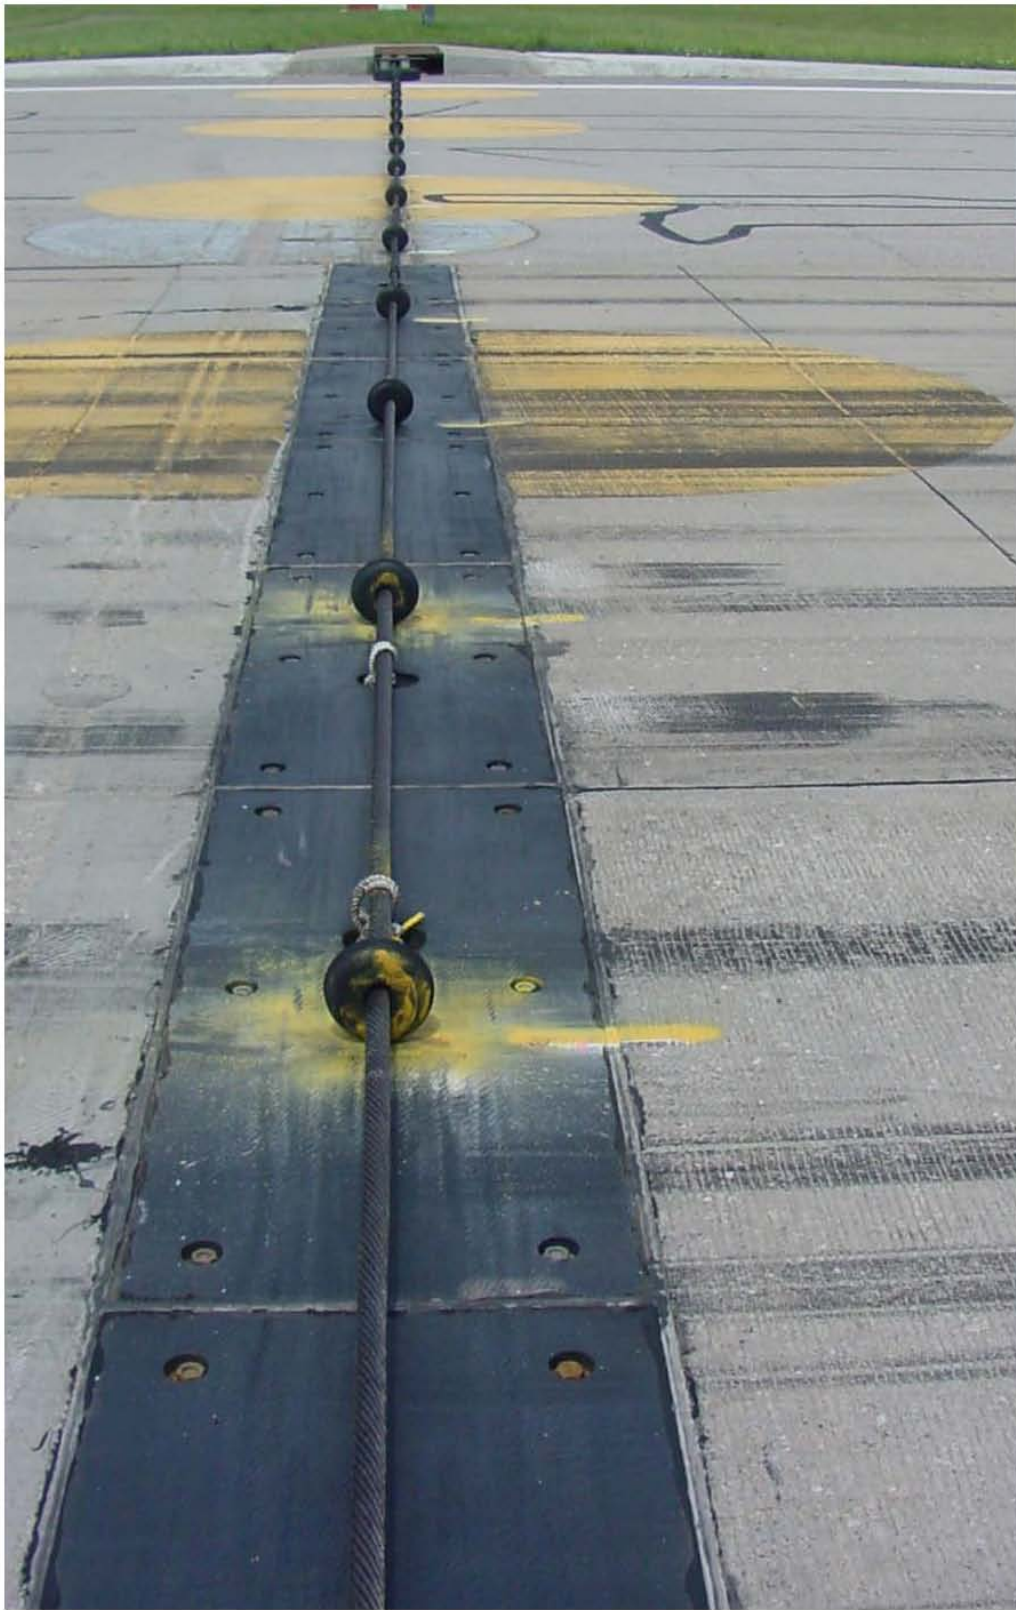
The keel section was concrete, and asphalt mixture was used on each side of the keel. The panels, which appeared to be 2 by 5 ft, seemed to be placed

Figure 83. Overview of panels at Tinker AFB.

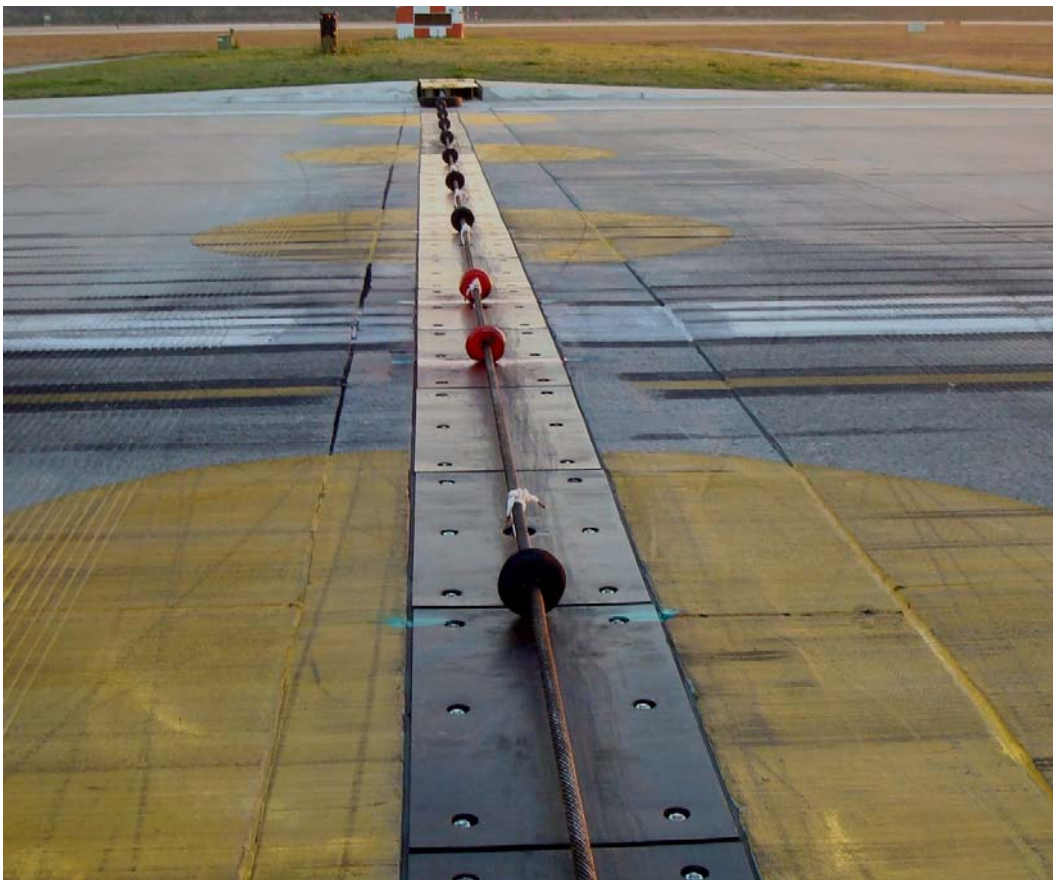
Figure 85. Barrier cables at Runway 13 L at Tyndall AFB.

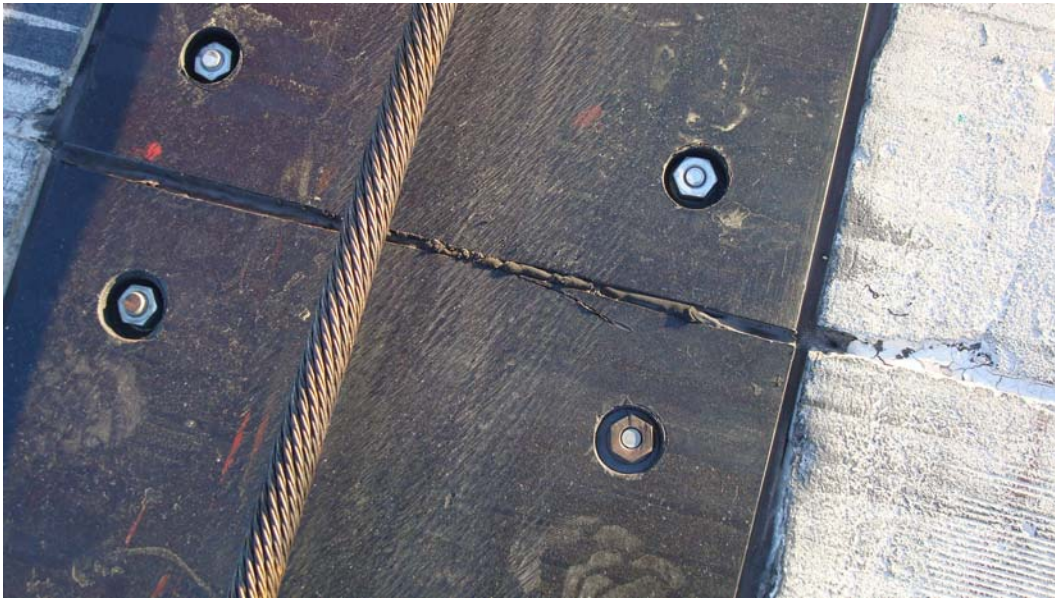
The sealer appeared to be in good condition in most cases; however, there were some places where the sealer had pulled away from the panel or concrete. Many of the recesses at the openings cut for the anchors did not contain sealer (Figure 86).

Figure 86. Barrier cable at Runway 13 L at Tyndall AFB showing no sealant in anchor recess.

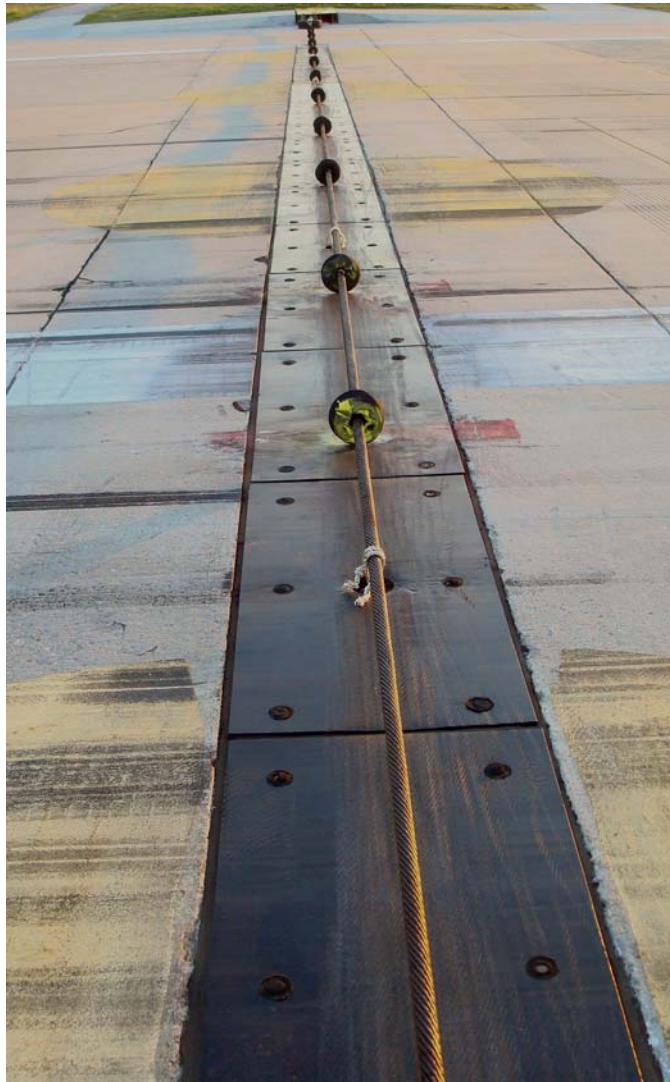
Figure 89. Overview of barrier cable at Runway 31 R at Tyndall AFB.

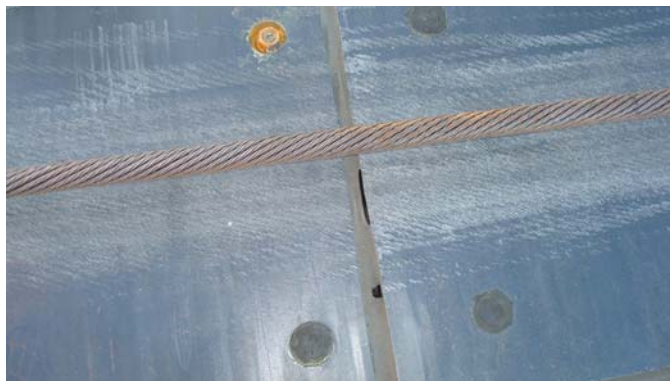
The panels on Runway 31 R were replaced in 2006. An overview of this panel system is shown in Figure 89. The recesses around the anchor ends had been sealed and were generally still sealed (Figure 90) at the time of inspection. One of the recesses, shown in Figure 90, did not have sealant, and the end of the anchor was beginning to show some rusting. The sealant in the joints was generally good, but some pulling away from the sides could be seen (Figure 90).

Figure 90. Rust in anchor recess where sealer had been lost at Runway 31 R at Tyndall AFB.

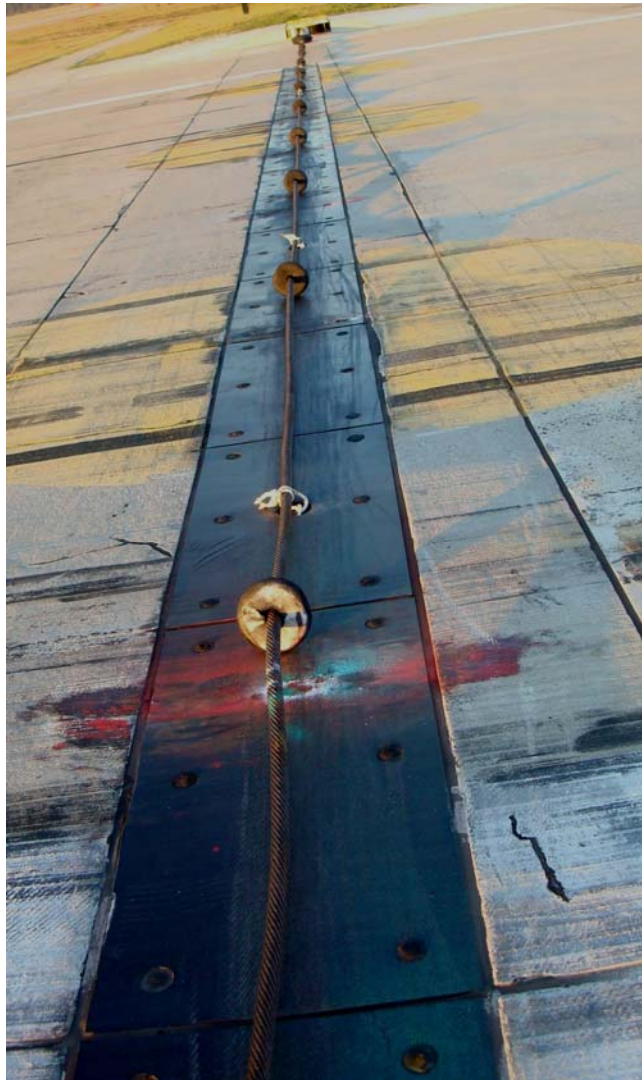
Figure 91. Overview of barrier cable (BAK-12) at Runway 31 L at Tyndall AFB.

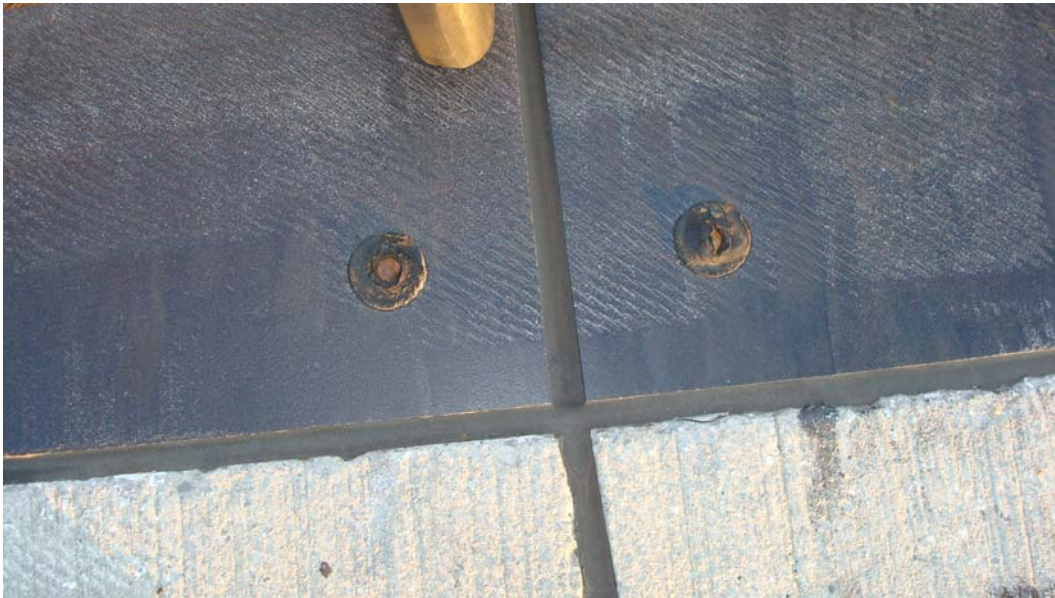
An overview of the panels on Runway 31 L (BAK-12) is shown in Figure 91. These were replaced in 2005. For the most part, the sealant was performing very well (Figure 92).

Figure 92. Barrier cable (BAK-12) at Runway 31 L at Tyndall AFB showing good sealant.

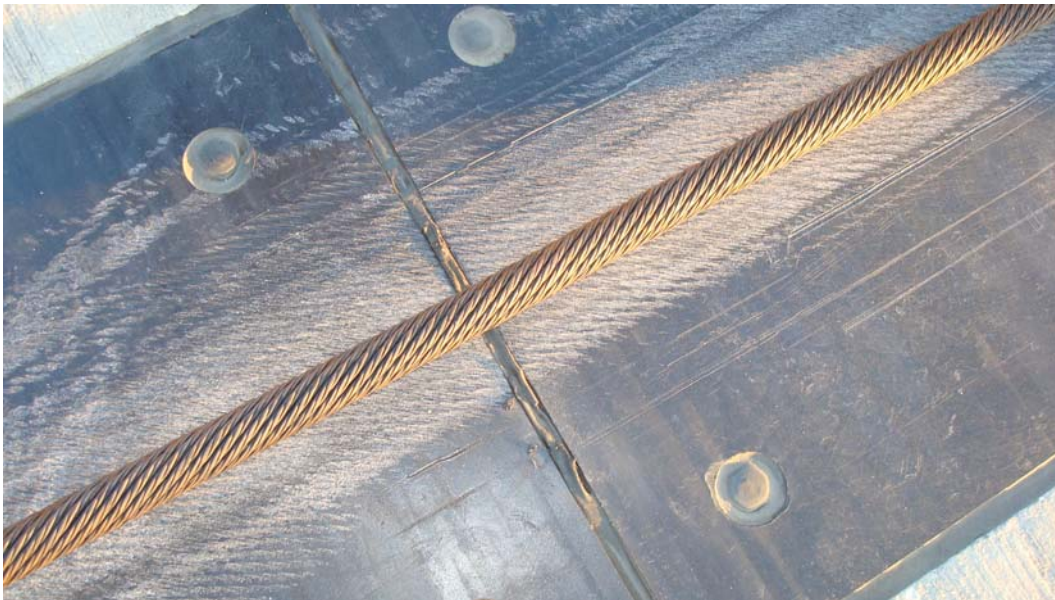
The cable had not caused any damage to the panels, but some scarring of the surface had occurred (Figure 93). There was some loss of performance of the sealant and some minor spalling of the adjacent concrete (Figure 94).

Figure 93. Some minor scarring at BAK-12 due to the cable beating the surface under traffic at Runway 31 L at Tyndall AFB.
