## **Evaluation of Ultra High Molecular Weight (UHMW) Polyethylene Panels for Aircraft Arresting Systems**

E. Ray Brown

August 2009

Final report

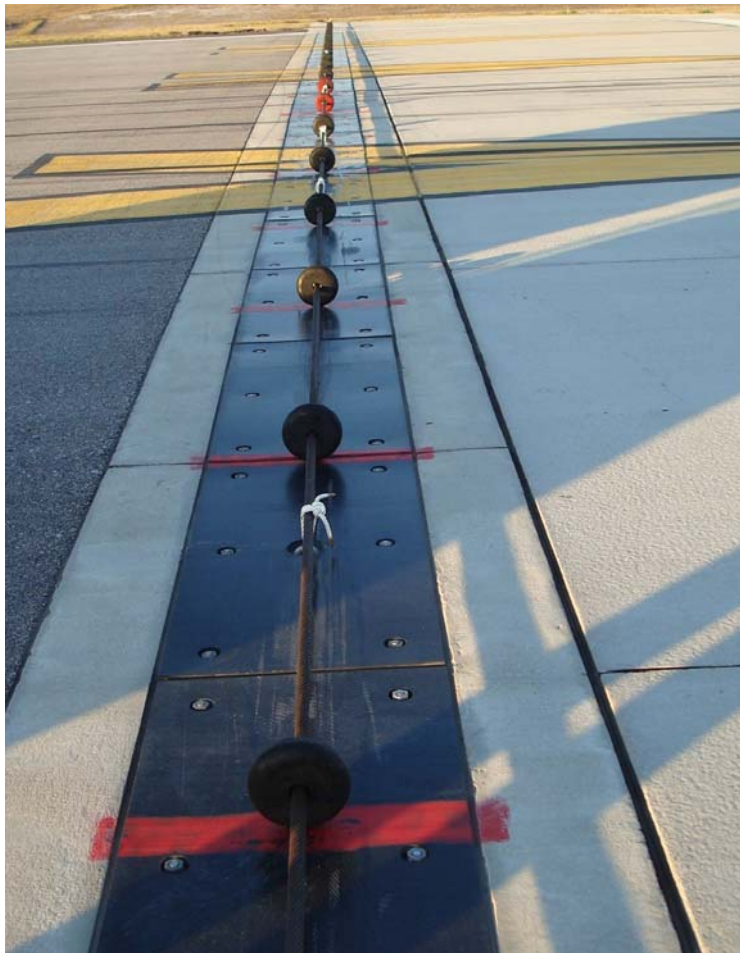
An overview image of Runway 31 L (E-5) is shown as Figure 95. There is concrete on one side of the panels and asphalt on the opposite side. On the side with asphalt, there is approximately a 1-ft strip of concrete between the panels and the asphalt.

Figure 95. Overview of panels (E-5) at Runway 31 L at Tyndall AFB.

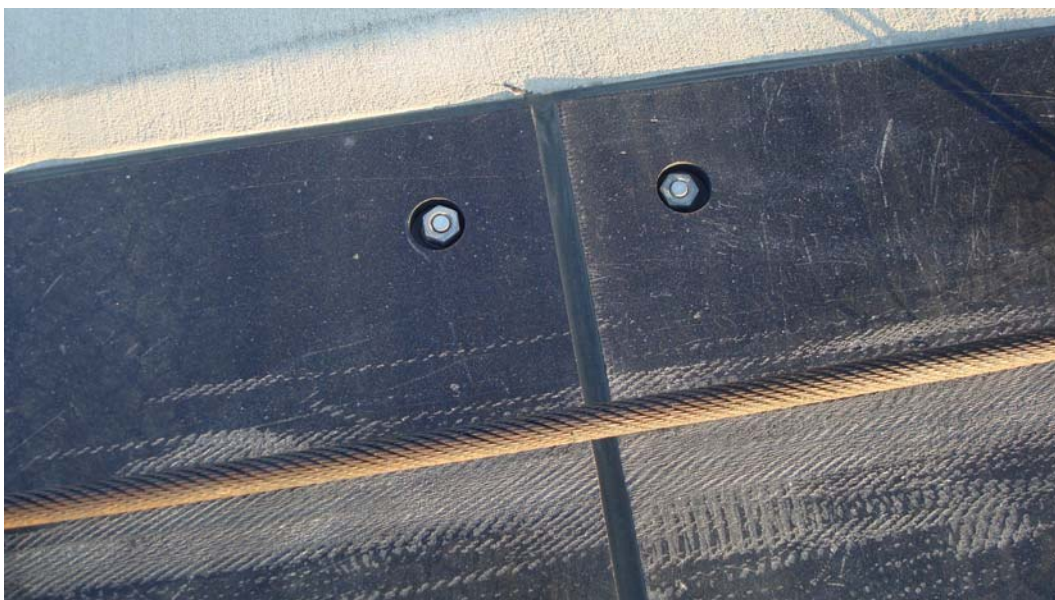
The panels were in good shape with some minor scarring on the surface (Figure 96). The sealant was in good shape in the joints, but the recesses had not been sealed (Figure 97). The adjacent pavement was in good shape on both sides of the panels.

Figure 96. Condition of panels (E-5) and sealant at Runway 31 L at Tyndall AFB.

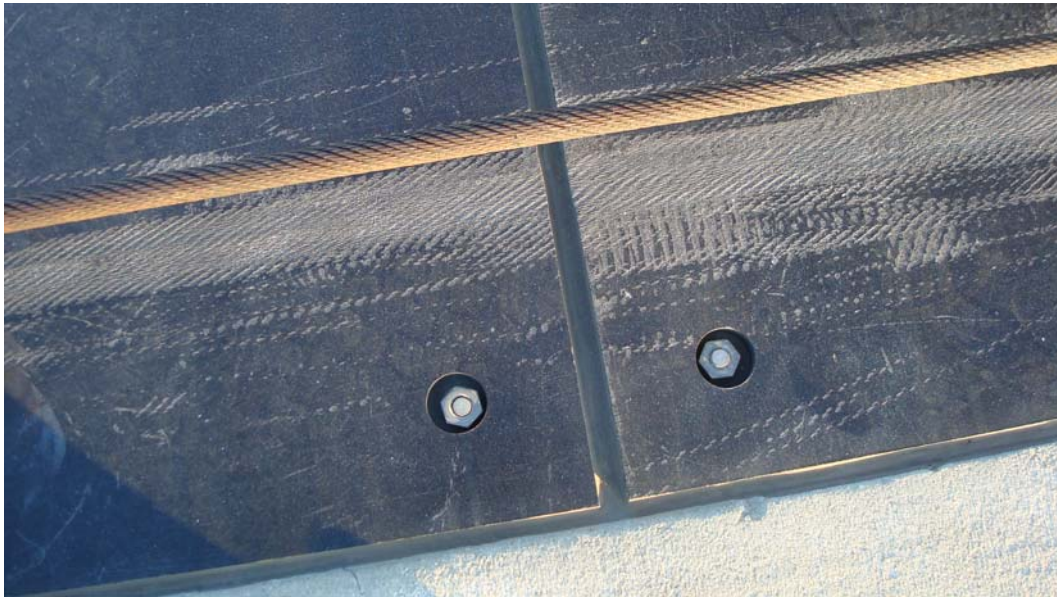
Figure 97. Condition of sealant and panels (E-5) at Runway 31 L at Tyndall AFB.

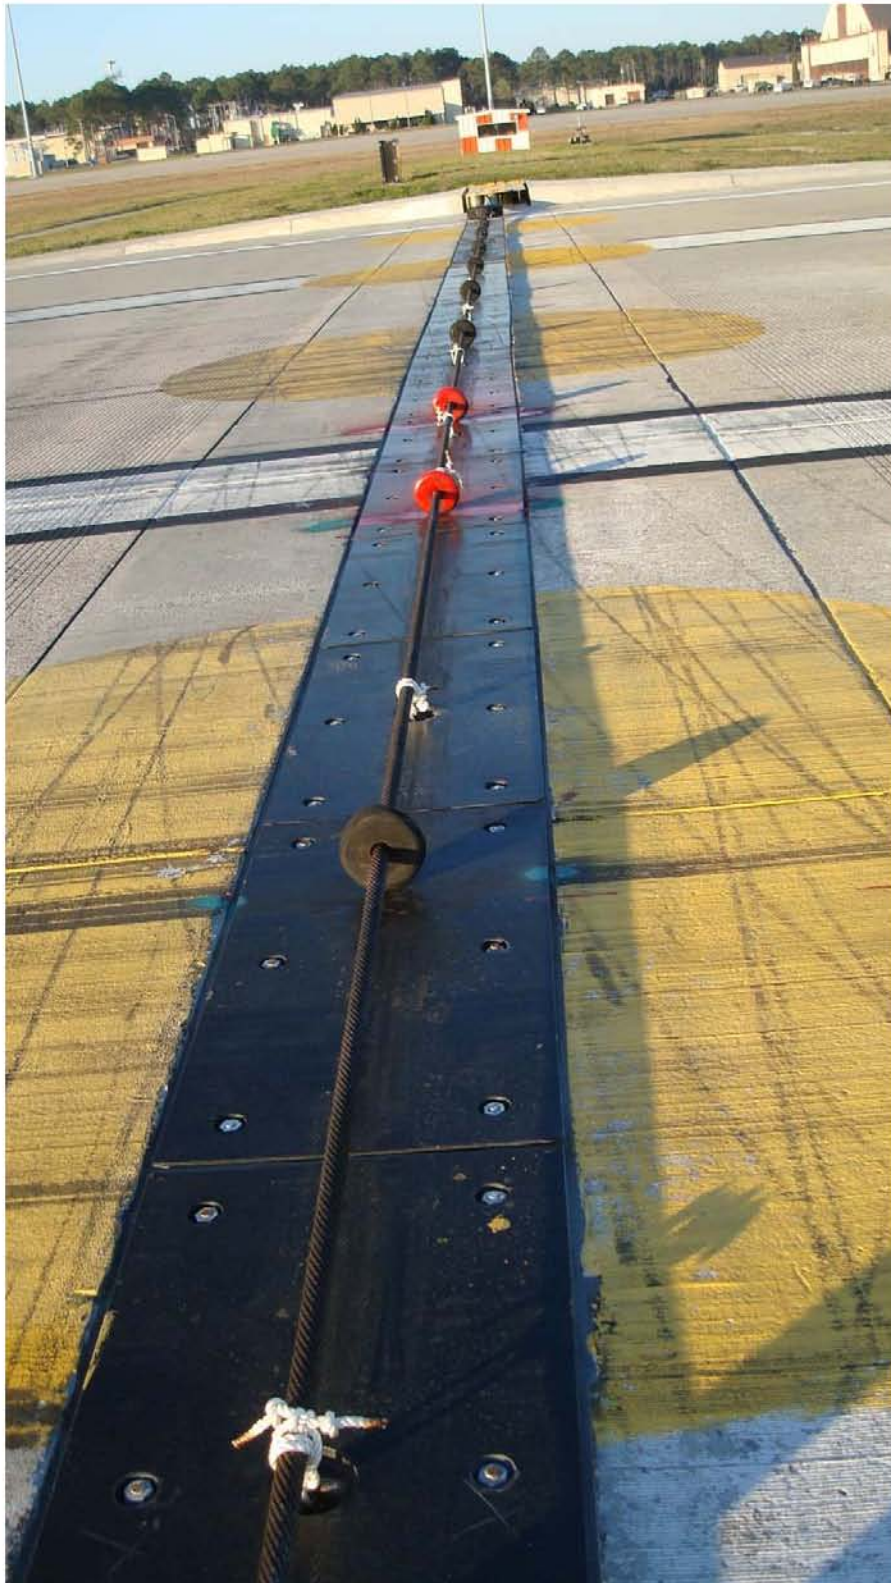
Figure 99. Overview of barrier cable at Runway 13 R at Tyndall AFB.

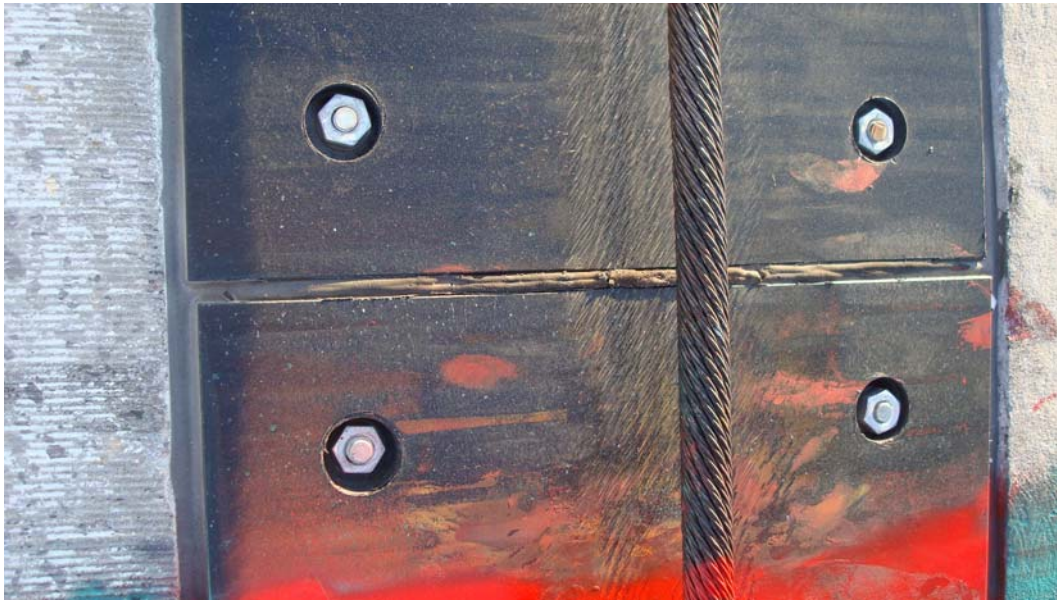
The sealant between the panels and the adjacent concrete was in good condition, but the sealant in the joints between the panels had lost its bond to the panels (Figure 100). This loss of bond is due to the large amount of movement during temperature changes. The joint generally reduces from an opening of up to 1 in. during cold weather to nearly closed during hot weather. It is very difficult for a sealant to perform satisfactorily with this high amount of movement.

Figure 100. Loss of sealant effectiveness at joint between panels at Runway 13 R at Tyndall AFB.

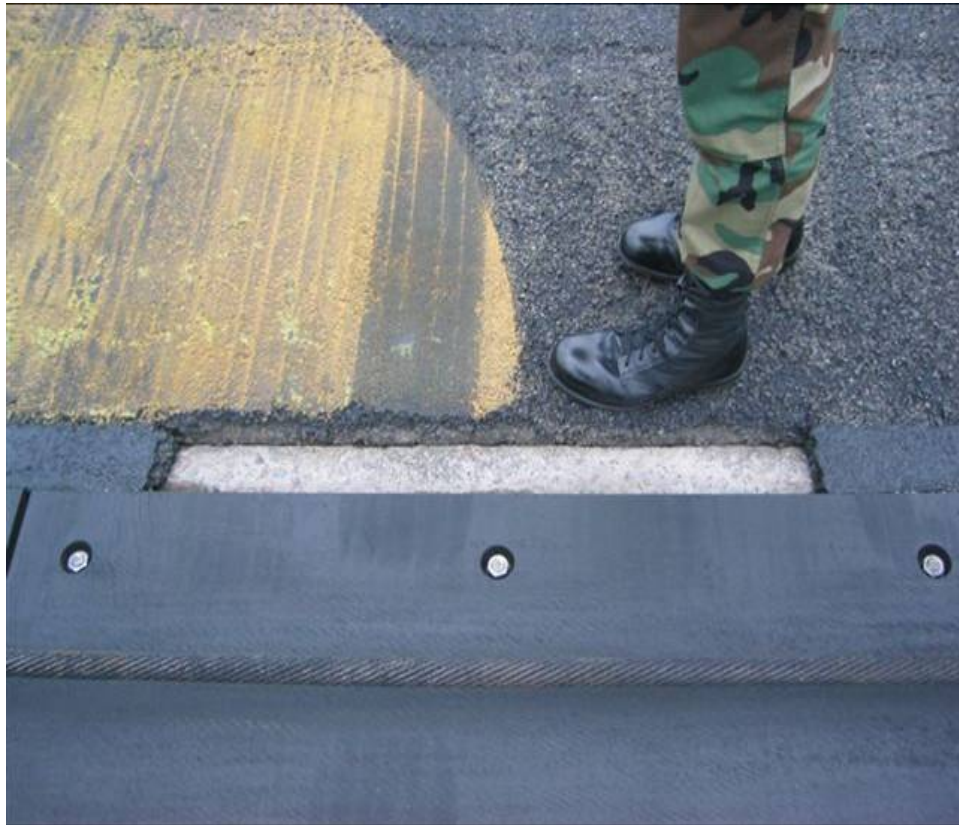
Figure 101. Remove damaged material and square up hole.

Constructing a quality patch in an asphalt mixture can be difficult. Good confinement is needed, and good compactive effort is required. The final compacted surface should be smooth and slightly higher than the adjacent panels. When good density is obtained, the susceptibility to breaking over under traffic is significantly reduced. An example of patching a narrow section immediately adjacent to the panels is shown in Figures 101 and 102. The first step is to cut out the bad material and square up the hole.

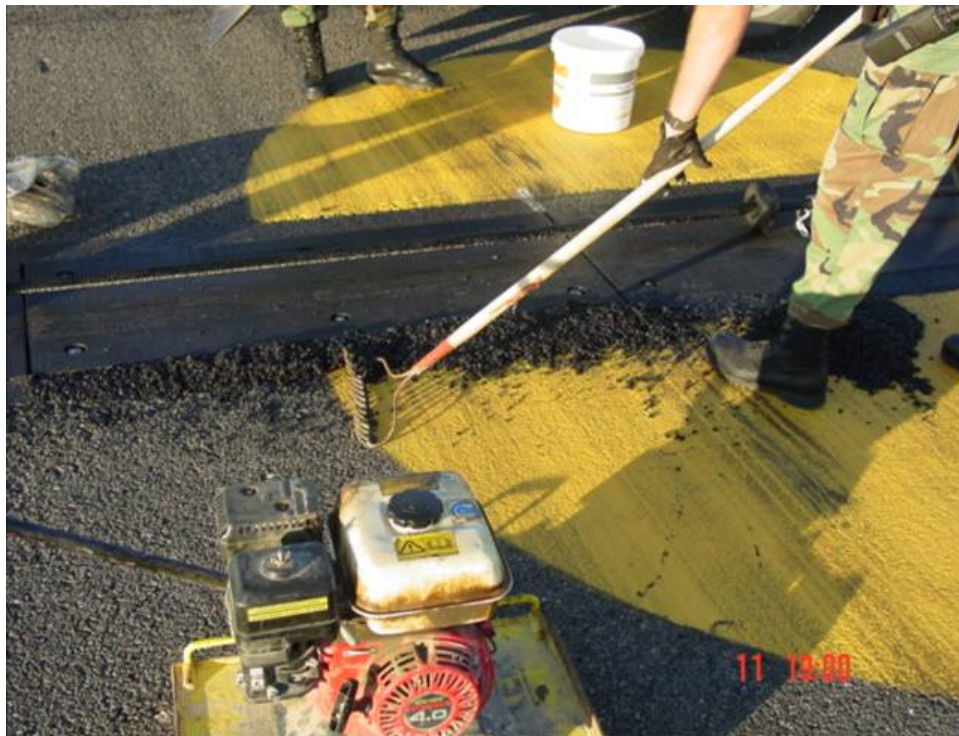
Figure 102. Fill hole with mix, level, and compact.

Then, add sufficient material so that, when compacted, the surface ties in with the adjacent surface, creating a smooth surface that has the desired elevation. Make sure a good, tight, dense surface is obtained. High-quality mixture with good angular aggregate and polymer modified asphalt is preferred. The panels and the adjacent pavement provide confinement that will aid in the compaction process. After compaction, a saw cut is needed to provide a reservoir for sealant between the patch and the panels. It is essential that the sawed pavement surfaces be adequately tacked, good mix be used, no segregation occur during handling, and adequate density be obtained.

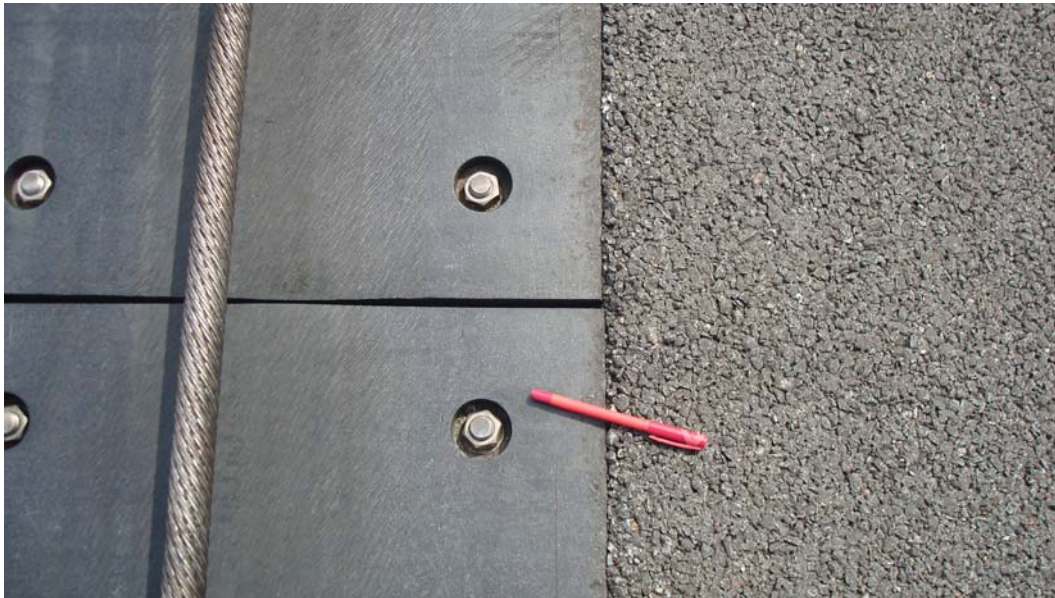
On some projects the mix was placed immediately against the panels, and no reservoir was created for the sealant. These projects generally performed very well up to the time of inspection. This type of process was generally used in mild climates, so this approach may result in a significant performance problem in more severe climates. The technique of not making a saw cut to create a reservoir for sealant is not generally recommended, and if used, should only be done in mild climates. Sealant is not used with this technique, since there is no opening in which to place the sealant.

Figure 103. Asphalt mixture placed up against panels at RAF Lakenheath.

When the asphalt damage adjacent to the panels is minor, small patches can typically be made to correct the problem. However, when the damage is significant, resulting in large areas or many small areas, it is often best to remove the material the width of a paver and place the mix transversely to the panels. For example, at Lakenheath, the PFC was placed immediately adjacent to the panels (Figure 103). The PFC was placed in the transverse direction, allowing the contractor to better match the elevation of the panels and to achieve better compaction adjacent to the panels. Using this technique should minimize any breakover of the asphalt pavement surface that may occur in the future. A saw cut is then made to create a reservoir for the sealant between the panels and the asphalt pavement.

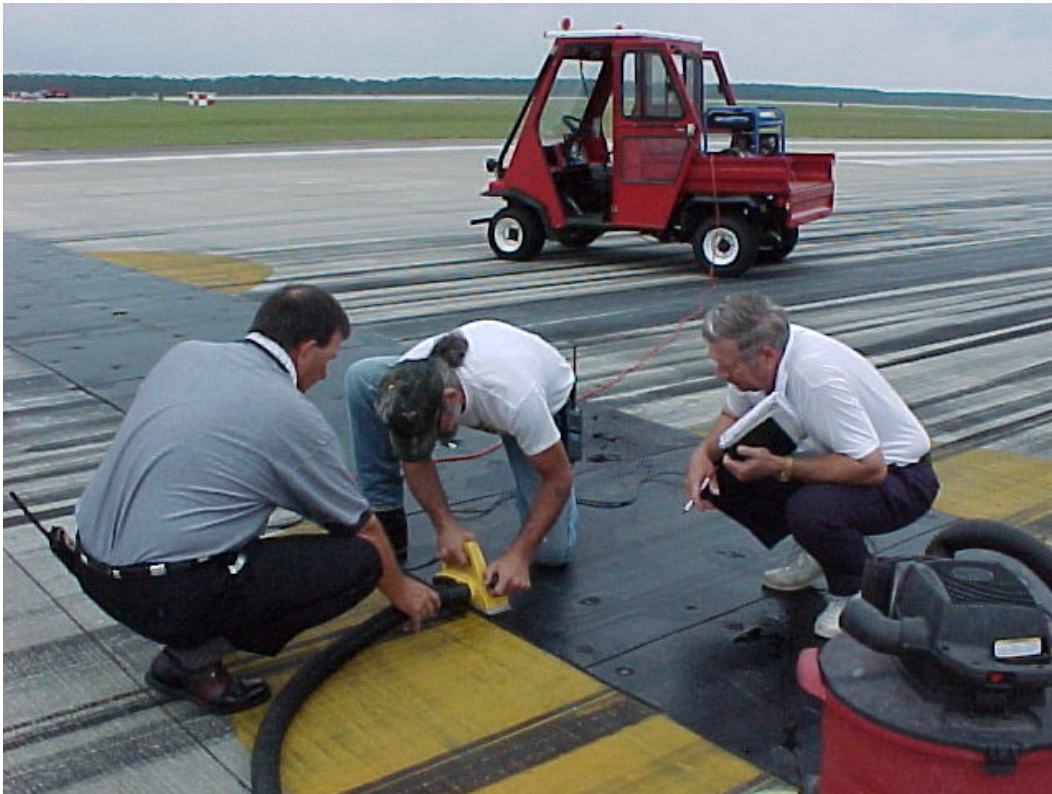
Figure 104. Grinding surface of panel to make smooth.

There was no area of the pavement adjacent to the panels where significant segregation, raveling, cracking, shoving, or rutting was taking place. Except in areas where warping had occurred or excessive breakover of the asphalt mixture had occurred adjacent to the joint, there were no areas where pavement roughness adjacent to the panels appeared to be a problem. When warping occurred, there was sometimes a bump created as a result of the panels having an uneven surface. When these bumps occurred, they were made level by grinding or planing the surface, as shown in Figure 104. Otherwise, hook skip could be a problem.
