**MUJARRAH CANAL BRIDGE
RAMADI, IRAQ**

**SIGIR PA-09-170
JULY 14, 2009**

Mujarrah Canal Bridge

Summary of Report: PA-09-170

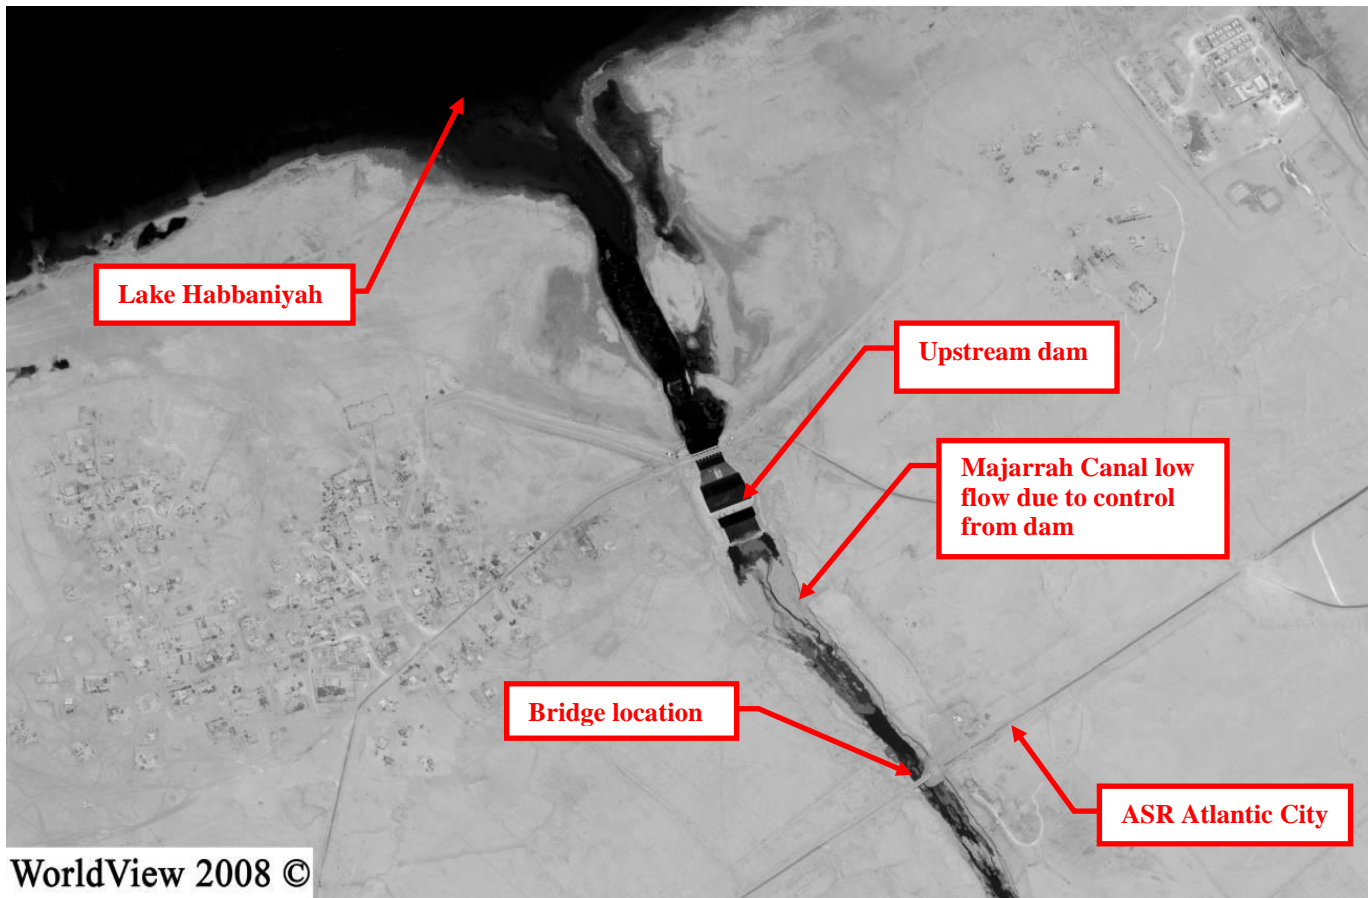
Figure 1. Location of Murrarrah Canal Bridge, dam, and Lake Habbaniyah (Courtesy of GRC)

In the confluence of the canal and Lake Habbaniyah, a dam appears to control flows into the canal (Figure 1). GRC Falluja Resident Office representatives did not know if there is potential for a rapid release of storage from the dam; however, the span and under-clearance of the structure appear to permit unimpeded flow in the channel.

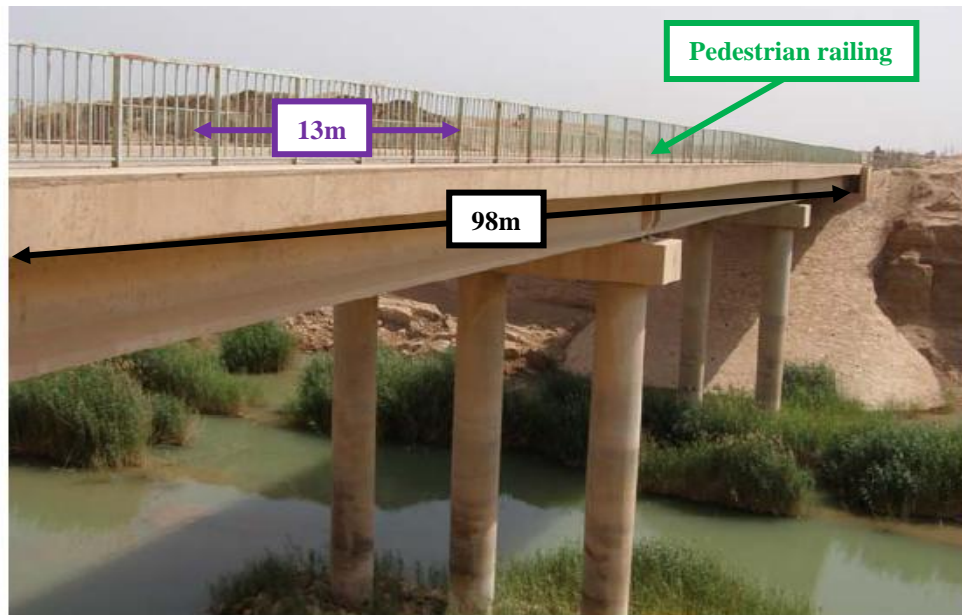
Site Photo 2. Mujarrah Canal Bridge prior to VBIED damage (Courtesy of GRC)

Constructed in 1983, the Murrarrah Canal Bridge is a three-span structure, 98m long and 13m wide (Site Photo 2). A reinforced-concrete deck carries a two-lane, 9m-wide cart way, with 2m-wide pedestrian walkways along both sides of the bridge. The cart way is covered with a bituminous asphalt wearing surface and is separated from the walkways by concrete curbing. The cart way has metal pedestrian railing along the outside edge of the walkways. At the end of each girder, pre-molded expansion joints accommodate movement and protect the bearing seats from runoff and debris accumulation.

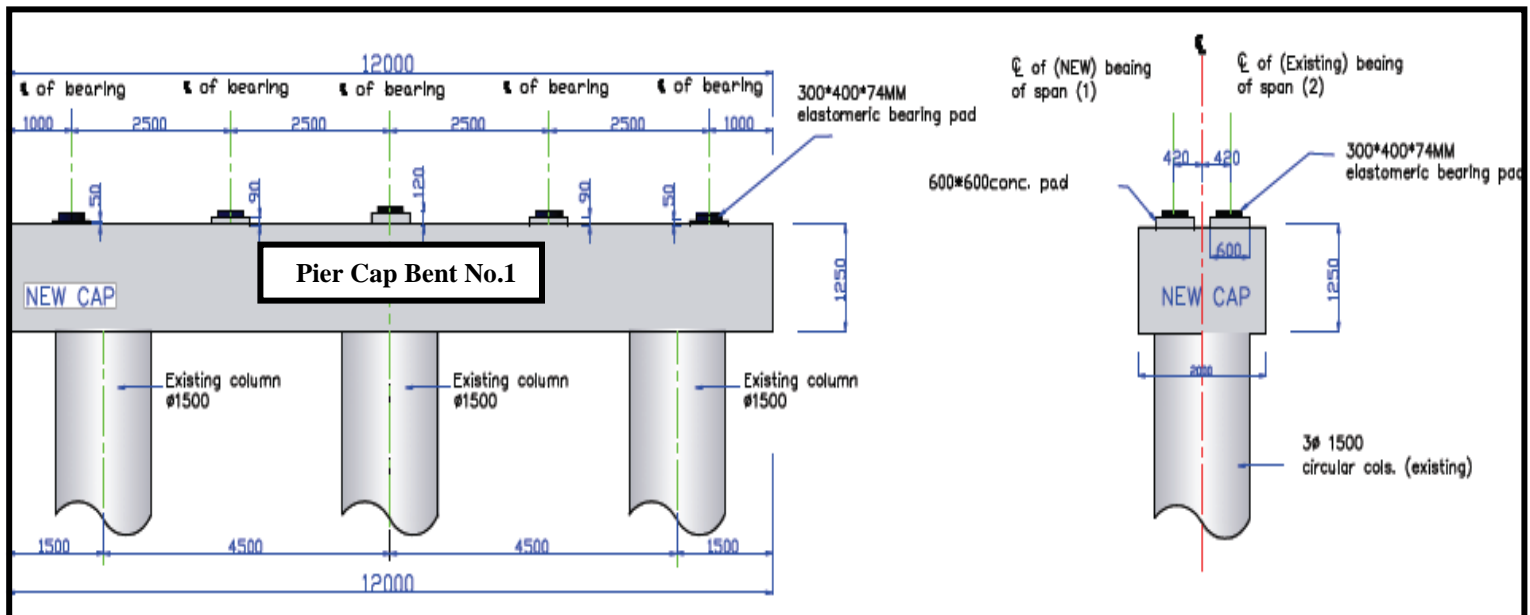
Figure 3. Typical Bent elevation and section (Courtesy of GRC)

The contractor's generated drawings contained specific information about the temporary jacking and support of the existing structure, construction of the post-tensioned concrete beams and reinforced-concrete deck, and other project features (Figure 3).

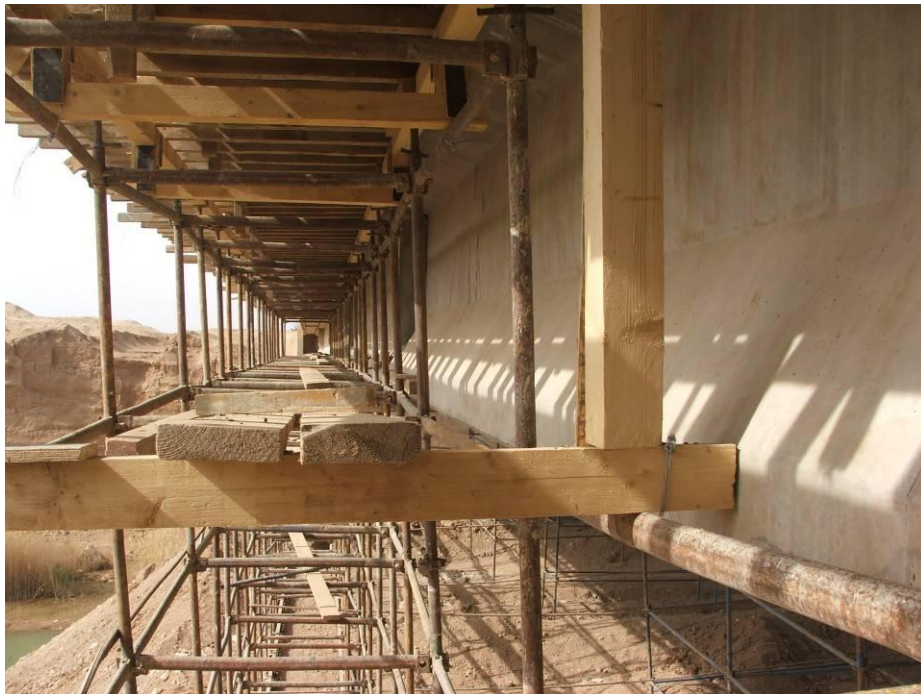
Site Photo 8. Falsework for forming concrete deck overhang

constructed on scaffolding, supported from the fill placed beneath the structure (Site Photo 8.)

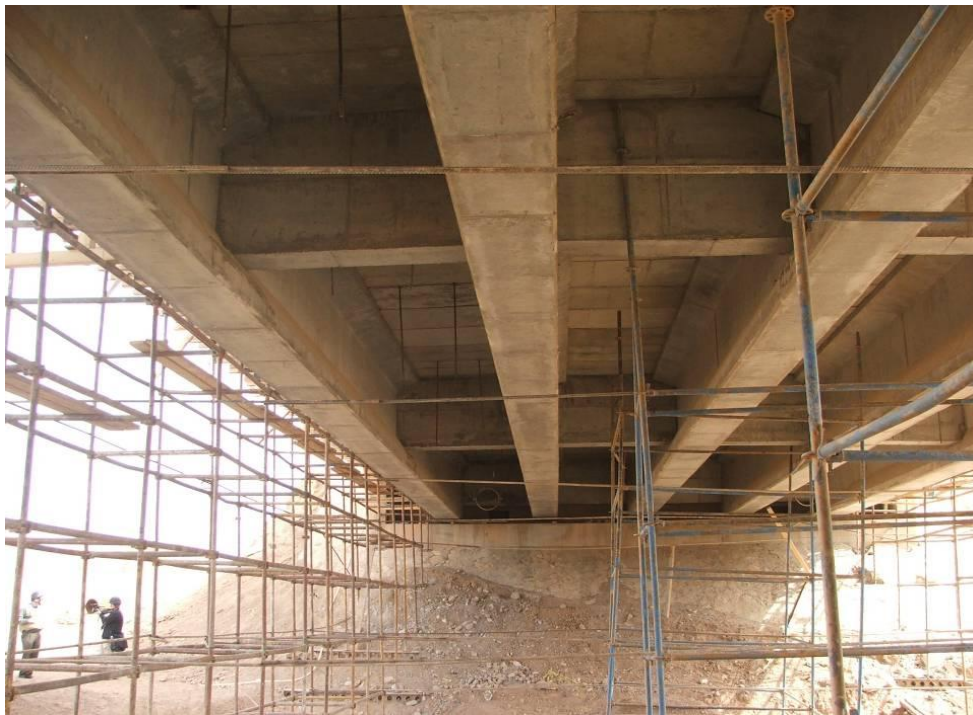
Site Photo 10. Post-tensioned concrete girders

The post-tensioned concrete girders appeared to be constructed per the contractor’s design drawings. SIGIR observed placement and uniform spacing aligned with the existing construction (Site Photo 10). Due to time constraints, SIGIR could not verify the sweep and chambers of the beams; however, GRC Falluja Resident Office representatives stated that the beams were within the tolerance of the design at the time of placement.
