**ROLL-ON/ROLL-OFF BERTH
PORT OF UMM QASR, IRAQ**

SUSTAINMENT ASSESSMENT

**SIGIR PA-08-162
JULY 8, 2009**

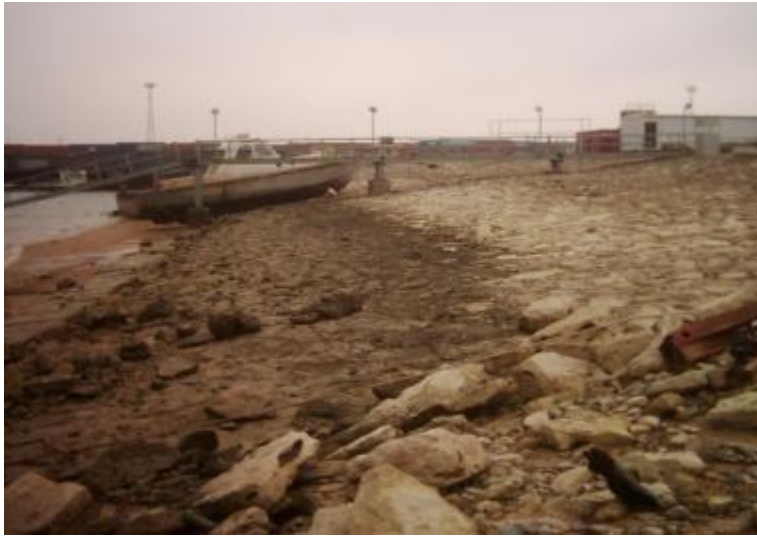
Before the contractor could begin new construction at RORO Berth 22, the contractor cleared the UXO and wreckage from the areas around both Berth 21 and the future Berth 22. Site Photos 1-3 show the obstructed future site of Berth 22 with ship wreckage and debris that needed removal, and Berth 22 constructed and cleared of wreckage and debris (Site Photo 4).

Site Photo 1. Obstructed future RORO Berth 22 site (Courtesy of GRS)

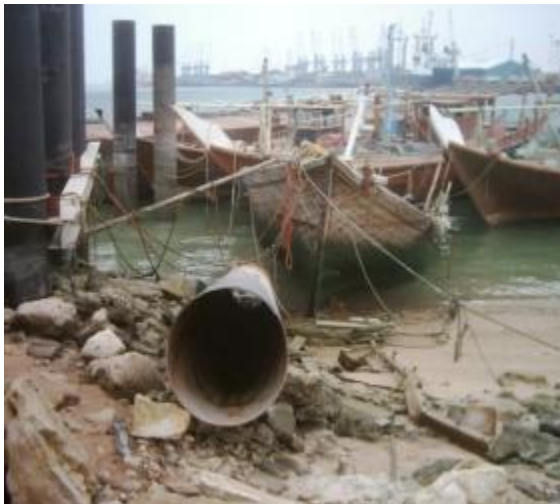
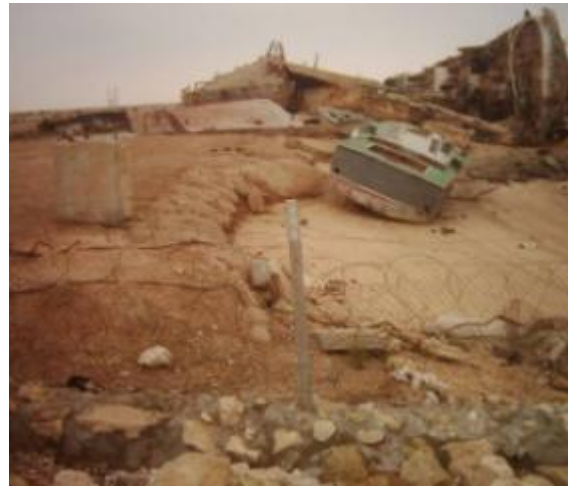
Site Photos 2 and 3. Wrecks at future RORO Berth 22 site (Courtesy of GRS)

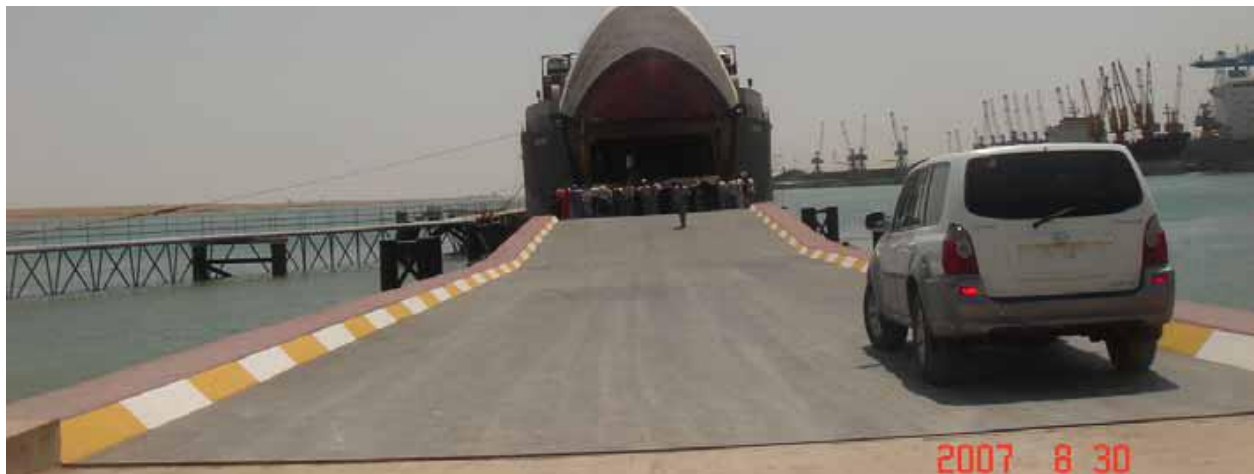
Site Photo 4. Constructed RORO Berth 22 (Courtesy of GRS)

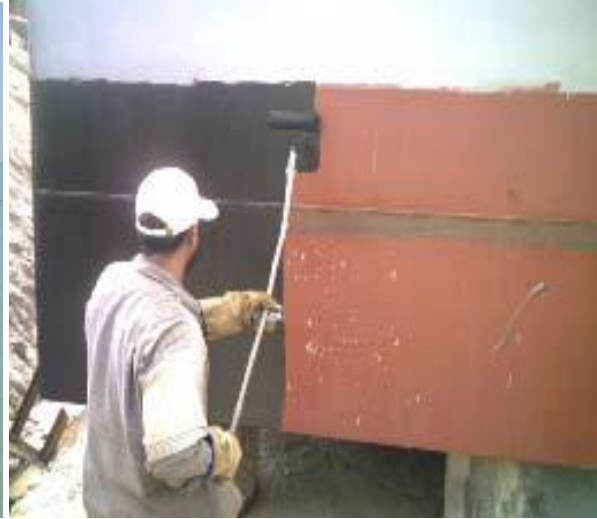
The contractor replaced the jetty fenders with new Seibu Polymer Corporation Trapezoid Type V 800HX1220L model rubber fenders. The new fenders include 400 millimeter (mm) H-piling⁹, section stiffeners between the piles, and anchor bolts to affix the fenders to the existing concrete pier. Site Photo 8 shows the contractor painting with a coal tar epoxy to prevent corrosion, and Site Photo 9 documents the construction of the new jetty fenders at Berth 5.

Site Photo 8. Painting with coal tar epoxy
(Courtesy of GRS)

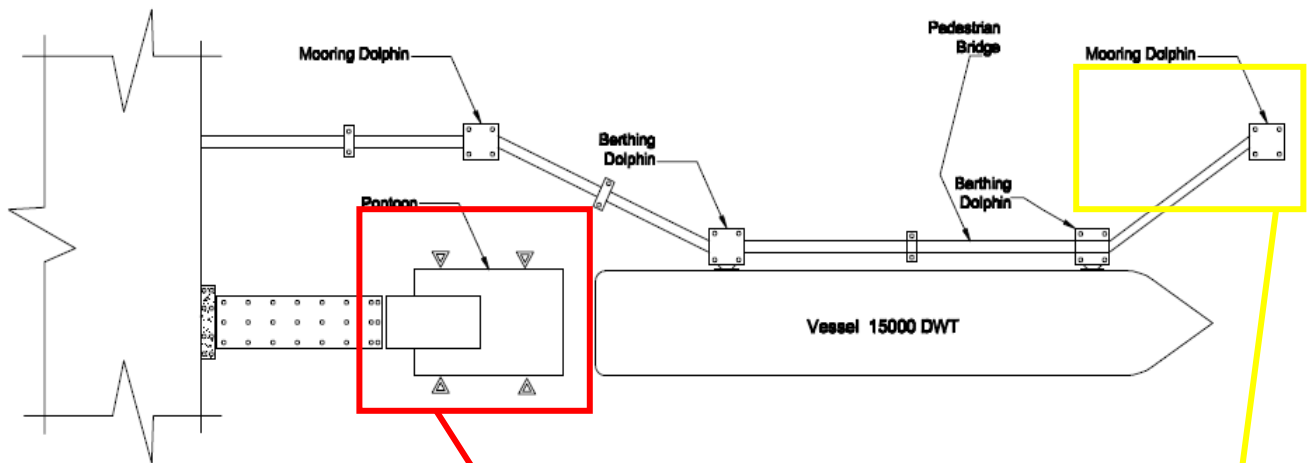
Figure 2 provides the design of the RORO Berth 22 project—a steel deck structure fixed to a concrete abutment and supported by piling. A pontoon is attached to the deck structure by a hinge mechanism, which can raise and lower according to the water level in the port (Site Photo 10). The pontoon has a steel deck structure, which allows ships to back up to the pontoon and load and unload cargo—rather than using a crane. This method of unloading is efficient for vehicles, passengers, and palletized cargo. The pontoon is affixed to four guide rail/roller assemblies, which allow the pontoon to raise and lower with the tide, but not to move laterally due to waves or ship movement.

Figure 2. RORO Berth 22 overview (Courtesy of GRS)

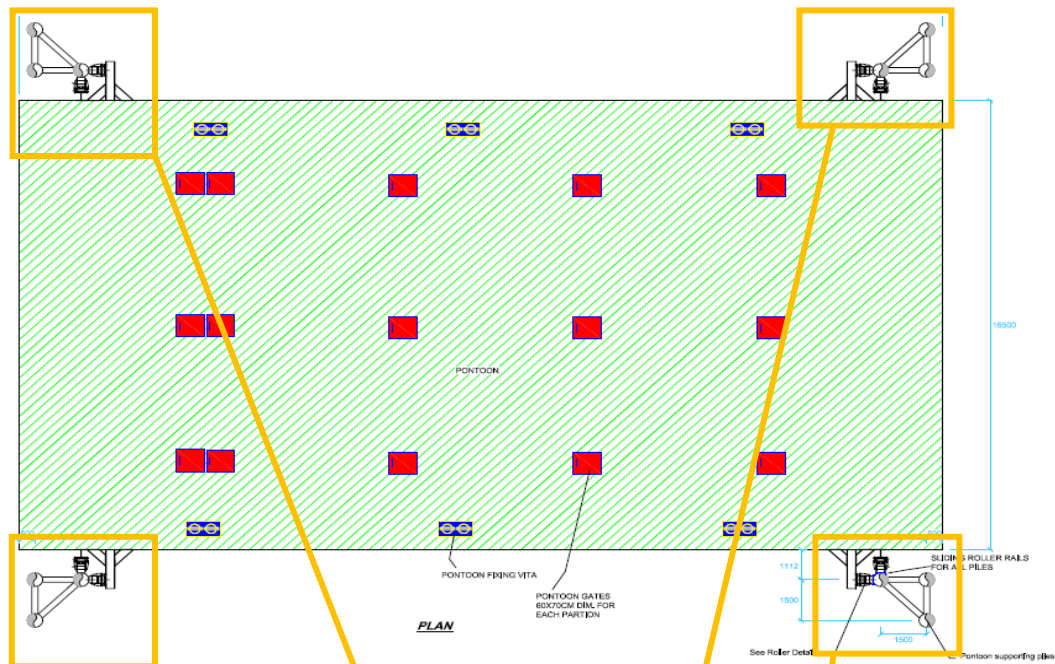
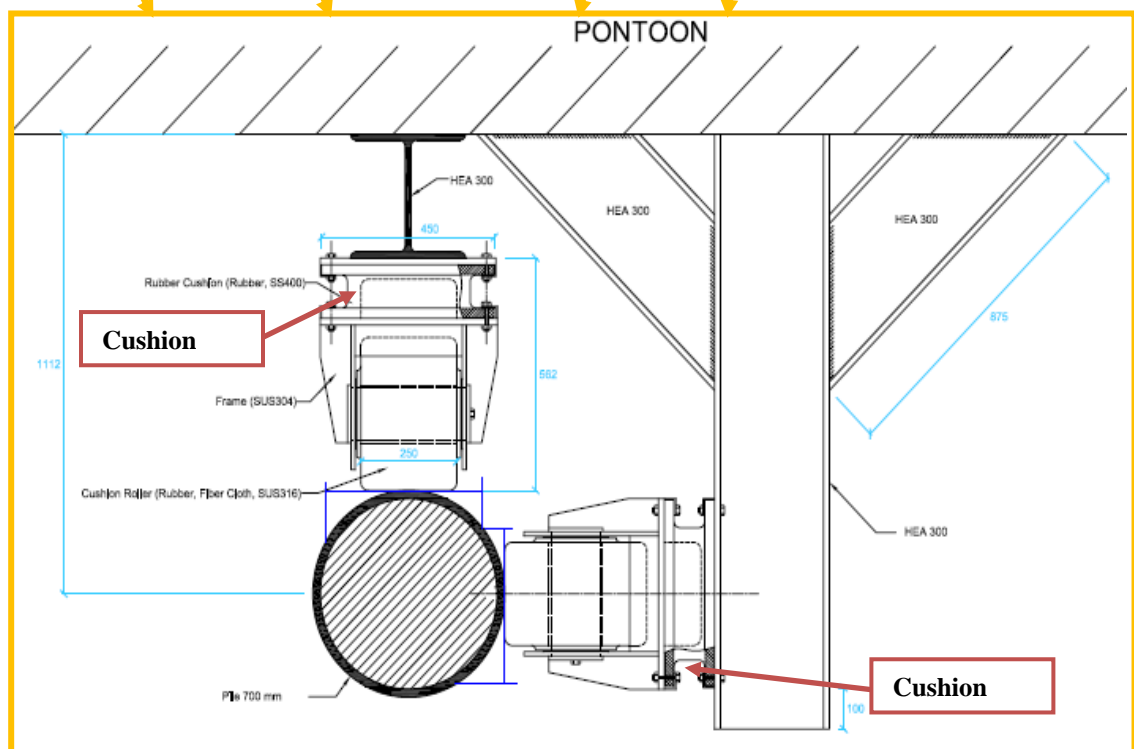
Originally, the contractor designed the cushion roller assemblies with flexible elastomeric mounts (cushions) (Figure 3). The mounts permit relative movement of the rollers and prevent binding on the vertical tracks caused by irregularities in the roller system geometry.

Factors such as ships approaching the pontoon too fast or poor mooring during storms would increase loading on the roller assemblies and exacerbate the issues with the assembly mounting and potential binding. If present, these factors would accelerate damage of the assemblies.

Another possible cause of the damage to the rail/roller assemblies would be exceeding the maximum ship size to use RORO Berth 22. According to the design calculations, RORO Berth 22 was designed for a 15,000 deadweight tonnage ship with a maximum displacement of 27,500 tons. GRS personnel could not provide information on the size of ships actually using the facility. The continued lack of maintenance or repair of the rail/roller assemblies will result in further damage to the pontoon structure.

Figure 3. Rails/rollers - enlarged (Courtesy of the USACE)
