A BRIEF DISCUSSION OF TWO RECENT MAGAZINE ACCIDENTS AT THE NAVAL SURFACE WARFARE CENTER

M. M. Swisdak, Jr.

Indian Head Division/Naval Surface Warfare Center

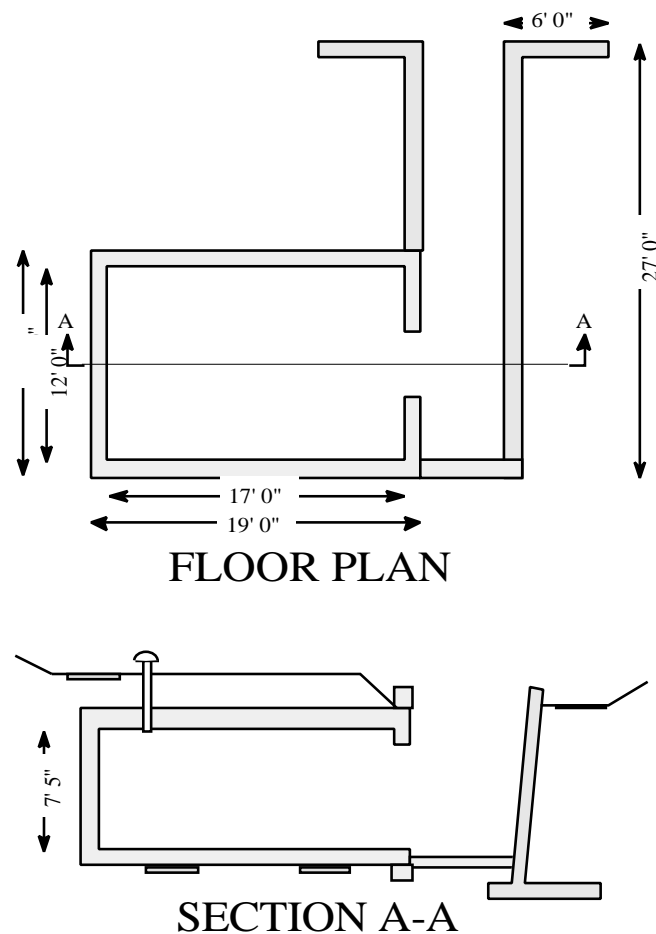
FIGURE 1. MAGAZINE 355 LAYOUT

White Oak. Magazine 355 was a reinforced concrete, earth-covered structure constructed in 1951. Figure 1 shows some details associated with the structure. Figure 2 is an exterior photograph of Magazine 353. This structure was adjacent to Magazine 355 and was constructed at the same time using the same plans. In appearance, it is identical to Magazine 355.

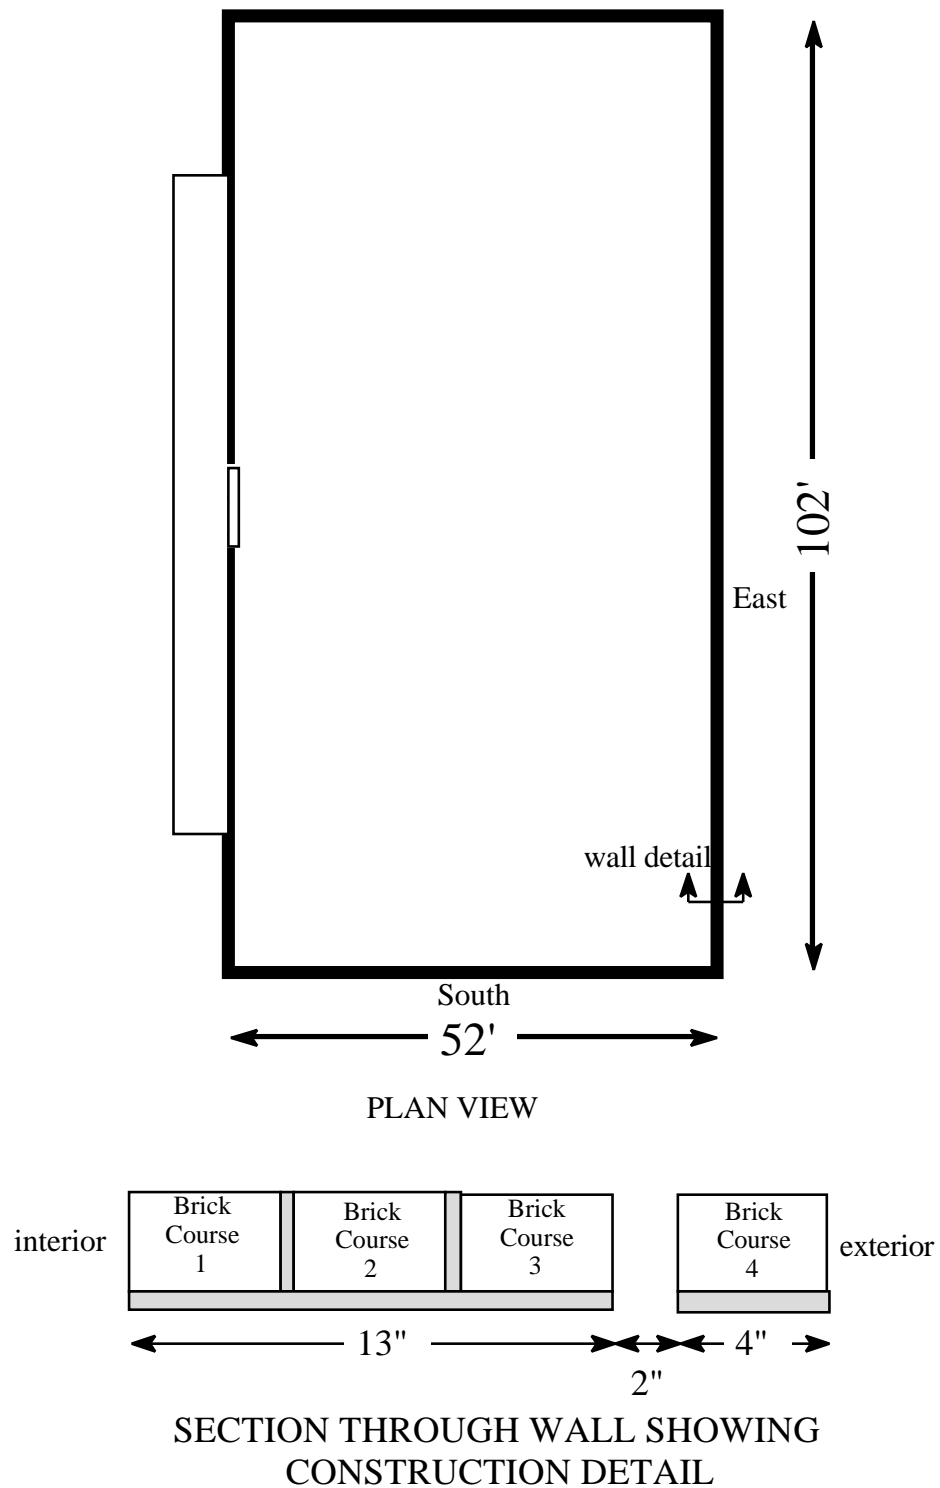
FIGURE 3. MAGAZINE 518 ARRANGEMENT

Indian Head. Magazine 518 was a nonstandard, aboveground, non-barricaded structure constructed in 1942. It was 52 feet wide and 102 feet long; the walls were constructed of four courses (thicknesses) of brick; the roof was transite (a construction material made from a mixture of 1-40% asbestos in Portland cement) supported by a steel truss frame and the floor was reinforced concrete (approximately 5" thick) over compacted earth. Figure 3 is a sketch of the layout of the building. Figure 4 shows two exterior views of another magazine whose appearance is identical to Magazine 518.
