HAMMAM AL ALIL DIVISION TRAINING  
CENTER  
MOSUL, IRAQ

**SIGIR PA-09-174**  
**JANUARY 7, 2010**

### Summary of Report: PA-09-174

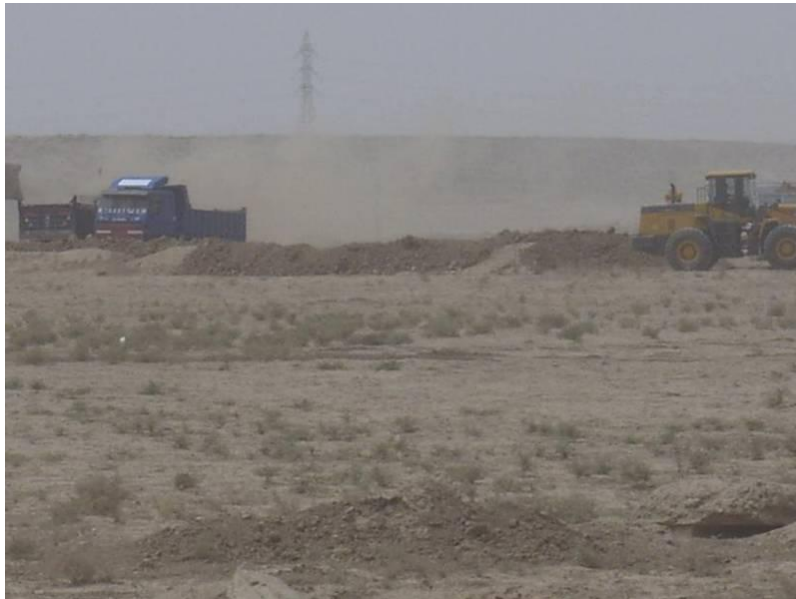
The site for the Hammam Al Alil Division Training Center project was at Forward Operating Base Scorpion, Hammam Al Alil, Iraq. The project site is approximately 15 miles south of Mosul, located near the Tigris River. The location for the proposed improvements consisted of vacant land. The site was relatively flat with little ground cover or vegetation (Site Photo 1).

**Site Photo 1. Site location prior to construction (Courtesy of USACE)**

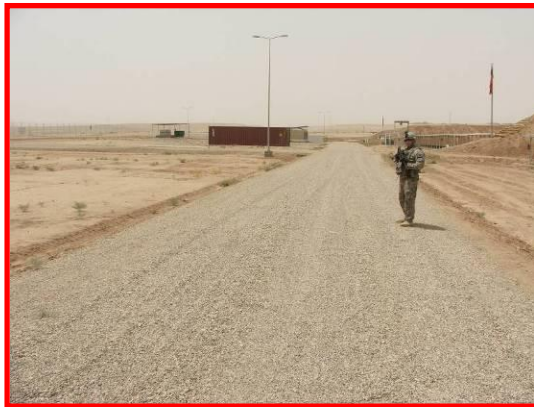
An access road was constructed between the multi-purpose small arms range and the MOUT facility. The access road was constructed of crushed gravel and appeared graded in a consistent and uniform manner with no depressions or significant irregularities present (Site Photo 2). There was a service road which connected the individual pads of the range to the access road. The access road led to the small arms range which was surrounded by a chain link fence. The chain link fence surrounded the entire range, preventing unauthorized use and controlling entry during live fire training.

**Site Photo 2. Access road**

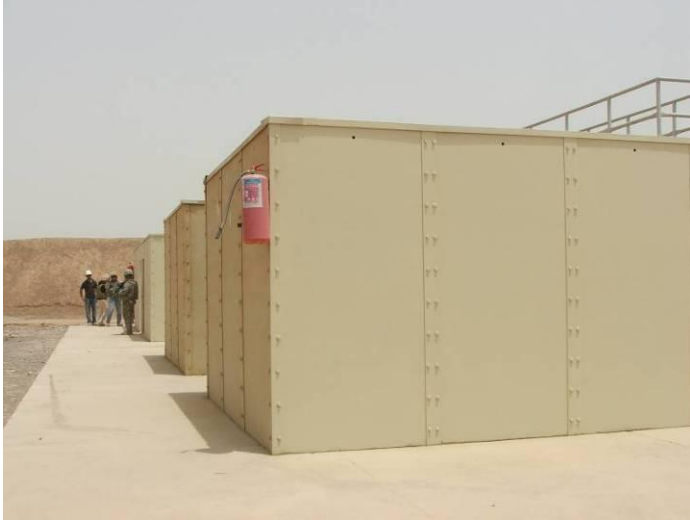
The MOUT facility consisted of two freestanding training structures— the larger one rectangular and the smaller one square. They were approximately 3m apart with independent overhead observation walkways (Site Photo 13). The facility was constructed on a concrete pad surrounded by an earthen berm of similar construction to those surrounding the multi-purpose small arms range. Power was supplied to the facility by a generator.

**Site Photo 13. MOUT facility exterior**

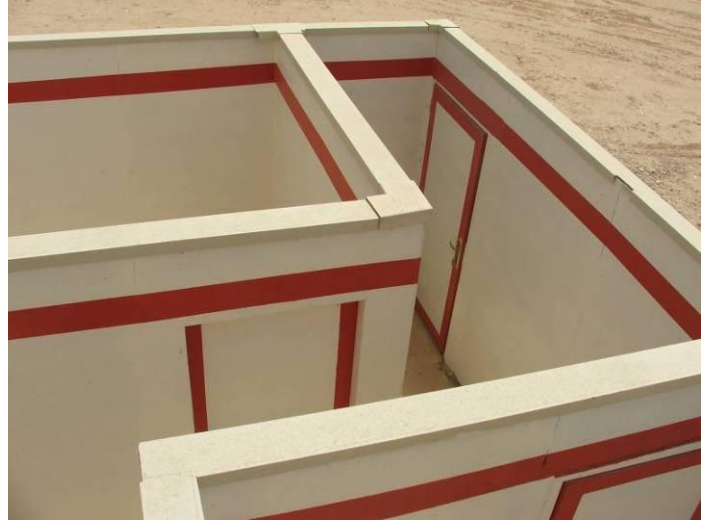
No significant cracking or displacement of the slab was observed, although minor shrinkage and cracking were present, which indicates poor curing practice. However, the minor shrinkage and cracking should not affect the structural integrity of the slab. The training structures utilized modular, panelized construction with bolted connections between the panels. The training structures were constructed without a roof. The panels were arranged to provide rooms and corridors with some panels containing entry doors (Site Photo 14).

**Site Photo 14. MOUT facility interior**

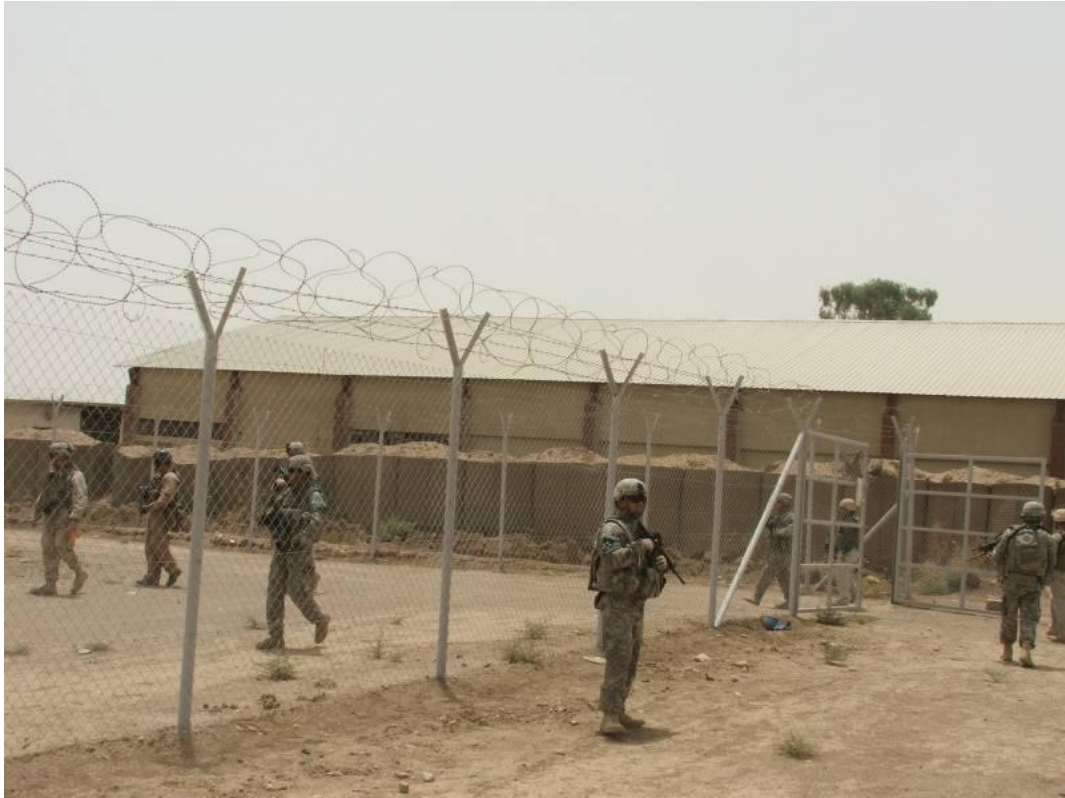
**Site Photo 19. Perimeter fence for combat assault course**
