ASC-TR-2010-5002

THREATS TO AIRCRAFT STRUCTURAL SAFETY, INCLUDING A COMPENDIUM OF SELECTED STRUCTURAL ACCIDENTS / INCIDENTS

**Engineering Directorate (ASC/EN)
Aeronautical Systems Center**

**MARCH 2010
Final Report**

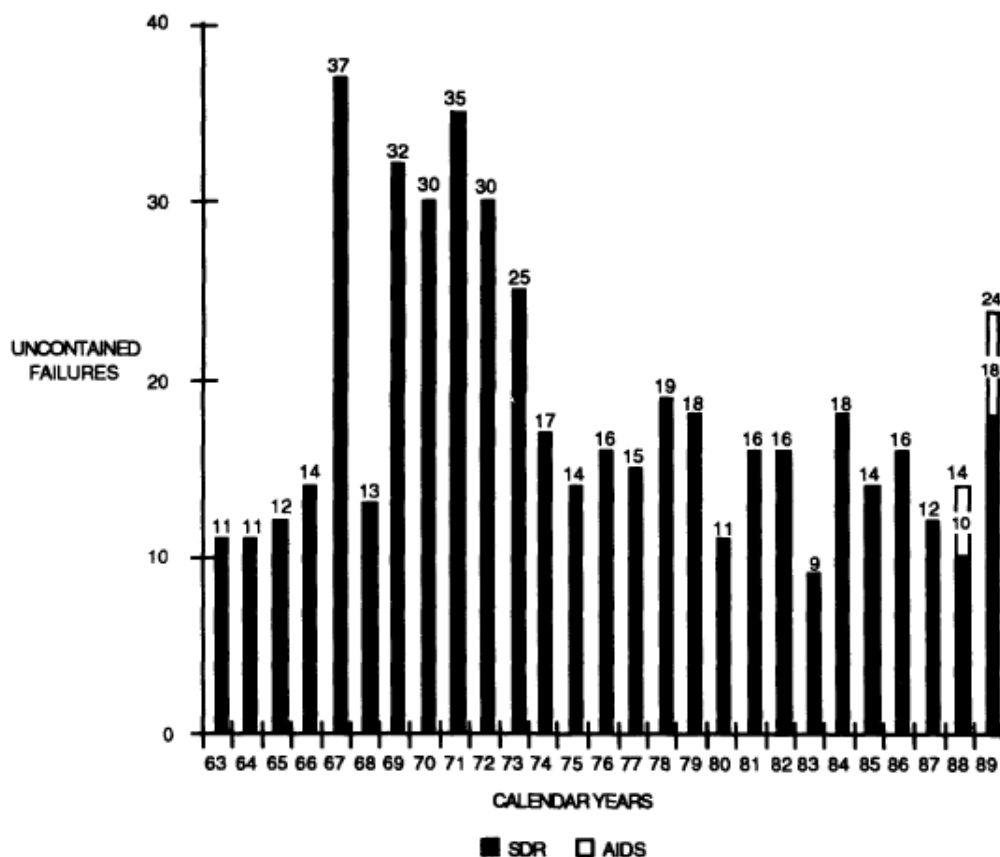
Figure 1: Uncontained Rotor Statistics (1963-1989) [22]

It should be noted that, prior to 1988, the data in Figure 1 include only the uncontained rotor failures that were reported in SDRs and not from AIDS, so those earlier years may underestimate the number of failures. In total the figure shows about 500 uncontained failures in the U.S. over the 27-year period.

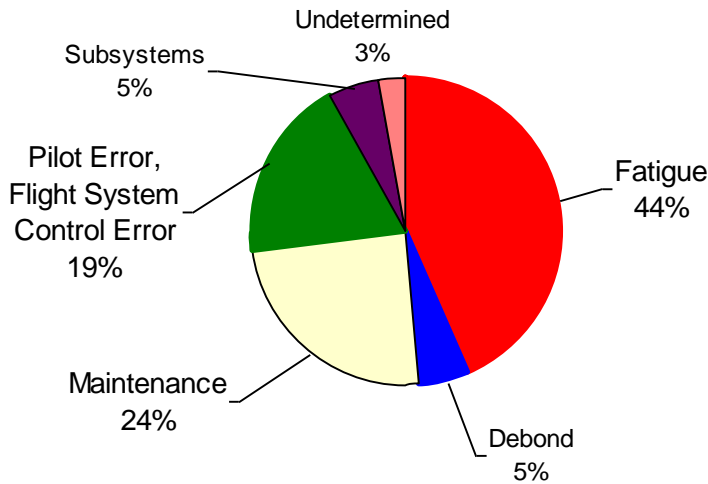
Babish [29] summarized all 37 USAF aircraft losses attributed to structural failures (as defined by the USAF Safety Center) that have occurred to since 1972. Babish determined that seven of the 37 structural failures were attributed to overloads caused by pilot error, flight control system errors or to a combination of these two errors. Figure 2 provides a summary of the percentages of catastrophic aircraft structural failures due to non-combat causes of the 37 aircraft.

Figure 2: Percentages Associated with Types of Causes Associated with 37 USAF Structural Failures [29]

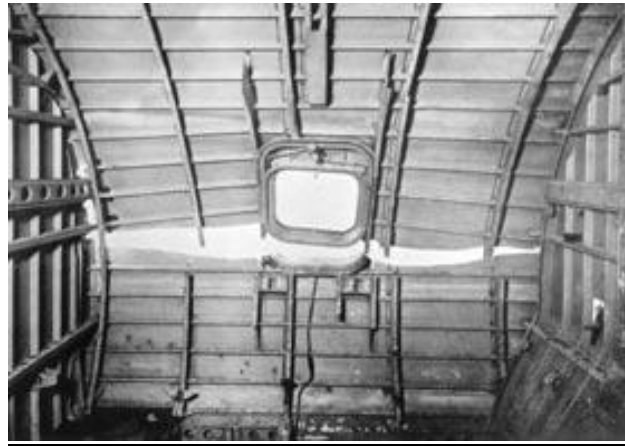
so as to achieve large critical crack sizes. If the structure had been designed to be fail-safe to today's standards initial manufacturing defects could have been tolerated without resulting in catastrophic failure. Figures illustrating this lack of crack containment capability of the fuselage structure (i.e., lack of fail-safety) and photographs taken as part of the failure investigation are shown in Figure A5.

Figure A.5: Uncontained Running Cracks Caused the Breakup of this Hydro Test of the Retired Comet 1 (G-ALYU). Cracks Propagating from Forward Escape Hatch on the Port Side. Note that No Straps or Shear Tied Frames were Used. No Crack Arrestment Capability was Provided by this Construction. [A2]

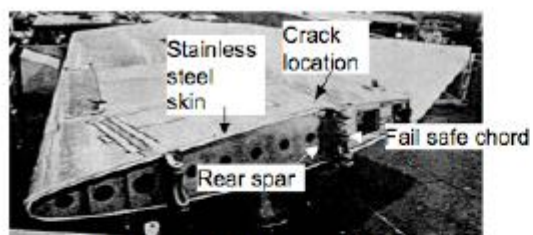
Boeing 707-300 series tailplane

On May 14, 1977, a Boeing 707-300 operated by Dan-Air Services crashed on approach to Lusaka International Airport, located in Lusaka, Zambia. The accident was caused by the fatigue failure of the right horizontal stabilizer or tail-plane. This was followed by a loss of control and the crash killing all 6 occupants. While the aircraft had been certified as fail-safe per the 1956 CAR 4b.270 requirements, the upper rear spar chord failure (which occurred about 100 flights earlier) was not discovered prior to the failure of the fail-safe chord during this final landing approach. See a photograph and a sketch of the design in Figure A18 [A19].

Post accident flight tests revealed that deployment of the speed brakes during landing role produced a horizontal load spectrum, which was significantly more severe than assumed during the original design. Obviously, a good knowledge of both the external loads (and load spectrum) and the local internal loads are essential in predicting crack initiation, crack growth and fail-safe residual strength, which leads to this second lesson-learned:

Figure A18: Photo of Right Horizontal Stabilizer that Separated from B-707-321C Aircraft and Details of “Fail-Safe” Structure Associated with the Accident

It is essential that load surveys be performed to develop accurate loads and load spectra (including both ground and flight loads) for use in damage tolerance (i.e., crack growth) analyses, fatigue analyses and fail-safe residual strength and life analyses. These load spectra are also very important for the full-scale fatigue test.

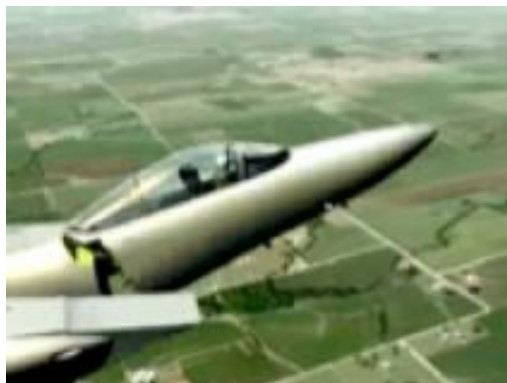
On November 2, 2007, an F-15C flown by the Missouri National Guard broke apart in mid-air and crashed during a training exercise. An artist rendition of how the forward fuselage of this aircraft manufactured by McDonnell-Douglas separated just behind the cockpit is shown in Figure A22 [A23].

Figure A22: Artist's Rendition of F-15C Forward Fuselage Separation

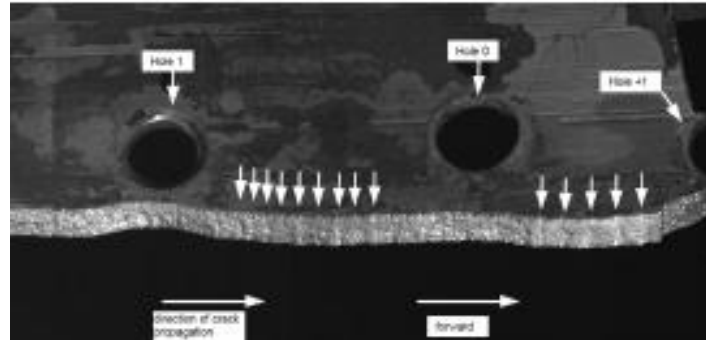
Figure C15 is a photograph of a portion of the fracture face showing bands of fatigue growth following increments of unstable crack growth and arrest (i.e., termed quasi stable growth by BMT). Each of the bands of fatigue growth represents a number pressurization cycles. Note that the crack location is outside the outer row of fastener holes, but still covered by the doubler.

Figure C15: Quasi-stable Crack Growth Identifying Numerous Starter Cracks (Prior to Final Fracture) [C9].

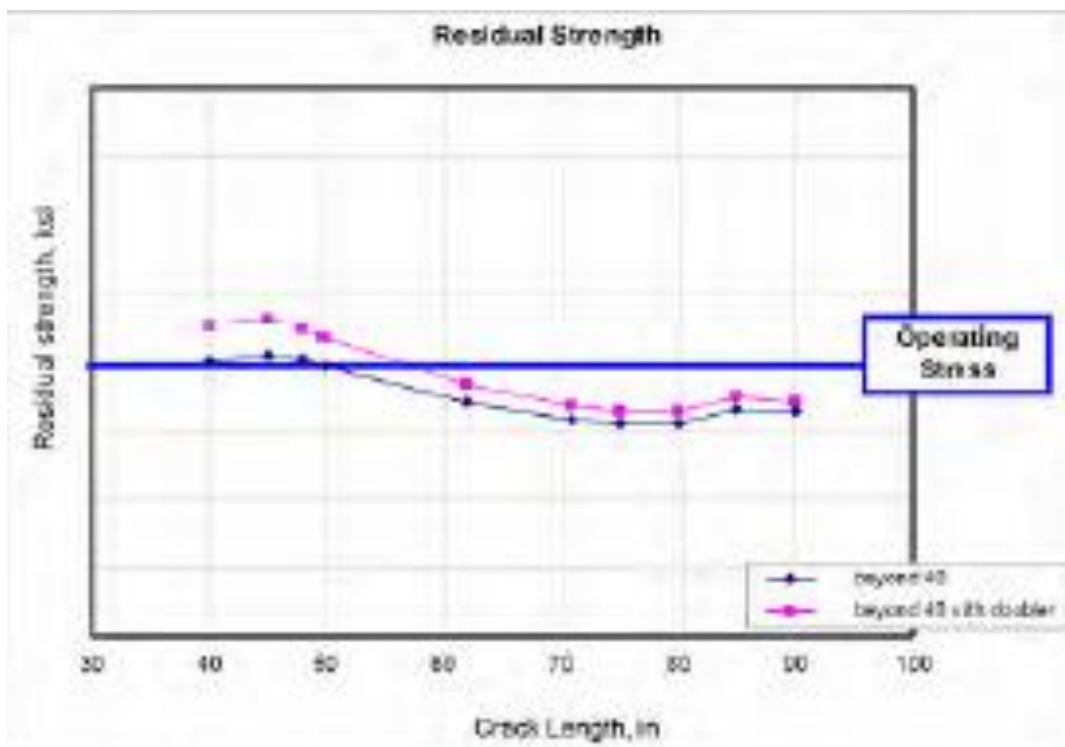
Boeing developed a non-linear finite element model to predict the effect of the doubler on the residual strength vs. crack length, when the skin was cracked in the observed location and not allowed to bulge because of the doubler. The analysis indicated that the doubler does increase the residual strength by a small amount and the crack length at failure was increased from about 50 inches to about 58 inches when the doubler was installed. This was attributed to the doubler allowing increased load redistribution around the cracking area and a small decrease in the crack tip stress intensity. This result is shown in Figure C16. It is noted that this prediction is conservative when compared to the previously mentioned 71 inch and 93 inch values. At any rate the structure has a very large damage capability in excess of a two bay crack length.

Figure C16: Predicted Residual Strength vs. Crack Length [C9]

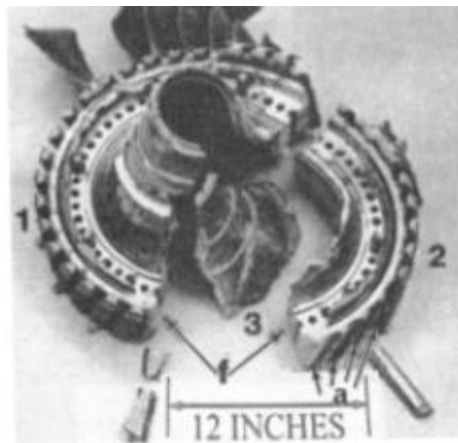
Figure F12. Photo of Fractured Pratt & Whitney Compressor Fan Disk

The National Transportation Safety Board determined that the probable cause of this accident was the fracture of the left engine's front compressor fan hub (i.e., disk) as shown in Figure F12, which resulted from the failure of Delta Air Lines' fluorescent penetrant inspection process to detect a detectable fatigue crack initiating from an area of altered microstructure (i.e., a manufacturing defect) that was created during the drilling process by Volvo for Pratt & Whitney and that the defect went undetected at the time of manufacture.

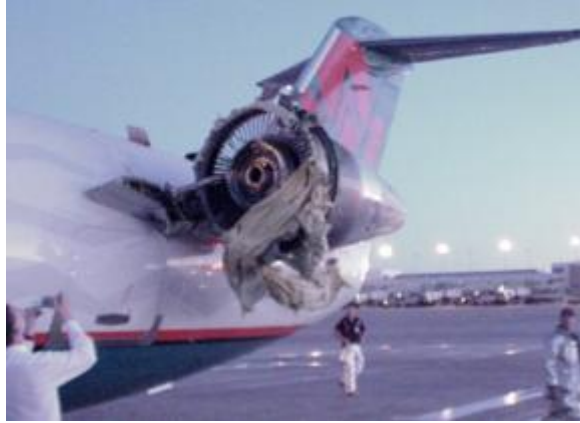
Figure F14: Photo of Damage Associated With Engine Failure

On January 25, 2007 a CRJ-200 aircraft operated by Mesa Airlines experienced an uncontained engine failure during a flight between Denver and Phoenix. The No. 1 engine, a GE CF34-3B1, threw a fan disk and blades during cruise. The debris took out the engine's forward cowling and punctured the fuselage as it departed the aircraft as shown in Figure F14 [F8].

While the No. 1 engine experienced a fan disk separation, it resulted in the separation of the inlet, fan rotor assembly, the fan containment case, and portions of the thrust reverser. The airplane reversed course and landed without further incident. Post incident examination revealed damage to the aft portion of the fuselage and empennage. An examination of the remaining airplane systems revealed no anomalies. Portions of the fan disk were recovered and examination of the fan disk revealed fatigue striations emanating from the aft bore corner of the fan disk. The striations came from an area that exhibited characteristics consistent with arc-out damage, which was the result of improper assembly and marking procedures during the electrochemical etching process. This damage was not detected during the manufacturer's quality assurance process used by the manufacturer. Further, the operator did not detect this damage while conducting the inspections prescribed through required airworthiness directives because the inspection procedures required were not detailed enough to detect the arc-out damage and the maintenance personnel did not receive appropriate training. Following the incident, the manufacturer issued alert service bulletins and the FAA issued an airworthiness directive to resolve these issues.

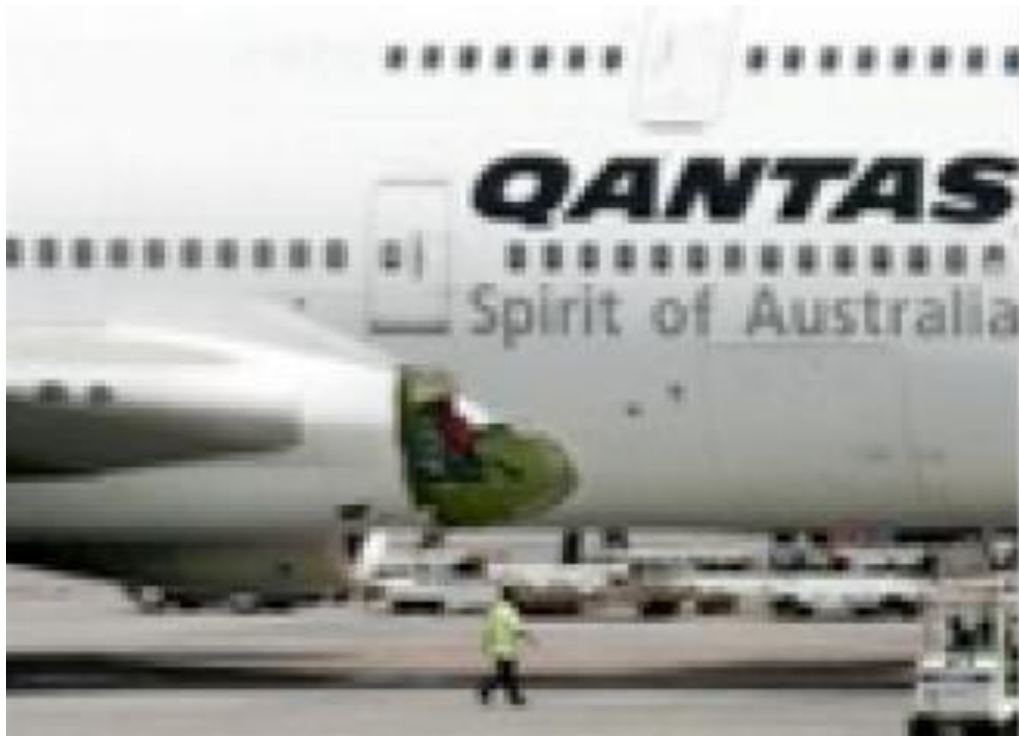
Figure I2: Photo of Boeing 747 Fuselage after On-Board Explosion

On July 25, 2008 a Qantas Airline Boeing 747 enroute to Melbourne, Australia from London was cruising at 29,000 feet when it experienced an explosive decompression of the fuselage. Per standard procedure the plane immediately descended to 10,000 feet and minutes later made an emergency landing at the Manila airport in the Philippines. There were 346 passengers onboard and there were no fatalities or injuries to any of the passengers or crew. Upon post flight examination a large hole was seen in the lower right side of the fuselage just forward of the wing. This is shown in the photographs in Figures I2 through I4 [I1].

On August 29, 2008, the Australian Transportation Safety Bureau (ASTB) confirmed that the incident was caused by the bursting of one of two oxygen bottles that were located in this area of the cargo compartment and has been found to be missing. Also, shards from the missing oxygen bottle and the oxygen regulator valve were found in the fuselage. This investigation the failure provides another strong testament to the importance of having fail-safe structures with large design damage sizes.

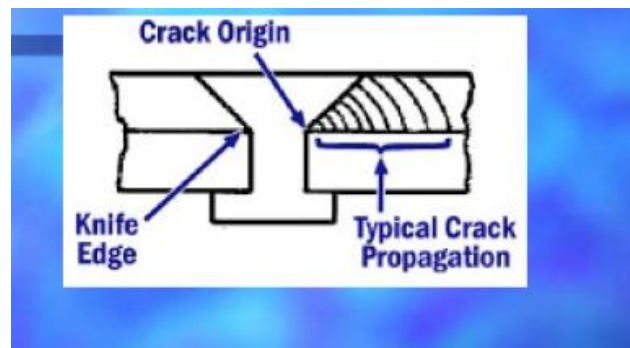
Figure J5: Sketch Illustrating the Development of Small Fatigue Cracks in the Skin

The investigation of the failure revealed that it initiated in the upper row of rivets in the stringer no. 10 (S-10) longitudinal lap splice that was a cold bonded and riveted joint. Boeing used this cold bonded design in the first 291 737 aircraft. However, it was later discovered that cold bonded joints can be subject to disbonding when moisture is present. When this occurs all of the pressure induced hoop load is transferred through the rivets rather than the bonded surface. This induces very high stress concentrations at the knife edge countersinks in the outer skin and fatigue cracks initiate. This is illustrated in the sketches shown in Figures J5. and J6.

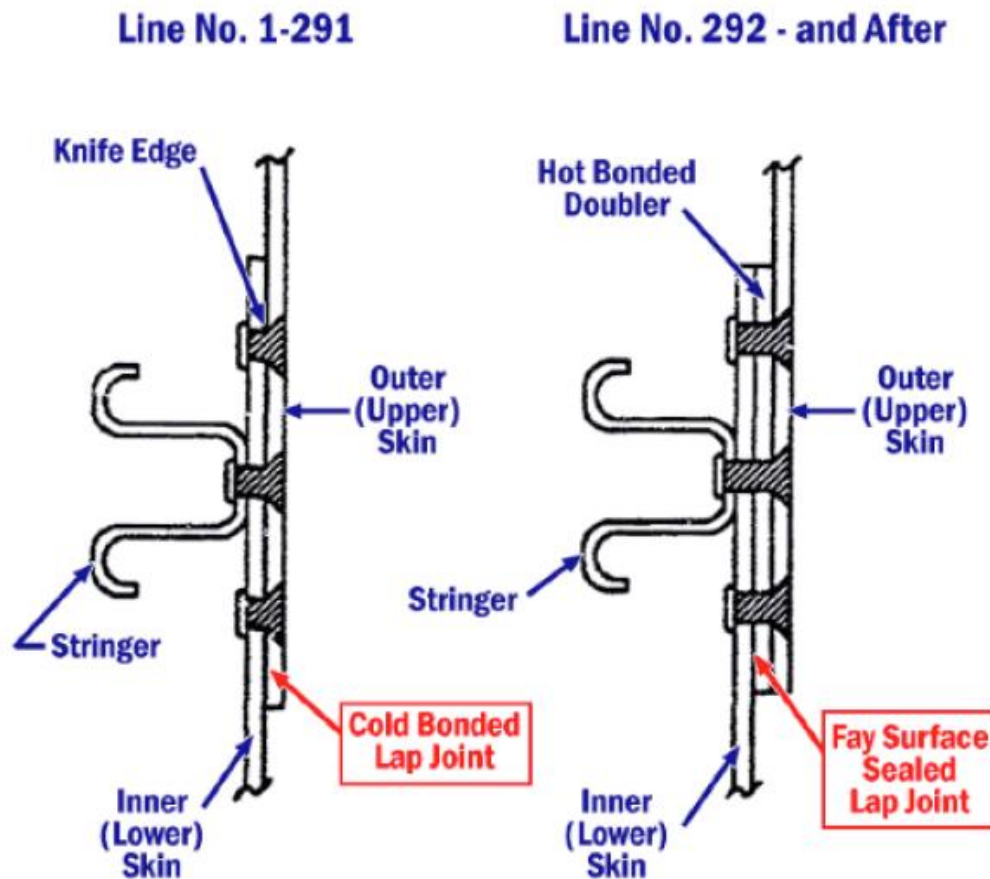
Figure J8: Sketches Illustrating the Lap Splice Joint Designs of the B737 Aircraft

On Boeing 737 aircraft beyond the 291st aircraft manufactured, the lap splice joint design was improved with the incorporation of a moisture resistant hot bonded doubler, which was expected to substantially delay the onset of WFD. This improvement is compared to the original design in Figure J8.

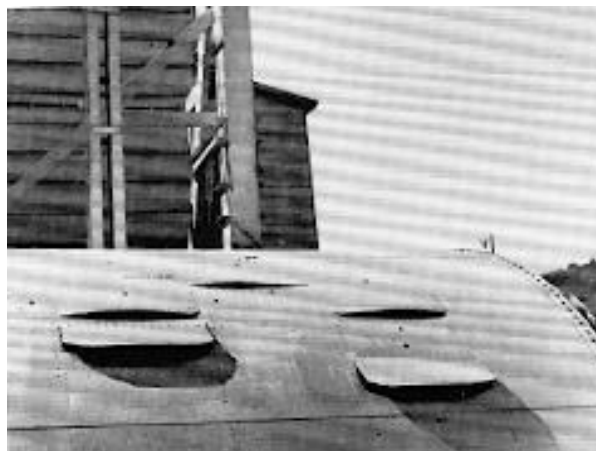
Figure K1: Boeing 707 Quonset Hut Test

In the 1950s Boeing conducted about 30 guillotine tests on pressurized sections of the 707 fuselage (called Quonset huts), where blades were dropped through various structural configurations until crack arrest designs were achieved. Figure K1 is a photo of an early 707 Quonset hut showing several arrested blade penetrations [K1].

Several of the 707 guillotine tests demonstrated arrested longitudinal crack lengths greater than 2 frame bays in length. The maximum-recorded length was 43.6 inches. The fail-safety of the 707 fuselage was subsequently demonstrated by an Aer Lingus incident in 1970 when a fuselage frame failed and a 40 inch skin crack was arrested. See Appendix A.10 for a discussion of the Aer Lingus incident in the Compendium of Accidents/Incident Data.

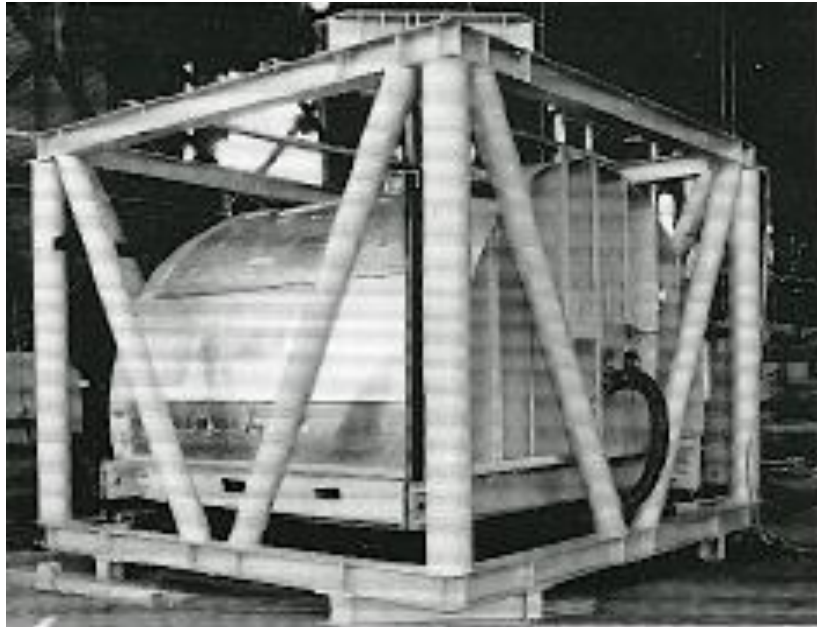
Figure K2: Boeing 737 Quonset Hut Test Setup

Fuselage fail-safe tests were continued with the development of the 737, but with a double bladed guillotine so as to sever the central frame as well as the skin. The test fixture is shown in Figure K2; the double bladed penetration is shown in Figure K3; and, the final two bay arrested crack with broken frame is shown in Figure K4.

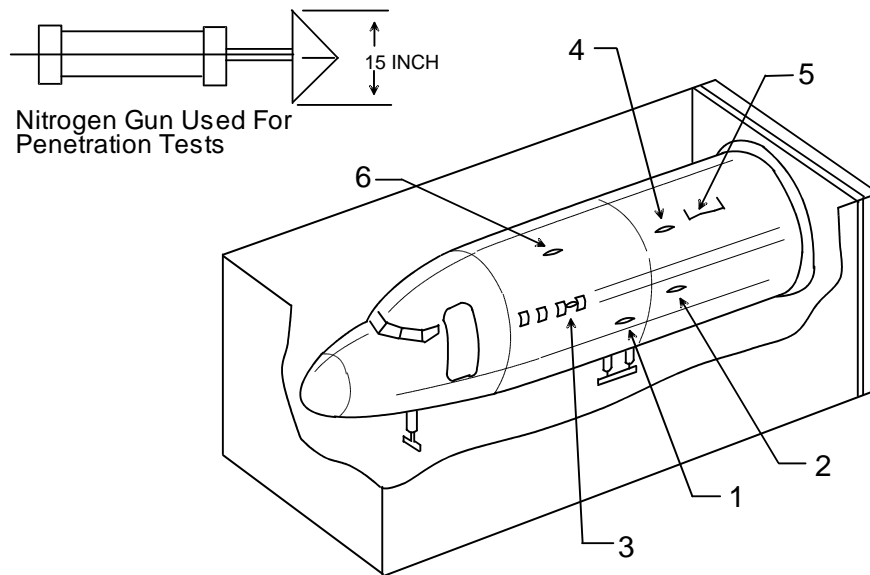
Figure K5: DC-8 Wedge Penetration Tests

Like Boeing, Douglas Aircraft was developing their first high altitude jet transport (i.e., the DC-8) at the time of the Comet accidents. Also, like Boeing they embarked on development testing to ensure that their new airplane had crack arrest fail-safe capability. This development testing involved many fatigue test specimens, more than 30 large curved panel tests pressurized fatigue tests and, finally, wedge penetration tests on a full-scale pressurized fuselage, which also had inertial loads applied. A nitrogen pressure gun with a 15 inch wide blade was used to penetrate the fuselage shell and various stiffening elements. Penetrations were made at six different locations on the fuselage as shown in Figure K5 [K2].

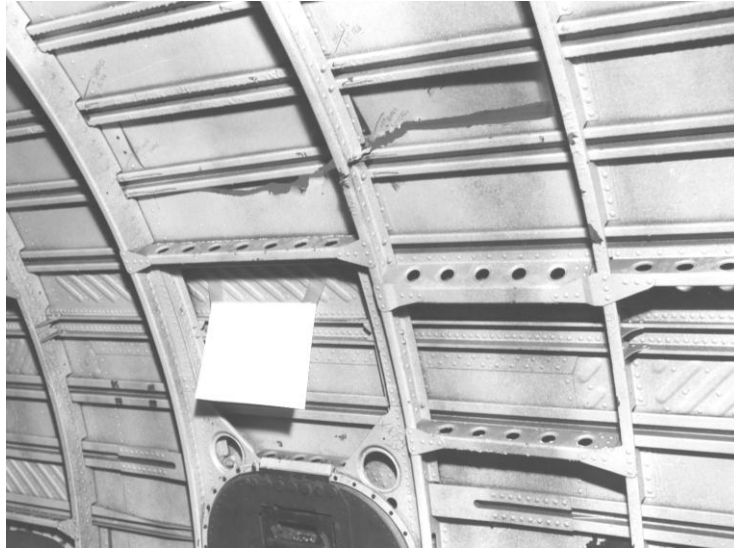
Figure K7: View Inside the DC-8 Fuselage

In Test number 5 the 15-inch blade penetrated the skin, the circumferential frame, the longitudinal stringer and the two bay crack flapped open and the fuselage safely depressurized. This is illustrated in the sketch in Figure K6 and shown in the photograph in Figure K7.

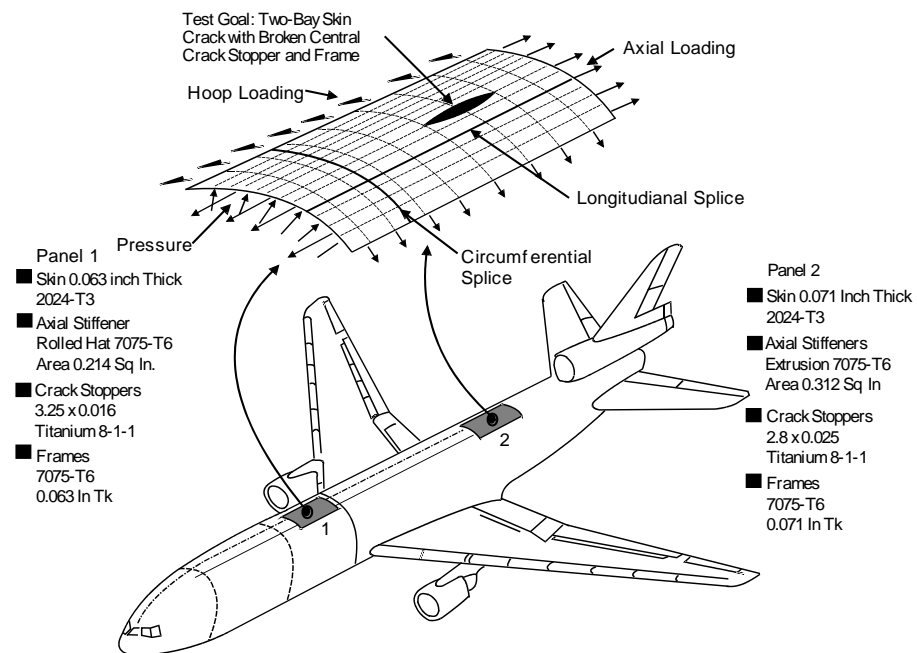
Figure K8: DC-10 Fuselage Curved Panel Tests

During the development of the DC-10 during the mid to late 1960's Douglas had another extensive analysis and test effort to ensure the large damage fail-safe capability of the pressurized fuselage. The entire fuselage was analyzed, tested and certified to be able to sustain a two-bay longitudinal skin crack with both the central frame and tear strap broken. Also, it was analyzed, tested and certified to be able to sustain a two-bay circumferential crack with a broken central stiffener. Numerous developmental tests were performed to select materials, to correlate with analyses, to assess crack stoppers, and to finalize detail designs. These tests included small specimens, stiffened panels and pressurized, externally loaded small cylinders and large curved panels. Finally, large curved panels were subjected to cyclic internal pressure, external loads, large damage and static over pressure to demonstrate the fail-safe capability of the structure. A sketch of the two most important residual strength tests is shown in Figure K8 and a photograph of the curved panel vacuum fatigue test machine is shown in Figure K9.
