RELIEF AND RECONSTRUCTION
FUNDED WORK AT MOSUL DAM
MOSUL, IRAQ

SIGIR PA-07-105
OCTOBER 29, 2007

SUBJECT: Report on Relief and Reconstruction Funded Work at Mosul Dam, Iraq
(Report Number SIGIR PA-07-105)

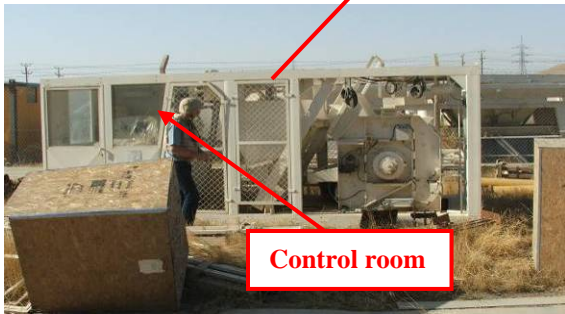
Site Photo 14. Concrete batch-mixing plant control room

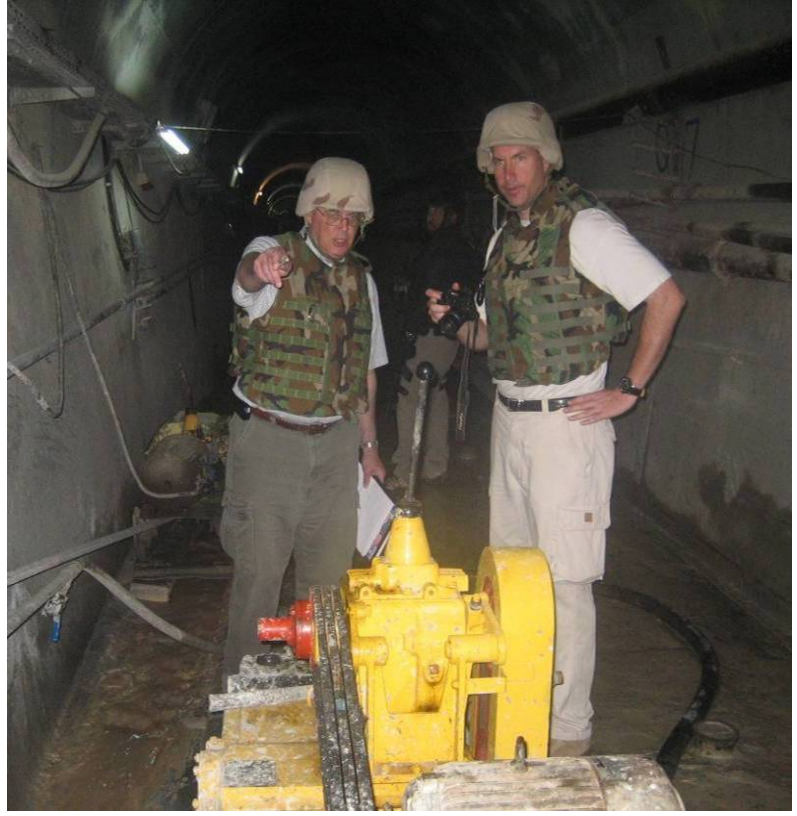
During our site visits, we observed dam personnel conducting drilling and grouting work outside and inside the gallery. We observed outdoor drilling (Site Photo 41), which must be done prior to grouting. Inside the gallery, we witnessed one hole being actively grouted. Specifically, we viewed an agitator actively mixing grout (Site Photo 42) and a grout pump actively placing the grout into a hole (Site Photos 43 and 44). In addition, ITAO representatives stated grouting activities were also ongoing during a previous site visit (Site Photo 45). Figures 8 and 9 also verify that the dam personnel are still operating a continuous grouting program.

Site Photo 43. SIGIR inspector pointing out an active grout pump placing grout into a hole
