**REPAIR OF THE AL GHAZALIYAH
G-7 SEWAGE LIFT STATION**

UNDER THE COMMANDER'S EMERGENCY RESPONSE PROGRAM

BAGHDAD, IRAQ

**SIGIR PA-07-118
JANUARY 25, 2008**

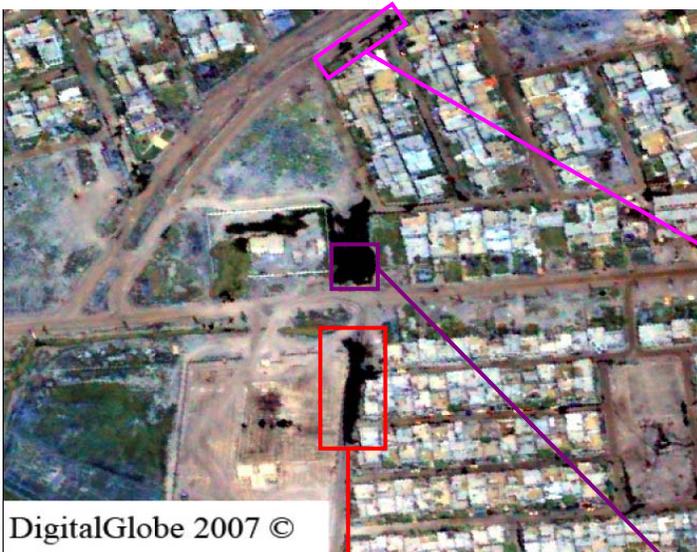
Aerial Image 3. Streets surrounding the G-7 lift station

During both site visits, SIGIR identified several streets in the Al Ghazaliyah area with backed-up sewer water (Aerial Image 3 and Site Photos 3-5).

The degree of the streets' backed-up sewer water varied from several inches deep near the gutters to the entire width of the street.

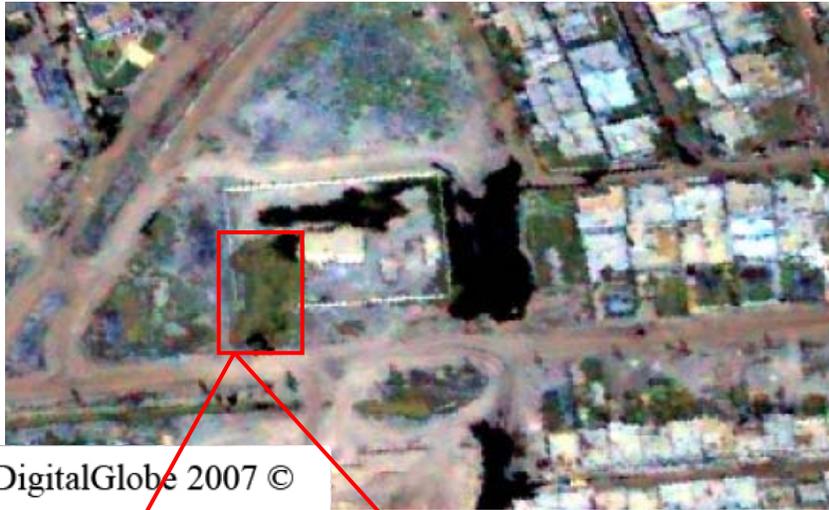
Aerial Image 4. Aerial view of the Al Ghazaliyah G-7 Sewage Lift Station

Inspectors also viewed a large pool of collected sewer water outside the sewage lift station building (Aerial Image 4 and Site Photos 6 and 7). During our site visit, maneuver unit personnel stated that the sewer pipes leading into the facility were old and broken. Considering the depth of the sewer water pool and the growth of weeds around it, the sewer line was broken for an extended period. However, the SOW did not address the problems with the broken sewer pipes. Without addressing this problem, the completion of this project will not lead to a "complete and useable facility" because the sewer water will not enter the lift station's wet well (to be pumped out to the next manhole).

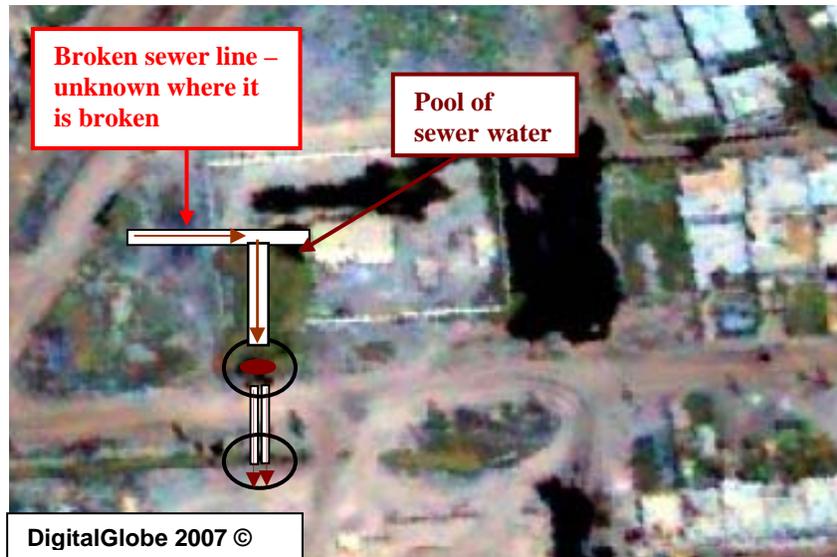
The use of the submersible pump inside the manhole appears to be a short term solution to deal with the large pool of sewer water outside the lift station building. Since the broken sewer pipe does not allow sewer water into the facility, the accumulation of sewer water grew each day. Installing the submersible pump into the wet well of the lift station would not help to alleviate the growing pool of sewer water outside.

Though nothing was documented in the contract file, it is our opinion that a decision was made to use the submersible pump to reduce the accumulated pool of sewer water. The sewer water was at least partially redirected to the outside manhole and the submersible pump attempted to pump the water out of this manhole to the next manhole across the street. SIGIR could not determine if the sewer water was redirected from the previous manhole or if a trench was dug from the standing pool of sewer water (Aerial Image 5). However, either the submersible pump was not operational or was limited by the lack of available power, which necessitated the use of the above ground diesel pump. The contract file did not address this diesel pump and it was not included in the original SOW.

It is not clear if the submersible pump will remain in the manhole or whether it will eventually be moved into the lift station facility. The use of the submersible pump and the diesel pump to alleviate the sewer water pool has had little effect because inspectors noticed a significant accumulation near the side of the lift station facility.

Aerial Image 5. Aerial view of the flow of sewer water from the manhole outside the G-7 lift station to the next available manhole across the street
