**REHABILITATION OF THE MANSOUR
PUMP STATION**

UNDER THE COMMANDER'S EMERGENCY RESPONSE PROGRAM

BAGHDAD, IRAQ

**SIGIR PA-07-111
JANUARY 24, 2008**

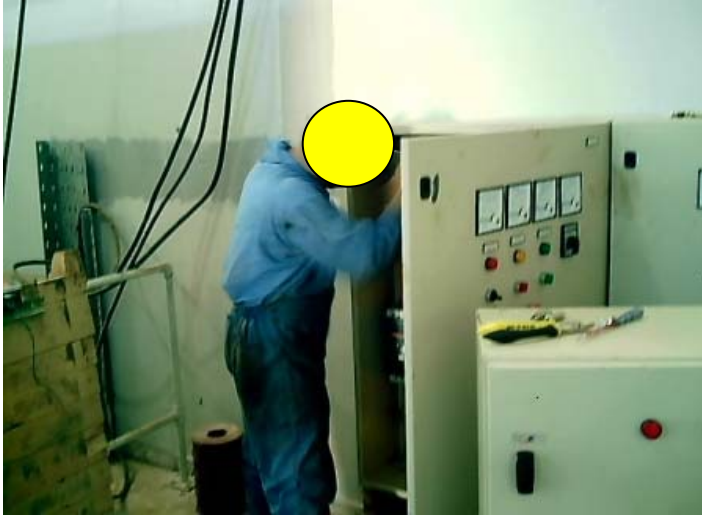
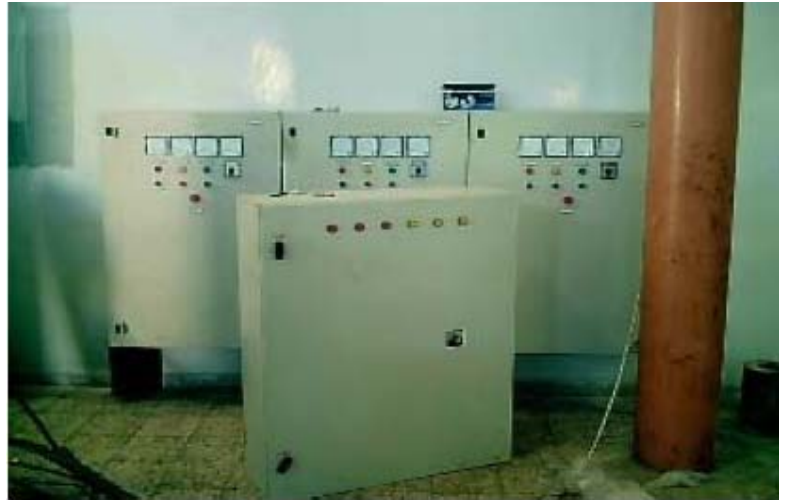
The USACE contract file documentation provided photographs of the contractor during installation of the electrical control panels and the finished product (Site Photos 1 and 2).

Site Photos 1 and 2. Contractor installation of the electrical control panels and the installed control panels.
(Photos courtesy of USACE)

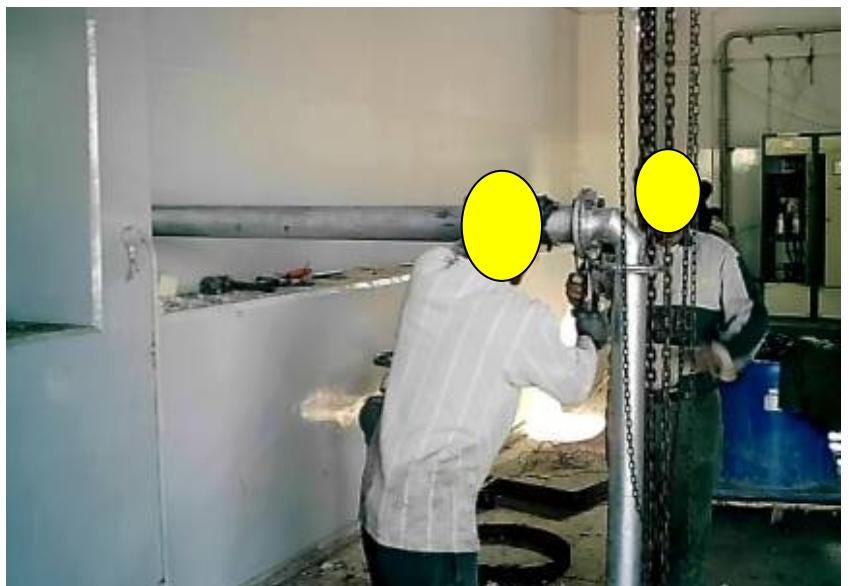
The USACE contract file documentation provided photographs of the contractor while installing the galvanized pipe for the submersible pump (Site Photos 3 and 4). According to the quality control (QC) report, dated 27 January 2007, the contractor “complete install the Submersible”; however, no quality assurance (QA) reports mentioned the installation of the contract-required submersible pump. The QC report did not provide any photographic evidence to document the installation of the submersible pump.

Site Photo 3 and 4. Contractors installing the galvanized pipe for the submersible pump.
(Photos courtesy of USACE)

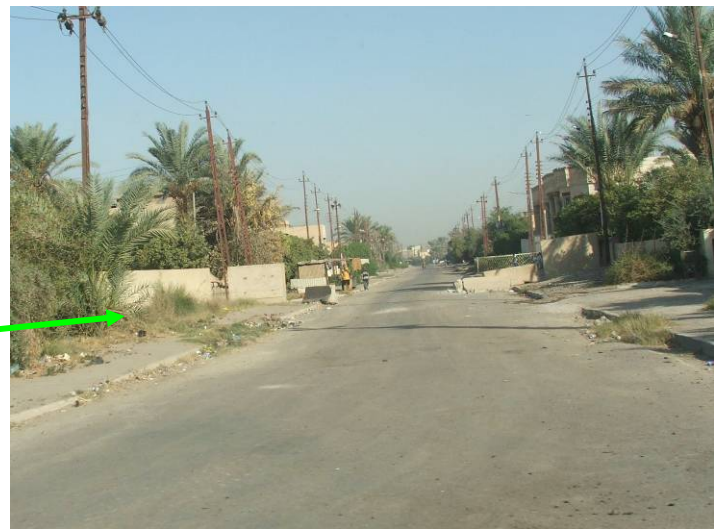
During our first site visit, we identified streets in the Al Amerea area with backed up sewer water and streets with no sewer water back up (Aerial Image 2 and Site Photos 9-11). While we conducted our site visit, a concerned resident of the area angrily complained about the backed up sewer water on his street.

Site Photo 9. Neighborhood street in Al Amerea

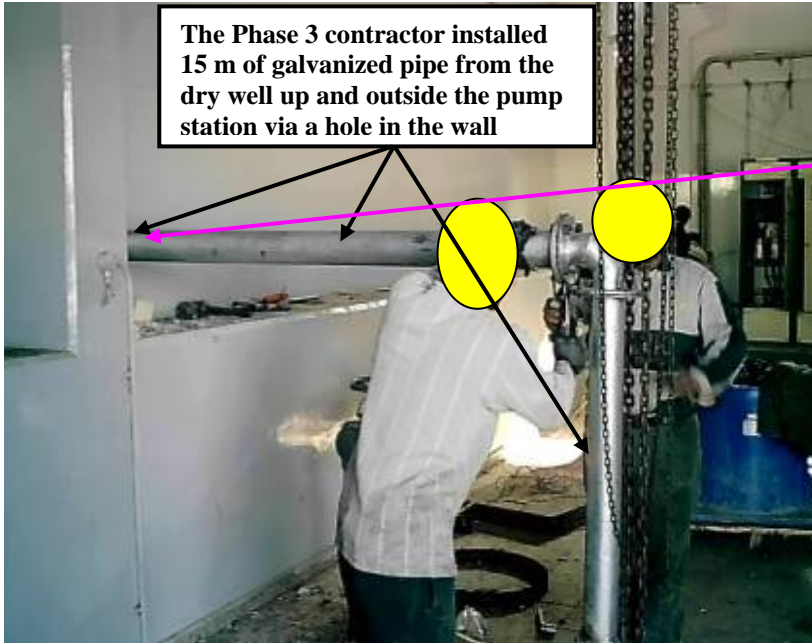
During our site visits, we first noticed that the galvanized pipe for the submersible pump that was installed by the contractor had been removed (Site Photos 15 and 16).

Site Photo 15. Installation of the 15m galvanized pump by the contractor. (Photo courtesy of USACE)

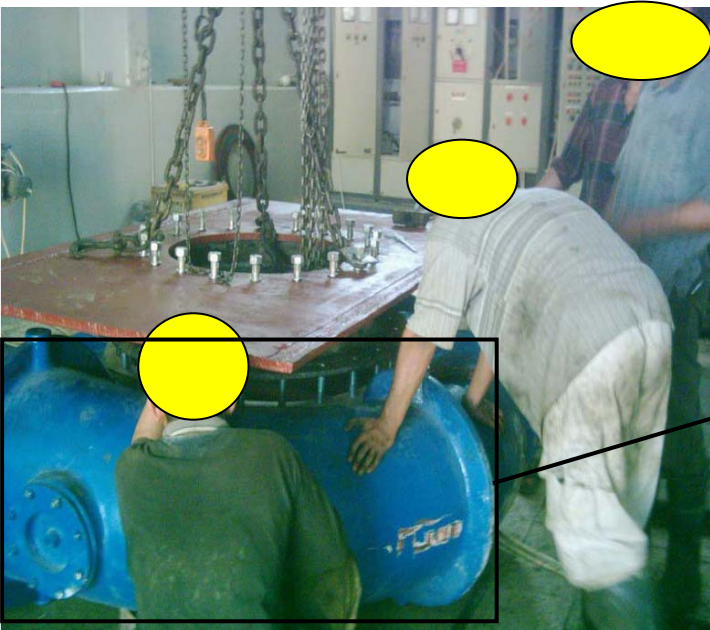
Without any contract file documentation to determine the condition of the vertical pumps prior to installation, we closely reviewed the vertical pumps from the QAR photographs. All we could determine was that, while sometimes cosmetically damaged, the vertical pumps appeared to be in relatively good condition (i.e. no rust or holes) (Site Photo 22).

Site Photo 22. View of the condition of 800 mm vertical pump installed by the contractor (Photo courtesy of the USACE)

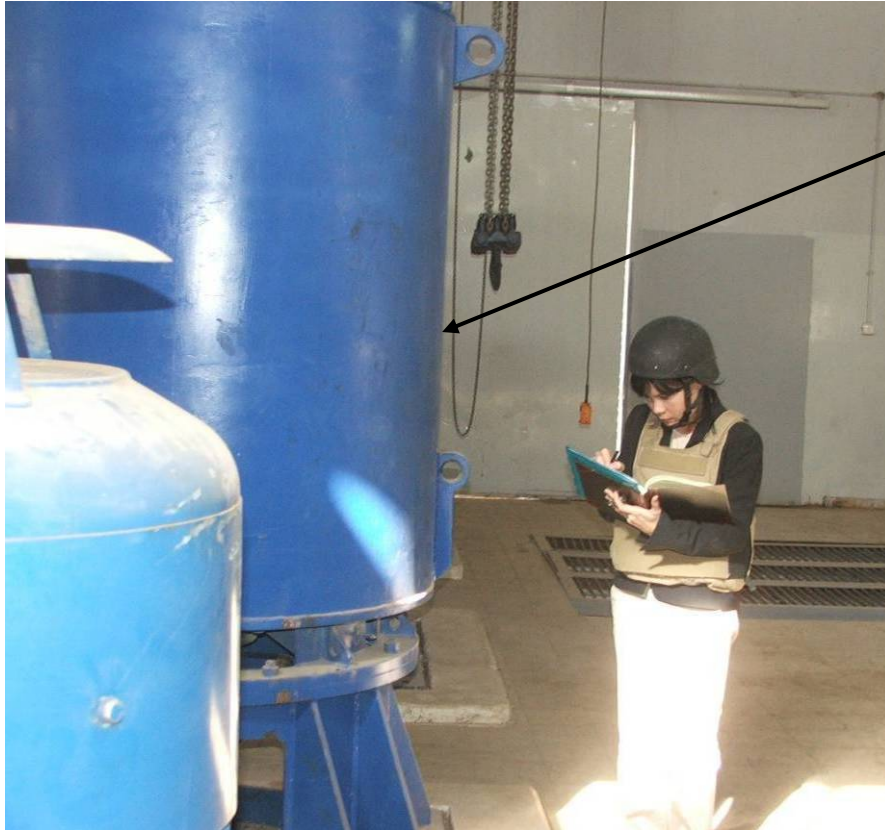
During our site visit, we recorded the vertical pump motor information to compare against the contract file documentation to determine if new motors had been installed (Site Photos 27 and 28 and Figure 3). Subsequent to the issuance of the draft report, the GRD officials provided a list of the serial numbers for the vertical pumps and motors. For example, we determined that the 800 mm vertical pump motor serial number matched the GRD's documentation.

Site Photo 27. SIGIR recording vertical pump motor information

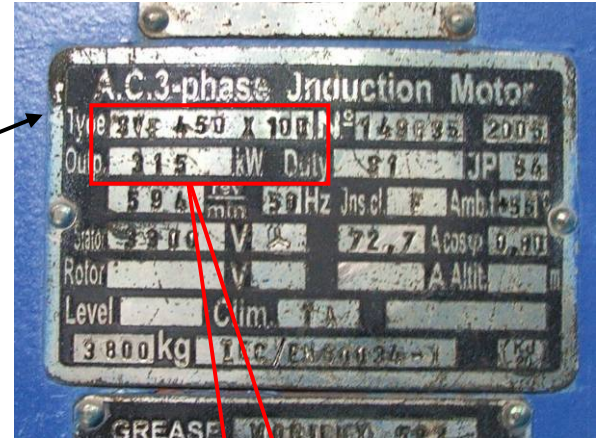
Site Photo 28. Face plate for vertical pump motor
