FIRE STATION CONSTRUCTION AINKAWA, IRAQ

SIGIR PA-06-036
APRIL 12, 2006

SUBJECT: Report on Project Assessment of the Fire Station Construction, Ainkawa,
Iraq (Report Number SIGIR-PA-06-036)

Fire Station Construction, Ainkawa, Iraq

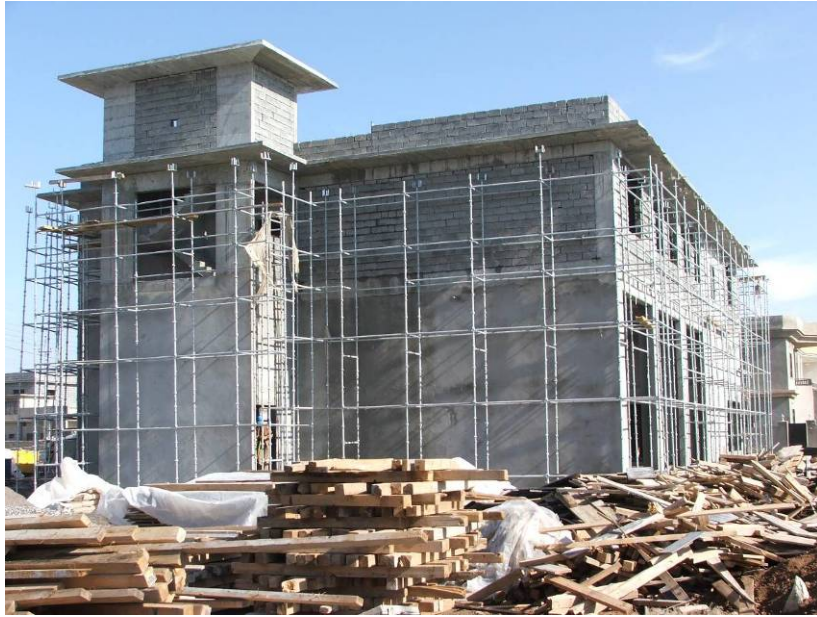
Structural components of the building included reinforced concrete foundations, beams, columns, floor slabs, and shear walls. The task order design and specification required all of the structural reinforced concrete on the project to be cast in place. Site Photo 2 shows the basic structure of the building and its general status at the time of our assessment and Site Photo 3 shows interior reinforced beams and columns.

Site Photo 2. Exterior view of the Ainkawa fire station

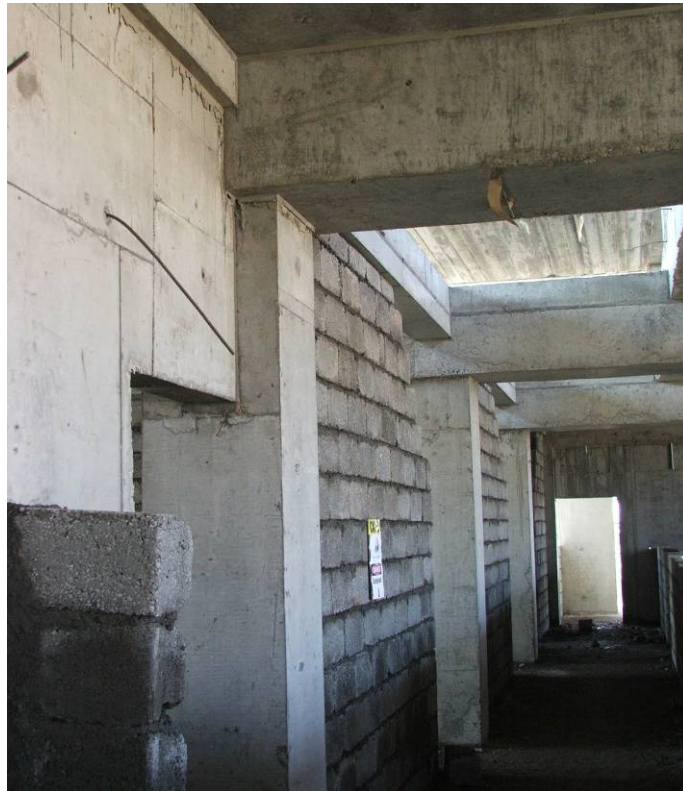
Site Photo 3: Interior structure showing concrete block walls, columns, and beams
