Considerations for Determining Safe Separation Distances from Mass Fires: a Literature Search

Thomas L. Boggs Jacobs Naval Systems Group, Ridgecrest, CA 93555

Policy Development Division Department of Defense Explosives Safety Board, Alexandria, VA

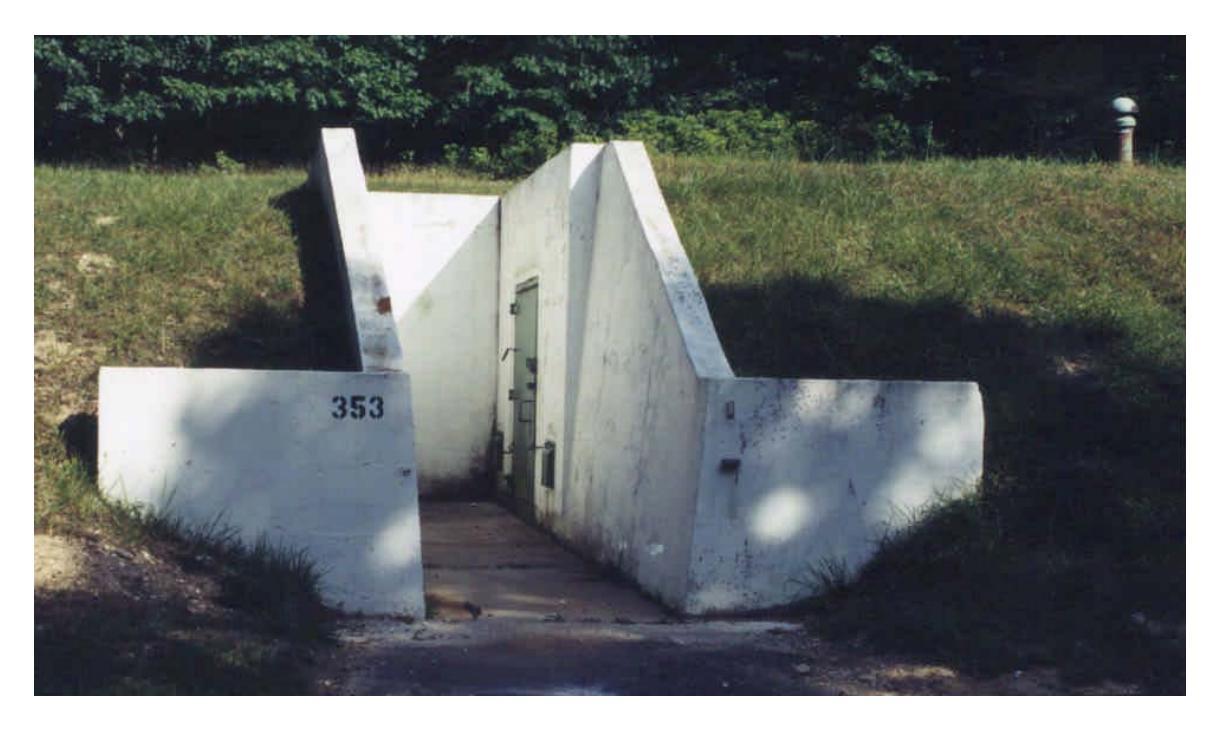
FIGURE 3. Magazine Similar in Design to One Destroyed at White Oak, Maryland, 28 June 1992.

Two explosions destroyed an earth-covered magazine similar to the one shown in Figure 3.

The magazine contained 5,180 pounds of largely HD1.1 materials. Fire was caused by decomposition of experimental energetic material, followed 2 minutes later by detonation of the other energetic materials. The magazine was destroyed. Debris including pieces of concrete 1 to 2 feet in diameter was thrown up to 800 feet. Smaller pieces of debris (concrete pieces up to 4 inches in diameter) were thrown as far as 2,000 feet.

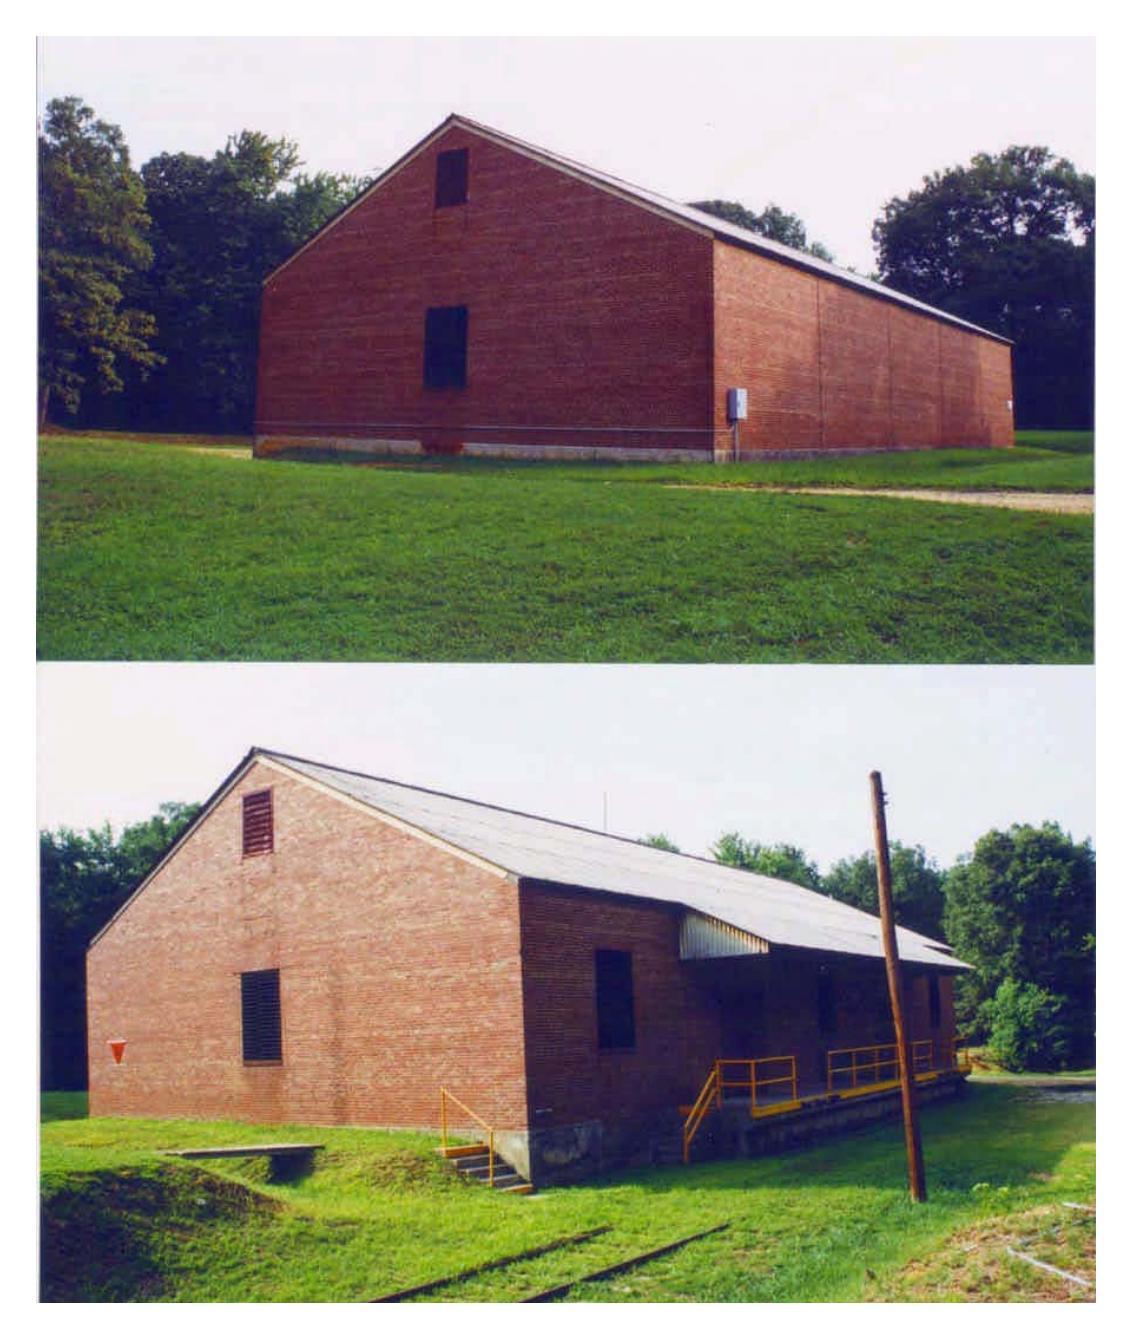
FIGURE 4. Magazines Similar in Construction to Magazine 518, Indian Head, Maryland. The structure after the fires and detonations is shown in Figure 5.

This accident occurred in a non-standard, above ground, non-barricaded structure similar to the ones shown in Figure 4.

The magazine was sited for storage of 500,000 pounds of HD1.3 materials. At the time of the accident, there were 93,522 pounds of HD1.3 material and 4,609 pounds of HD1.1 material. Most of the materials were bulk powders and propellants for cartridge-activated devices or propellant-activated devices (CAD/PAD). The HD1.1 material in the magazine was pyrotechnic/propellant material for which the hazard classification was in question. Later analysis determined it was HD1.1.

The surmised sequence of events started with auto-ignition of nitrocellulose gun propellant. The fire spread and involved a relatively large quantity of magnesium-teflon-viton flare material, which provided an intense boost to the fire. This in turn led to the first and largest detonation followed by a series of smaller detonations.

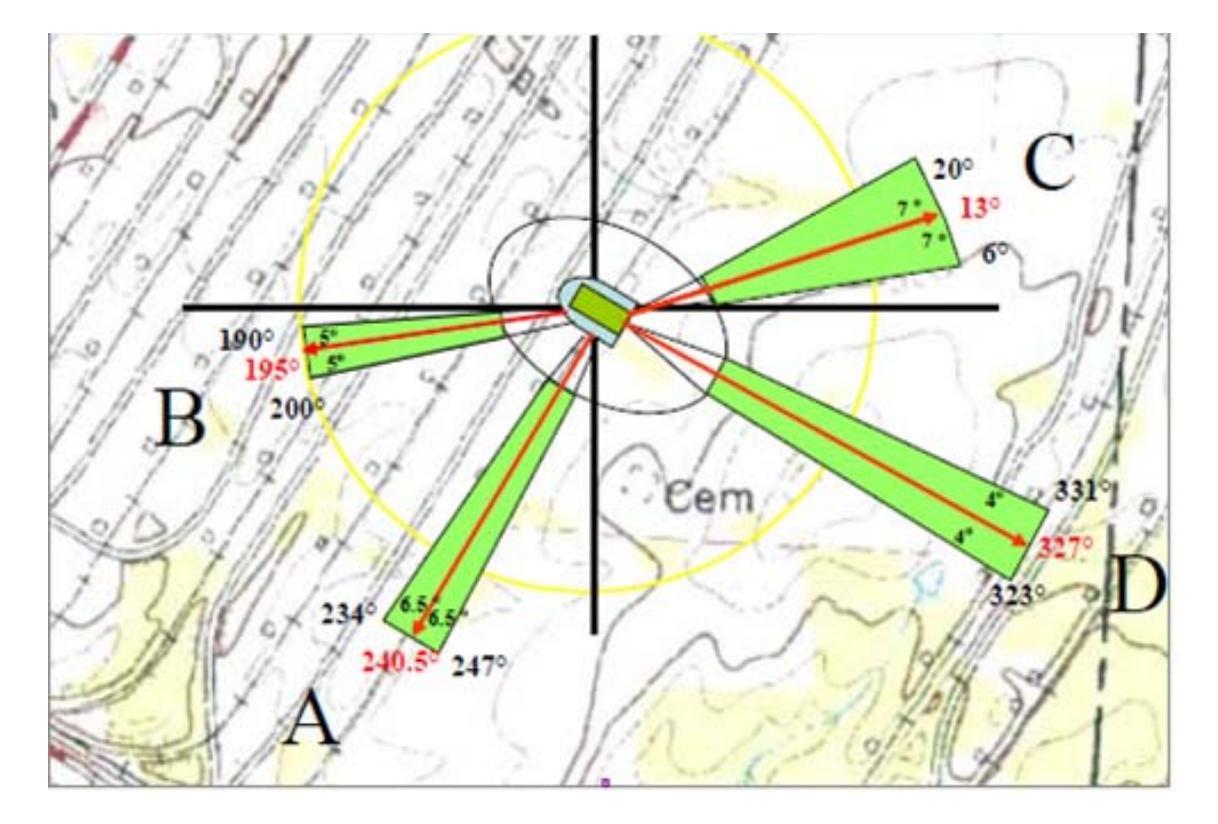
FIGURE 8. Search Sectors, Milan Accident 2004.

Subsequent debris mapping was conducted. All of the debris was from the structure of the earthcovered magazine. Four sectors were defined and the debris within each of the sectors was mapped. The four sectors are shown in Figure 8.

Most of the fragments were concrete, rebar, or a combination of both. Emphasis was placed on hazardous fragments having an impact energy of 58 ft-lb or greater and/or a weight greater than 6.17 ounces (175.5 grams). The vast majority of the fragments were hazardous. The fragments were addressed in the following two fashions: one was simply a unit count, each fragment counted as one item, and the other was a weight-equivalent count where each fragment's weight was divided by the minimum weight of a hazardous fragment (6.17 ounce). The results show the following in terms of less than one hazardous fragment per 600 square foot area:

- Sector A. For the unit count method, there is a problem (more than one hazardous fragment/ 600 ft²) from 1,250 to 1,300 foot radius, and no problem out to 1,750 feet. However, for the weight-based count, there is a problem from 1,250 to 1,350 feet and again at about 1,550 feet.
- Sector B. There are essentially no problems for either the unit- or weight-based count from 1,250 to 2,400 feet radius.

- The use of unit count indicates excessive hazardous fragment density beyond the 1,250 IBD arc in one sector (A).
- The use of weight-equivalent count indicates excessive hazardous fragment density beyond the 1,250 IBD arc in three sectors (A, C, and D).

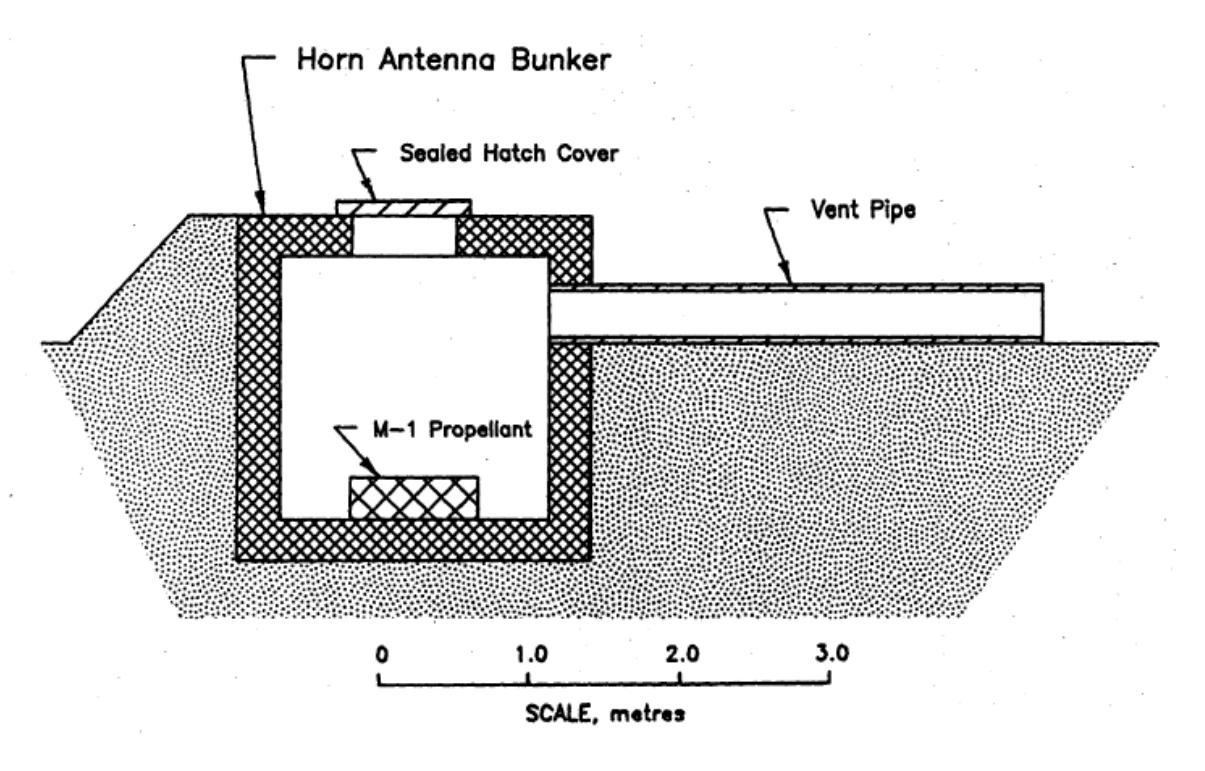
FIGURE 15. Schematic of Bunker, Vent Pipe, and Sample Location.

In the test described by Joachim (Reference 6), the plume distance from subscale tests depended on the loading density of propellant to available volume of chamber, and vent area to chamber volume. Joachim had a single container of 1.4 by 1.9 by 1.9 meters with a 35.6-cm-diameter vent tube. The reinforced concrete walls, roof, and floor were 30 cm thick. Single perf M-1 gun propellant was placed in the container in varying amounts to provide loading densities of 2, 5, 20, 50, and 100 kg/m³. The bunker, vent pipe, and sample location are shown in Figure 15.

Test C-1 was 10 kg of M-1 propellant in the 5 m³ chamber giving a 2 kg/m³ loading density. Initially black smoke was observed coming out the end of the vent pipe. The smoke quickly changed to flame and, by 4 seconds after assumed initiation, the flame extended approximately 5 meters from the end of the pipe. The total duration of the external flame was about 11 seconds. The initial gas flow out the end of the pipe was 3.47 m/sec. The pressures beyond the vent pipe were higher than the chamber pressures indicating that unburned gas and propellant were carried outside the chamber and burning was occurring in the vented gas plume. The video recorded a pulsating flame in the gas plume. Heat flux measured within the tube reached 30 cal/cm² sec (1256 kW/m²) with the average heat flux being about 25 cal/cm² sec (1047 kW/m²).

Test C-2 had 25 kg of M-1 propellant (5 kg/m³ loading density). Initially a glowing plume was observed to extend about 3 meters beyond the end of the vent pipe within approximately 1 second after ignition. The plume of smoke and flame quickly extended to a length of 10 meters after approximately 10 seconds. Although it burned violently, the length of the plume decreased after 10 seconds, retreating to the end of the pipe. The total duration of the external plume was about 18 seconds. The results still indicated that unburned gas and propellant were propelled outside, and then burned outside the chamber.

Test C-4, in the series of tests described by Joachim (Reference 6), had 250 kg of M-1 propellant (50 kg/m^3) in the chamber shown previously in Figure 15. Initially a smoke plume was observed to extend 1.3 meter past the end of the pipe within approximately 0.3 seconds. The plume quickly extended from the vent and filled the entire video field of view (greater than 25 meters) in approximately 5.3 seconds. Shortly after, the structure failed at approximately 6 seconds, releasing all pressure. The remaining propellant then burned rapidly in the air outside. The chamber failed from excessive internal pressure. Post-test observation showed that the concrete bond to the rebar had failed and the rebar pulled out of the concrete. At the time of the failure, the hatch cover and roof section were hurled high into the air at an average velocity of about 33 m/sec (hatch) and 11 m/sec (roof). The peak pressure on the side wall was about 10^3 kPa. This test indicated that over-pressure caused the failure, not a transition to detonation.

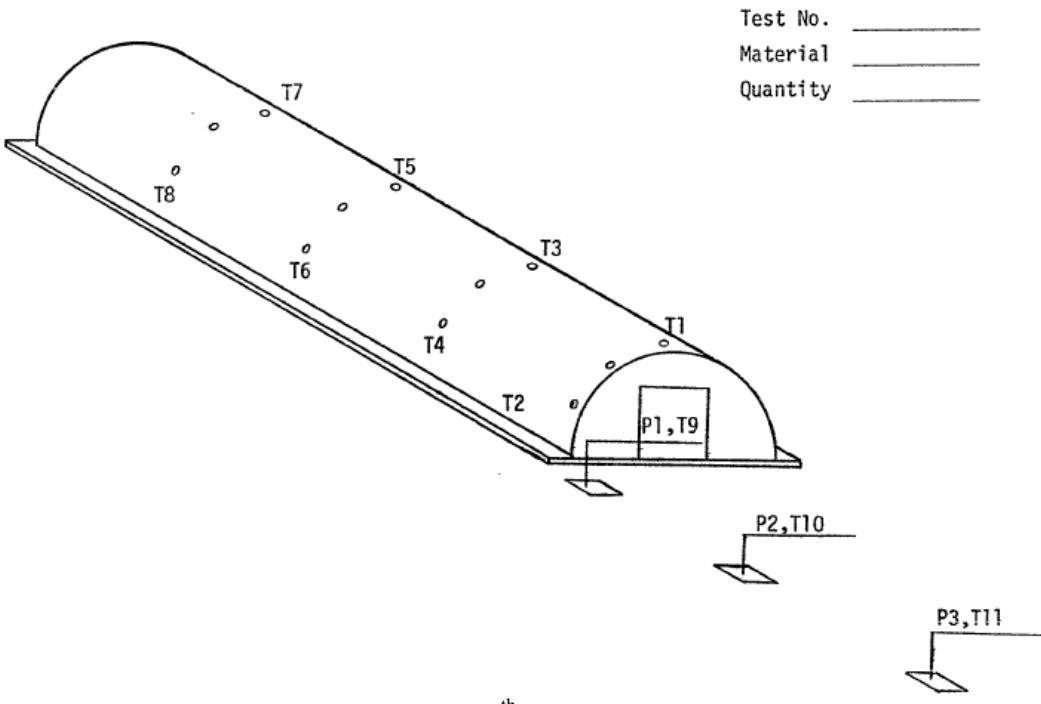
FIGURE 16. Schematic of 1/10th Scale Igloo with Sensor Locations.

Herrera and Vargas continued the testing of various gun propellants and flares in the $1/10^{\text{th}}$ scale igloo with pressure and temperature sensors shown in Figure 16. In the tests, the energetic material type and quantity and the vent size were varied. The vents were square, so a 12-inch vent was 12 inches by 12 inches. A 12-inch vent would correspond to an igloo with double doors and multiple vents (vent area ratio of 0.1234), a 9-inch vent would correspond to an earth-covered magazine with double door (vent area ratio of 0.07), and a 6-inch vent would correspond to an earth-covered igloo with single door (vent area ratio of 0.03).

Temperature data also showed interesting behavior. The data showed that the maximum temperatures outside of the igloo were hotter as compared to the maximum temperatures inside of the igloo. This strongly indicates that unburned propellant is carried outside of the igloo and burns out in the plume.

Reference 3 presented predicted scaling effects in going from $1/10^{\text{th}}$ scale to full scale. They predicted that the 25 foot plume obtained with the $1/10^{\text{th}}$ scale and 10 pounds of propellants would be approximately 250 feet of plume with a velocity of 1500 fps for full scale igloo and 10,000 pounds of propellant.

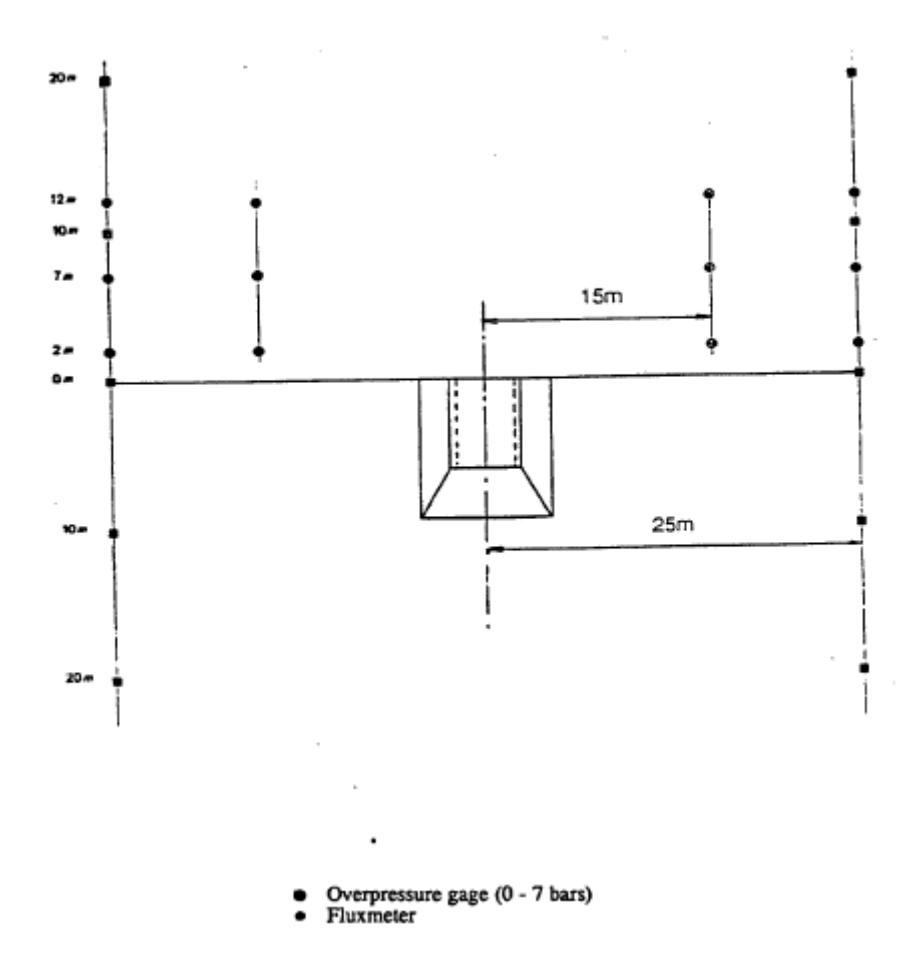
FIGURE 17. Location of Flux Sensors and Overpressure Gauges.

Allain (Reference 5) presents the results of four 1/3rd scale igloo tests. The first three tests used three different structures with approximately 2.22 metric tons of LB 7 T 72 (0,8) propellant. This gun propellant is similar to M-1. In the tests, over-pressure gauges and flux-meters were placed in locations shown in Figure 17.

Unburned propellant was found 45 meters from the igloo.

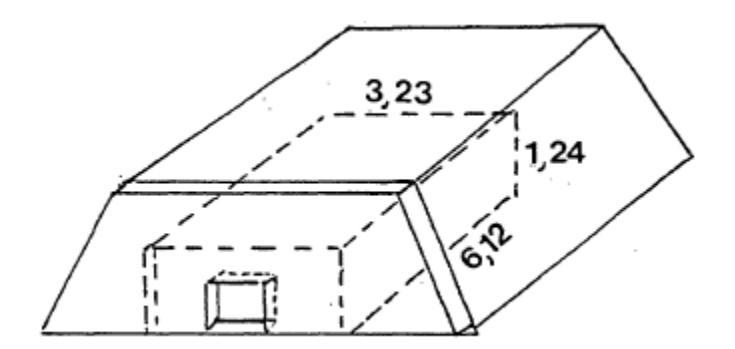
FIGURE 18. Igloo Shape for Test 4.

The fourth test differed from the previous tests in that a different magazine design was used and a different stacking of the cartridge bags. Figure 18 shows the magazine shape for Test 4.

The construction of the igloo consisted of earth covering (0.4 m on top and extending 2 m at the base of the sides and over 4 m at the base of the rear) the concrete box structure that had an internal metal liner, all mounted on a concrete base. The vent opening was 0.33 m^2 .

Test 4 resulted in the igloo bursting <u>1 second after ignition</u>, releasing a fireball. At ground level, no trace of a plume was observed. The igloo separated along its structural lines or corners. It separated into five main parts, each comprising two pieces—one concrete and one steel as shown in Figure 21.

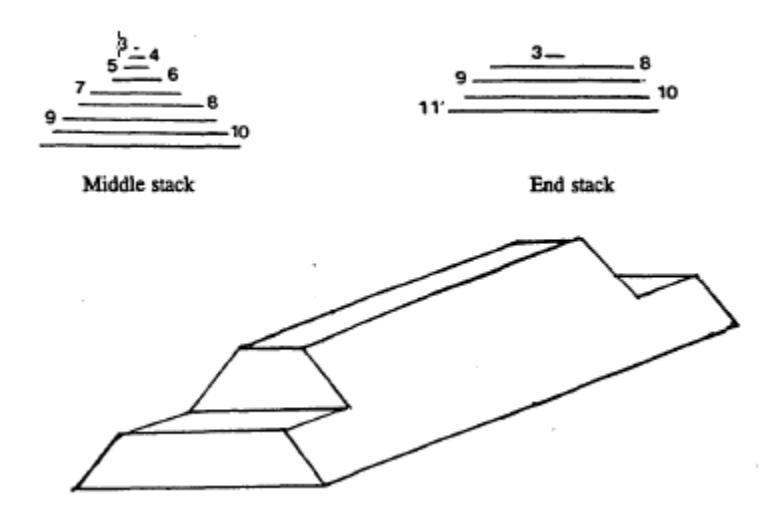
FIGURE 19. Charge Configuration for Test 4.

In order to keep the same loading density as the previous tests, the amount of gun powder and the loading configuration were changed. The new quantity was 2.037 metric tons and 334 cartridge bags, configured as shown in Figure 19.

The volume of the igloo was 24.5 m^3 and the opening area was 0.33 m^2 , giving a volume of charge to volume of chamber of 0.11 and ventilation coefficient of 0.013.

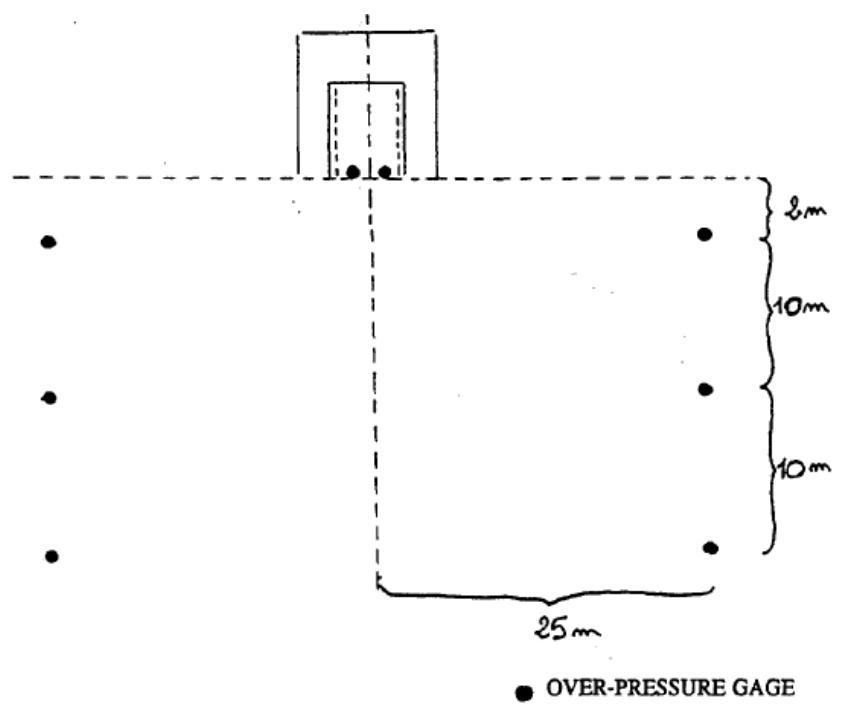
FIGURE 20. Location of Over-pressure Gauges Relative to Magazine in Test 4.

In Test 4, instrumentation was simply two rows of three overpressure gauges at 25 meters on both sides of igloo axis, as indicated in Figure 20.

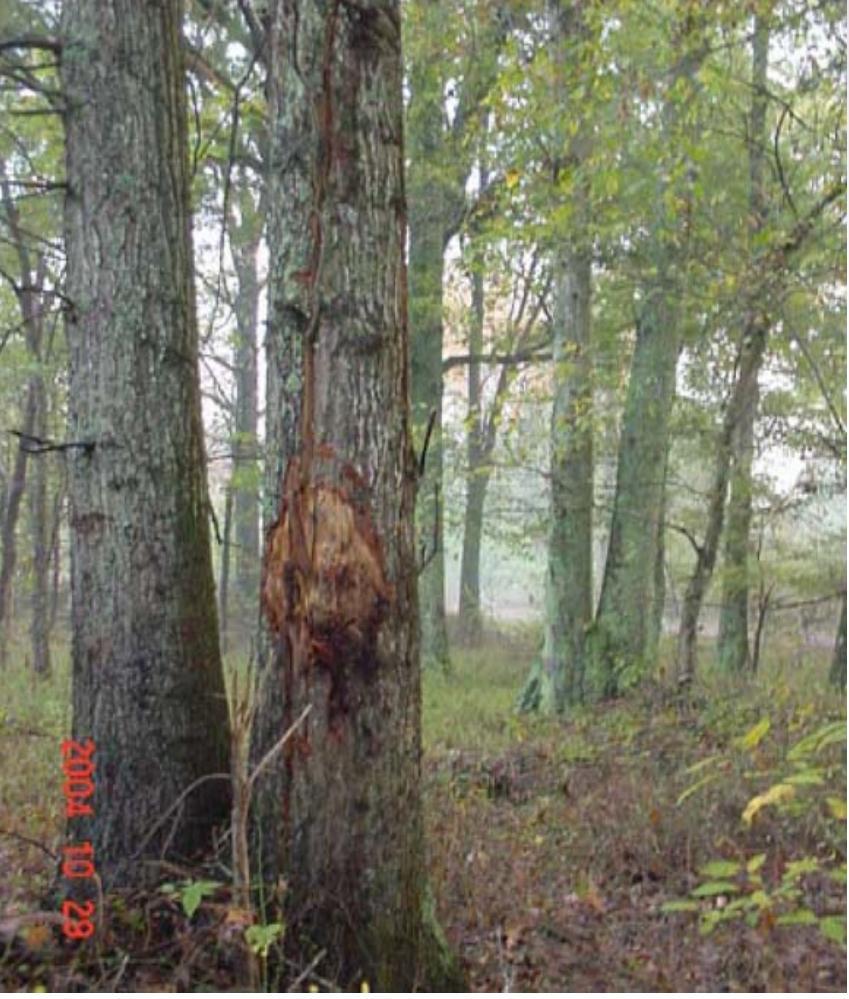
Tree at 2100' impacted by large piece of headwall. Piece of hinge found at base of tree. Rebar and angle iron also found at base of tree. Concrete shattered on impact, concrete debris found beyond tree.
