In-bore Detonation of Non-standard Ammunition,
Testing a Russian T-55 Tank

Steven J. Reeves and Ralph Scutti

In-bore Detonation of Non-standard Ammunition

Testing a Russian T-55 Tank

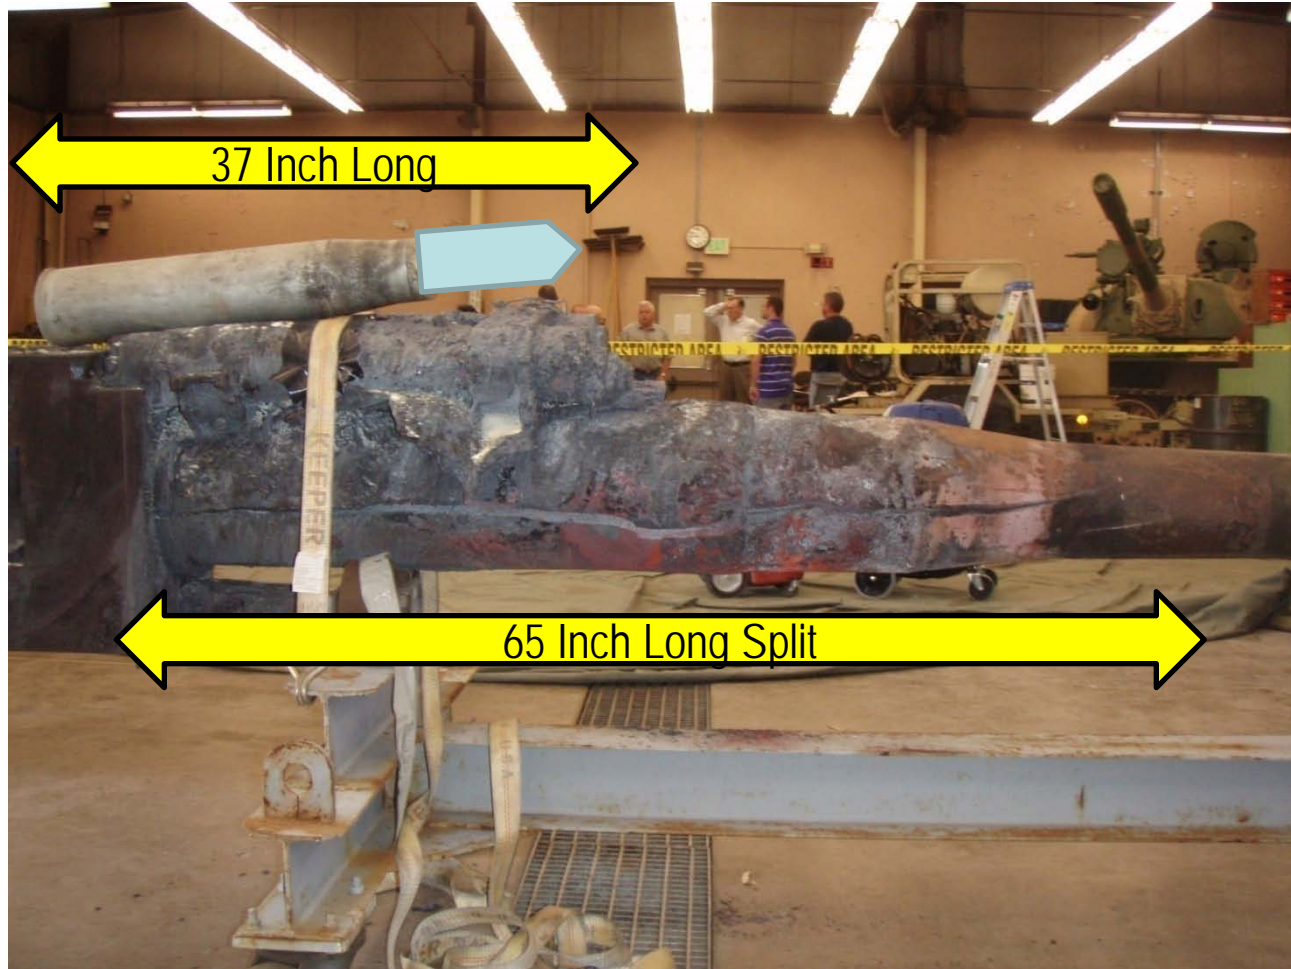
Post Incident

- Gun tube manufactured ~ 1974
- No inspection records prior to 1995
- Benet Labs post incident failure analysis
 - Gun Tube could safely fire HEAT round
 - Projectile detonated in gun tube
 - Projectile traveled ~ 16 inches prior to event
 - Projectile was near maximum acceleration at event
