Army Corrosion Summit

Army Aviation Corrosion Engineering Case Studies

**Aviation and Missile Research,
Development and Engineering Center**

Date: 10 February 2010

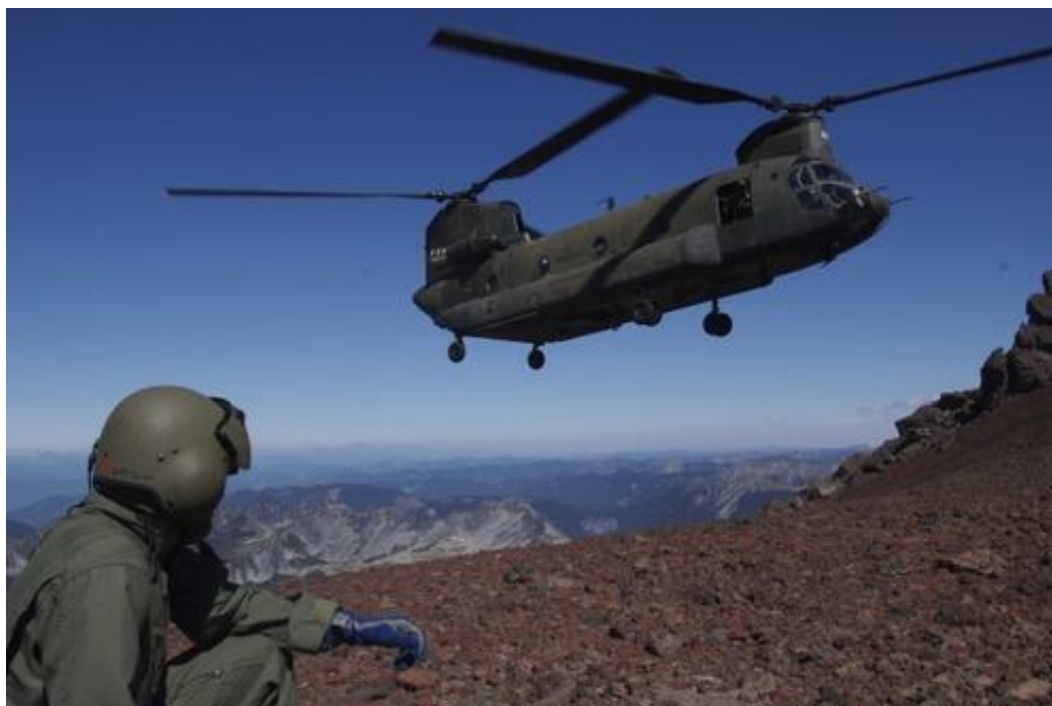
- **The Problem**
- During ground taxi of a Navy aircraft, it would not turn right despite full right pedal input. Inspection of the aircraft revealed the Stability Augmentation System (SAS) Link, PN 70410-02334-044, on the Yaw Boost Servo was fractured. Analysis determined that the Link failed due to Stress Corrosion Cracking (SCC), and indicated the material to be 7075-T6 Temper.

Problem: HS-11 reported that during preflight flight control checks, pilot noticed a thump. Pilot continued with preflight checks and noted that all flight controls felt normal and that the anomaly did not return. During ground taxi aircraft would not turn right despite full right pedal input. The aircraft was shutdown at which time the SAS Link, P/N 70410-02334-044, on Yaw Boost Servo, P/N 70410-22910-045, was found fractured.

Cause: Lab analysis determined that the link failed due to stress corrosion cracking (SCC) through its cross section. Subsequent to this failure, the link further fractured due to overload. Hardness and conductivity testing indicate a -T6 temper condition which has poor resistance to SCC. Newer SAS Links (-045) are manufactured in the -T73 temper condition which is less susceptible to SCC. However, drawing for older SAS Links (-044) allows manufacture in the T-6 temper condition. SAS Link is used on Yaw and Collective Boost Servo Assemblies (P/N 70410-22910-045) and Pitch and Roll Trim Assemblies (P/Ns 70410-22760-050/-051/-053).

Required Action: Bulletin for one-time inspection:

- Inspect for and remove all -044 SAS Links .
- Inspection to be conducted either visually if link p/n is legible or via eddy current conductivity testing if p/n is not legible.

- **The Resolution**
- Issue a message H060-10-ASAM-04
- Inspect all subject links for evidence of corrosion
- Conductivity check to determine alloy
- Touch up and apply CPC MIL-C-81309 Type II
- Ongoing inspections of T6 links
