UMM QASR WATER SCHEME, IRAQ

PROJECT NUMBER SIGIR-PA-05-028

JULY 24, 2006

SUBJECT: Report on Project Assessment of the Umm Qasr Water Scheme, Iraq (Report
Number SIGIR-PA-05-028)

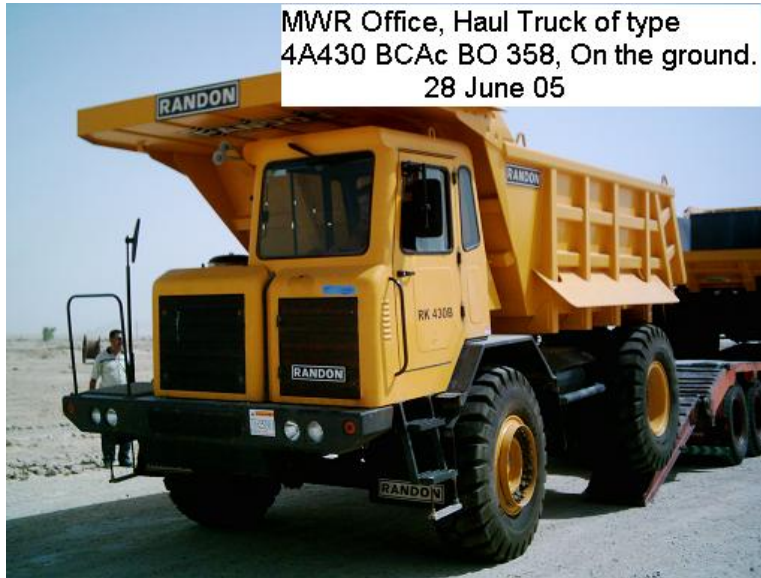
In addition to the Umm Qasr water scheme project, U.S. Agency for International Development contracted with Bechtel in 2004 to complete an engineering assessment of the entire canal system, repair pumping stations, and complete emergency repairs of the SWC. Under a separate non-construction project, PCO purchased and supplied approximately 30 vehicles and heavy equipment for transfer to the Iraqi Ministry of Water Resources (MWR) for the purpose of maintaining the canal system. Site Photo 1 shows an example of the type of haul truck purchased and transferred to the MWR.

Site Photo 1. Haul truck purchased through PCO (Photo courtesy of USACE)

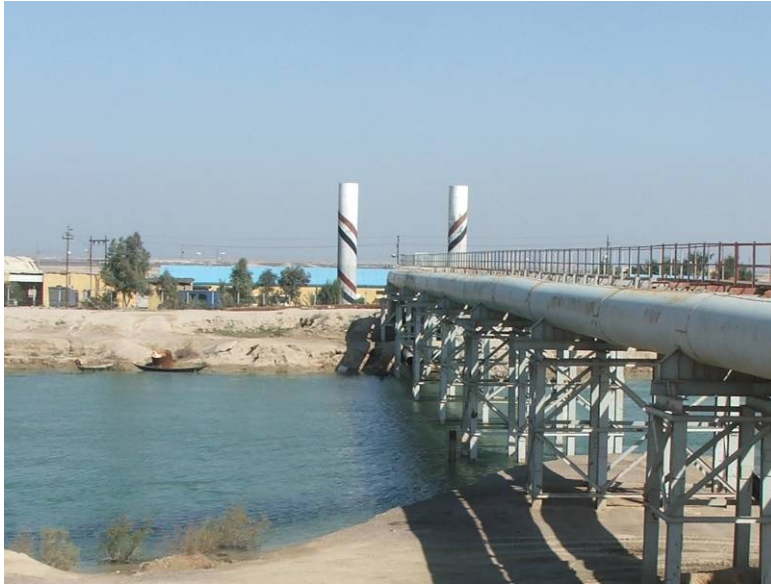
Pump Station # 2 is located at km mark 165 of the Sweetwater Canal. The contract and modification required the design and installation of permanent power to the facility. The installation of the permanent power is currently being deleted from the task order. Currently Pump Station #2 utilizes electric pumps operating with electricity produced by on-site generators and also diesel powered pumps. The contract required emergency repairs which included maintenance of pumps and repair of generators and diesel engines for the diesel driven pumps. The site assessment team visited the outflow of Pump Station #2. Access to Pump Station #2 was not feasible because it was located on the far side of the river from the outflow, with no assessable crossing point. At the time of the assessment, three of the three outflows from Pump Station #2 to the Sweetwater Canal were pumping water. Site Photo 2 shows the exterior of the Pump Station #2 and Site Photo 3 shows an example of the pumps located within Pump Station #2 (photo courtesy of USACE). Site Photo 4 shows the three outfalls of Pump Station #2 pumping water into the Sweetwater Canal system.

Site Photo 2. Pump Station #2

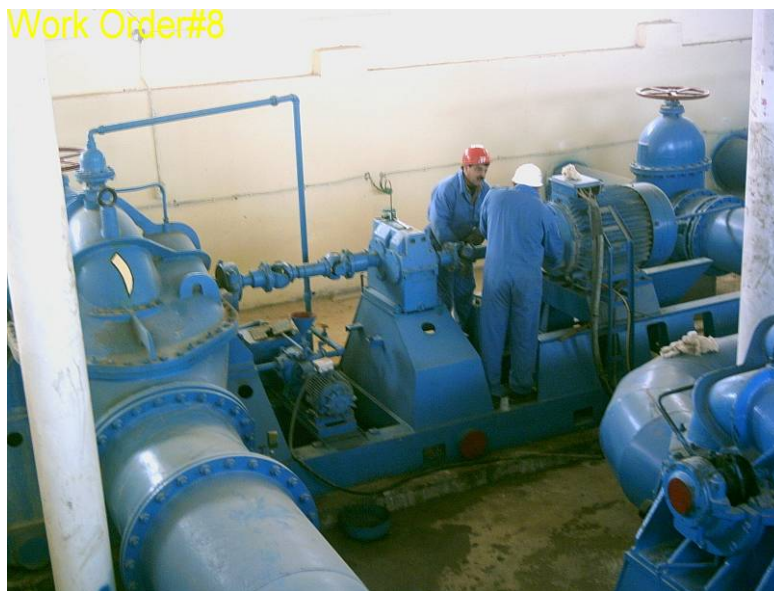
Site Photo 3. Pumps located at Pump Station #2 (Photo courtesy of USACE)

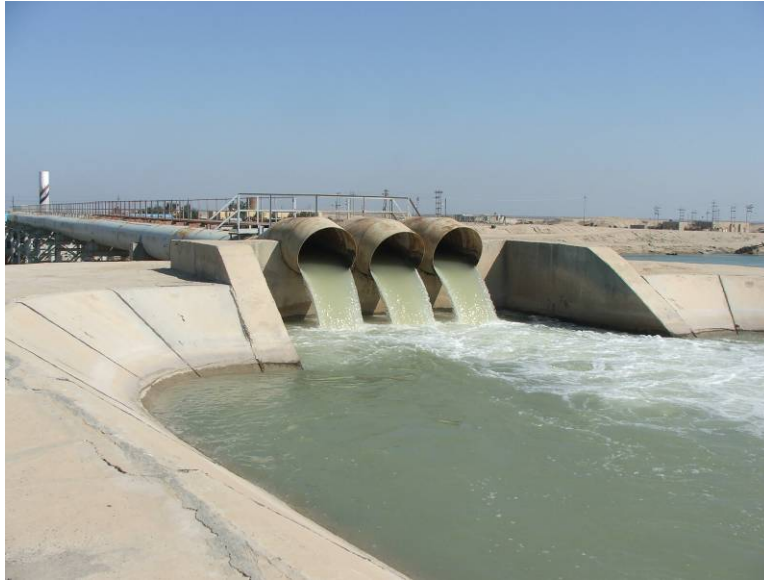
Site Photo 4. Water flowing out of all three pipelines from Pump Station #2 into the Sweetwater Canal

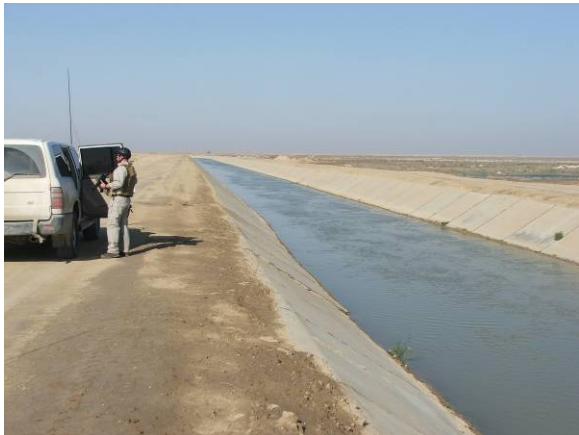
Site Photo 5 shows an example of the SWC with undamaged embankment and concrete liners. Site Photos 6 through 9 show examples of areas along the lined section of the canal where repairs and maintenance are required. Site Photo 10 shows an area where native rock instead of concrete panels was used for repair.

Site Photo 5. Undamaged section of canal

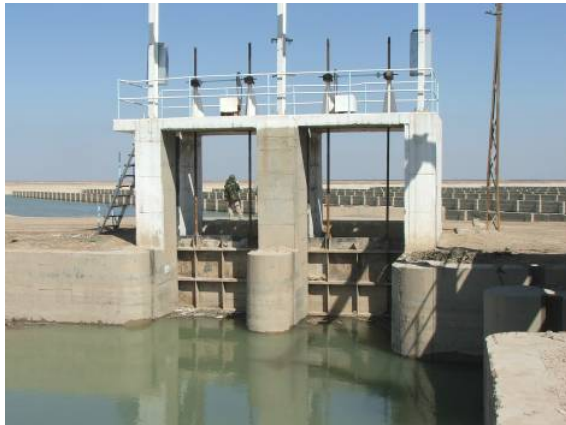
The 45 km unlined portion of the SWC we were able to visit was located between km 193 and the settling basins (km 238). Signs of past maintenance activities were observed and included dredge spoils located parallel to the canal route. Dredge spoils included a combination of soils and vegetation. Maintenance equipment, maintenance staff, or signs of recent maintenance activities were not observed at any point of the unlined section of the canal. A single set of tire prints from a heavy equipment vehicle was observed parallel to the canal. The main channel appeared free of vegetation, although vegetation was observed growing on the sides of the canal. The sluice gates which control water from the SWC to the settling basins and the settling basins themselves appeared serviceable.

Site Photo 18 shows an example of the unlined section of the SWC, Site Photo 19 shows recent tire prints from a heavy equipment vehicle, and Site Photo 20 shows dredge spoils located parallel to the canal. Site Photo 21 shows sluice gates used to control water at the entrance of the settling basin and Site Photo 22 shows the settling basin.

Site Photo 21. Slice gates controlling water from SWC to settling basins

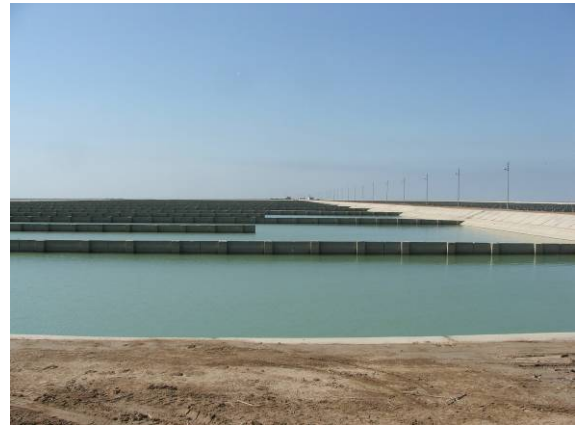
Site Photo 22. Settling basins
