PRIMARY HEALTH CARE CENTERS
NUMBERED KE-01, KE-02,
KE-03, KE-04, AND KE-05
KIRKUK, IRAQ

SIGIR PA-06-042
SIGIR PA-06-043
SIGIR PA-06-044
SIGIR PA-06-045
SIGIR PA-06-046

APRIL 25, 2006

SUBJECT: Report on Project Assessments of Primary Health Care Centers Numbered
KE-01, KE-02, KE-03, KE-04, and KE-05 in Kirkuk, Iraq (Report Numbers
SIGIR-PA-06-042, PA-06-043, PA-06-044, PA-06-045, and PA-06-046)

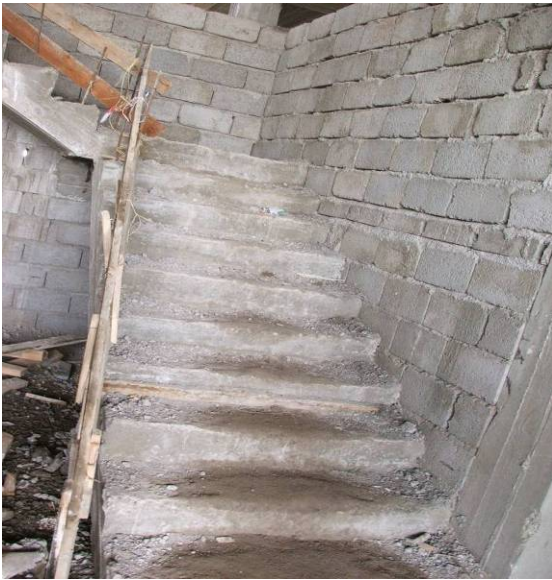
The project design required the construction of one stairwell from the interior ground floor to the first floor, consisting of “cast in-place” reinforced concrete. During our site visit, we verified that in each PHC the concrete stairwells were in-place, although the workmanship of the concrete placement was poor. We identified the following: uneven surfaces (Site Photo 7), small pieces of the stair steps were chipped (Site Photo 8), the appearance of concrete segregation on the side and underneath the stairwell (Site Photos 9 and 10, respectively). Site Photos 11 and 12 show a stairwell and the poor quality of the concrete mixture. During its construction, each PHC’s stairwell appears to have been utilized by the construction crews to move equipment from the ground floor to the first floor. While some of the damage may be attributed to construction activities, the majority of the deficiencies appeared to be due to poor concrete workmanship.

Site Photo 7. Uneven steps (PHC Hai Tis'een)

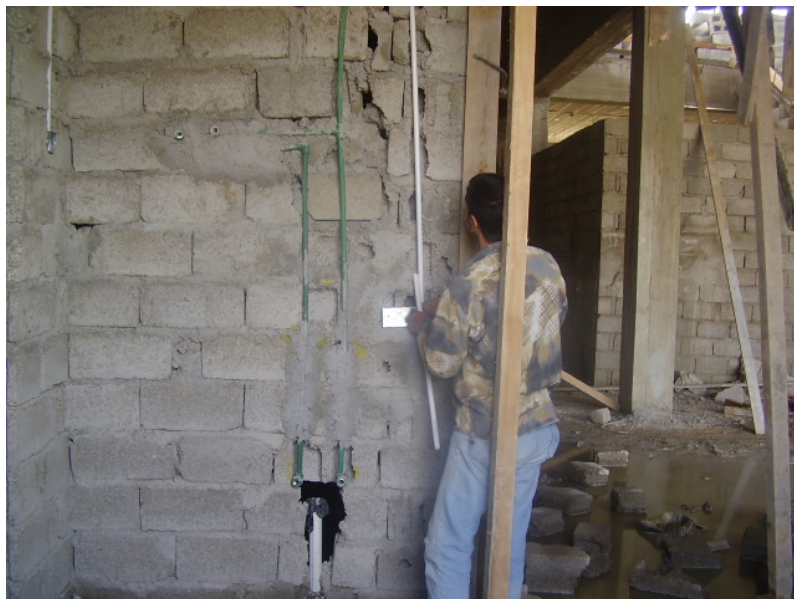
example of the 14 Feb 2006 QA report for the Hai Tis'een PHC. The USACE LN QA engineer attached a photograph (Site Photo 5 repeated below) to the daily QA report with the caption "KE-03 – installing pipe for electrical works." The daily QA report does not identify the obvious poor quality concrete workmanship, and the Gulf Region Division's project engineer did not document this issue either. There is no indication this problem was brought to the contractor's attention for corrective action.

Site Photo 5. Local National Quality Assurance Engineer photograph

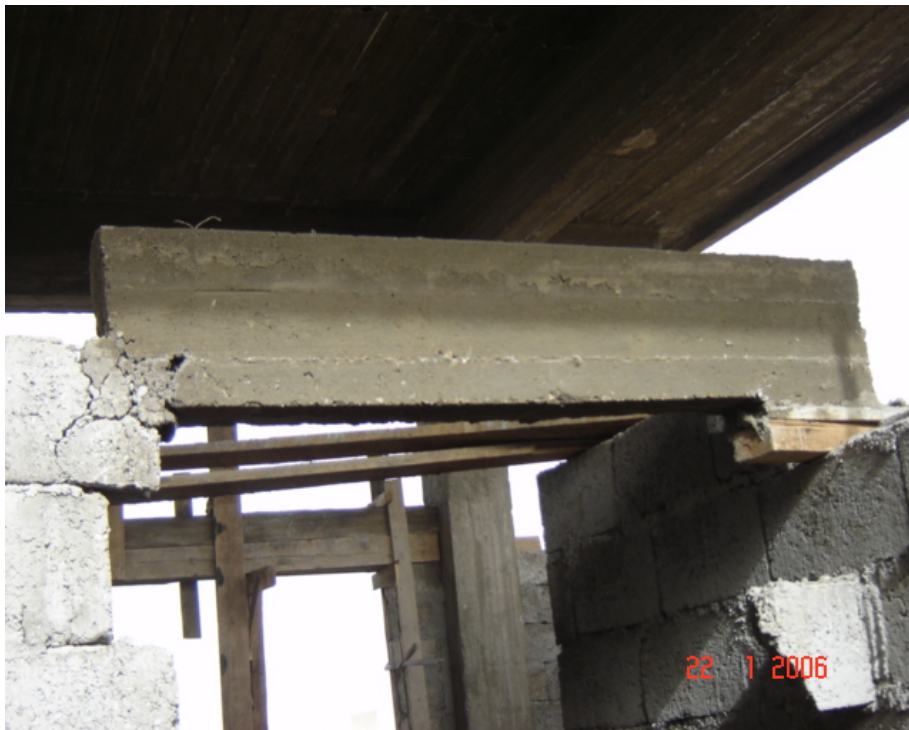
In the instances in which the LN QA engineer documented construction issues within the QA daily reports, there was no certainty that the contractor took corrective actions. For example, on 22 January 2006, the LN QA daily report and site photo documenting the poor installation of a lintel (Site Photo 24). The QA daily report, in the General Remarks section stated, “Some of the lintels have bad installation.” Yet, there is no mention in the daily report that the LN QA addressed this problem with the contractor. The contractor’s QC daily report did not identify this problem and did not mention any discussions with the LN QA regarding this issue. After reviewing the next few days QC and QA daily reports, there was no documentation that the contractor addressed and corrected this issue.

Further, the Gulf Region Division's comments to our report do not address concrete work for poorly constructed load bearing lintels (Site Photos 23 and 24, repeated below). Both Site Photos, provided in the draft report, document poorly constructed lintels. While the Gulf Region Division may believe that gaps, broken blocks, and improper block placement are "acceptable" for non load-bearing walls, lintels are load bearing members used to support material over doorways and windows.

Site Photo 24. Example of a site photo included with the daily report. Taken by the USACE LN QA (Photo courtesy of the USACE)

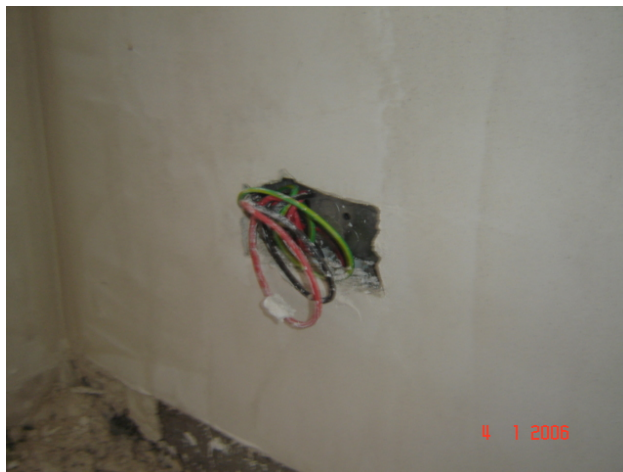
The SORS required all electrical design and construction to comply with the International Electrotechnical Commission Standards (IECS). The SORS required new energy efficient lighting, switched power outlets, and lighting switches. Electrical power and lighting requirements included interior and exterior lighting, surgical lighting, commercial grade wiring, panels, breakers, switches, outlets, junction boxes, transformers, connectors, and fixtures. Additional submittal requirements included switchgear, electric heaters, sump pumps, lightning protection, radio paging, emergency lighting, fire alarm system, central control and maintenance system, and the circuit protection. In addition, the SORS required a safe and sufficient power connection to the local grid and critical, standby, and primary power generators. At the time of the assessment, the electrical system installation was underway. We observed basic electrical preparatory work. The electrical work assessed consisted of the installation of polyvinyl chloride (PVC) conduit and plastic or metal electrical boxes attached to the surface of the block walls or recessed in a chiseled section of the wall. We observed plaster coating on some walls. We identified wiring installed inside the PVC conduit in some areas. For a picture of the basic electrical work completed, see Site Photo 34.

Site Photo 34. Electrical wiring (Photo courtesy of USACE)

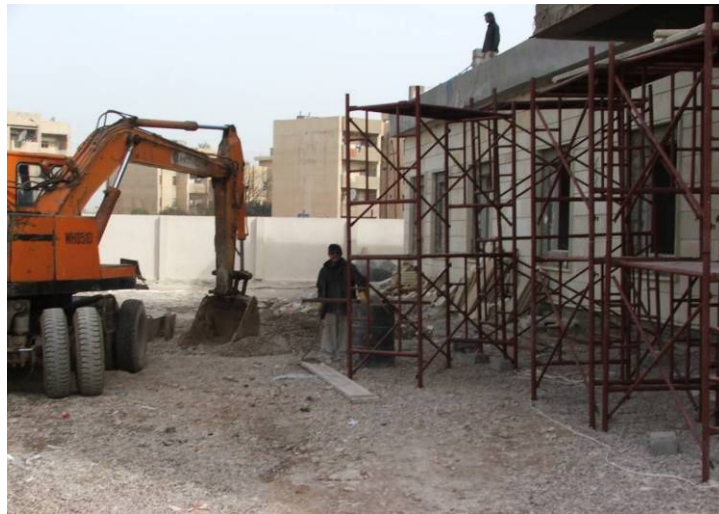
Site Photo 42. Beginning excavation of the septic tank

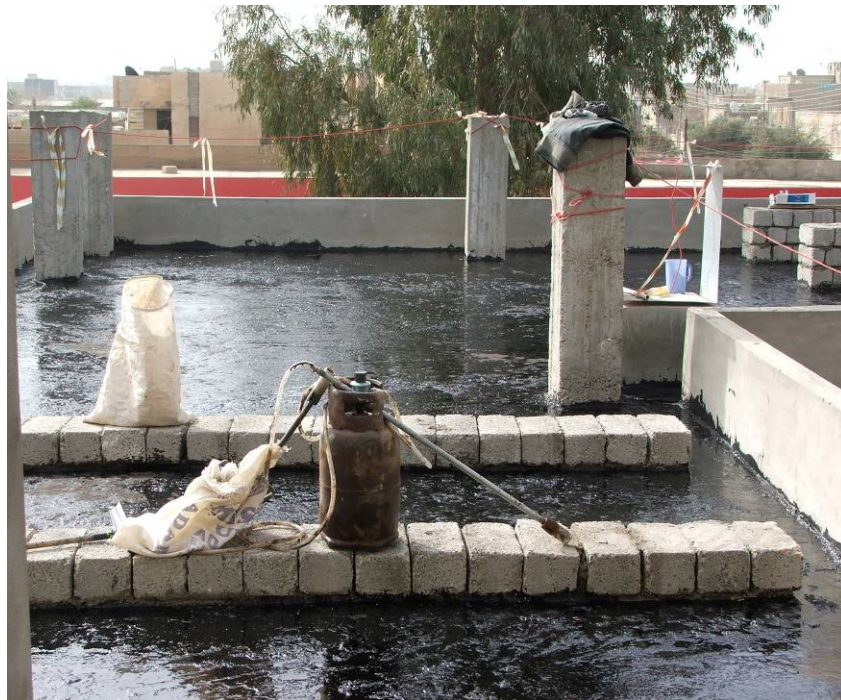
At the time of the site visit, all reinforced concrete columns, slabs, and ceiling beams appeared complete and most of the formwork was removed. The contract and design specifications required cast in-place reinforced concrete structural beams, columns, and slabs. Due to time constraints on site, we assessed only a fraction of the structural concrete work. The ground floor columns, ground floor structural beams, ground floor ceiling slab, interior stairwell, x-ray room walls, first floor structural beams, first floor columns, and first floor ceiling slab all appeared complete; however, we identified quality issues. During the assessment, we observed work in progress on the block walls and roof. The block walls appeared to have quality problems. For instance, we observed block rows not level, walls with unfilled gaps between blocks, broken blocks and bricks of different sizes used in the wall construction and blocks improperly installed. For a picture of poor concrete quality due to the use of different sized bricks at the Shiqaq Hai Musalla PHC, see Site Photo 23 (in the QA section of report). We observed a recent application of tar on the roof; however, placement of concrete roofing tiles had not begun. For a picture of the recent application of tar on the roof, see Site Photo 43.

Site Photo 43. Tar applied to the roof

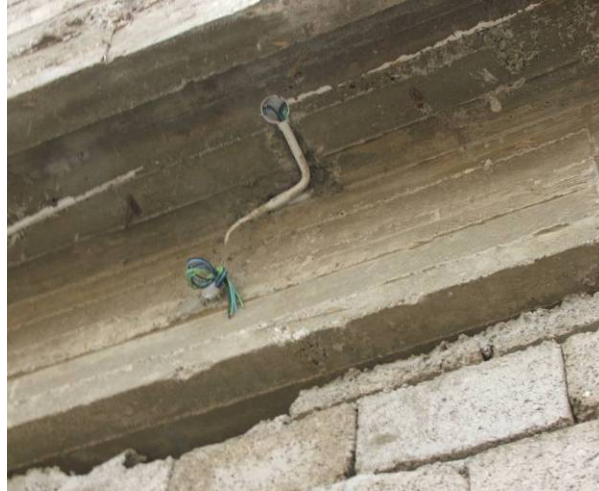
electrical preparatory work. The electrical work assessed consisted of the installation of PVC conduit and plastic or metal electrical boxes attached to the surface of the block walls or recessed into a chiseled section of the wall. We identified wiring installed inside the PVC conduit in some areas. For a picture of the basic electrical work completed, see Site Photo 44.

Site Photo 44. PVC conduit installed in structural concrete

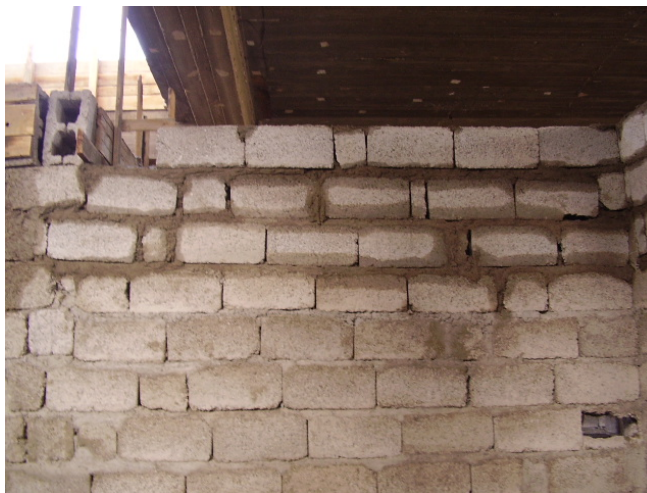
All reinforced concrete columns, slabs and ceiling beams appeared complete and most of the formwork removed. For a picture of the remaining formwork and structural beams, see Site Photos 52 and 53, respectively. The contract and design specifications required cast in-place reinforced concrete structural beams, columns, and slabs. Due to time constraints on site, we assessed only a fraction of the structural concrete work. The ground floor columns, ground floor structural beams, ground floor ceiling slab, interior stairwell, x-ray room walls, first floor structural beams, first floor columns, and first floor ceiling slab all appeared almost complete; however, we identified quality issues. During the site assessment, we observed work in progress on the block walls. The block walls appeared to be of substandard construction with quality problems. For instance, we observed block rows not level, walls with unfilled gaps between blocks, broken blocks, blocks improperly installed, and different sizes of bricks used in the wall construction. For a picture of wall construction using different sized blocks, see Site Photo 54. We did not observe roof construction underway.

**Site Photo 54. Example of different sized blocks in wall construction
(Photo courtesy of the USACE)**

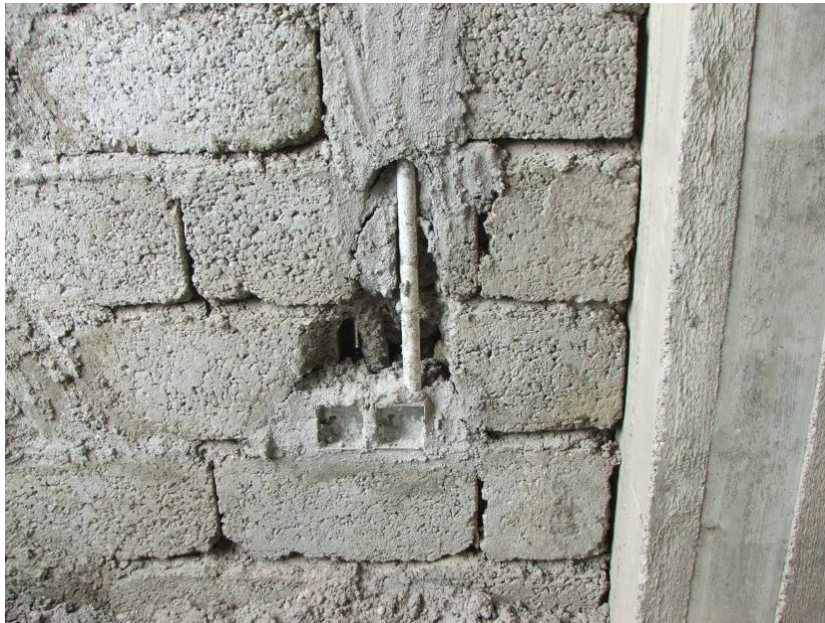
The SORS required all electrical design and construction to comply with the IECS. The SORS required new energy efficient lighting, switched power outlets and lighting switches. Electrical power and lighting requirements included interior and exterior lighting, surgical lighting, commercial grade wiring, panels, breakers, switches, outlets, junction boxes, transformers, connectors, and fixtures. Additional submittal requirements included switchgear, electric heaters, sump pumps, lightning protection, radio paging, emergency lighting, fire alarm system, central control and maintenance system, and the circuit protection. In addition, the SORS required a safe and sufficient power connection to the local grid and critical, standby and primary power generators. At the time of the assessment, the electrical system installation was underway. We observed basic electrical preparatory work. The electrical work assessed consisted of the installation of PVC conduit and plastic or metal electrical boxes attached to the surface of the block walls or recessed in a chiseled section of the wall. We observed no wiring inside the electrical boxes or PVC conduit. For a picture of the basic electrical work completed, see Site Photo 55.

Site Photo 55. PVC conduit and electrical box

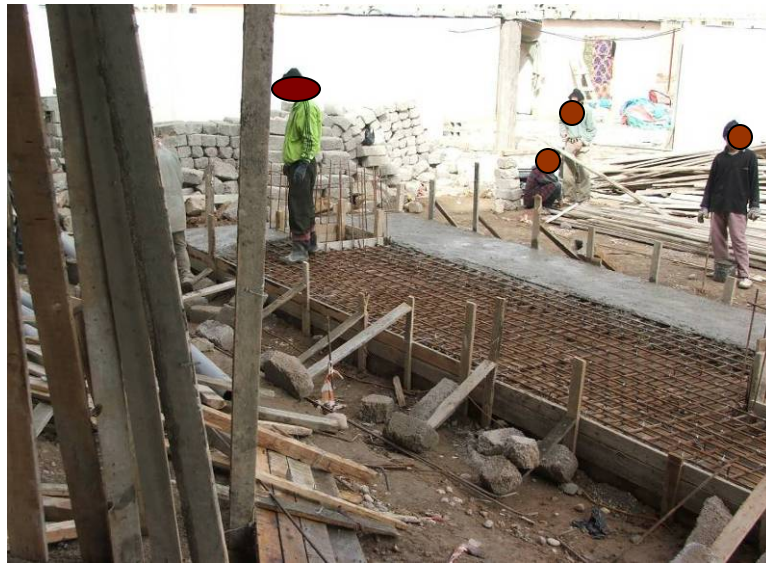
The contractor had not installed most fixtures, fittings, faucets, valves, drains and accessories; nor did the hardware or fixtures appear to be on site. The contractor had started the excavation and fabrication of the underground septic tank as indicated in the “Earthwork” section of this assessment (Site Photo 56). We witnessed construction workers mixing and pouring concrete on the ground in front of the PHC (Site Photo 57). This measuring and mixing procedure appeared to be inconsistent with the standard concrete specifications. We observed pipes placed through the concrete slabs to accommodate future drainage lines for the sinks and toilets (Site Photo 58). We did not observe water heaters and elevated water storage tanks on site.

Site Photo 56. Workers applying rebar to top of septic tank

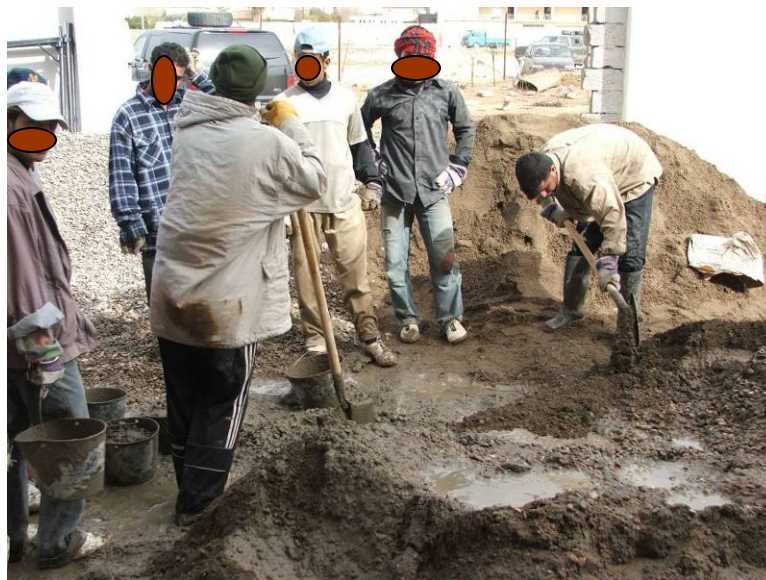
Site Photo 57. Concrete mixing

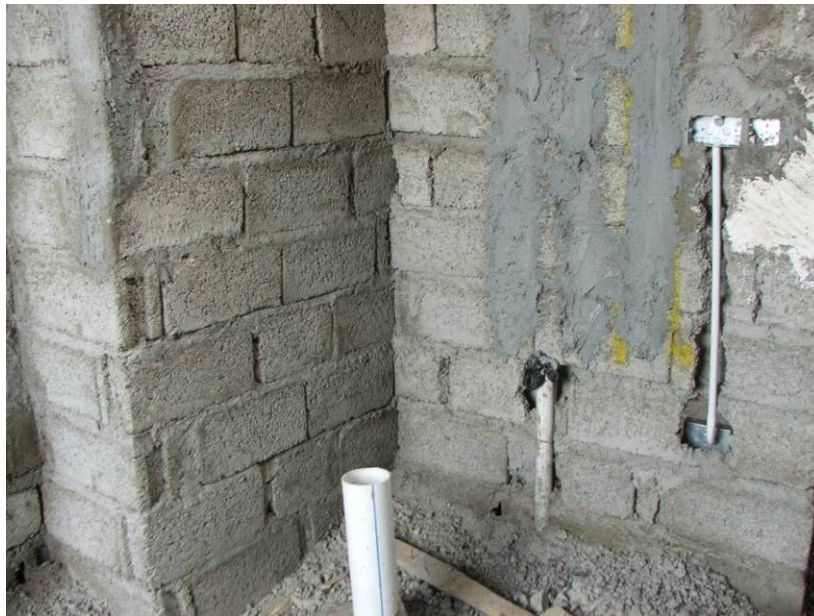
Site Photo 58. Plumbing pipes placed in concrete slab

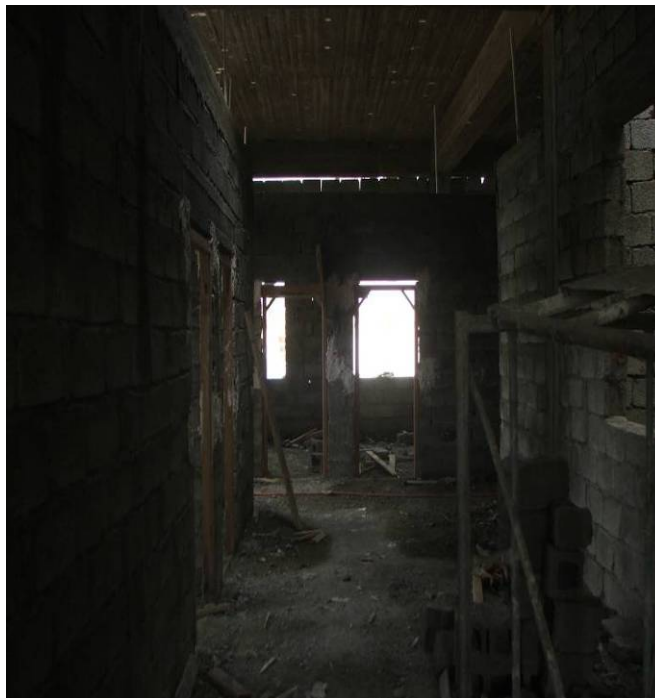
At the time of the assessment, we observed the partial installation of some wooden interior doorframes (Site Photo 59); however, we did not assess the doorframes due to time restrictions on site. We identified additional wooden doorframes on site (Site Photo 60). We did not observe any exterior doors, windows, or hardware on site.

Site Photo 59. Doorframes partially completed

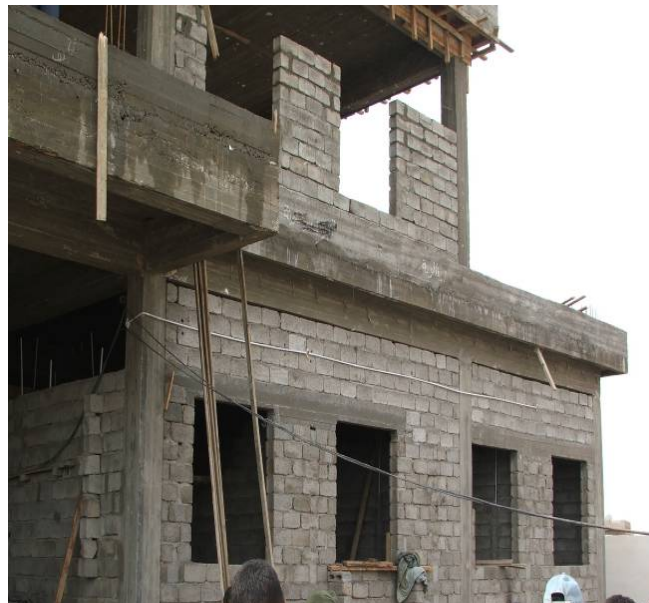
The contractor had not completed the window frames and had not installed any windows or security grilles (Site Photo 61). We did not observe the initiation of tile work, painting of the interior walls, or fabrication of the suspended ceiling. We did not observe any doors, windows, or hardware on site.

Site Photo 61. Window frames

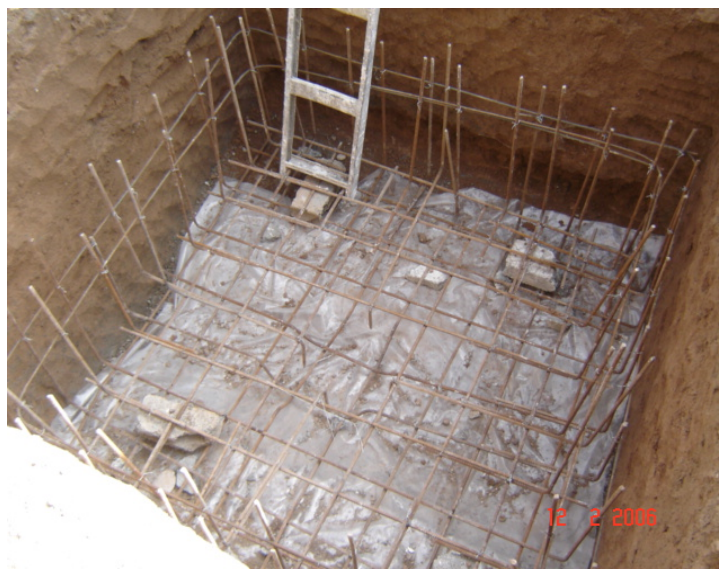
Significant work had been accomplished or was underway at the time of the assessment. The earthwork and the construction of this facility's structural concrete elements were almost complete. The SORS required site demolition and clearance, if needed, construction of sidewalks, parking, fencing, lighting, roads, water, and sewer. Site clearing, excavation and backfilling appeared almost complete. Excavation for the septic tank was underway (Site Photo 63).

Site Photo 63. Excavated hole for septic tank (Photo courtesy of the USACE)

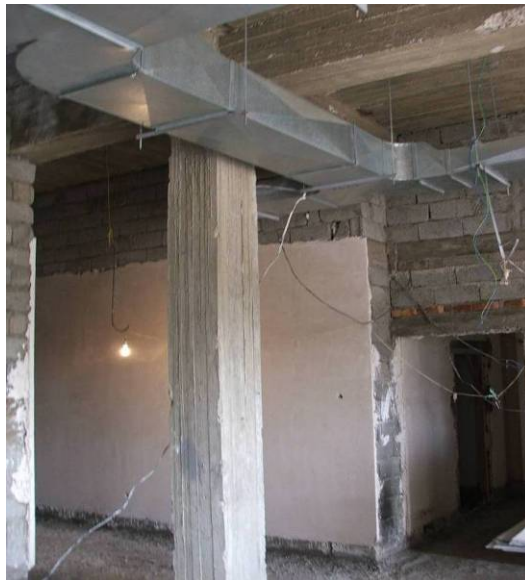
At the time of the site assessment, all reinforced concrete columns, slabs, and ceiling beams appeared complete and most of the formwork removed. For a picture of the concrete column and beams, see Site Photo 64. The contract and design specifications required cast in-place reinforced concrete structural beams, columns, and slabs. We assessed only a fraction of the structural concrete work due to time constraints on site. The ground floor columns, ground floor structural beams, ground floor ceiling slab, interior stairwell, x-ray room walls, first floor structural beams, first floor columns, and first floor ceiling slab all appeared almost complete; however, we identified quality issues. During the site assessment, we observed work in progress on the block walls. The block walls appeared to be of substandard construction with quality problems. For instance, we observed block rows not level, walls with unfilled gaps between blocks, broken blocks, blocks improperly installed, and bricks of different sizes used in the wall construction. For a picture of broken and different sized blocks used in wall construction, see Site Photo 65. The roof was in need of cleanup prior to tarring (Site Photo 66).

Site Photo 64. First floor structural column and beams

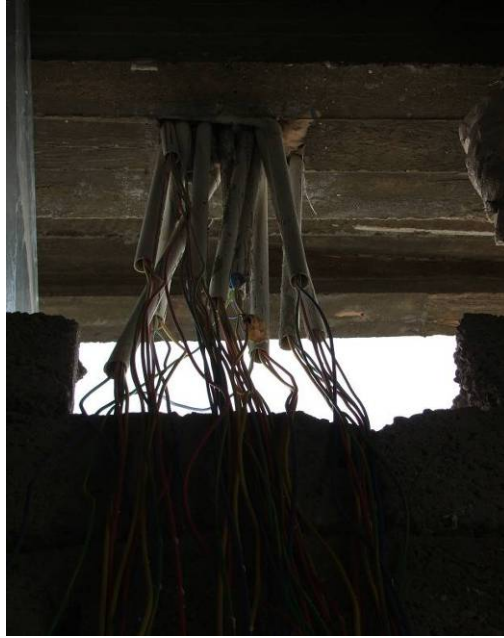
The SORS required all electrical design and construction to comply with IECS. The SORS required new energy efficient lighting, switched power outlets, and lighting switches. Electrical power and lighting requirements included interior and exterior lighting, surgical lighting, commercial grade wiring, panels, breakers, switches, outlets, junction boxes, transformers, connectors, and fixtures. Additional submittal requirements included, switchgear, electric heaters, sump pumps, lightning protection, radio paging, emergency lighting, fire alarm system, central control and maintenance system, and the circuit protection. SORS also required a safe and sufficient power connection to the local grid and critical, standby and primary power generators. At the time of the assessment, the electrical system installation was underway. We observed basic electrical preparatory work. The electrical work observed consisted of the installation of PVC conduit and plastic or metal electrical boxes attached to the surface of the block walls or recessed in a chiseled section of the wall. We observed wiring installed inside the PVC conduit in some areas (Site Photo 67) and some outlet boxes with wiring (Site Photo 68).

Site Photo 67. Electrical wire running through PVC conduit

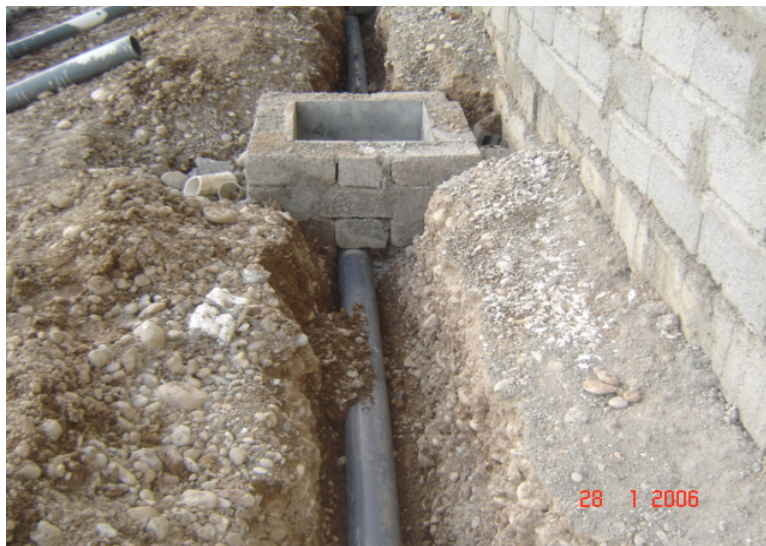
The contractor had not installed most fixtures, fittings, faucets, valves, drains and accessories; nor did the hardware or fixtures appear to be on site at the time of the assessment. The contractor had started the excavation and the fabrication of the underground septic tank as indicated in the “Earthwork” section of this assessment (Site Photo 63). We observed water pipes attached to the interior walls (Site Photo 70) and the installation of sewer piping (Site Photo 71). We observed pipes placed through the concrete slabs to accommodate future drainage lines for the sinks and toilets (Site Photo 72). We did not observe water heaters and elevated water storage tanks on site.

Site Photo 71. Partial installation of sewer drain (Photo courtesy of the USACE)

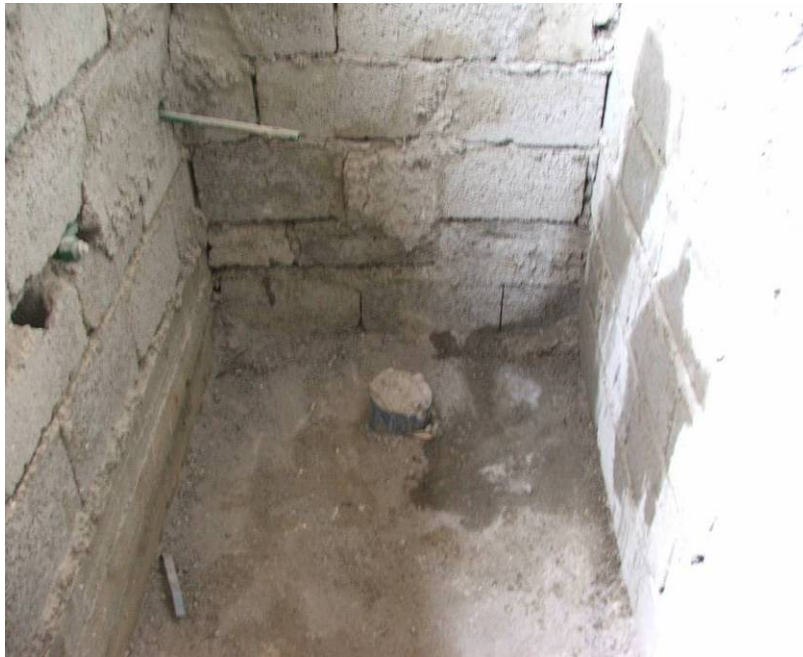
Site Photo 72. Plumbing pipes placed in concrete slab

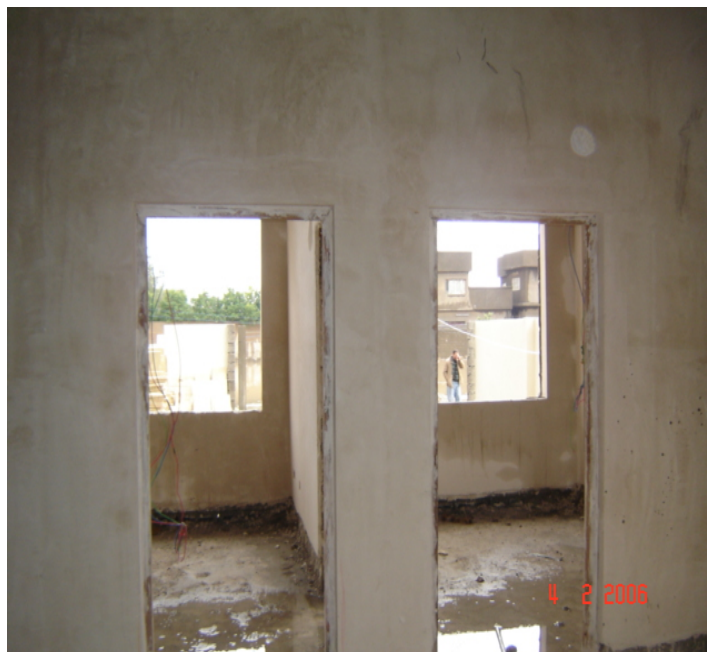
At the time of the assessment, we observed the installation of some wooden interior doorframes (Site Photo 73); however, we did not assess the doorframes due to time restrictions on site. We did not observe the installation of exterior doors nor did they appear to be on site. The contractor had not installed any windows or security grilles (Site Photo 74). Interior walls were not painted and the fabrication of the suspended ceiling had not started. We did not observe any doors, windows or hardware on site.

Site Photo 73. View of completed doorframes (Photo courtesy of the USACE)

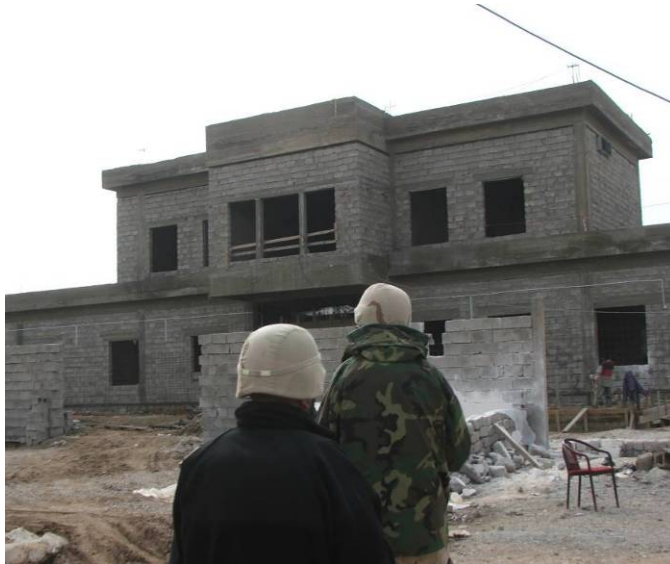
Site Photo 75. View of outside the Hai Alasra Wa Al Mafqoodeen PHC

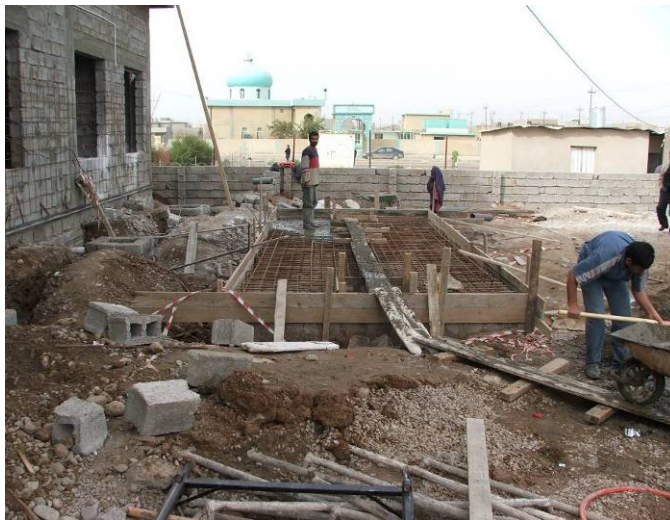
Significant work had been accomplished, or was underway, at the time of the assessment. The earthwork and the construction of this facility’s structural concrete elements were almost complete. The SORS required site demolition and clearance, if needed, and construction of sidewalks, parking, fencing, lighting, roads, water, and sewer. Site clearing, excavation and backfilling appeared almost complete. Excavation for the septic tank was underway (Site Photo 76).

Site Photo 76. Rebar and formwork for the top of the septic tank

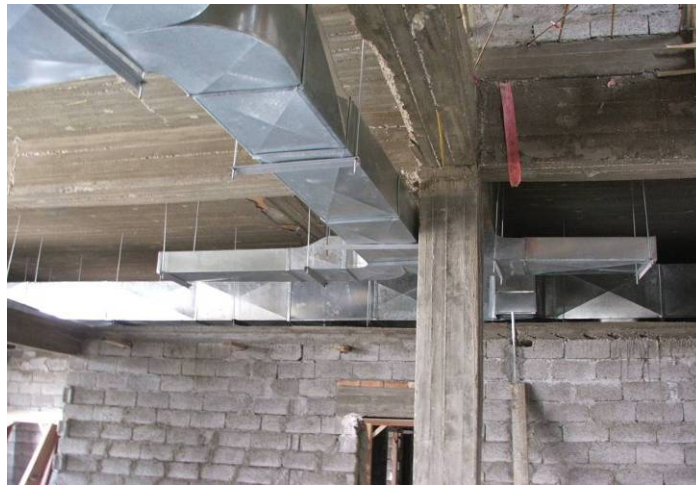
At the time of the site assessment, all reinforced concrete columns, slabs, and ceiling beams appeared complete and most of the formwork removed. For a picture of the concrete columns and remaining formwork, see Site Photos 77 and 78, respectively. The contract and design specifications required cast in-place reinforced concrete structural beams, columns, and slabs. We assessed only a fraction of the structural concrete work due to time constraints on site. The ground floor columns, ground floor structural beams, ground floor ceiling slab, interior stairwell, x-ray room walls, first floor structural beams, first floor columns, and first floor ceiling slab all appeared almost complete; however, we identified quality issues. During the site assessment, we observed work in progress on the block walls. The block walls appeared to be of substandard construction with quality problems. For instance, we observed block rows not level, walls with unfilled gaps between blocks, broken blocks, blocks improperly installed, and bricks of different sizes used in the wall construction. Site Photo 79 shows broken blocks in wall construction. We observed preparatory work in progress on the roof; however, at the time of the assessment, we did not observe roof construction activities underway (Site Photo 80).

Site Photo 77. First floor structural beams and column

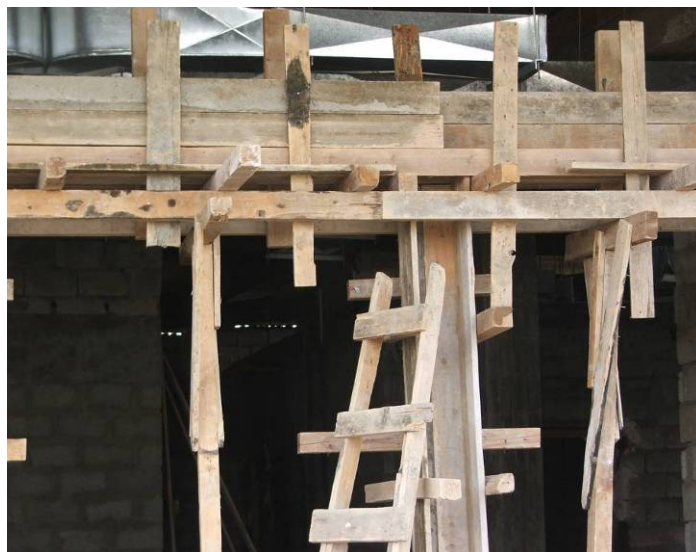
Site Photo 78. Example of remaining formwork

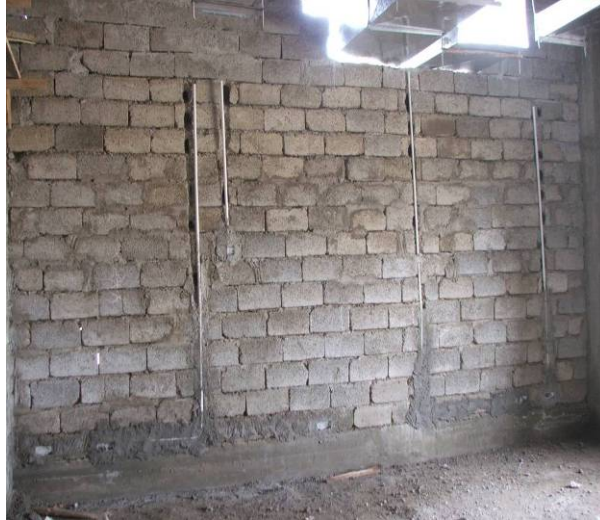
assessment, the electrical system installation was underway. We observed basic electrical preparatory work. The electrical work observed consisted of the installation of PVC conduit and plastic or metal electrical boxes attached to the surface of the block walls or recessed in a chiseled section of the wall. We did not observe wiring installed inside the PVC conduit. For a picture of the PVC conduit, see Site Photo 81.

Site Photo 81. PVC conduits attached to brick wall

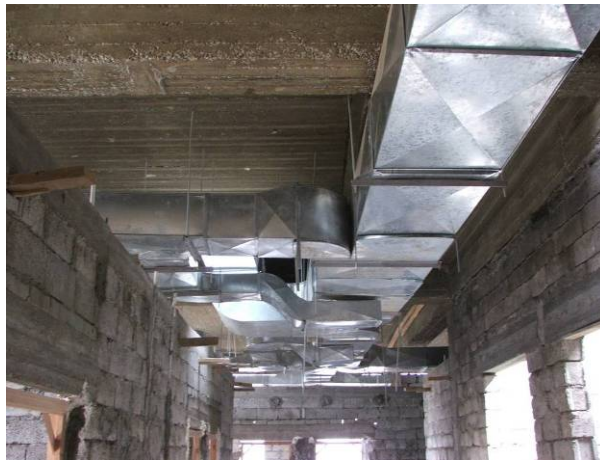
The SORS required new thermostats, heating, exhaust, ventilation and cooling systems. Work and equipment required also included condensing units, air handling units, coils, piping, ventilation and exhaust fans, grilles, registers, ductwork, hangars, insulation, and fasteners. The SORS required that all work comply with the IMC. At the time of the assessment, the mechanical work was underway. The fabrication and construction of the ventilation ductwork was nearly complete and appeared to meet the contract requirements (Site Photo 82). We did not observe duct fittings such as grilles, registers and diffusers on-site. We did not observe the connection of heating and cooling equipment to the ductwork or the equipment on site.

Site Photo 82. Completed ventilation ductwork

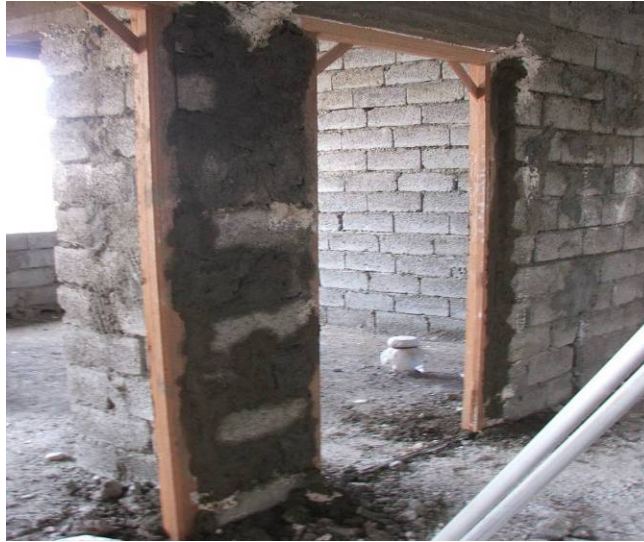
At the time of the assessment, we observed the partial installation of some wooden interior doorframes; however, due to time restrictions on site, we did not assess the doorframes. For a picture of the partially completed interior doorframes, see Site Photo 85. We did not observe the installation of exterior doors nor did they appear to be on site.

Site Photo 85. Partially installed doorframe
