SUMMARY REPORT
GROUND PROJECT SURVEYS
FOR THE QUARTER ENDED
DECEMBER 31, 2005

SIGIR PA-06-048
APRIL 13, 2006

SUBJECT: Summary Assessment Report of Ground Project Surveys for the Quarter
Ended 31 December 2005 (Report Number SIGIR-PA-06-048)

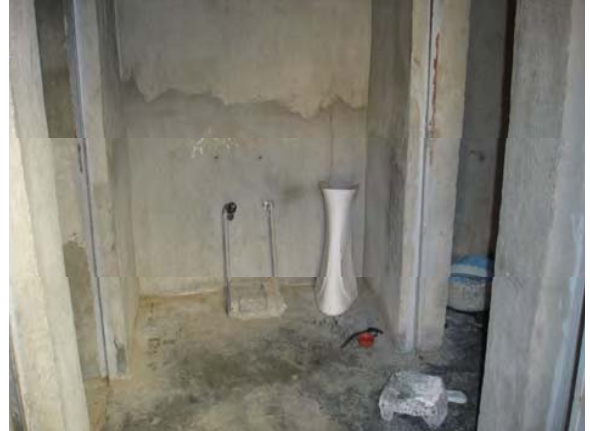
- Although a small generator was on site, fuel storage was not available.
- The plastering of external walls and sidewalks contained cracks and fractures. Site Photo 9 shows the exterior of a building with missing plaster.
- Most of the lights were broken and electrical wires were un-insulated.
- Bathroom fixtures appeared to be inoperative (Site Photo 10).
- The facility lacked security fences.
- The facility showed a lack of any recent maintenance or remodeling.

Site Photo 10: Bathroom fixtures at Project 20568

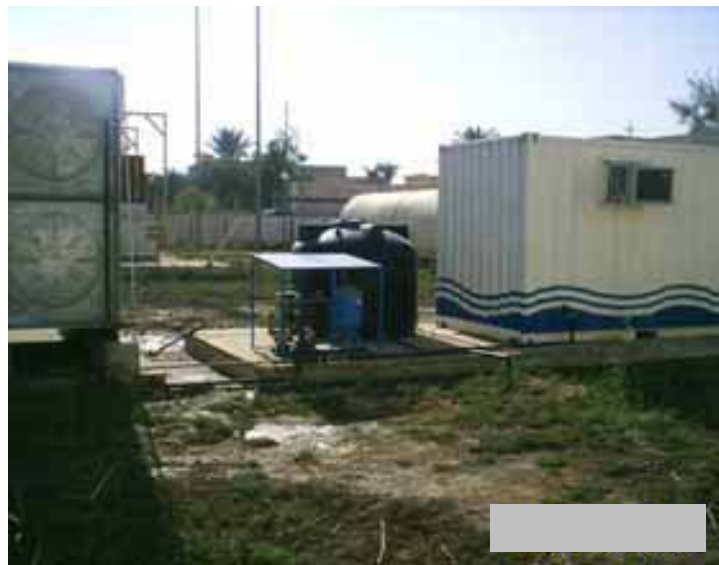
This building appeared to be an existing structure with renovations on going at the time of the site visit. A new reverse osmosis water purification unit, medical incinerator, and two generators were observed at the facility. Site Photo 19 shows the containerized reverse osmosis water purification unit with exterior pumps and water tanks. Renovation had not begun or was only partially complete on the plumbing, fixtures, electrical, and waste water systems. Observations during the site visit were:

- The interior finish is poor in some areas and there is staining on the ceiling and floors indicating water leakage either from pipes or from the roof. The floors require repair before tiling can be completed.
- New electrical boards are on site but not installed. Power cables were inappropriately passed through a window into the electrical room.

Site Photo 19: Containerized reverse osmosis unit with exterior pumps and storage tanks at Project 1270

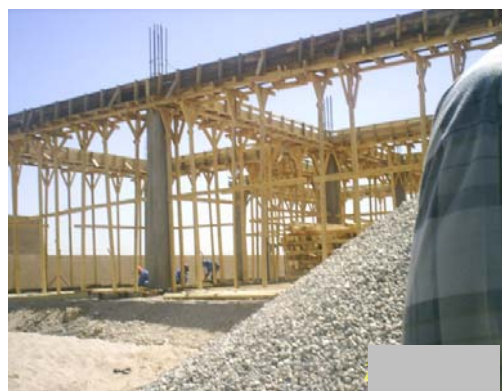
Site Photo 24: Aggregate stockpile at Project 11943

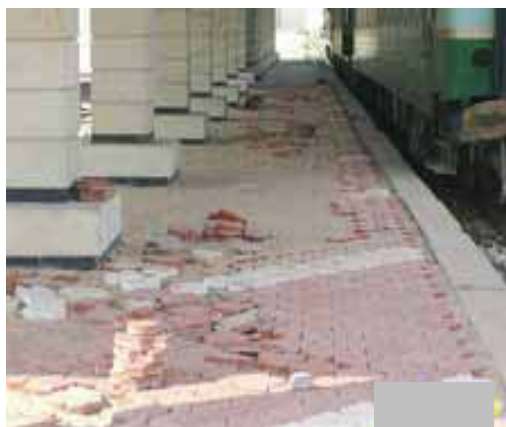
Site Photo 56: Installation of brickwork at Project 21251

The renovation project was in-progress at the time of the survey site visit. Placement of exterior patio brick over sand base was partially complete. Site Photo 56 shows the brick installation. The survey team observed brick and cement manholes and trenches between the manholes. Site Photo 57 shows manholes under construction. Minor electrical work had also begun. Discrepancies noted were:
