NASIRIYAH FIRE STATION
NASIRIYAH, IRAQ

SIGIR PA-06-053
JULY 24, 2006

SUBJECT: Report on Project Assessment of the Nasiriyah Fire Station, Nasiriyah, Iraq
(Report Number SIGIR-PA-06-053)

Nasiriyah Fire Station, Nasiriyah, Iraq

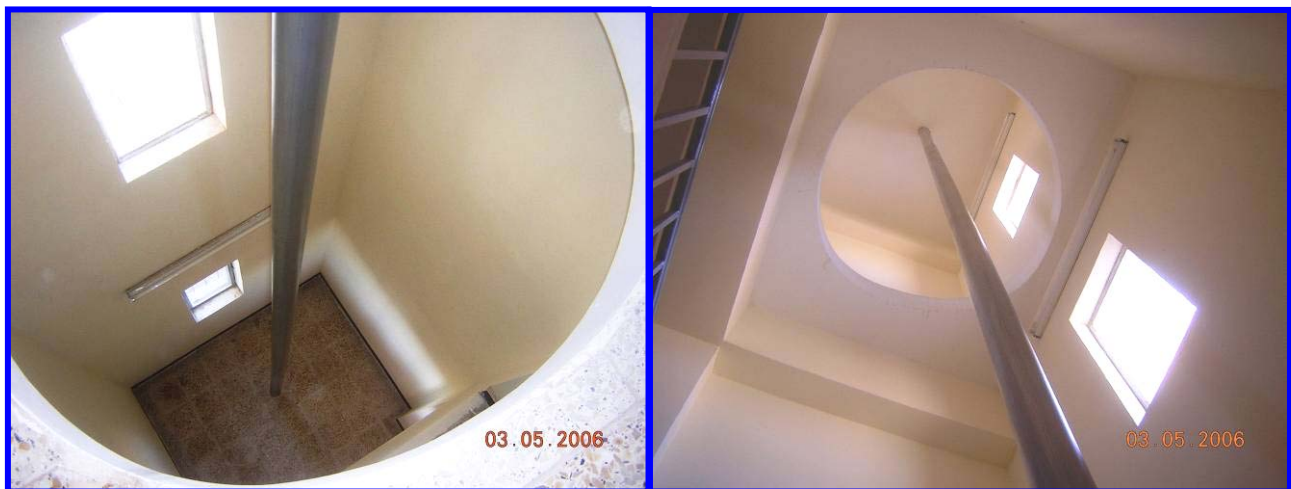
Another architectural feature in the building inherent with fire stations is the fireman's pole. The contractor's design showed a four inch diameter steel pole to provide direct access to the ground floor level from the living areas on the third level. Site Photo 12 shows two perspectives of the completed fireman's pole and the opening through the floor slab.

Site Photo 12. Top and bottom perspective of the fireman's pole
