WEST BAGHDAD INTERNATIONAL
AIRPORT SPECIAL FORCES BARRACKS
BAGHDAD, IRAQ

SUSTAINMENT ASSESSMENT

SIGIR PA-07-100
APRIL 24, 2007

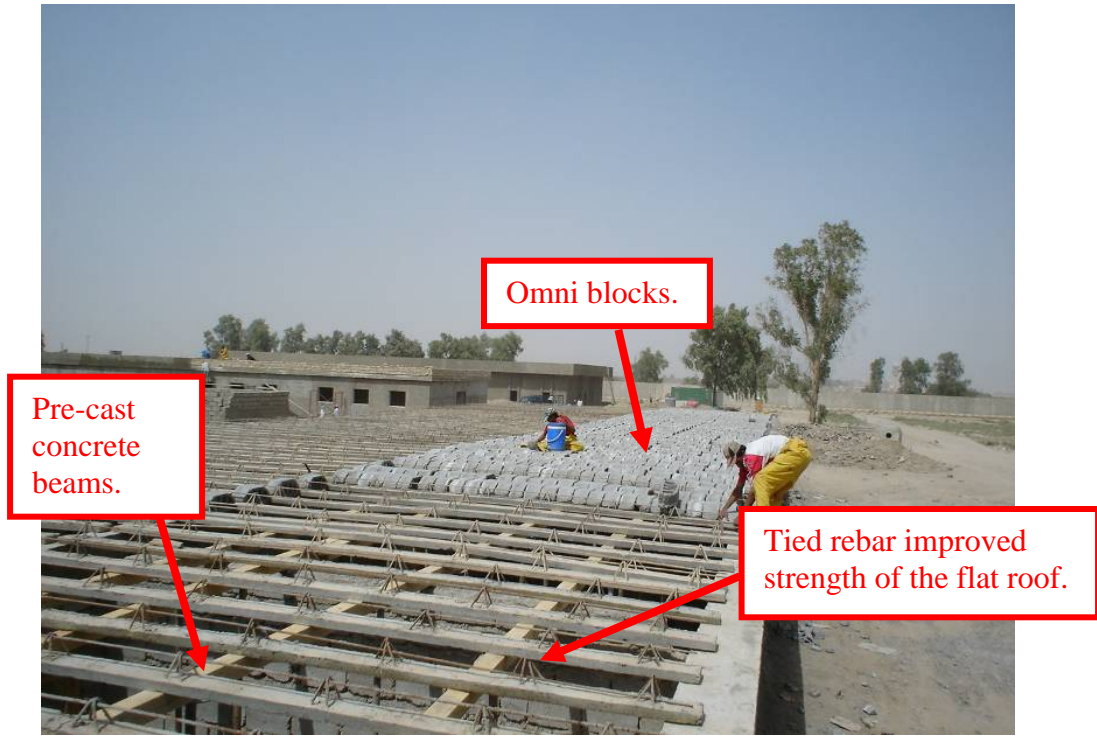
USACE Construction Progress Photos 5 and 6 illustrate stages of the construction of a barrack's roof. In USACE Construction Progress Photos 5, workers placed prefabricated "Omni" blocks on evenly spaced steel reinforced concrete beams to fabricate the roof's support structure system with tied rebar between beams. Subsequently, the roof's solid flatwork concrete was cast and clean dirt and sand was placed atop the flatwork casting and leveled before steiger plates (concrete tile) were laid in place. Overall, beam spacing and "Omni" block placement appeared even, straight and uniform.

USACE Construction Progress Photo 5. “Omni” blocks were placed on evenly spaced concrete beams.

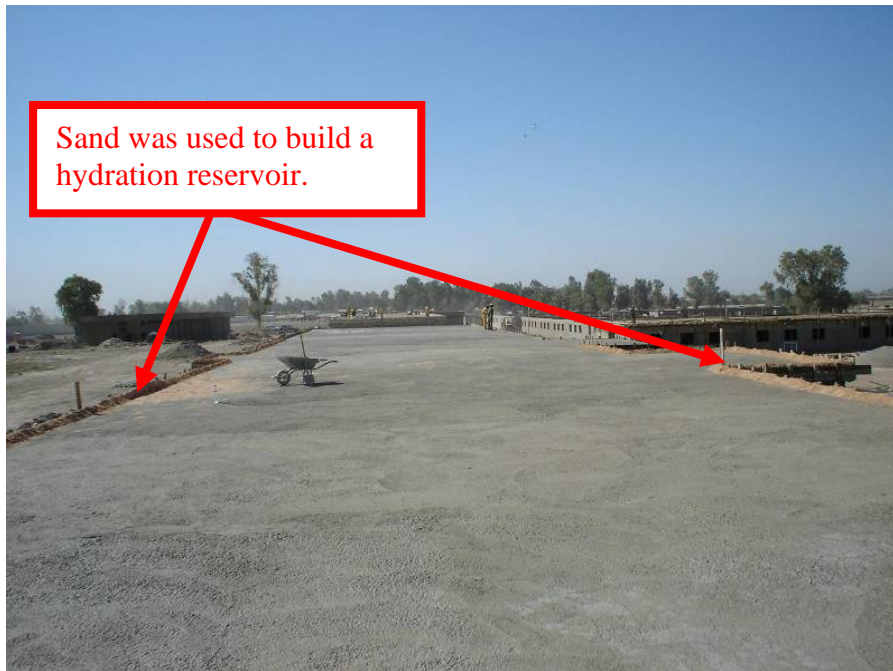
USACE Construction Progress Photo 6 taken 12 June 2005 shows the completed flatwork casting on the Senior NCO Barracks. June is a hot month in Iraq and flatwork concrete cast/placed in such conditions can dry and cure too rapidly. To slow down the drying process, sand was used to build a hydration reservoir of water above recently cast concrete.

USACE Construction Progress Photo 6. Each Company Barracks roof was over 14,000 sq. ft.
