BAB SHAMS POLICE STATION  
MOSUL, IRAQ

SUSTAINMENT ASSESSMENT

**SIGIR PA-06-091**  
**APRIL 25, 2007**

SUBJECT: Report on Bab Shams Police Station Sustainment, Mosul, Iraq  
(Report Number SIGIR PA-06-091)

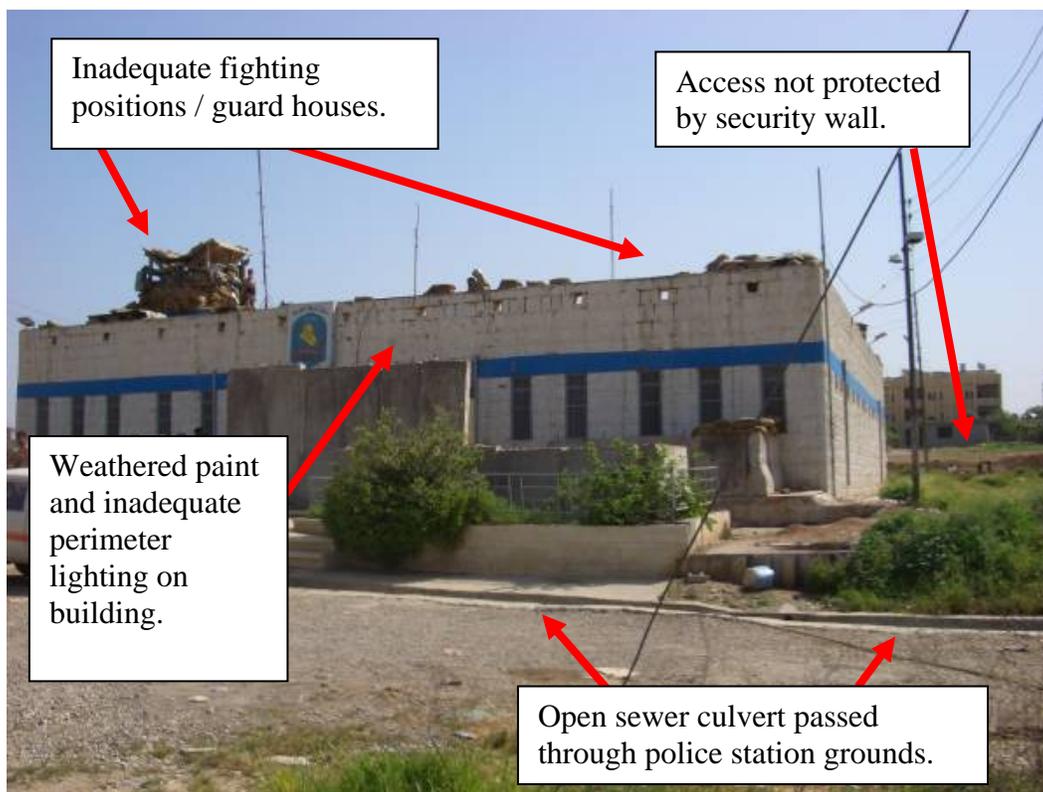
**USACE Pre-Construction Photo 1.**

As an overview of general requirements, USACE Pre-Construction Photo 1 documented several pre-existing conditions that needed to be addressed in the renovation project. For example, an open sewer, shown in USACE Pre-Construction Photo 2, passed near the front of the station; the building and grounds were not protected by a solid material security wall, building perimeter security lighting was inadequate, exterior paint was severely weathered, and rooftop fighting positions were inadequate. The subsequent status of all of the aforementioned pre-existing conditions are described and/or shown more clearly via photos taken by USACE officials during construction or by SIGIR inspectors while on site on 28 January 2007. Significant issues relating to the (1) open sewer, (2) electrical system improvements, and (3) construction of the security wall are discussed in detail later in this report.

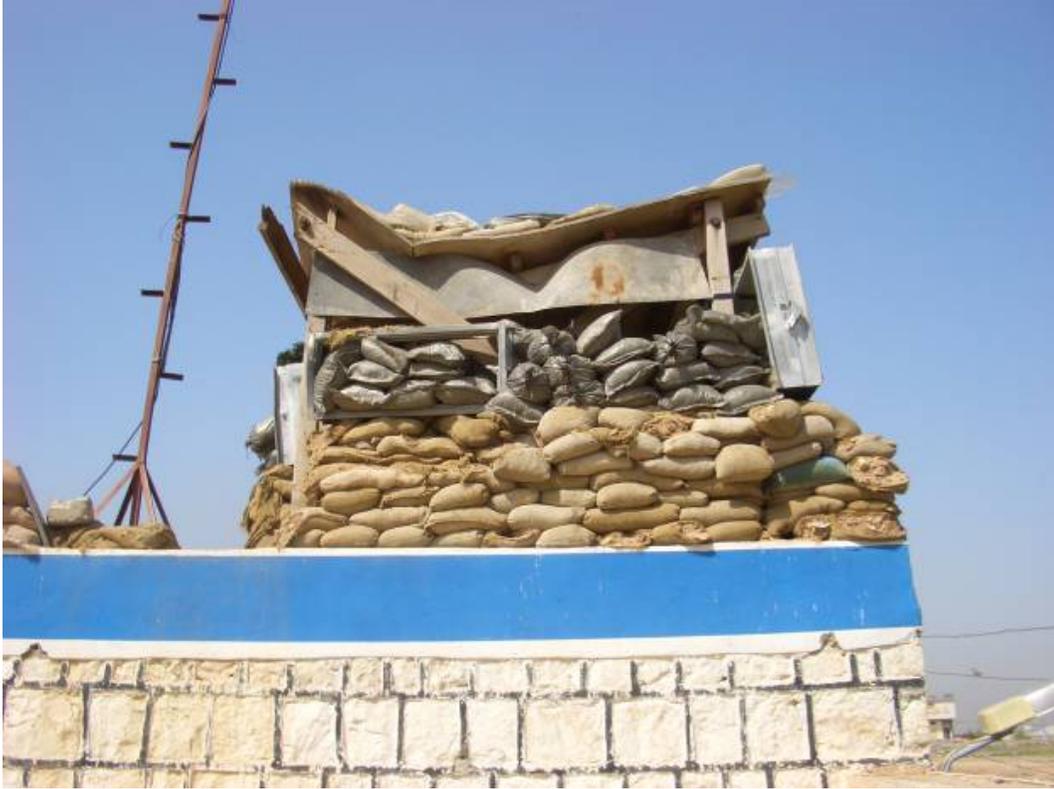
Pre-existing rooftop fighting positions and guard houses were constructed in a crude and non-uniform manner. Some positions did not have overhead cover and were nothing more than a makeshift berm made of sand bags (USACE Pre-Construction Photo 5). Another corner position included overhead protection, but fields of fire were very likely too narrow to provided sufficient defensive coverage because field of vision was constrained. Accordingly, the contract's SOW required the contractor to build a suitable fighting position/guard house at each corner of the police station building.

**USACE Pre-Construction Photo 5. Rooftop fighting positions/guard houses before renovation.**

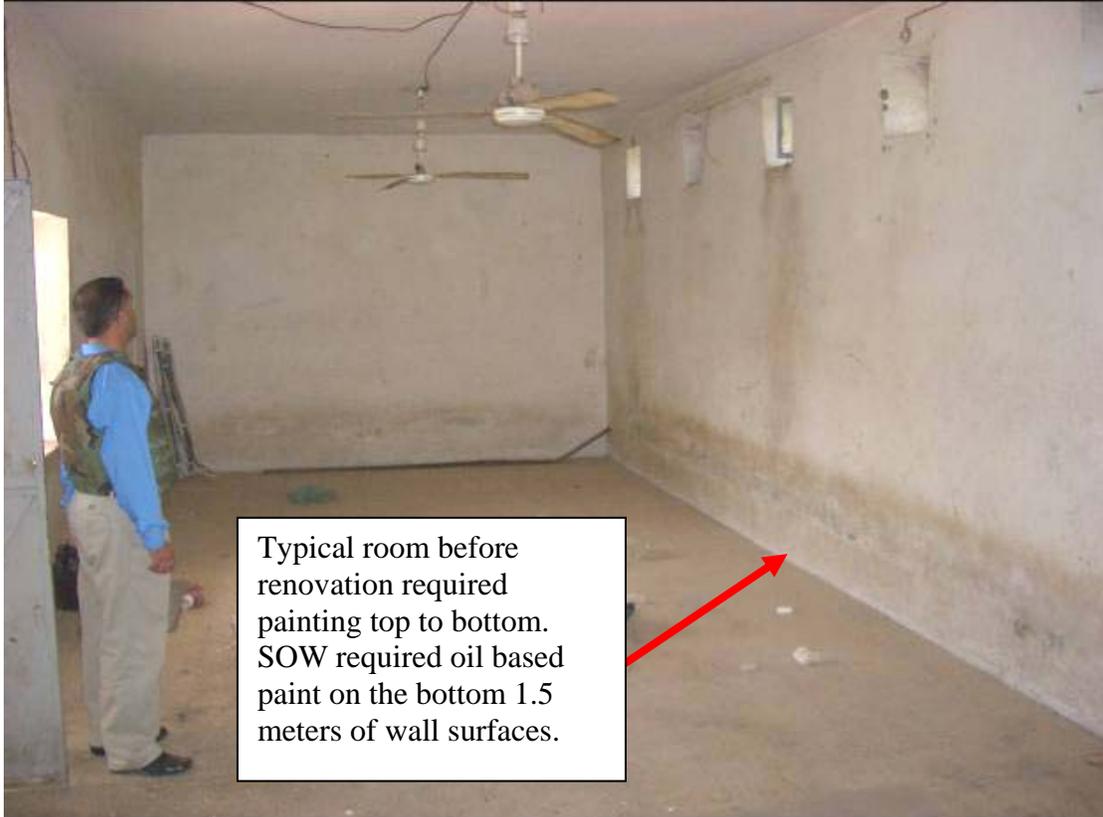
**USACE Pre-Construction Photo 7.**

The renovation also required the contractor to paint interior rooms and place tile on all steps. The SOW specified that oil based paint was to be used on the lower 1.5 meters of walls. USACE Pre-Construction Photo 7 shows a typical room in need of new paint while unsealed concrete steps are shown in USACE Pre-Construction Photo 8.

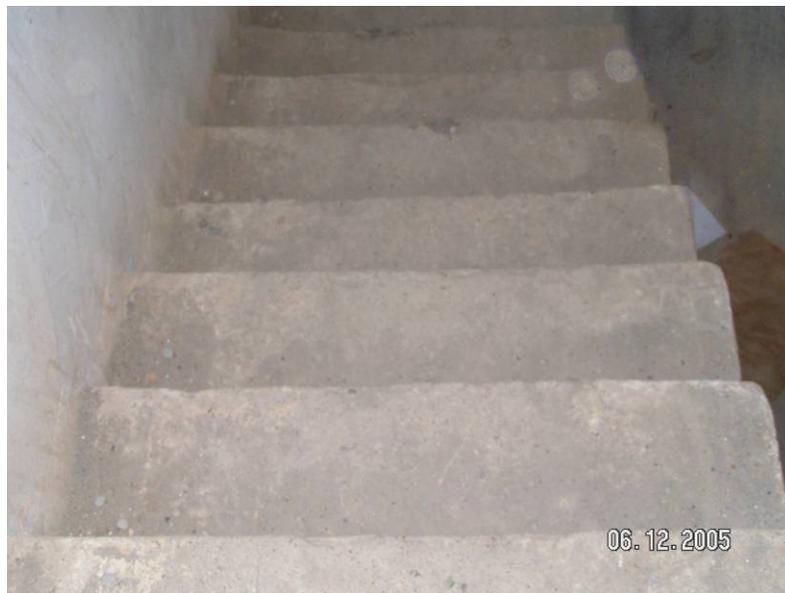
**USACE Pre-Construction Photo 8. Before renovation, steps were bare, unsealed concrete.**

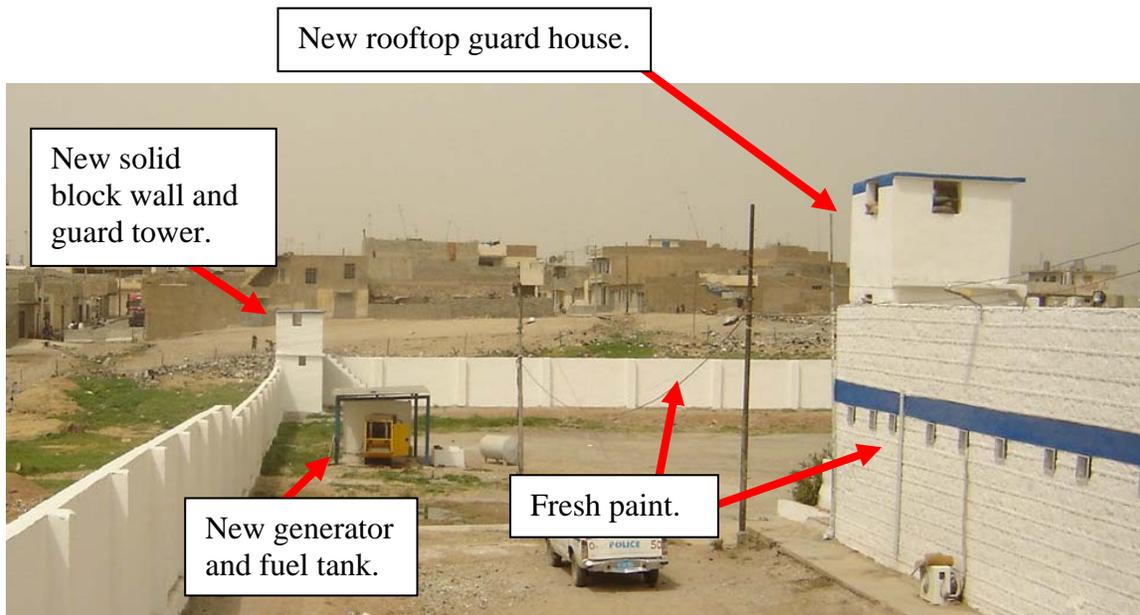
USACE Construction Photo 1 (12 Aug 05)

USACE Construction Photo 1 shows five high value requirements: generator system (\$79,000), painting (\$58,800), rooftop guard houses (\$18,000), solid block security wall (\$120,000) and guard towers (\$22,000). All were very likely constructed or installed in accordance with contract requirements. When combined, the aforementioned high value requirement totaled \$297,800 or approximately 84% of the contact's total value of \$353,400.

Lastly, complete installation of the generator and system components appeared imminent based on a close-up review of USACE Construction Photo 1. However, the close-up picture of the generator shown in USACE Construction Photo 1 was not included in this report because picture quality decreased when the original photo was electronically cropped to isolate the generator. In the review of the close-up photo, SIGIR inspectors confirmed that the generator, fuel tank, and automatic transfer switch and control panel

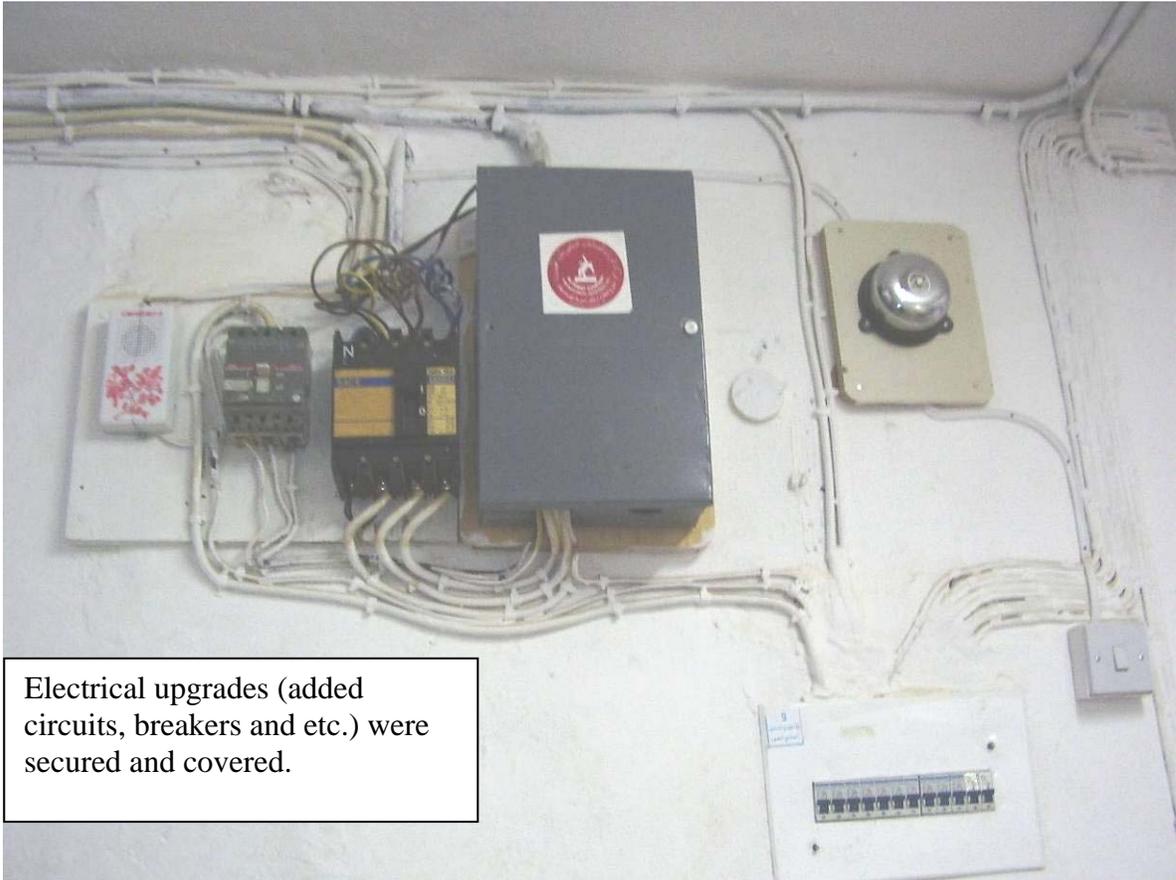
USACE Construction Photo 5 (23 Sep 05)

Electrical upgrades (added circuits, breakers and etc.) were secured and covered.

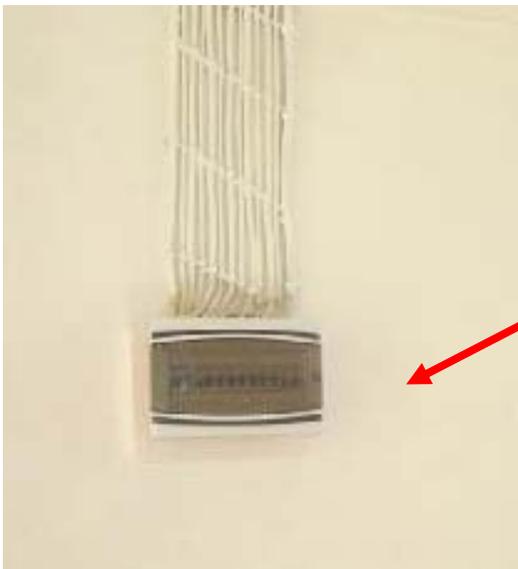
USACE Construction Photo 6 (15 Aug 05)

Breaker boxes were covered and free off tampering.

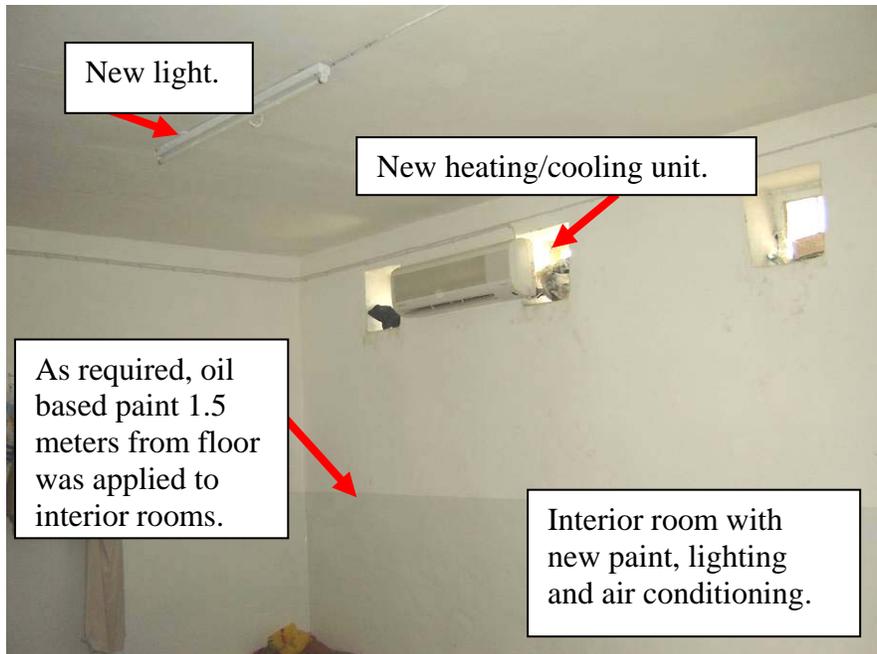
**USACE Construction Photo 10 (11 Aug 05)**

New light.

New heating/cooling unit.

Interior room with new paint, lighting and air conditioning.

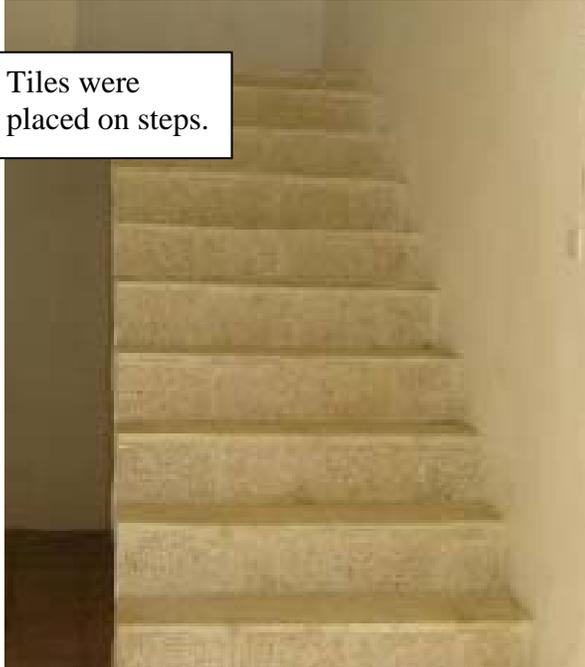
USACE Construction Photo 12 (15 Aug 05)

Tiles were placed on steps.

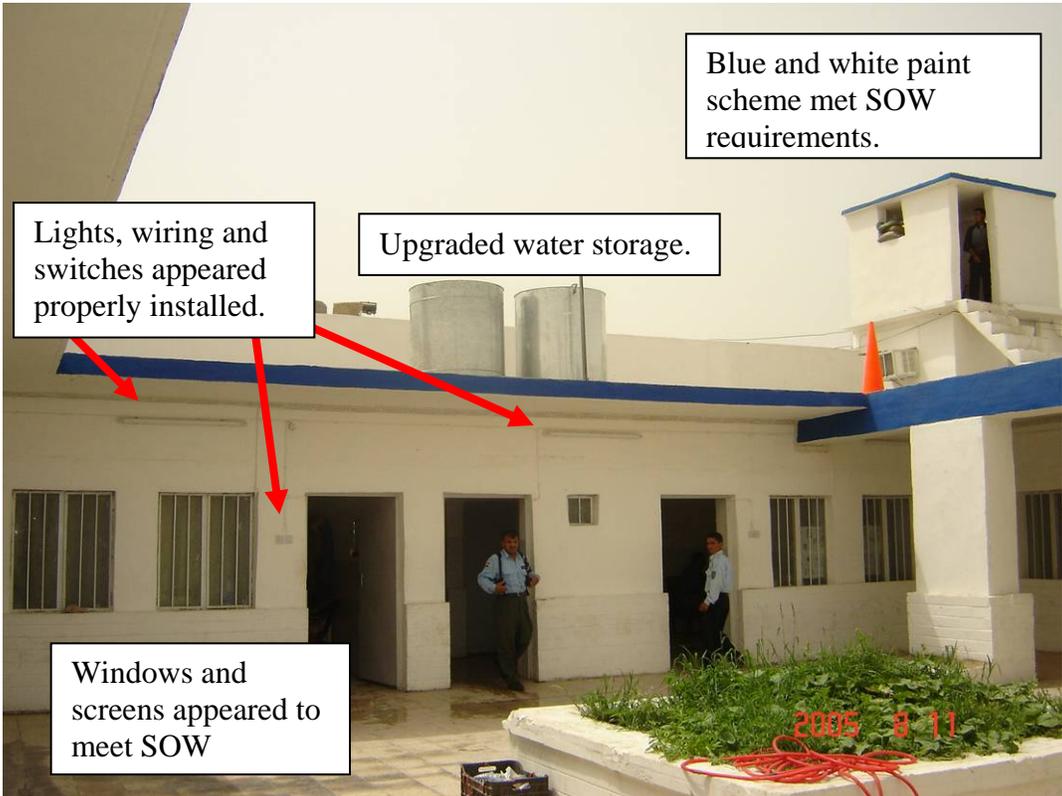
USACE Construction Photo 13 (11 Aug 05)

SIGIR inspectors used USACE Construction Photo 13 to present a general overview of the facilities' interior condition following renovation. The interior is that part of the facility inside the outside perimeter of the building and generally accessed from the courtyard area. In USACE Construction Photo 13, it appeared that windows, screens, and painting met SOW requirements. In addition, an upgraded water storage system can be seen in USACE Construction Photo 13.

Blue and white paint scheme met SOW requirements.

Lights, wiring and switches appeared properly installed.

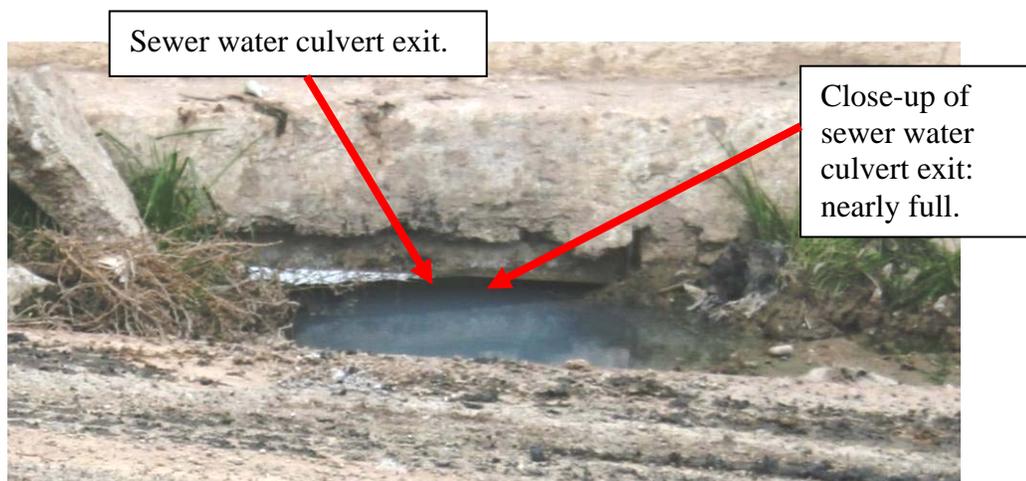
Site Photo 8.

At the time of the site inspection, the conditions were dry and not impacted by recent rains. Nevertheless, Site Photo 7 shows that the open culvert on the high side or half of the compound was running free and able to handle the waste water volume entering the compound that day. However, Site Photo 8 taken at the exit and the open culvert's lowest spot within the confines of the compound shows the open culvert nearly full. It would not take much rain water runoff to create a flooded condition within parts of the IP compound area.
