MINISTRY OF DEFENSE BUILDING  
BAGHDAD, IRAQ

SUSTAINMENT ASSESSMENT

**SIGIR PA-07-102**  
**JULY 17, 2007**

## Ministry of Defense Building Baghdad, Iraq

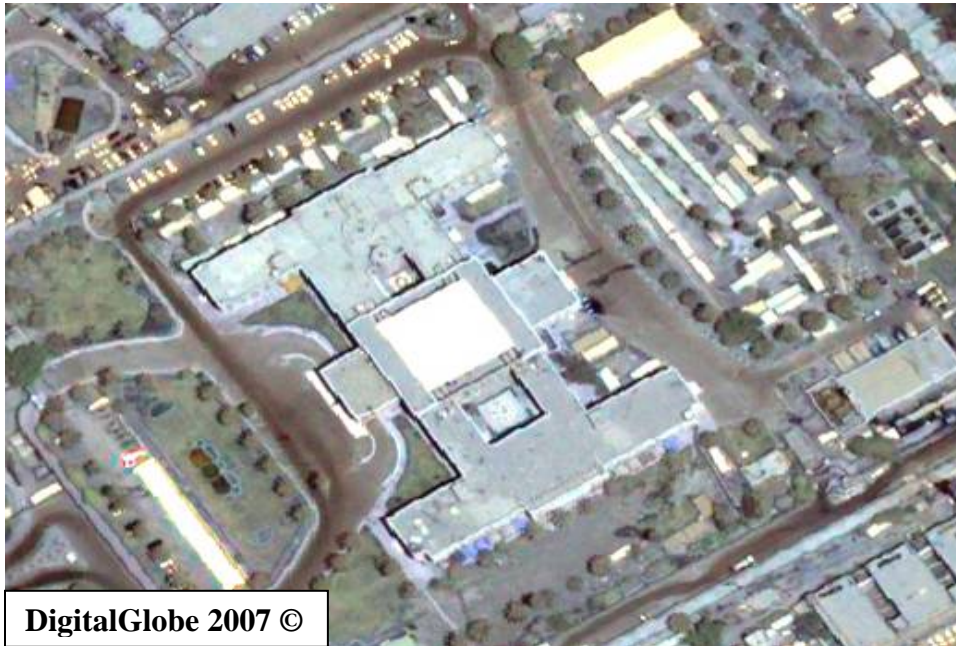
The MOD HQ complex is situated in the International Zone. The facility consisted of an H shaped building with entrance and exit foyers (Aerial Image 1). The original construction of this building started in 1957 and was completed in 1961. This complex received catastrophic damage from both the 2003 Joint Direct Attack Munition (JDAM) bombing barrage of Baghdad and subsequent looting (Aerial Image 2 and Site Photos 1 and 2).

**Aerial Image 1. Aerial view of MOD HQ complex**
