WASTE WATER TREATMENT PLANT
AL KASIK MILITARY TRAINING BASE
AL KASIK, IRAQ

SIGIR PA-06-074
JANUARY 29, 2007

SUBJECT: Report on Waste Water Treatment Plant, Al Kasik Military Training Base, Al Kasik, Iraq (Report Number SIGIR PA-06-074)

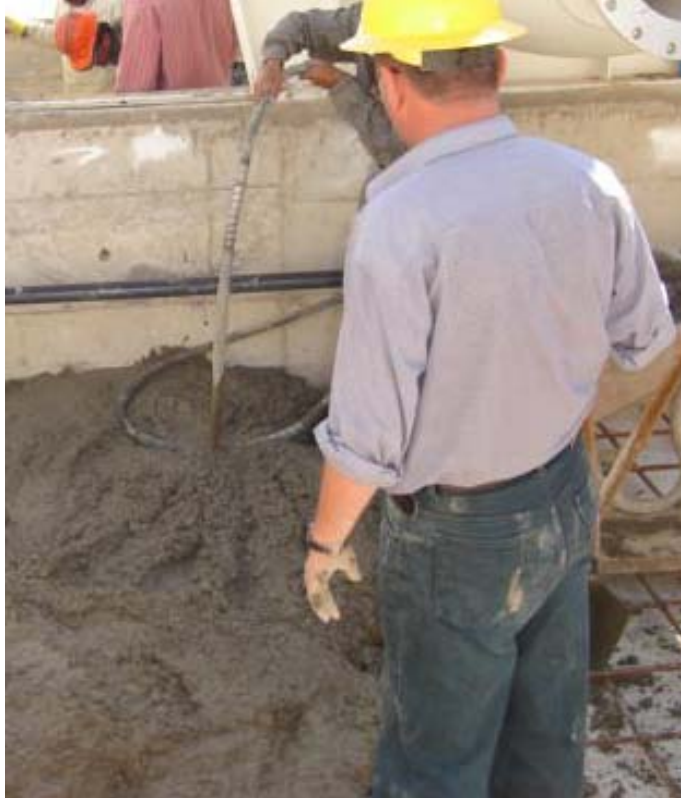
QA Photo 7. Supervisor watched worker consolidate concrete with a hand held mechanical vibrator⁴ (from QA Report 26 Oct 2005).
