ERDC/CERL TR-11-21

Civil Works Hydropower R&D Program

Cavitation-Resistant Coatings for Hydropower Turbines

Final report

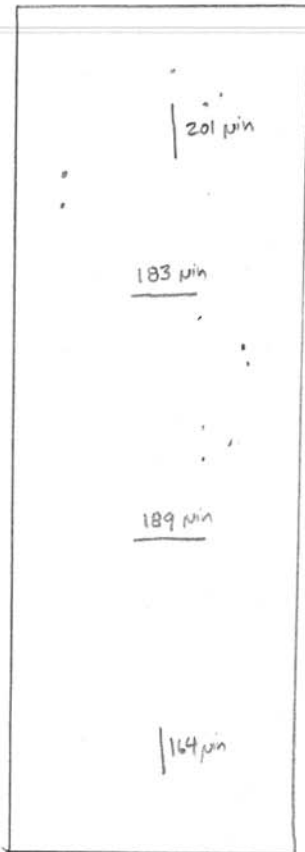
TEST BUCKET #2

photos: 350, 351

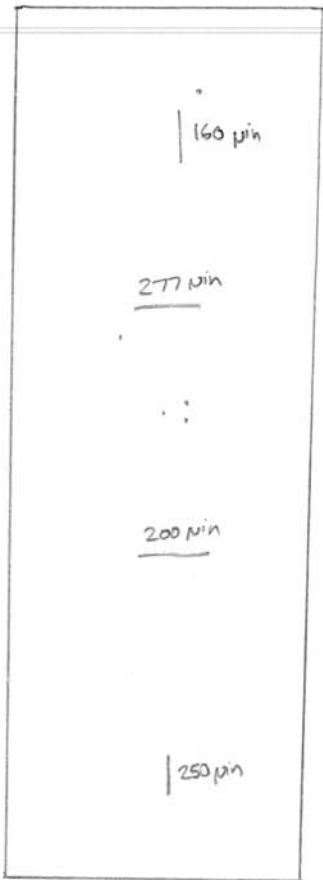
TEST BUCKET # 4

photo 353

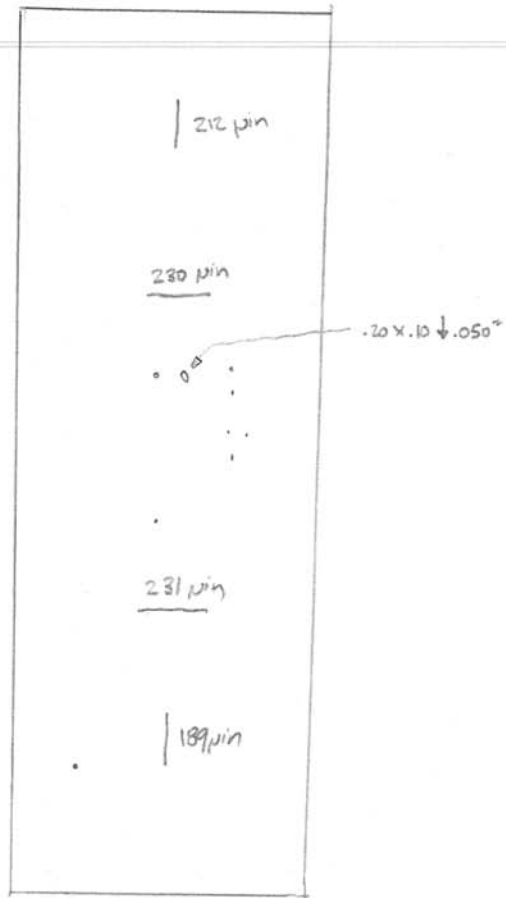
TEST BUCKET #3

photos 348, 349

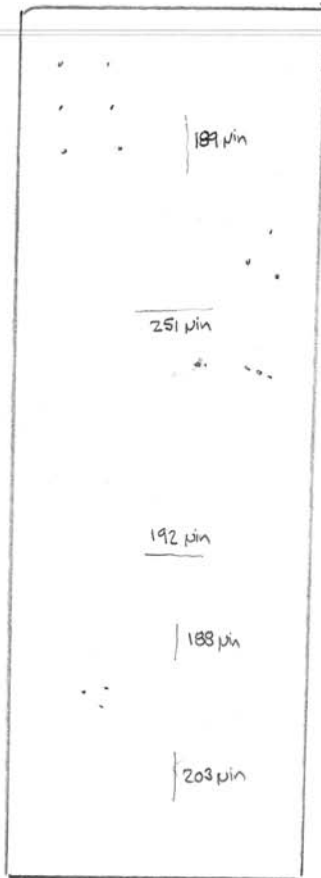
TEST BUCKET # 1

photos: 362, 363, 364, 365, 366

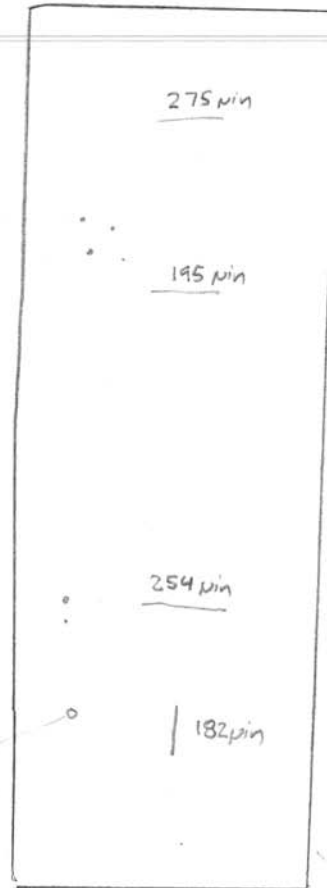
TEST BUCKET # 7

Photos: 359, 360, 361

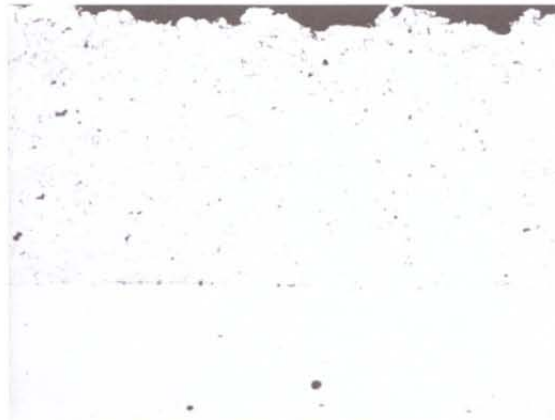
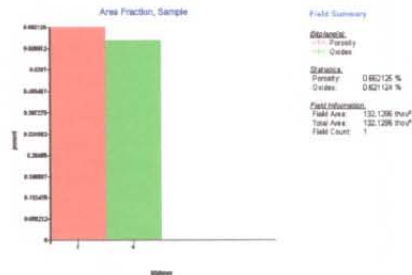
Work Order #:	18668	Application Spec:	AMS 2447				
Purchase Order #:	W9127N-10-Q-0002	Lab. Technician:	Ricky Lee				
Customer:	U.S. Army Green River Dam Project	Objective:	200X				
Material:	Nano Steel 9172 SHS Lot # 08-050	Applicator:	Ricky T.				
Date:	11/23/09	Sample Number:	1T-B				
Acceptance Criteria							
Cracks (None)	NONE	Porosity Max 2%	0.66%	Interface Contamination No Delam.	Acceptable No Delam.	Oxide Max 1%	0.62%
Unmelted Particles Max 0.01%	Acceptable	Abrasive Particles	Acceptable

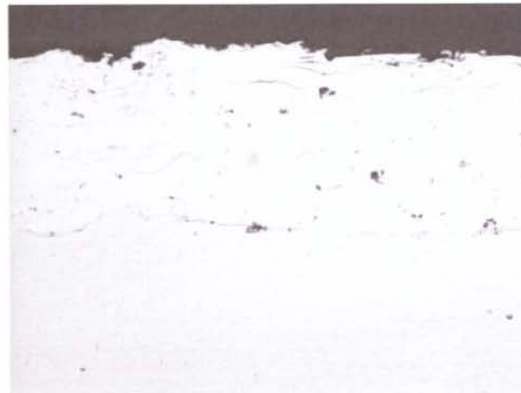
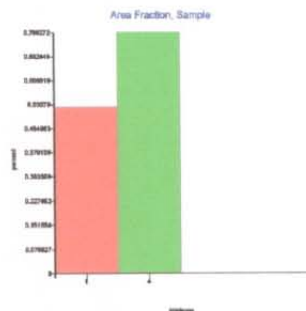
Work Order #:	18668	Application Spec:	AMS 2447
Purchase Order #:	W9127N-10-Q-0002	Lab. Technician:	Ricky Lee
Customer:	U.S. Army Green River Dam Project	Objective:	200X
Material:	Vecalloy Lot # 07-227	Applicator:	Ricky T.
Date:	11/23/09	Sample Number:	2T-B
Acceptance Criteria			
Cracks (None)	NONE	Porosity Max 2%	0.52%
		Interface Contamination No Delam.	Acceptable No Delam.
		Oxide Max 1%	0.75%
Unmelted Particles Max 0.01%	Acceptable	Abrasive Particles	Acceptable

Statistics:
 Porosity: 0.522017 %
 Oxides: 0.750272 %

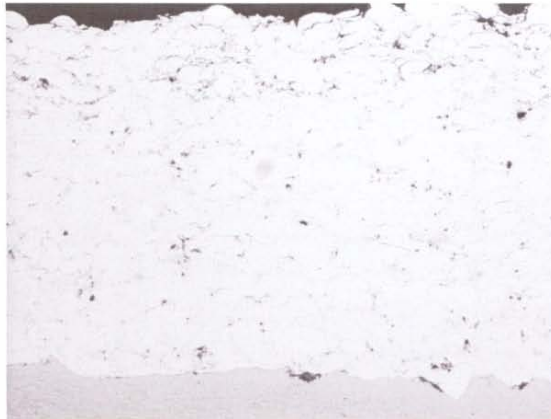
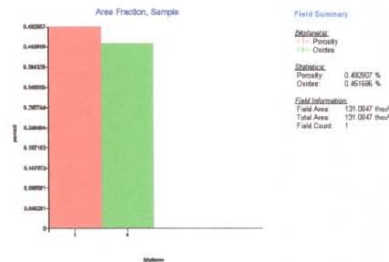
Work Order #:	18668	Application Spec:	AMS 2447
Purchase Order #:	W9127N-10-Q-0002	Lab. Technician:	Ricky Lee
Customer:	U.S. Army Green River Dam Project	Objective:	200X
Material:	Stellite Ultimet Lot # 5090137-2	Applicator:	Ricky T.
Date:	11/23/09	Sample Number:	3T-B

Acceptance Criteria							
Cracks (None)	NONE	Porosity Max 2%	0.49%	Interface Contamination No Delam.	Acceptable No Delam.	Oxide Max 1%	0.45%
Unmelted Particles Max 0.01%	Acceptable		Abrasive Particles		Acceptable

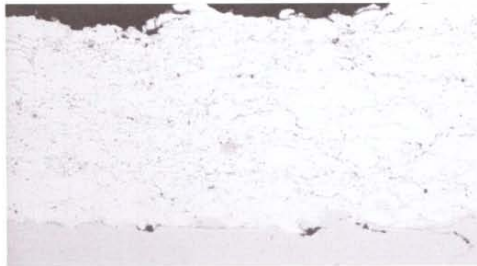
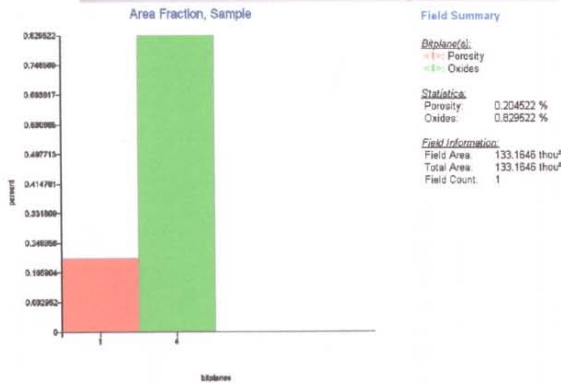
Work Order #:	18668	Application Spec:	AMS 2447
Purchase Order #:	W9127N-10-Q-0002	Lab. Technician:	Ricky Lee
Customer:	U.S. Army Green River Dam Project	Objective:	200X
Material:	Praxair Co-106-1 Lot # 46 Ref. Stellite 6	Applicator:	Ricky T.
Date:	11/24/09	Sample Number:	4T-A
Acceptance Criteria			
Cracks (None)	NONE	Porosity Max 2%	0.20%
		Interface Contamination No Delam.	Acceptable No Delam.
		Oxide Max 1%	0.82%
Unmelted Particles	Acceptable	Abrasive Particles	Acceptable

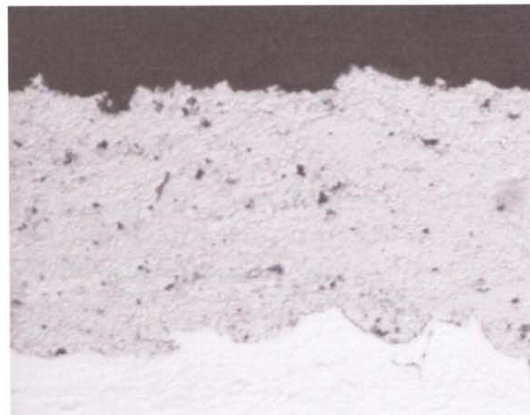
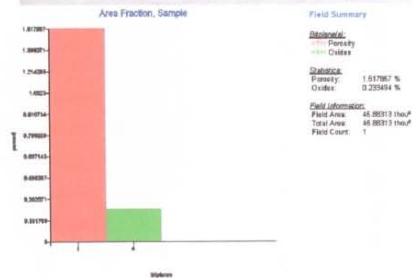
Work Order #:	18668	Application Spec:	AMS 2447
Purchase Order #:	W9127N-10-Q-0002	Lab. Technician:	Ricky Lee
Customer:	U.S. Army Green River Dam Project	Objective:	200X
Material:	Praxair 1350VM Lot # 418	Applicator:	Ricky T.
Date:	11/23/09	Sample Number:	5T-A
Acceptance Criteria			
Cracks (None)	NONE	Porosity Max 2%	1.51%
		Interface Contamination	Acceptable
		No Delam.	No Delam.
Unmelted Particles Max 0.01%	Acceptable	Abrasive Particles	Acceptable
		Oxide Max 1%	0.23%

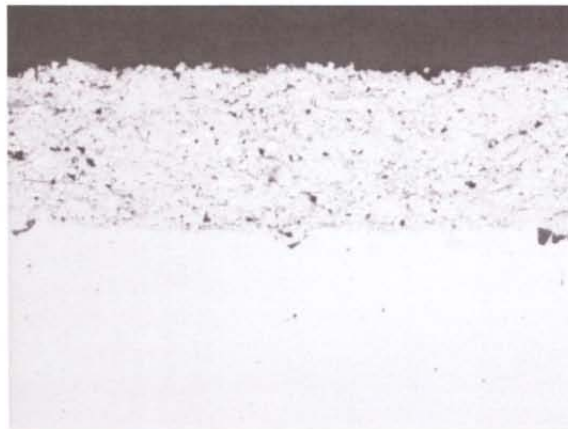
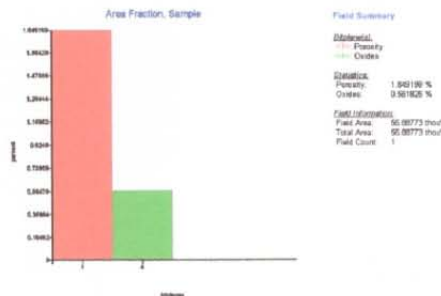
Work Order #:	18668	Application Spec:	AMS 2447
Purchase Order #:	W9127N-10-Q-0002	Lab. Technician:	Ricky Lee
Customer:	U.S. Army Green River Dam Project	Objective:	200X
Material:	Amperit 588.074 Lot # 4100900	Applicator:	Ricky T.
Date:	11/23/09	Sample Number:	6T-A
Acceptance Criteria			
Cracks (None)	NONE	Porosity Max 2%	1.84%
		Interface Contamination No Delam.	Acceptable No Delam.
		Oxide Max 1%	0.56%
Unmelted Particles Max 0.01%	Acceptable	Abrasive Particles	Acceptable

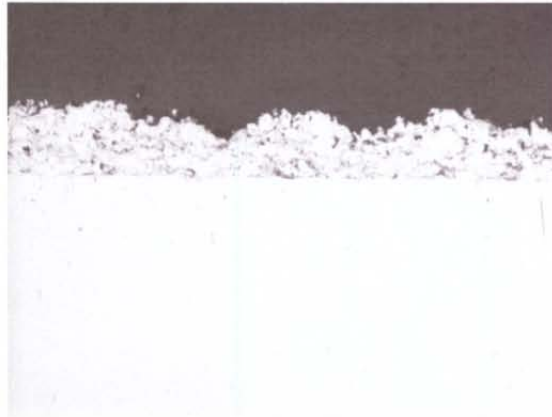
Work Order #:	18668	Application Spec:	AMS 2447
Purchase Order #:	W9127N-10-Q-0002	Lab. Technician:	Ricky Lee
Customer:	U.S. Army Green River Dam Project	Objective:	200X
Material:	Amperit 584.1 Lot # 4220840	Applicator:	Ricky T.
Date:	11/23/09	Sample Number:	7T-B
Acceptance Criteria			
Cracks (None)	NONE	Porosity Max 2%	1.89%
		Interface Contamination No Delam.	Acceptable No Delam.
		Oxide Max 1%	0.89%
Unmelted Particles Max 0.01%	Acceptable	Abrasive Particles	Acceptable

Material:
 Porosity: 1.89216 %
 Oxides: 0.89276 %

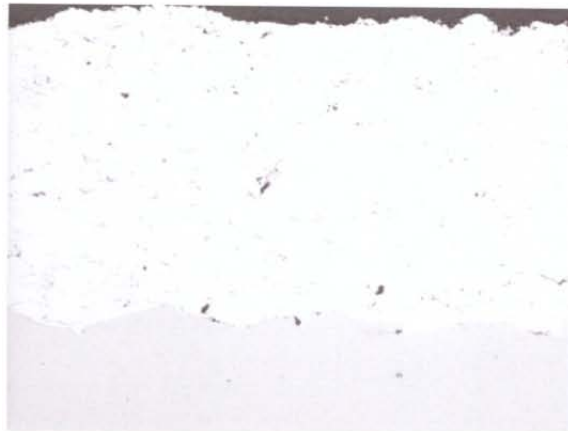
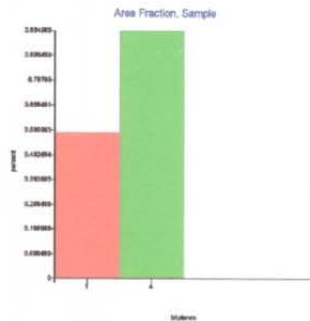
Work Order #:	18668	Application Spec:	AMS 2447
Purchase Order #:	W9127N-10-Q-0002	Lab. Technician:	Ricky Lee
Customer:	U.S. Army Green River Dam Project	Objective:	200X
Material:	Stellite 21 Lot # 5090136-2	Applicator:	Ricky T.
Date:	11/24/09	Sample Number:	8T-A
Acceptance Criteria			
Cracks (None)	NONE	Porosity Max 2%	0.58%
		Interface Contamination No Delam.	Acceptable No Delam.
		Oxide Max 1%	0.98%
Unmelted Particles	Acceptable	Abrasive Particles	Acceptable
