Monitoring Completed Navigation Projects Program

Periodic Inspections of Hilo, Kahului, Laupahoehoe, and Nawiliwili Breakwaters, Hawaii

Armor Unit Monitoring for Period 2001-2005

October 2011

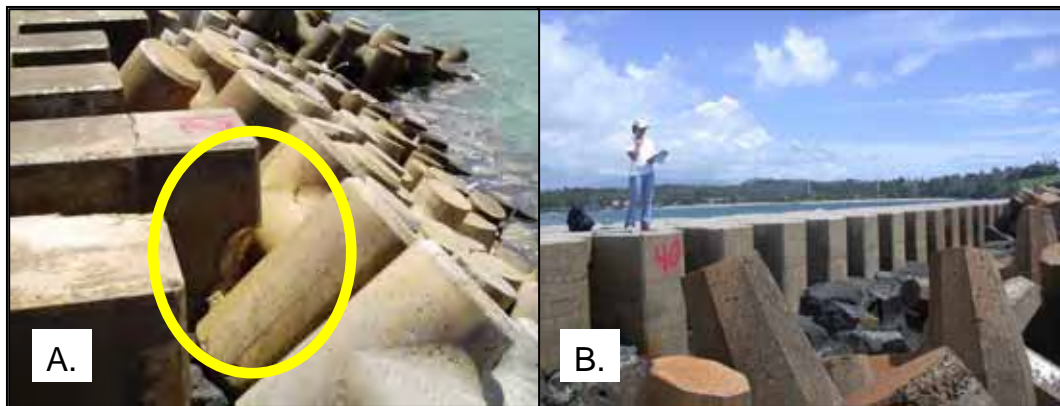
Settling of armor units along the structure has occurred causing a void between the rib cap and armor units (Figure 38a and b). The circle on Figure 38a indicates an example of a void created as the result of tribar detaching from the rib cap. The side slope subsidence of dolosse is shown in Figure 38b.

Figure 38. Evidence of armor stone subsidence.

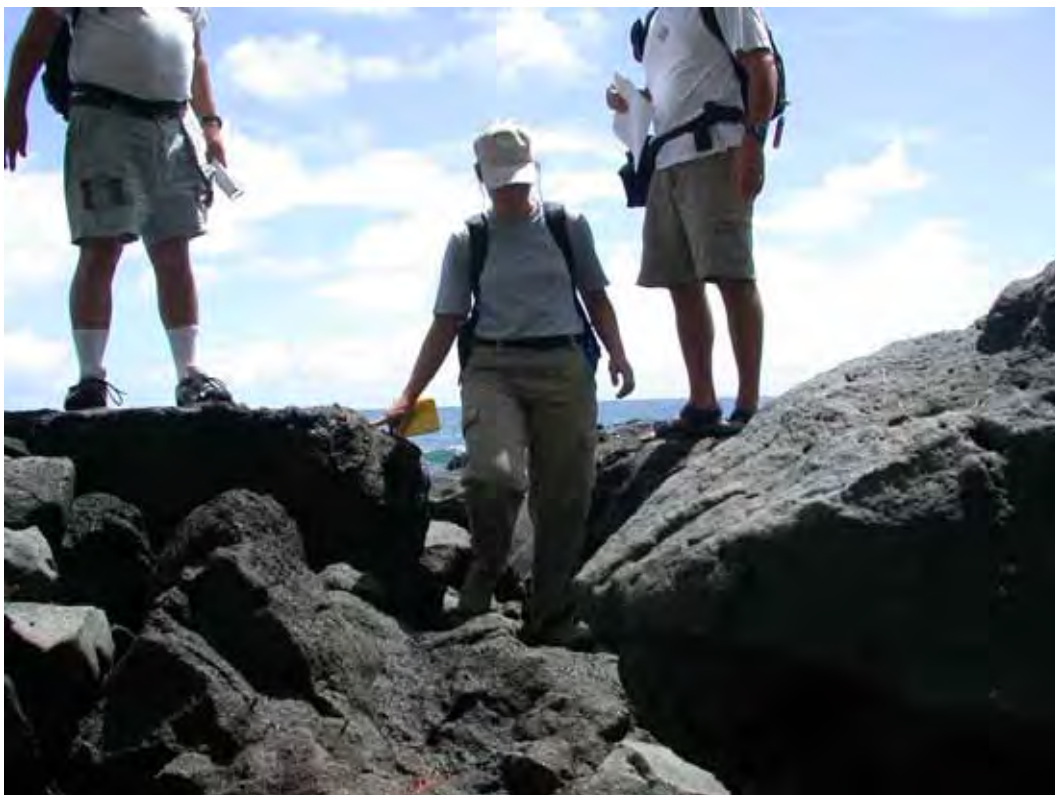
Figure A2. Damage location 1, sta 2+60, harbor side, missing armor stone, 8-ft x 4-ft void.

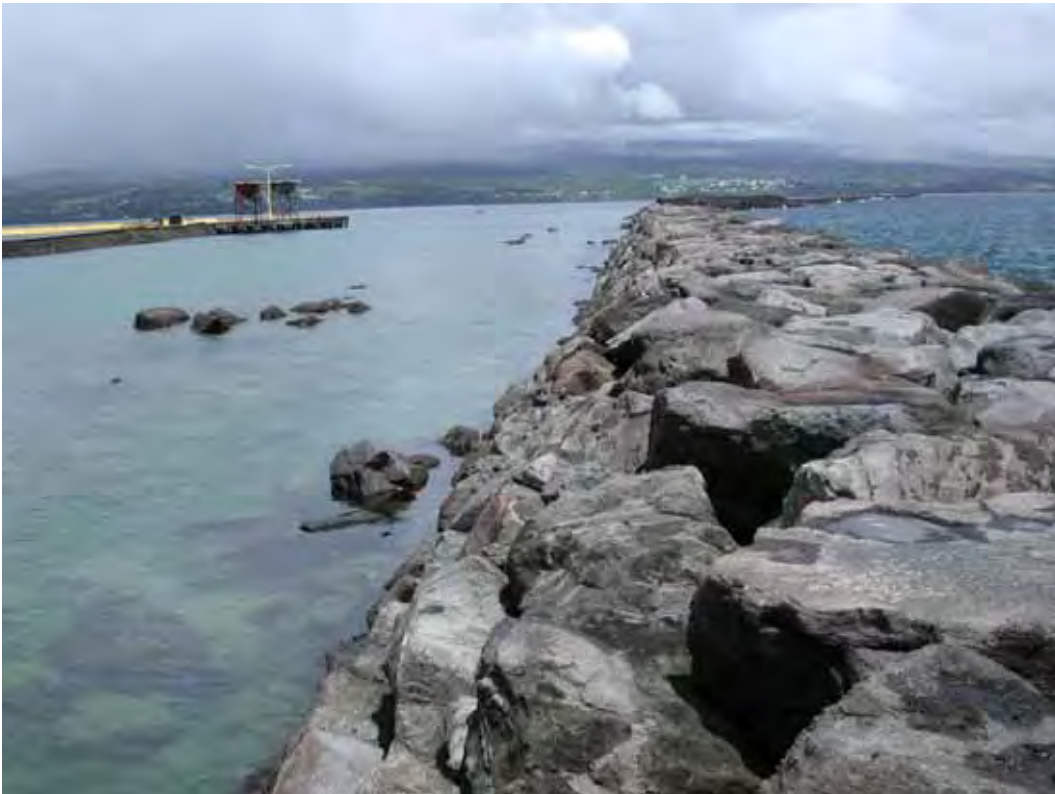
Figure A3. Damage location 2, sta 4+00, harbor side, minor settling on crest and side slope.

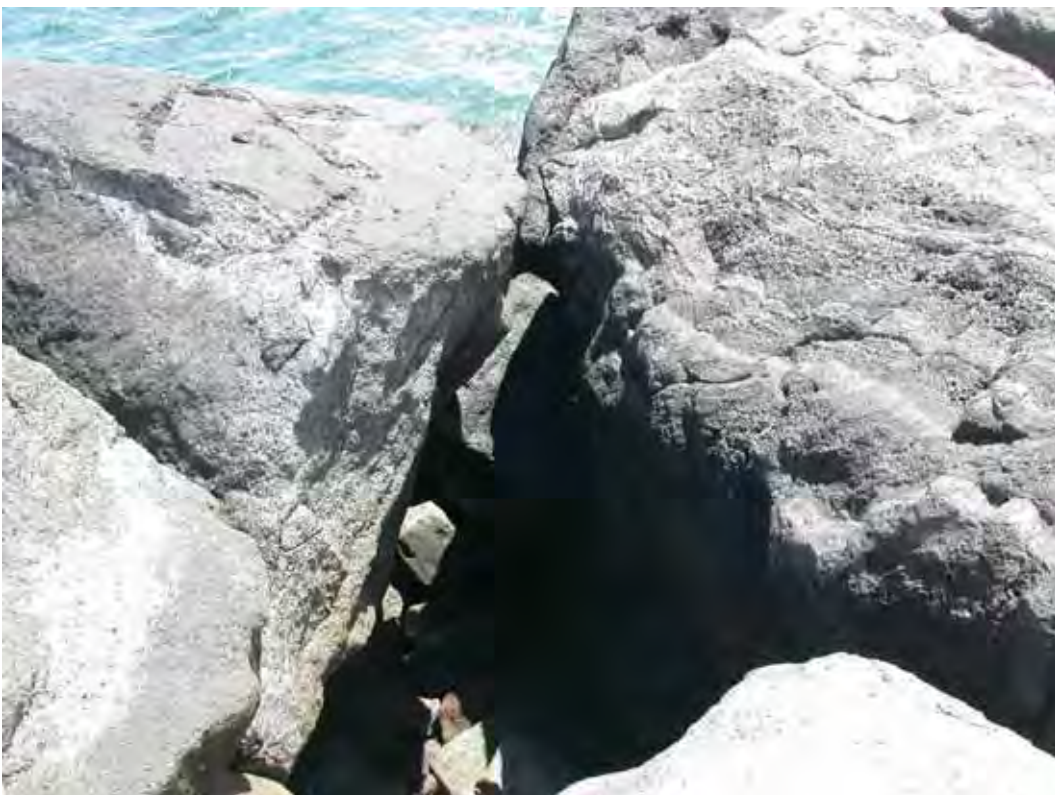
Figure A4. Damage location 3, sta 8+15, ocean side, 4-ft-wide void, 6.5 ft deep, slight sinking.

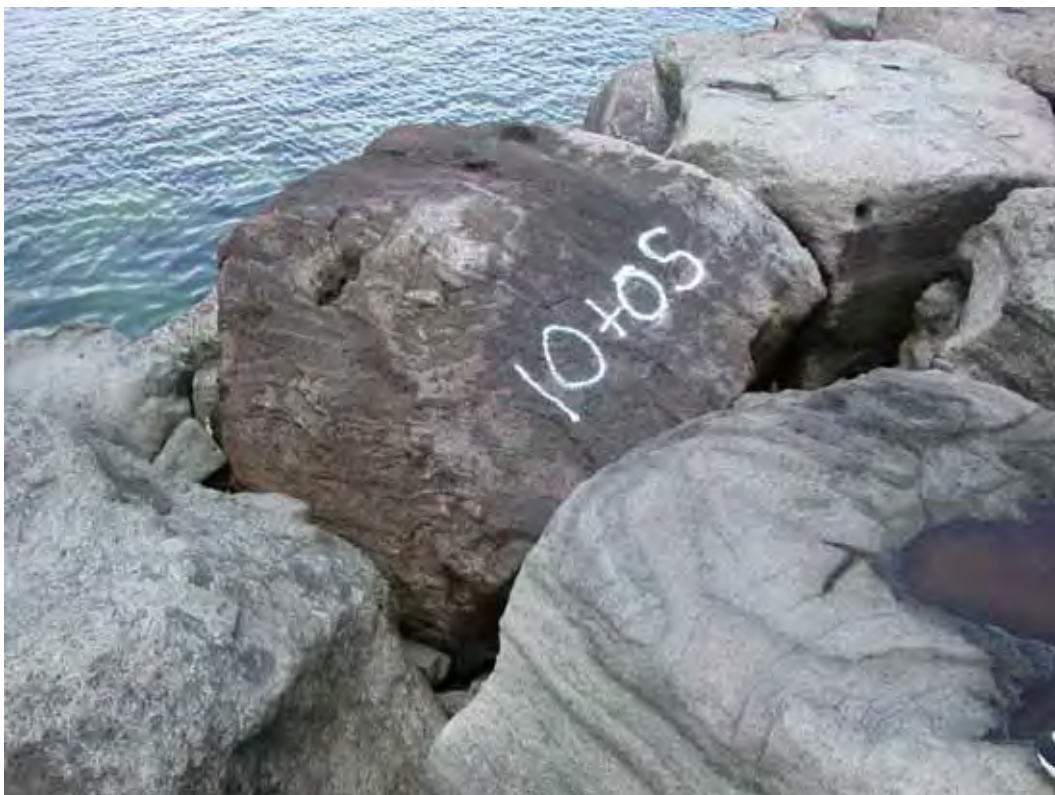
Figure A6. Damage location 5, sta 10+05, harbor side, void.

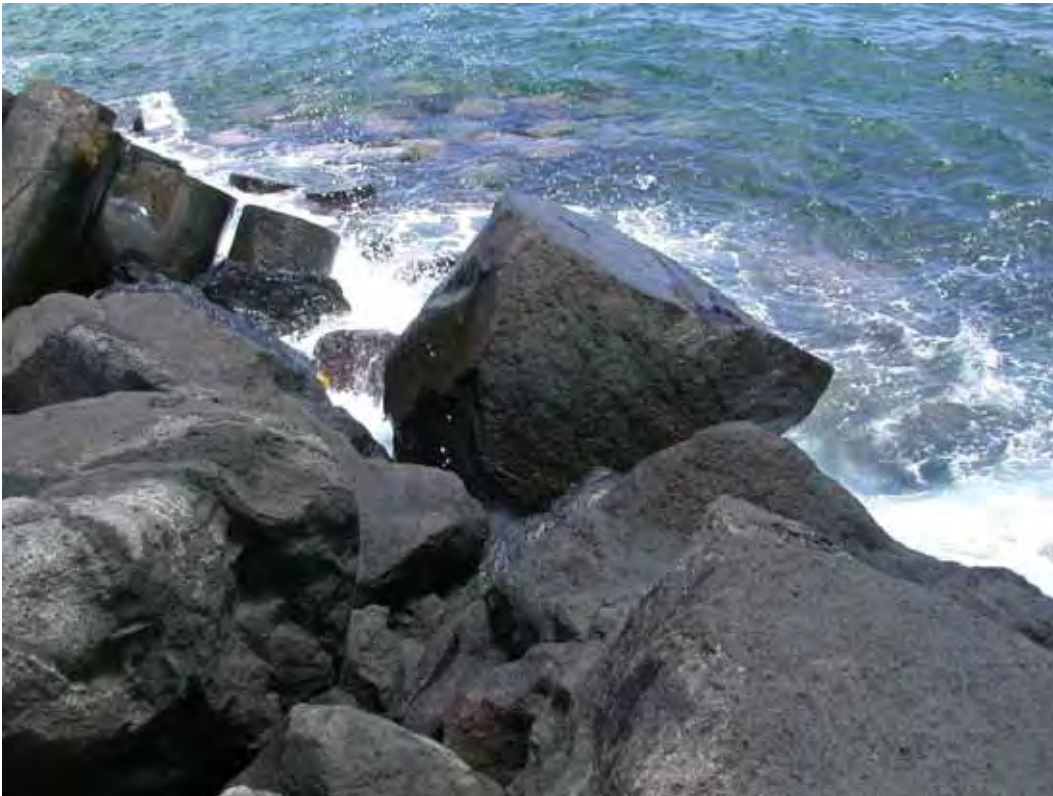
Figure A7. Damage location 6, sta 10+80, ocean side, dislodged stone.

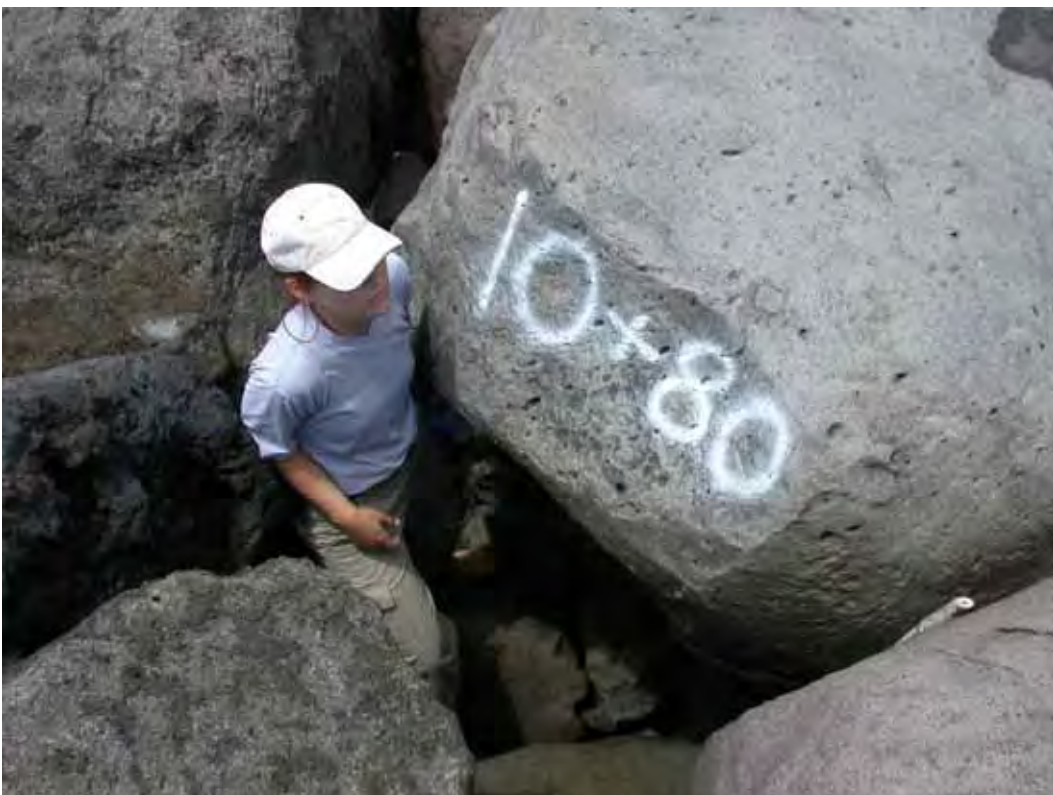
Figure A8. Damage location 7, sta 10+80, harbor side, void approximately 5 ft deep.

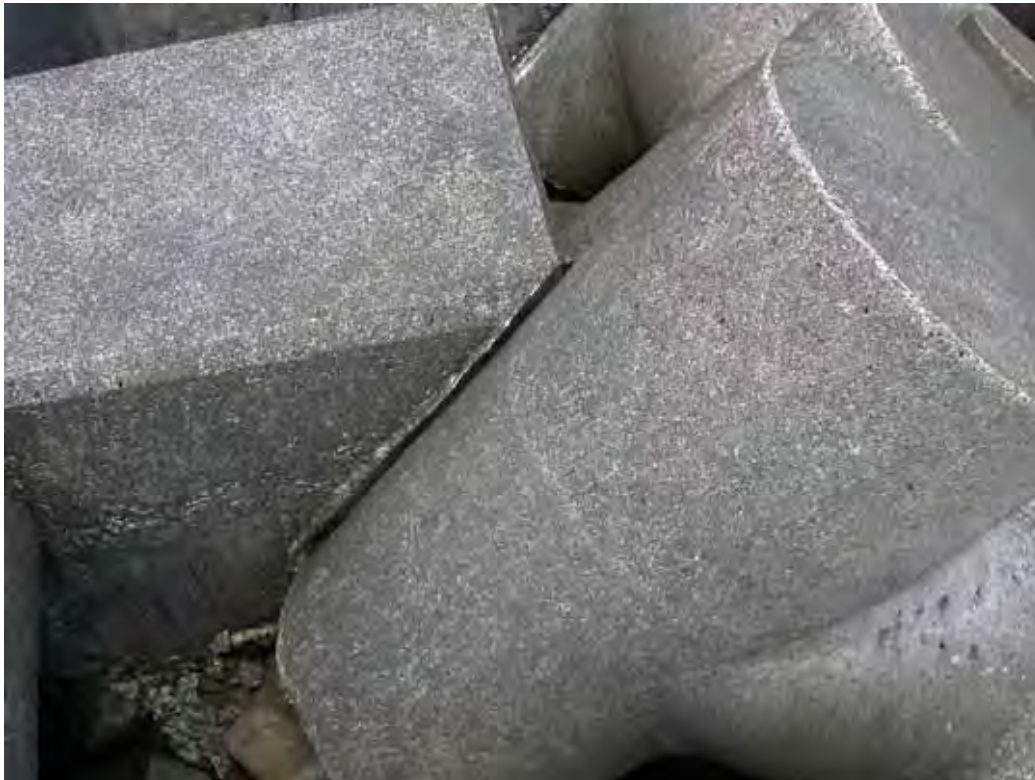
Figure A9. Damage location 8, sta 11+18, tribars separating from rib cap, side slope steepening.

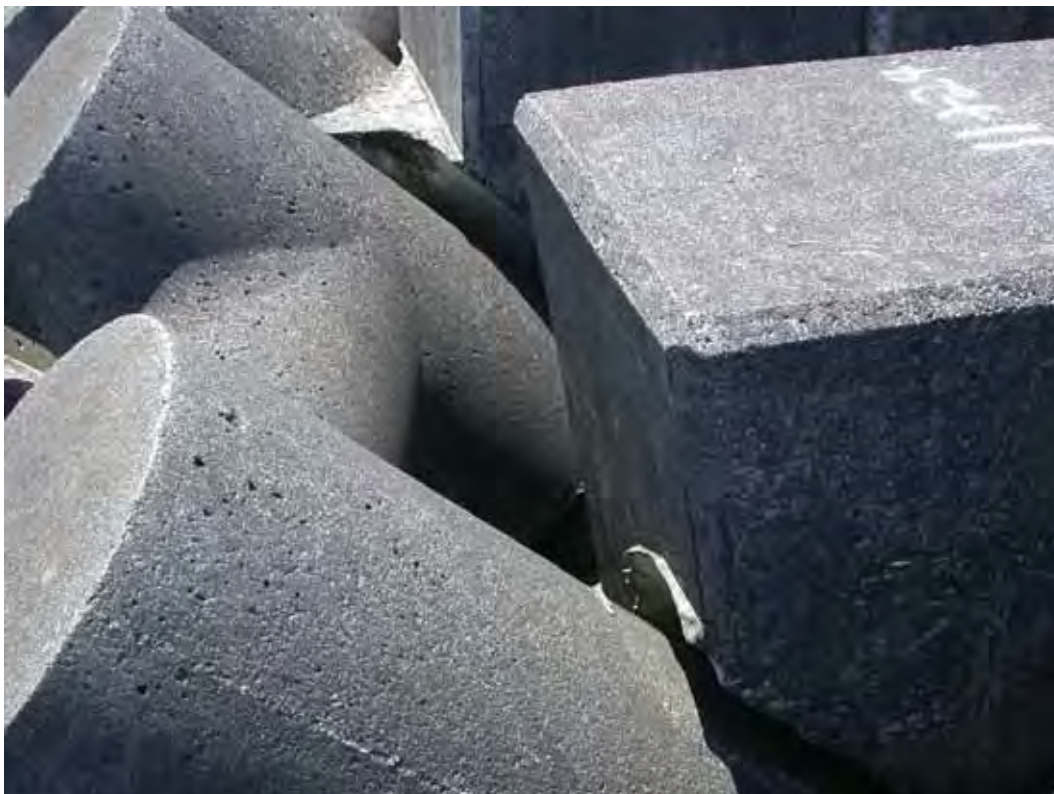
Figure A10. Damage location 9, sta 11+24, tribar separating from rib cap.

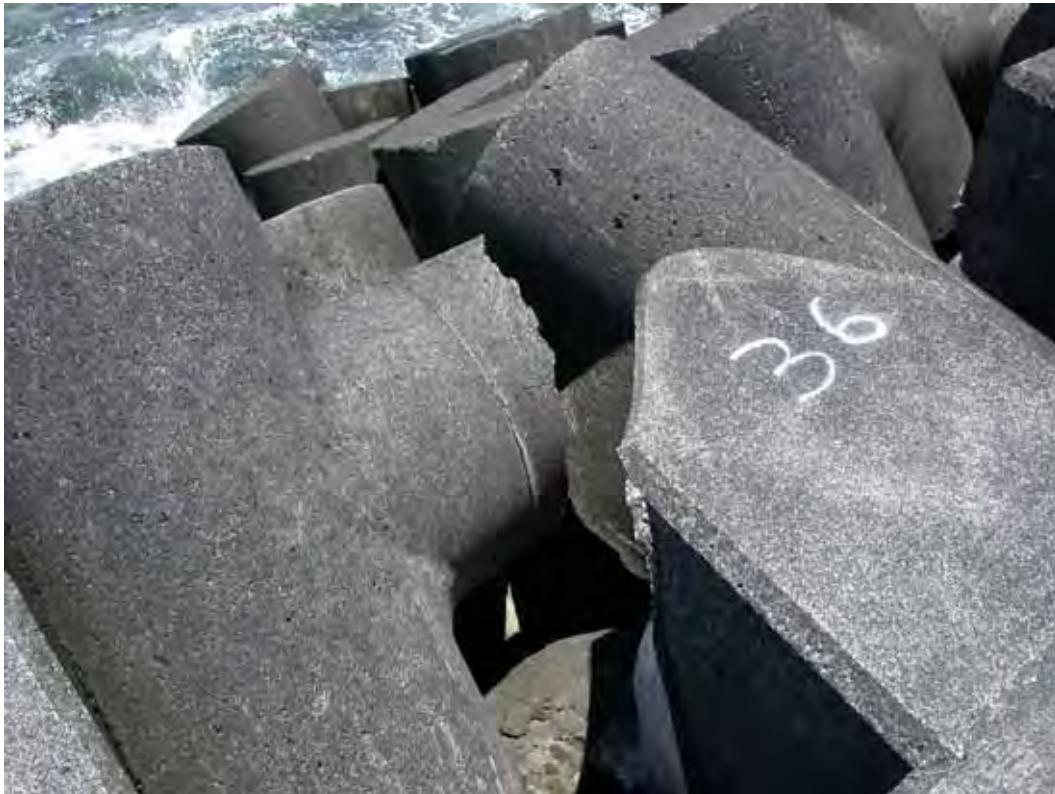
Figure A11. Damage location 13, sta 13+10, ocean side, rib #36, tribar with broken leg.

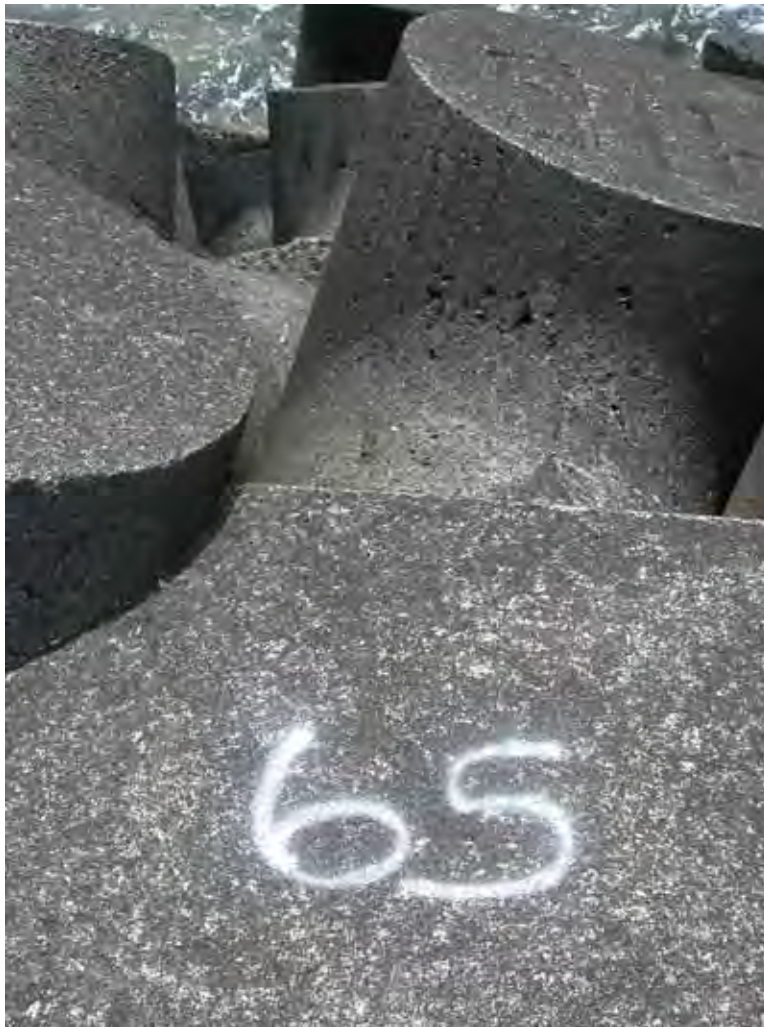
Figure A12. Damage location 14, sta 14+80, rib #65, tribar with broken leg.

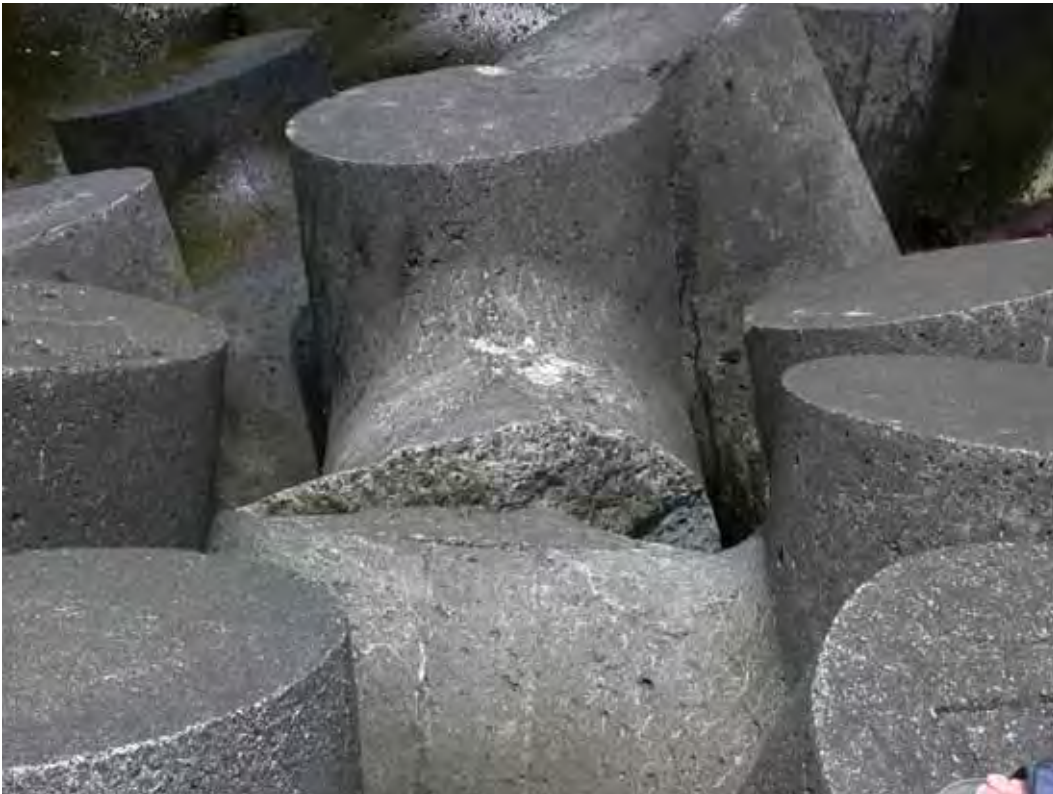
Figure A13. Damage location 15, sta 16+00, rib #85, tri-bar broken through center.

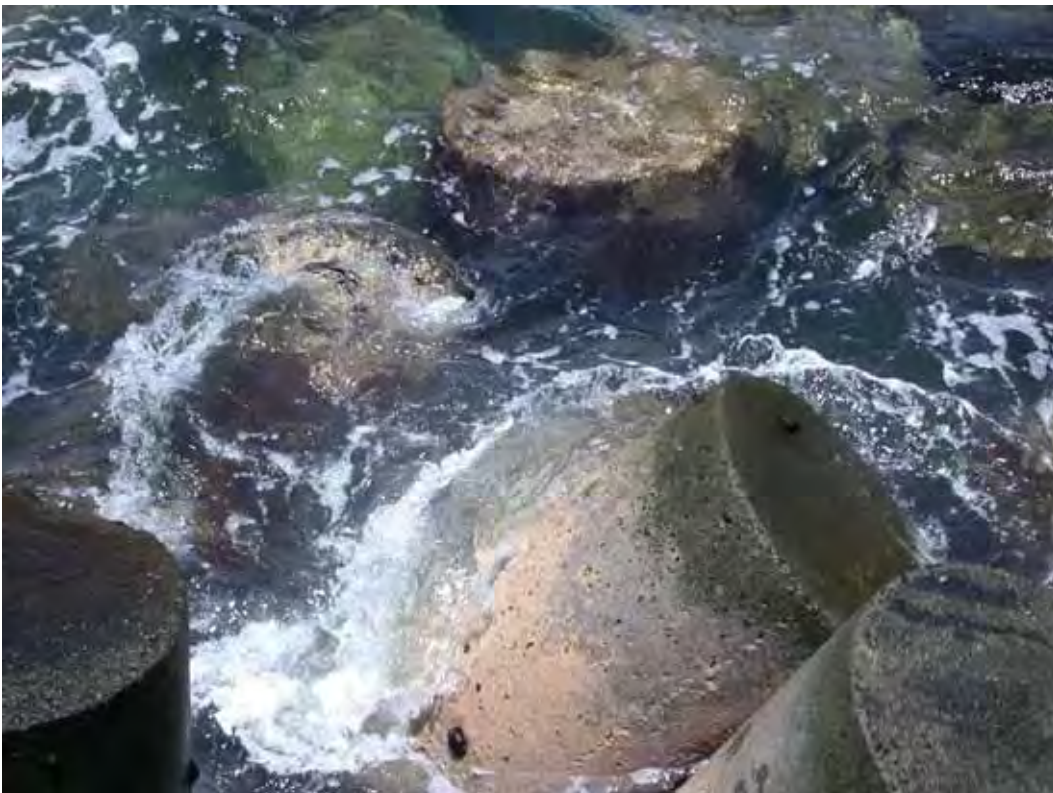
Figure A14. Damage location 16, sta 17+40, ocean side, broken tri-bar at waterline.

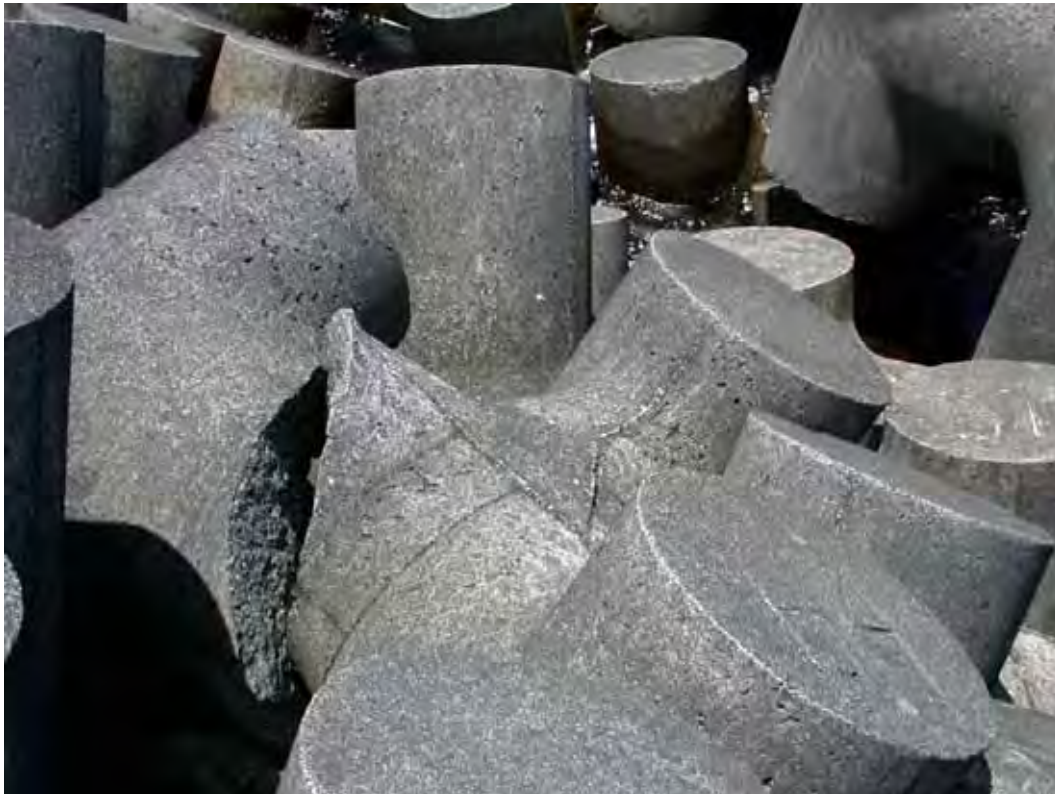
Figure A17. Damage location 17, sta 19+52, rib #143, tribar #64, broken leg.

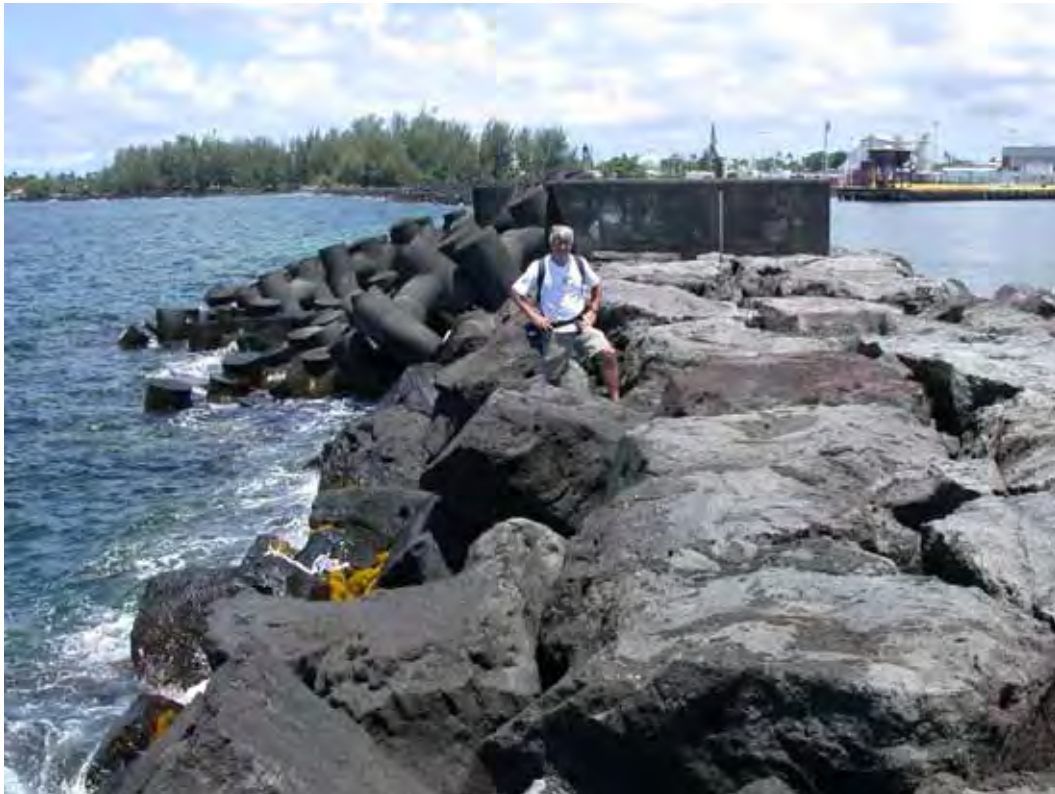
Figure A19. Damage location 18, sta 20+30, ocean side, void.

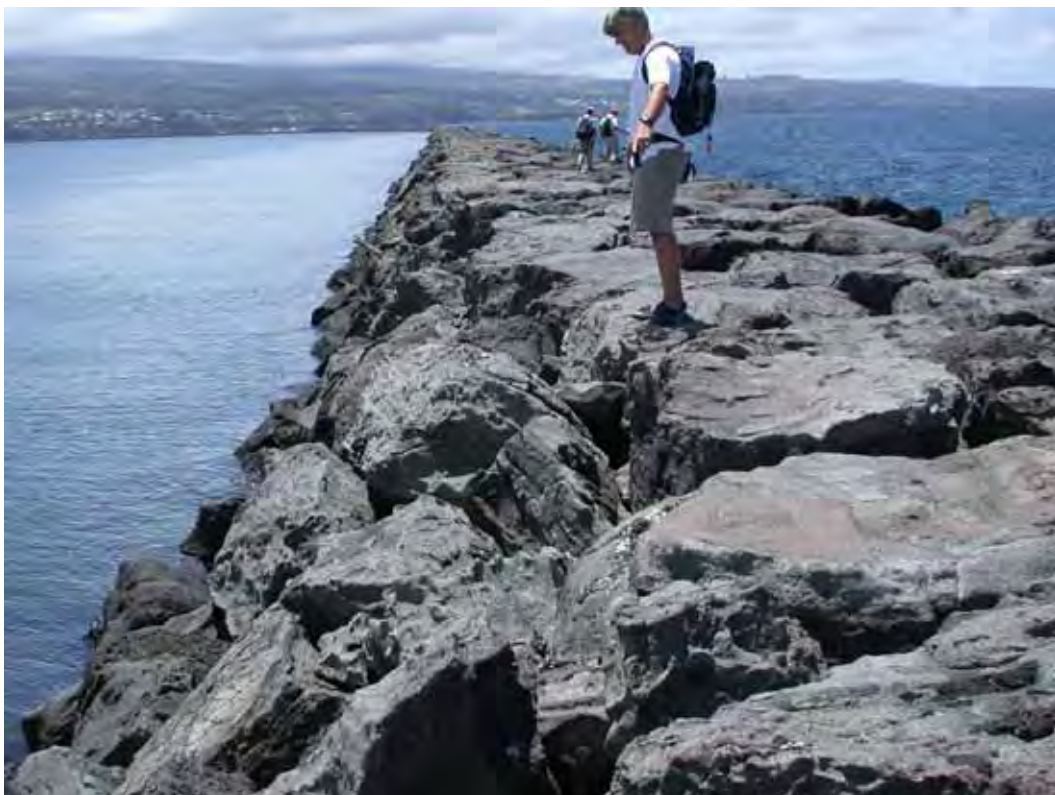
Figure A20. Damage location 19, sta 22+10, harbor side, sloped crest.

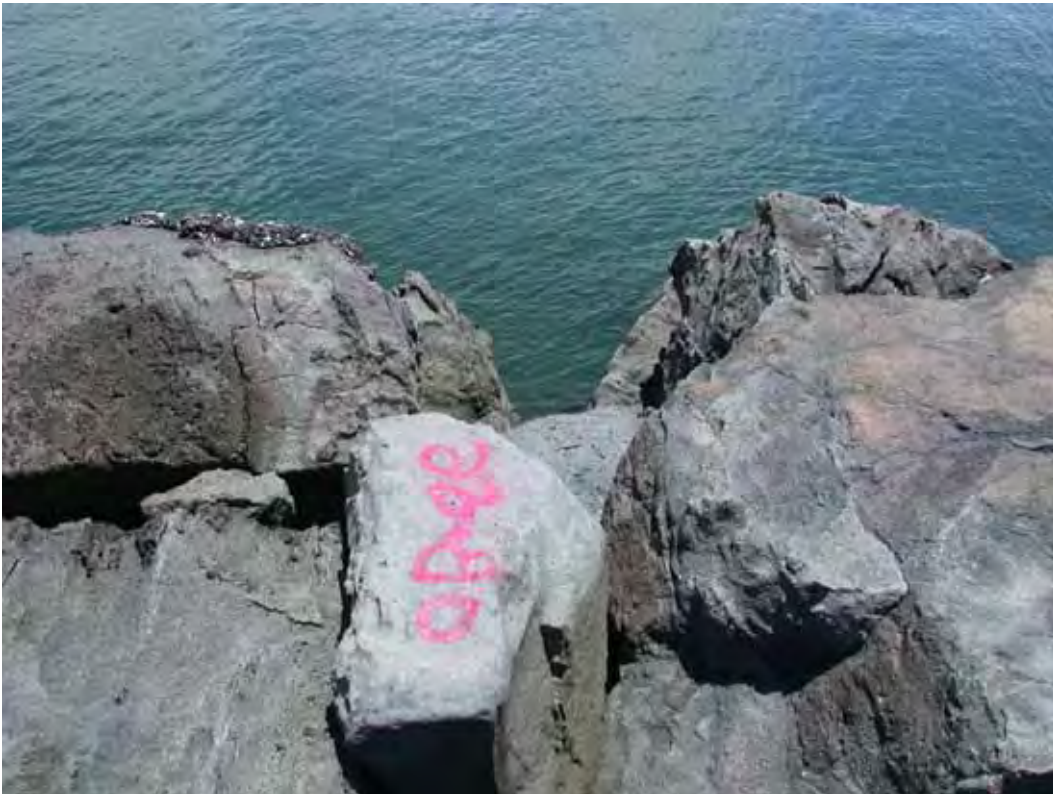
Figure A21. Damage location 20, sta 22+80, harbor side, missing armor stone at hinge.

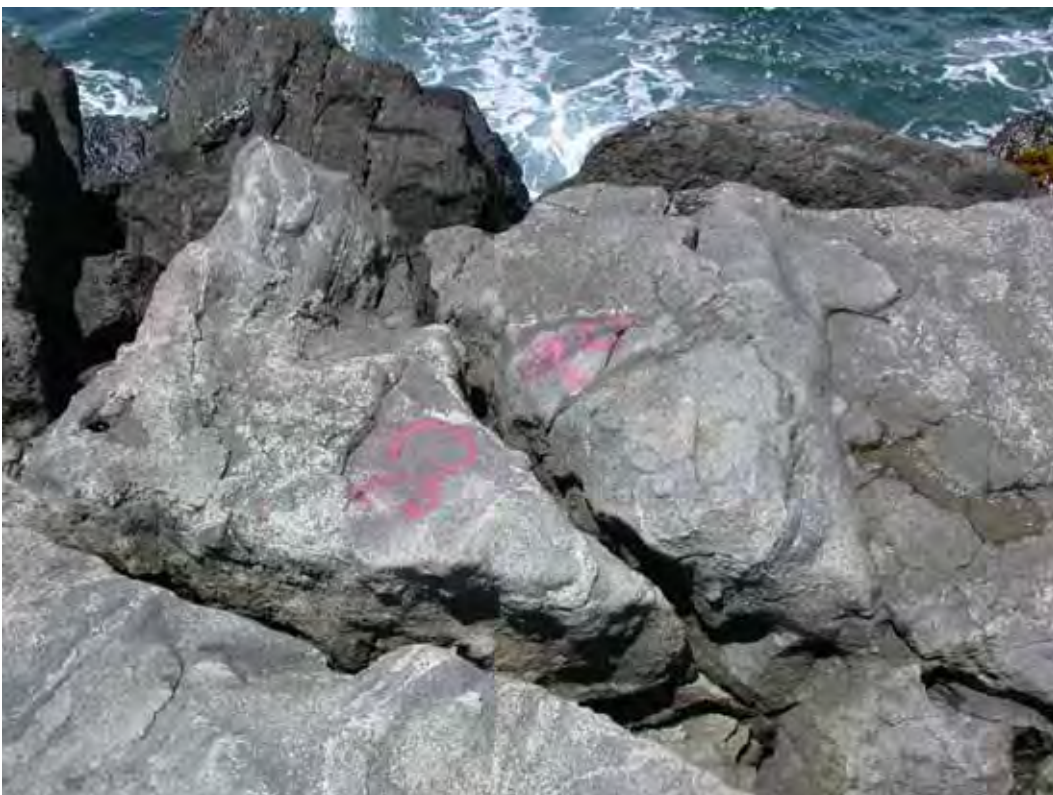
Figure A22. Damage location 21, sta 22+90, ocean side, cracked armor stone.

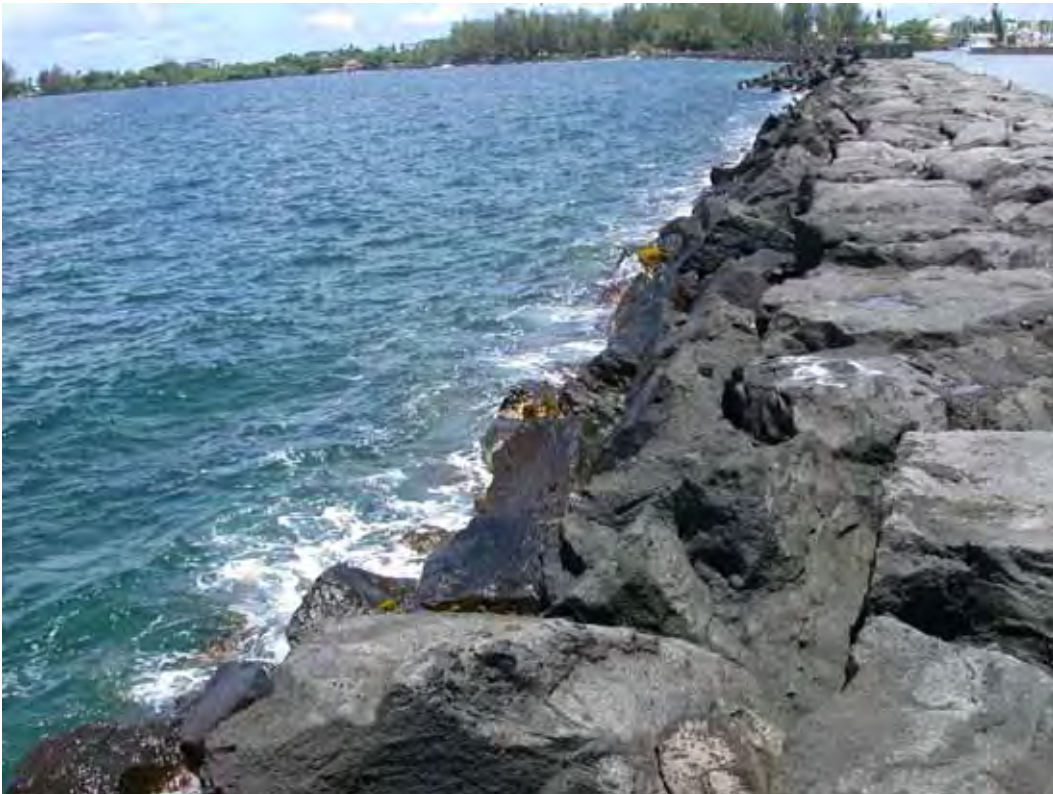
Figure A23. Damage location 22, sta 23 +40, ocean side, sharp drop.

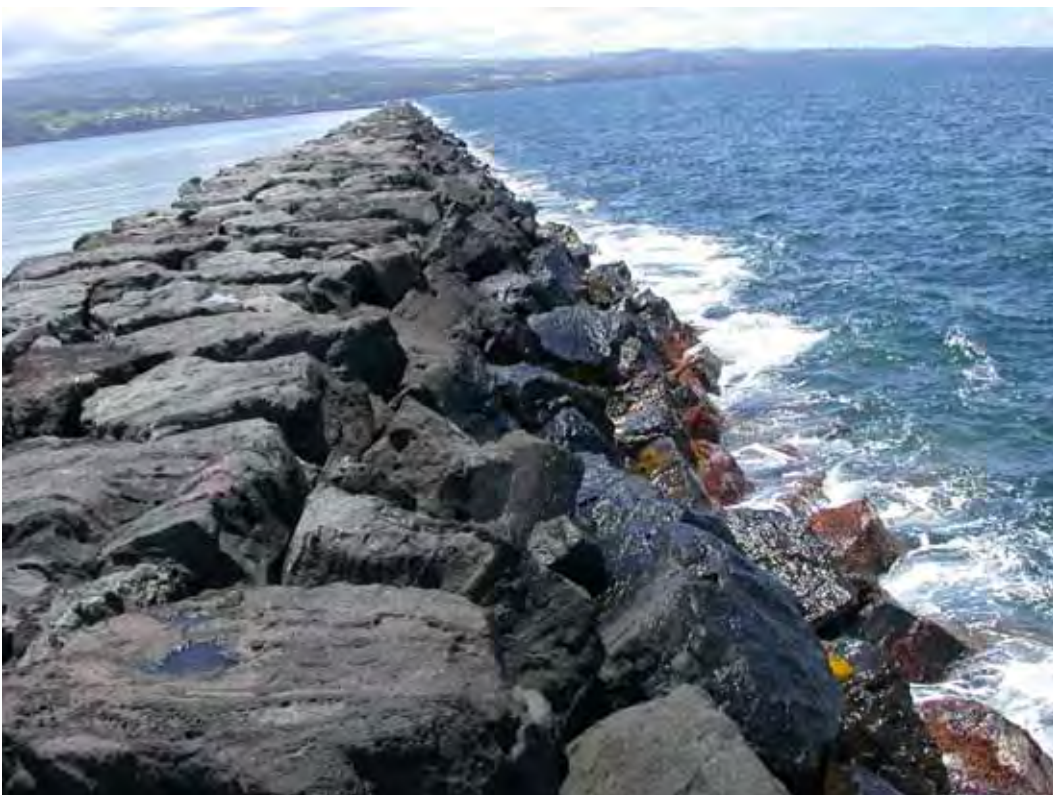
Figure A24. Damage location 23, sta 23+90-24+15, ocean side, void and settling.

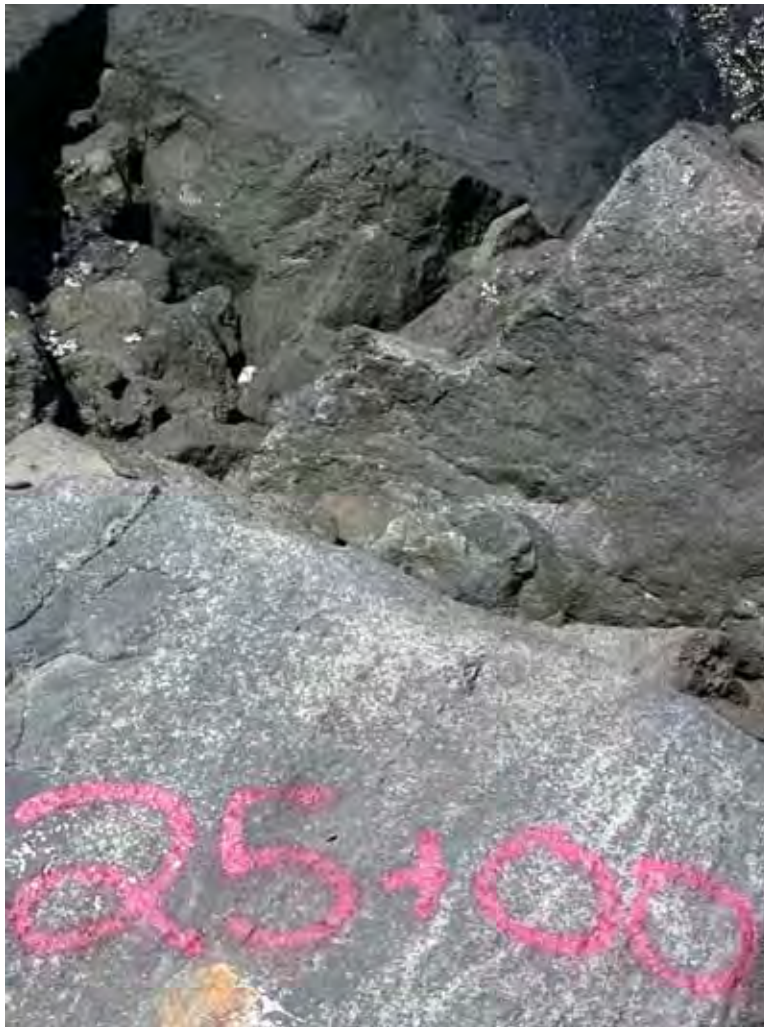
Figure A25. Damage location 24, sta 25+00, hinge stone breaking apart.

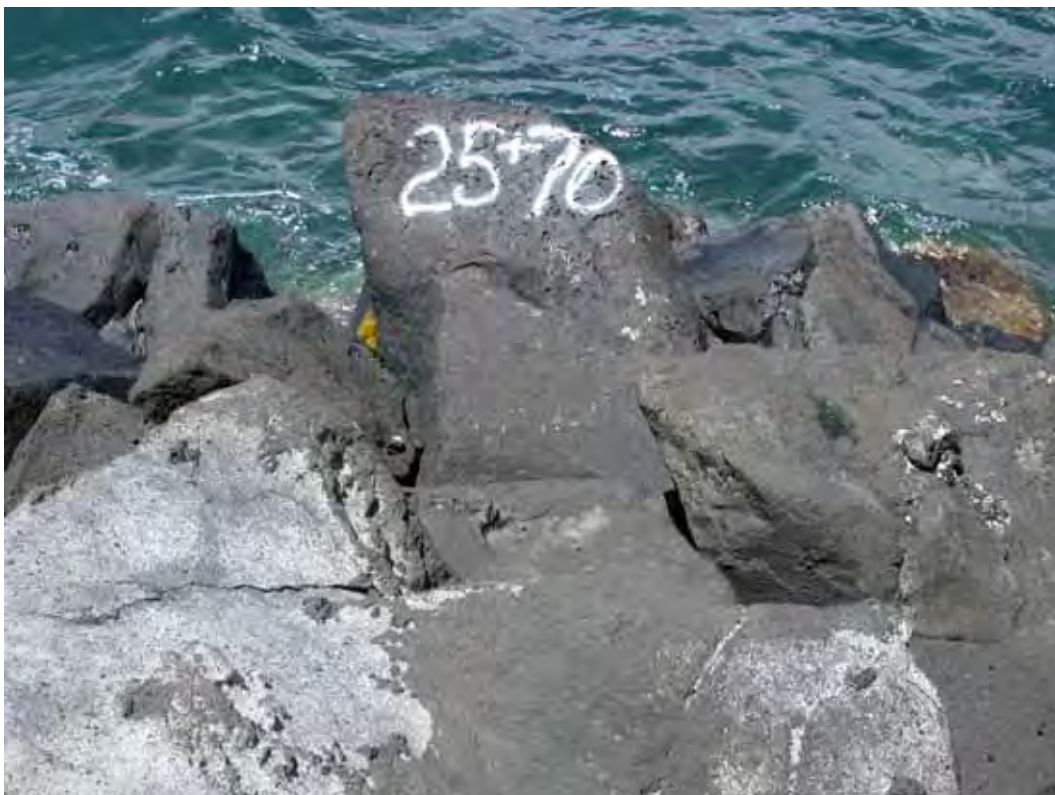
Figure A27. Damage location 26, sta 25+70, ocean side, dislodged stone.

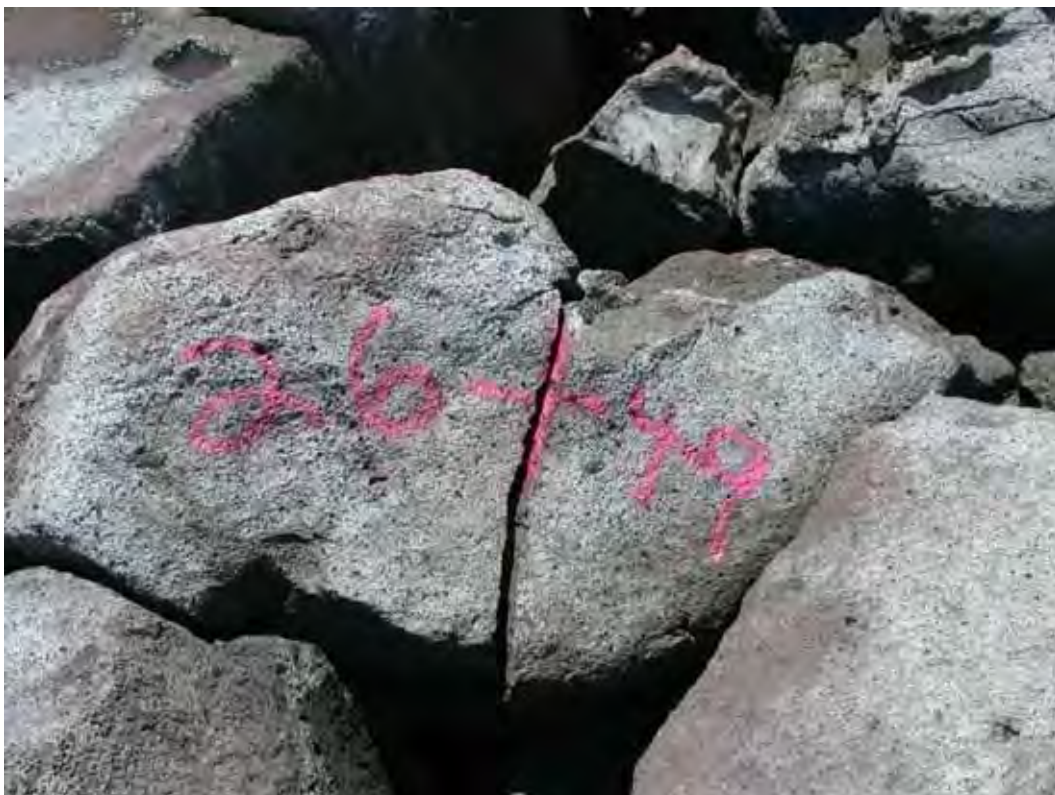
Figure A29. Damage location 29, sta 26+49, harbor side, broken armor stone.

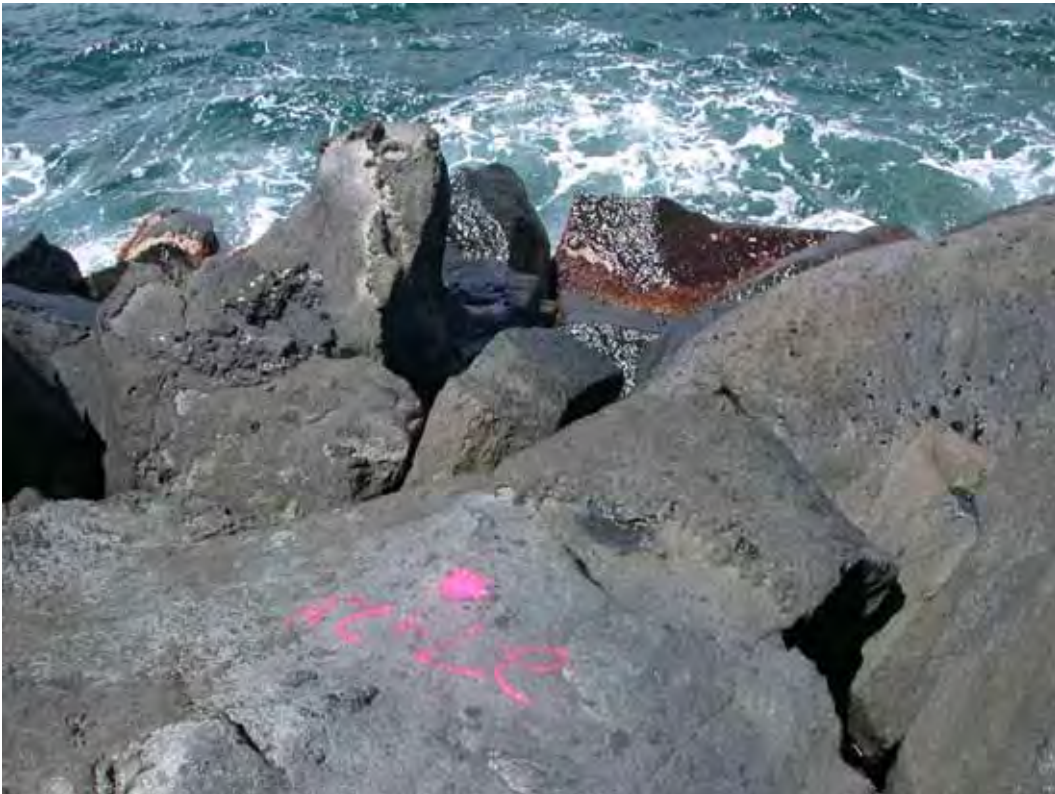
Figure A30. Damage location 30, sta 27+28, ocean side, hinge stone settling.

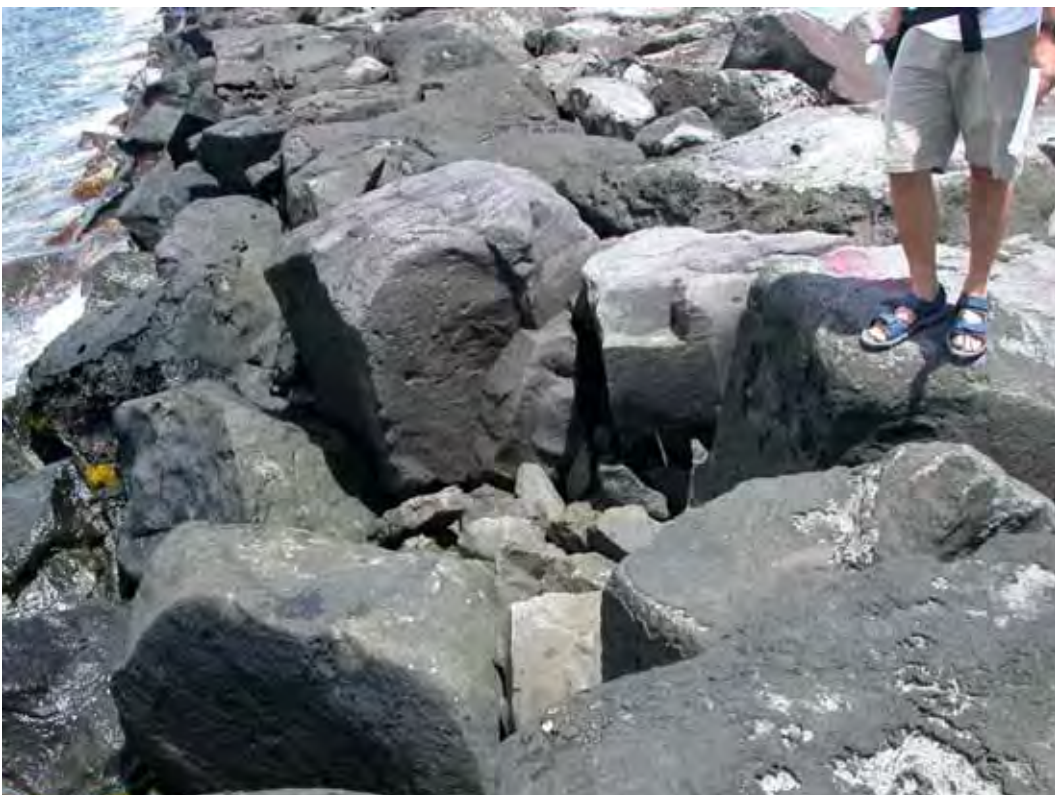
Figure A31. Damage location 31, sta 28+78, missing crest stone.

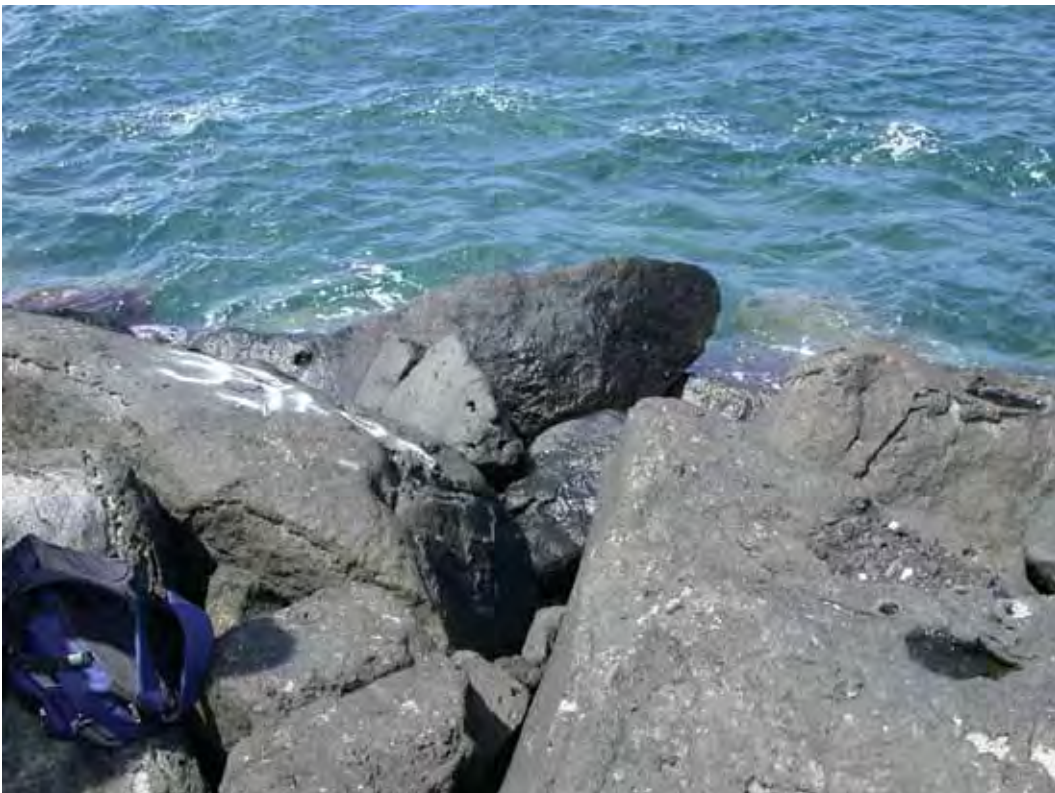
Figure A35. Damage location 37, sta 33+00, ocean side, void with dislodged hinge stone.

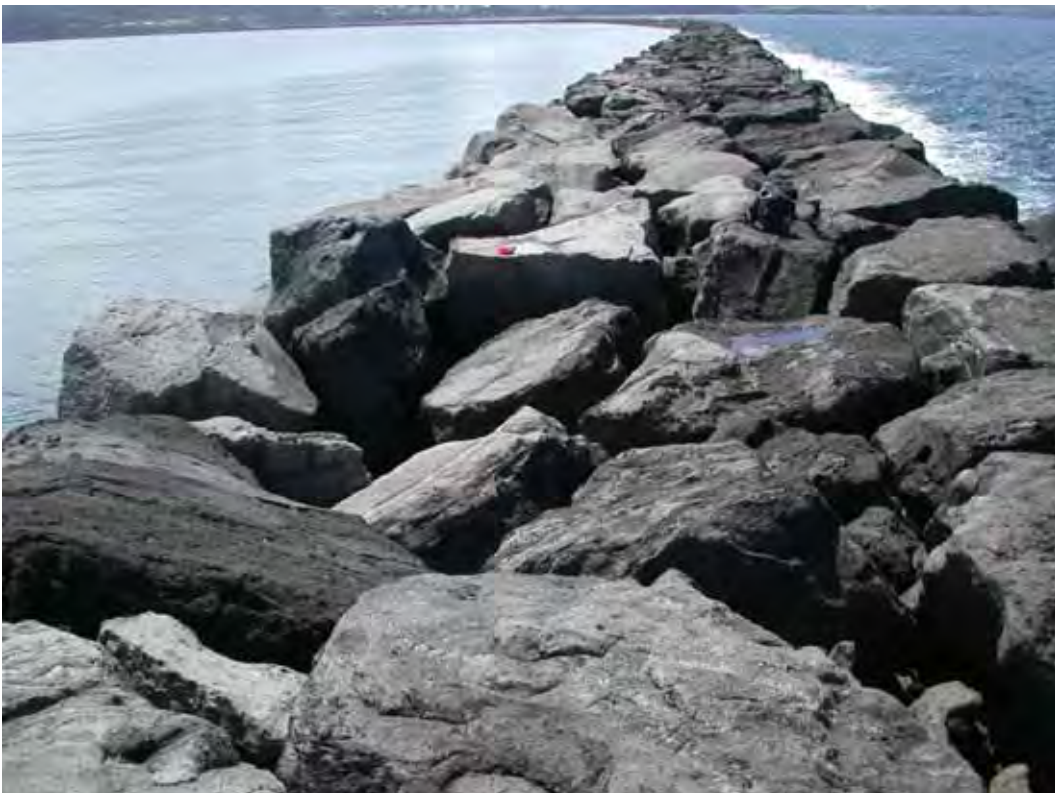
Figure A37. Damage location 39, sta 34+40, ocean side, settled hinge stone, void at crest.
