Monitoring Completed Navigation Projects Program

Periodic Inspections of Hilo, Kahului, Laupahoehoe, and Nawiliwili Breakwaters, Hawaii

Armor Unit Monitoring for Period 2001-2005

October 2011

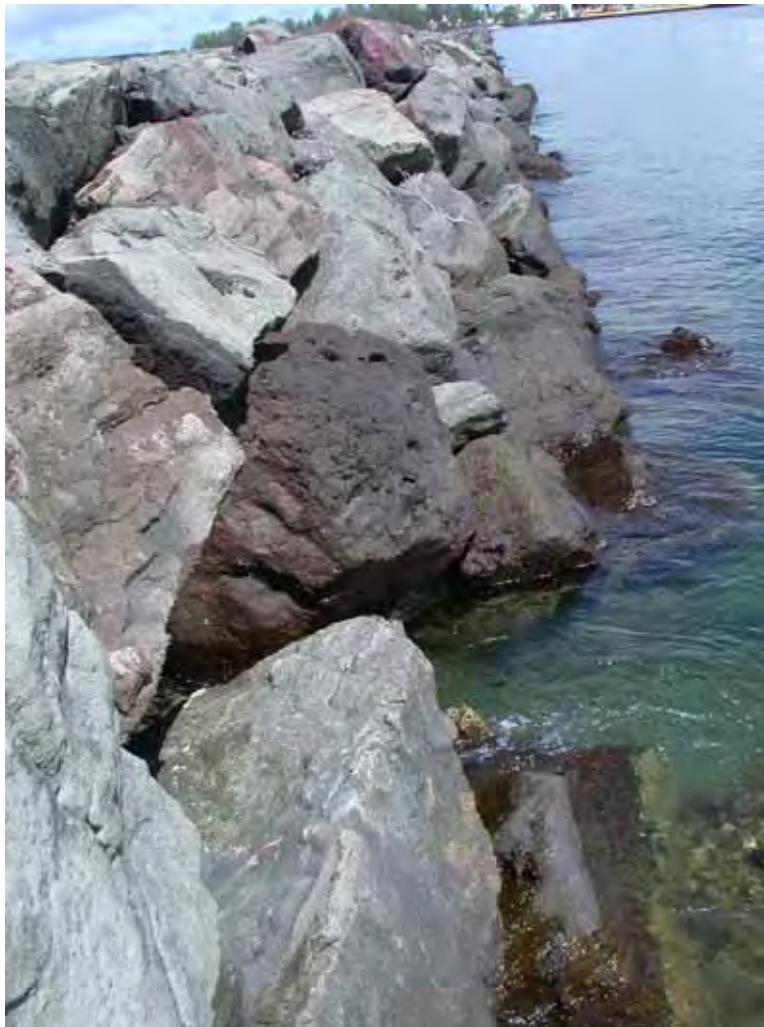
Figure A39. Damage location 41, sta 36+10, large void at crest from centerline to harbor side, missing toe stone, two large rock separations.

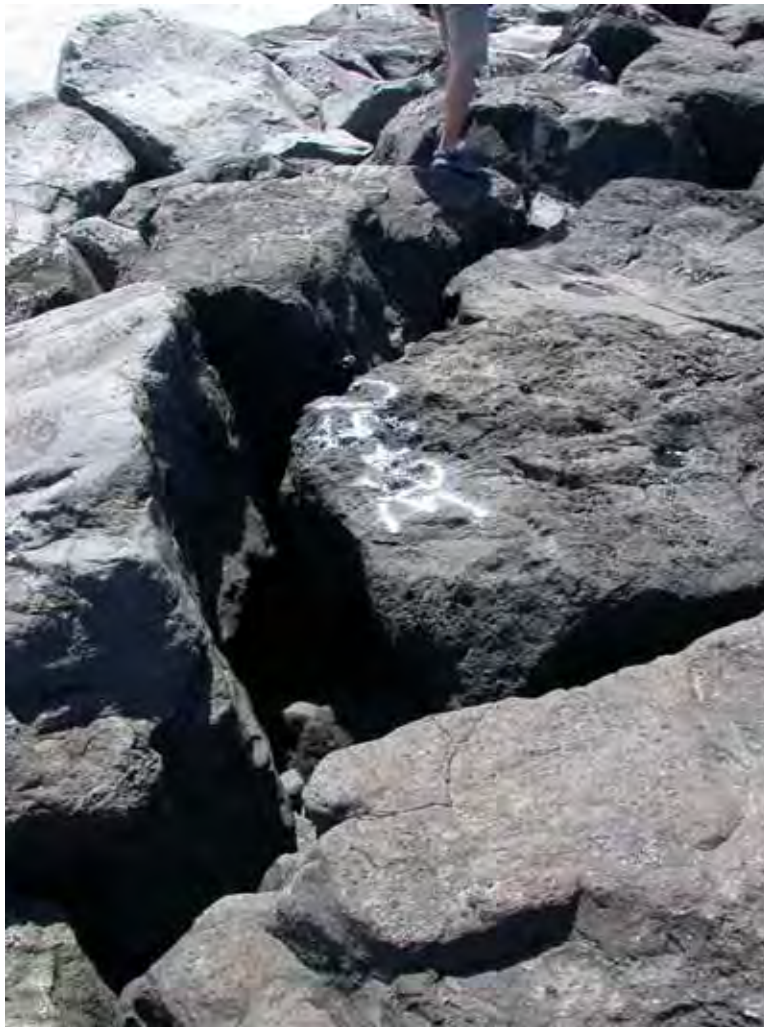
Figure A40. Damage location 42, sta 36+50, void at crest.

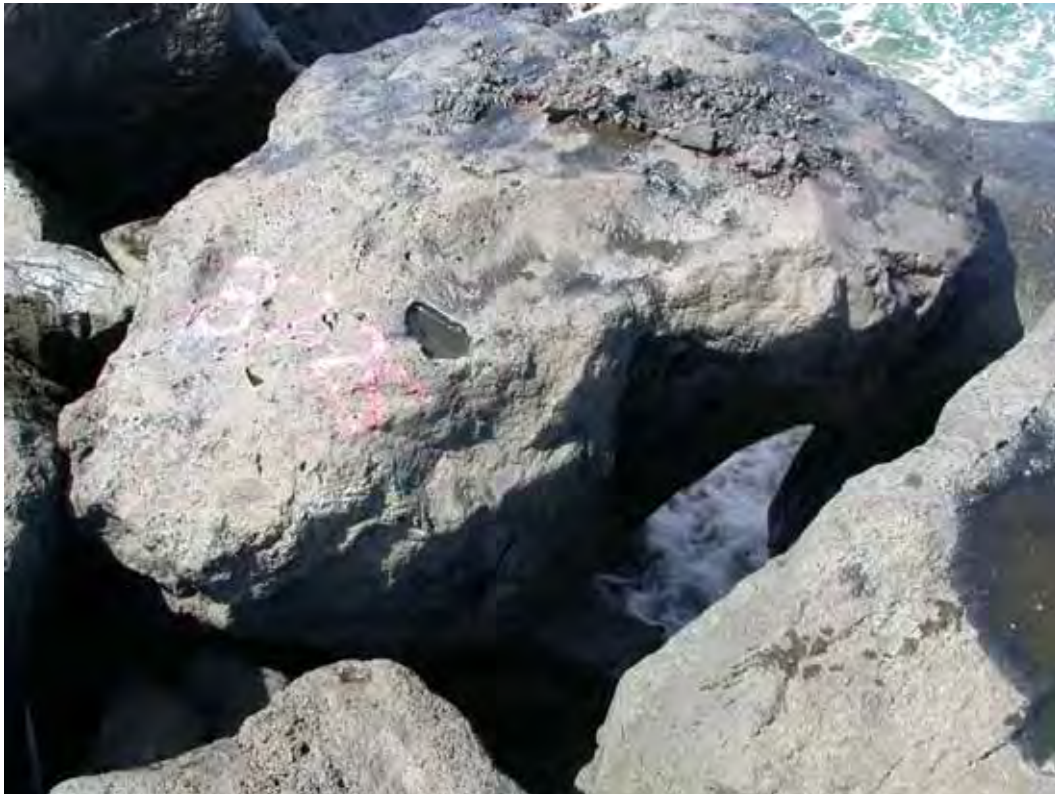
Figure A41. Damage location 43, sta 37+25, ocean side, bridging at crest.

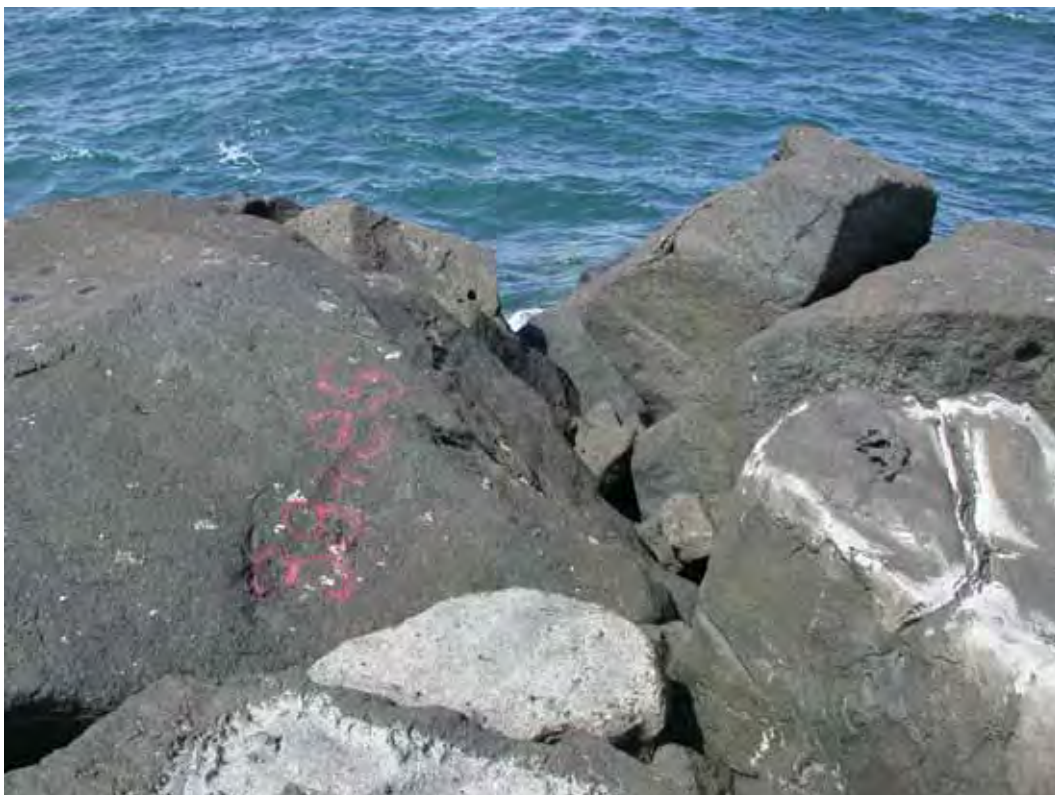
Figure A42. Damage location 44, sta 38+85, two perched armor stones.

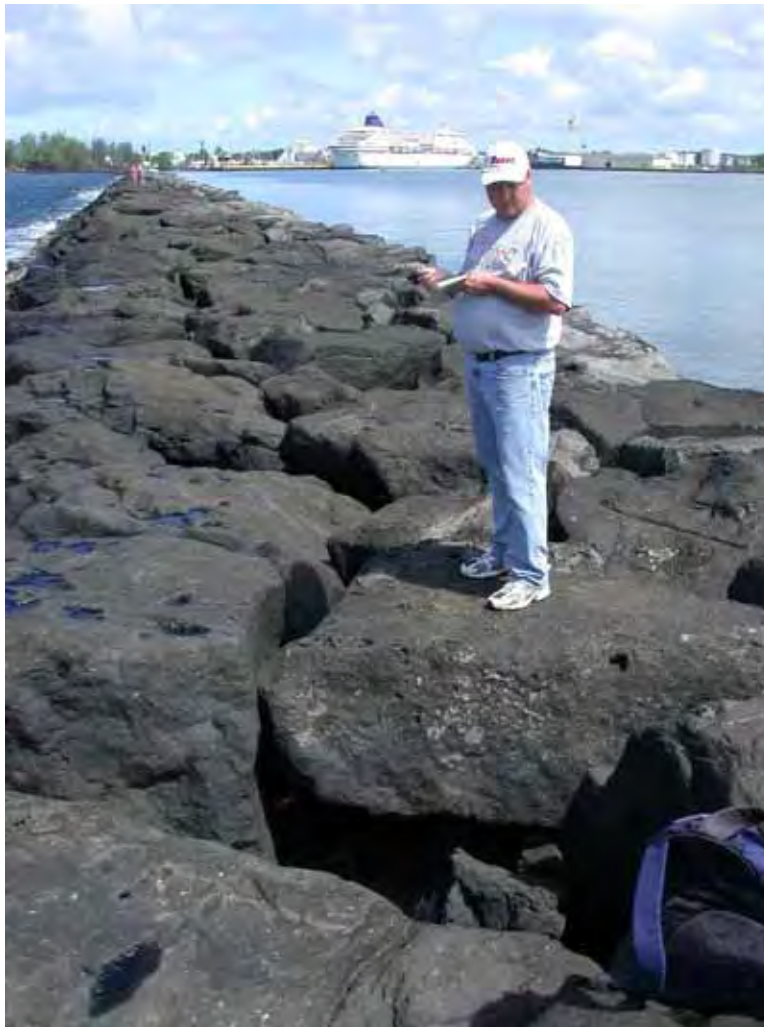
Figure A43. Damage location 45, sta 40+55, major settling and bridging from centerline to waterline; void extends to waterline but structure is not completely breached.

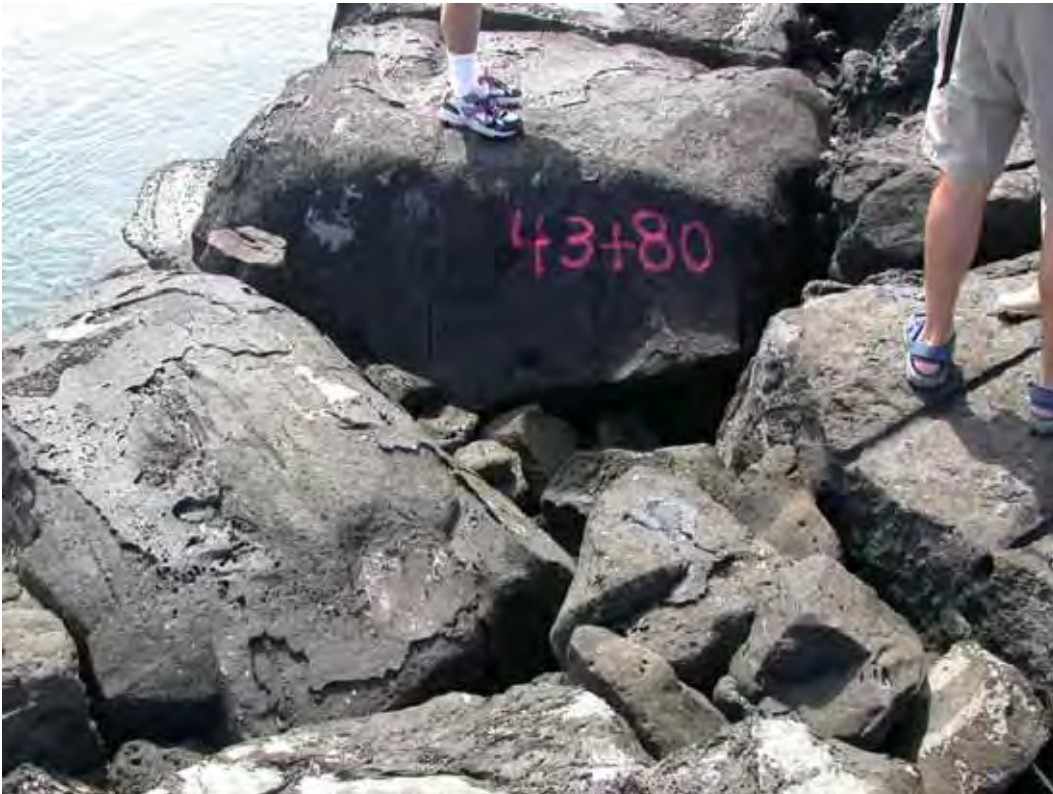
Figure A44. Damage location 46, sta 43+80, harbor side, void at crest (4 ft x 3 ft x 4 ft).

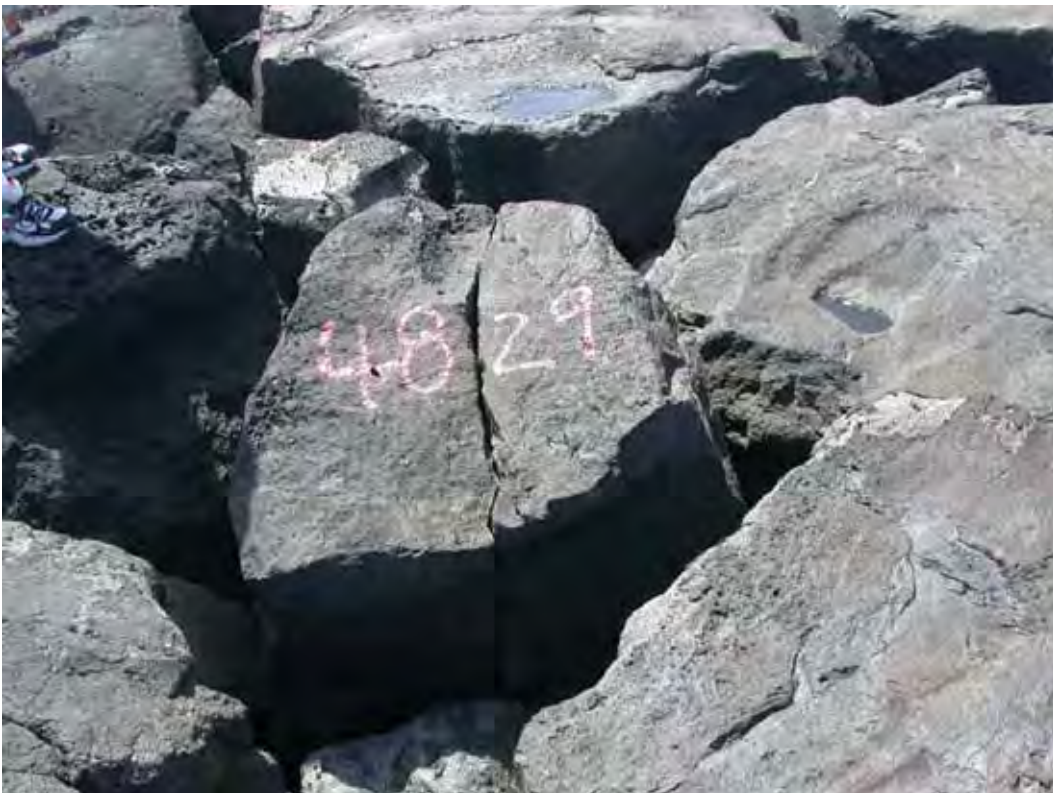
Figure A45. Damage location 48, sta 48+29, broken stone on crest.

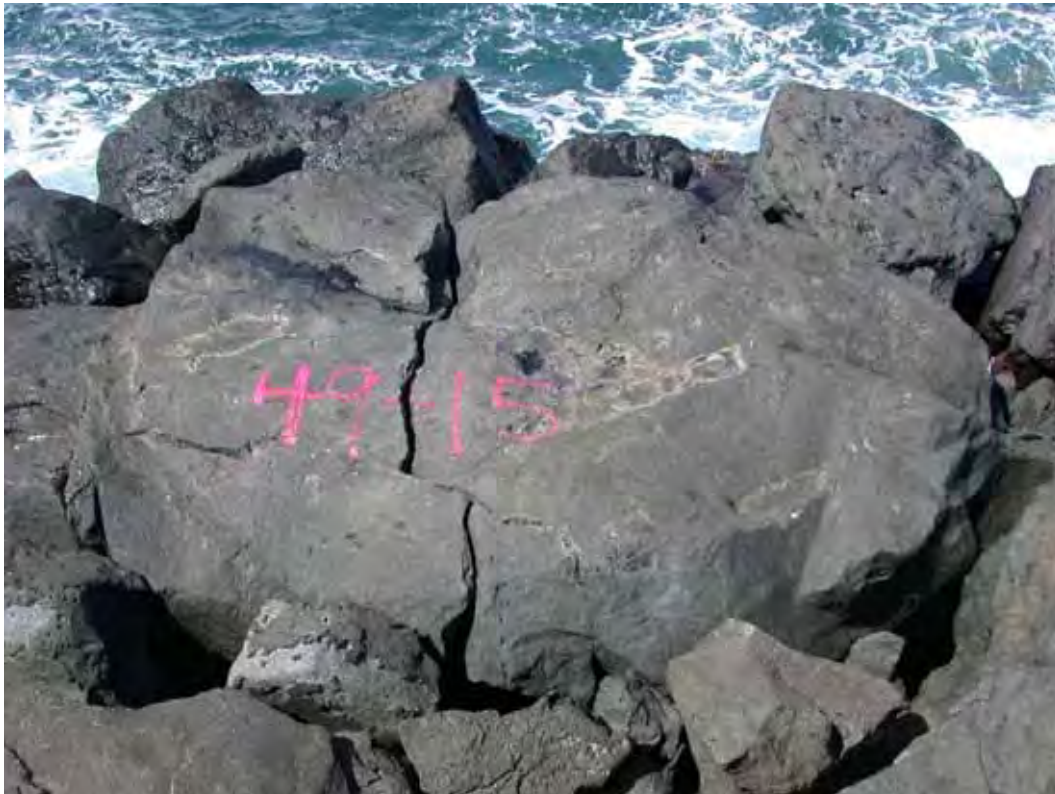
Figure A46. Damage location 49, sta 49+15, ocean side, broken stone on crest.

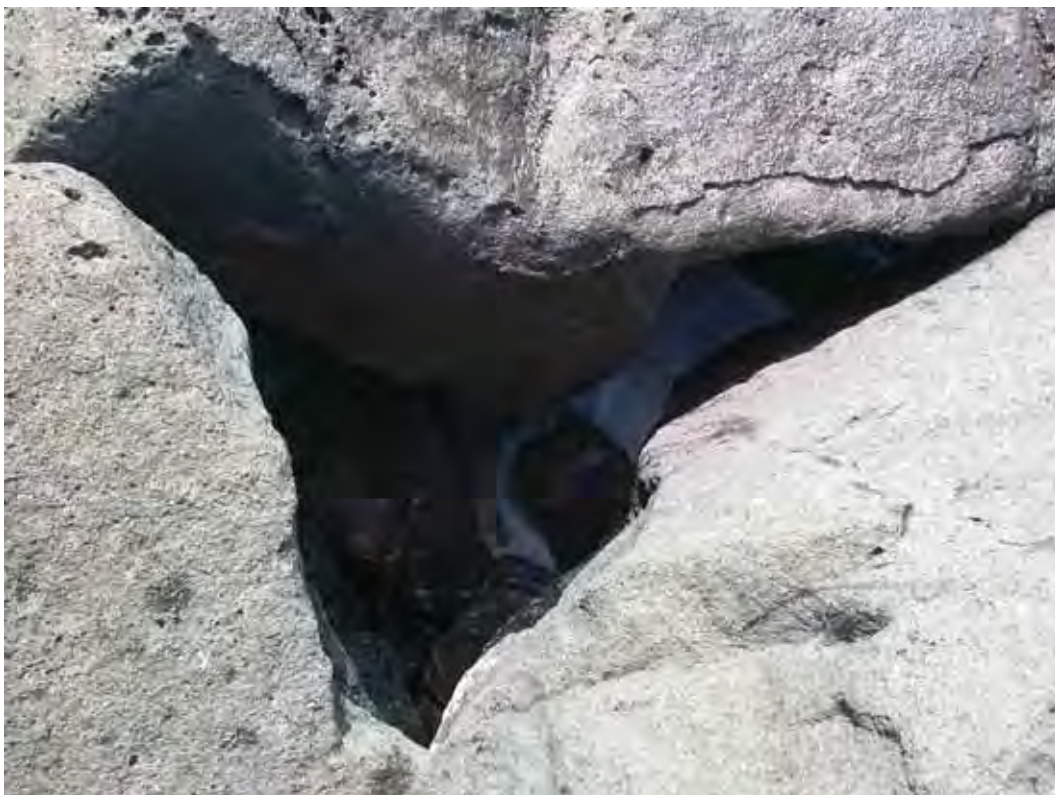
Figure A47. Damage location 51, sta 52+60, bridging.

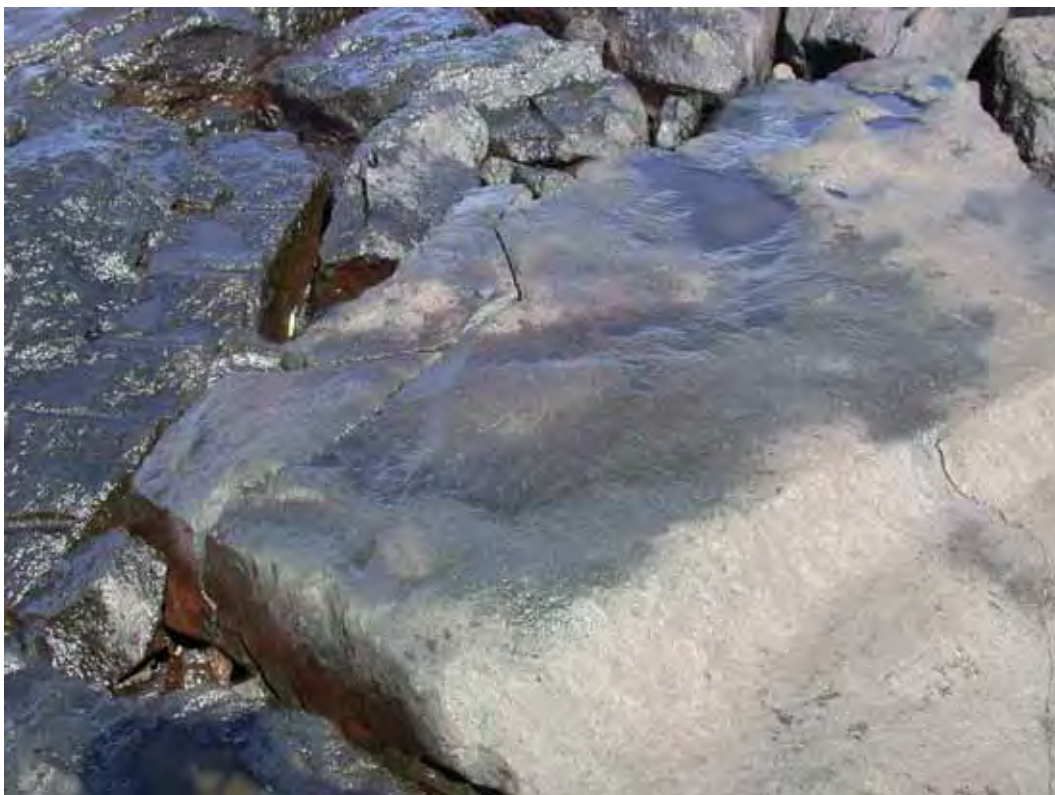
Figure A49. Damage location 53, sta 54+30, broken stone on crest.

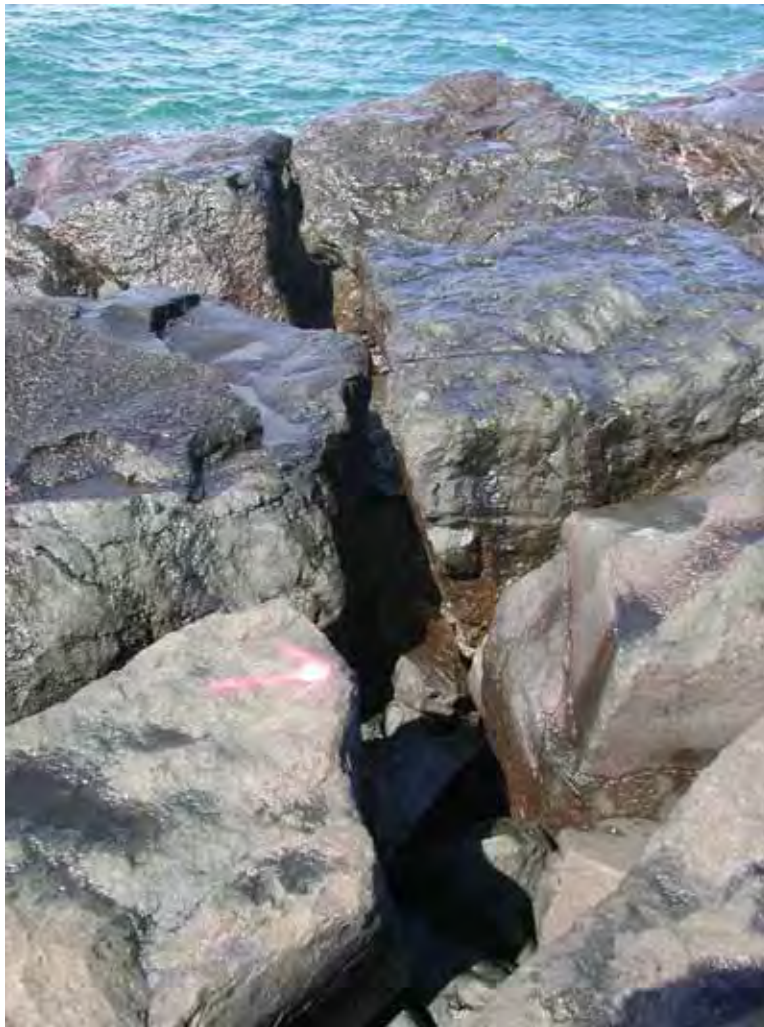
Figure A50. Damage location 54, sta 56+10, ocean side, void at crest.

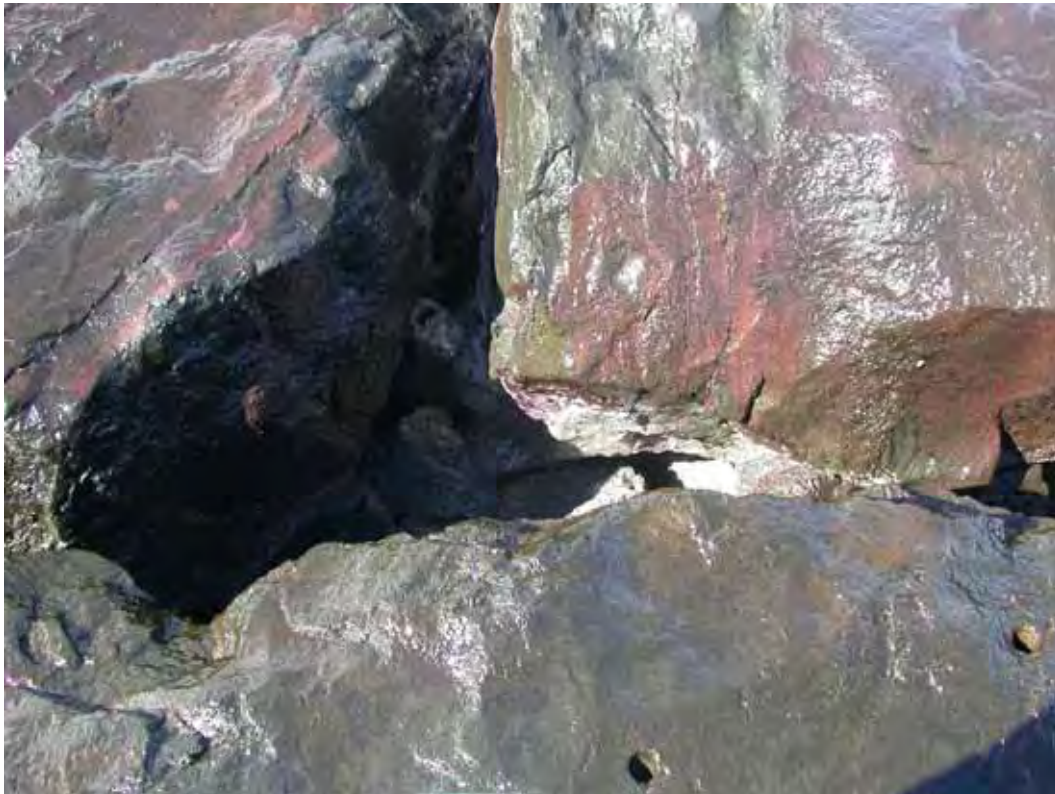
Figure A51. Damage location 55, sta 57+35, void at crest (10 ft x 2 ft x 4 ft).

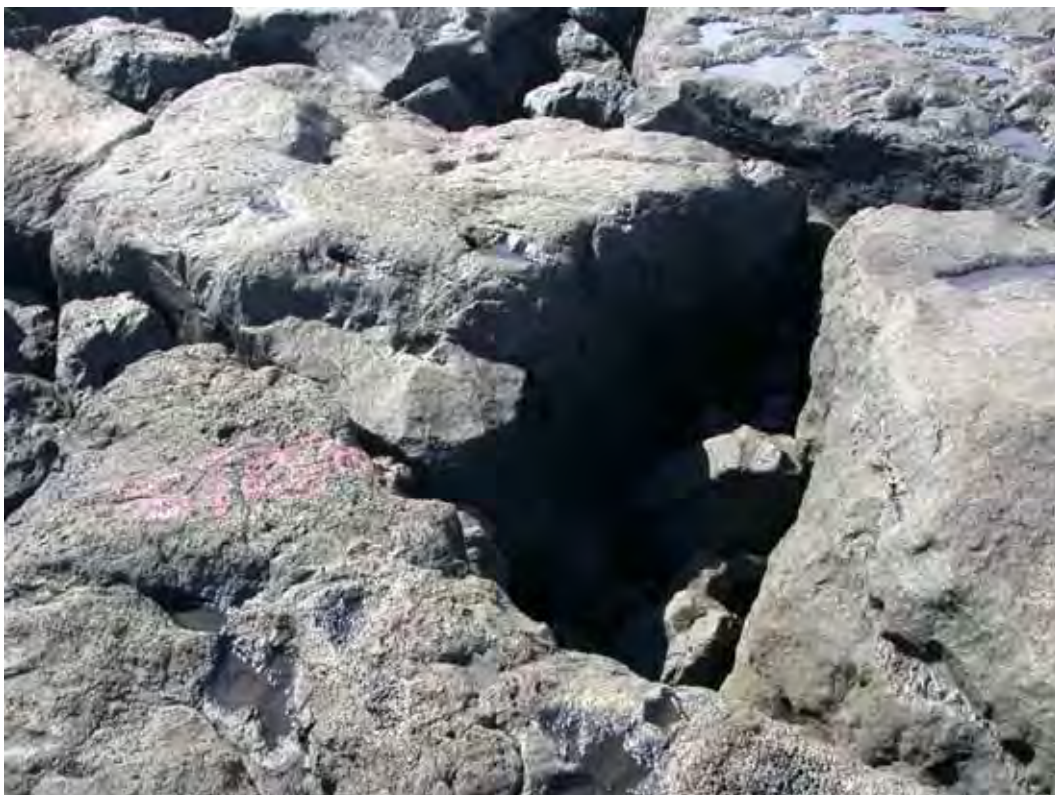
Figure A52. Damage location 56, sta 57+58, void at crest (2 ft x 4 ft x 3 ft).

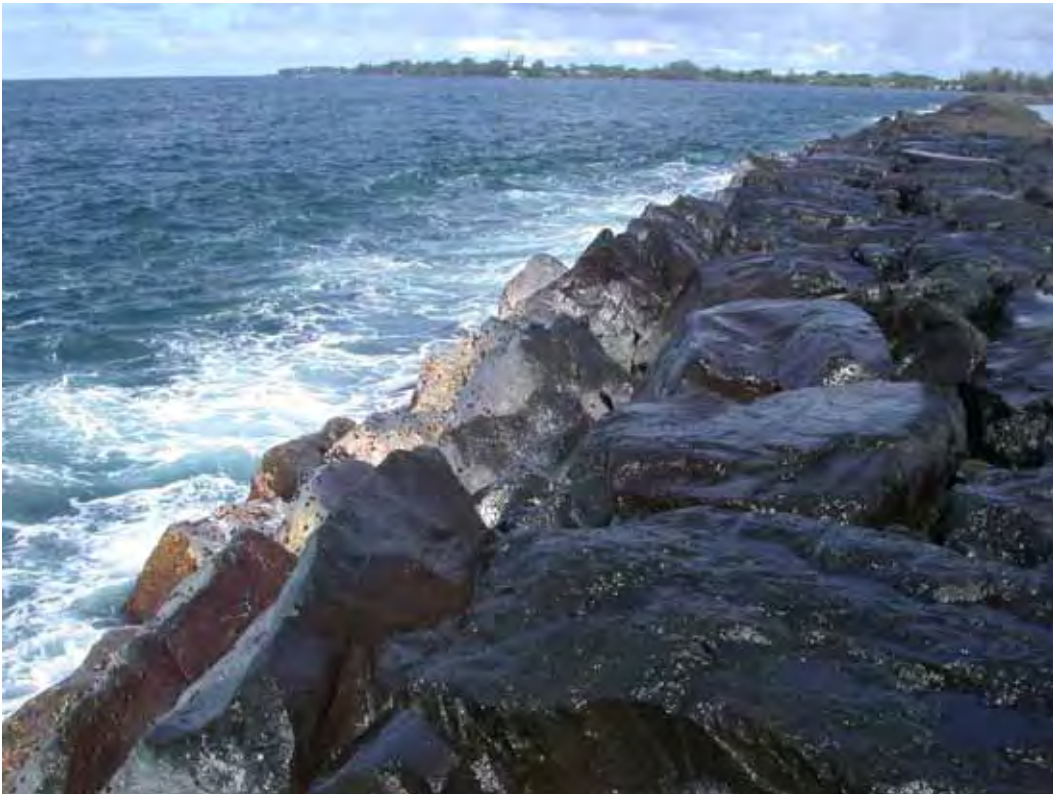
Figure A53. Damage location 57, sta 55+56 and 59+30, ocean side, settling at crest.

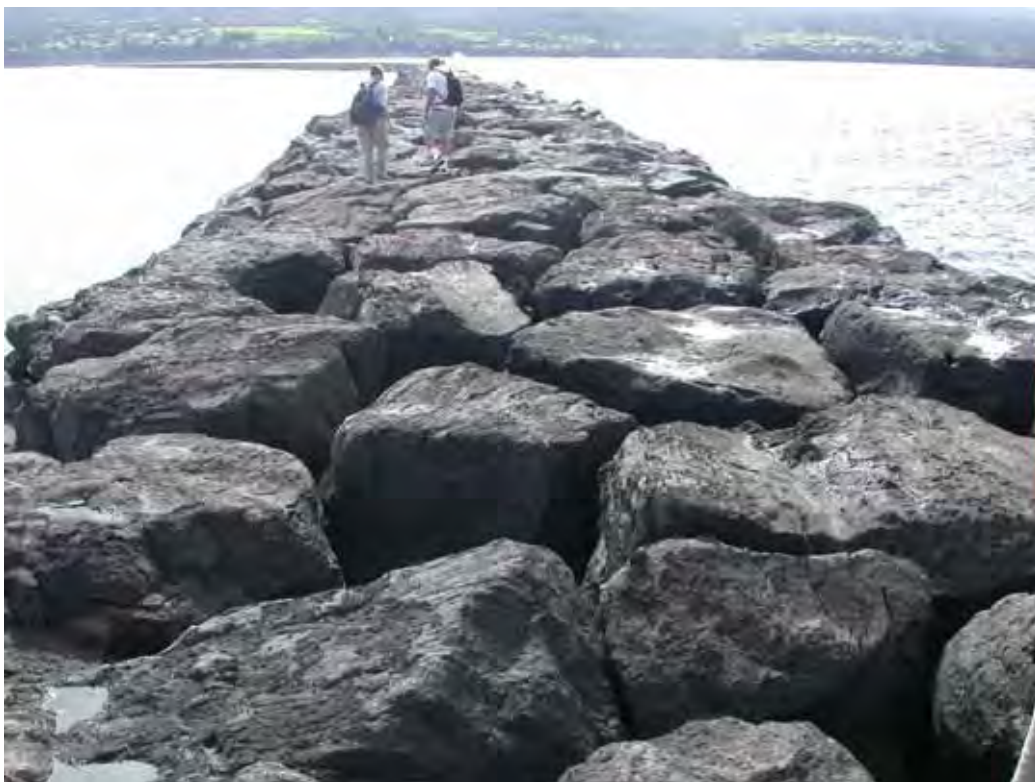
Figure A56. Damage location 60, sta 61+13-and 61+50, numerous armor stone separations and voids.

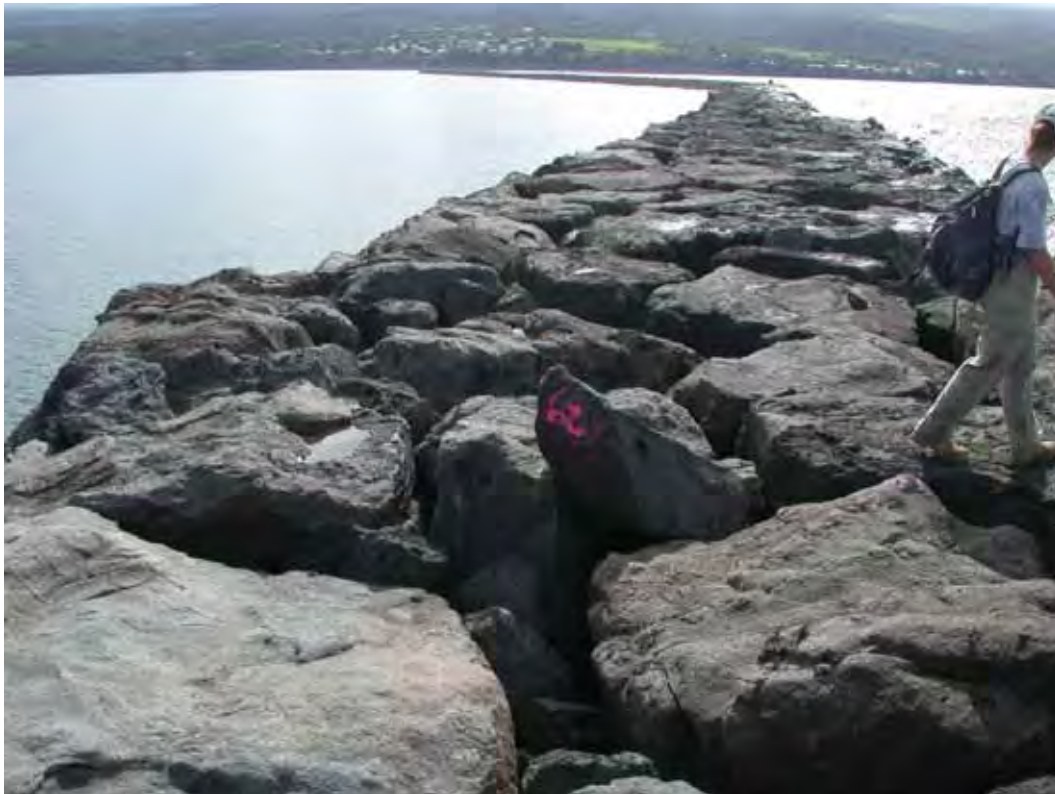
Figure A57. Damage location 61, sta 62+00, perched stone.

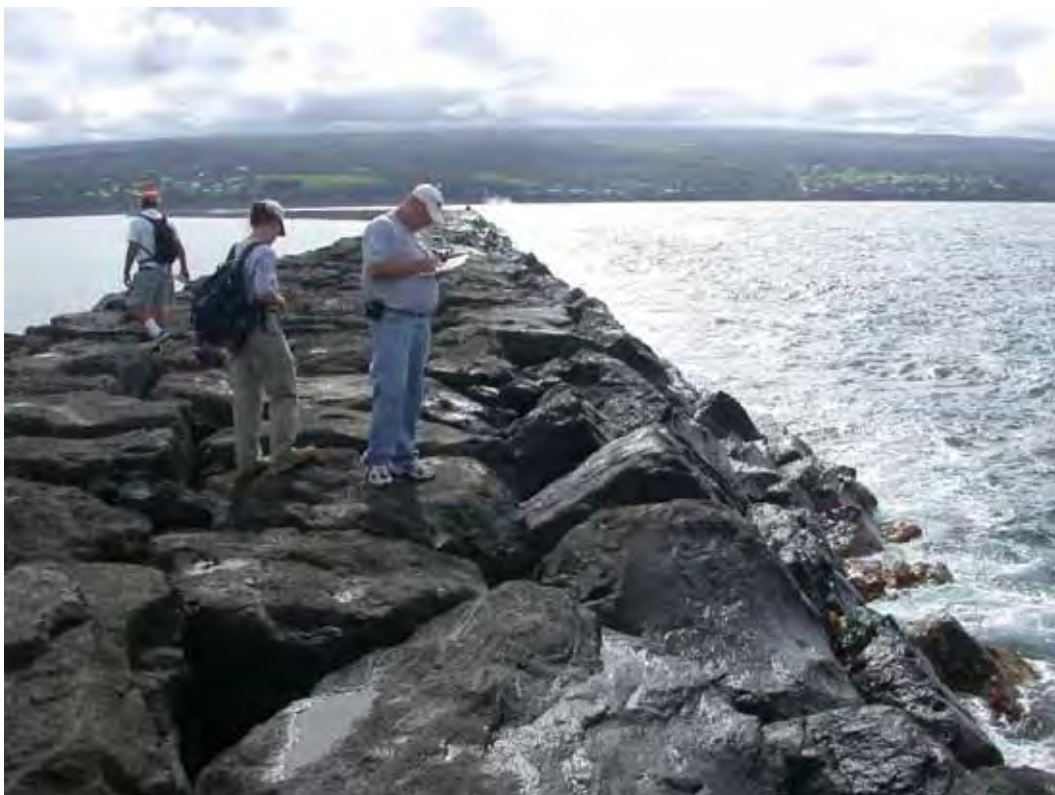
Figure A58. Damage location 62, sta 62+30 - 63+50, ocean side, hinge bowing out, bridging.

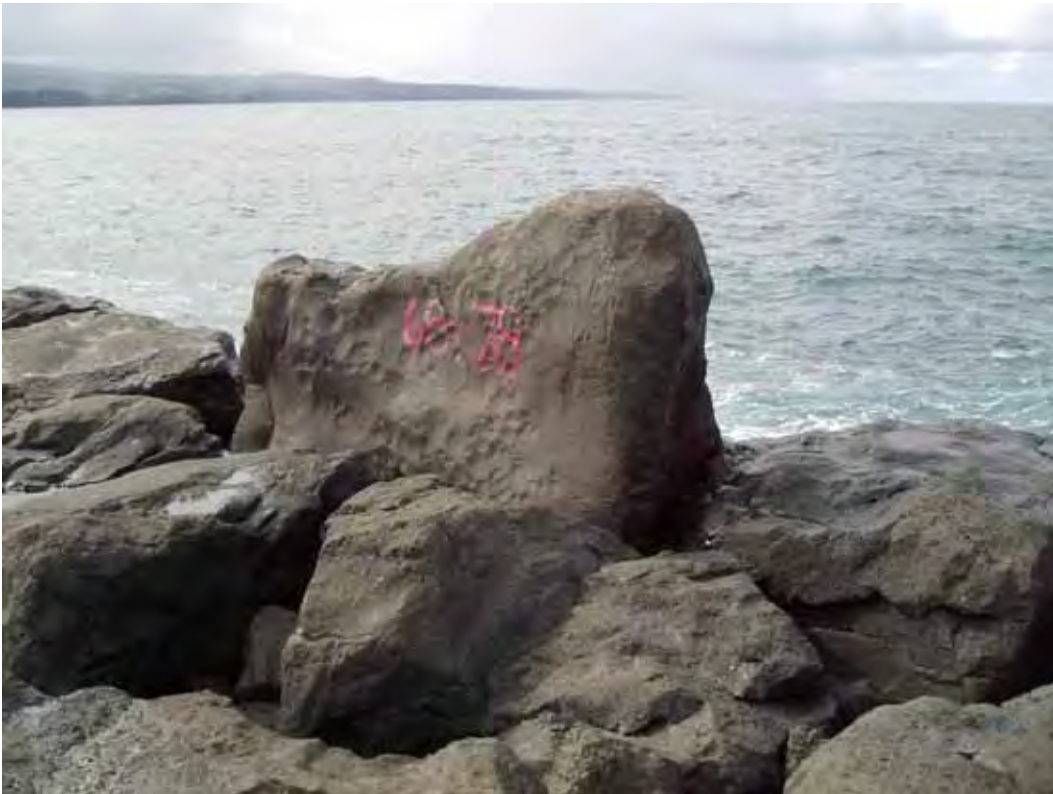
Figure A59. Damage location 67, sta 68+78, ocean side, perched armor stone "Tombstone."

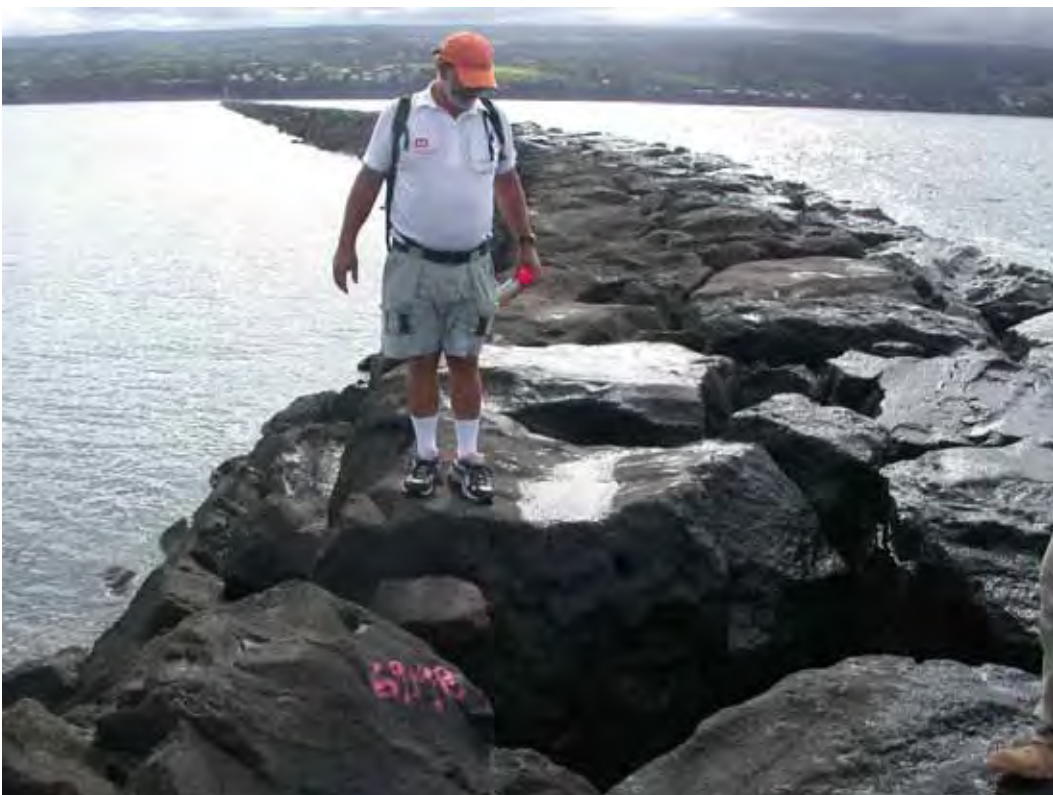
Figure A60. Damage location 68, sta 69+98, harbor side, void at crest (3 ft x 6 ft x 10 ft).

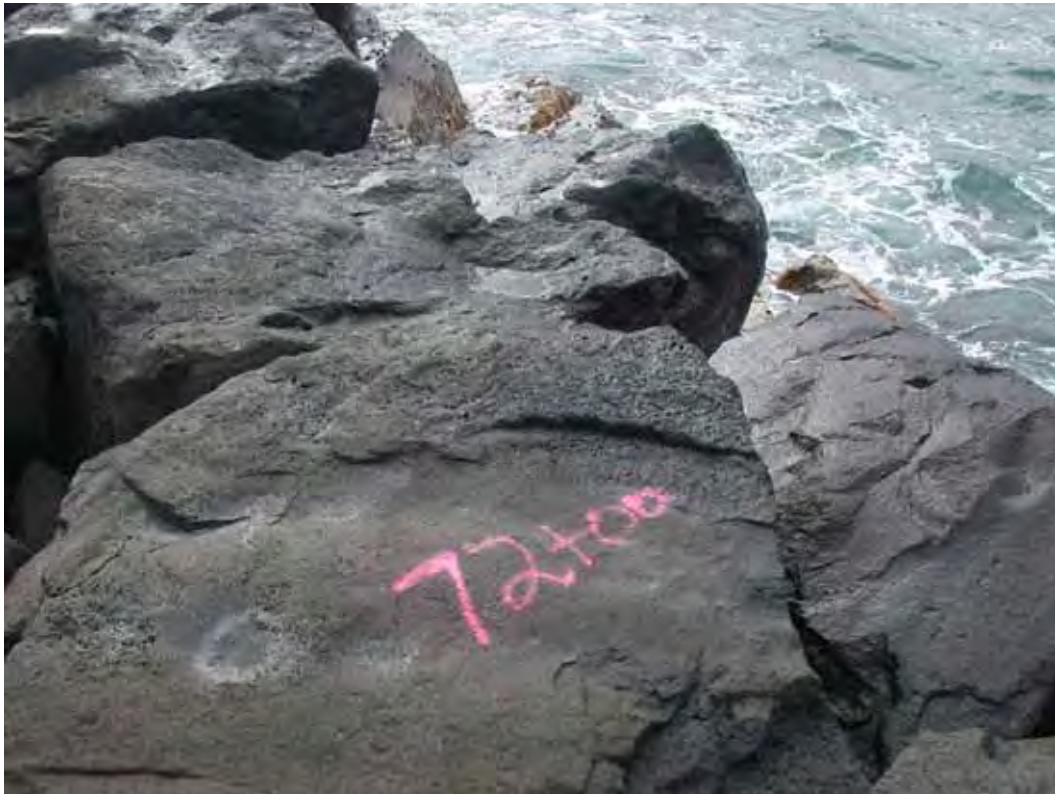
Figure A61. Damage location 70, sta 72+00, ocean side, hinge settling.

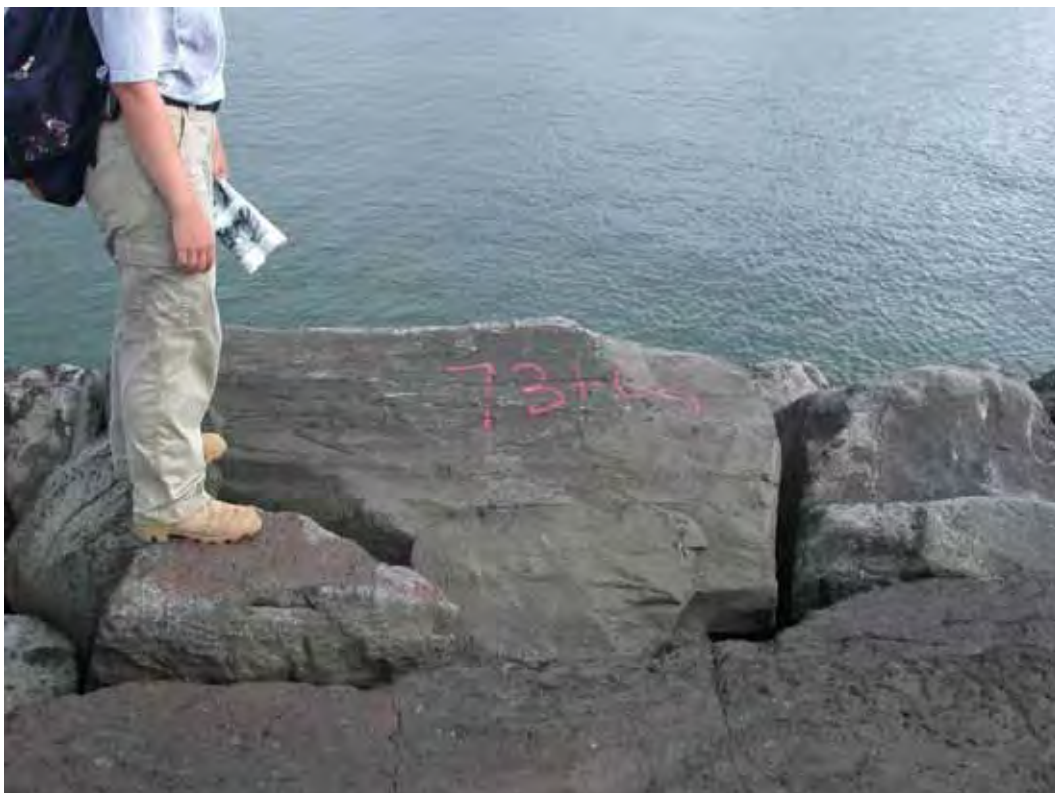
Figure A62. Damage location 71, sta 73+00, harbor side, slight settling of crest.

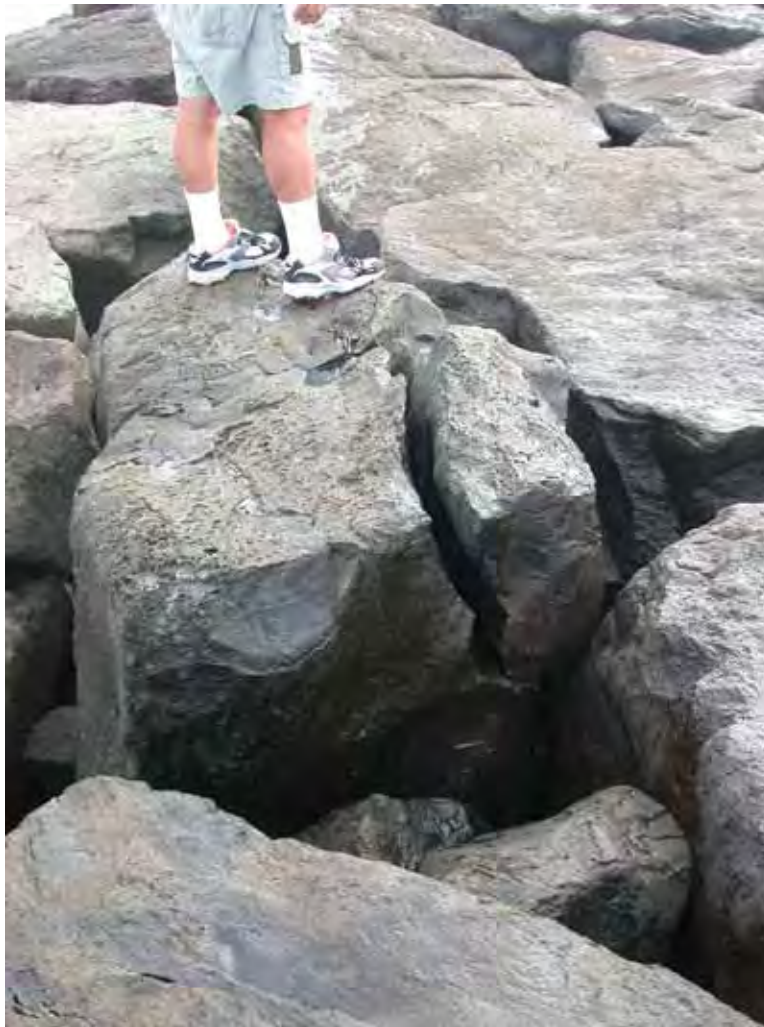
Figure A63. Damage location 72, sta 74+40, broken armor stones and bridging at crest.

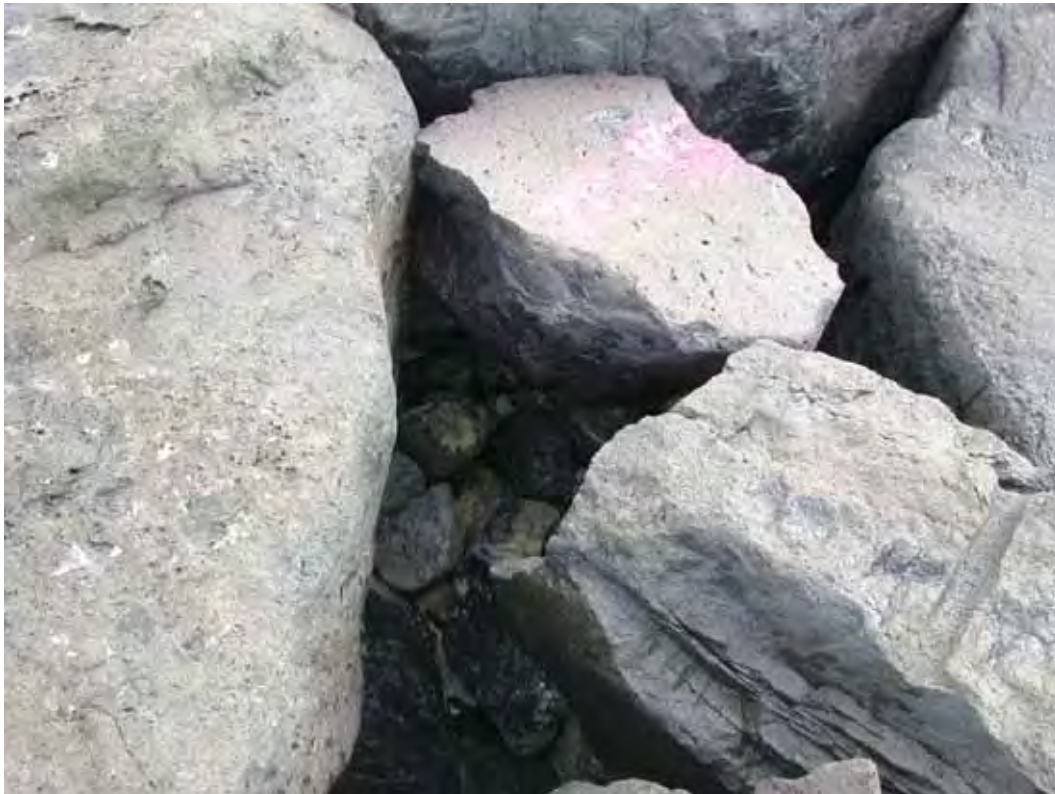
Figure A64. Damage location 75, sta 75+95, void.

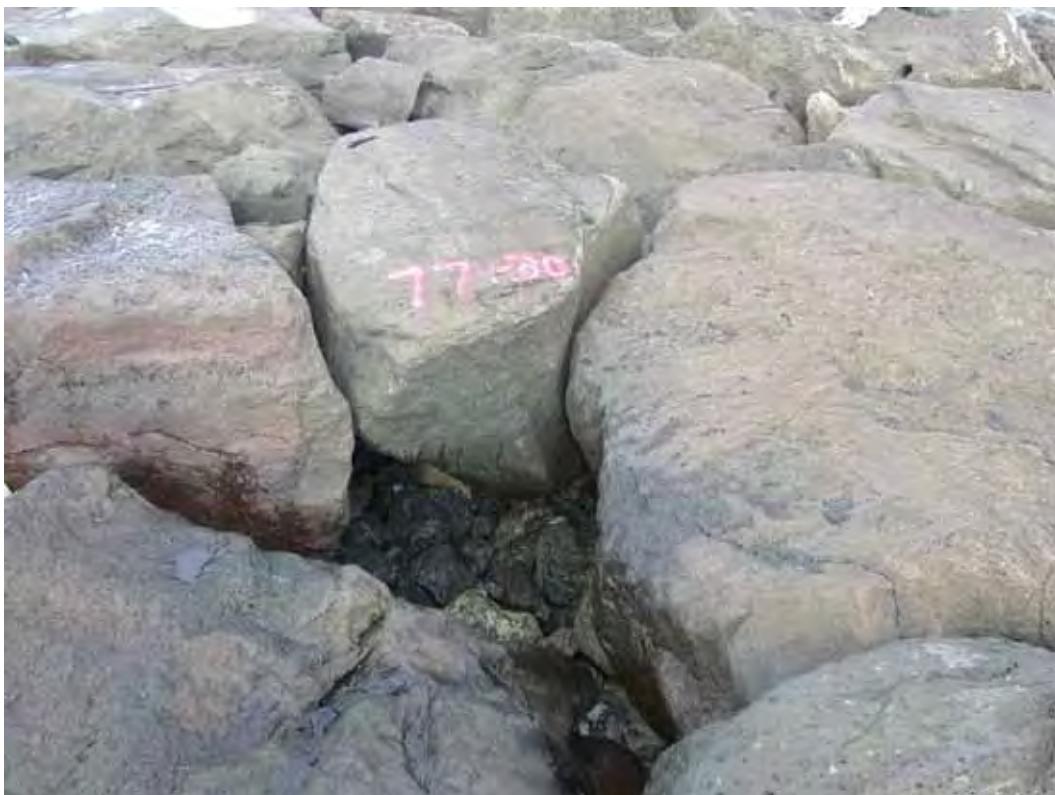
Figure A65. Damage location 76, sta 77+30, ocean side, bridging and settling.

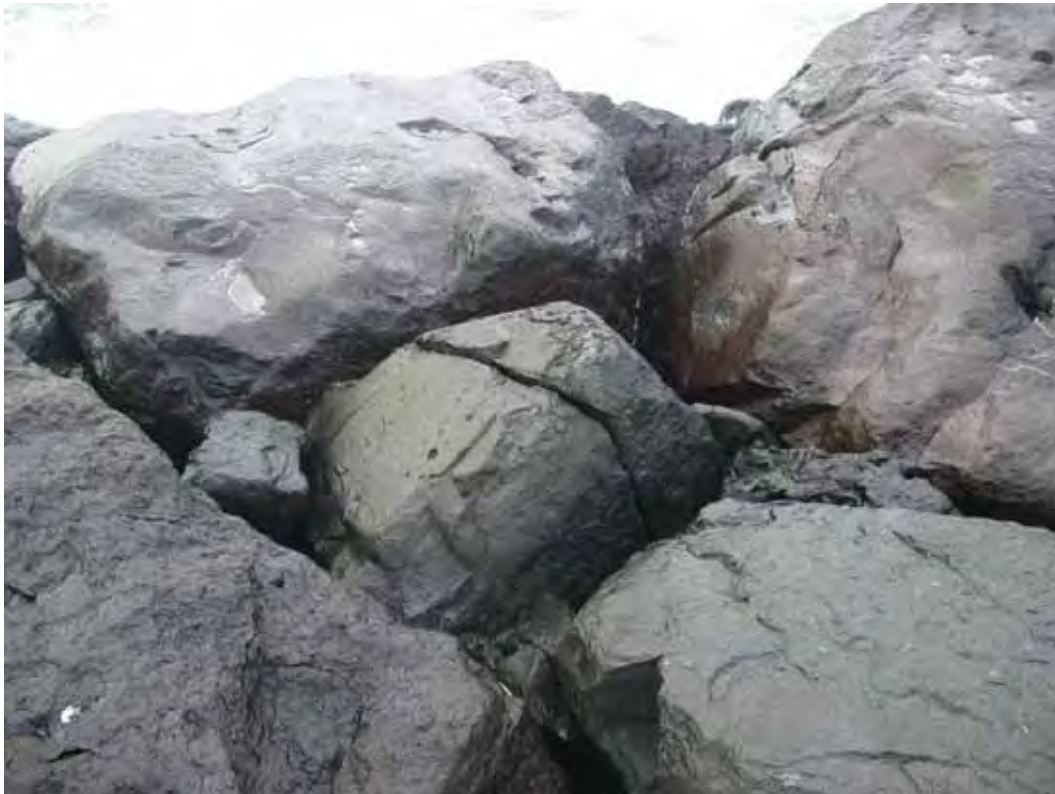
Figure A66. Damage location 77, sta 77+80, cracked armor stone on centerline of crest.

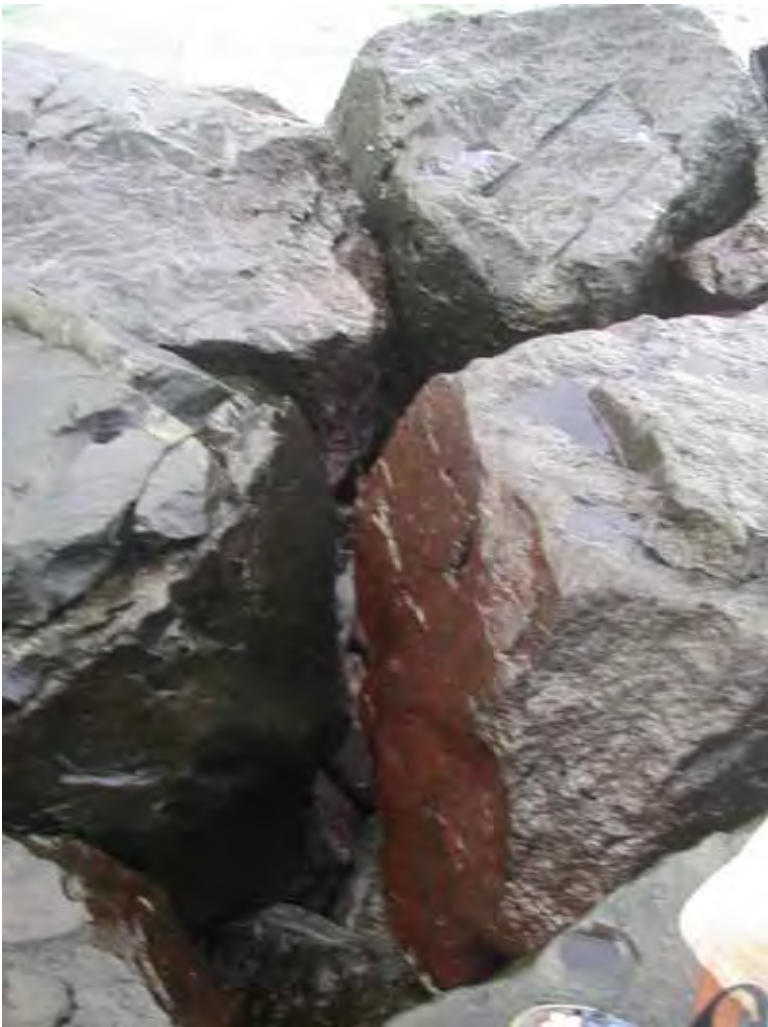
Figure A67. Damage location 80, sta 89+30, bridging.

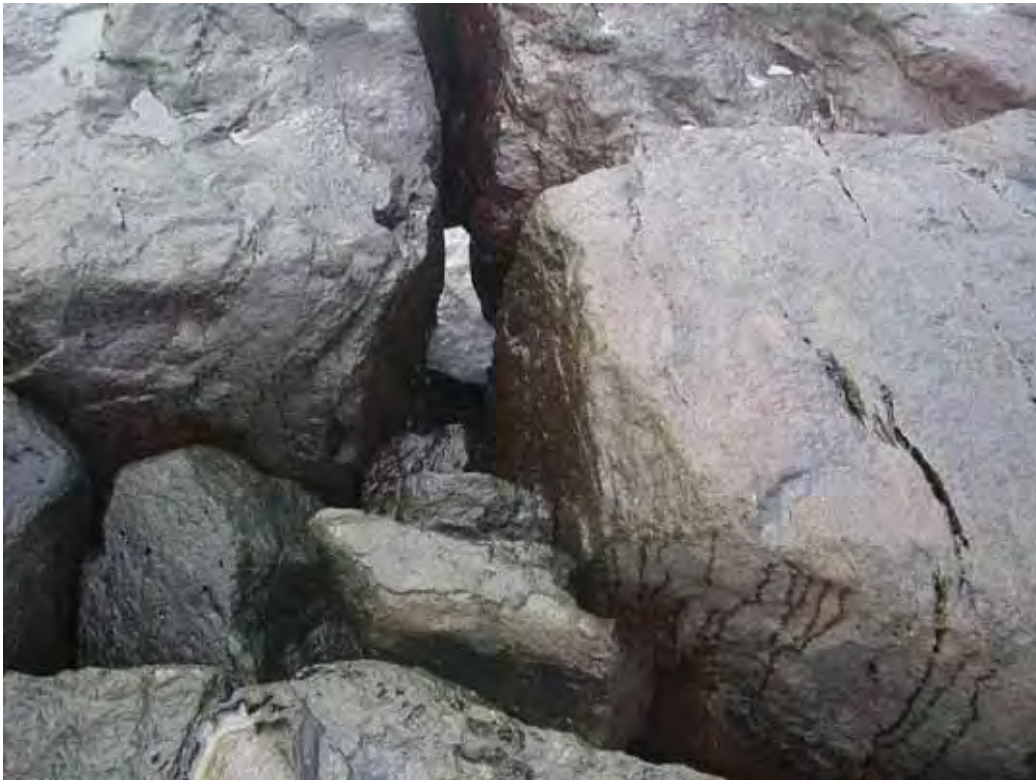
Figure A68. Damage location 81, sta 90+00, harbor side, aerial survey marker; settling at hinge; void at centerline of crest; bridging.
