Monitoring Completed Navigation Projects Program

Periodic Inspections of Hilo, Kahului, Laupahoehoe, and Nawiliwili Breakwaters, Hawaii

Armor Unit Monitoring for Period 2001-2005

October 2011

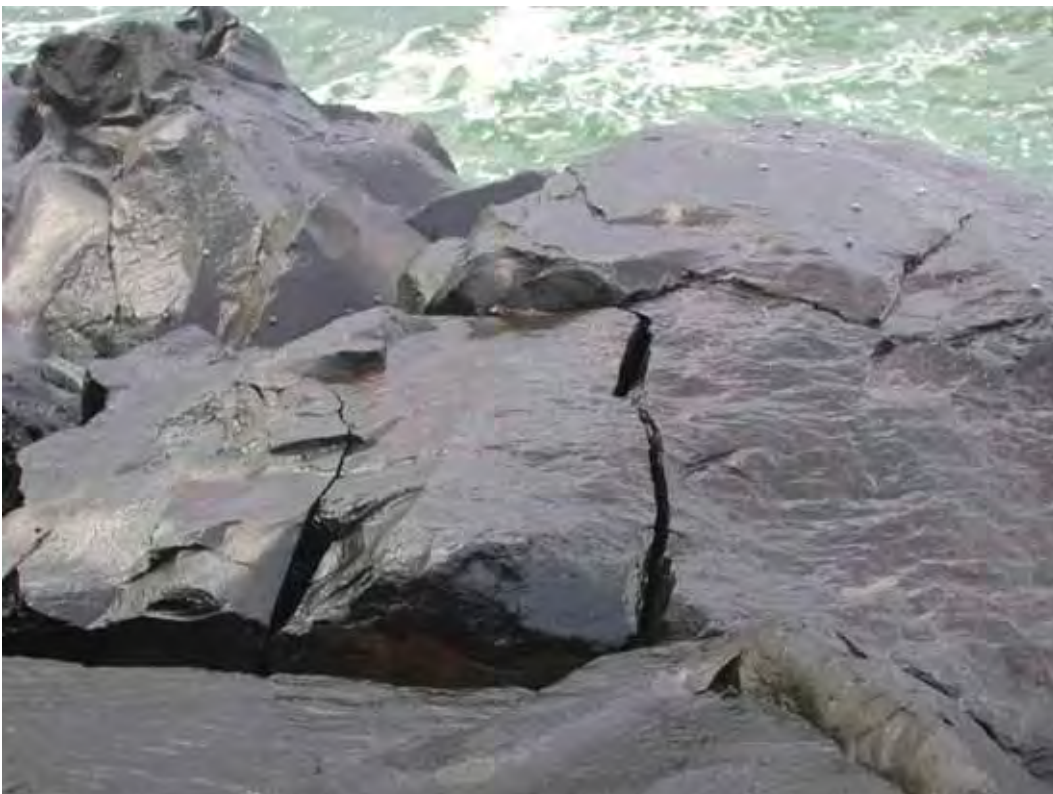
Figure A69. Damage location 82, sta 92+20, ocean side, broken armor stone and bridging.

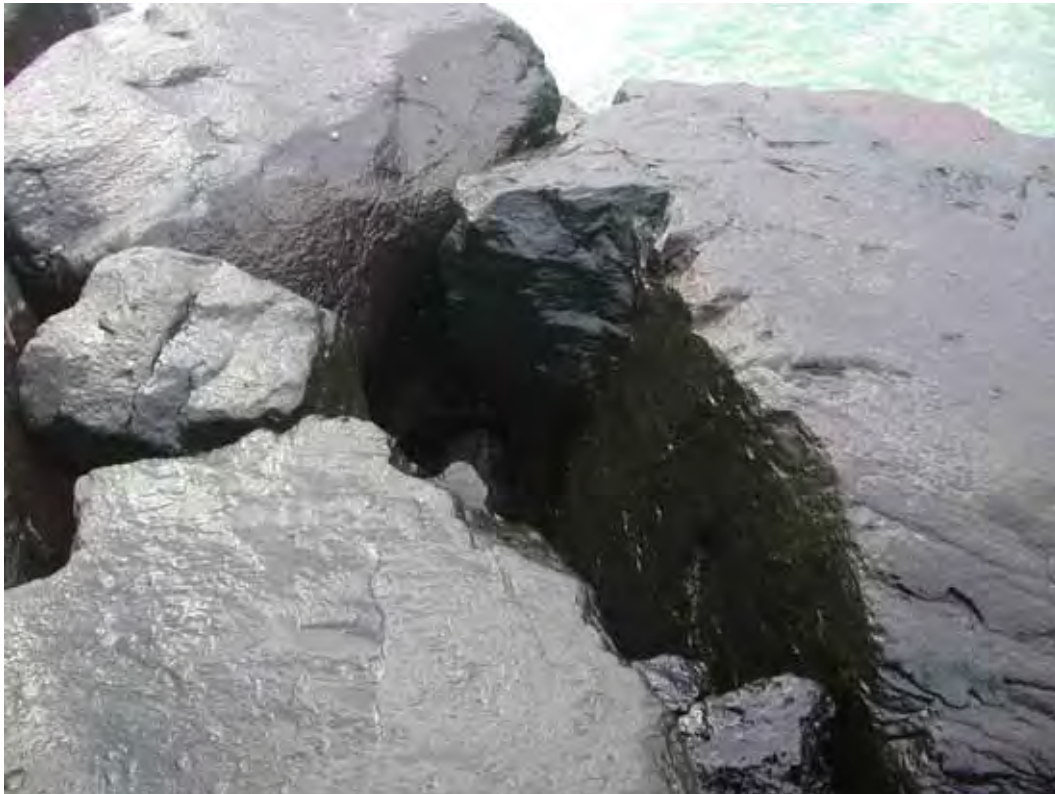
Figure A70. Damage location 84, sta 94+10, ocean side, void and bridging.

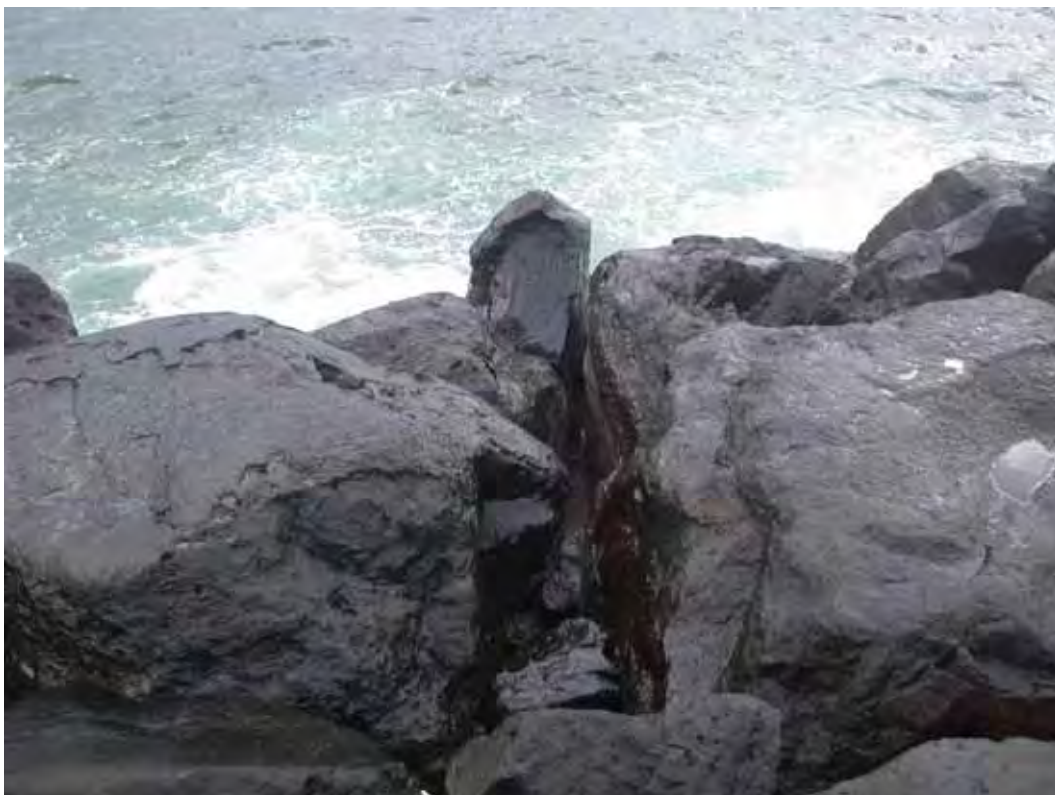
Figure A71. Damage location 85, sta 95+50, ocean side, separation of slope, flipped stone.

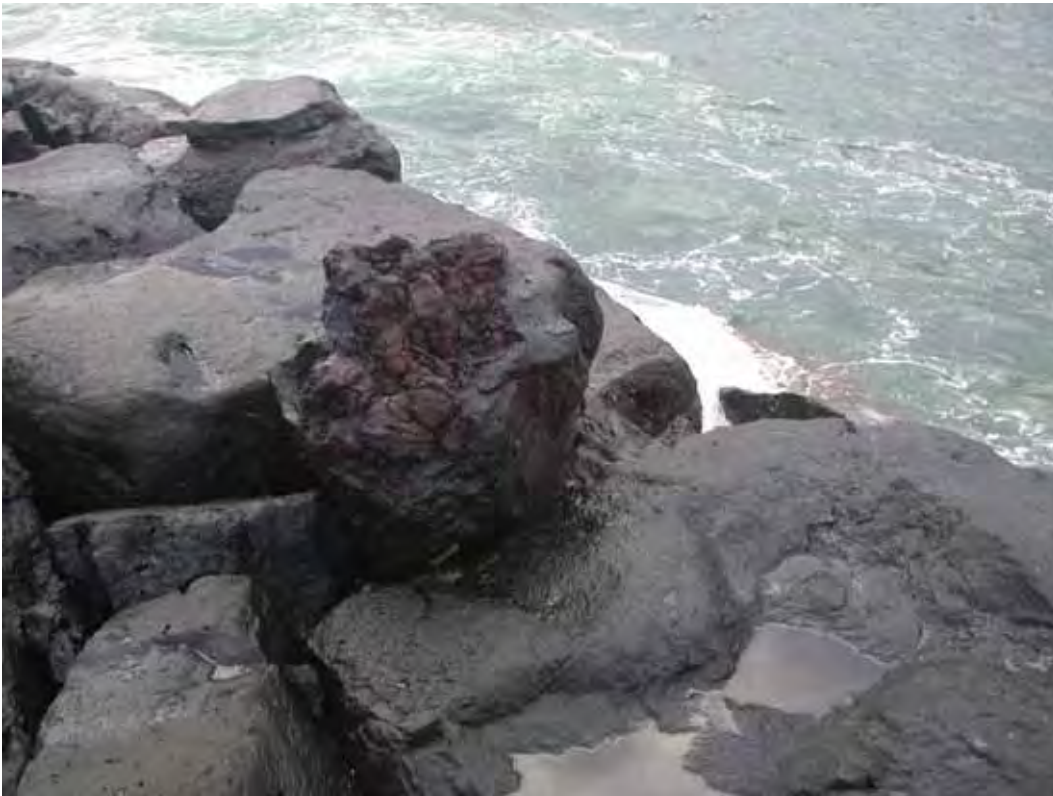
Figure A72. Damage location 86, sta 95+70, ocean side, flipped stone at hinge.

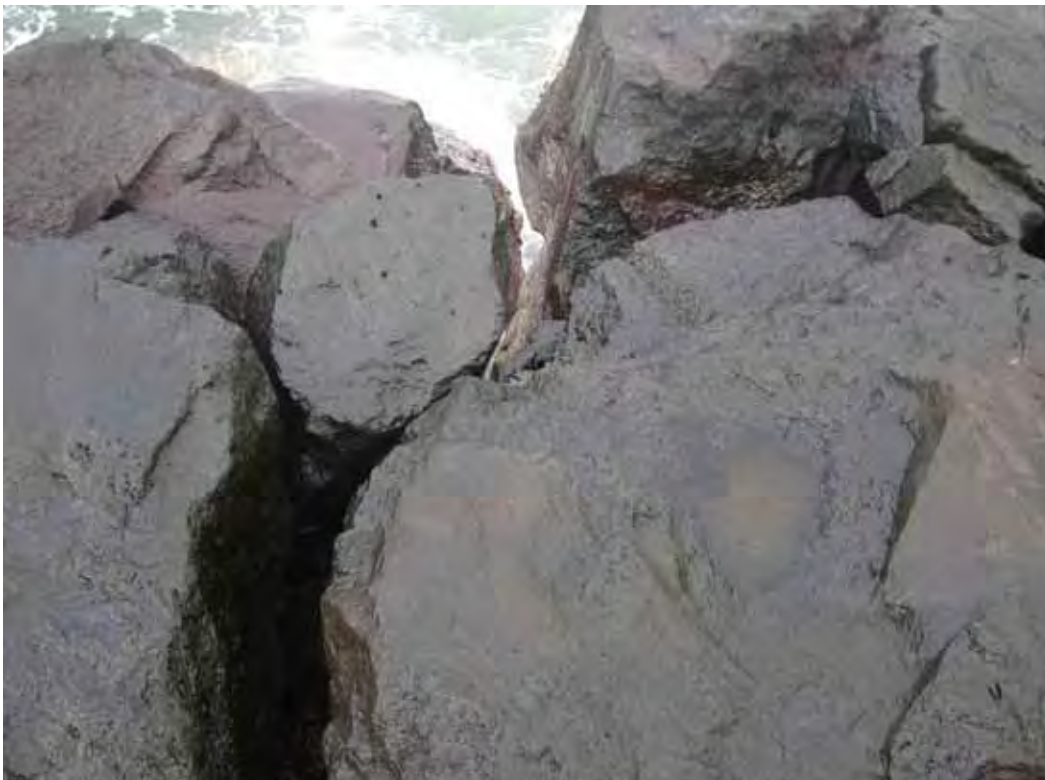
Figure A73. Damage location 87, sta 98+50, ocean side, 2-ft-wide fissure extending from crest down to waterline.

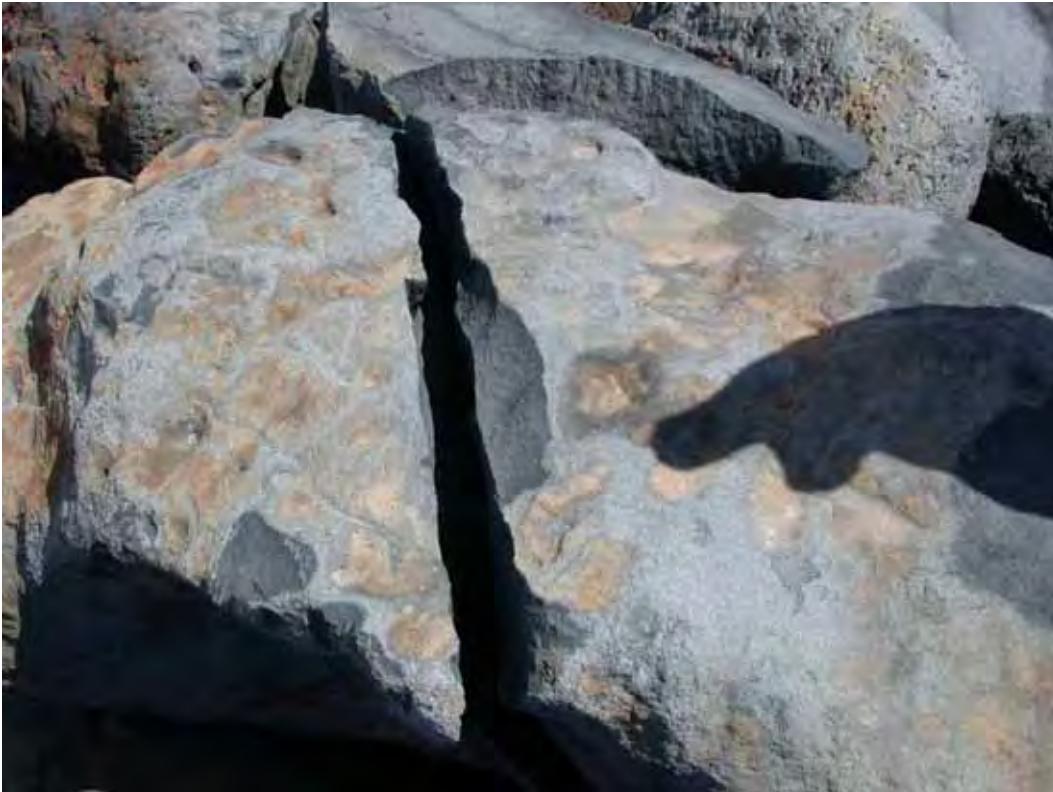
Figure B1. Damage location 1, sta 3+08, harbor side, broken armor stone.

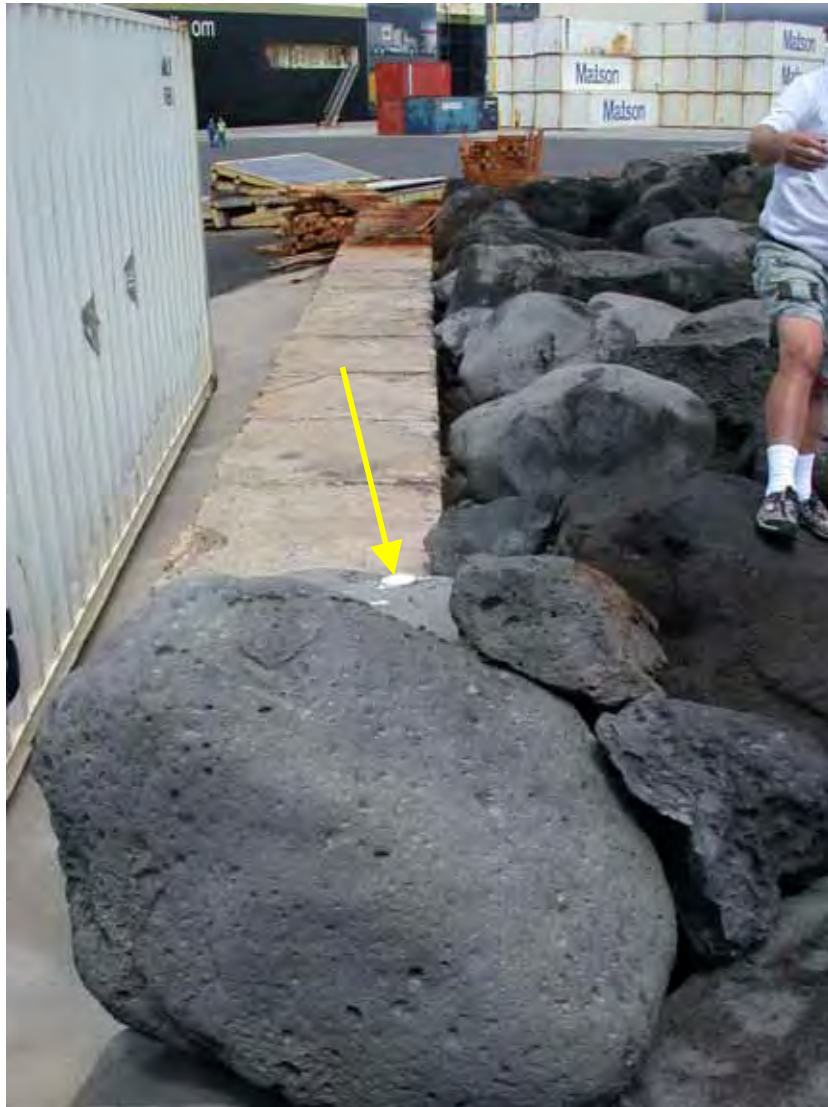
Figure B2. Sta 18+86, beginning of concrete wall adjacent to structure (marker shows 18+25).

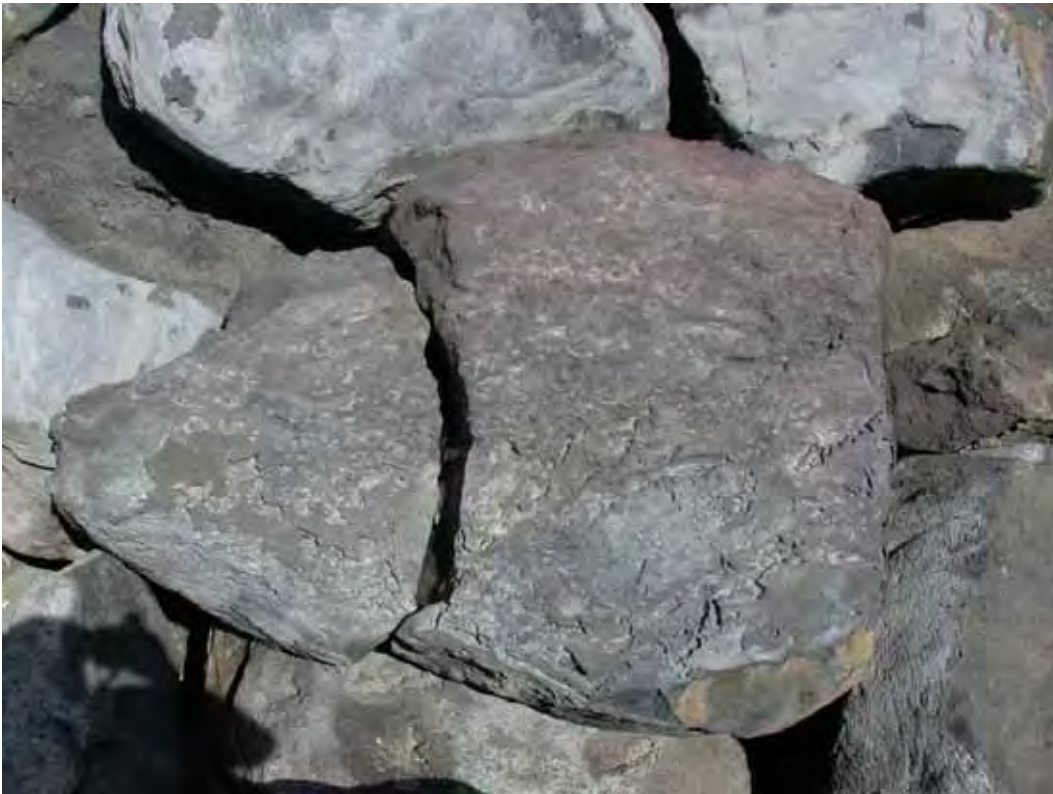
Figure B4. Damage location 9, sta 21+60, crest, broken armor stone.

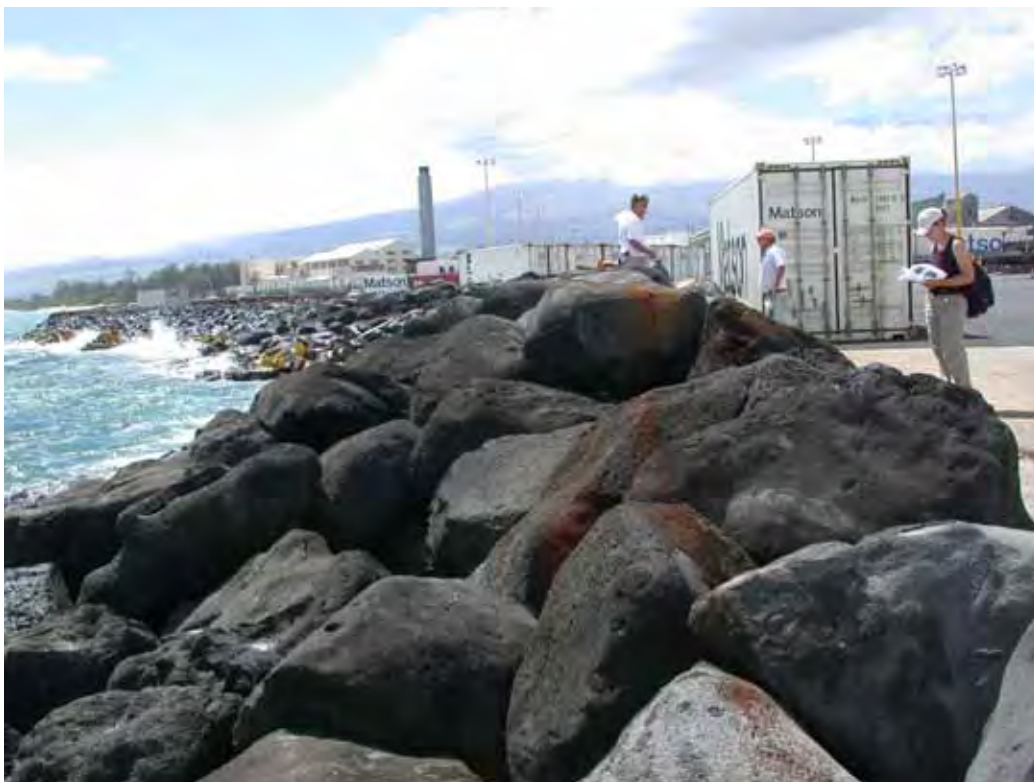
Figure B5. Damage location 10, sta 22+40, transition of repair zones, crest elevation drop, monitor side slope settling.

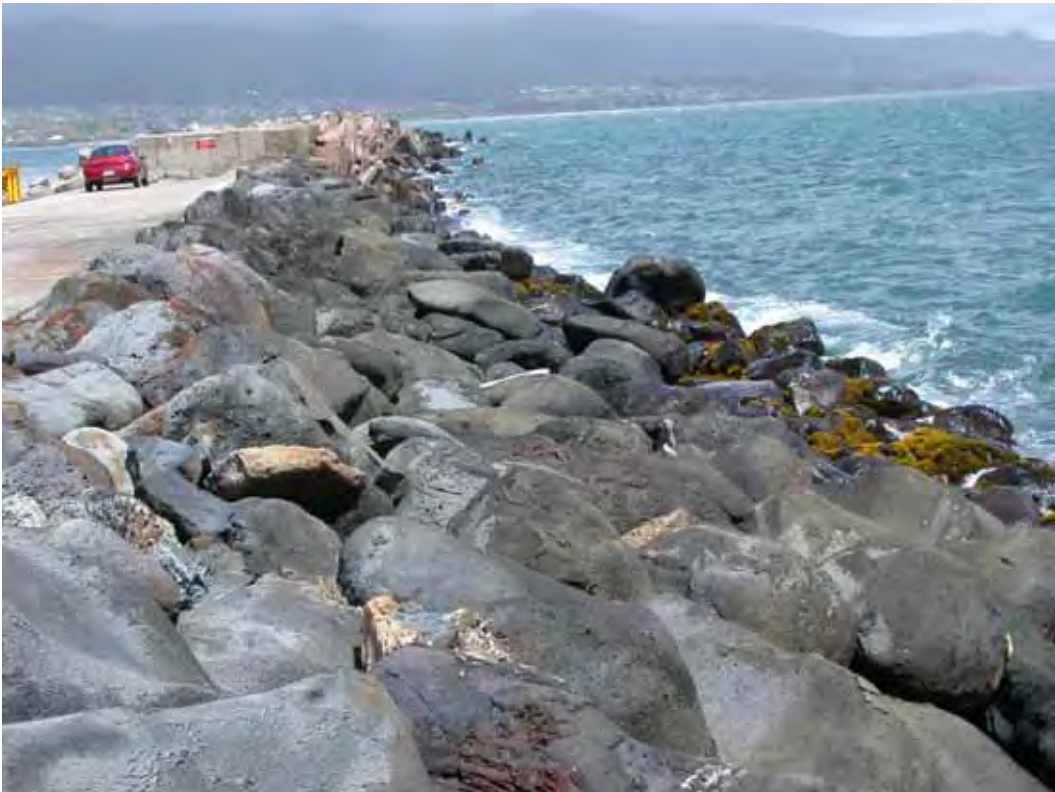
Figure B6. Damage location 11, sta 23+20, ocean side, slight settling.

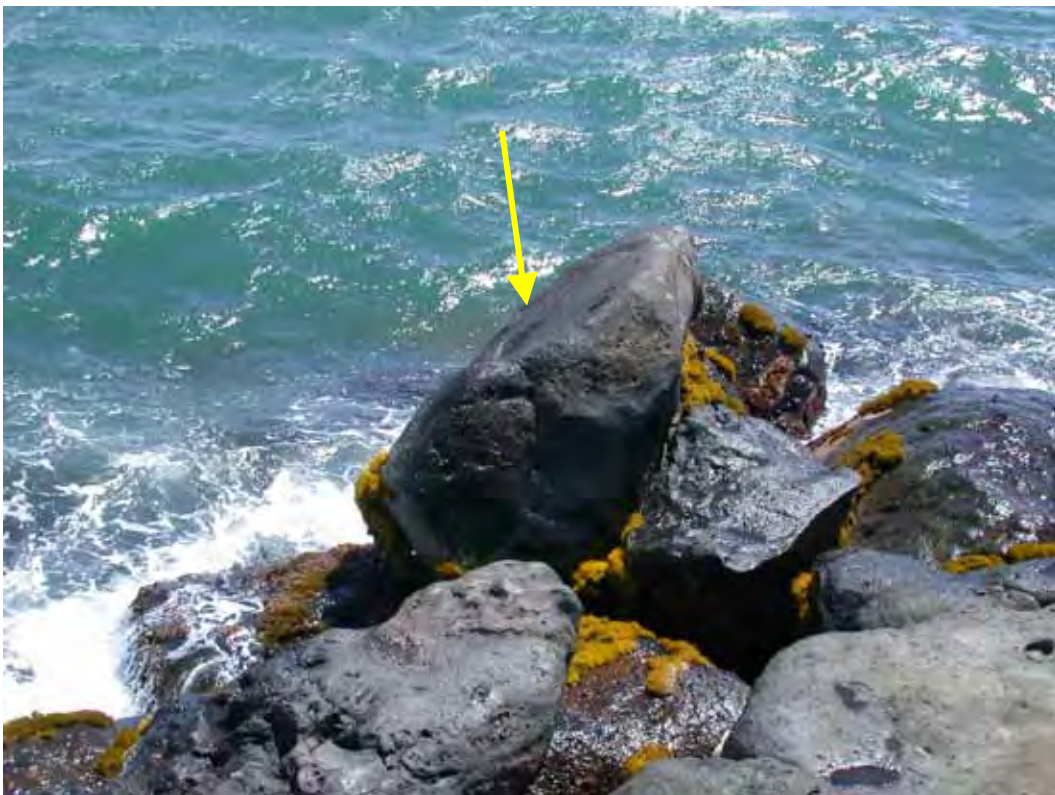
Figure B7. Damage location 12, sta 24+50, ocean side, flipped armor stone.

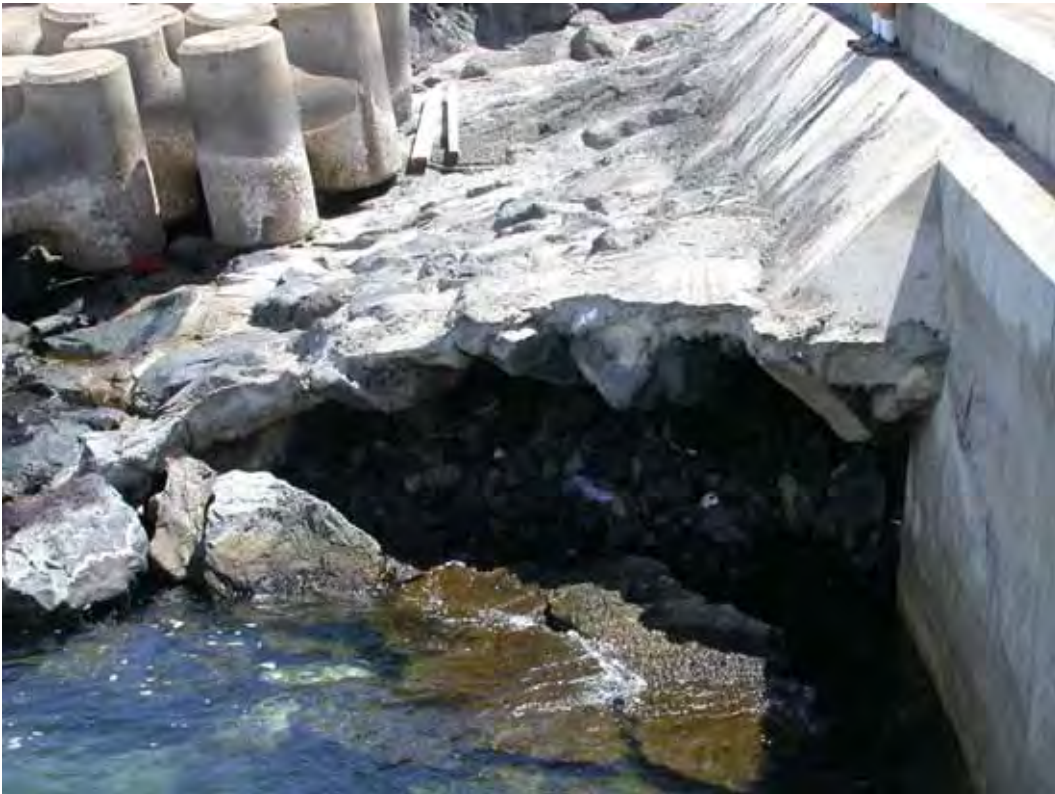
Figure B10. Damage location 13, sta 26+26, harbor side, eroded side slope.

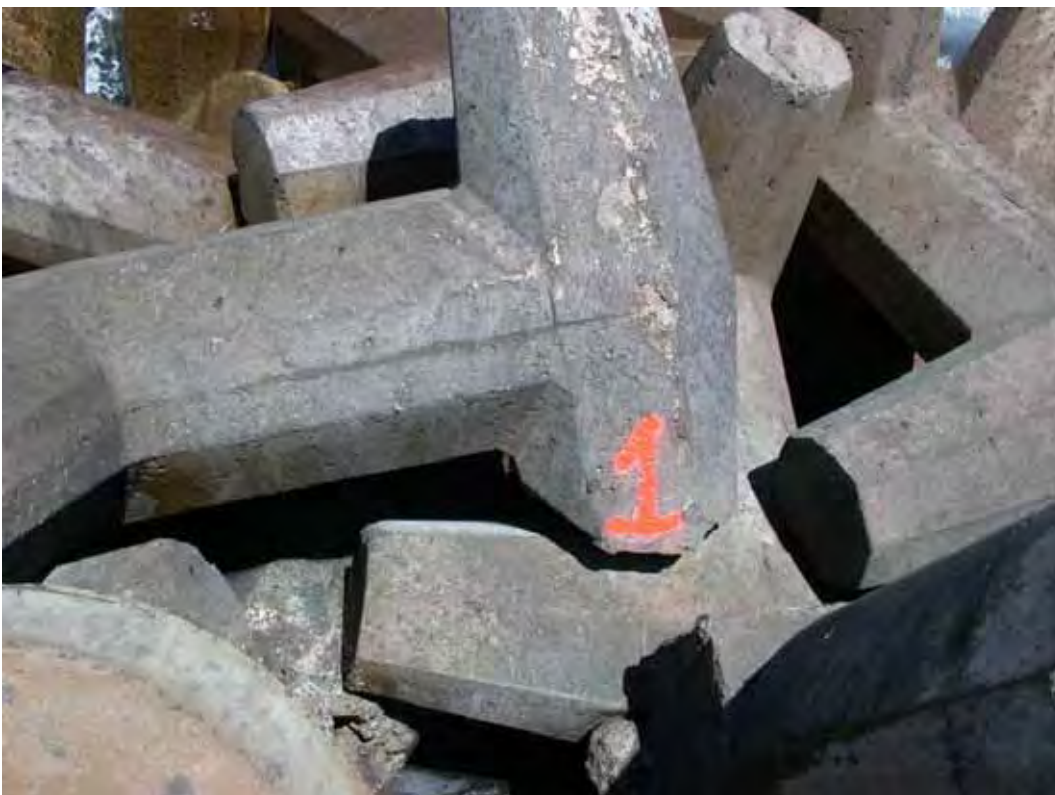
Figure B11. Damage location 14, sta 26+70, ocean side, rib #8, dolosse with fluke tip break.

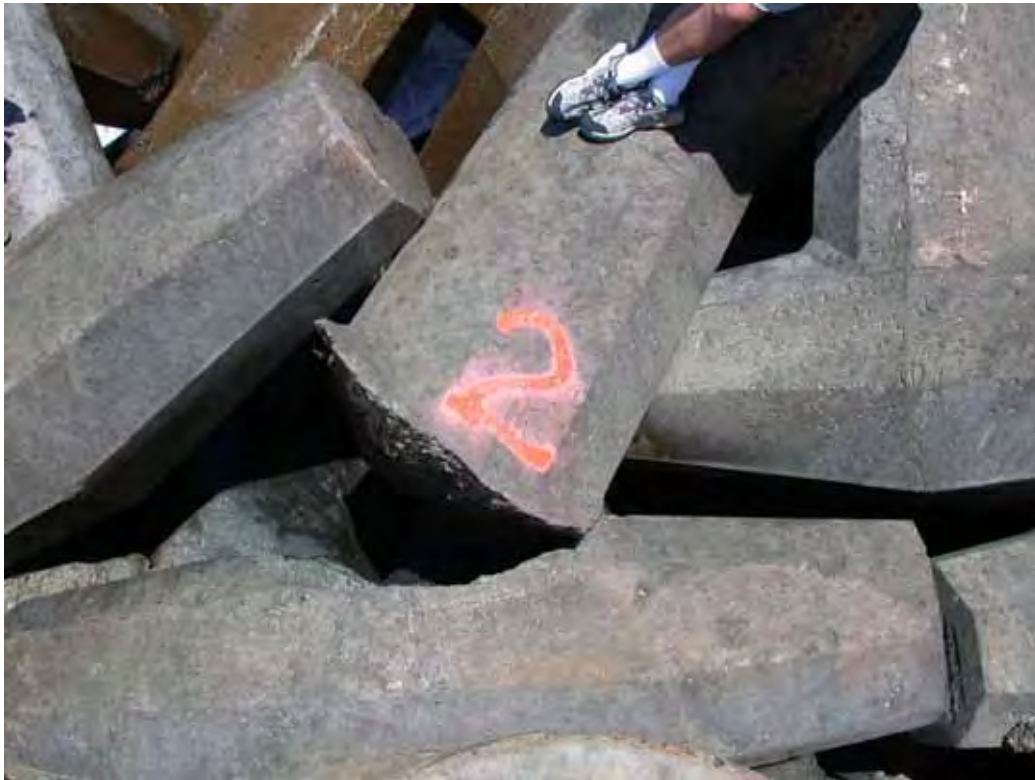
Figure B12. Damage location 15, sta 26+92, ocean side, rib #12, dolosse with straight shank-fluke break.

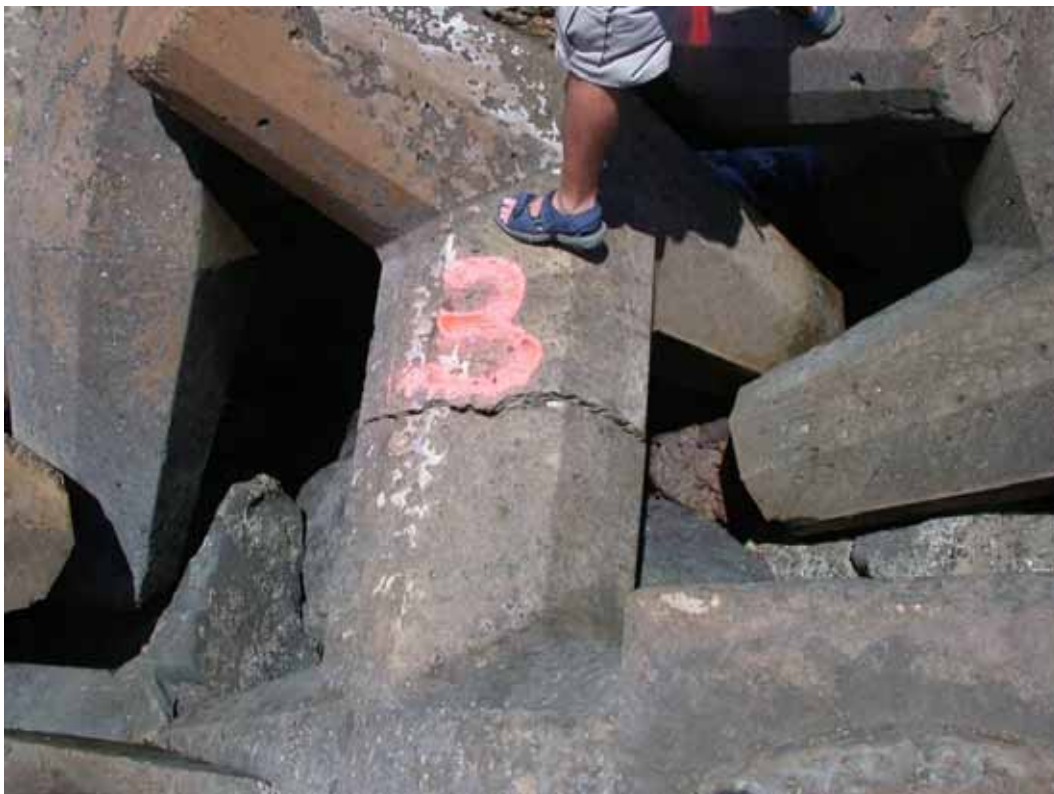
Figure B13. Damage location 16, sta 26+97, ocean side, dolosse with mid-shank break.

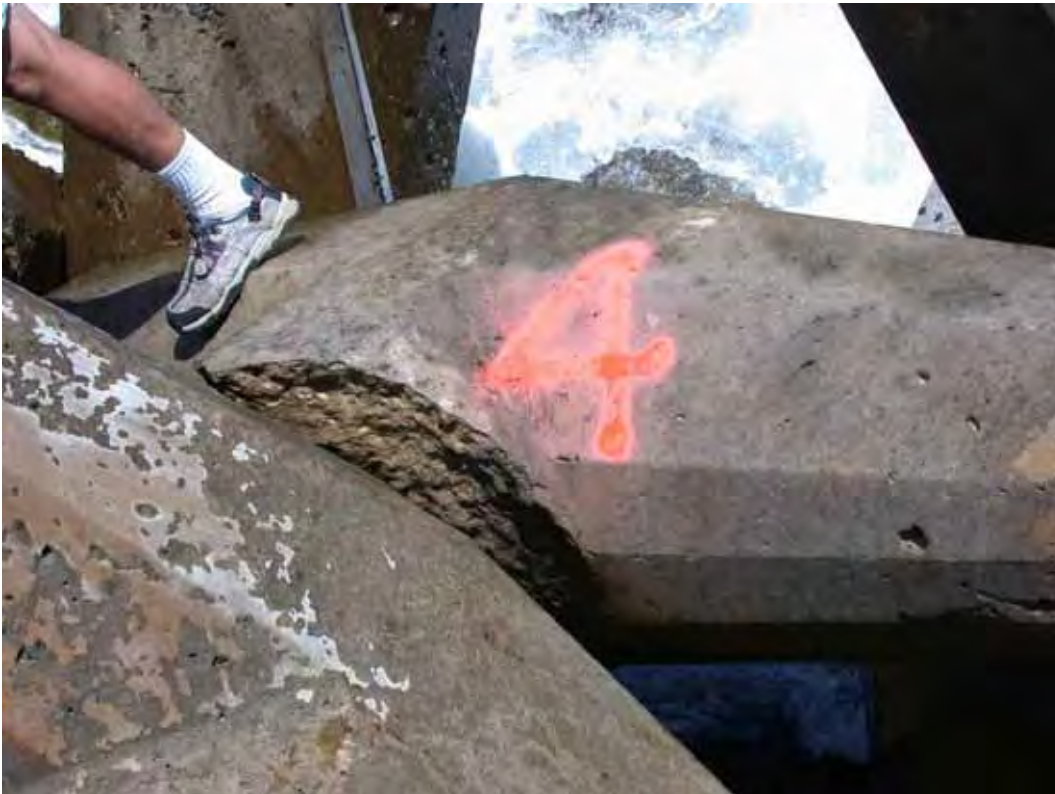
Figure B14. Damage location 17, sta 26+97, ocean side, dolosse with shank-fluke break.

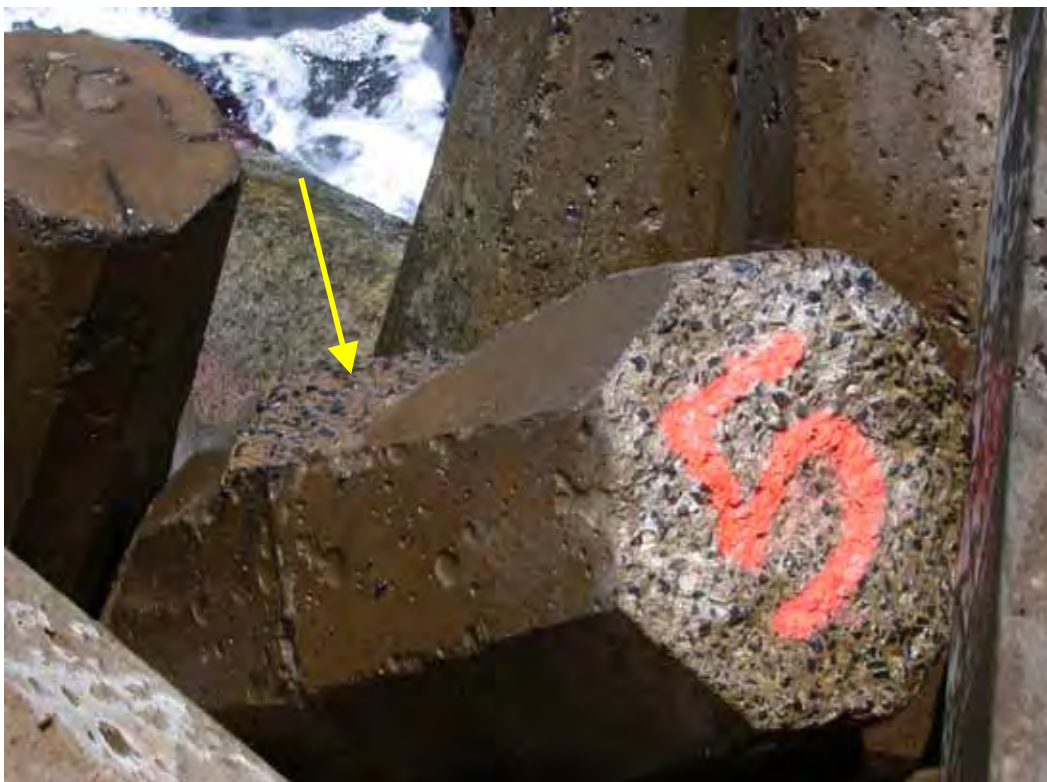
Figure B15. Damage location 18, sta 27+09, ocean side, rib #15, dolosse with shank-fluke break.

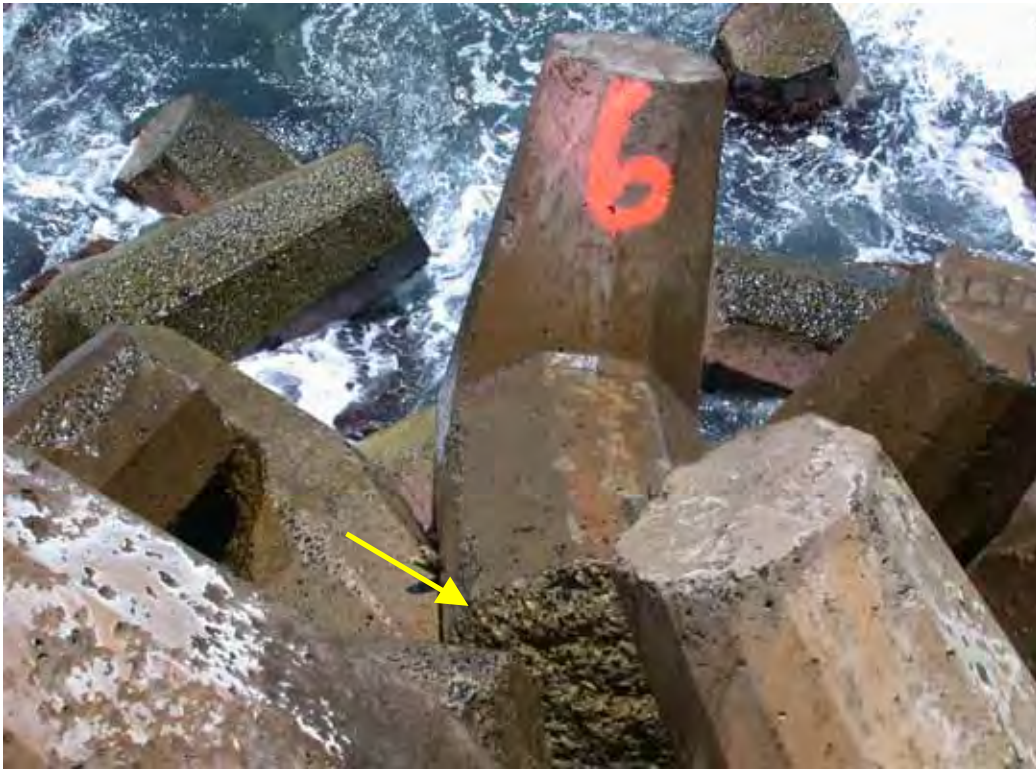
Figure B16. Damage location 19, sta 27+09, ocean side, rib #15, dolosse with shank-fluke break.

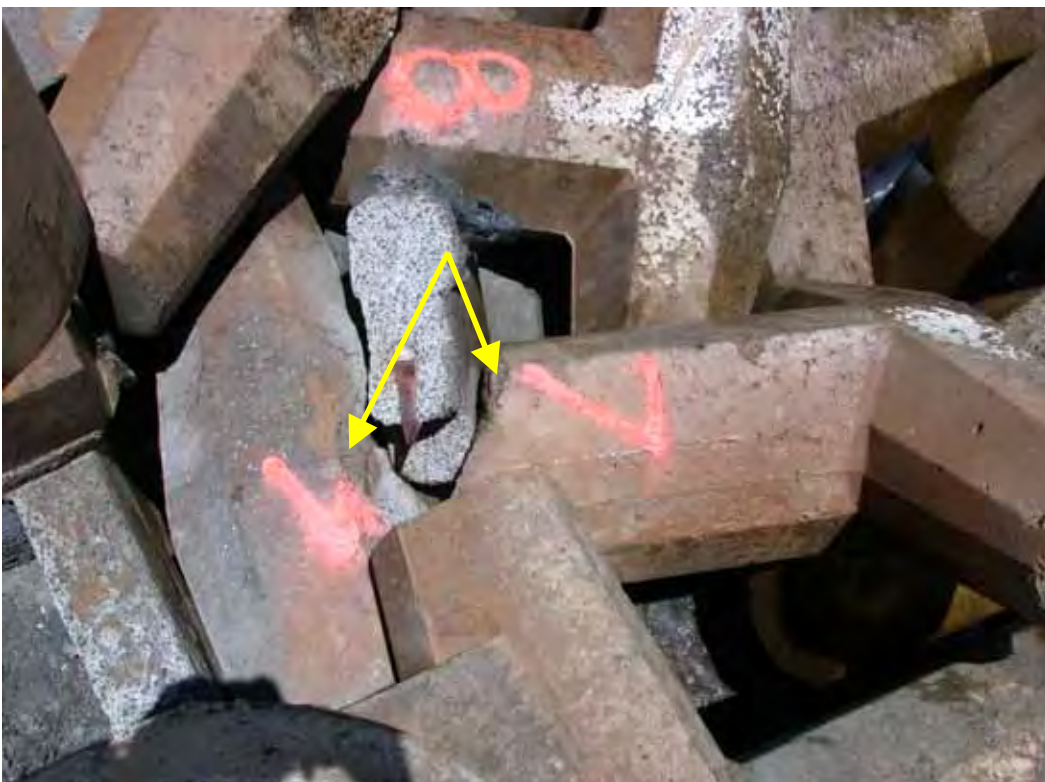
Figure B17. Damage location 20, sta 27+09, ocean side, rib #15, dolosse with shank-fluke break.

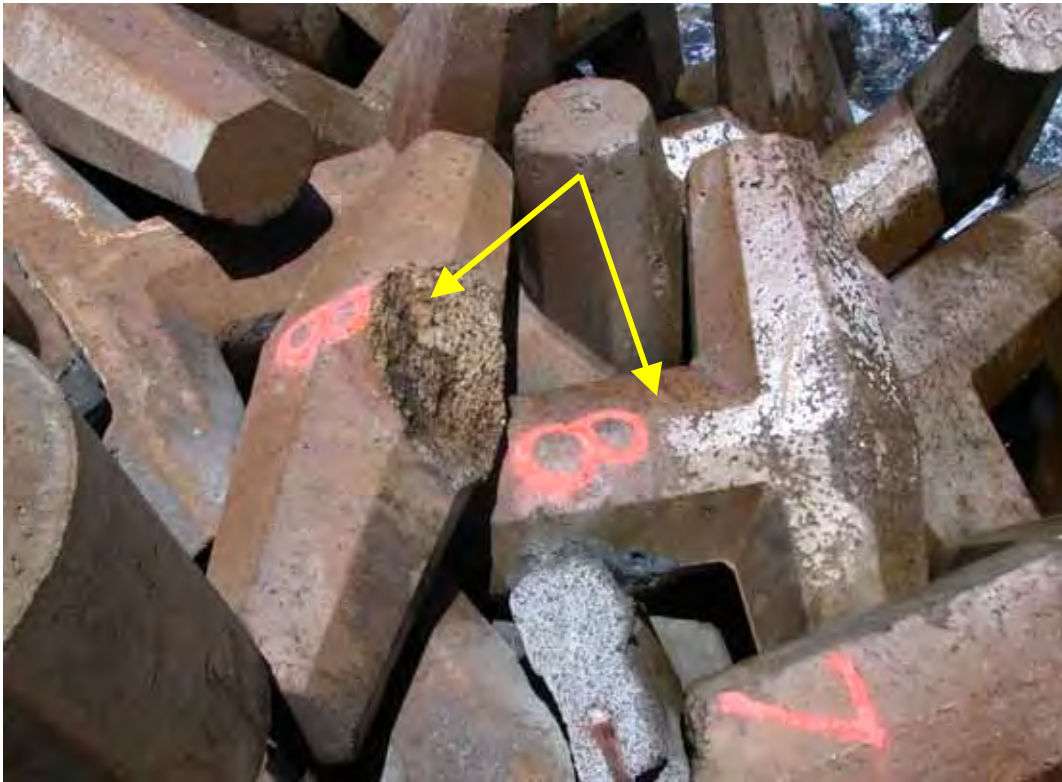
Figure B18. Damage location 22, sta 27+19, ocean side, rib #17, dolosse with straight shank-fluke break.

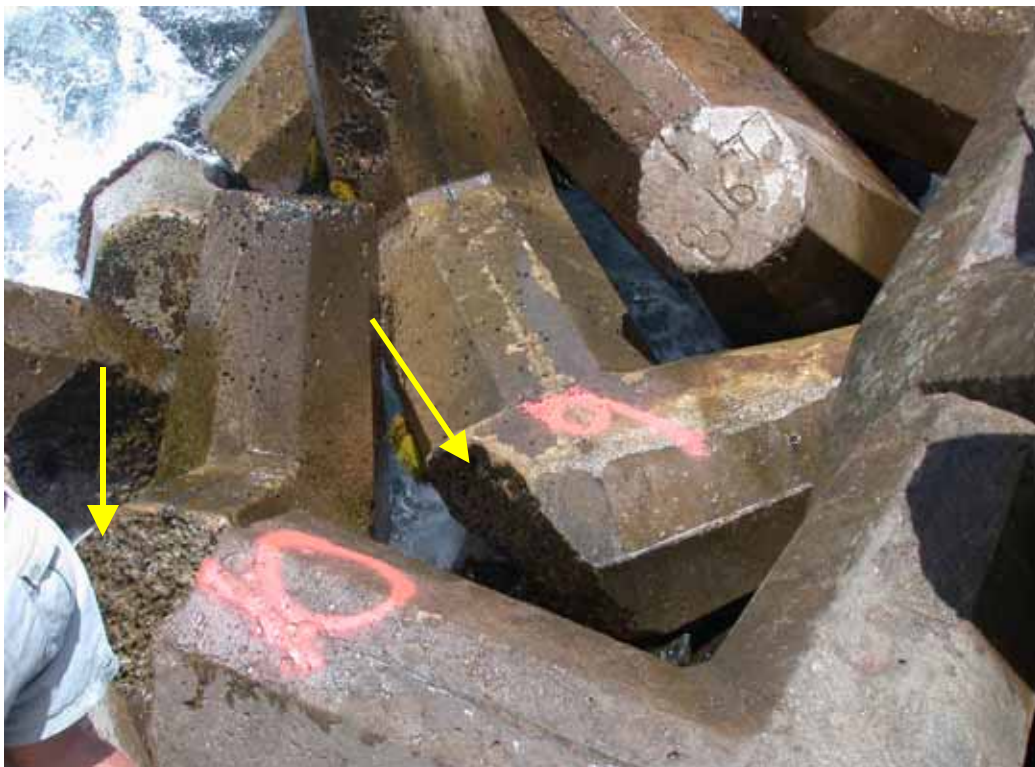
Figure B19. Damage locations 23 & 24, sta 27+69, ocean side, rib #23, dolosse with fluke-shank break and dolosse with shank-fluke break.

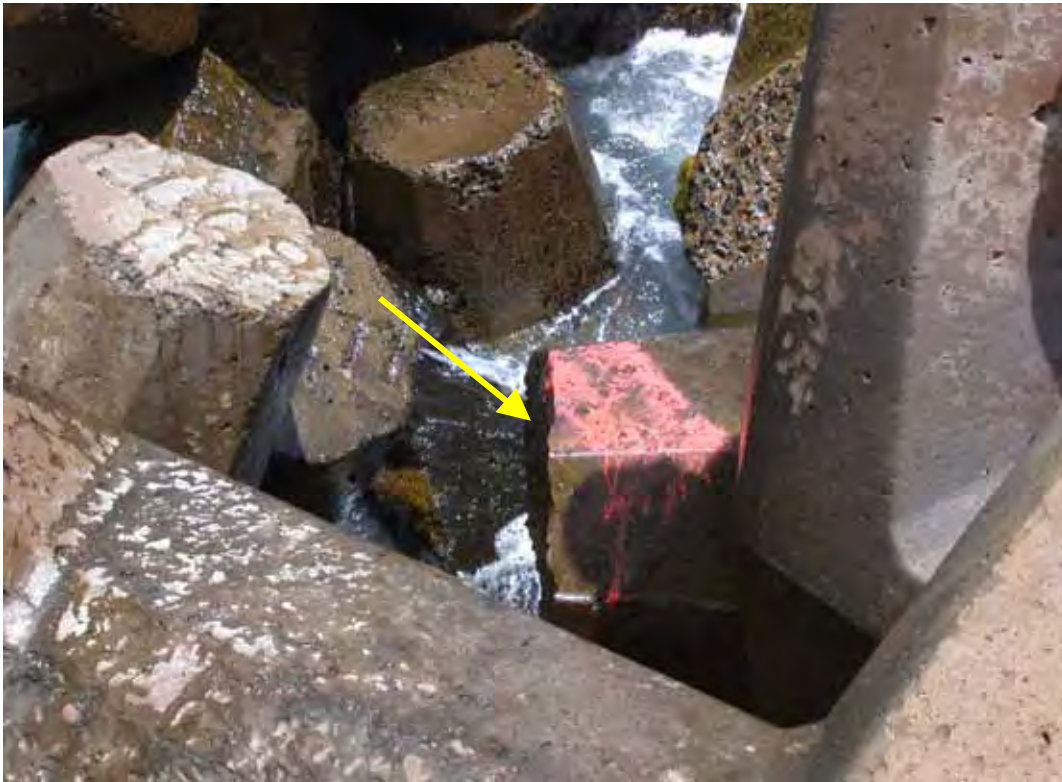
Figure B20. Damage location 25, sta 27+69, ocean side, rib #23, dolosse with shank-fluke break.

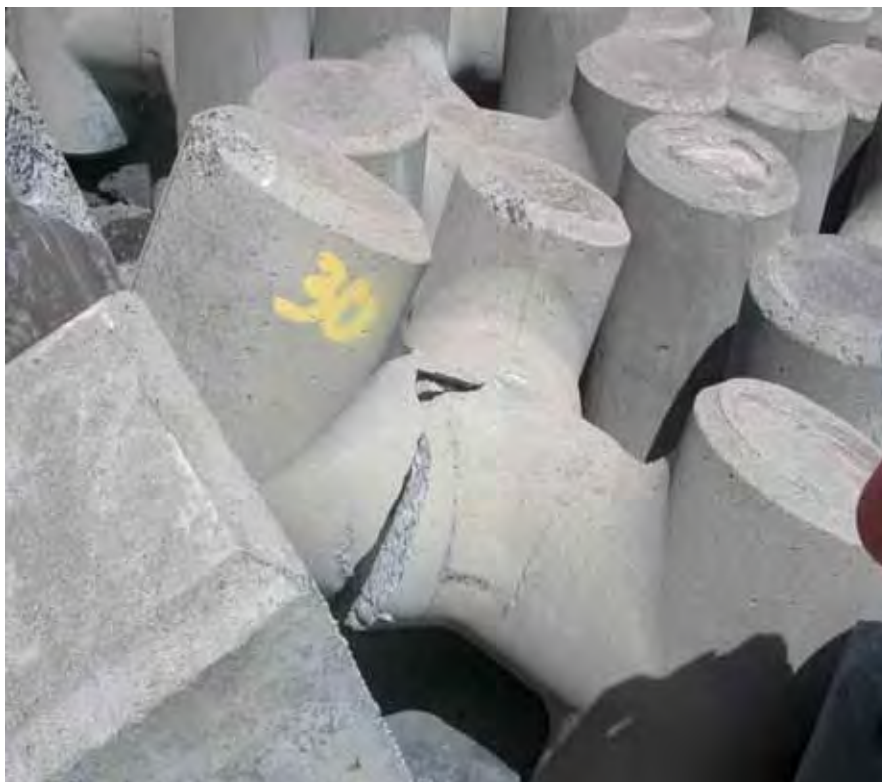
Figure B24. Damage location 29, sta 28+30, harbor side, rib #34, tribar with break through center.

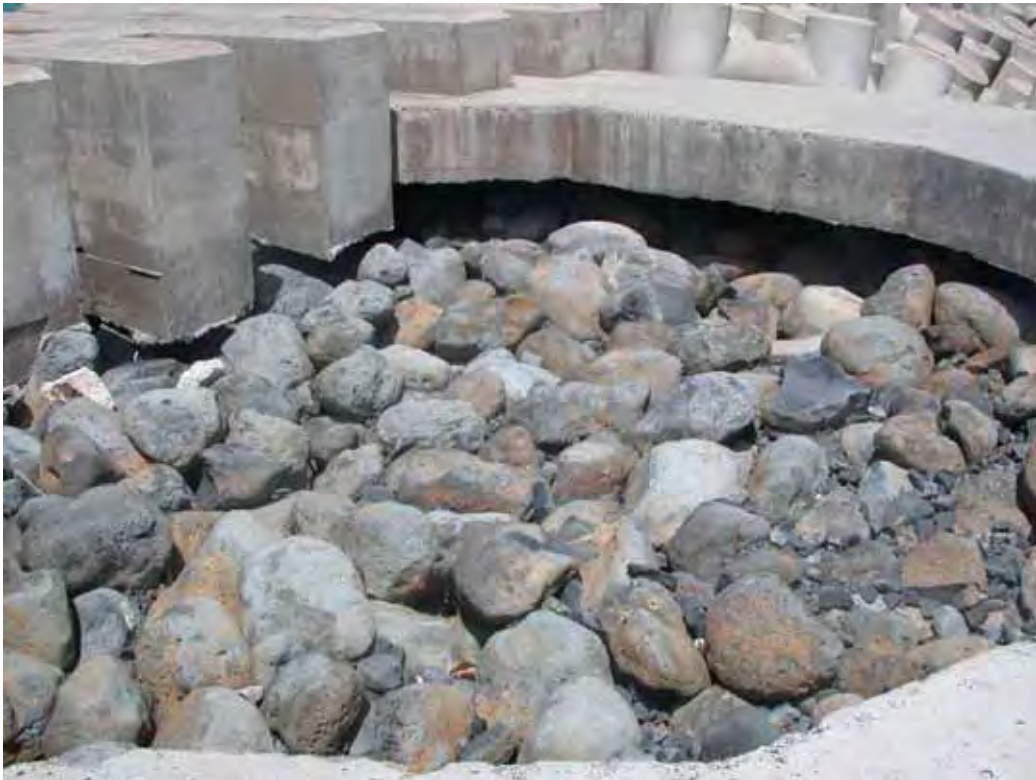
Figure B25. Damage location 31, sta 29+27, harbor side, rib #50, Centerline of first turnaround; settling of armor stone - unsupported rib cap.

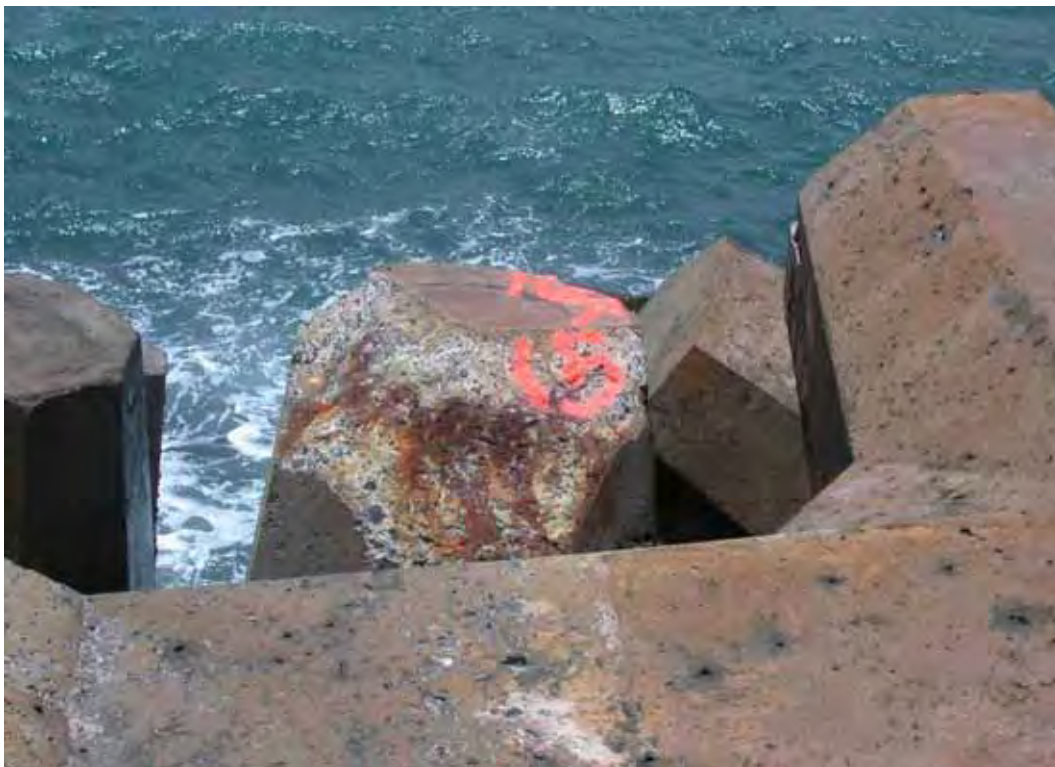
Figure B26. Damage locations 32 and 33, sta 30+04, ocean side, rib #63, two dolosse with tip chips (one visible in photograph).

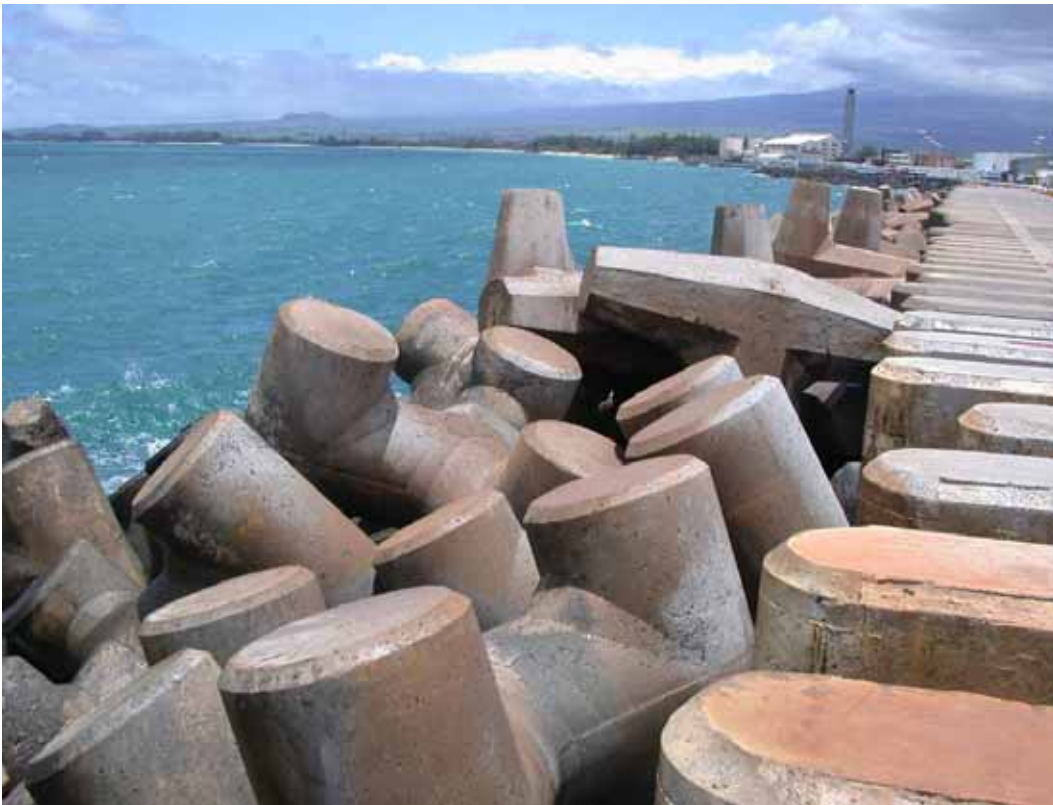
Figure B27. Sta 30+64 – 30+70, ocean side, ribs #73 - #74, transition of dolosse to tribar.

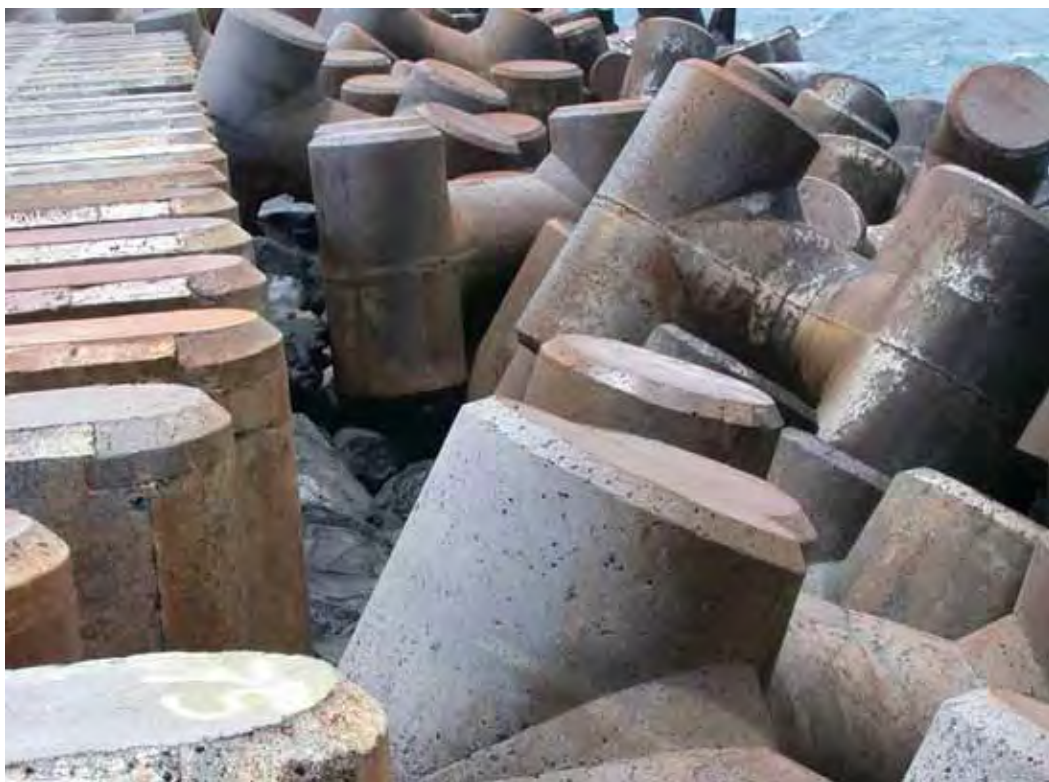
Figure B28. Damage location 37, sta 30+88 - sta 31+48, ocean side, rib #77 - #87, 10 ft separation of tribar from ribcap.
