Monitoring Completed Navigation Projects Program

Periodic Inspections of Hilo, Kahului, Laupahoehoe, and Nawiliwili Breakwaters, Hawaii

Armor Unit Monitoring for Period 2001-2005

October 2011

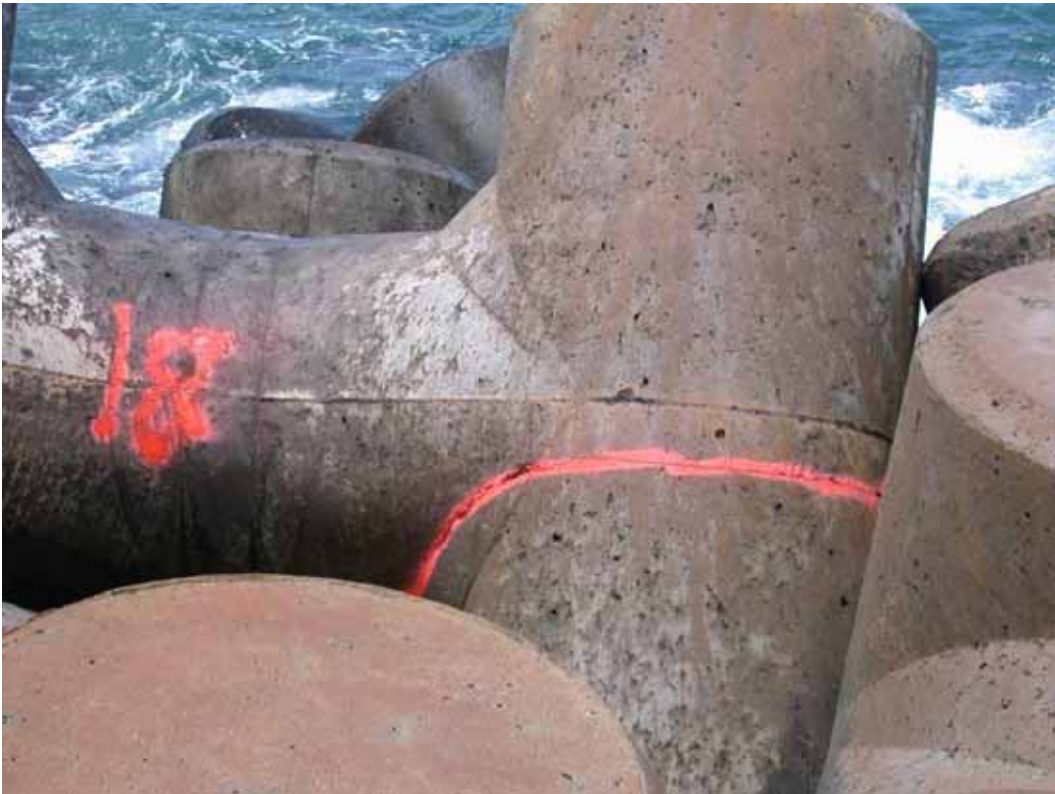
Figure B29. Damage location 38, sta 31+54, ocean side, rib #88, tribar with leg crack.

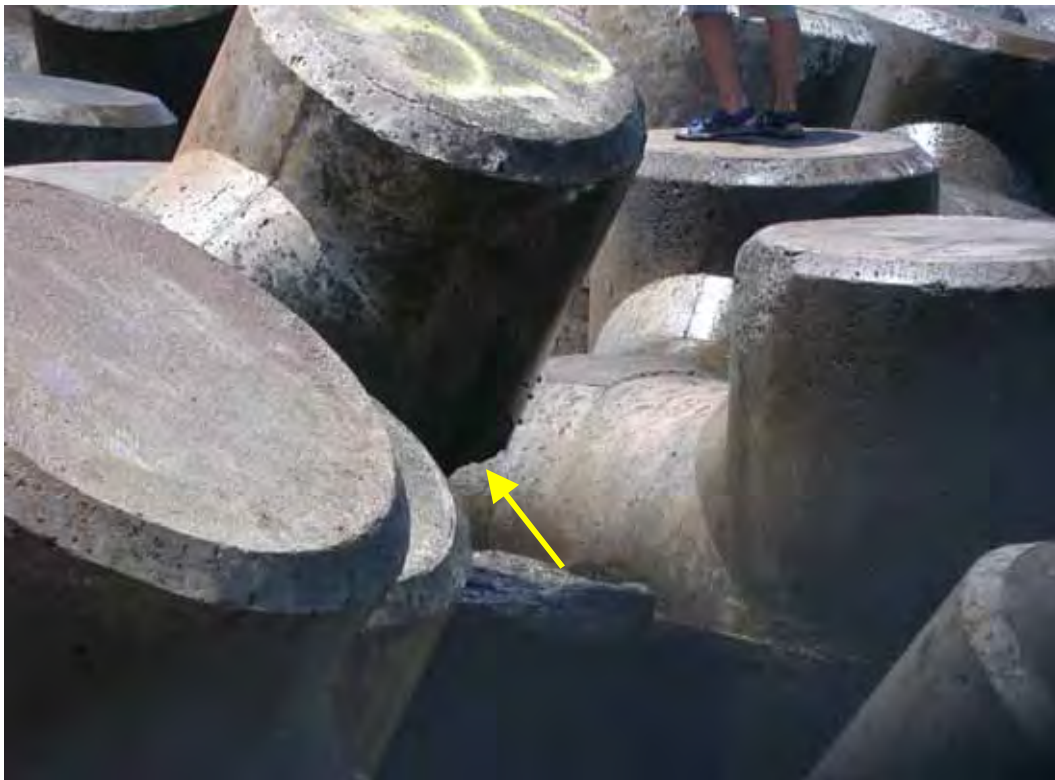
Figure B33. Damage location 44, sta 32+62, ocean side, rib #106, tribar with broken leg.

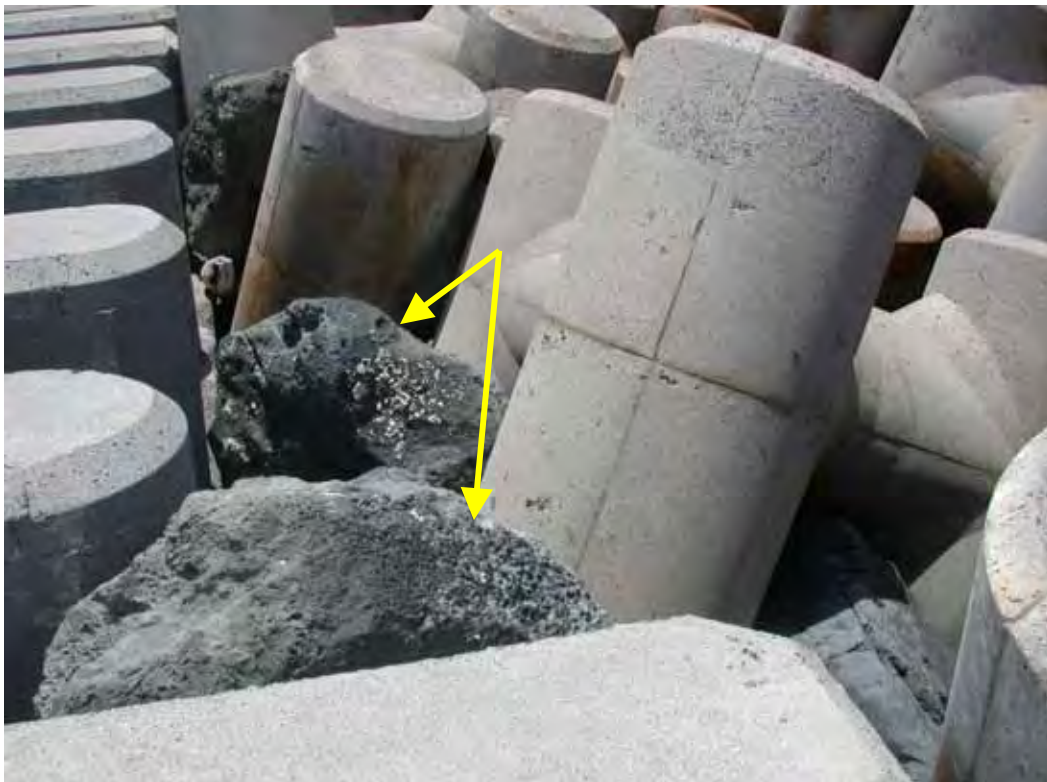
Figure B35. Damage location 46, sta 32+80 - 33+04, ocean side, rib #109 - 113, stones tossed up between ribs and tribars.

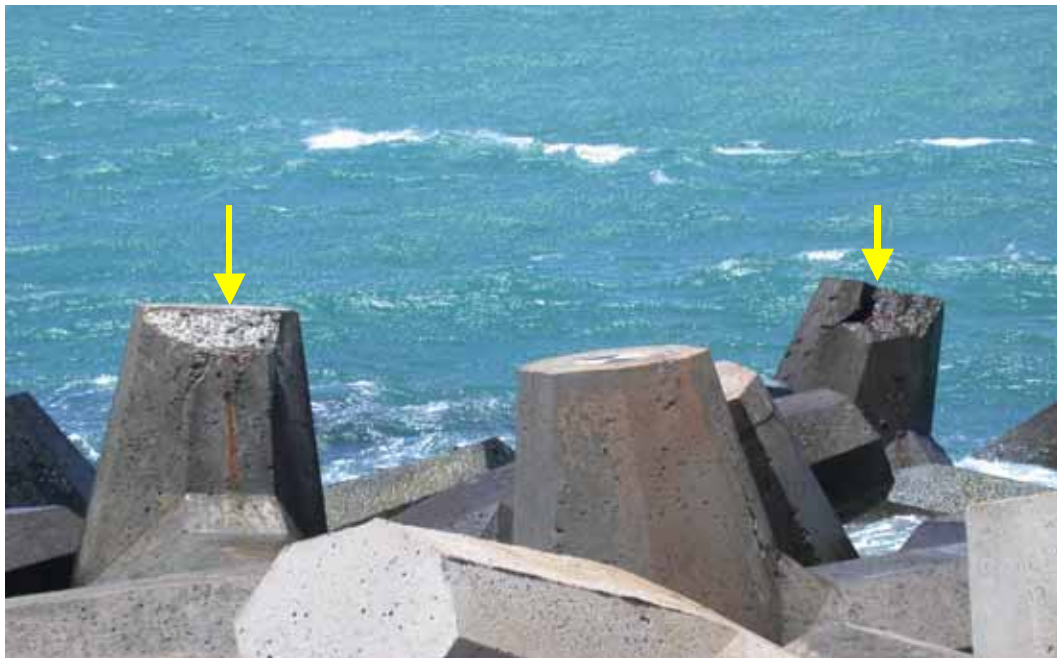
Figure B38. Damage locations 52 & 53, sta 33+82 and sta 34+09, ocean side, rib #126 and 129, dolosse with fluke tip breaks.

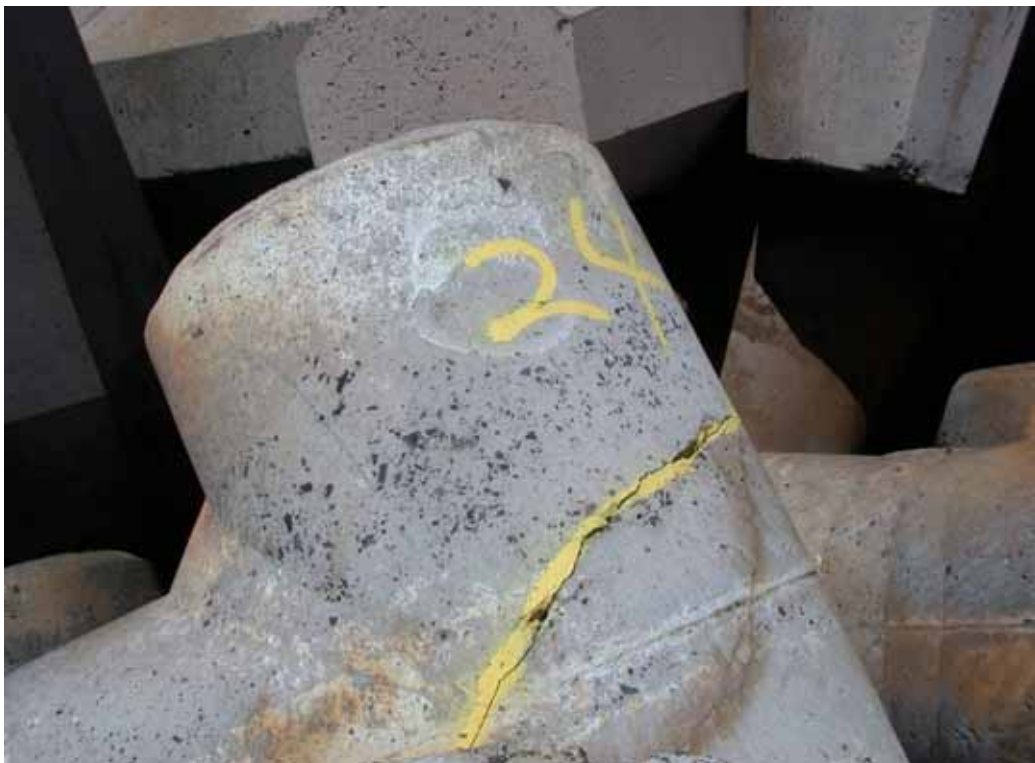
Figure B40. Damage location 55, sta 34+27, ocean side, rib #132, tribar with mid leg break.

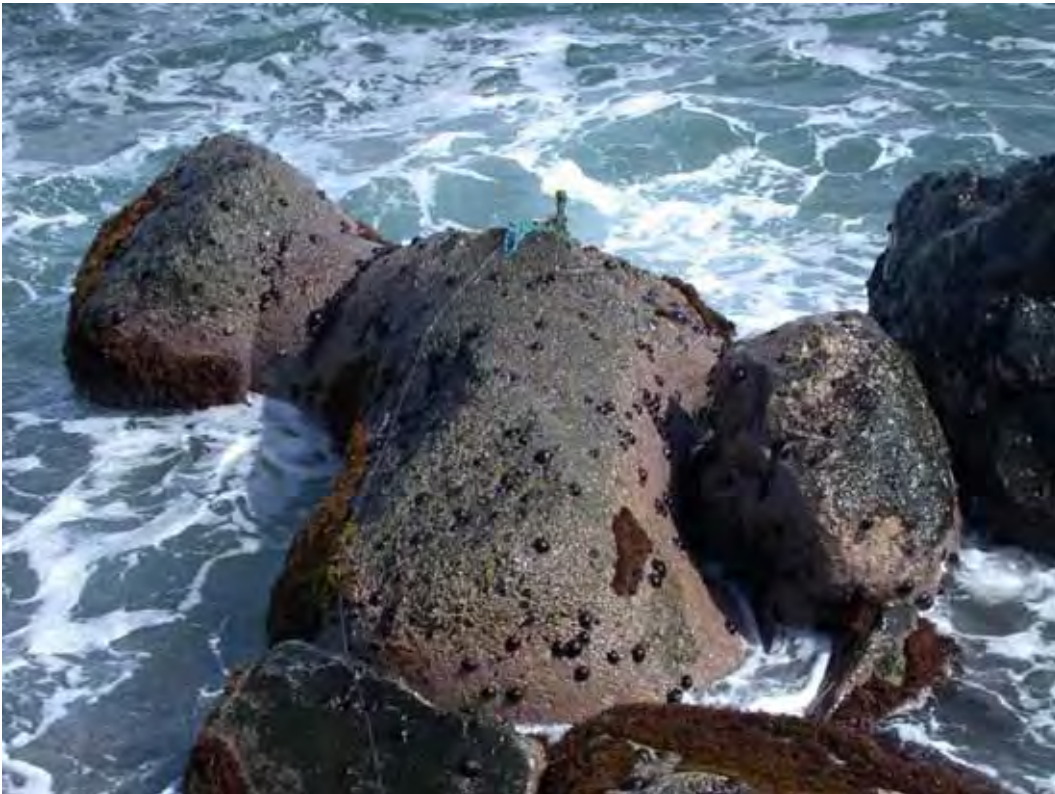
Figure B44. Damage location 1, sta 17+10, ocean side, tribar out of place at waterline.

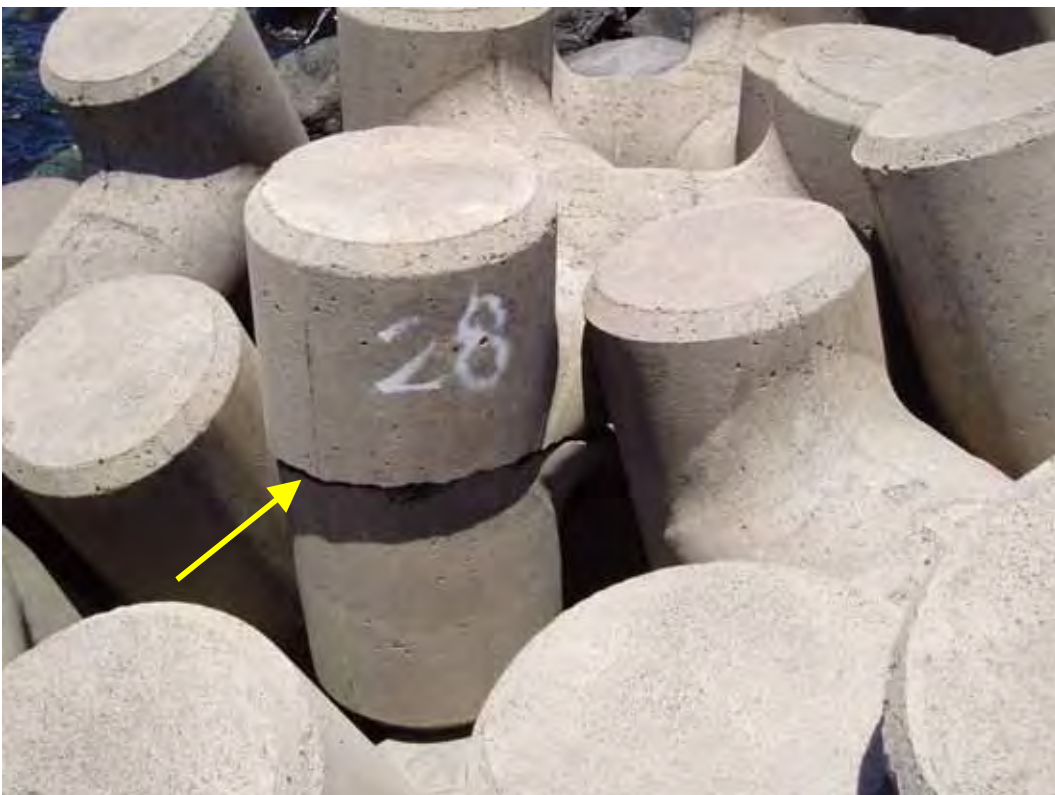
Figure B45. Damage location 2, sta 18+08, harbor side, rib #6, tribar with broken can.

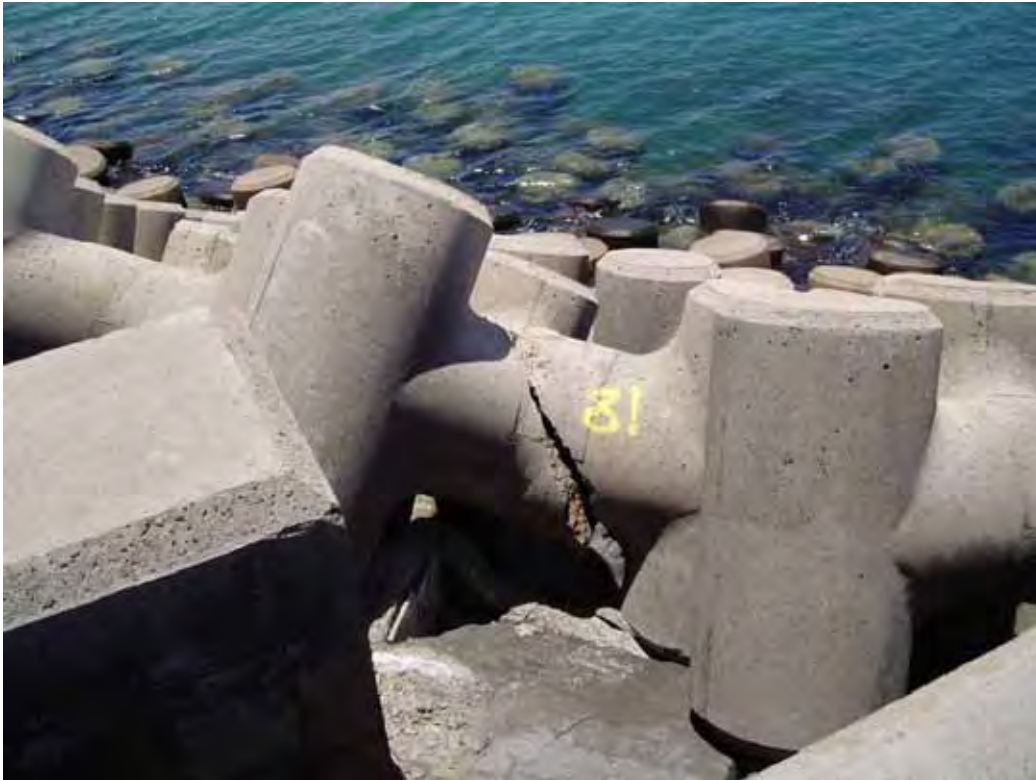
Figure B47. Damage location 4, sta 18+82, harbor side, rib #14, tribar with crack through center.

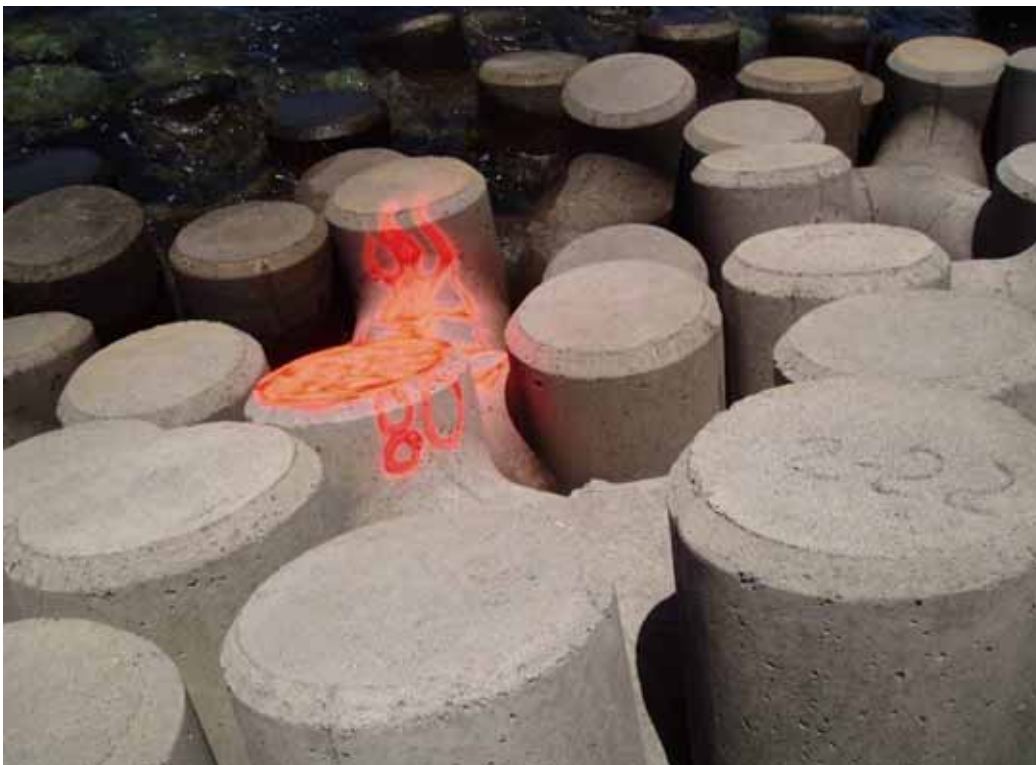
Figure B48. Damage location 5, sta 18+90, harbor side rib #15, tribar with crack through center.

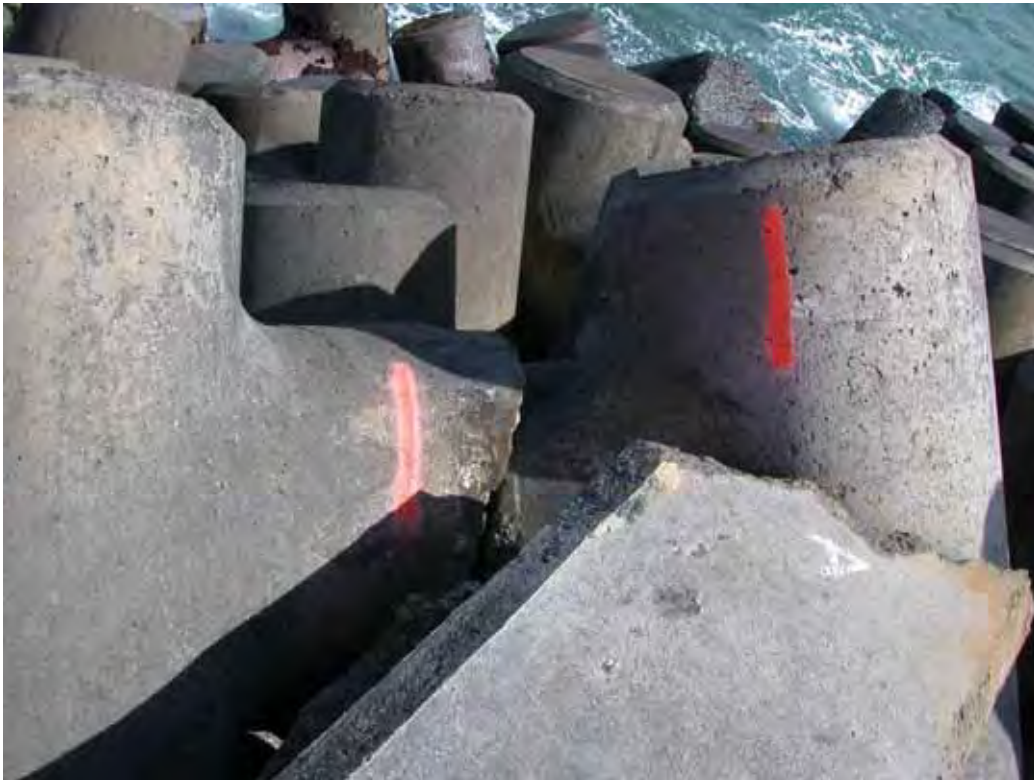
Figure B49. Damage location 6, sta 19+14, ocean side, rib #18, tribar with break through center and 4" separation from rib cap.

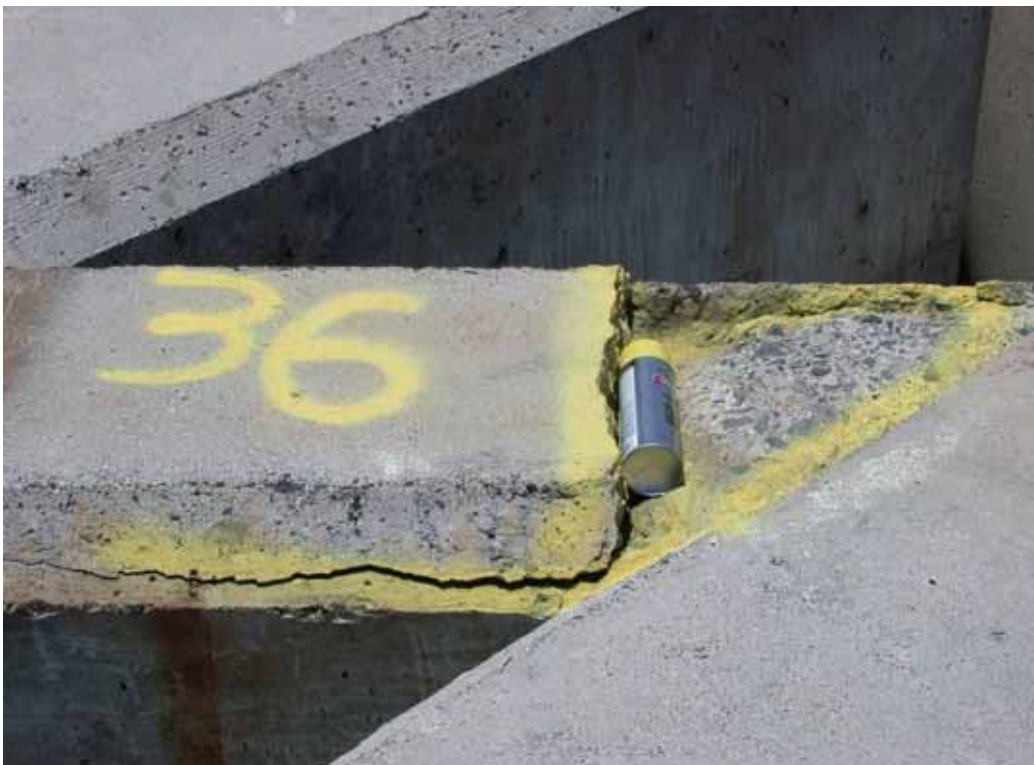
Figure B50. Damage location 8, sta 20+58, rib #36, red cross painted on rib cap (not visible in photograph) and spalling.

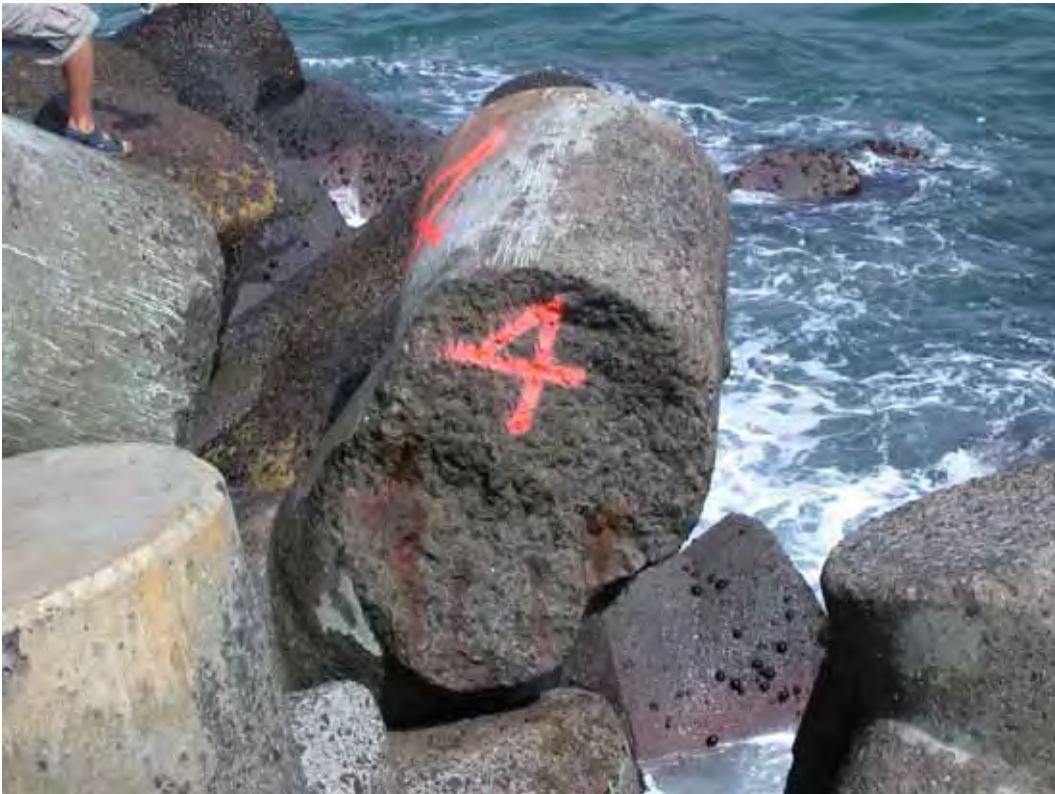
Figure B53. Damage location 13, sta 20+90, ocean side, rib #40, tribar with can missing.

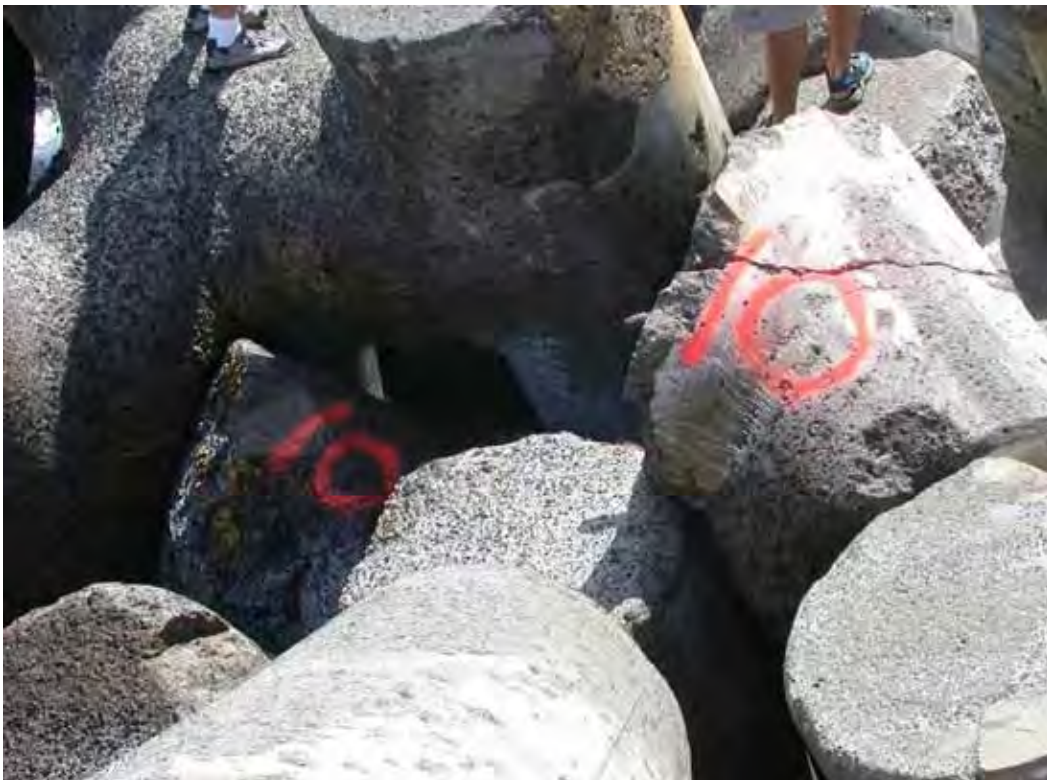
Figure B54. Damage location 15, sta 21+22, ocean side, rib #44, tribar broken into three pieces.

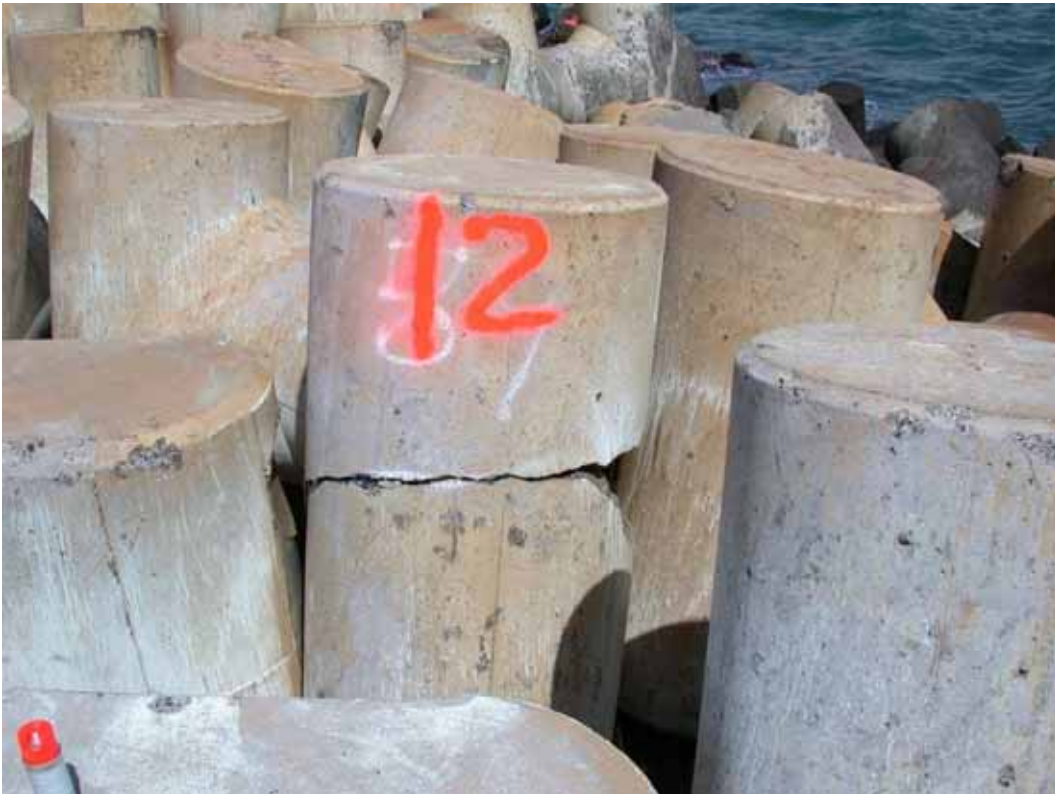
Figure B55. Damage location 17, sta 21+38, ocean side, rib #46, tribar with broken leg.

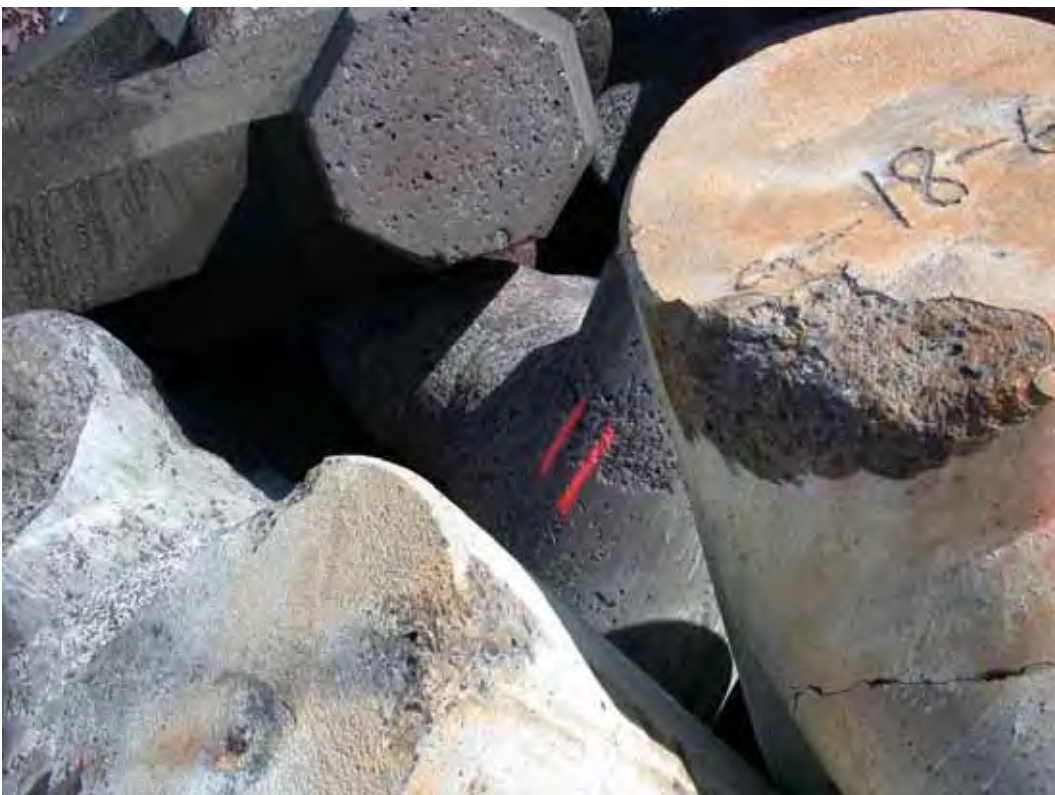
Figure B56. Damage location 18, sta 21+54, ocean side, rib #48, tribar with can missing.

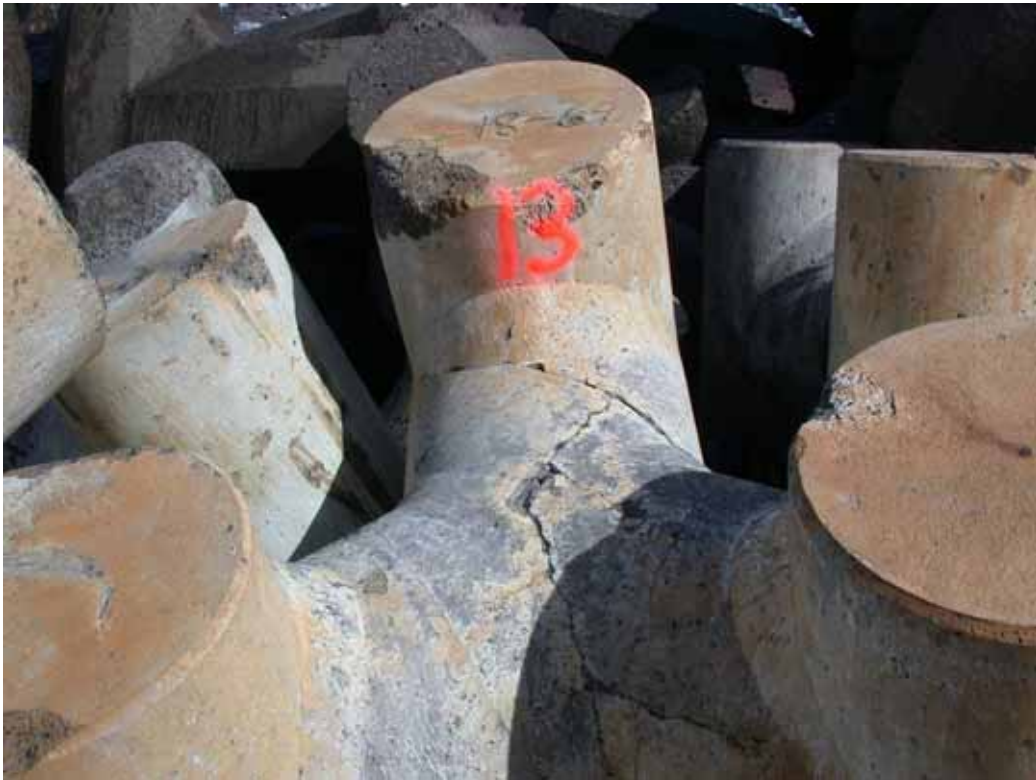
Figure B57. Damage location 19, sta 21+54, ocean side, rib #48, tribar with multiple cracks through center.

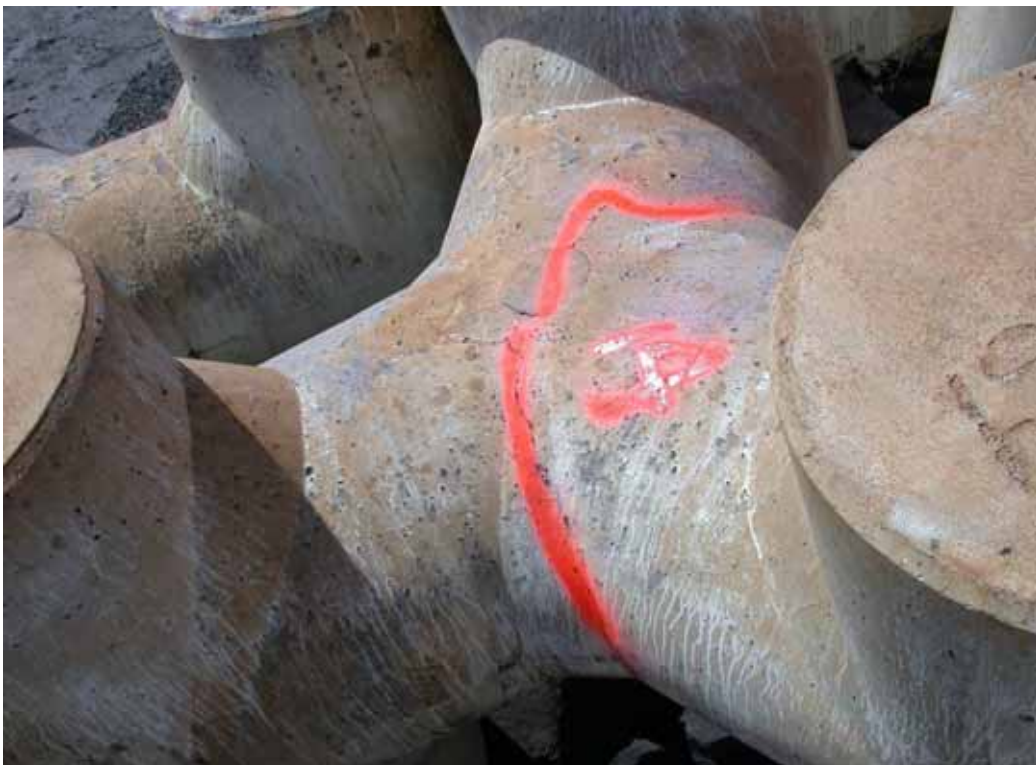
Figure B58. Damage location 20, sta 21+54 - 21+60, ocean side, rib #48-49, tribar with cracks through center.

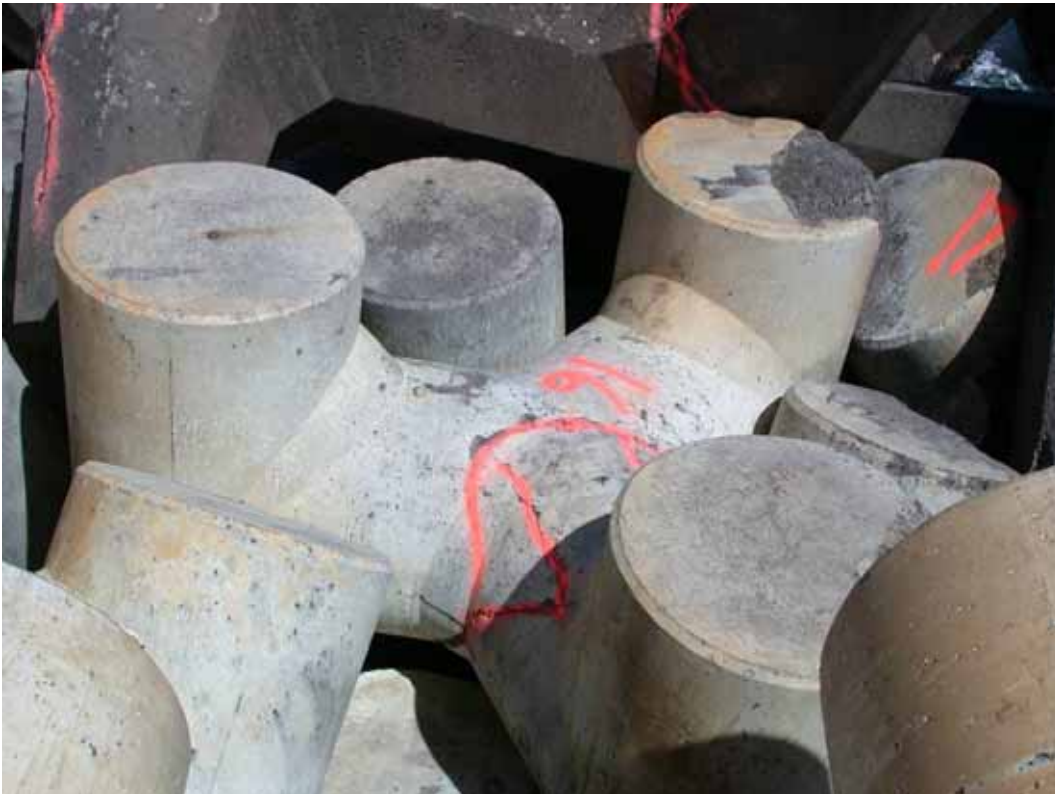
Figure B59. Damage location 21, sta 21+81, ocean side, tribar with cracks through center.

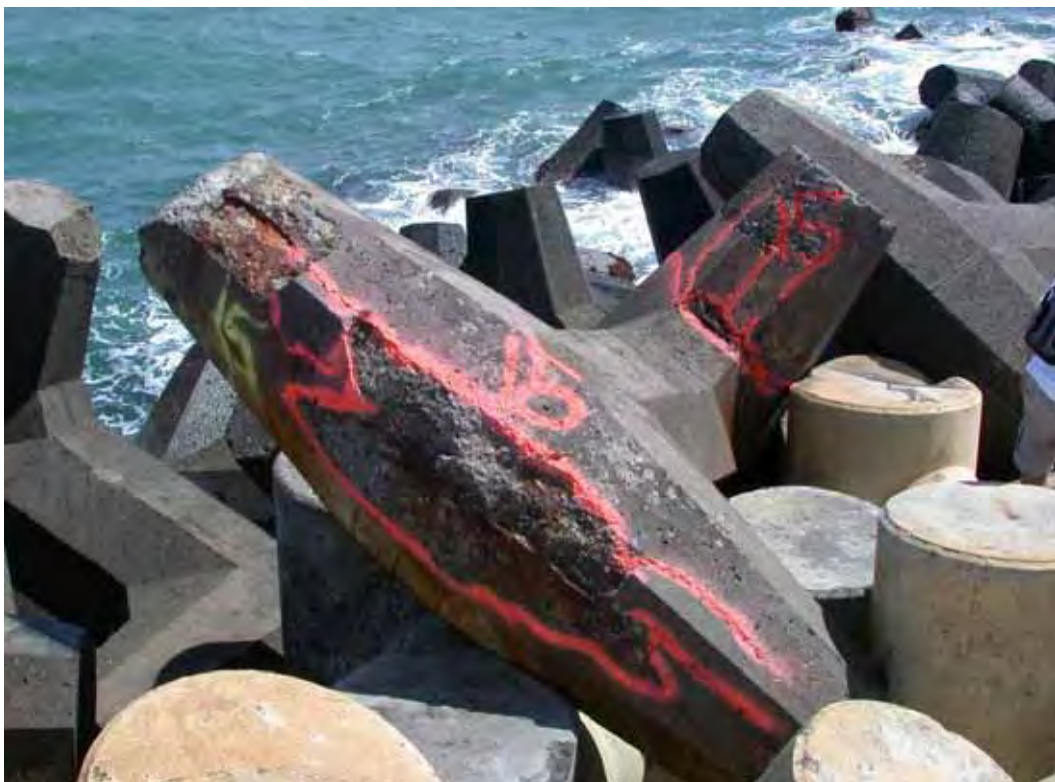
Figure B60. Damage location 23, sta 21+83, ocean side, spalling of dolosse and concrete rib cap.

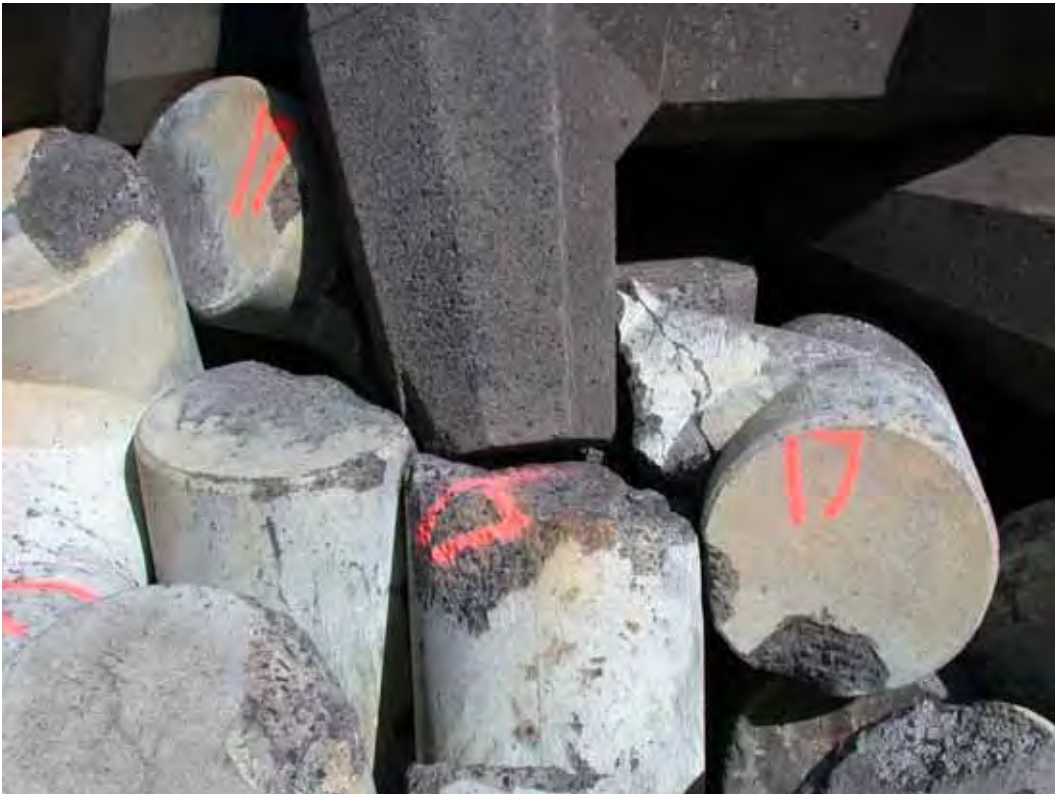
Figure B61. Damage location 24, sta 21+90, ocean side, tribar broken into three pieces.

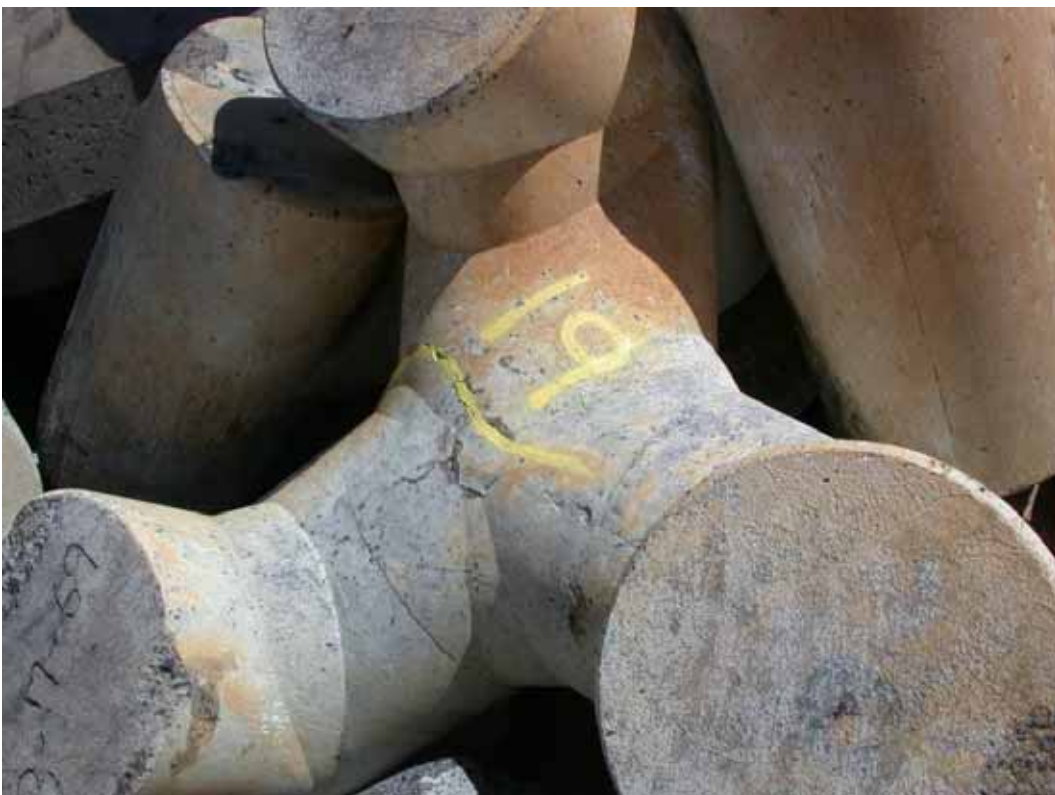
Figure B62. Damage location 25, sta 21+95, ocean side, tribar with crack.

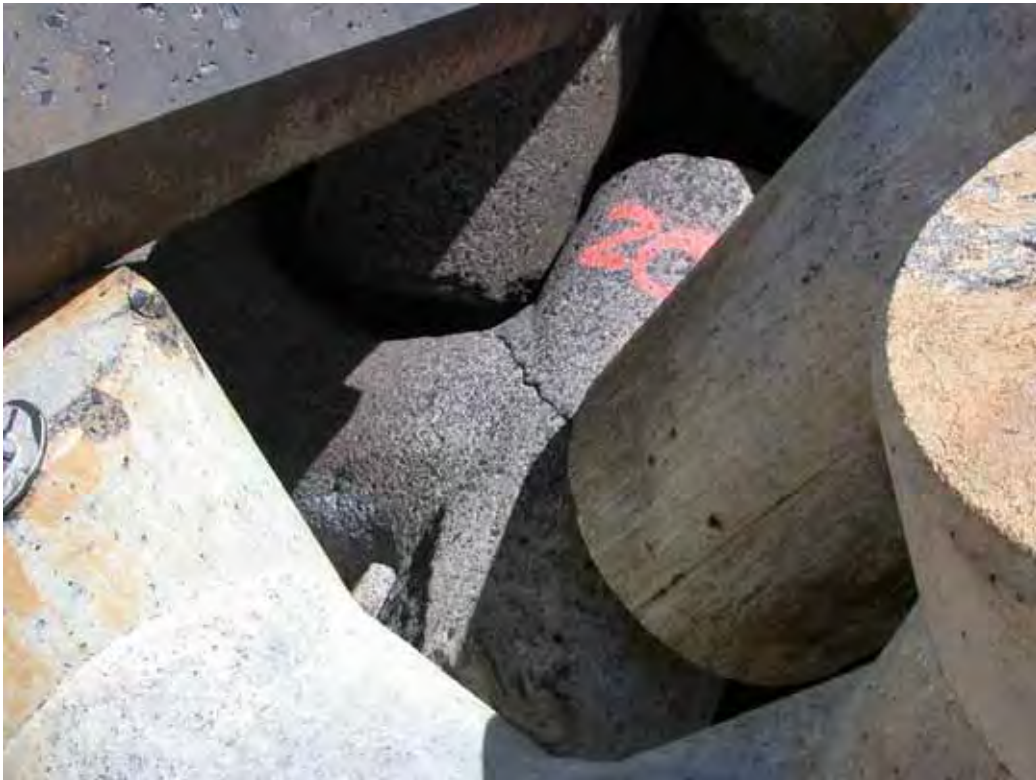
Figure B63. Damage location 26, sta 22+10, ocean side, tribar with crack held together by rebar.

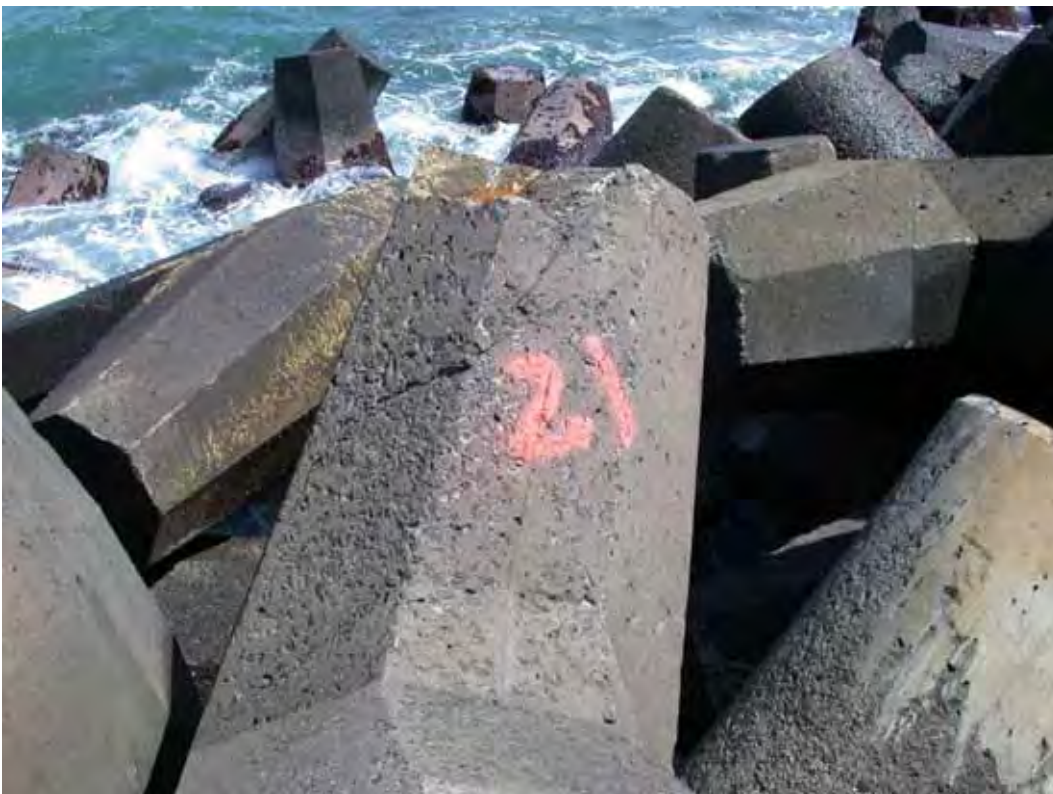
Figure B64. Damage location 27, sta 22+10, ocean side, dolosse with tip chip and crack.

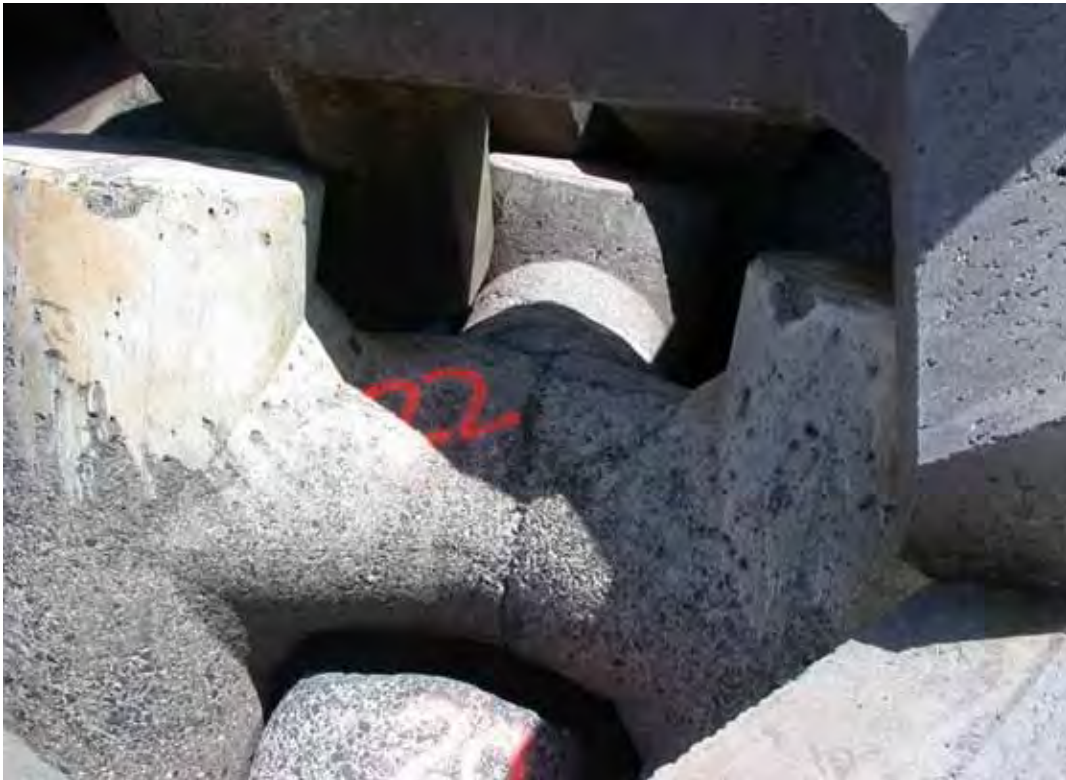
Figure B65. Damage location 28, sta 22+14, ocean side, tribar with broken can held together by rebar.

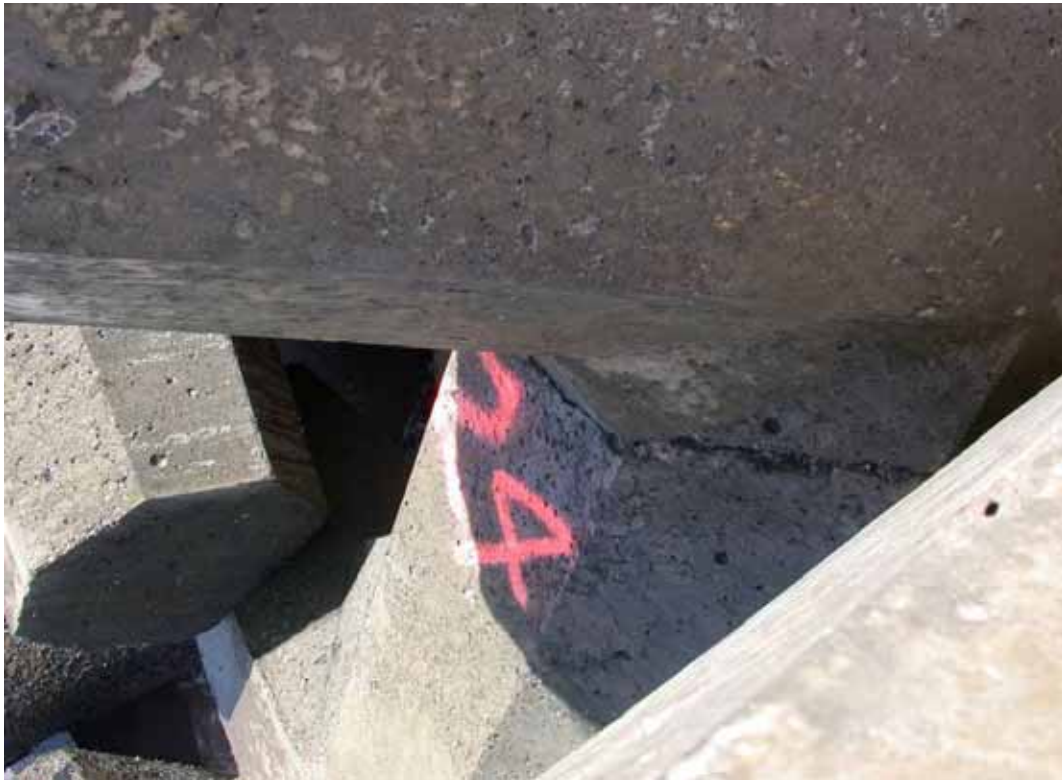
Figure B67. Damage location 30, sta 22+20, ocean side, dolosse with shank-fluke break held together by rebar.

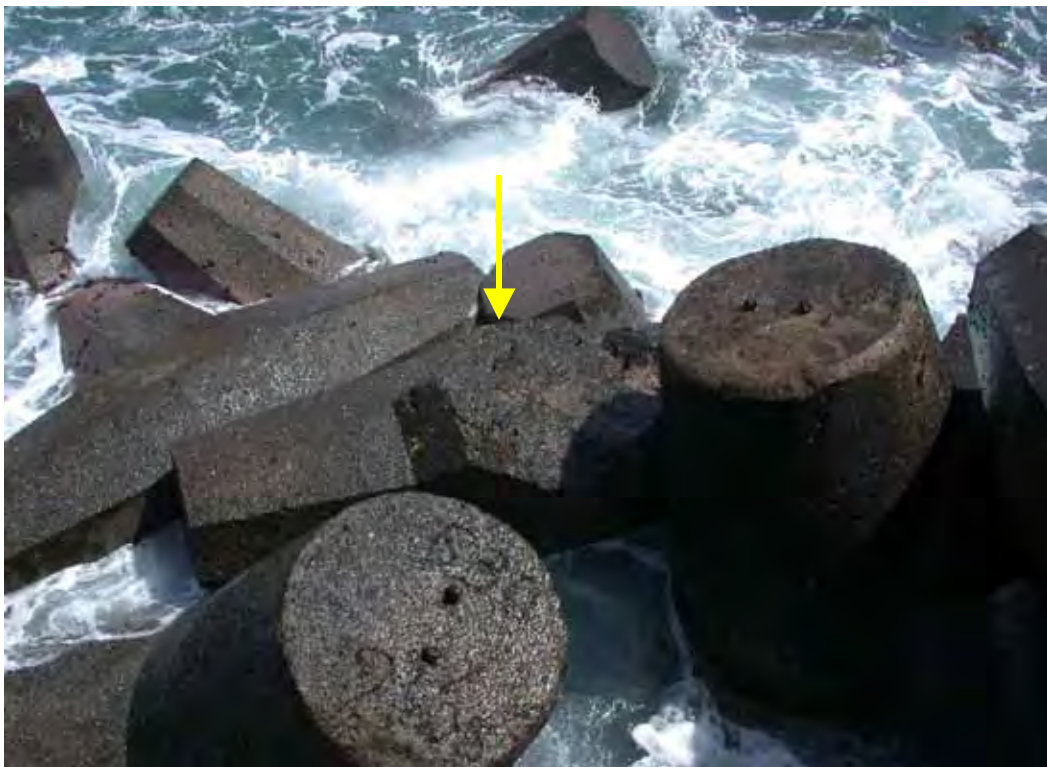
Figure B68. Damage location 31, sta 22+20, ocean side, dolosse with shank-fluke break at waterline.

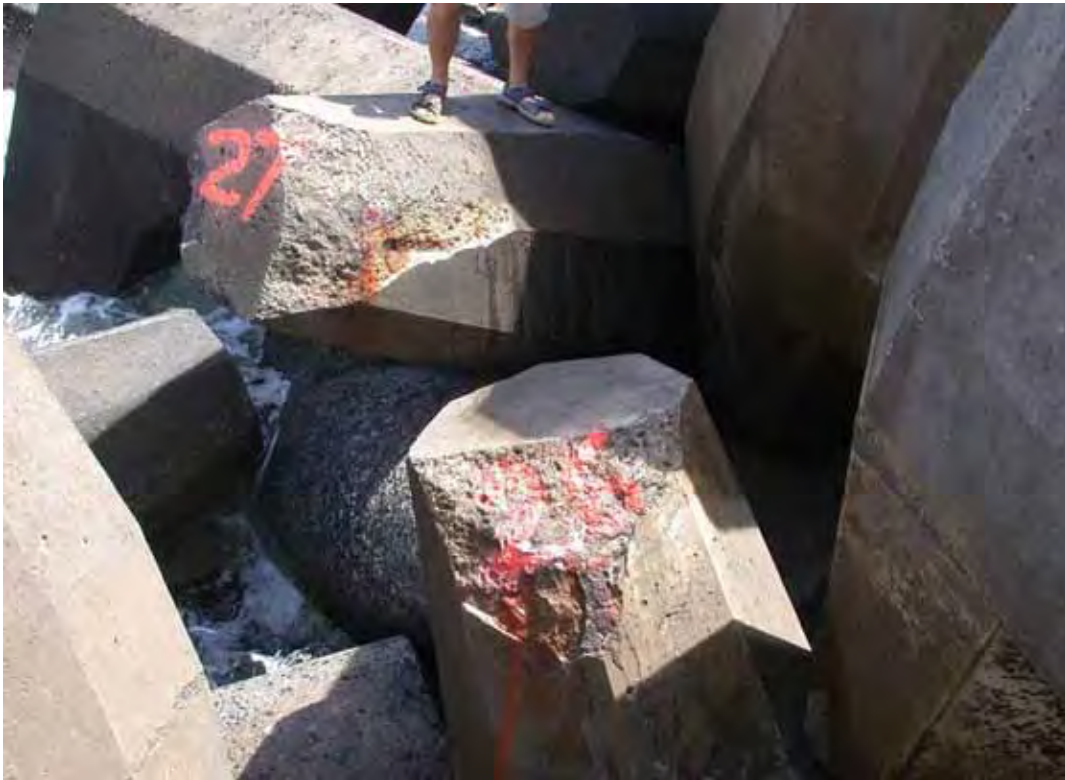
Figure B69. Damage locations 33 & 34, sta 22+35, ocean side, two dolosse with fluke tip breaks.
