Monitoring Completed Navigation Projects Program

Periodic Inspections of Hilo, Kahului, Laupahoehoe, and Nawiliwili Breakwaters, Hawaii

Armor Unit Monitoring for Period 2001-2005

October 2011

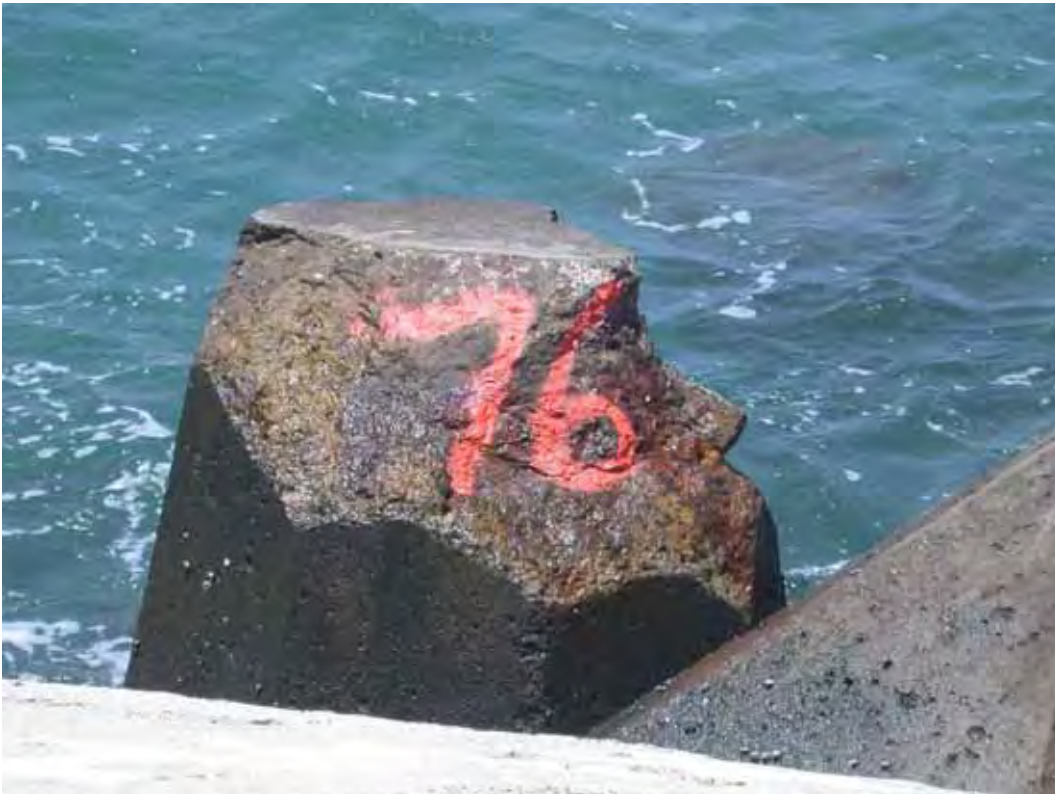
Figure B71. Damage location 36, sta 22+48, harbor side, dolosse with fluke tip break.

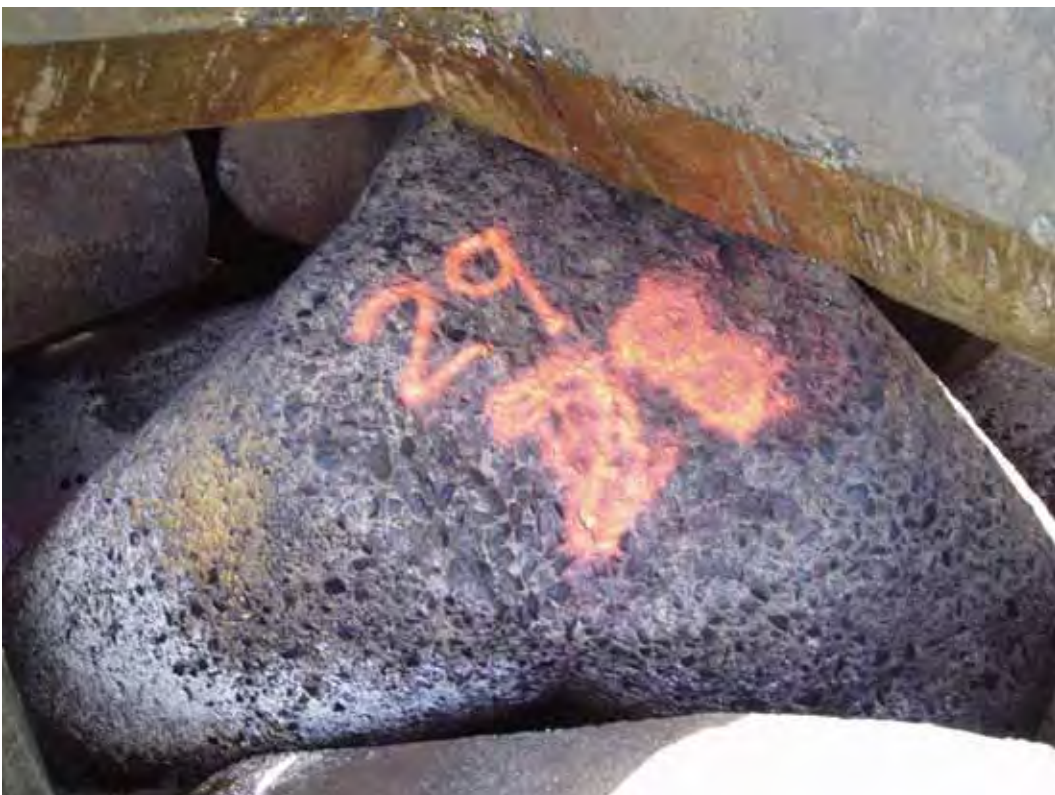
Figure B72. Damage location 37, sta 22+49, ocean side, tetrapod with broken top.

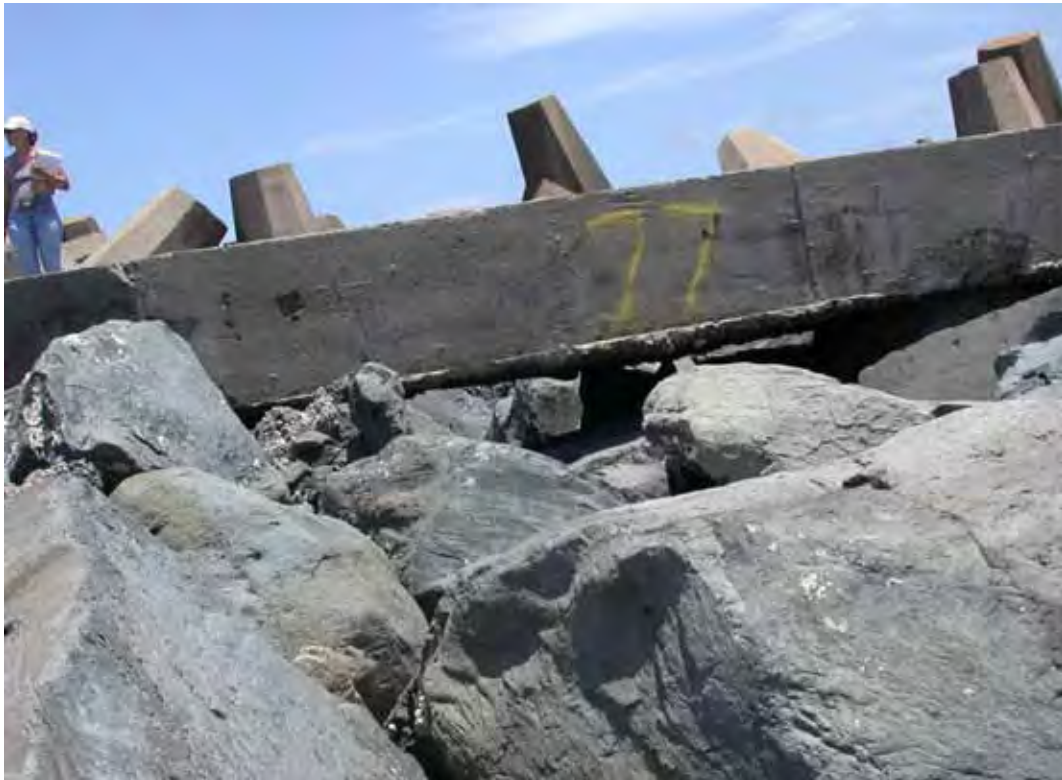
Figure B73. Damage location 38, sta 22+50, harbor side, center of turnaround, settling and unsupported rib cap.

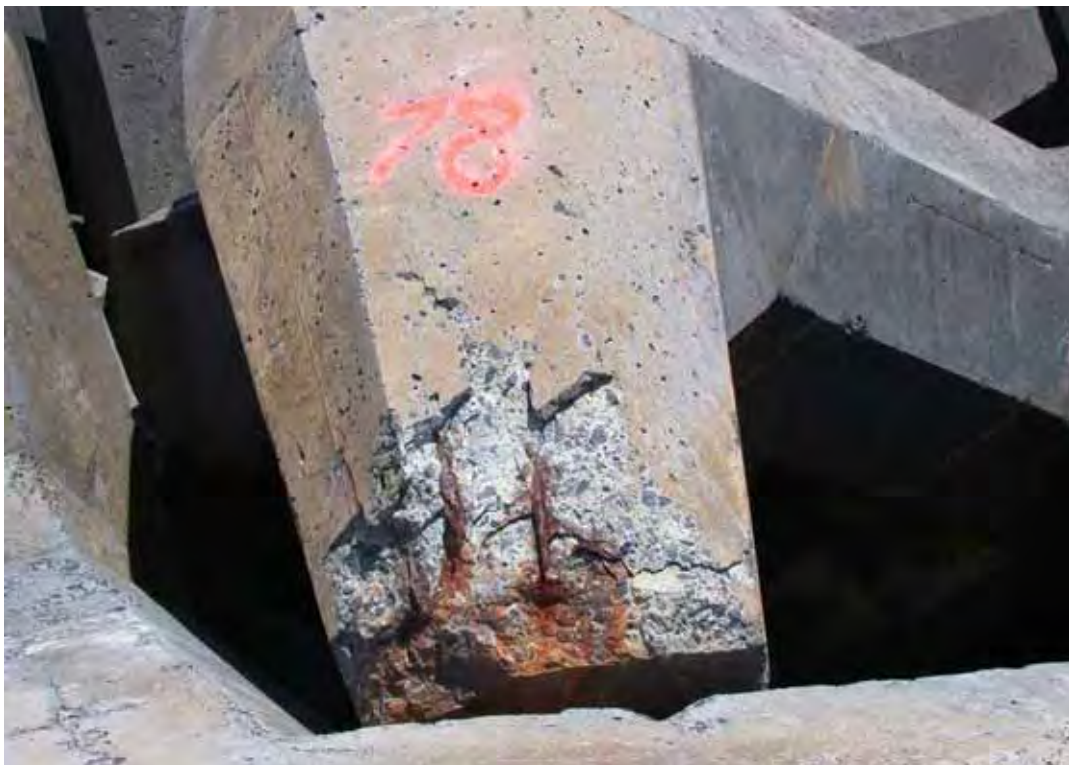
Figure B74. Damage location 40, sta 22+70, ocean side, dolosse with spalling and exposed rebar on fluke tip.

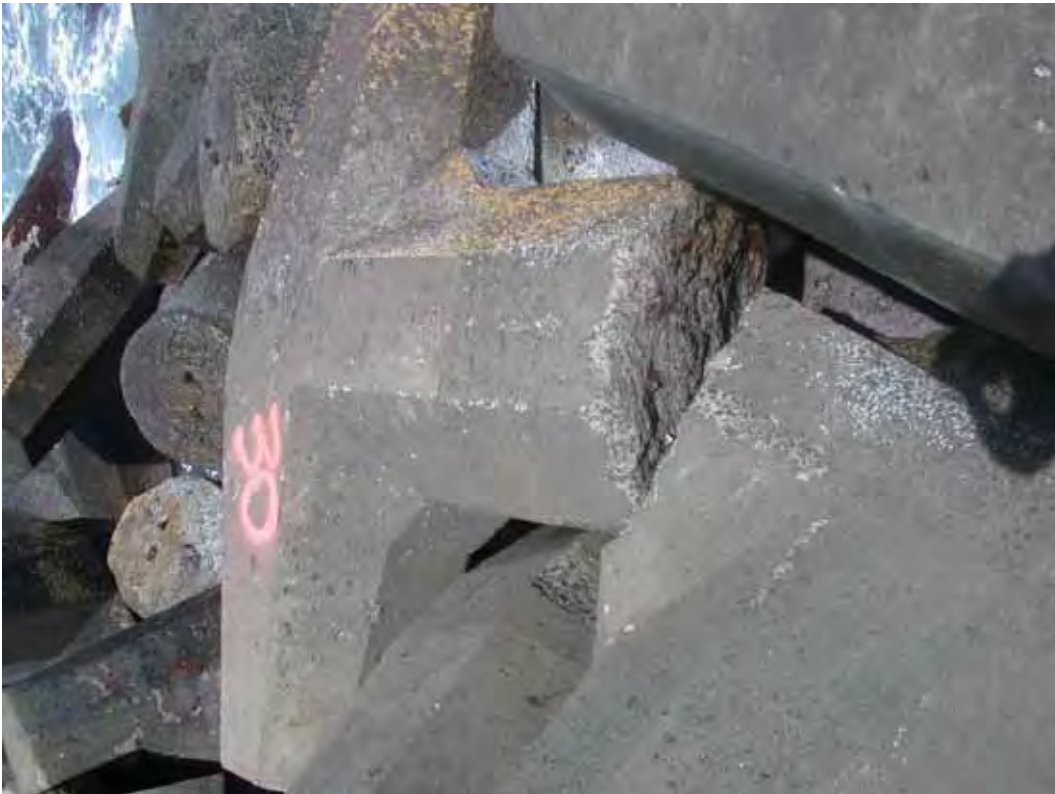
Figure B75. Damage location 41, sta 22+72, ocean side, dolosse with shank-fluke break.

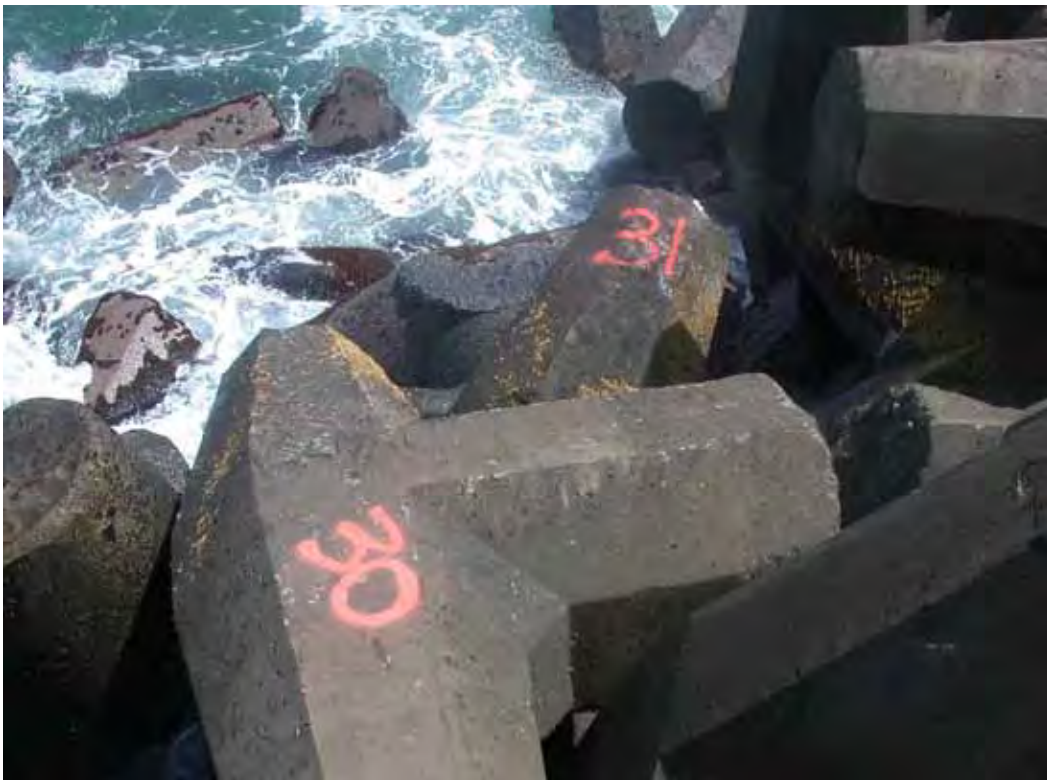
Figure B76. Damage locations 42 & 43, sta 22+74, ocean side, two dolosse with shank-fluke breaks.

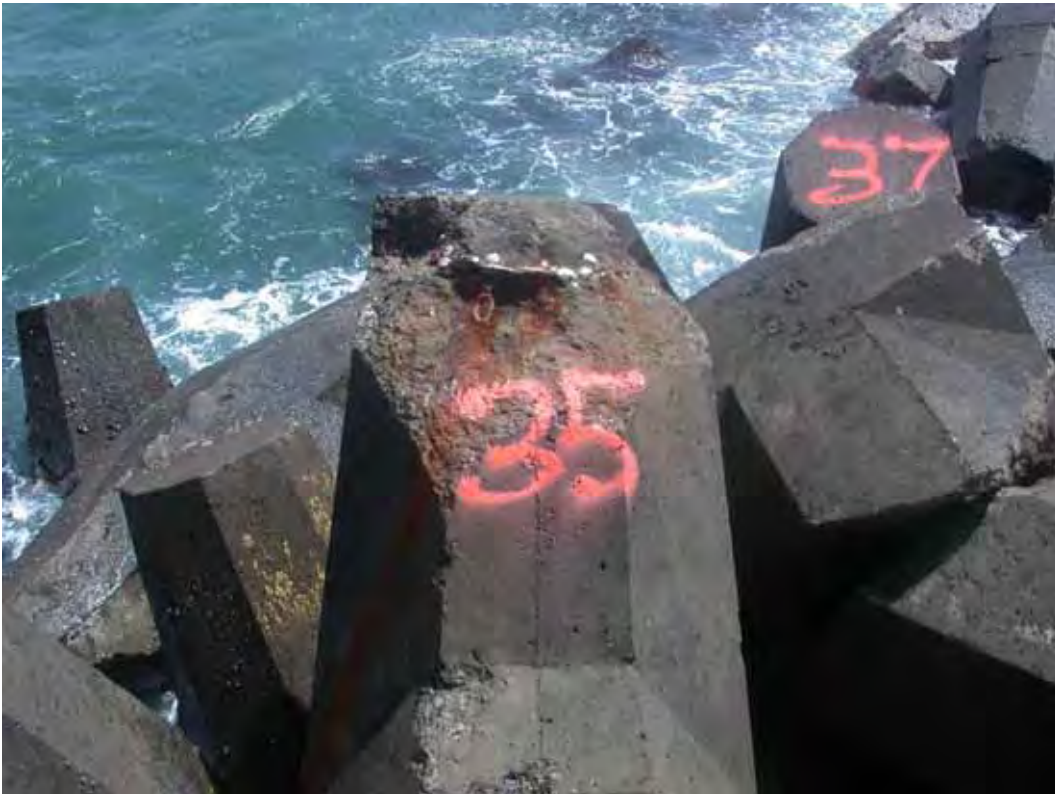
Figure B77. Damage location 46, sta 22+88, ocean side, dolosse with fluke tip break.

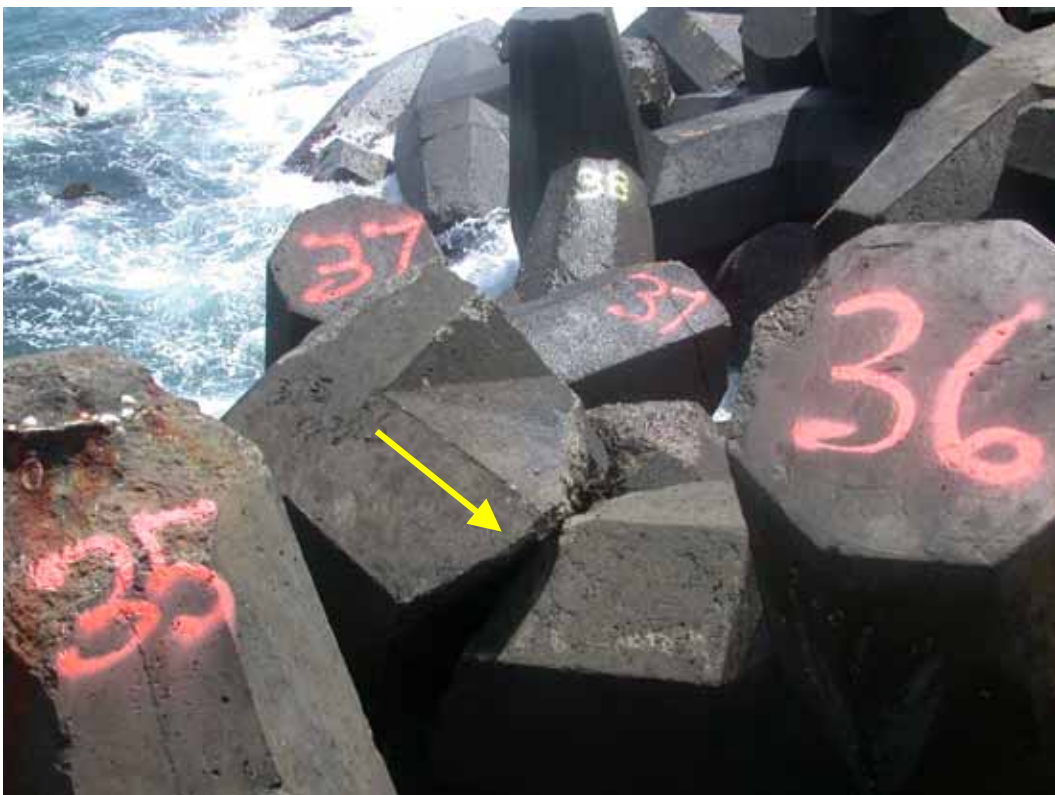
Figure B78. Damage location 47, sta 22+89, ocean side, dolosse with mid shank break.

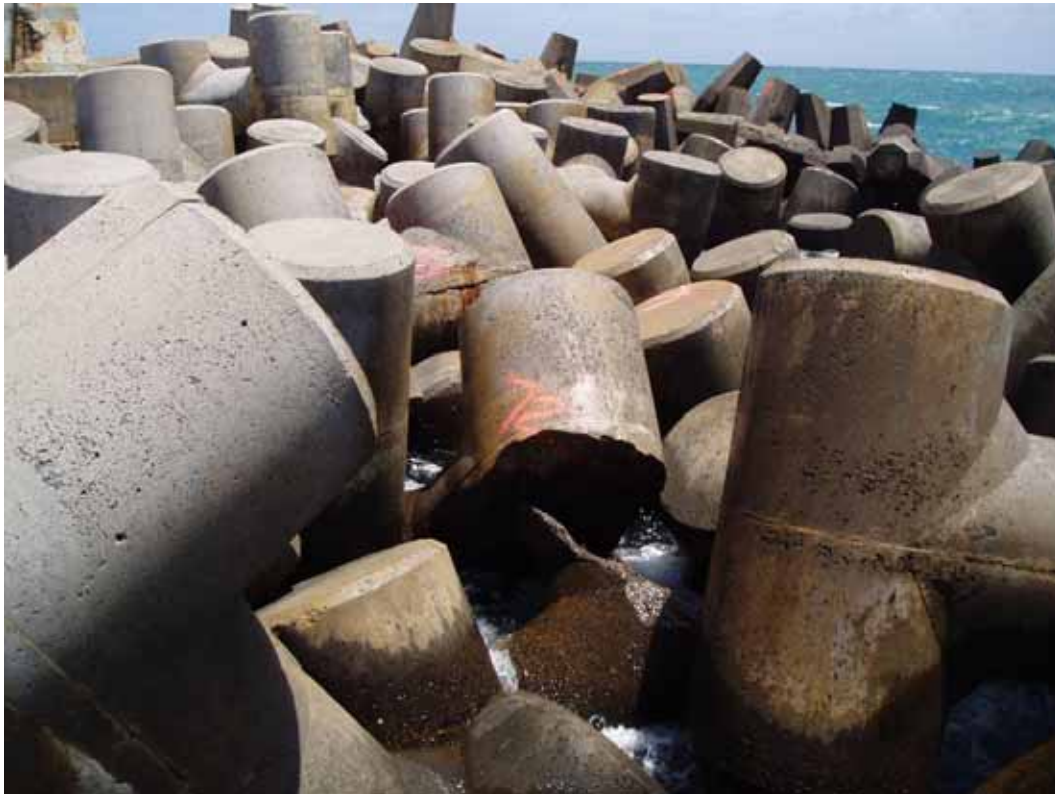
Figure B79. Damage location 48, sta 22+90, harbor side, tribar with broken can.

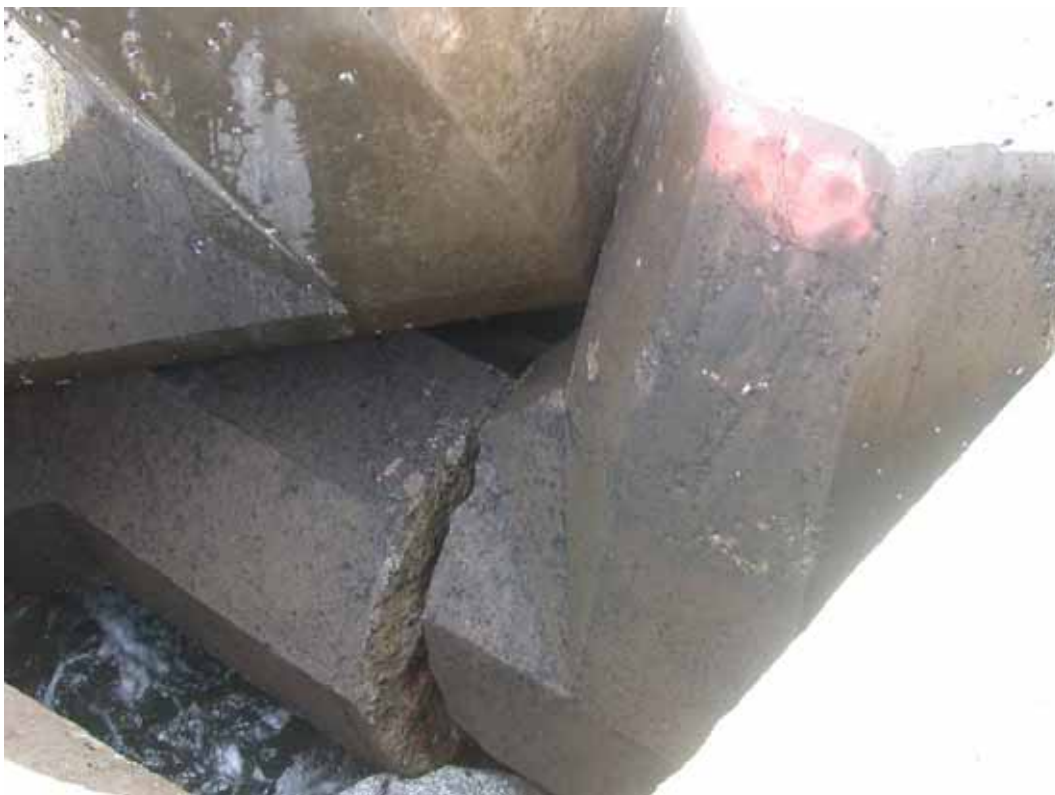
Figure B80. Damage location 49, sta 22+92, ocean side, dolosse with shank-fluke break.

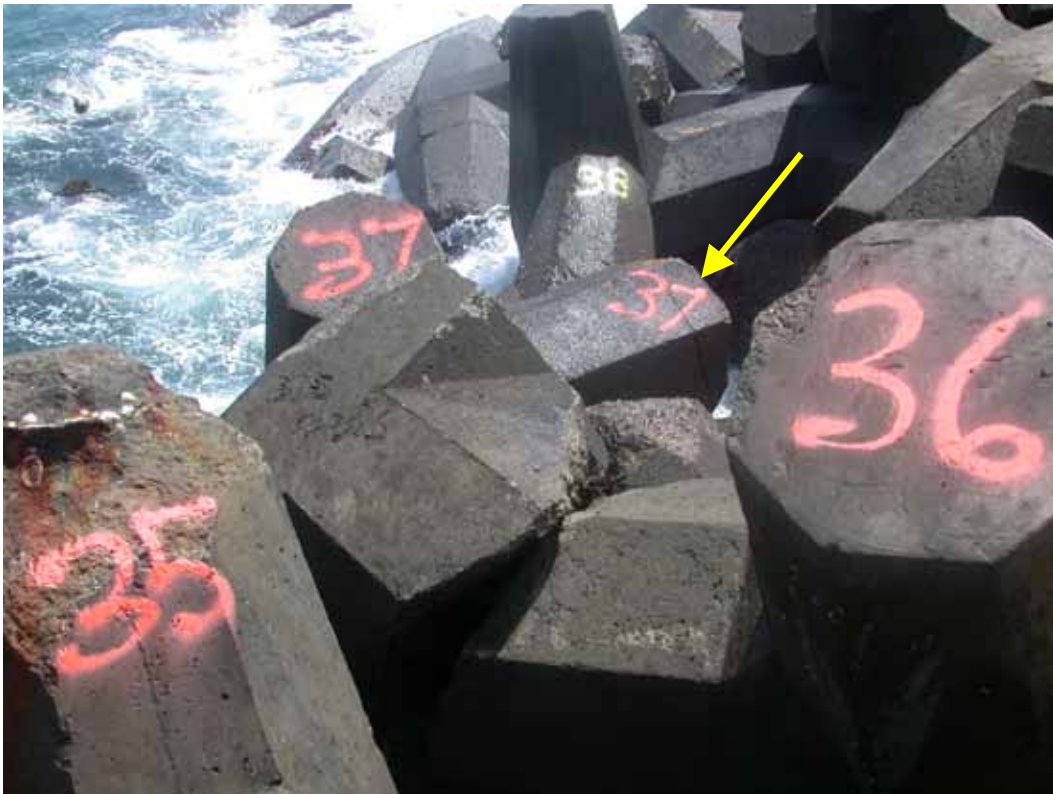
Figure B81. Damage location 50, sta 22+94, ocean side, dolosse with mid shank break.

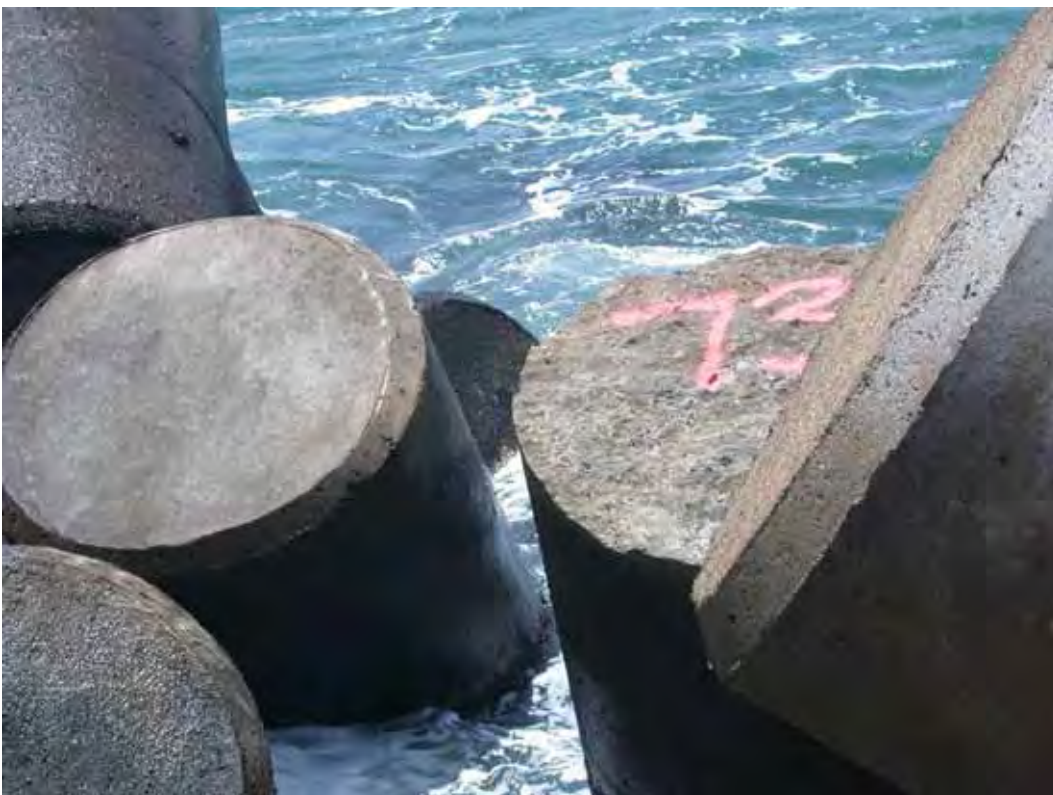
Figure B82. Damage location 51, sta 22+98, harbor side, tribar with broken can.

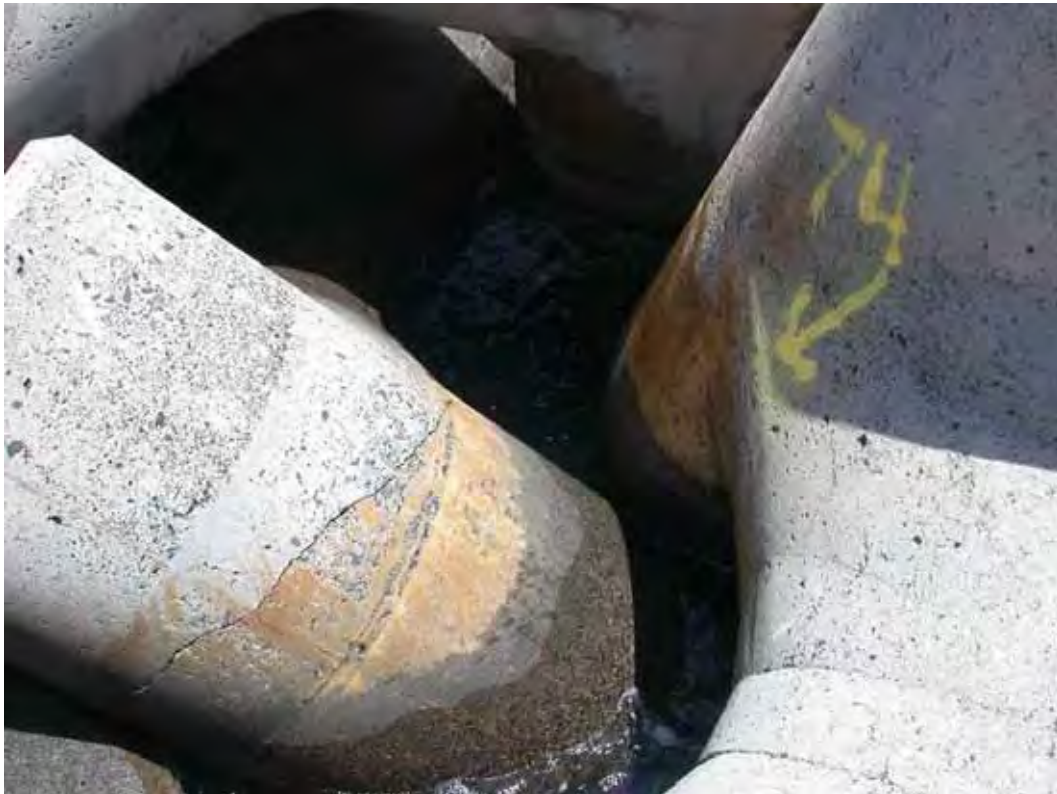
Figure B83. Damage location 52, sta 22+98, harbor side, cracked tribar.

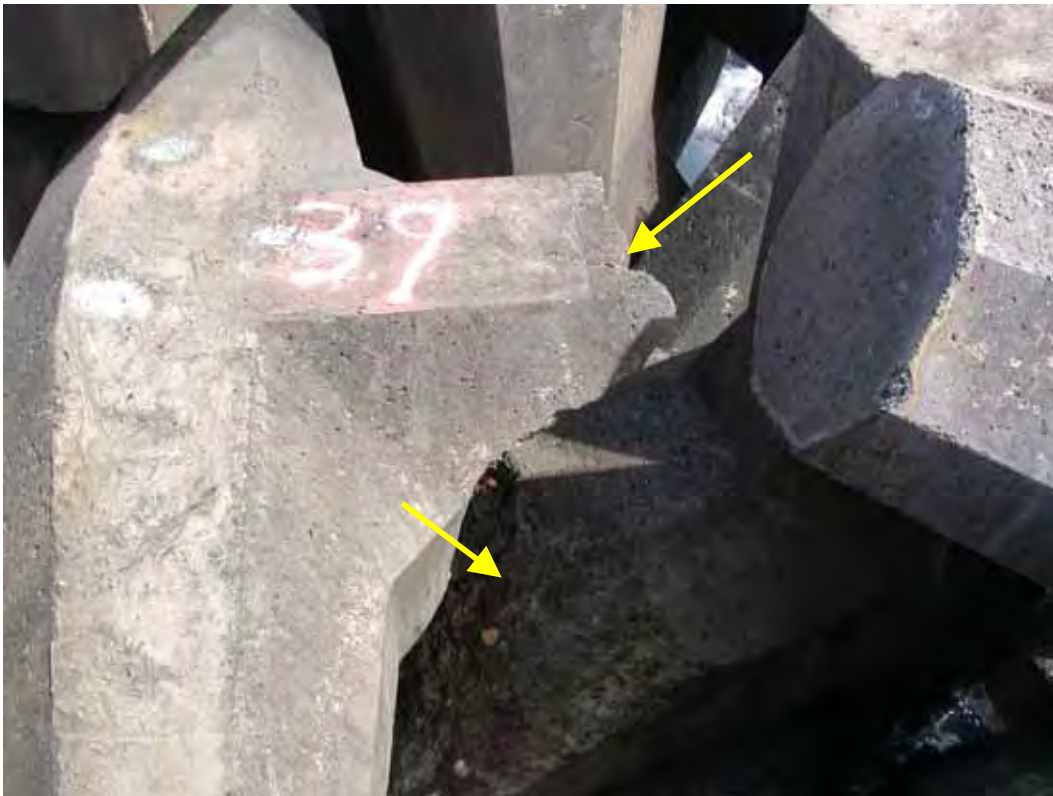
Figure B85. Damage location 54, sta 23+05, ocean side, dolosse with mid shank break.

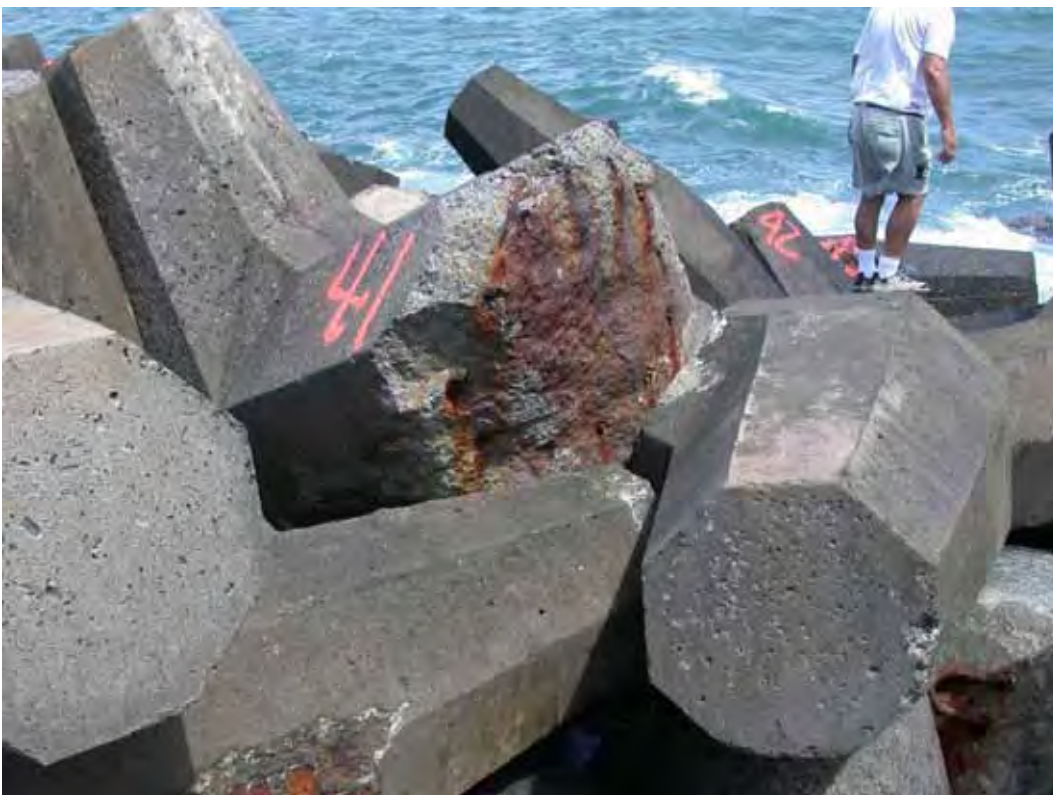
Figure B86. Damage location 55, sta 23+19, ocean side, dolosse with shank-fluke break.

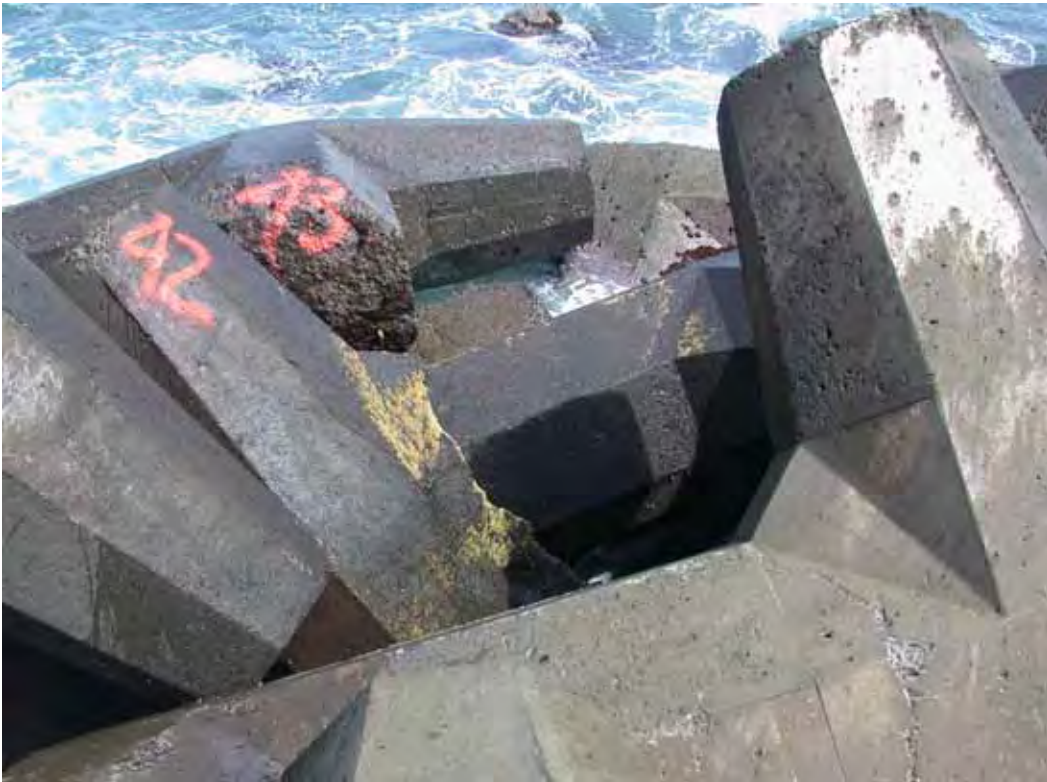
Figure B87. Damage locations 56 & 57, sta 23+19, ocean side, two dolosse with shank-fluke breaks.

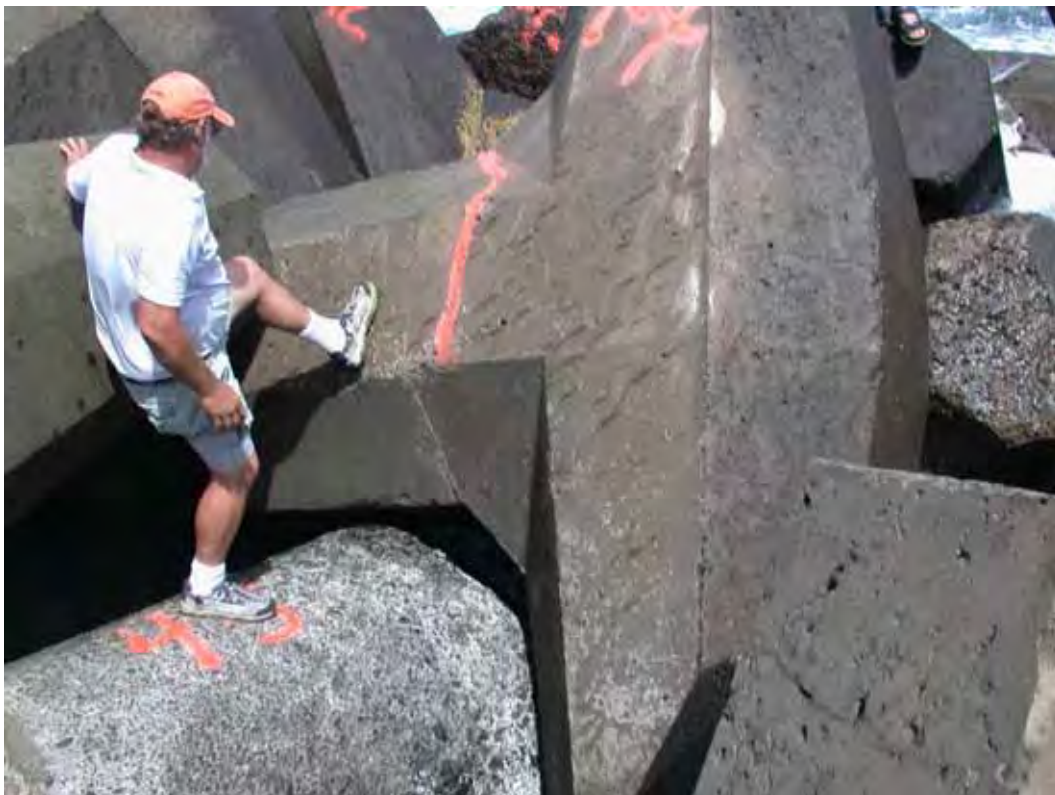
Figure B88. Damage location 58, sta 23+25, ocean side, dolosse with shank-fluke crack.

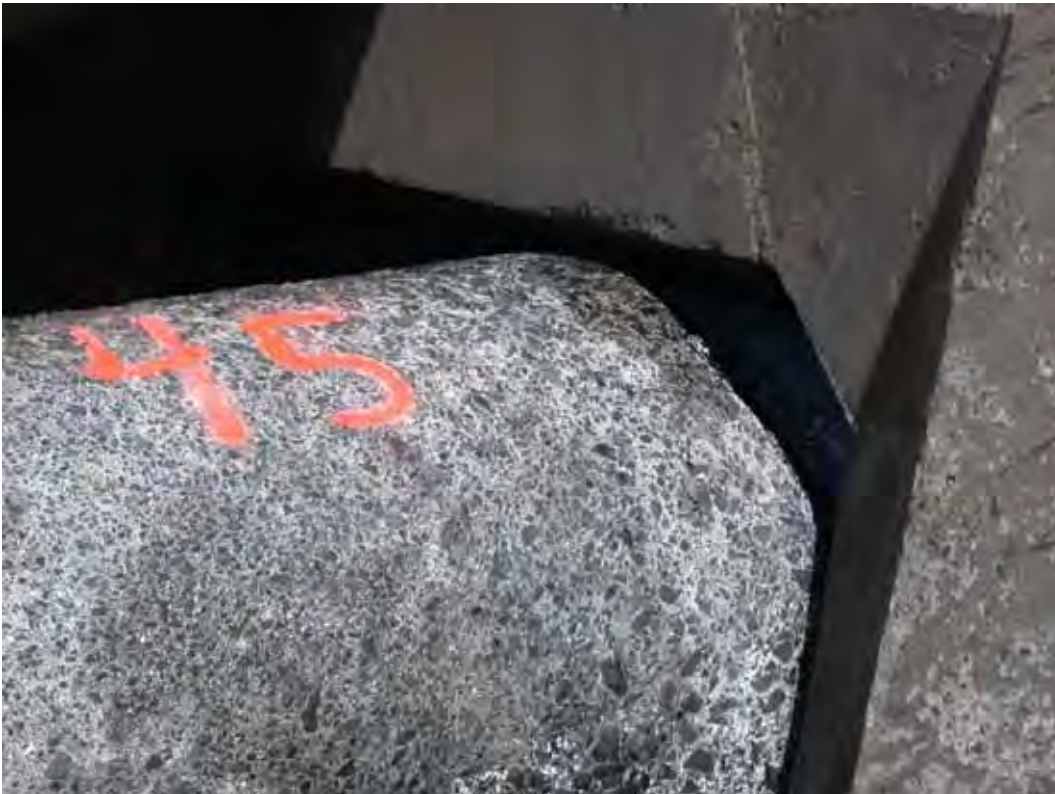
Figure B89. Damage location 59, sta 23+28, ocean side, tetrapod with missing top.

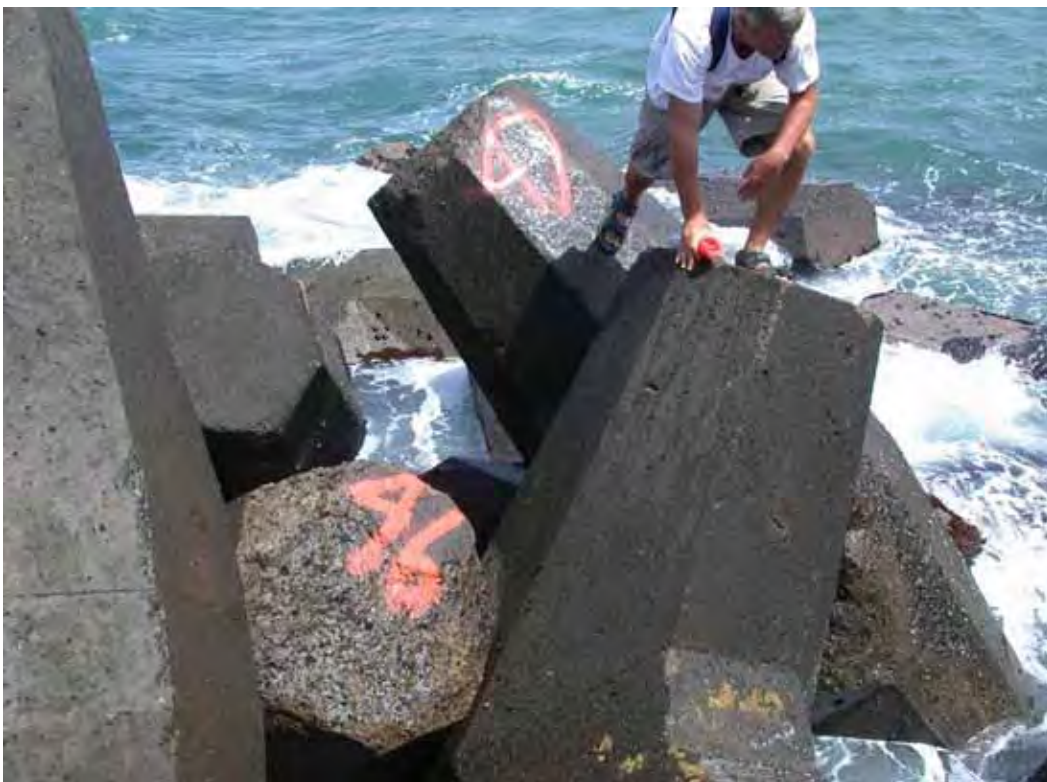
Figure B90. Damage locations 60 & 61, sta 23+30, ocean side, dolosse with mid-shank break and dolosse with shank-fluke break.

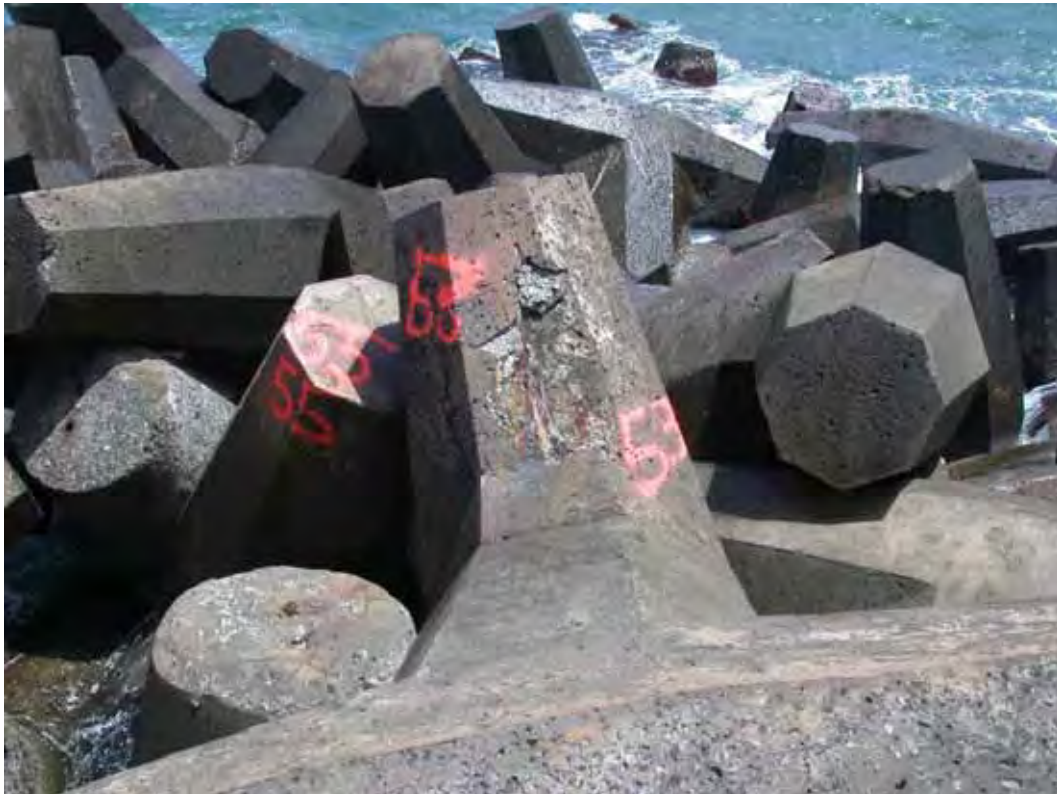
Figure B91. Damage location 67, 45 deg ocean side of head, dolosse with spalling.

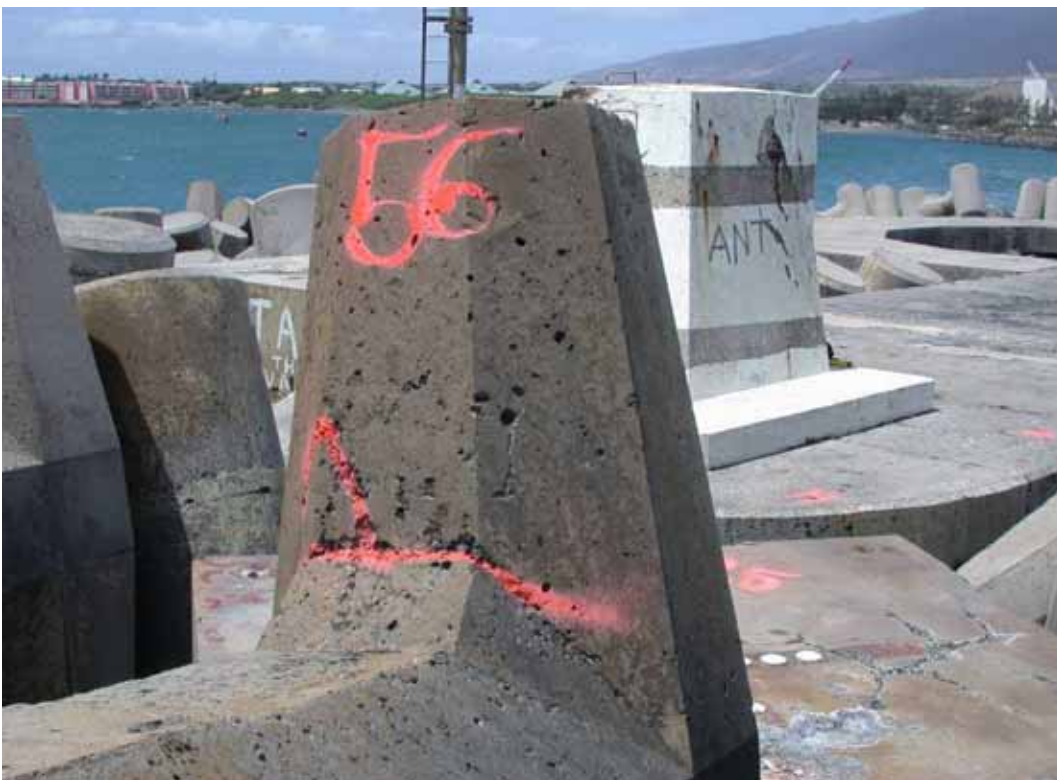
Figure B92. Damage location 70, 45 deg ocean side of head, dolosse with fluke crack and spalling.

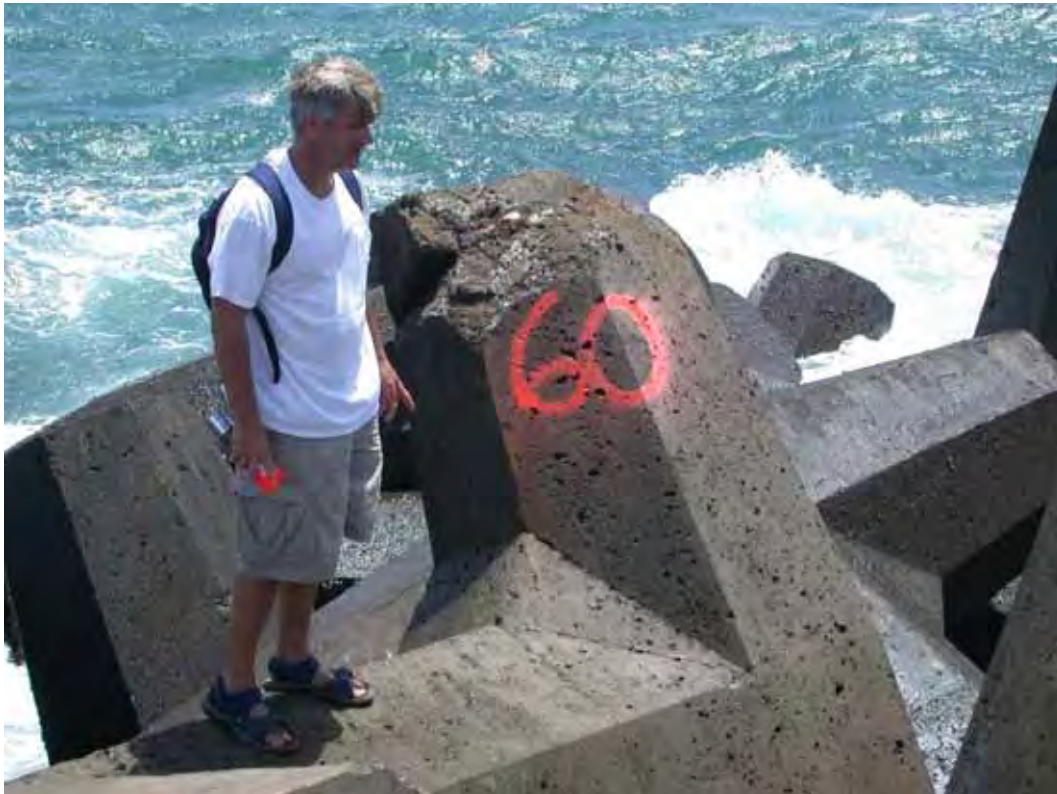
Figure B94. Damage location 72, 30 deg ocean side of head, dolosse with fluke tip chip.

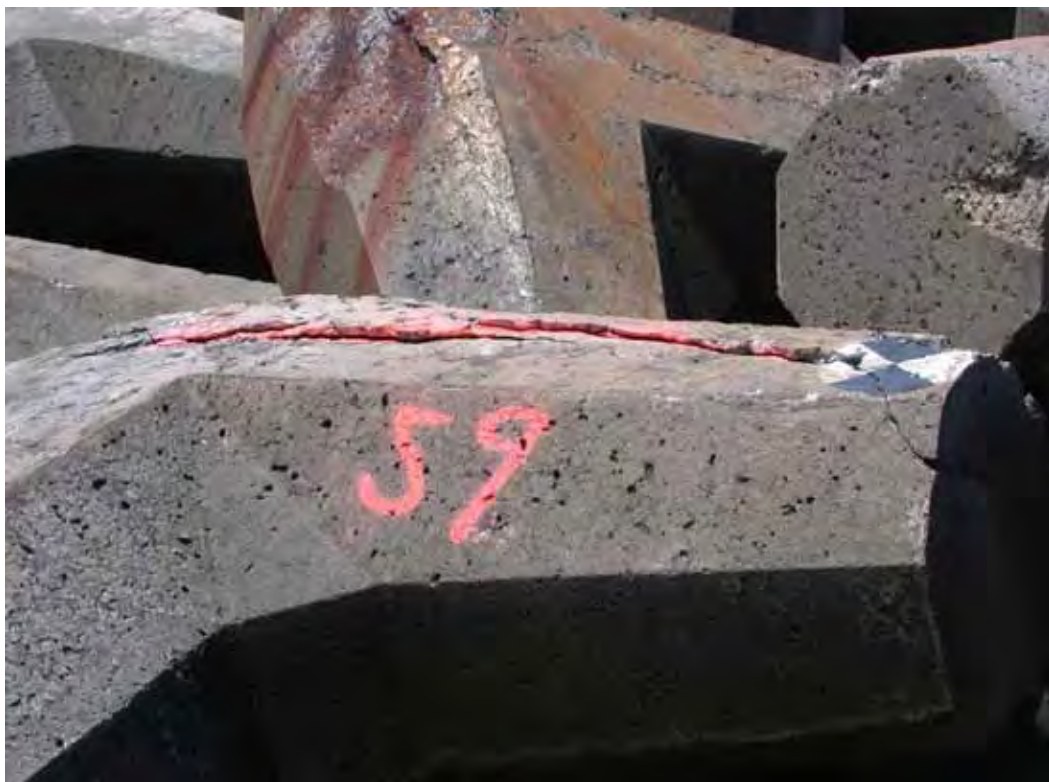
Figure B95. Damage location 75, head, 0 deg, dolosse with longitudinal fluke crack and spalling.

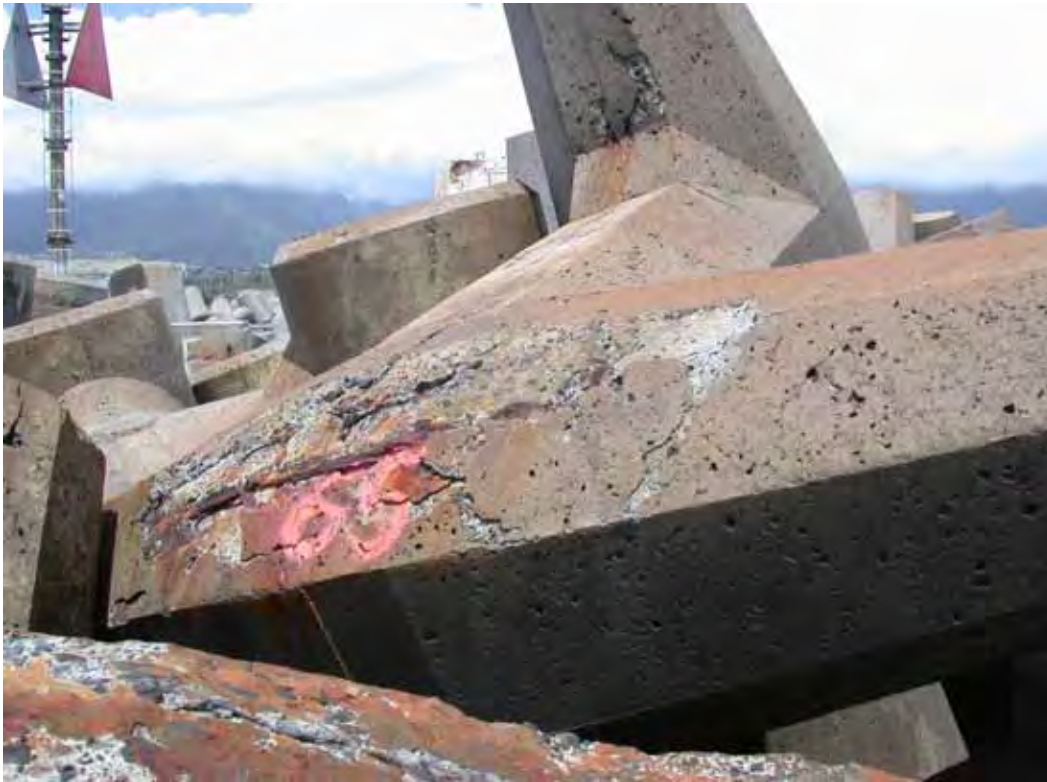
Figure B97. Damage location 79, 6 deg harbor side of head, dolosse with spalling and exposed rebar on fluke.

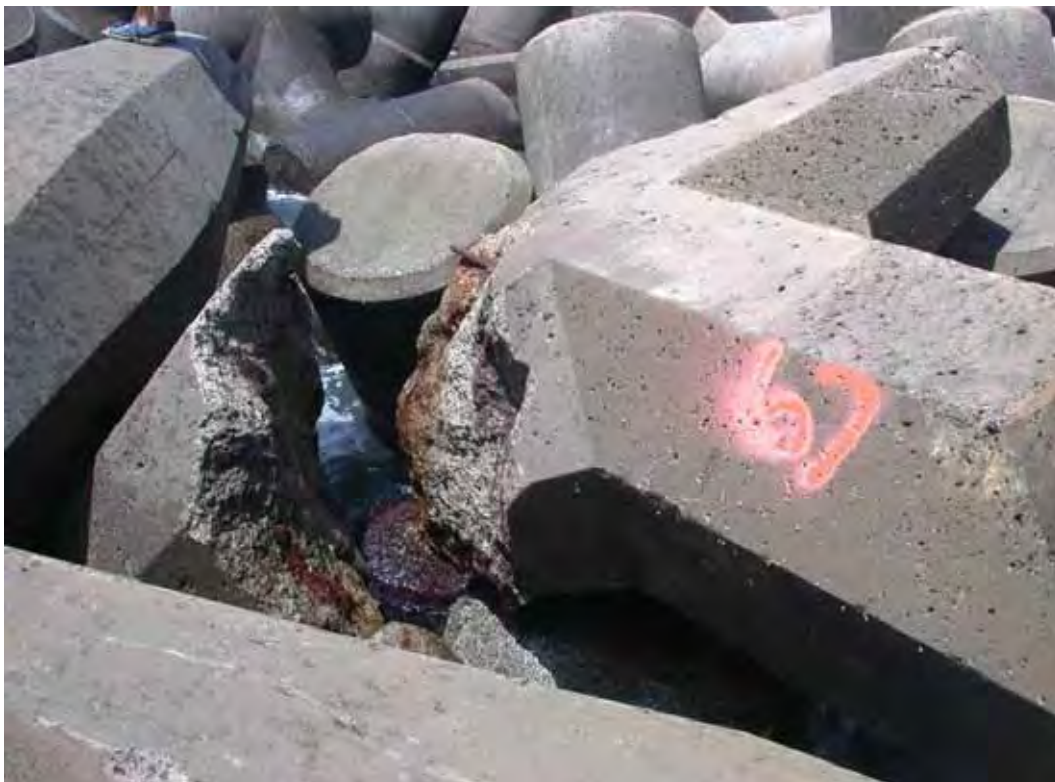
Figure B98. Damage location 81, 15 deg harbor side of head, dolosse with fluke-shank break.

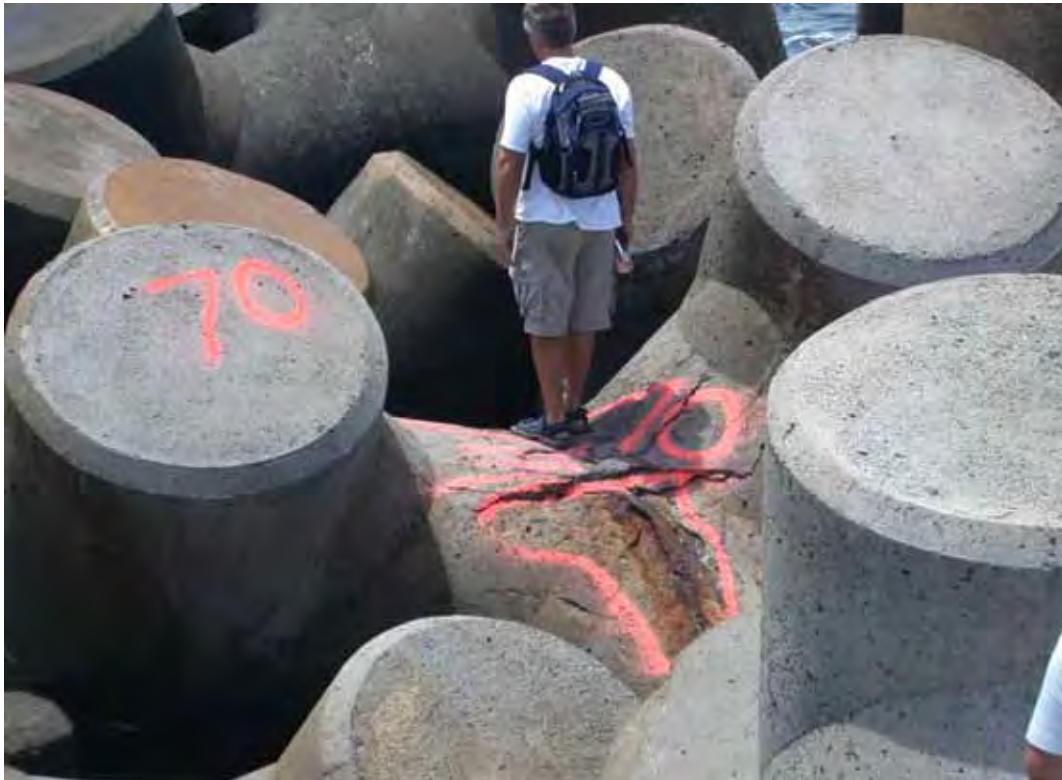
Figure B99. Damage location 84, 90 deg harbor side of head, tribar with exposed and rusted rebar at center.

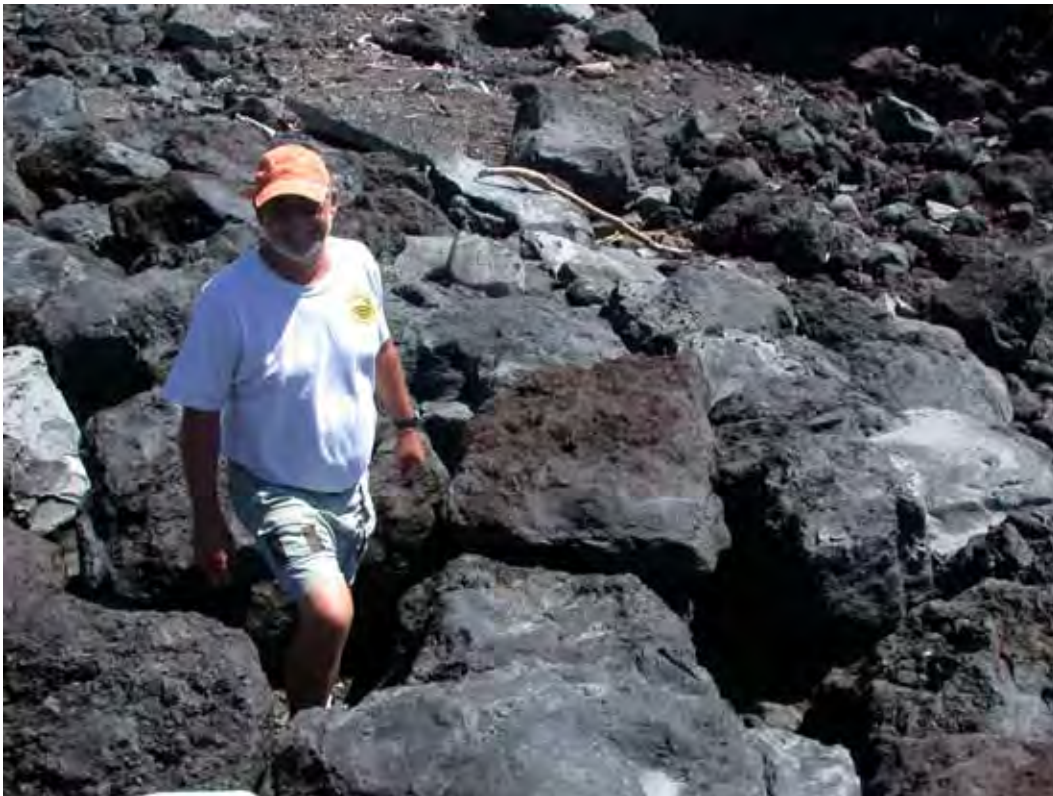
Figure C1. Sta 0+25 - 0+28, voids and missing armor stones.
