Monitoring Completed Navigation Projects Program

Periodic Inspections of Hilo, Kahului, Laupahoehoe, and Nawiliwili Breakwaters, Hawaii

Armor Unit Monitoring for Period 2001-2005

October 2011

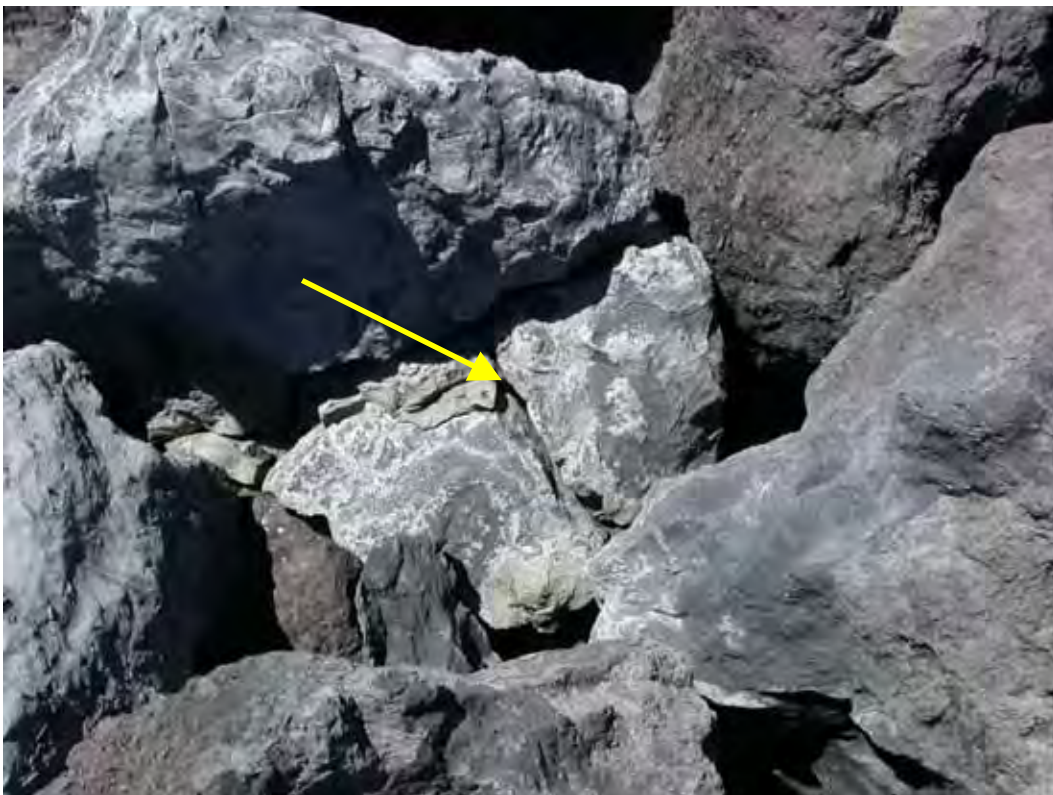
Figure C2. Sta 0+40, cracked armor stone.

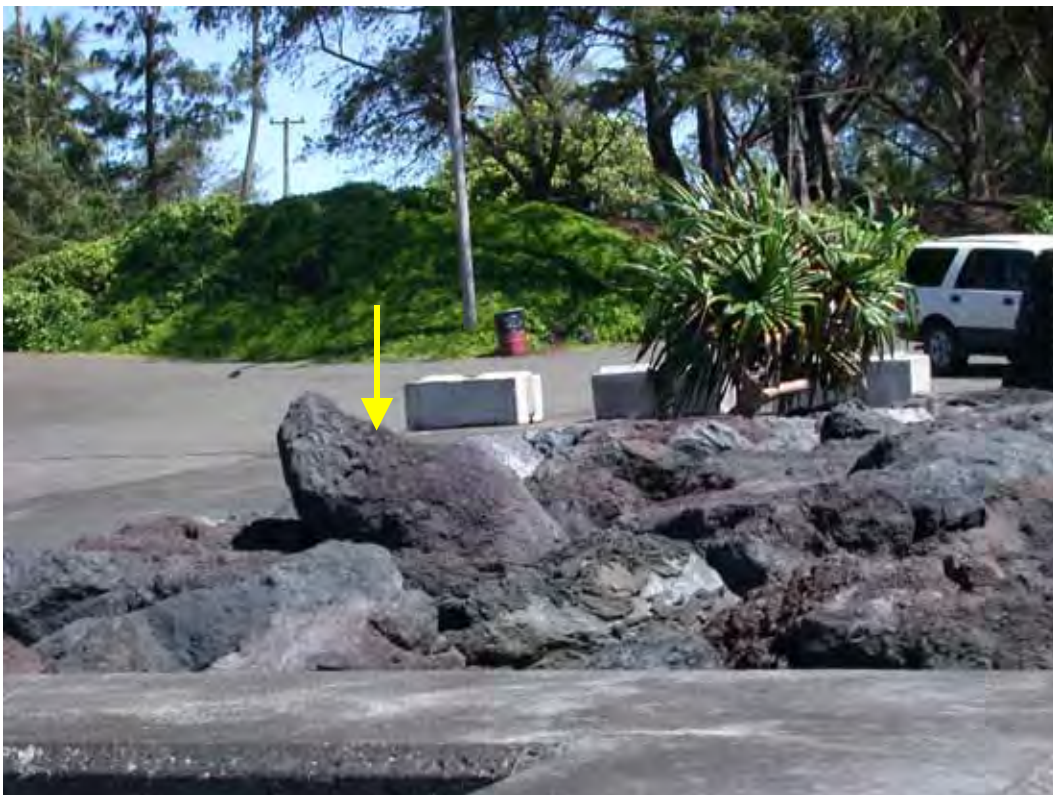
Figure C7. Harbor side, perched armor stone.

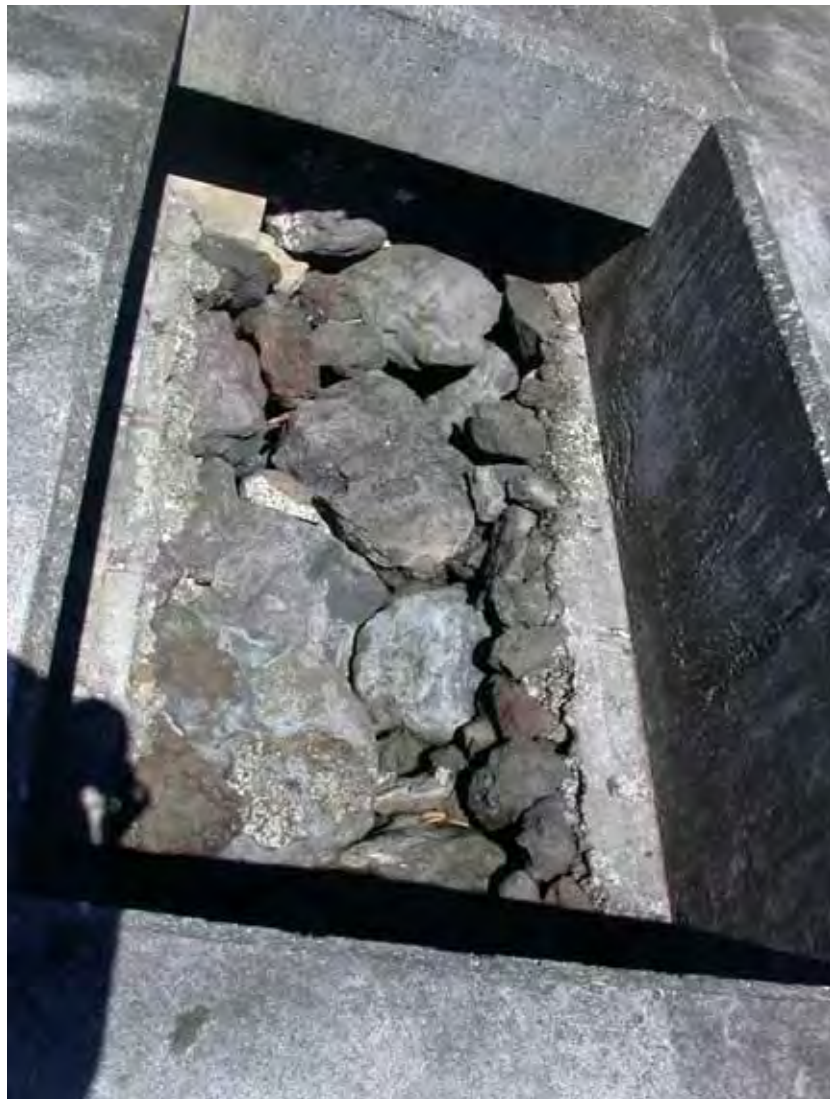
Figure C8. Shifting of stones between ribs.

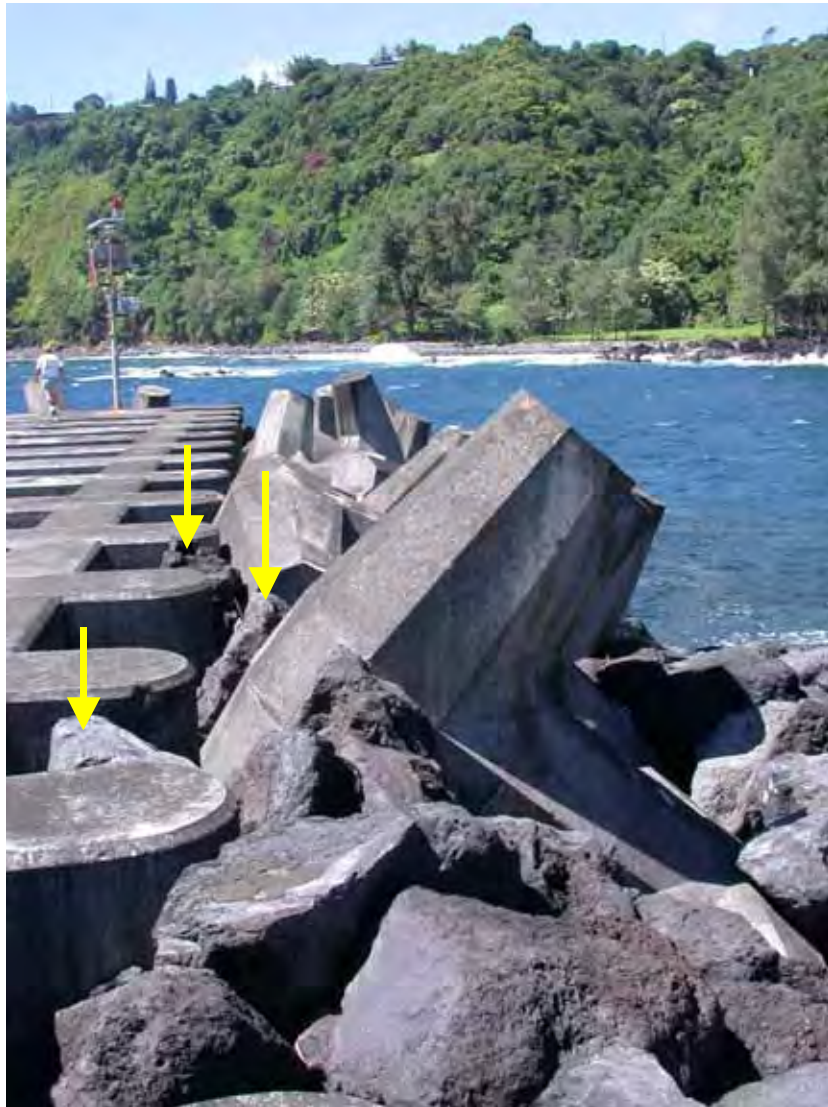
Figure C9. Displaced armor stone, tossed onto dolosse.

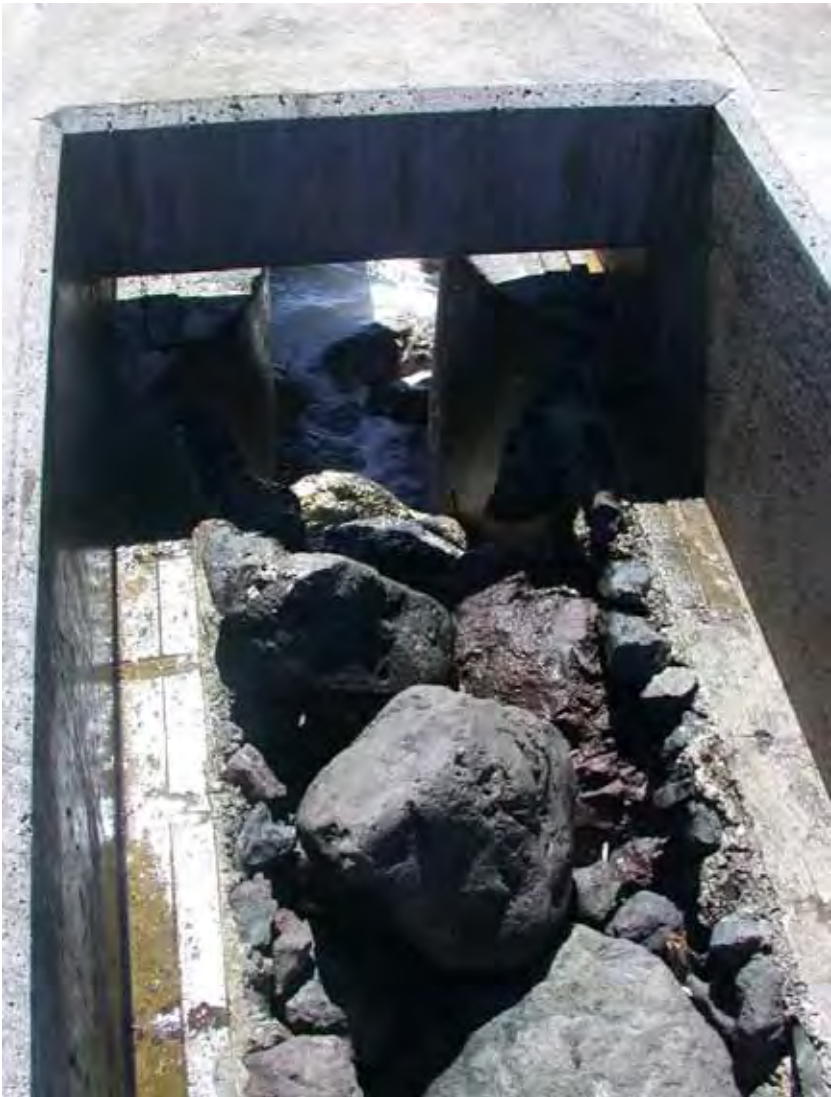
Figure C10. Underlayer loss and shifting of stones between ribs.

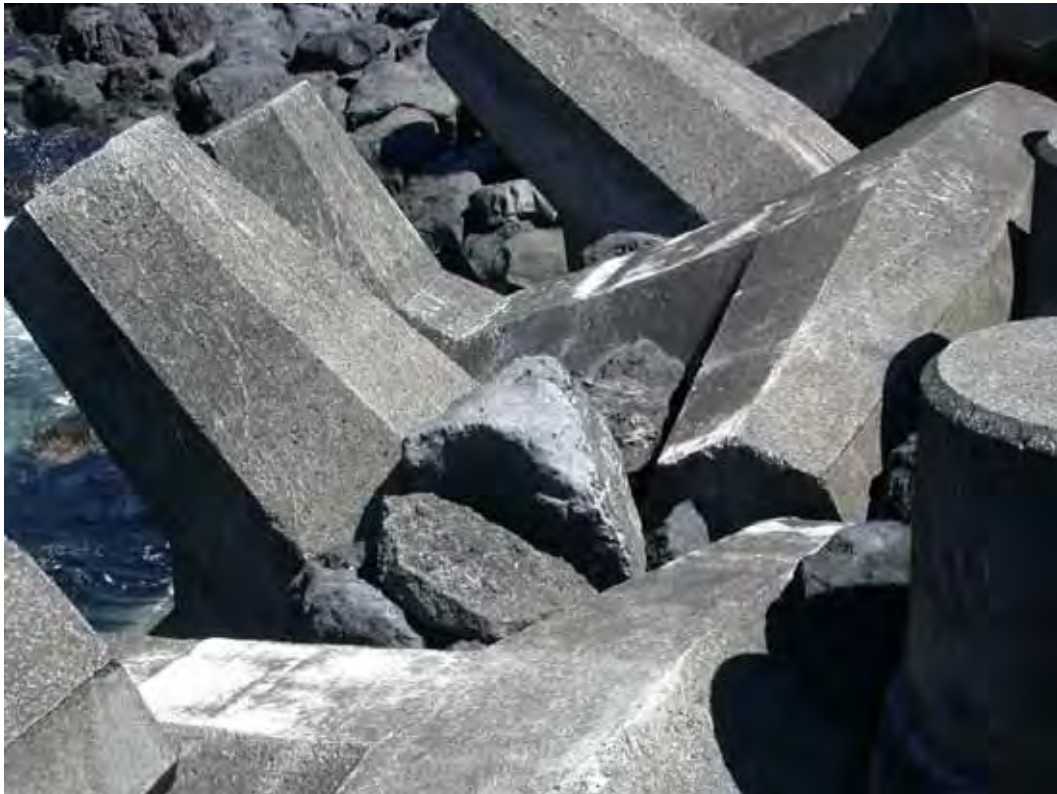
Figure C11. Displaced armor stone, tossed onto dolosse.

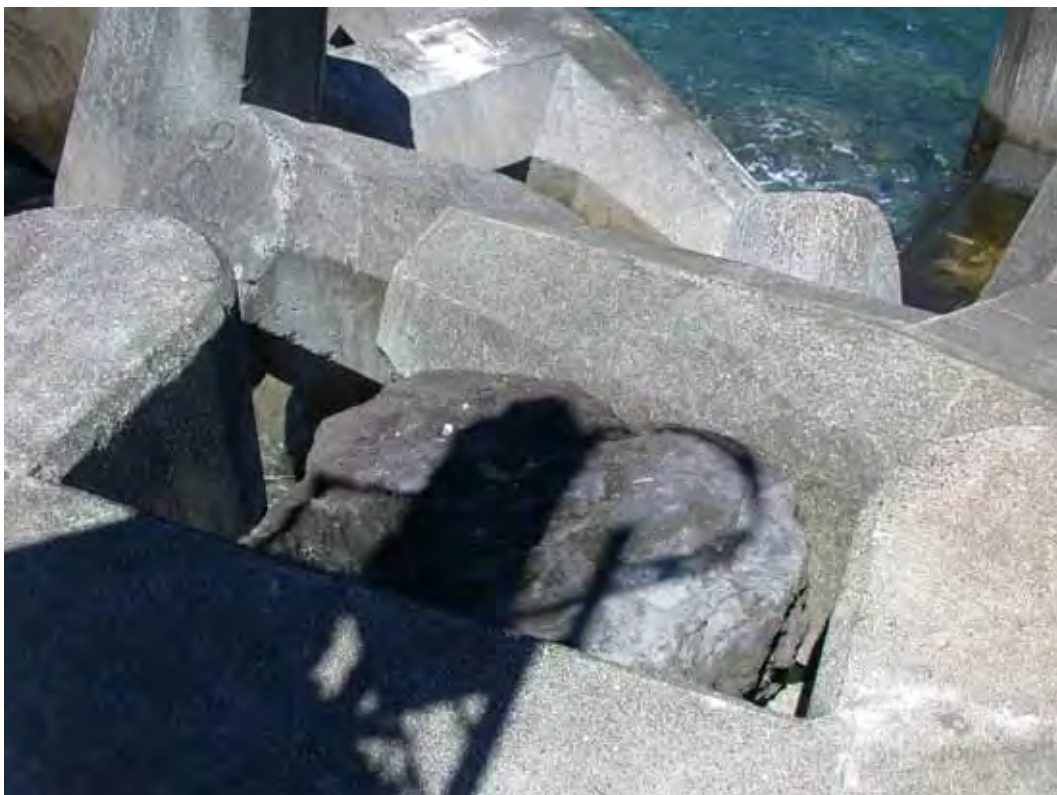
Figure C12. Displaced armor stone, tossed onto dolosse.

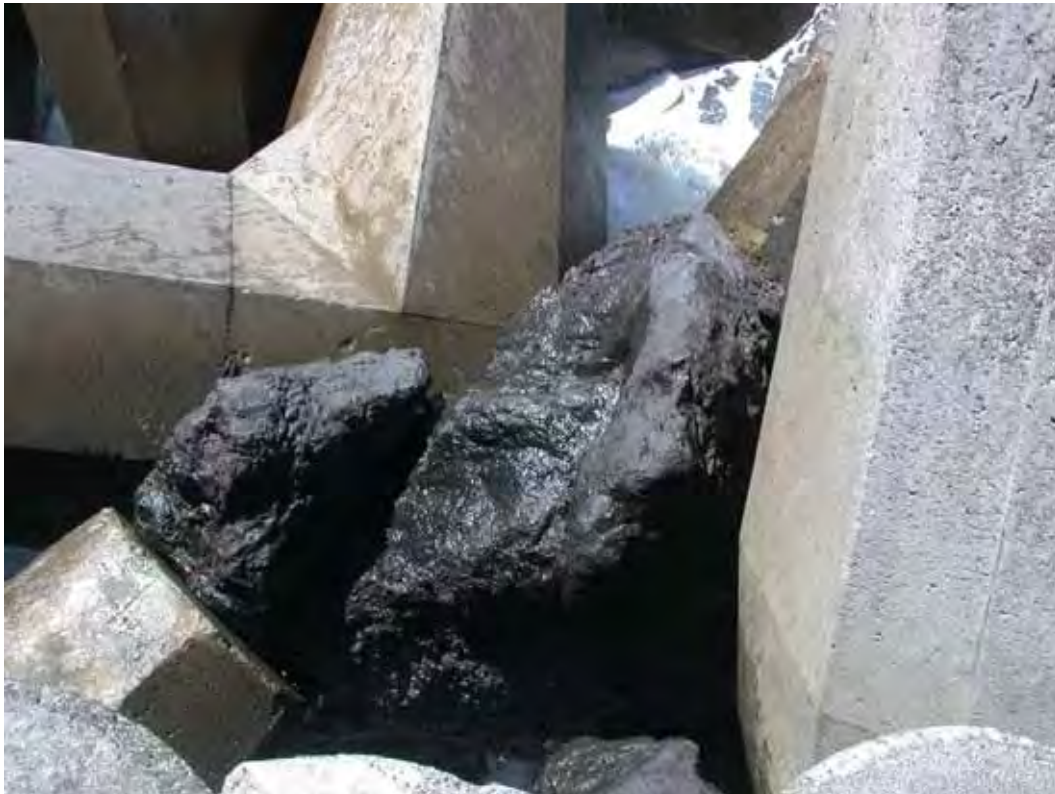
Figure C13. Displaced armor stone, tossed onto dolos.

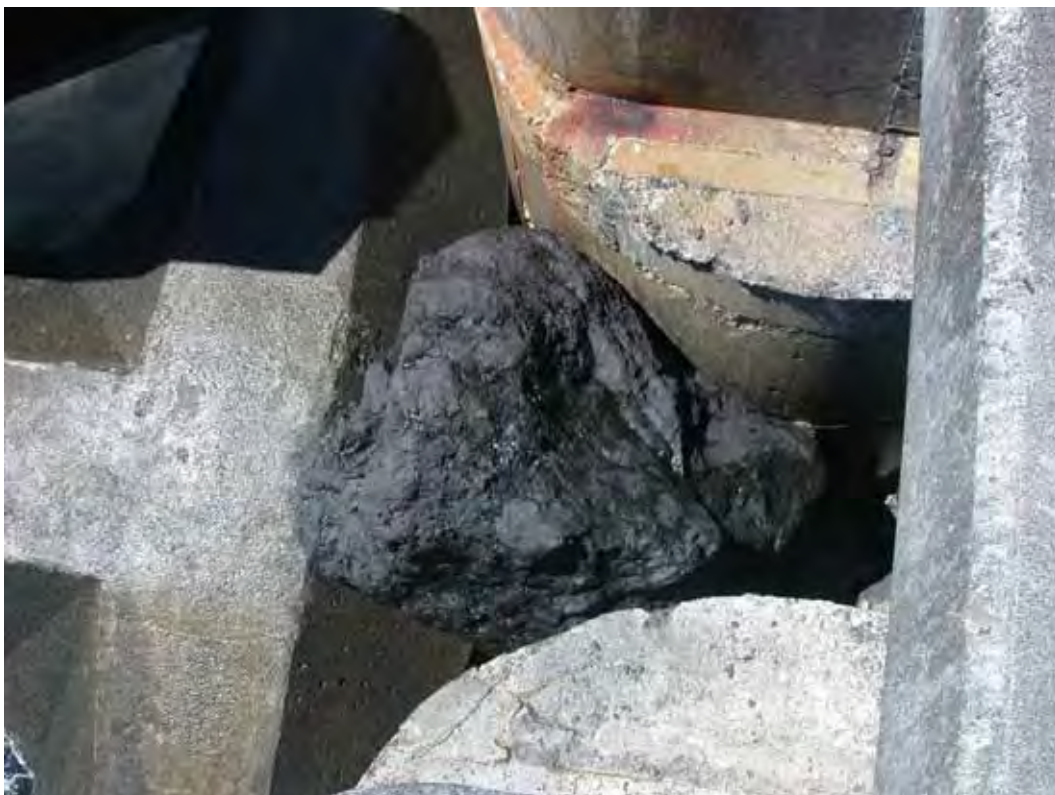
Figure C14. Displaced armor stone, tossed onto dolos.

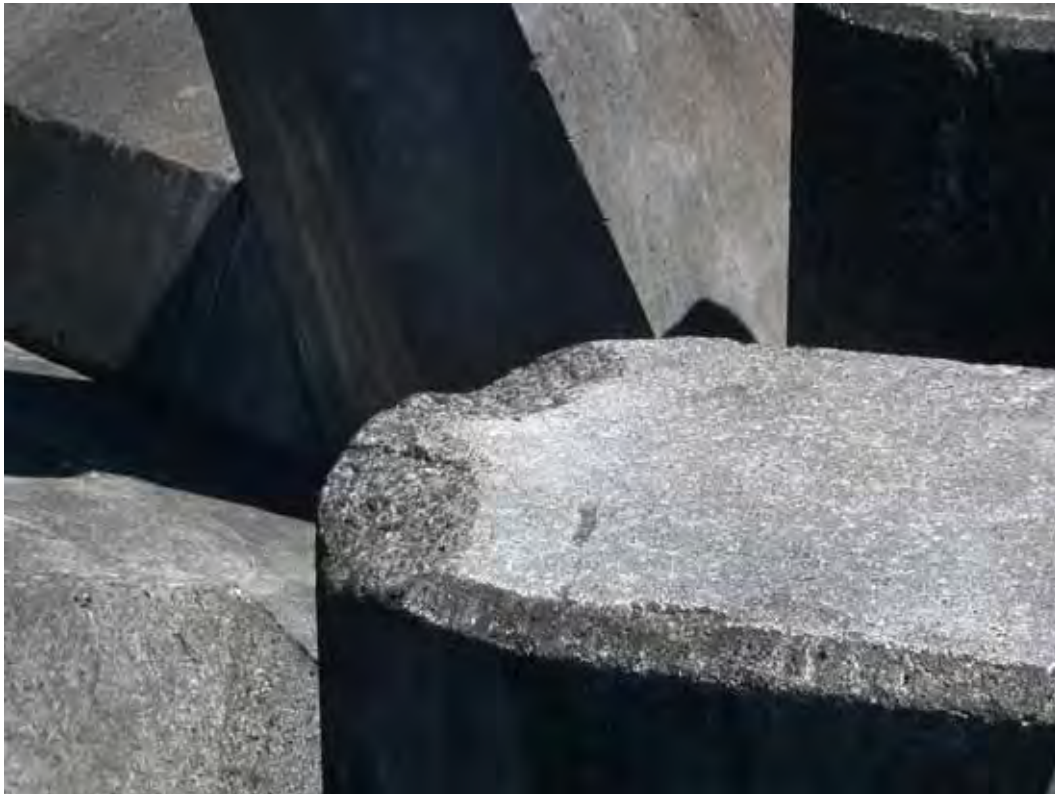
Figure C19. Rib damage possibly caused by displaced armor stones.

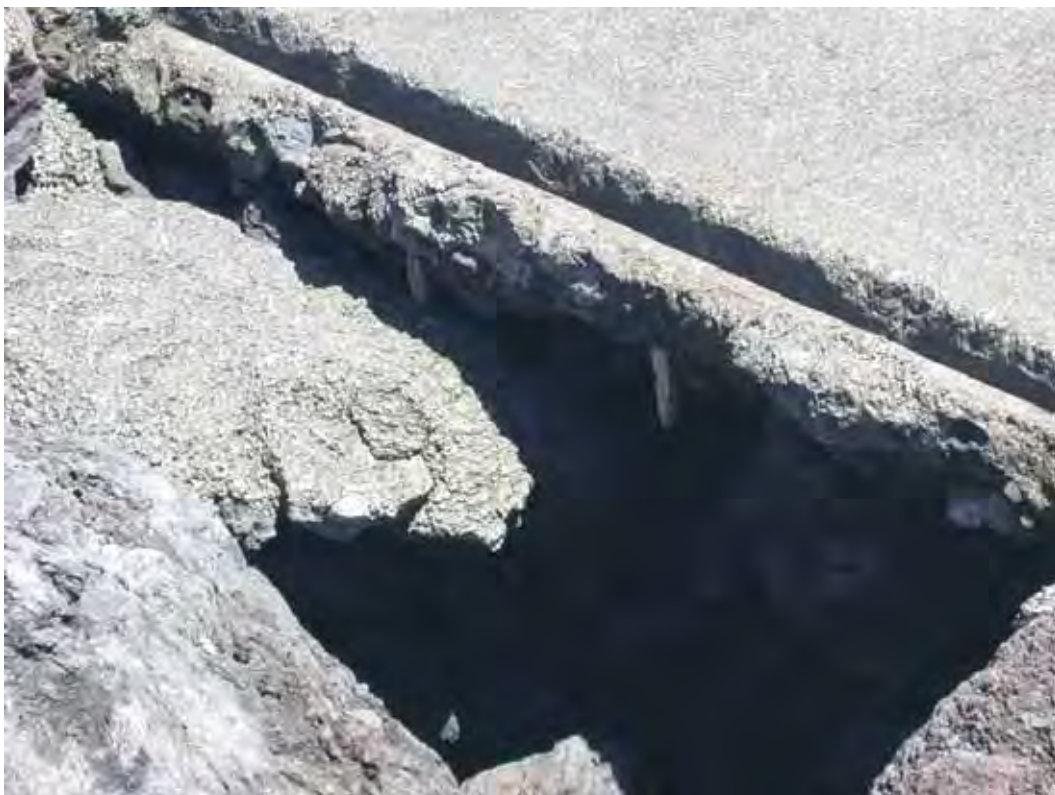
Figure C20. Undermining of concrete slab adjacent to breakwater and boat launch.

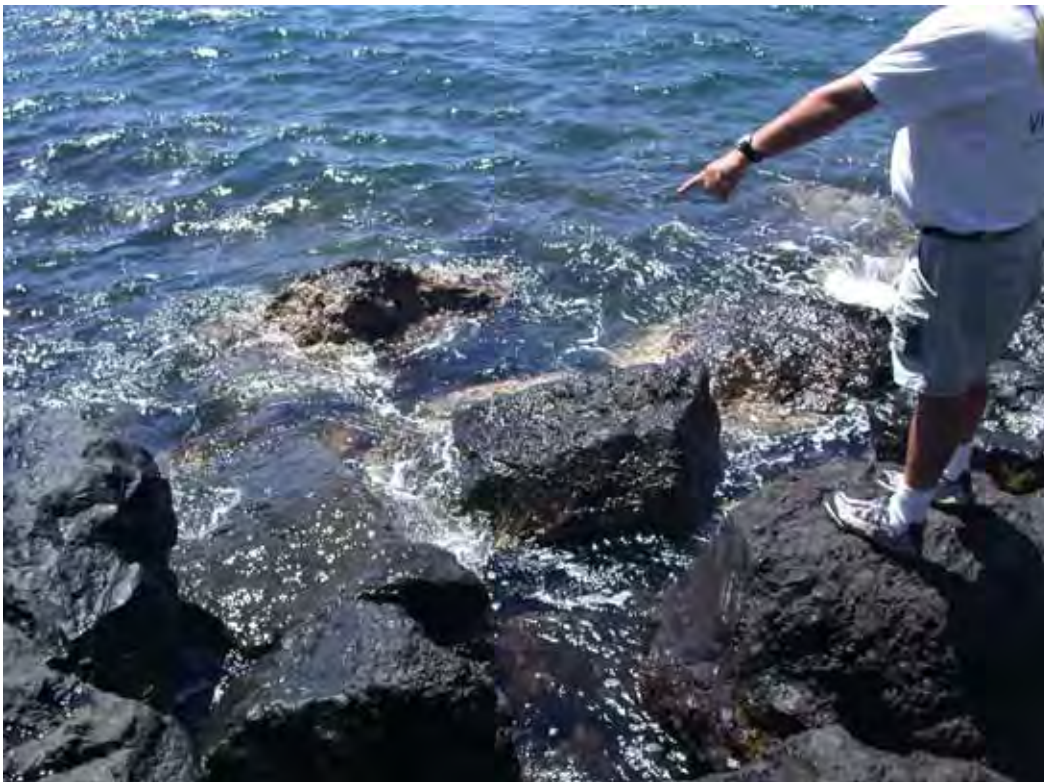
Figure C21. Displaced armor stones at wave absorber along shoreline, harbor side of breakwater.

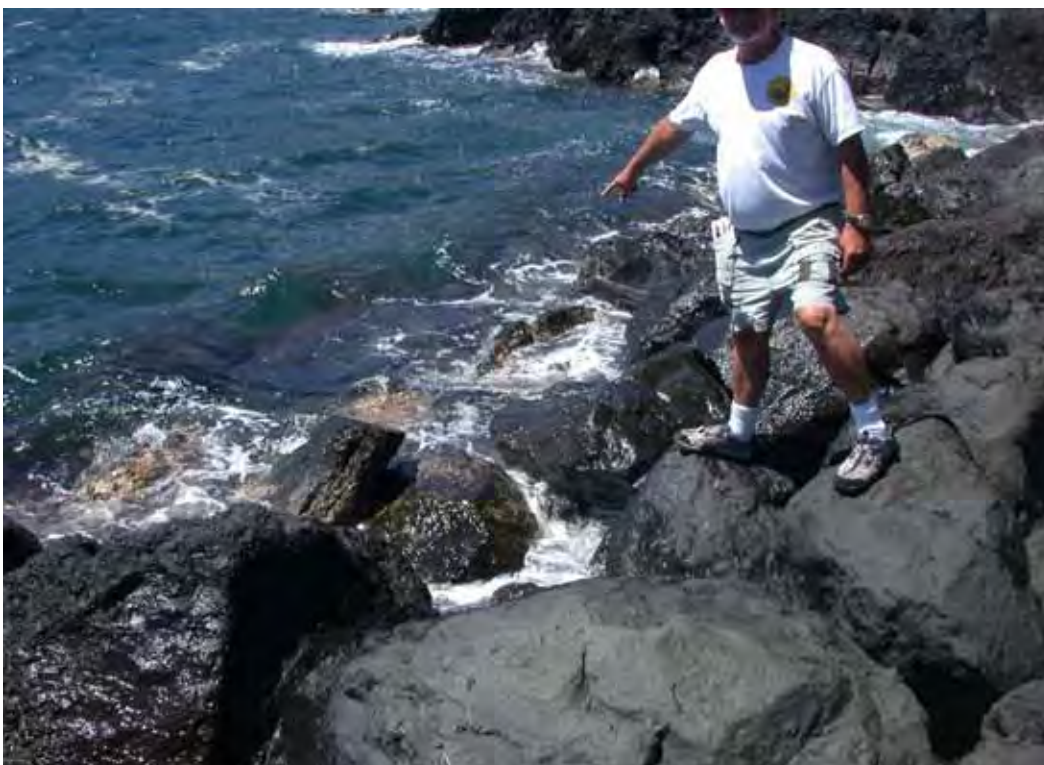
Figure C22. Displaced armor stones at wave absorber along shoreline, harbor side of breakwater.

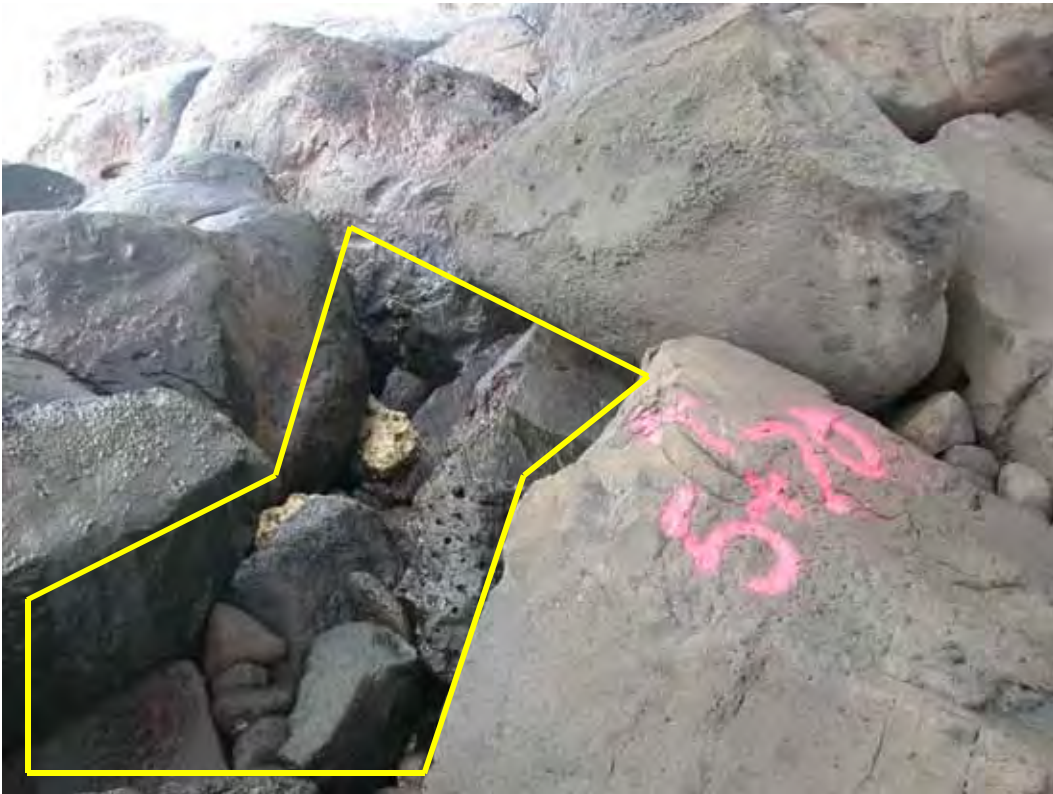
Figure D3. Damage location 2, sta 5+70, ocean side, void at hinge.

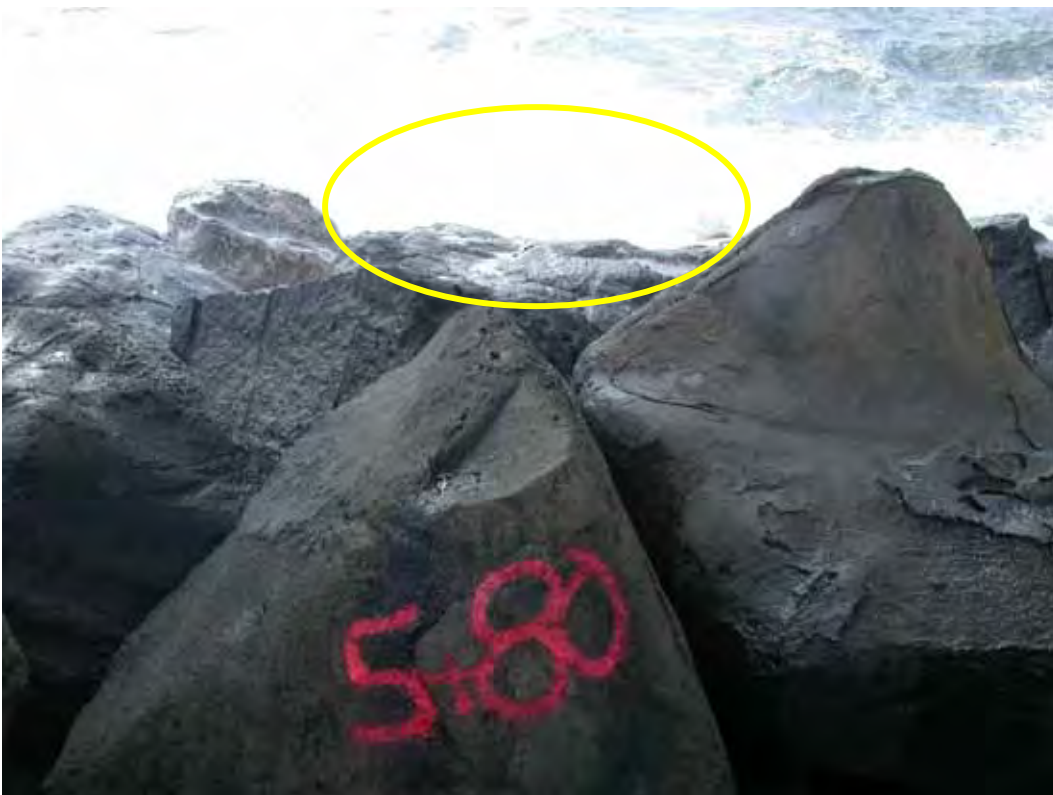
Figure D4. Damage location 3, sta 5+80, ocean side, void at toe.

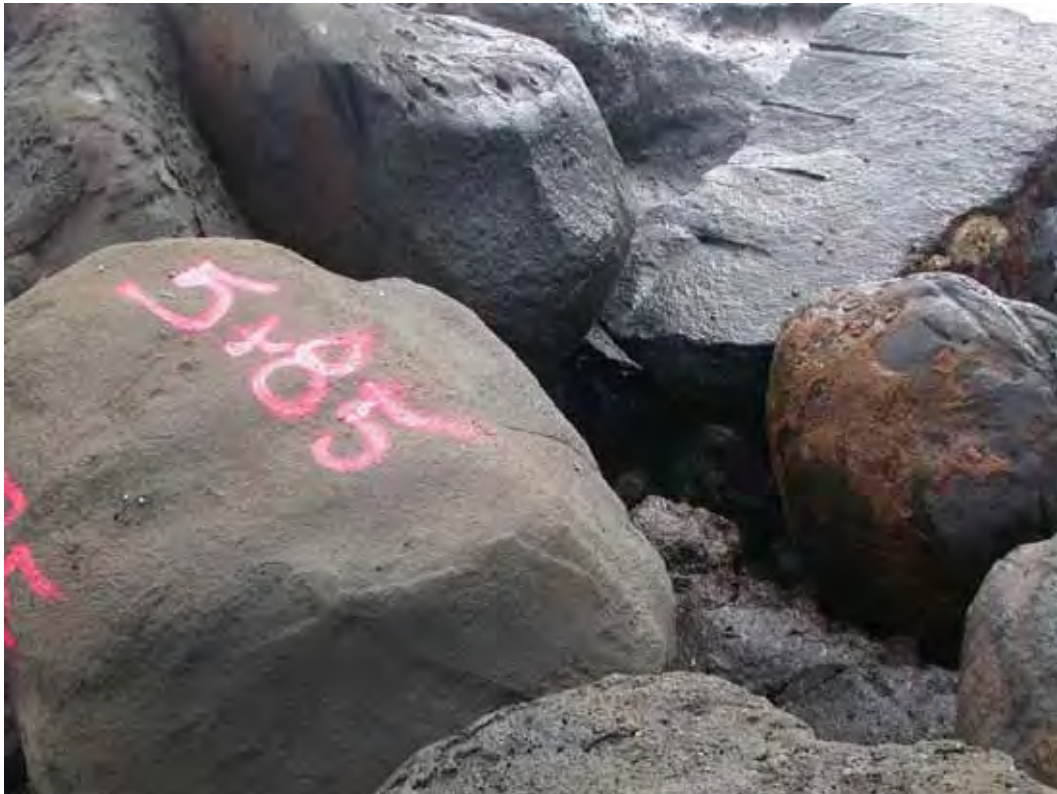
Figure D5. Damage location 4, sta 5+85, ocean side, void on side slope.

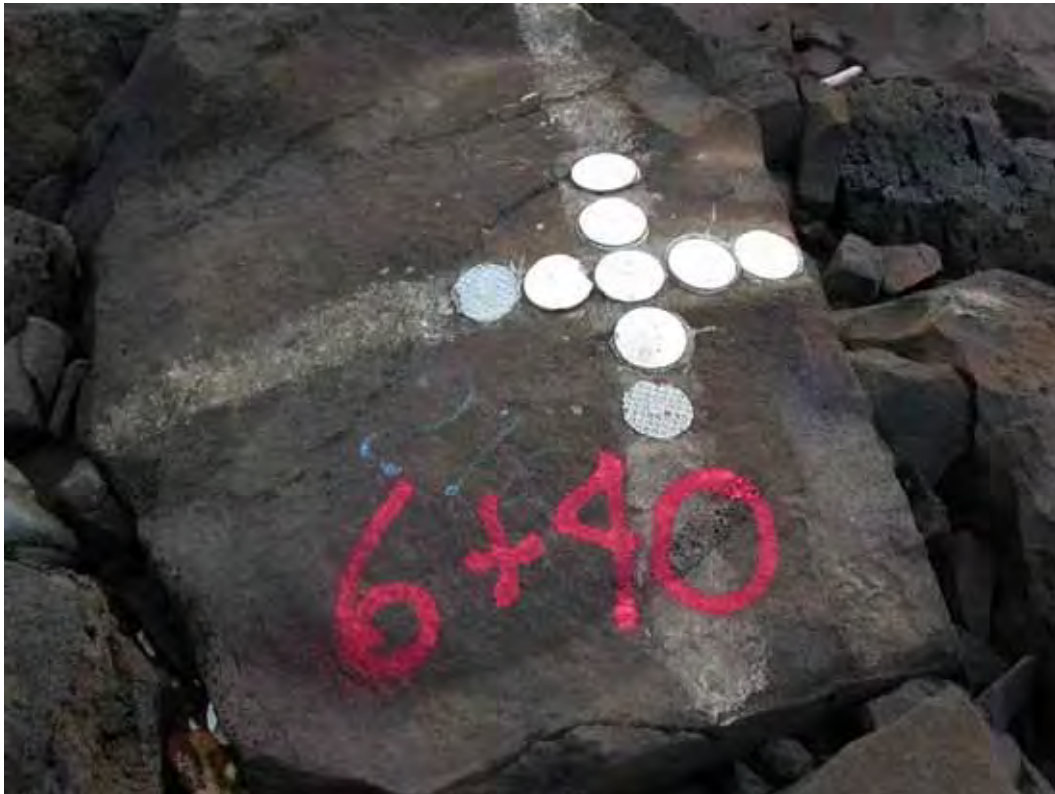
Figure D7. Sta 6+40, survey marker.

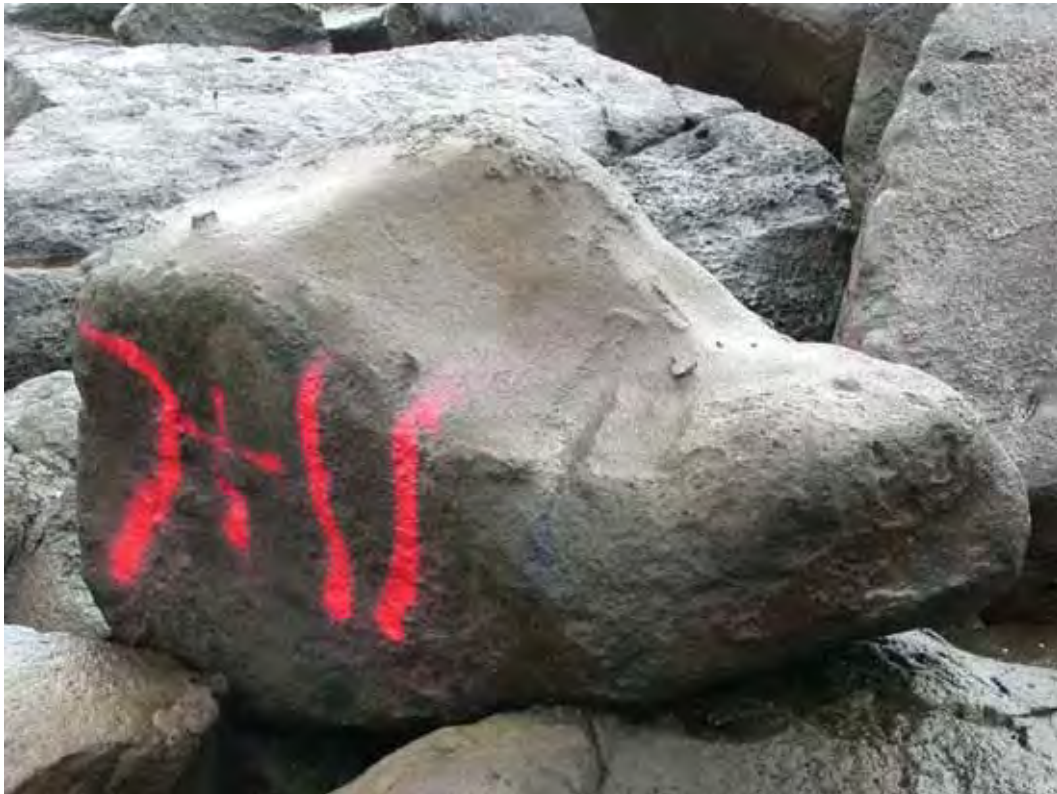
Figure D9. Damage location 8, sta 7+11, perched armor stone on crest.

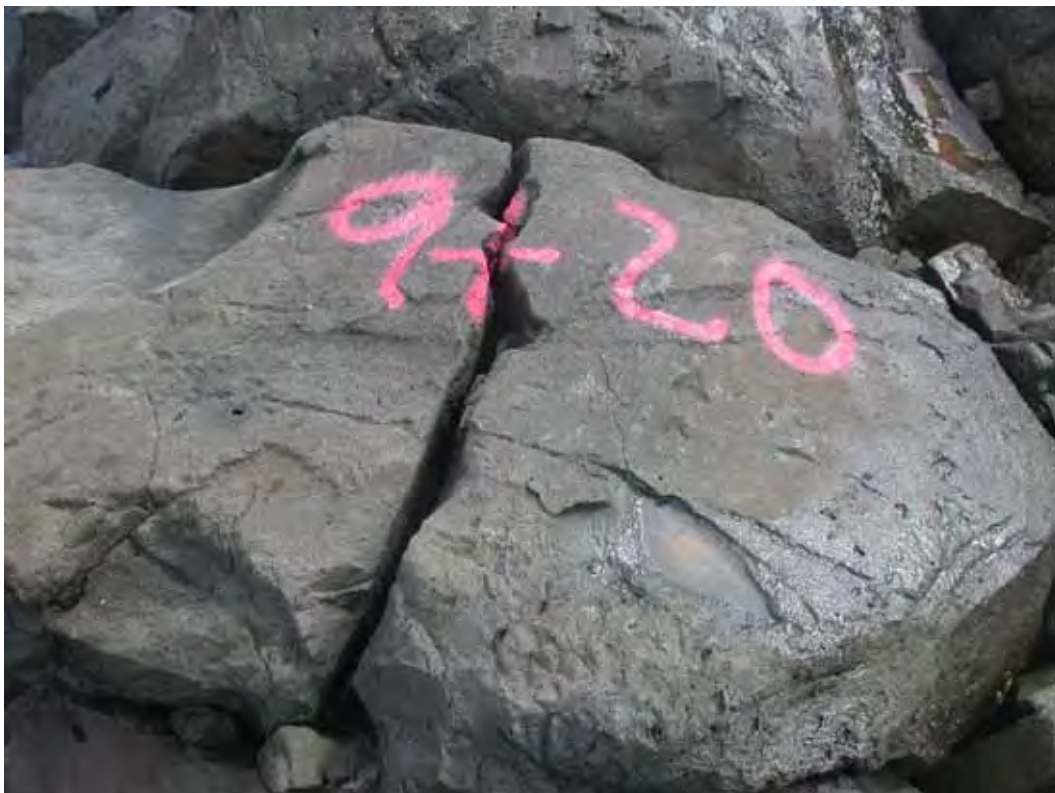
Figure D14. Damage location 13, sta 9+20, harbor side, cracked armor stone at hinge.

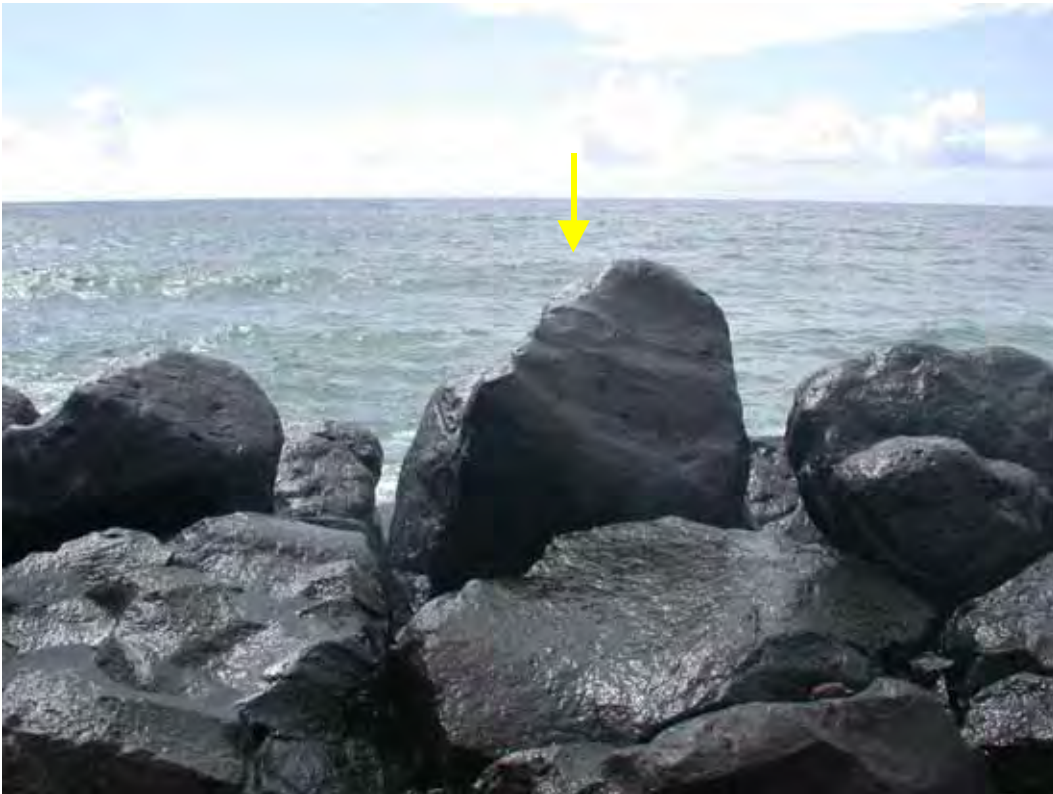
Figure D15. Damage location 14, sta 9+20, ocean side, flipped armor stone and void.

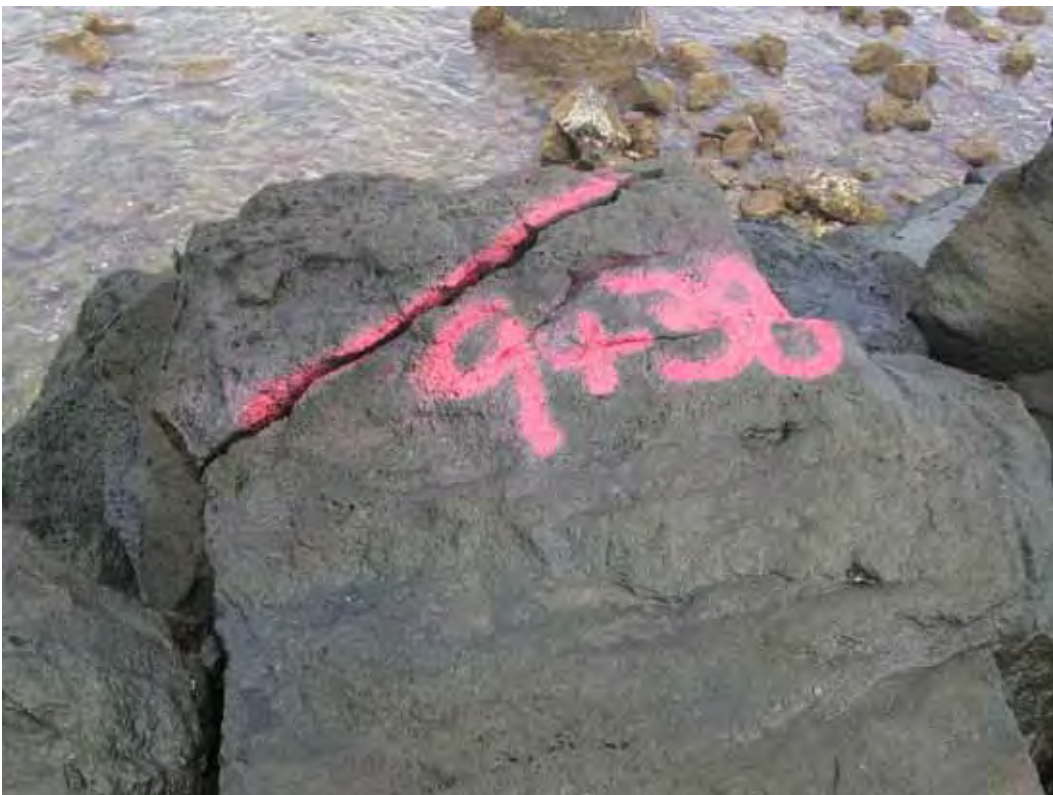
Figure D16. Damage location 15, sta 9+38, harbor side, cracked armor stone at hinge.

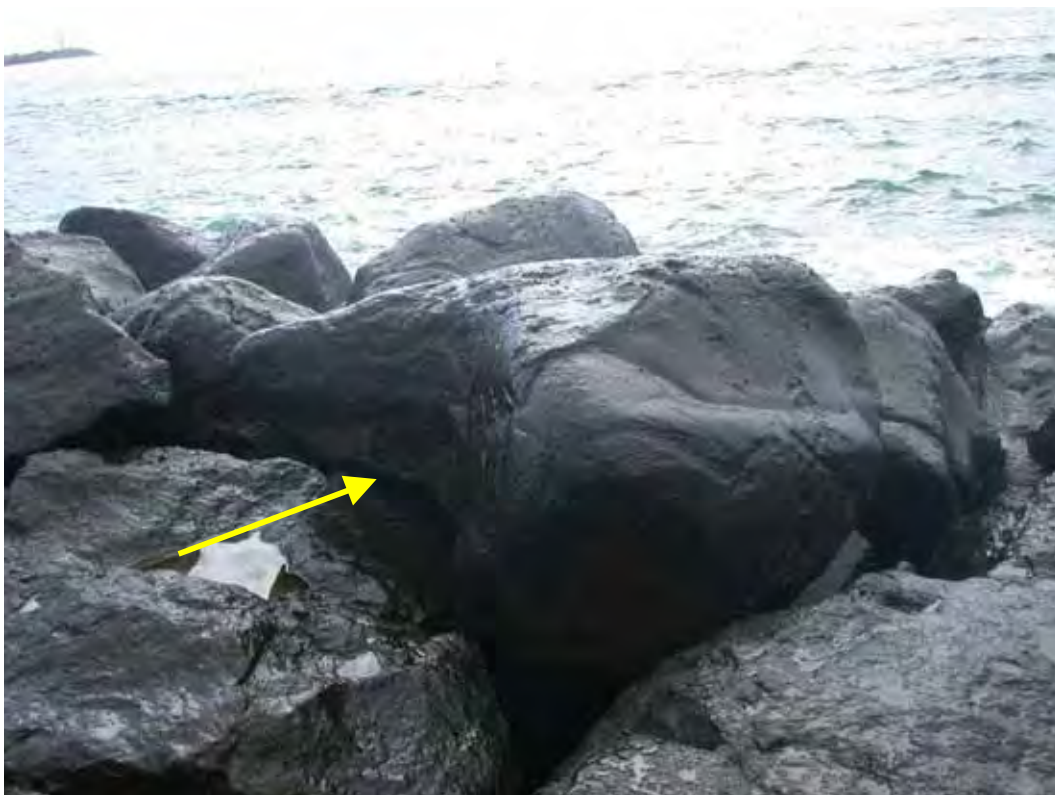
Figure D18. Damage location 17, sta 9+87, ocean side, perched armor stone.

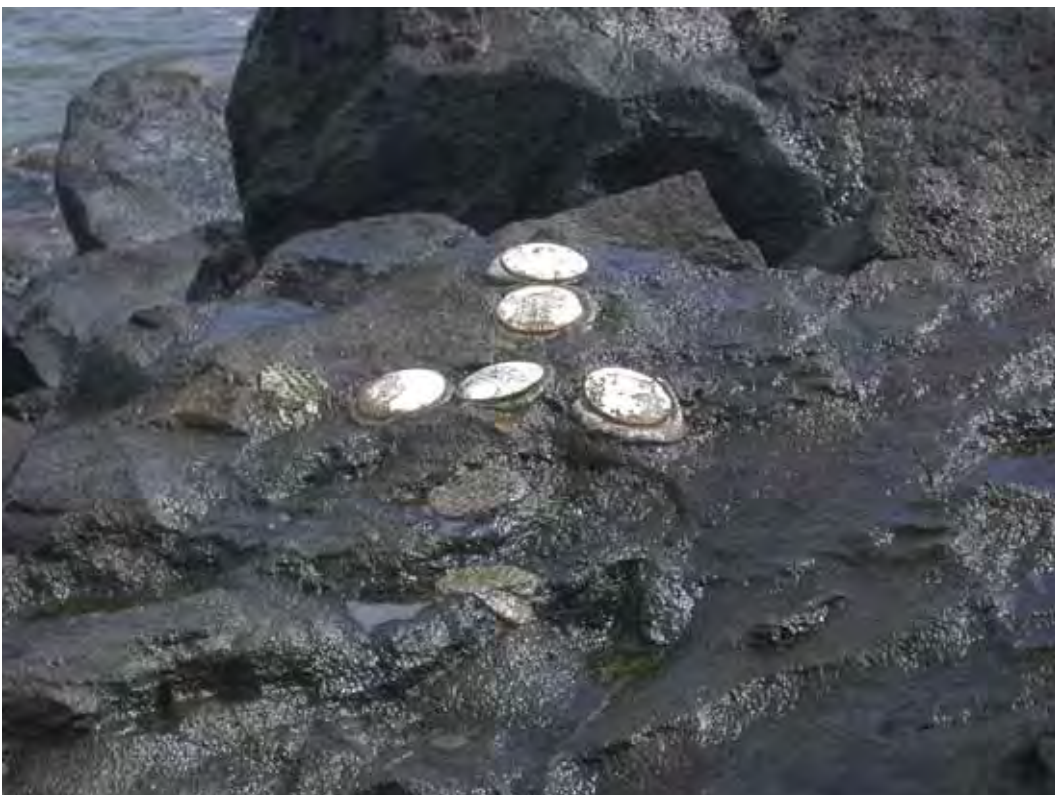
Figure D20. Sta 10+21, survey marker.

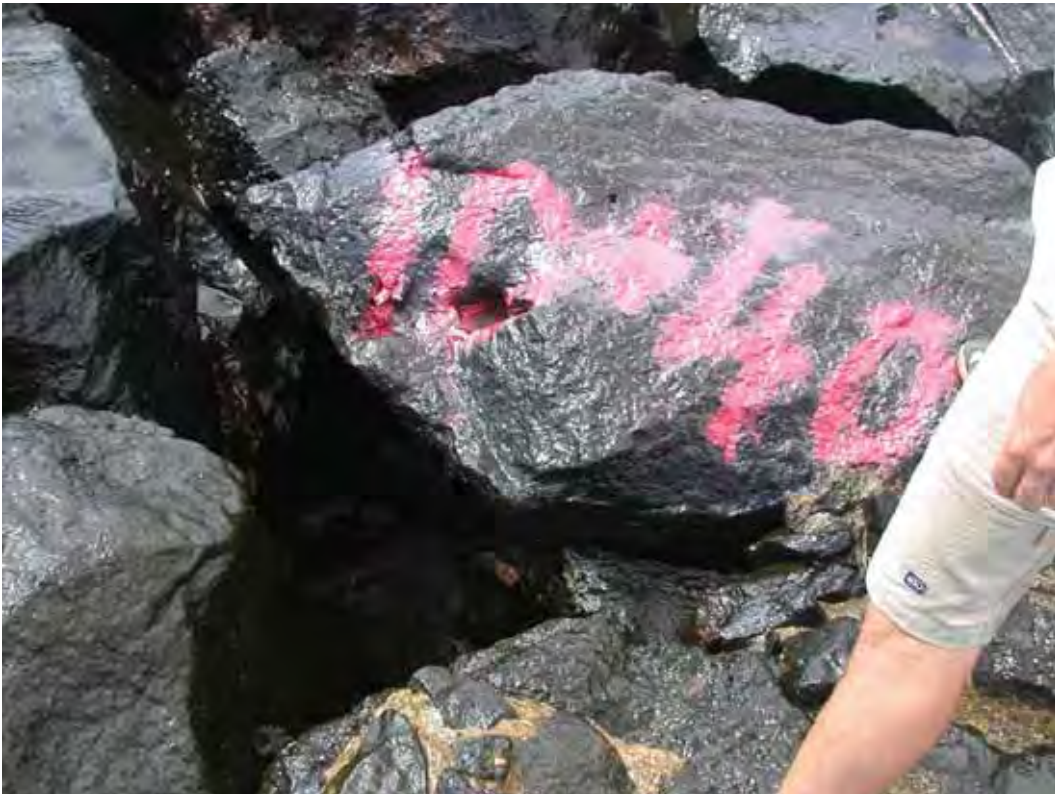
Figure D21. Damage location 20, sta 10+40, void (depth to waterline) at centerline of crest.

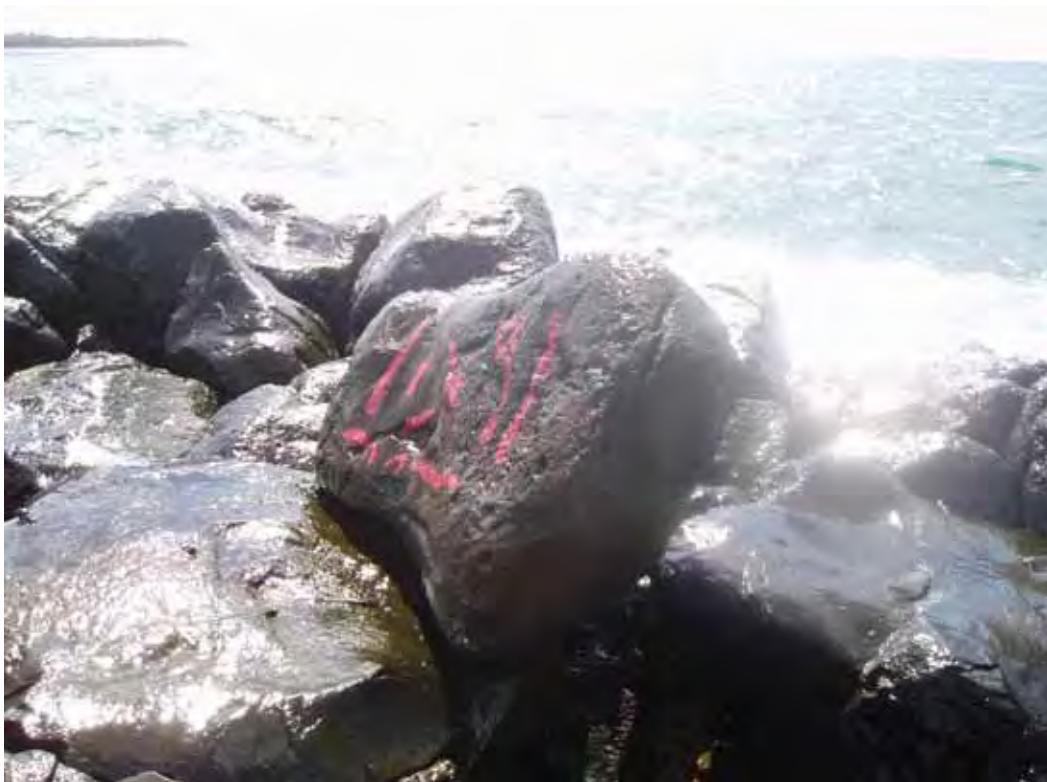
Figure D22. Damage location 24, sta 10+91, ocean side, flipped armor stone, settling, bridging, void.

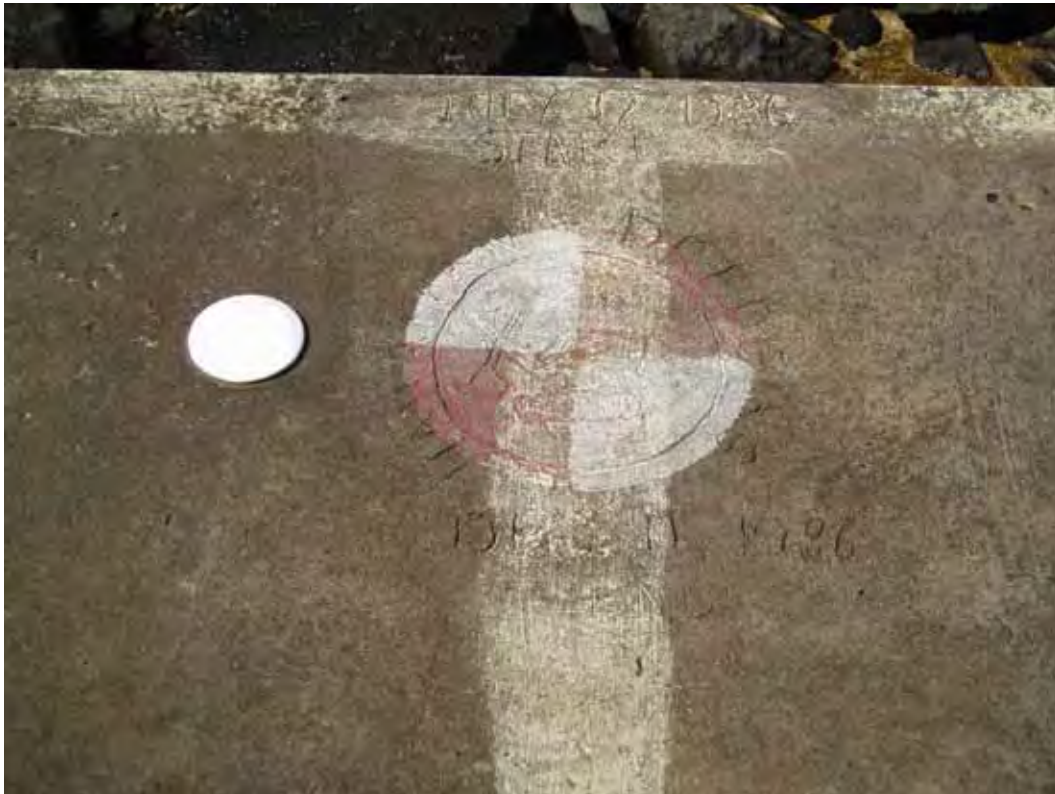
Figure D24. Sta 12+00, rib cap begins (Note: Centerline to centerline of rib dimension = 6 ft).

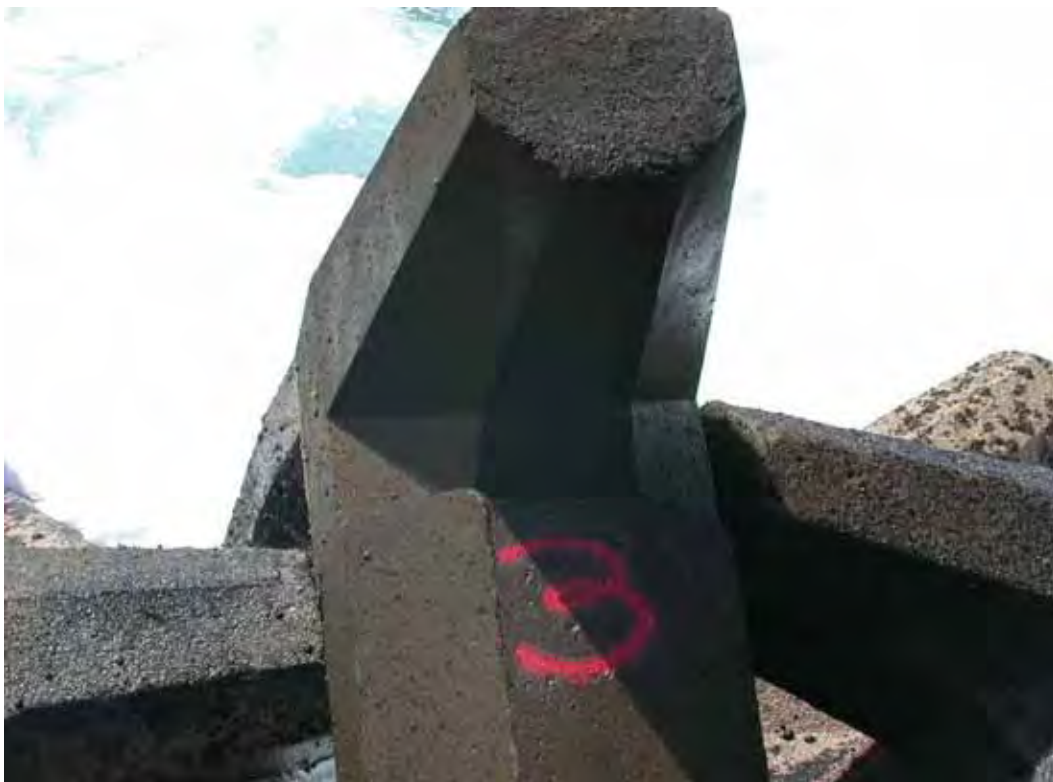
Figure D25. Damage location 26, sta 12+06, ocean side, rib #2, dolosse with shank-fluke break.
