Monitoring Completed Navigation Projects Program

Periodic Inspections of Hilo, Kahului, Laupahoehoe, and Nawiliwili Breakwaters, Hawaii

Armor Unit Monitoring for Period 2001-2005

October 2011

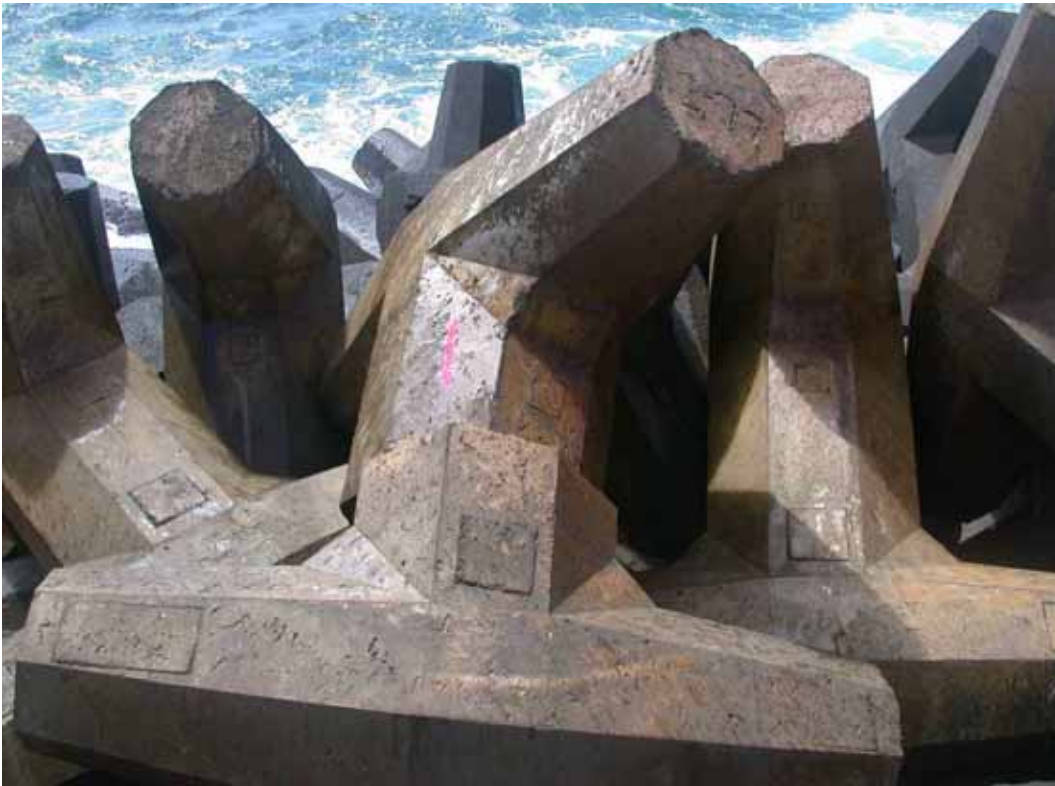
Figure D26. Damage location 27, sta 12+24, ocean side, rib #5, dolosse with mid-shank break.

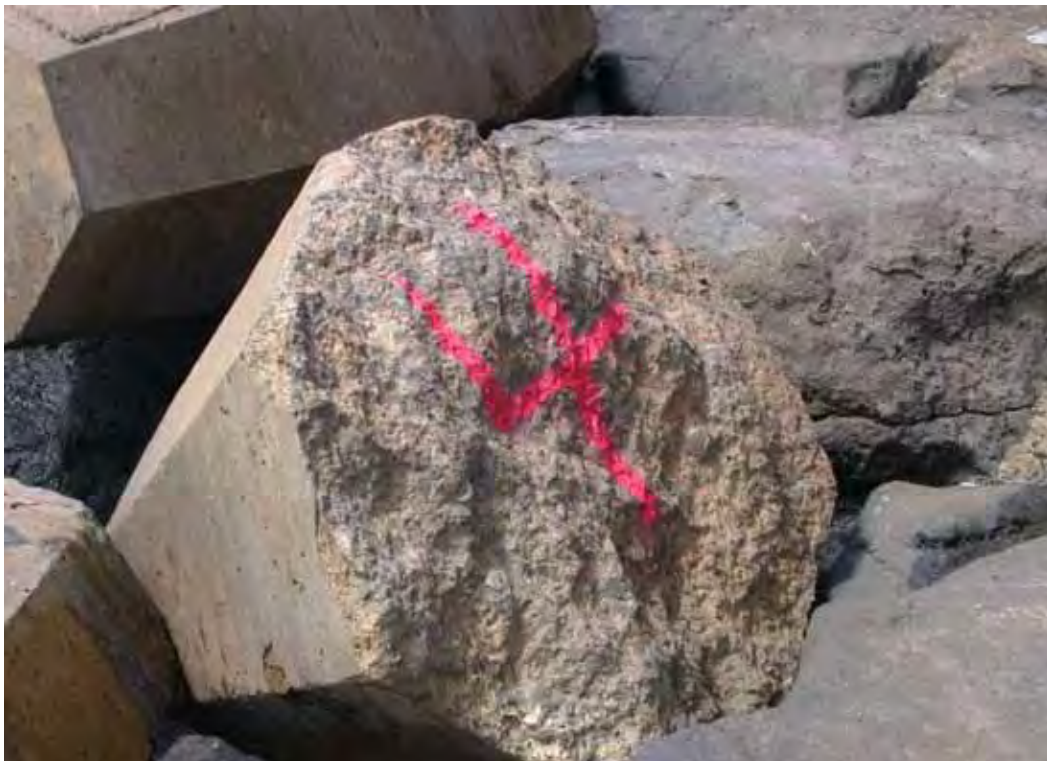
Figure D27. Damage location 28, sta 12+30, ocean side, rib #6, detached dolosse fluke tip, origin unknown.

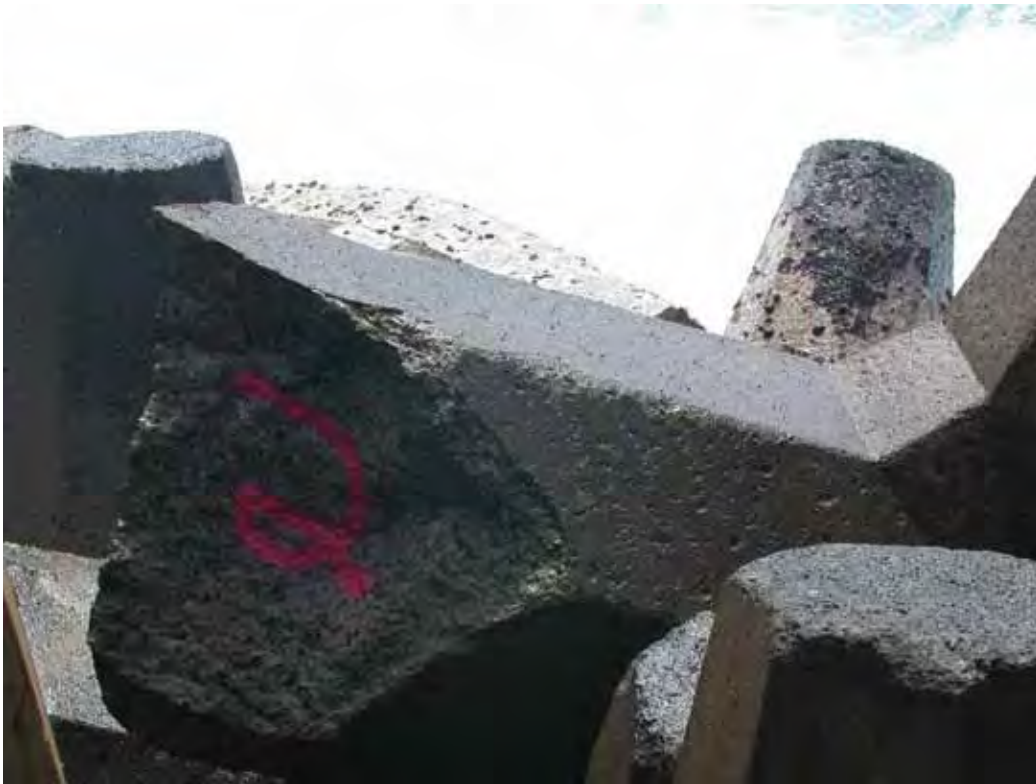
Figure D28. Damage location 29, sta 12+36, ocean side, rib #7, dolosse with mid-shank and shank-fluke breaks.

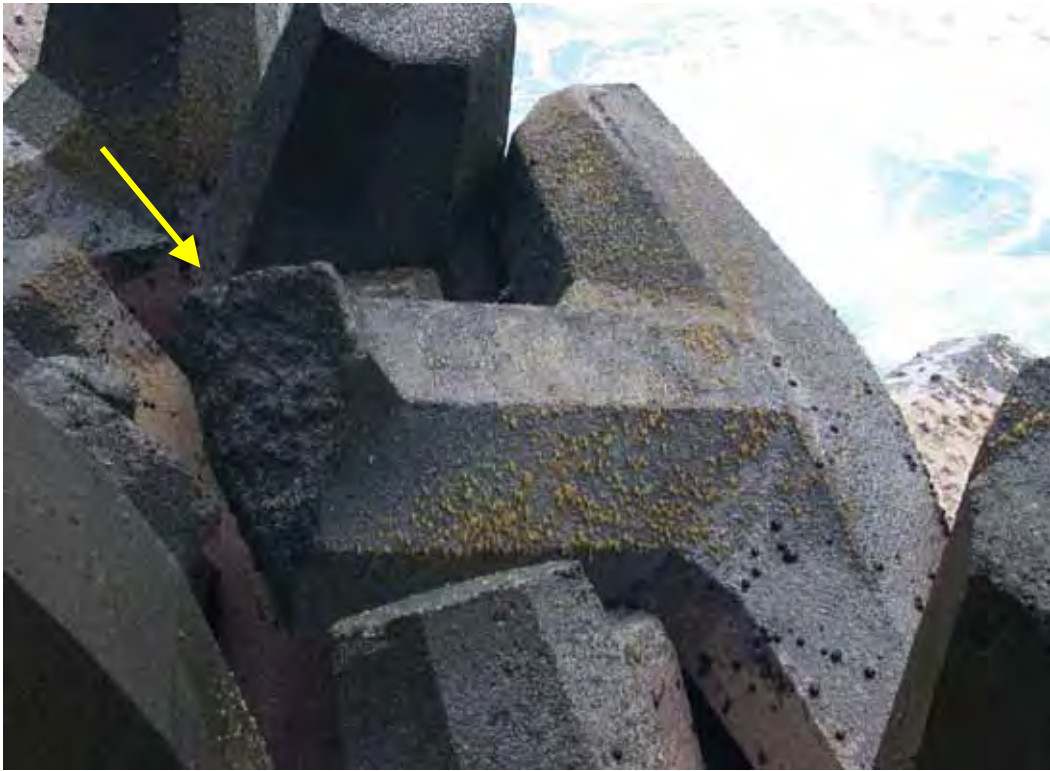
Figure D30. Damage location 33, sta 12+72, ocean side, rib #13, dolosse with shank-fluke break at waterline, ocean side of target NA.

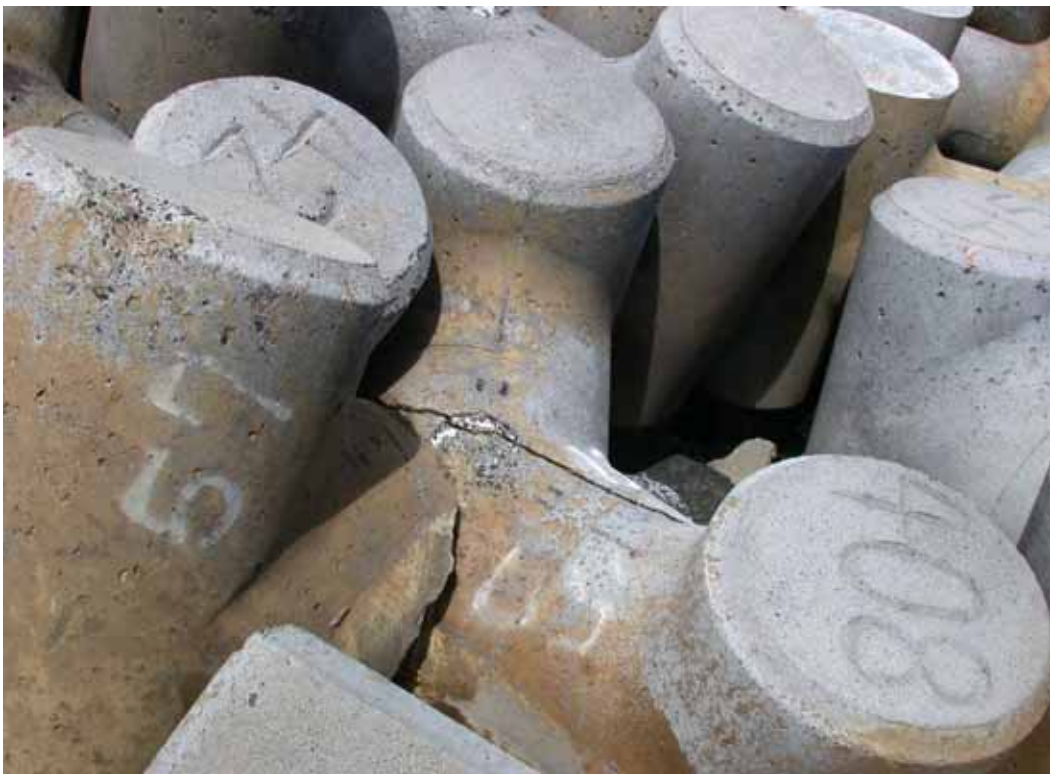
Figure D31. Damage location 34, sta 12+90, harbor side, rib #16, tribar with leg broken at center.

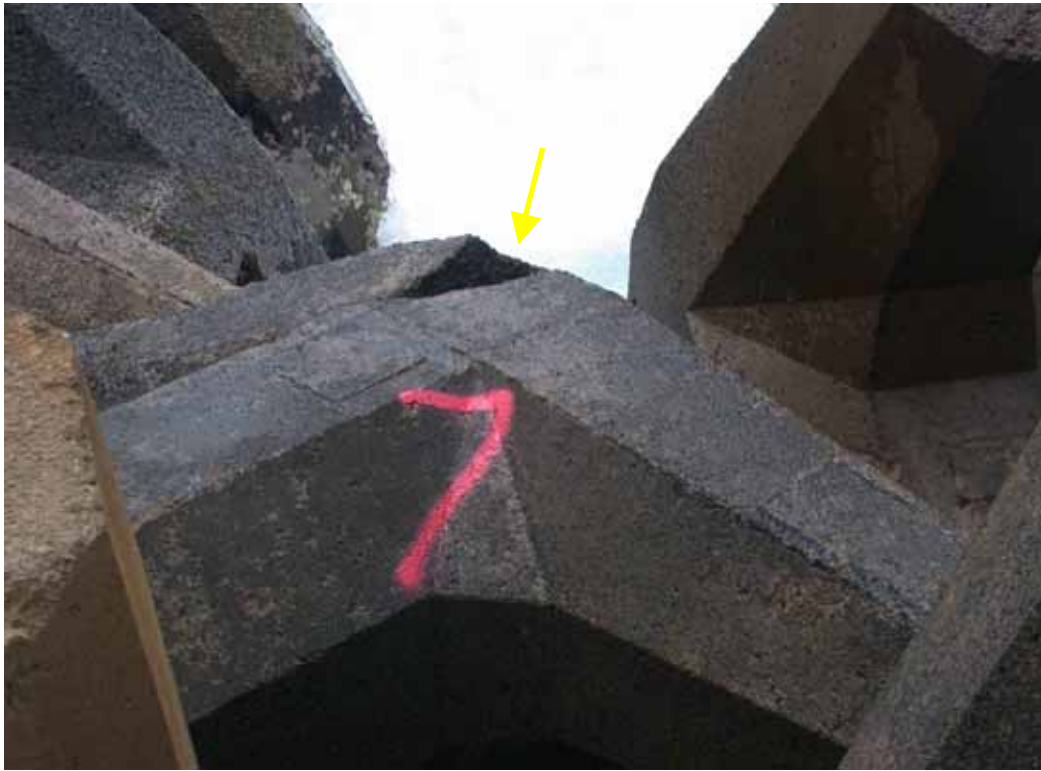
Figure D32. Damage location 37, sta 13+38 – 13+44, ocean side, rib #24 & 25, dolosse with fluke-shank break.

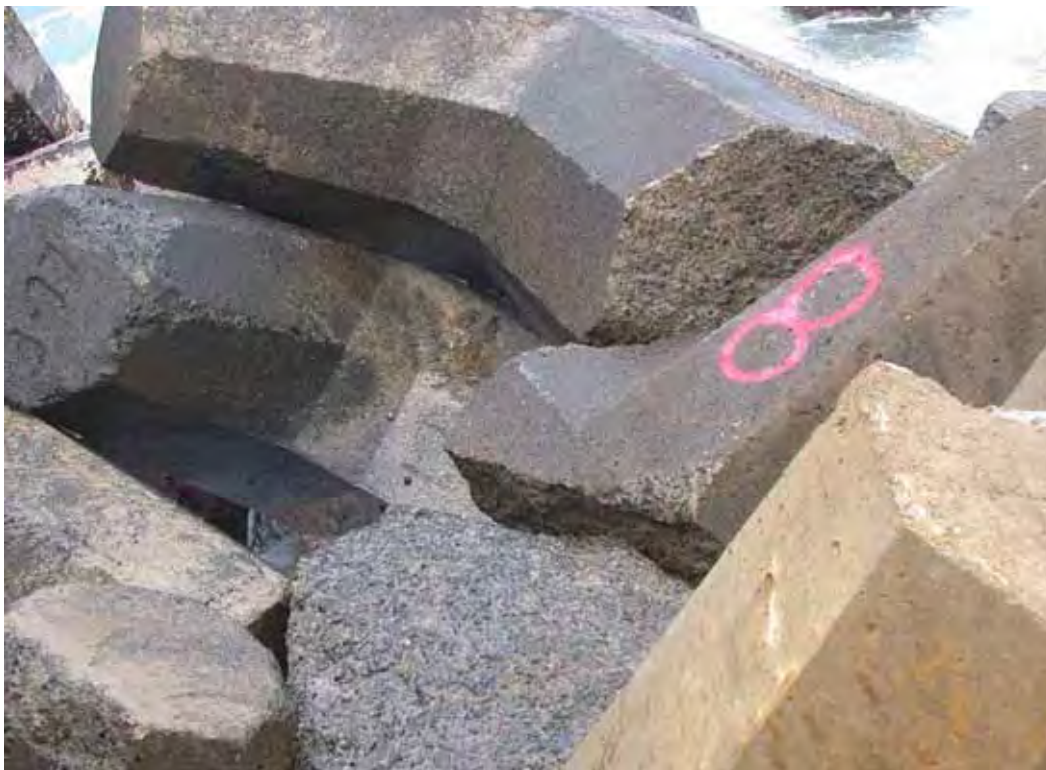
Figure D33. Damage location 38, sta 13+44 – 13+50, ocean side, rib #25 & 26, dolosse with mid-shank and fluke-shank breaks.

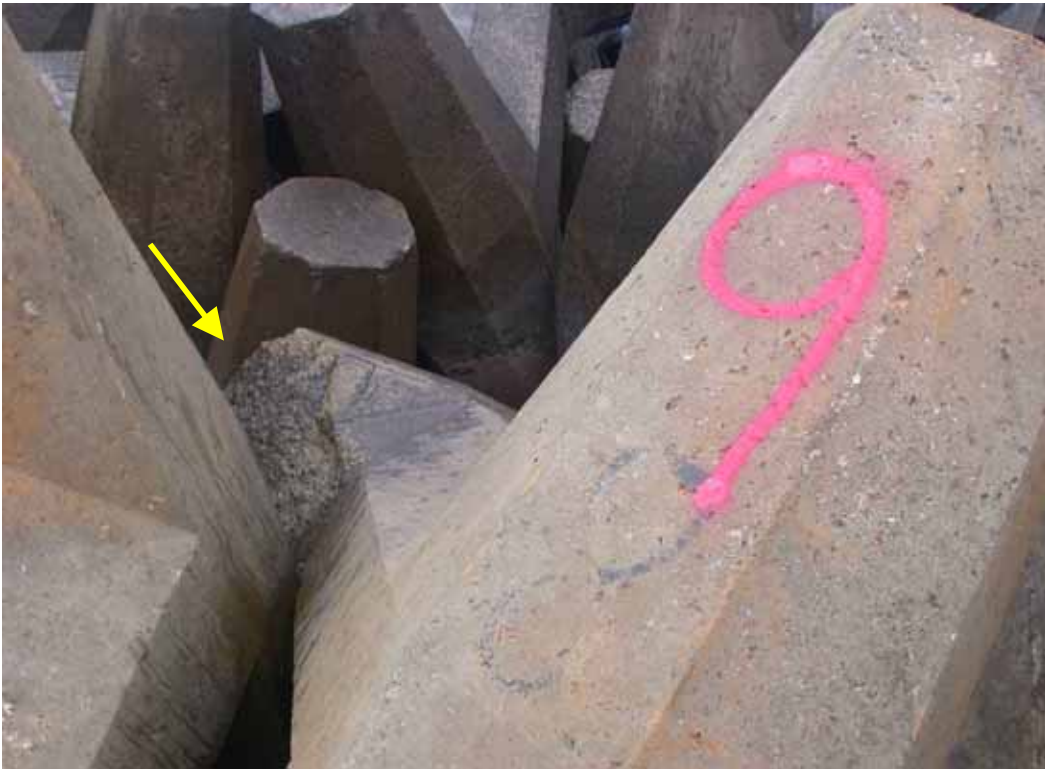
Figure D34. Damage location 39, sta 13+62, ocean side, rib #28, dolosse with fluke-shank break.

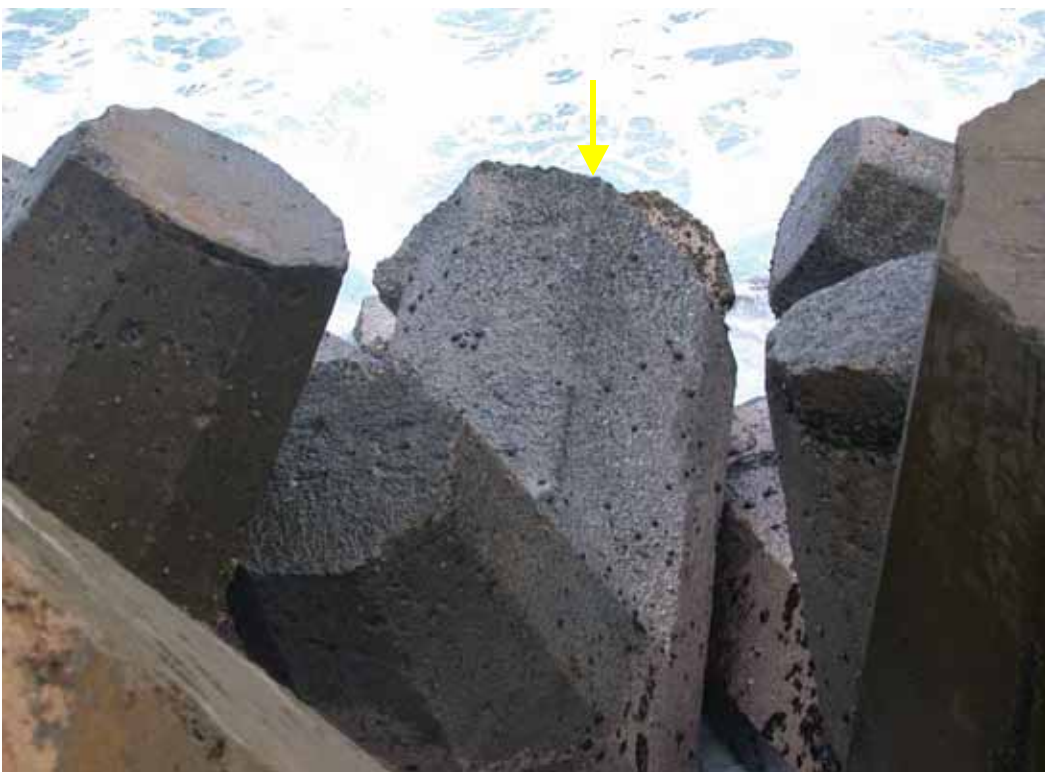
Figure D35. Damage location 40, sta 13+80, ocean side, rib #31, dolosse with shank-fluke break at waterline.

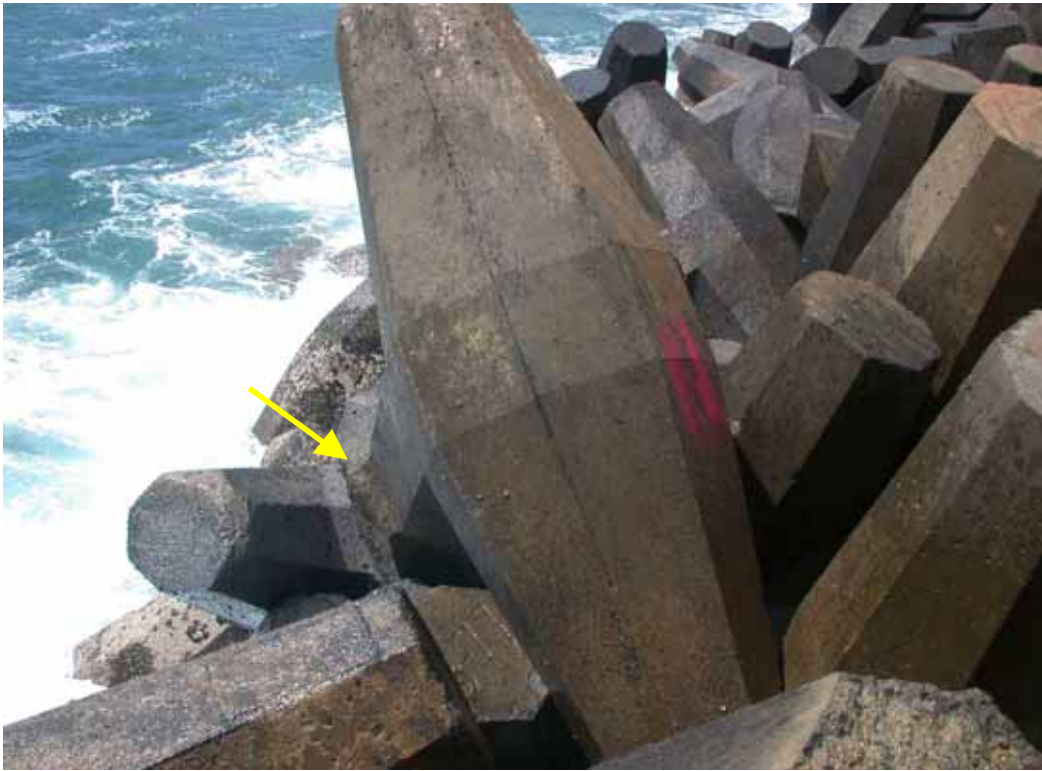
Figure D36. Damage location 41, sta 13+92 – 13+98, ocean side, rib #33 & 34, dolosse with fluke-shank break.

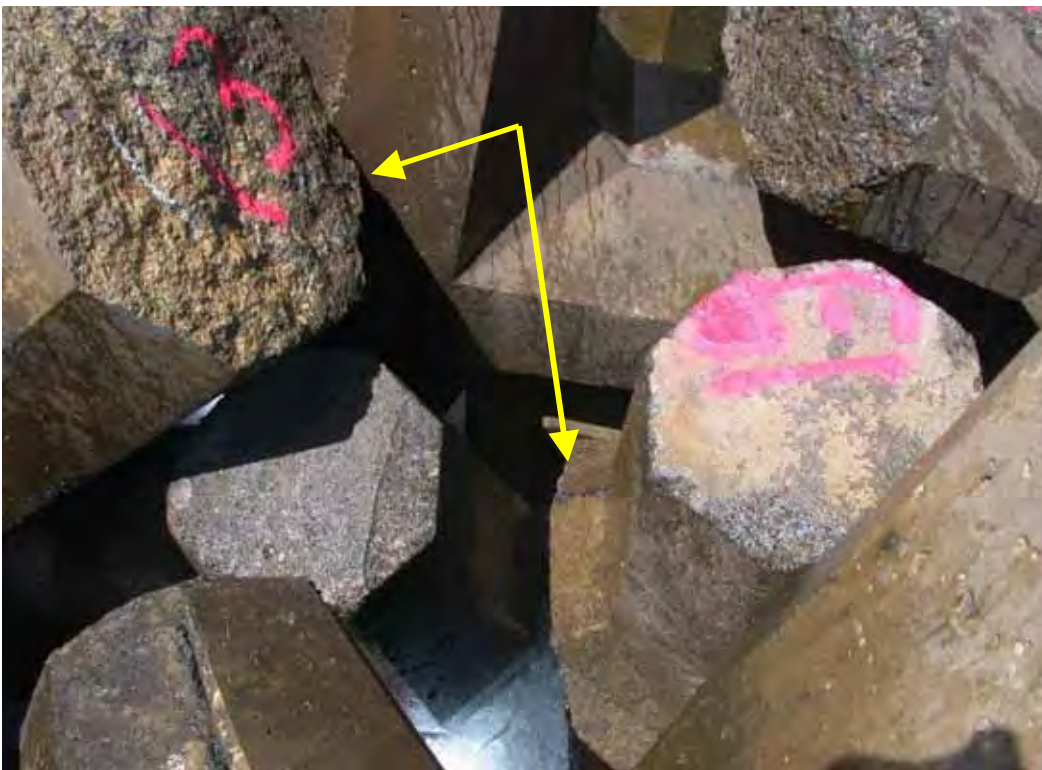
Figure D37. Damage location 43, sta 14+04, ocean side, rib #35, dolosse with mid-shank break.

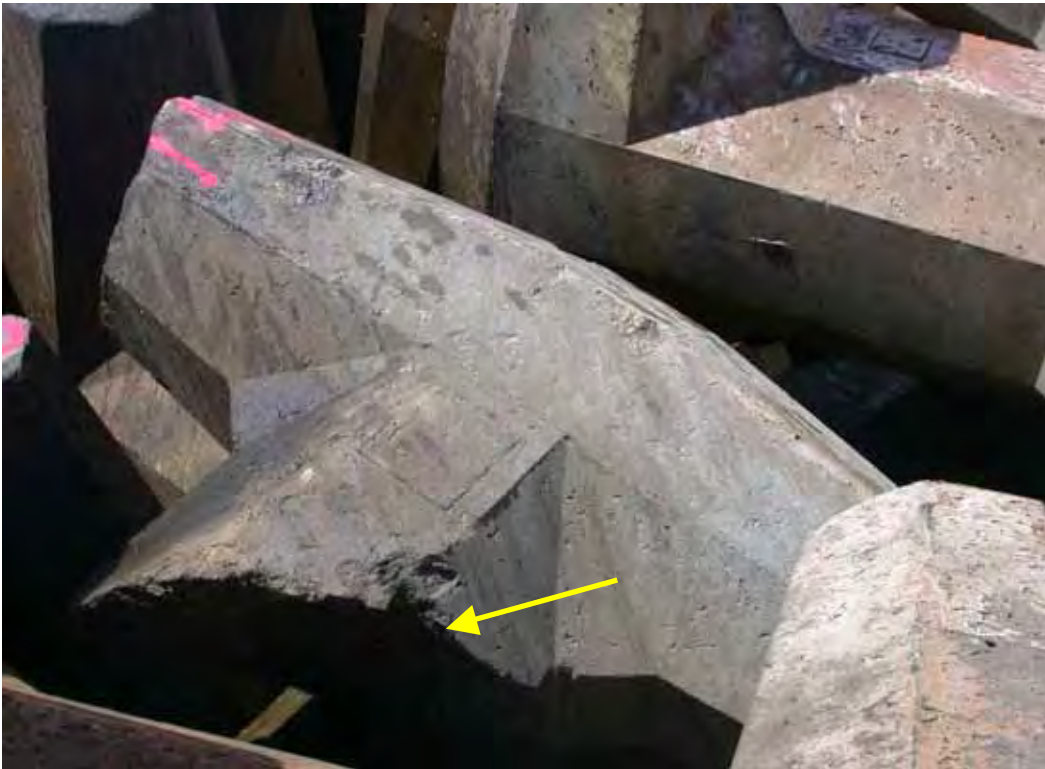
Figure D38. Damage location 44, sta 14+04, ocean side, rib #35, dolosse with mid-shank break.

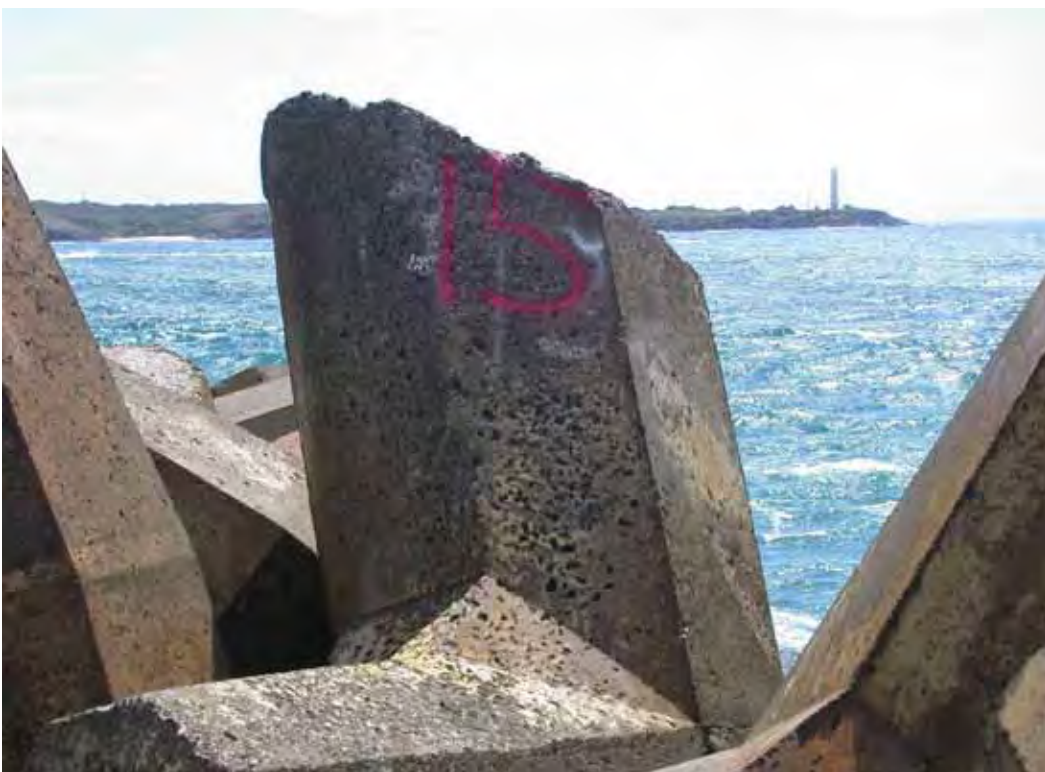
Figure D39. Damage location 45, sta 14+52, ocean side, rib #43, dolosse with shank-fluke break.

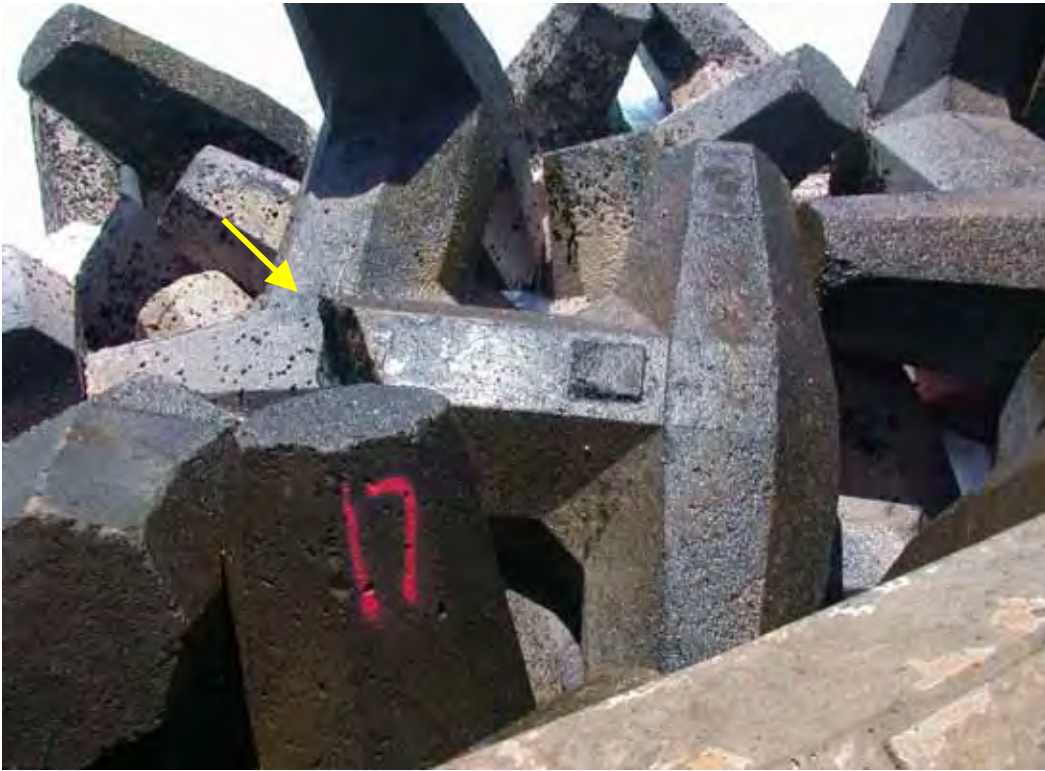
Figure D40. Damage location 49, sta 14+88, ocean side, rib #49, dolosse with fluke-shank break.

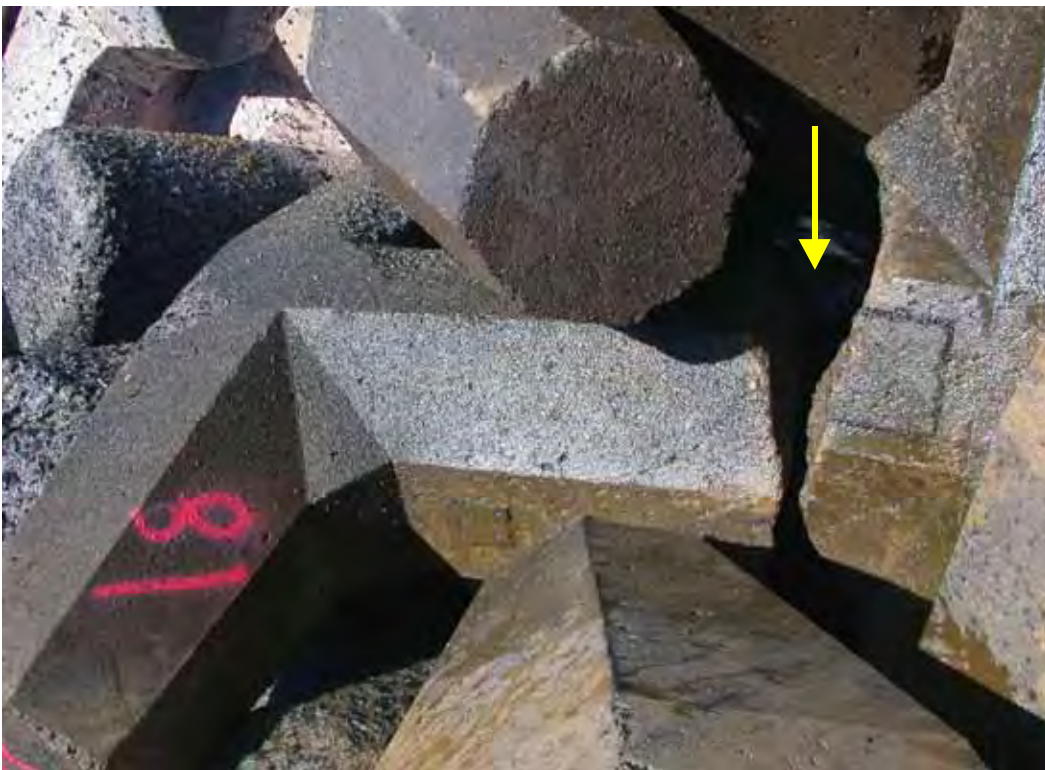
Figure D41. Damage location 50, sta 14+94, ocean side, rib #50, dolosse with shank-fluke break.

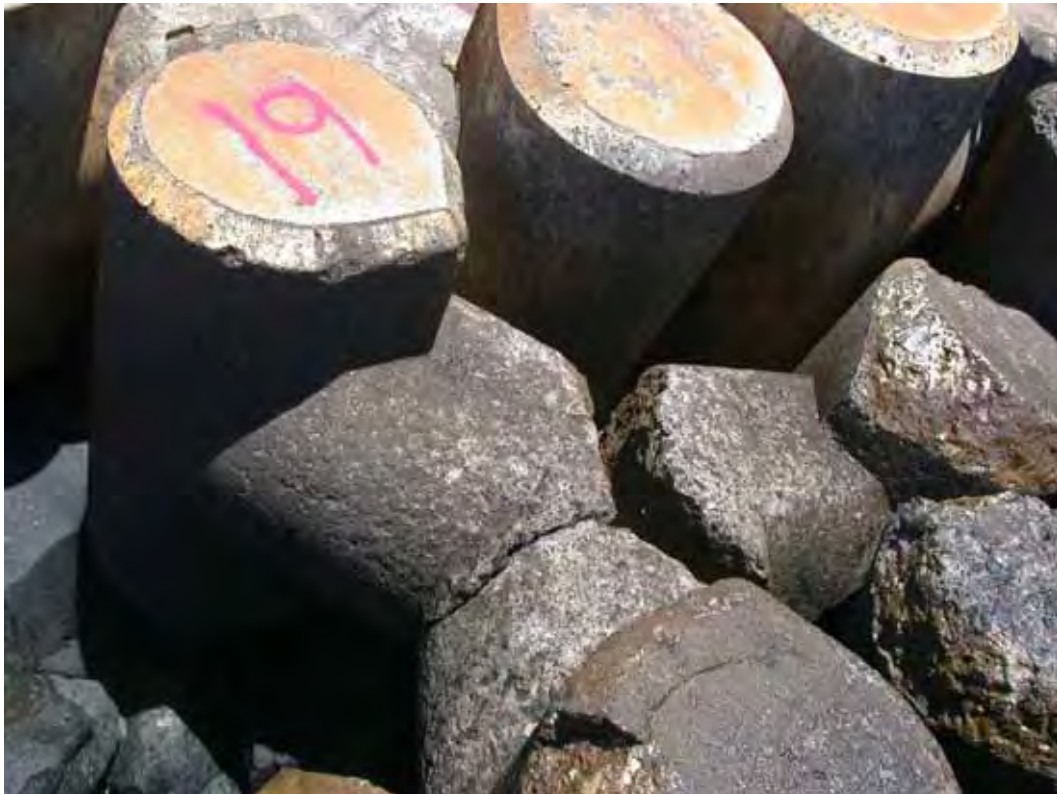
Figure D42. Damage location 51, sta 15+00, ocean side, rib #51, tribar with 3-way split.

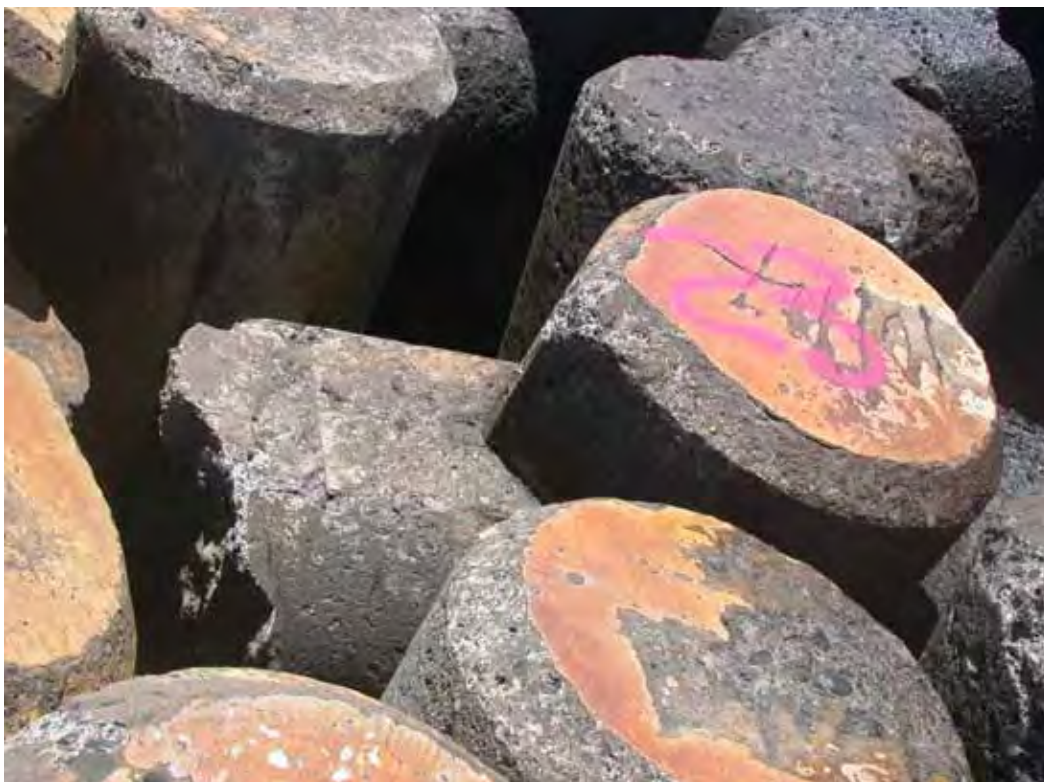
Figure D43. Damage location 55, sta 15+60, ocean side, rib #61, tribar with 3-way break at center.

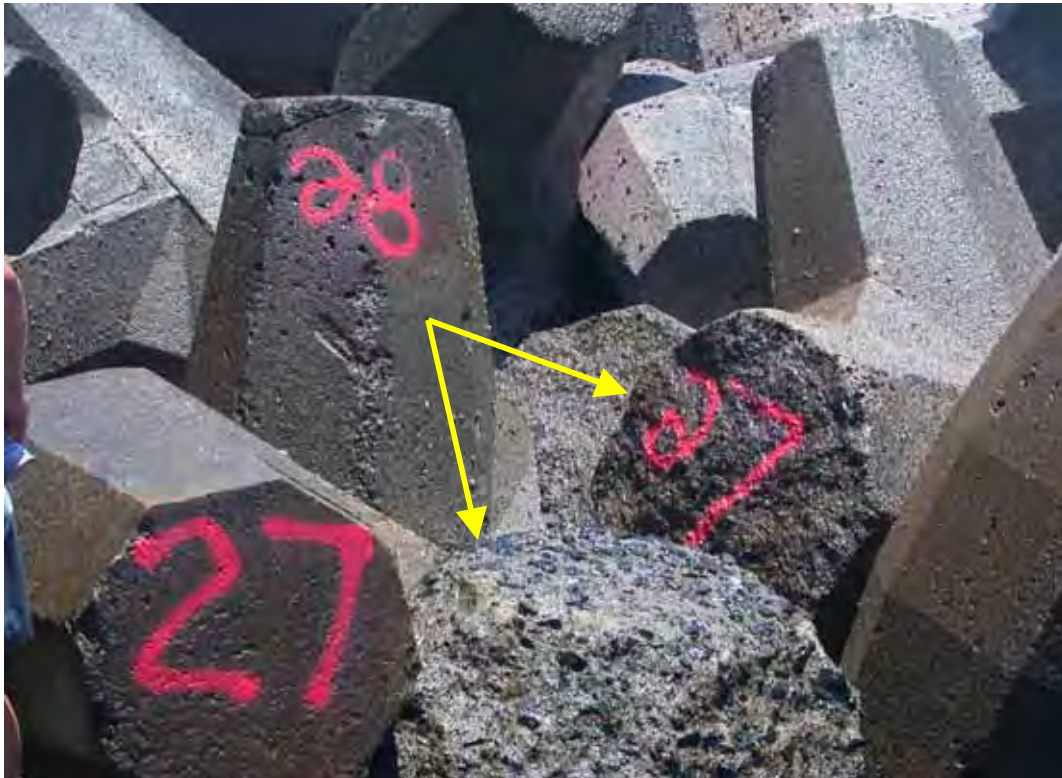
Figure D44. Damage locations 59 & 60, sta 15+96 - 16+02, ocean side, rib #67 & 68, two dolosse with mid-shank breaks.

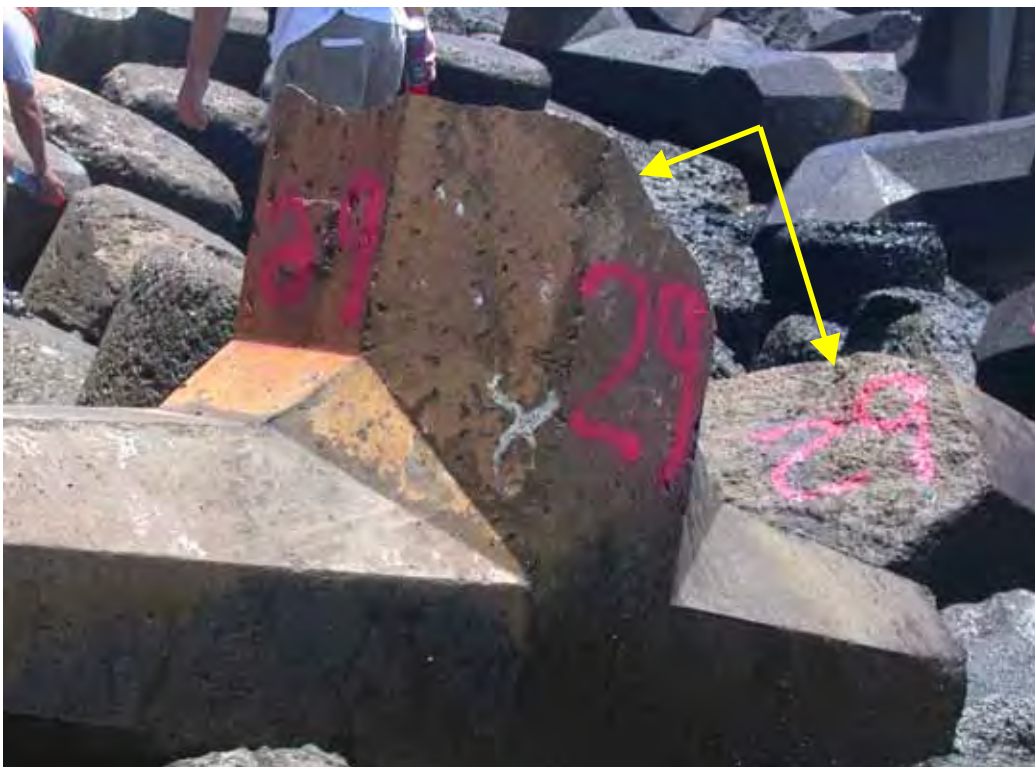
Figure D45. Damage location 61, sta 16+02, ocean side, rib #68, dolosse with mid-shank break.

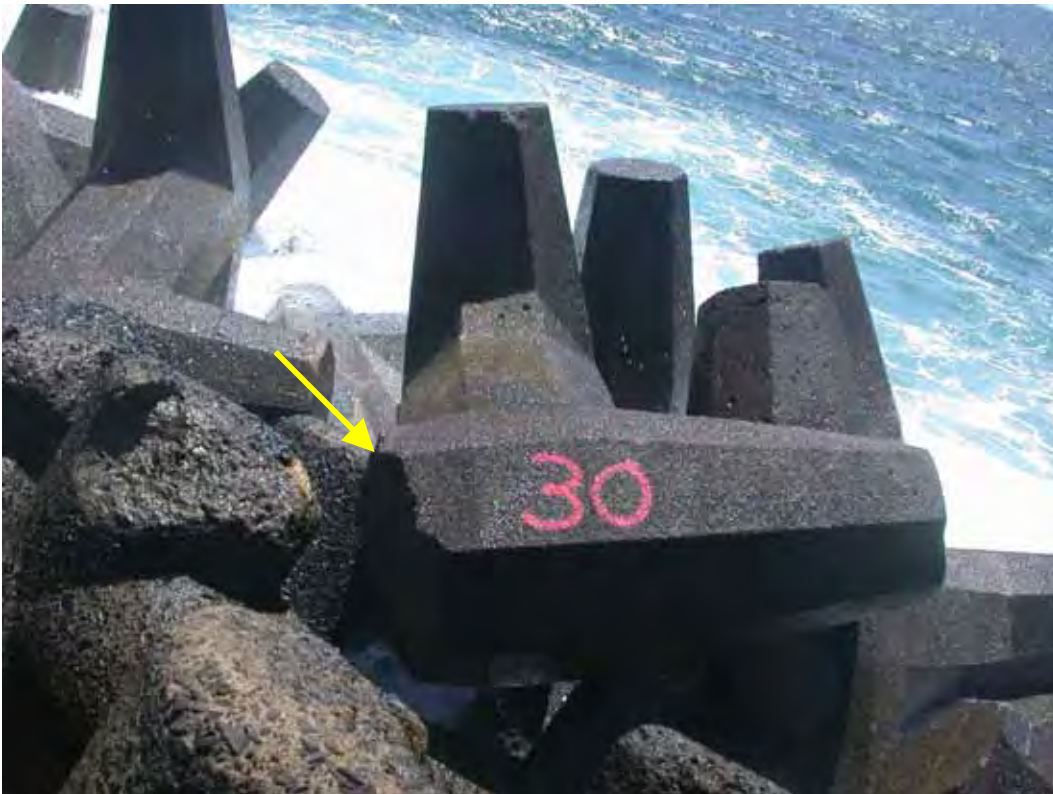
Figure D46. Damage location 63, sta 16+14, ocean side, rib #70, dolosse with fluke tip break.

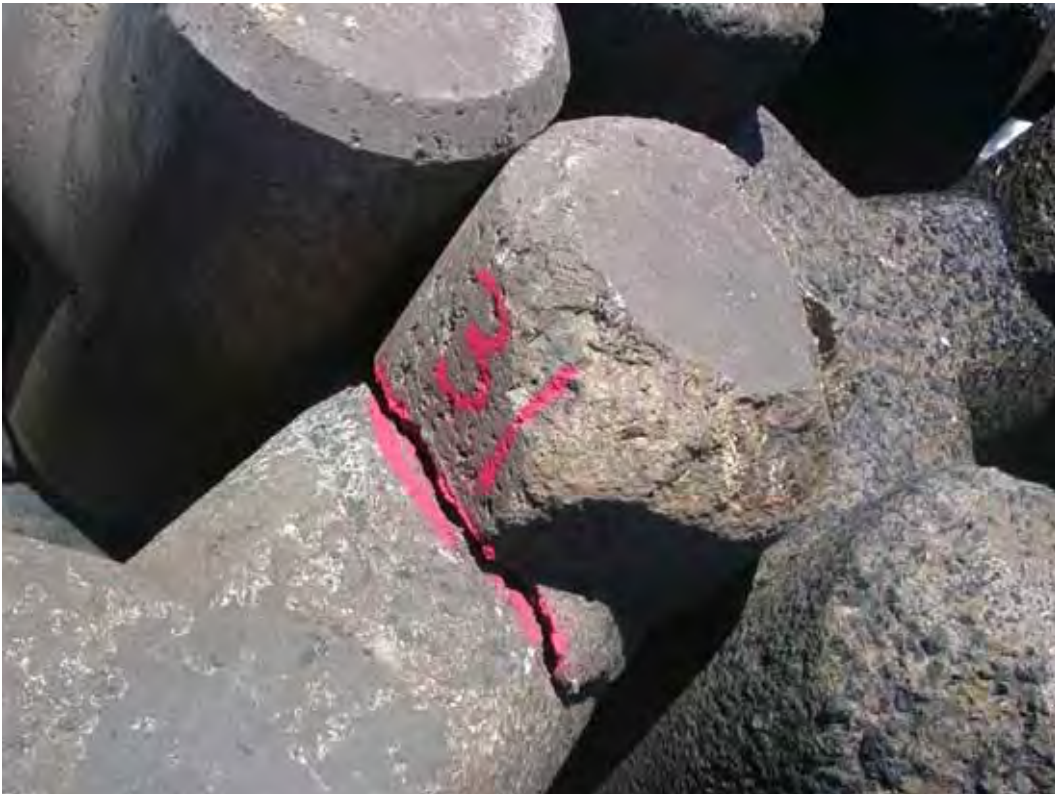
Figure D47. Damage location 64, sta 16+14, ocean side, rib #70, tribar with broken can.

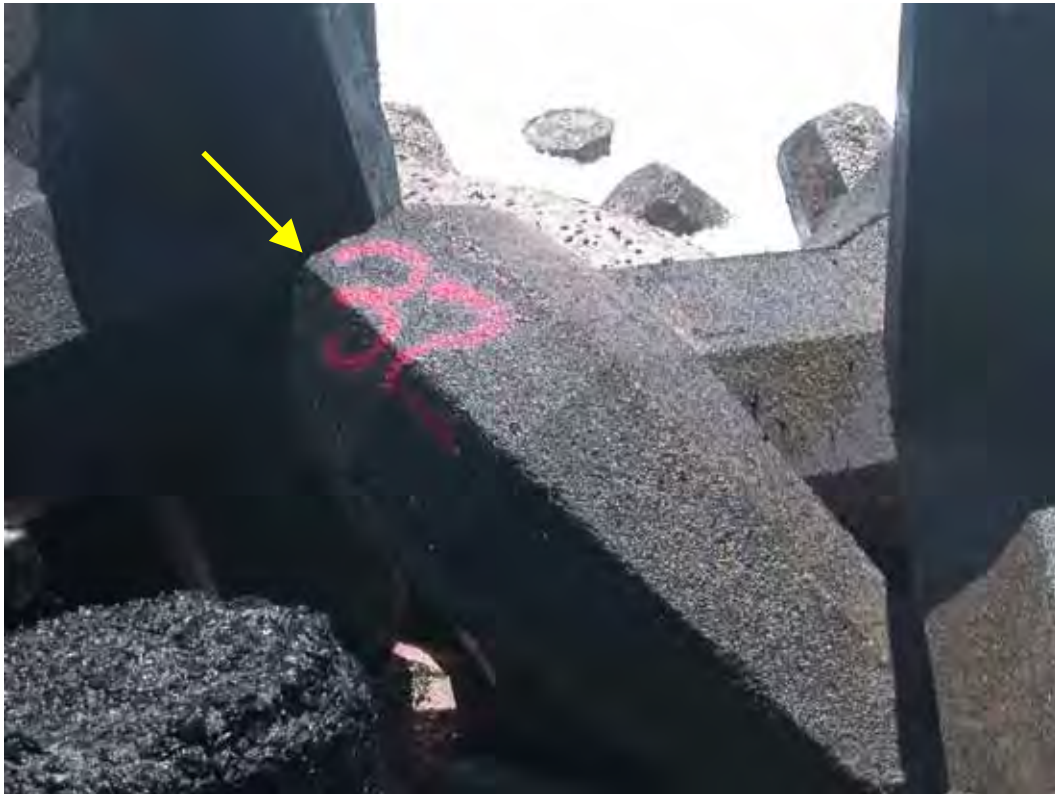
Figure D48. Damage location 64, sta 16+32, ocean side, rib #73, dolosse with fluke tip break.

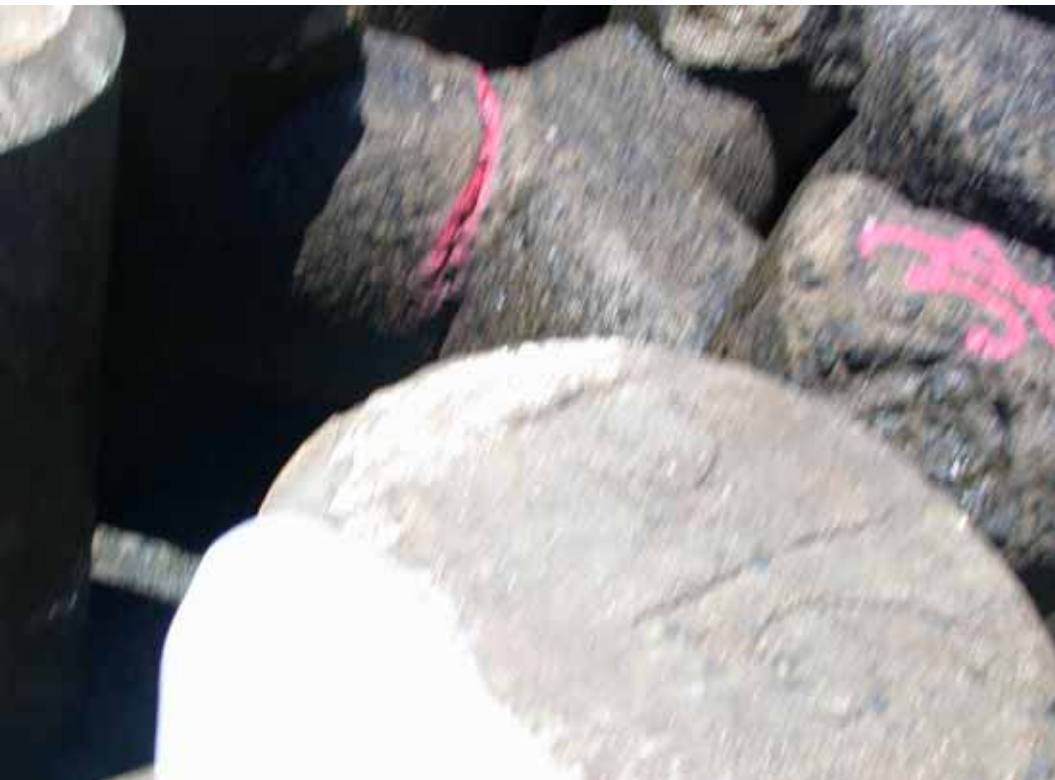
Figure D50. Damage location 66, sta 16+68, ocean side, rib #79, tribar broken through center-no separation.

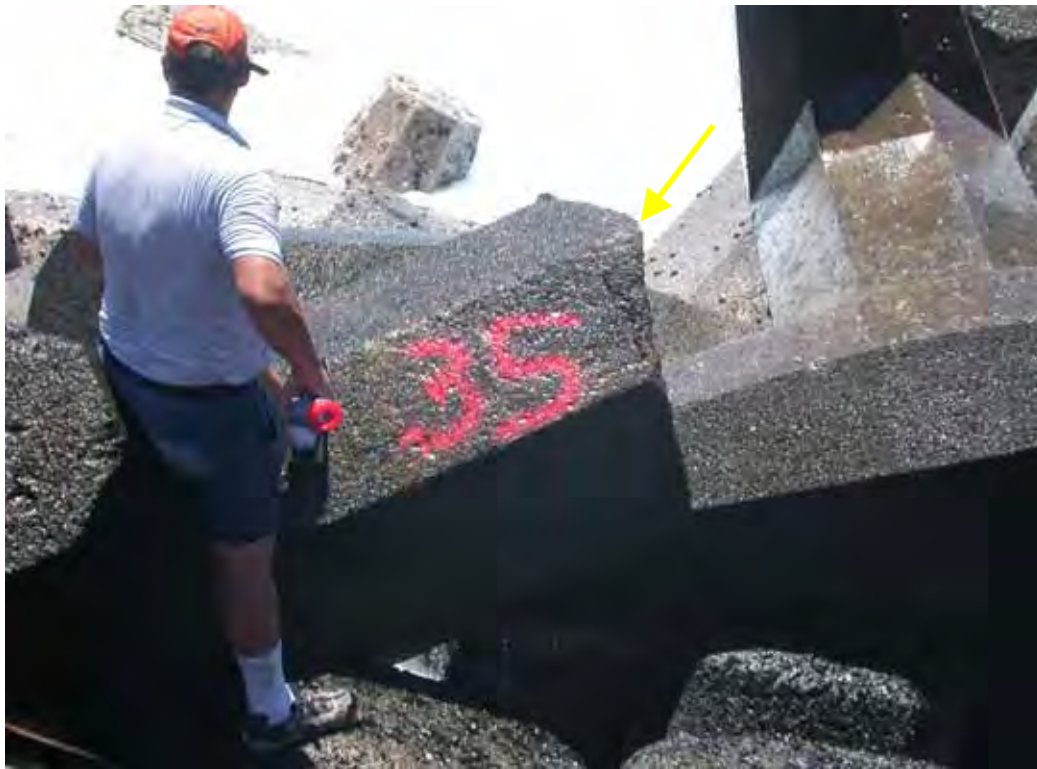
Figure D51. Damage location 67, sta 16+74, ocean side, rib #80, dolosse with shank-fluke break.

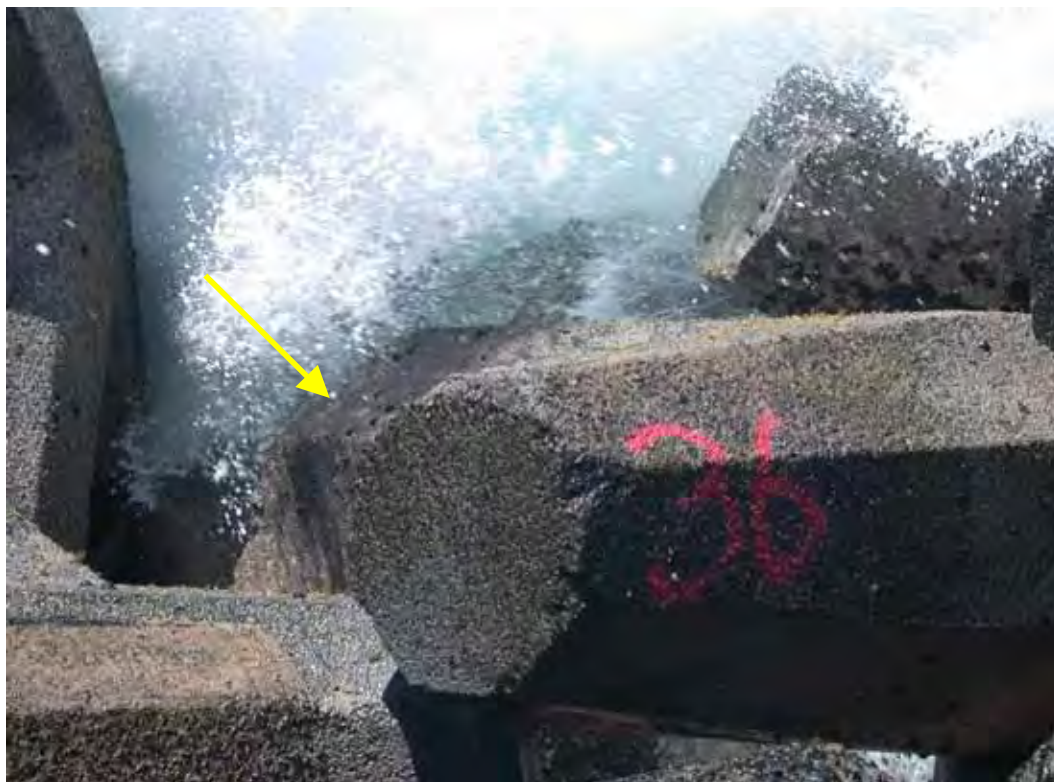
Figure D52. Damage location 68, sta 16+80, ocean side, rib #81, dolosse with shank-fluke break.

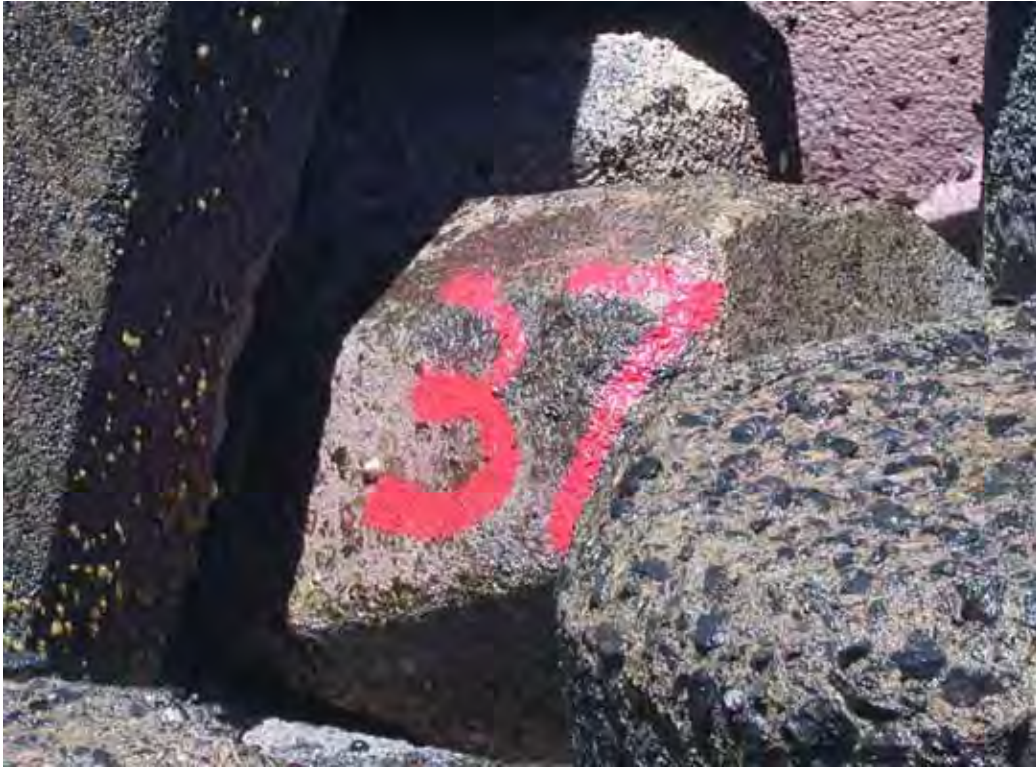
Figure D53. Damage location 69, sta 16+98, ocean side, rib #84, detached dolosse fluke tip, origin unknown.

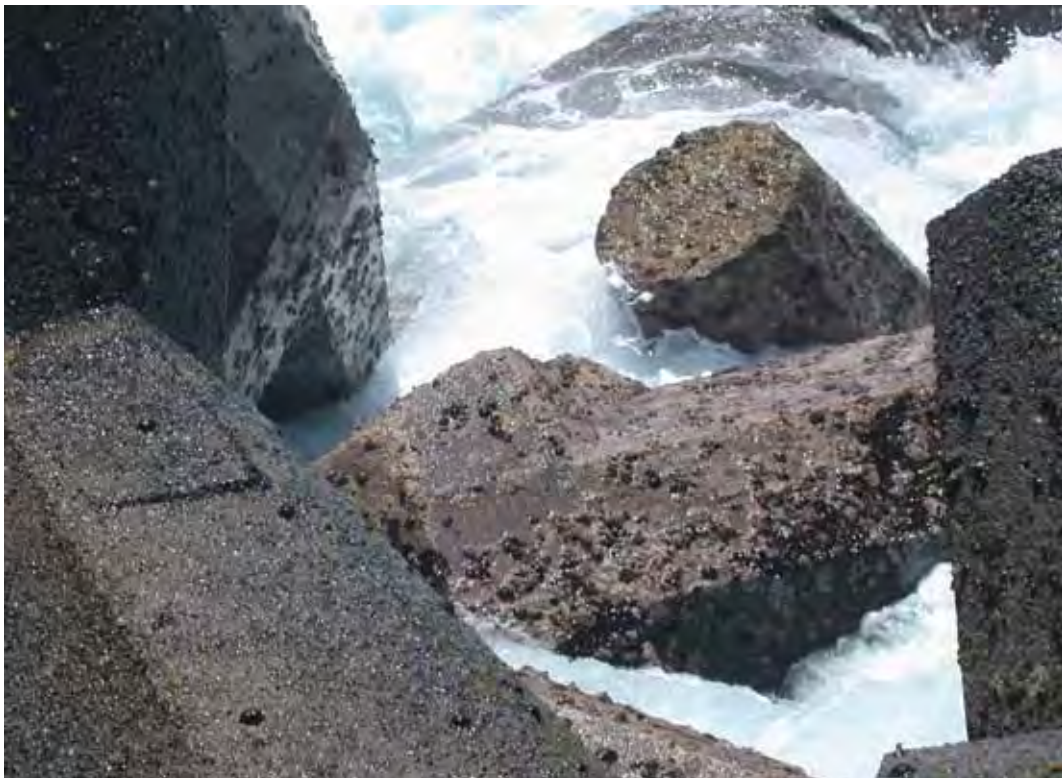
Figure D54. Damage location 71, sta 17+22, ocean side, rib #88, dolosse with multiple breaks at waterline.
