Monitoring Completed Navigation Projects Program

Periodic Inspections of Hilo, Kahului, Laupahoehoe, and Nawiliwili Breakwaters, Hawaii

Armor Unit Monitoring for Period 2001-2005

October 2011

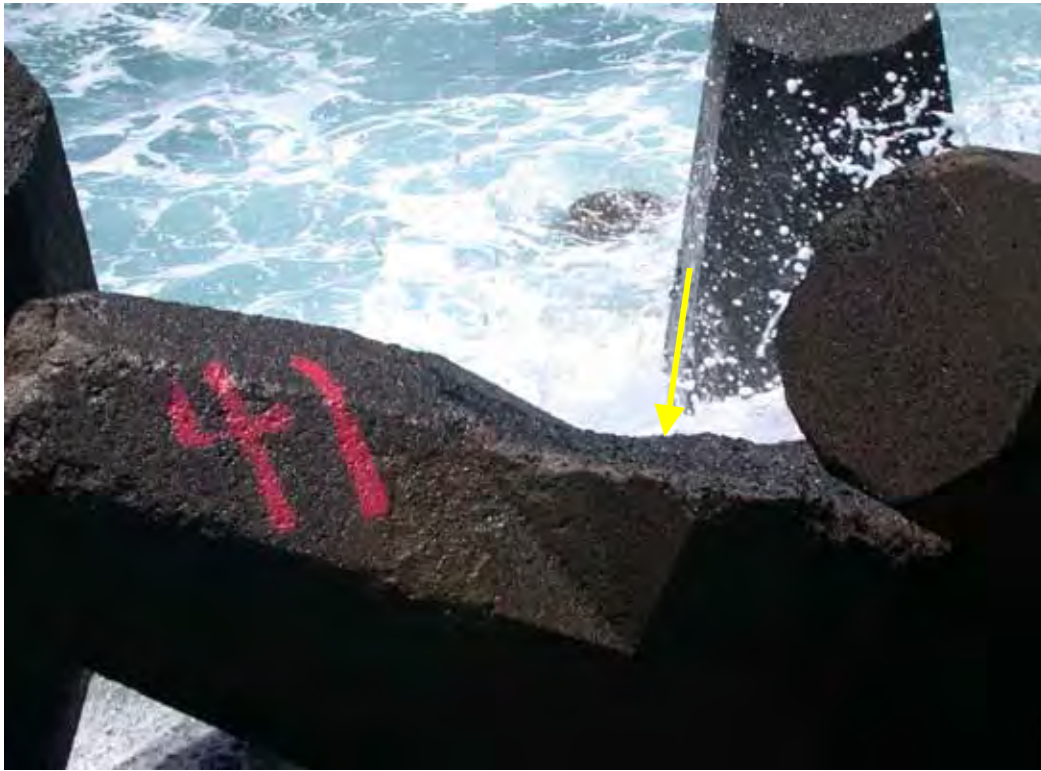
Figure D55. Damage location 73, sta 17+58, ocean side, rib #94, dolosse with shank-fluke break.

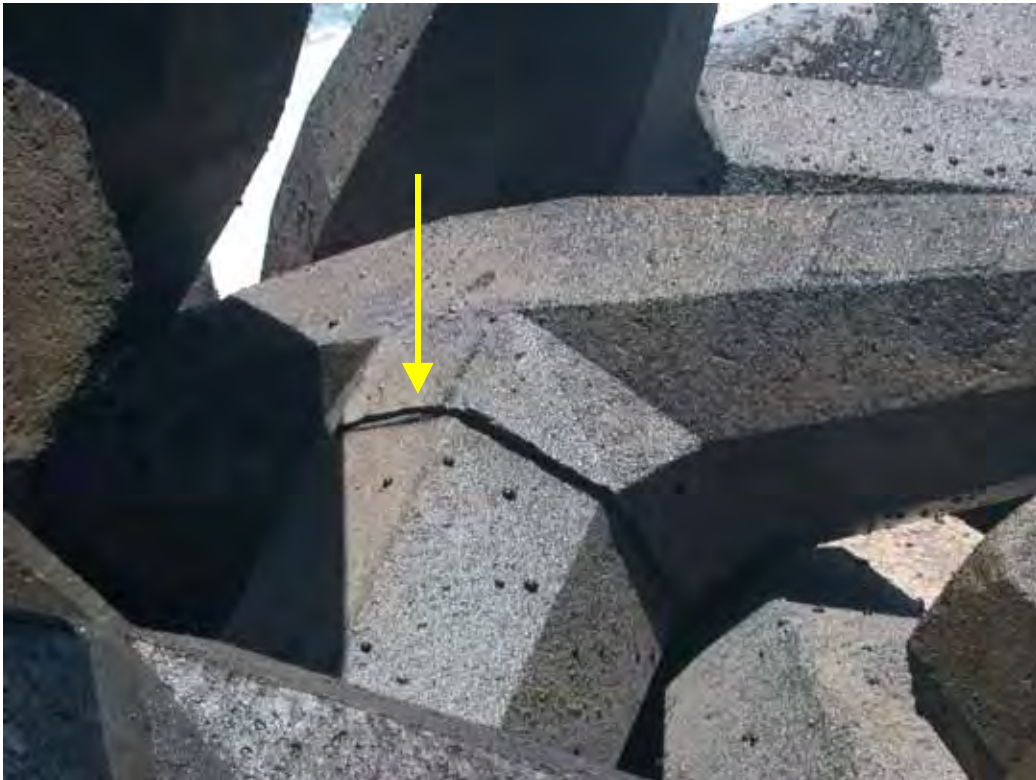
Figure D56. Damage location 74, sta 17+94, ocean side, rib #100, dolosse with broken fluke tip.

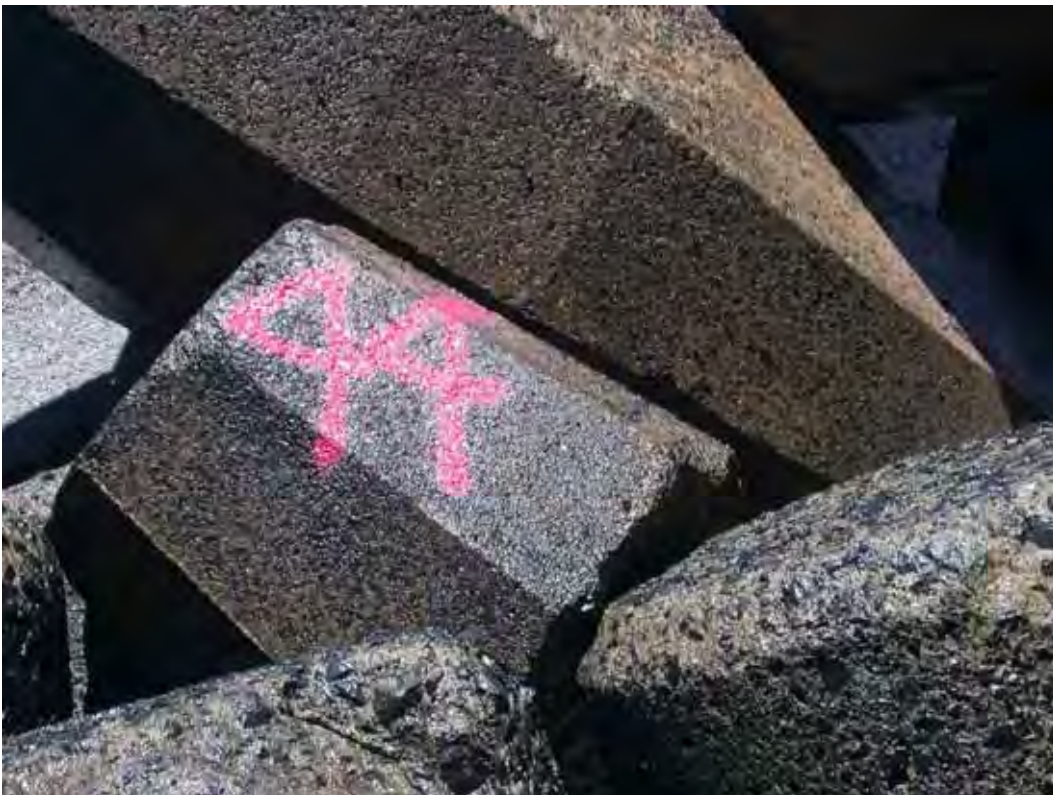
Figure D57. Damage location 75, sta 18+18, ocean side, rib #104, dolosse with shank break.

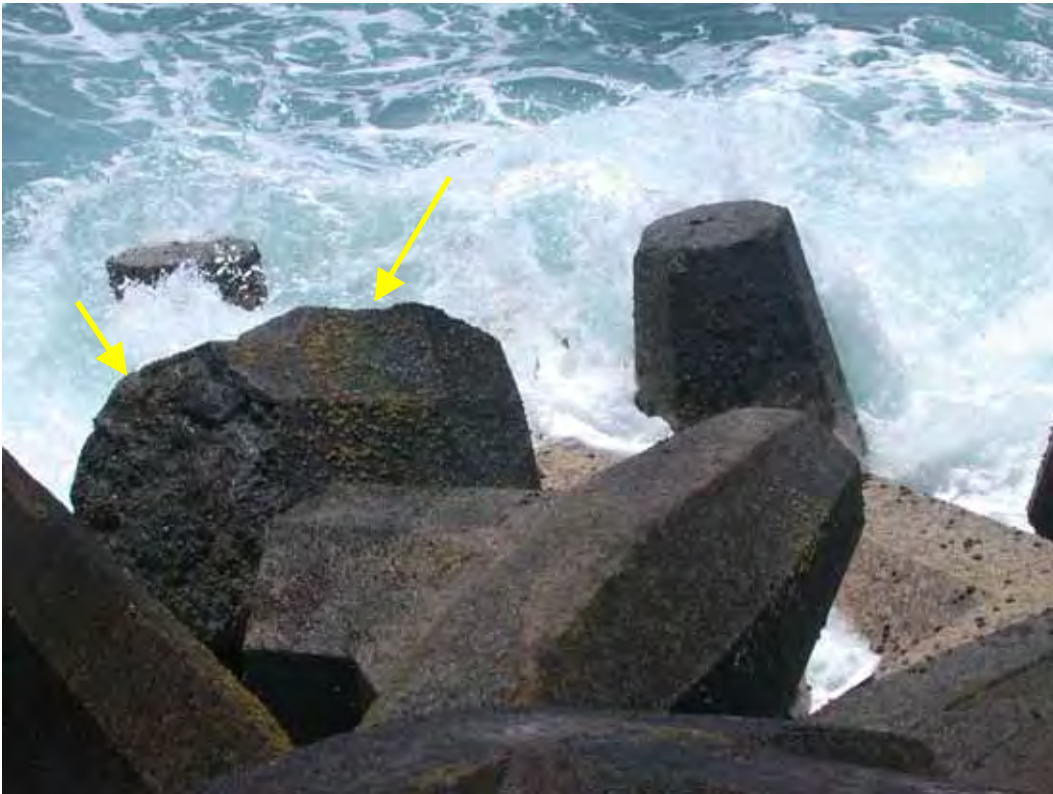
Figure D58. Damage location 76, sta 18+24, ocean side, rib #105, dolosse with fluke tip break.

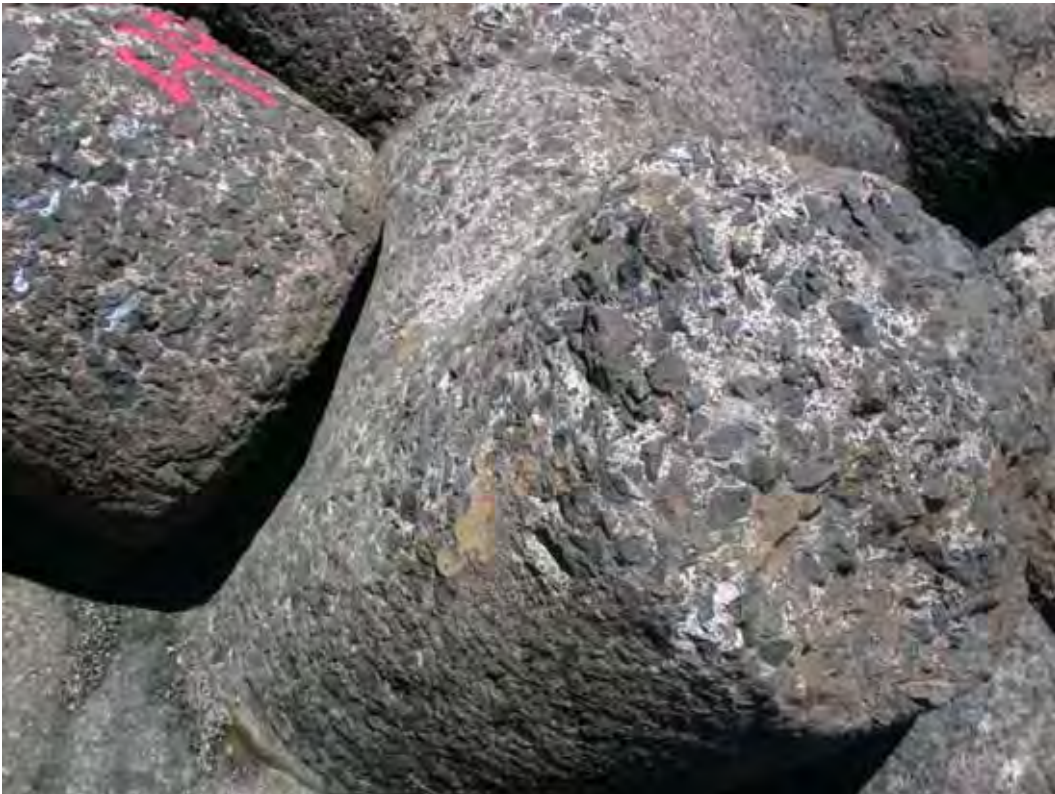
Figure D59. Damage location 79, sta 18+54, ocean side, rib #110, dolosse with multiple breaks.

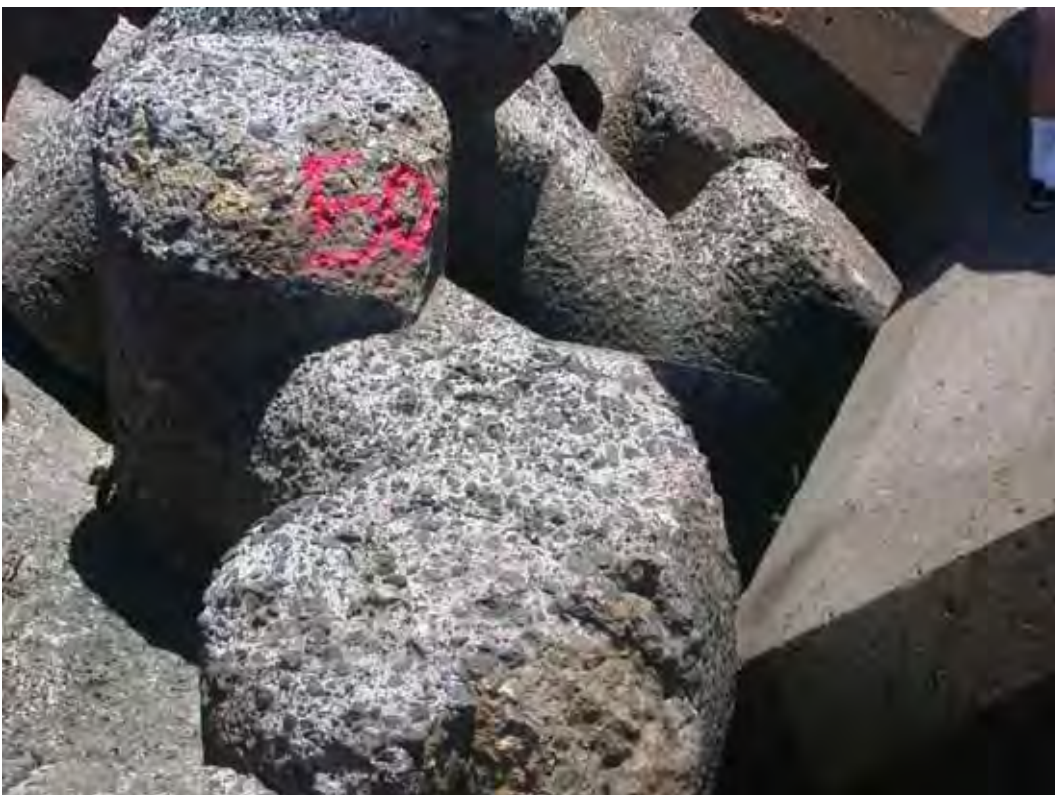
Figure D60. Damage location 81, sta 18+72, ocean side, rib #113, tribar with broken can.

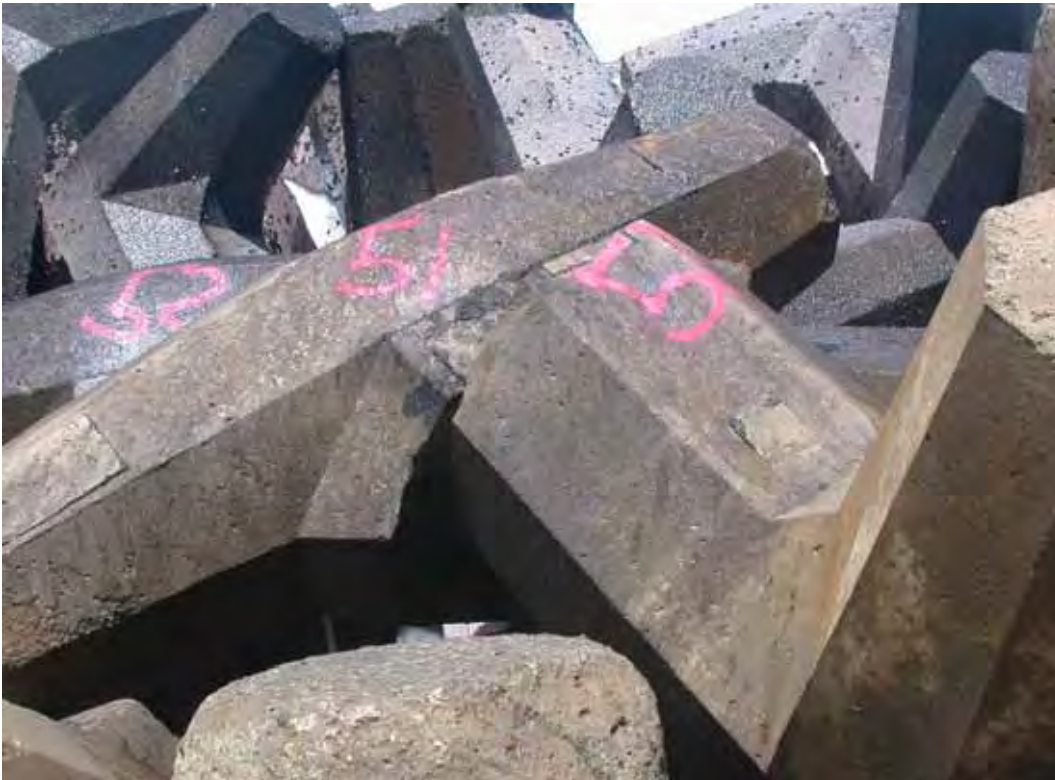
Figure D61. Damage location 82, sta 18+84, ocean side, rib #115, tribar with broken can.

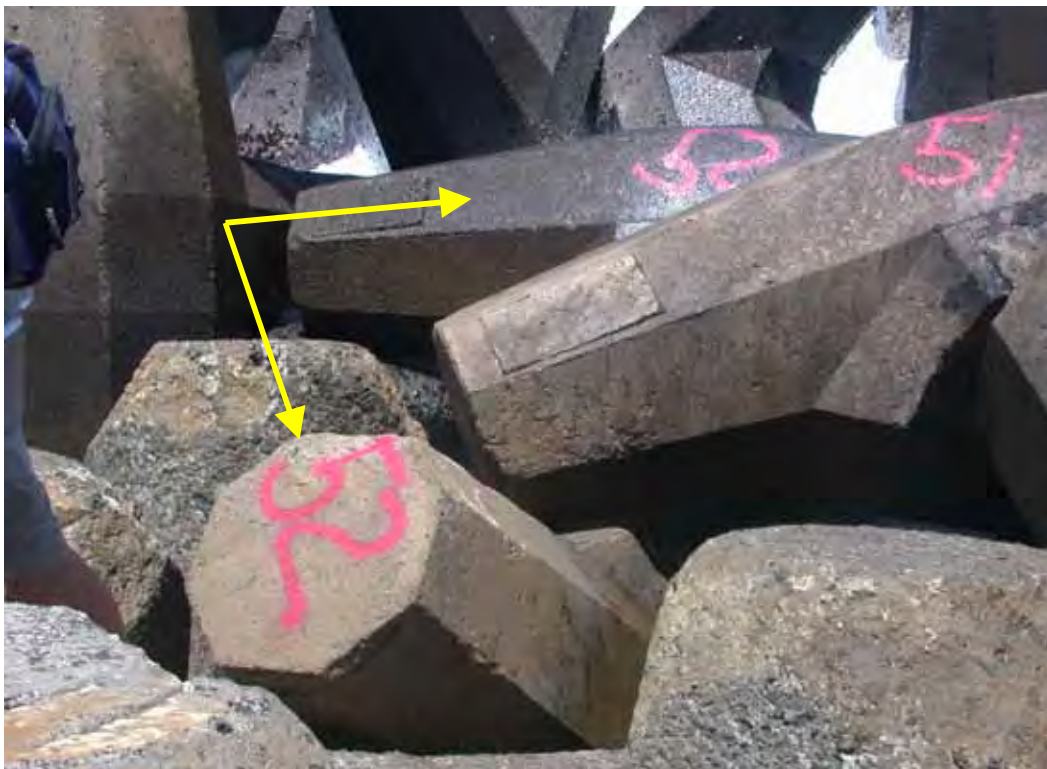
Figure D62. Damage location 83, sta 19+08, ocean side, rib #119, dolosse with shank-fluke break.

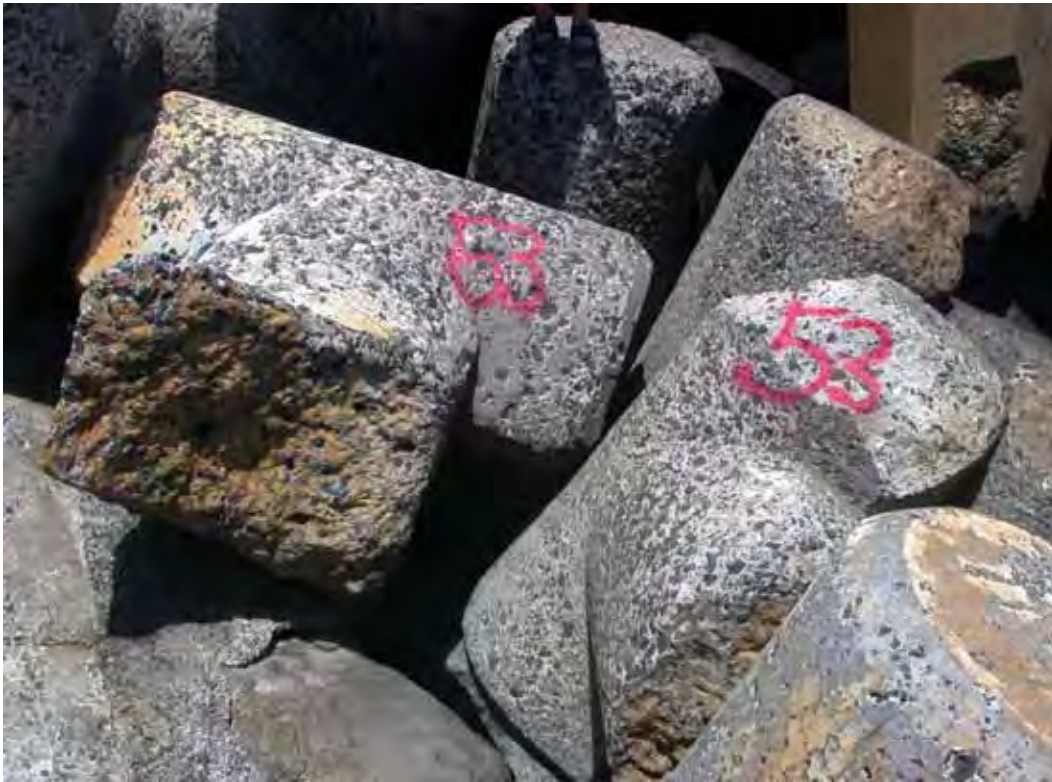
Figure D63. Damage location 84, sta 19+14, ocean side, rib #120, dolosse with shank-fluke break.

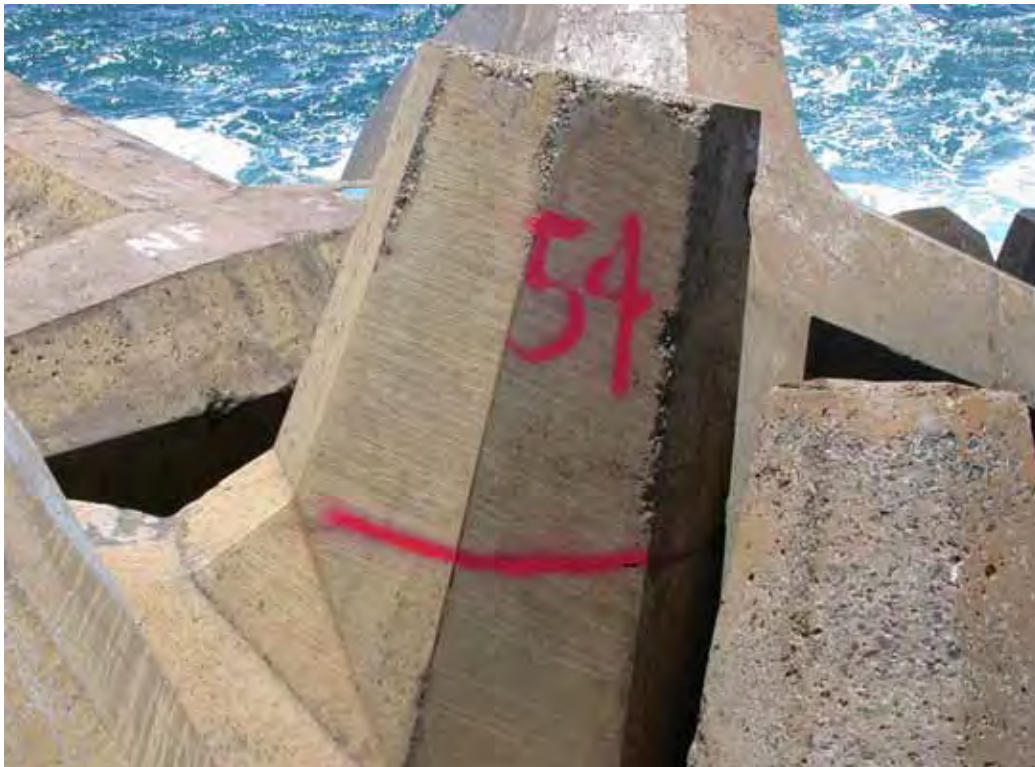
Figure D64. Damage location 85, sta 19+20, ocean side, rib #121, tribar broken through center.

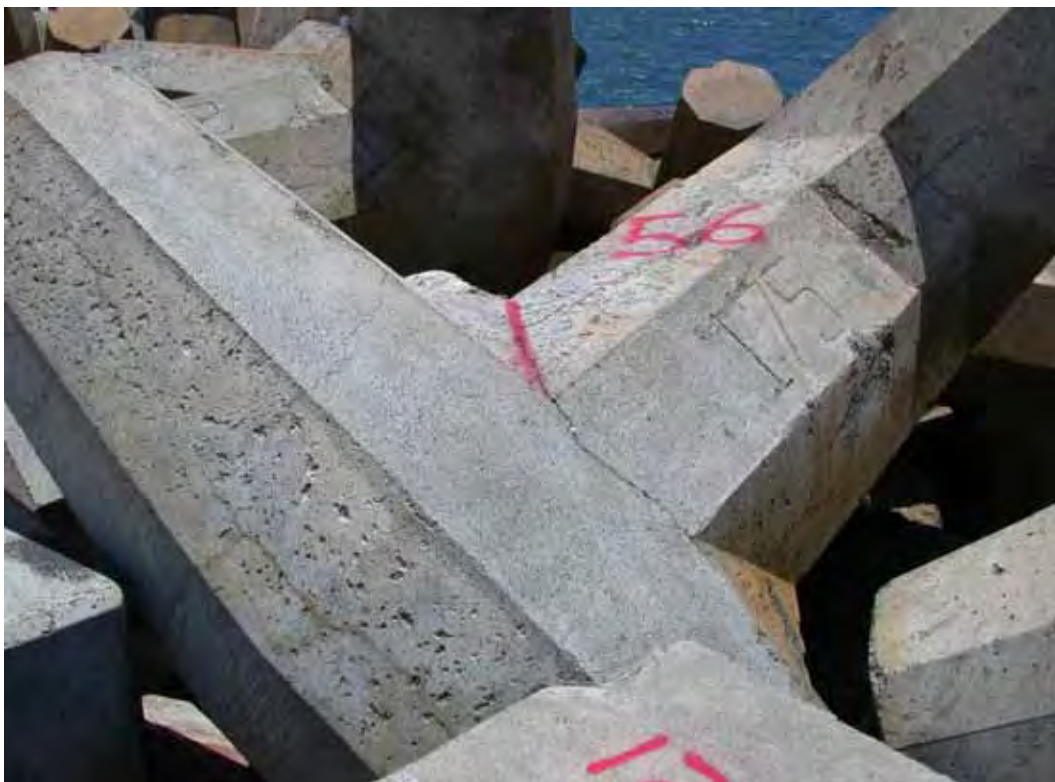
Figure D66. Damage location 88, sta 19+48, ocean side, rib #124, tribar with broken leg.

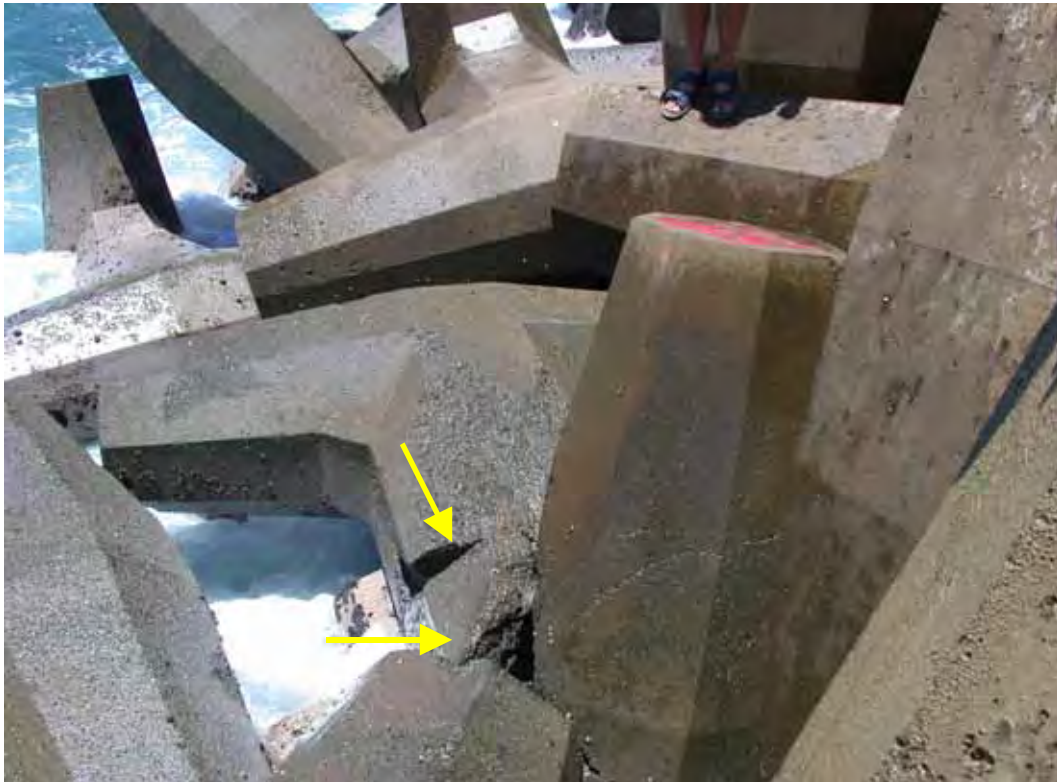
Figure D67. Damage location 89, sta 19+60, ocean side, rib #126, dolosse with shank-fluke crack, still intact.

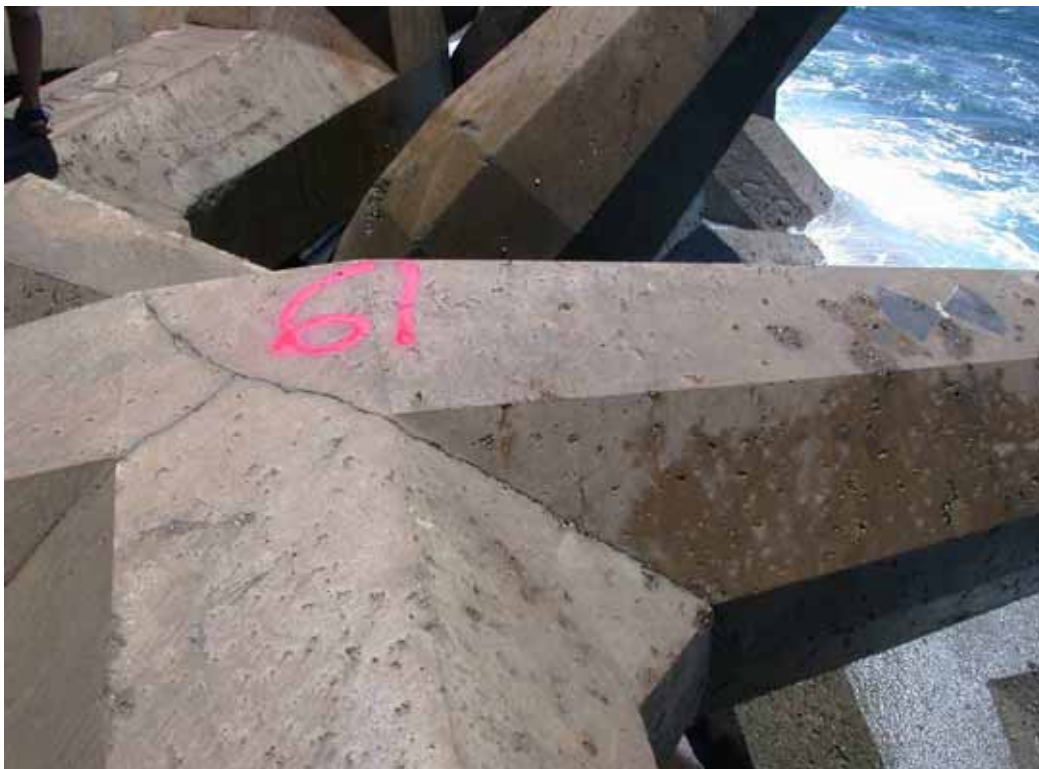
Figure D68. Damage location 91, sta 19+66, ocean side, rib #127, dolosse with multiple breaks.

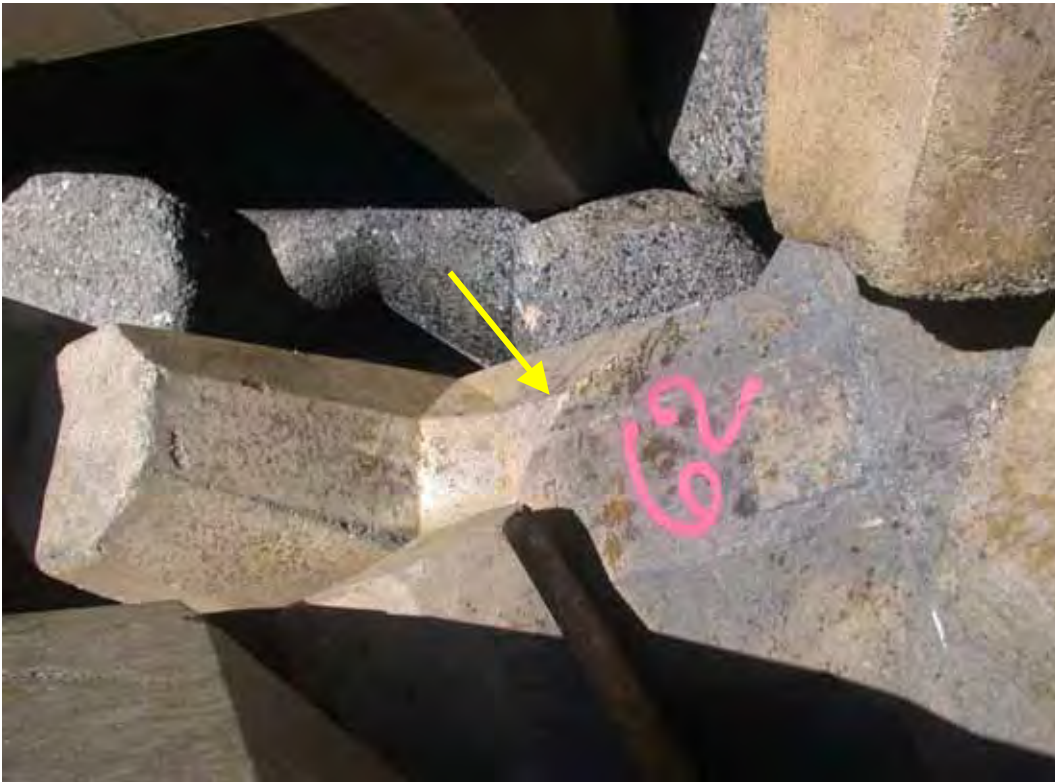
Figure D69. Damage location 93, sta 19+78, ocean side, rib #129, target dolosse cracked through fluke.

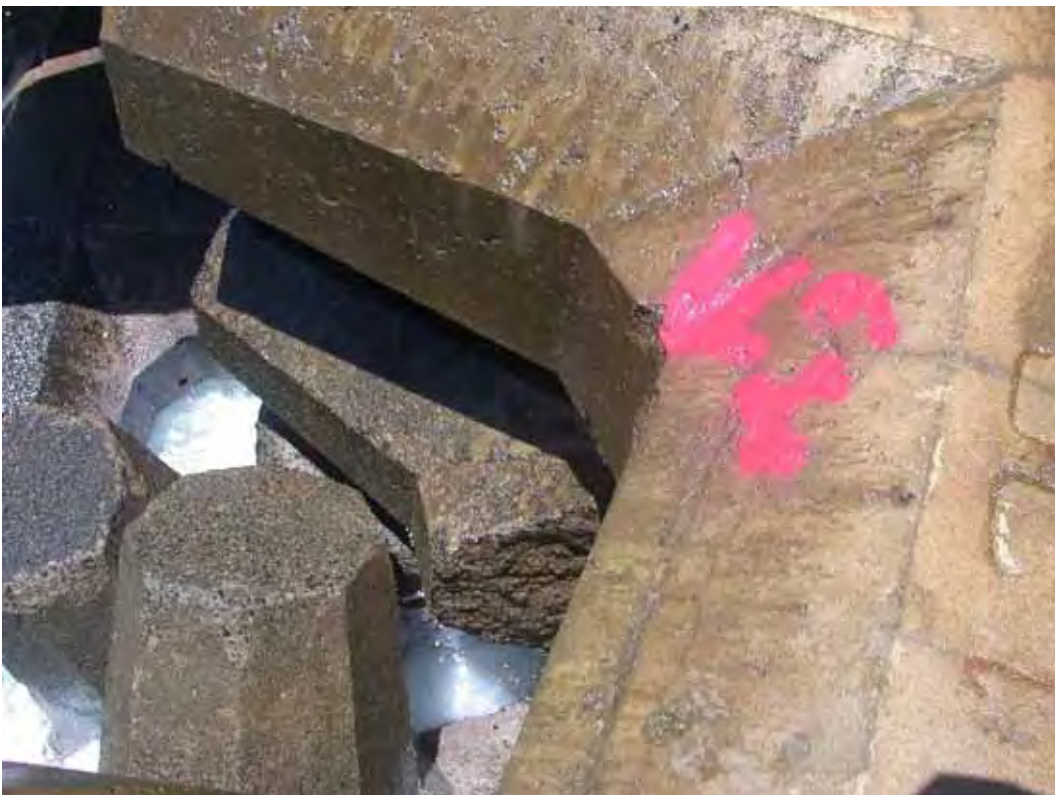
Figure D70. Damage location 94, sta 19+78, ocean side, rib #129, dolosse with mid-shank break.

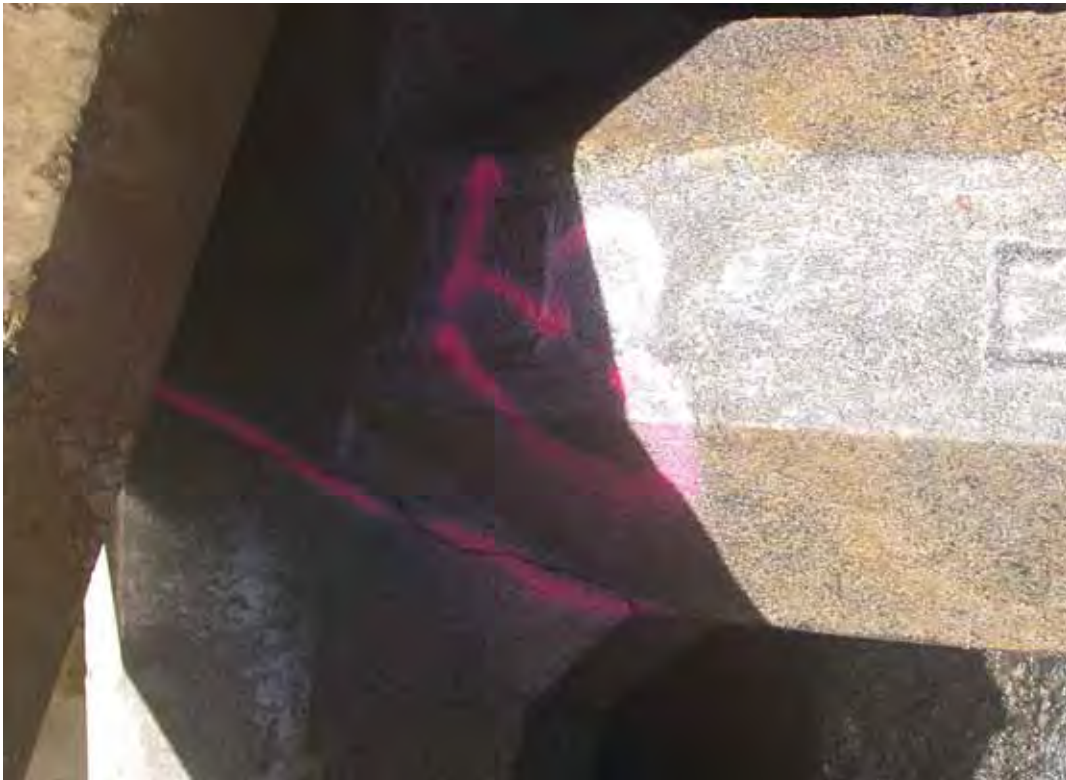
Figure D71. Damage location 96, sta 19+90, ocean side, rib #131, dolosse with shank break.

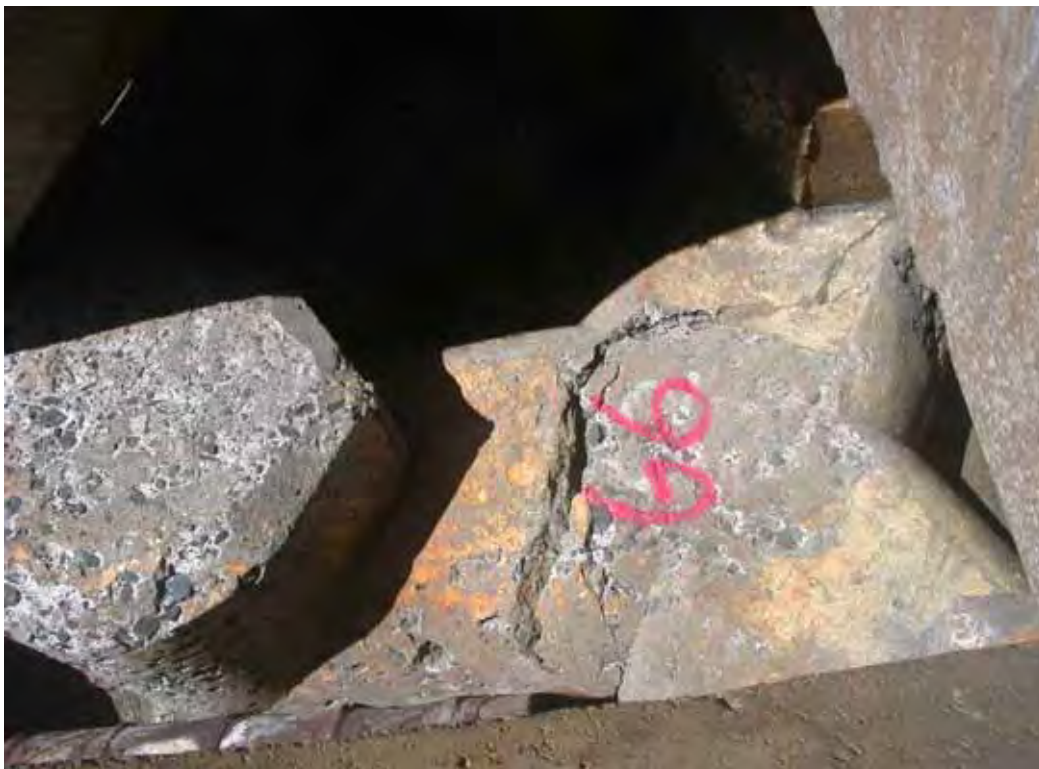
Figure D72. Damage location 97, sta 19+96, ocean side, rib #132, dolosse with fluke-shank crack.

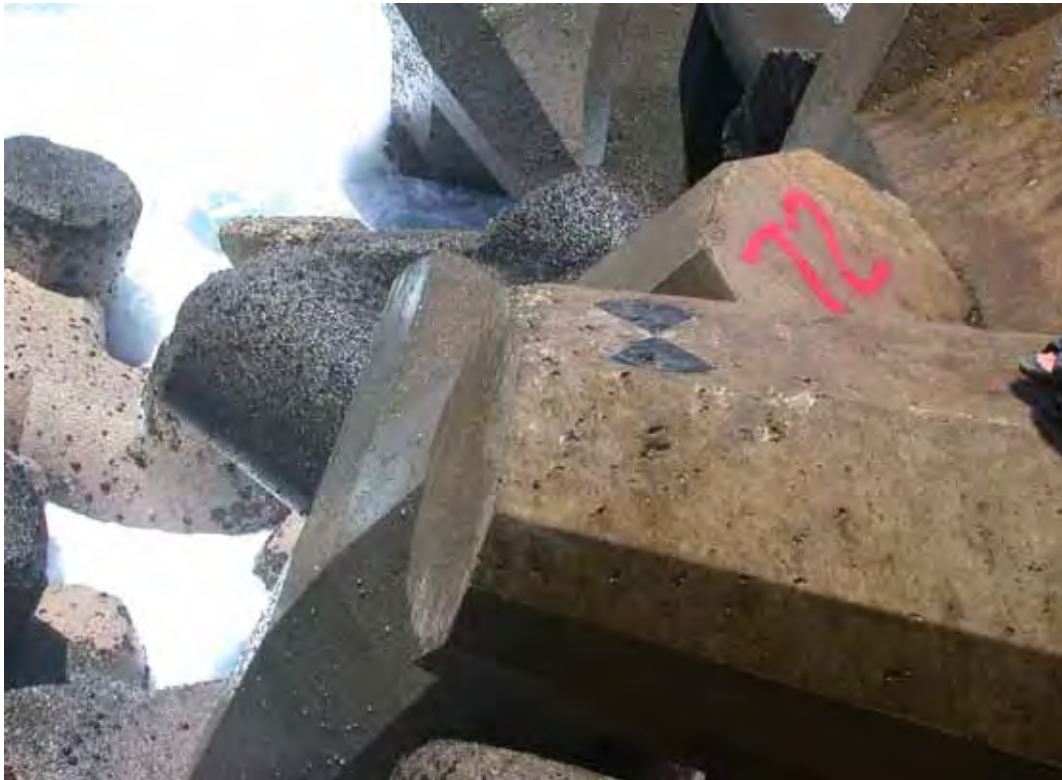
Figure D73. Damage location 99, sta 20+14, ocean side, rib #135, tribar with break through center.

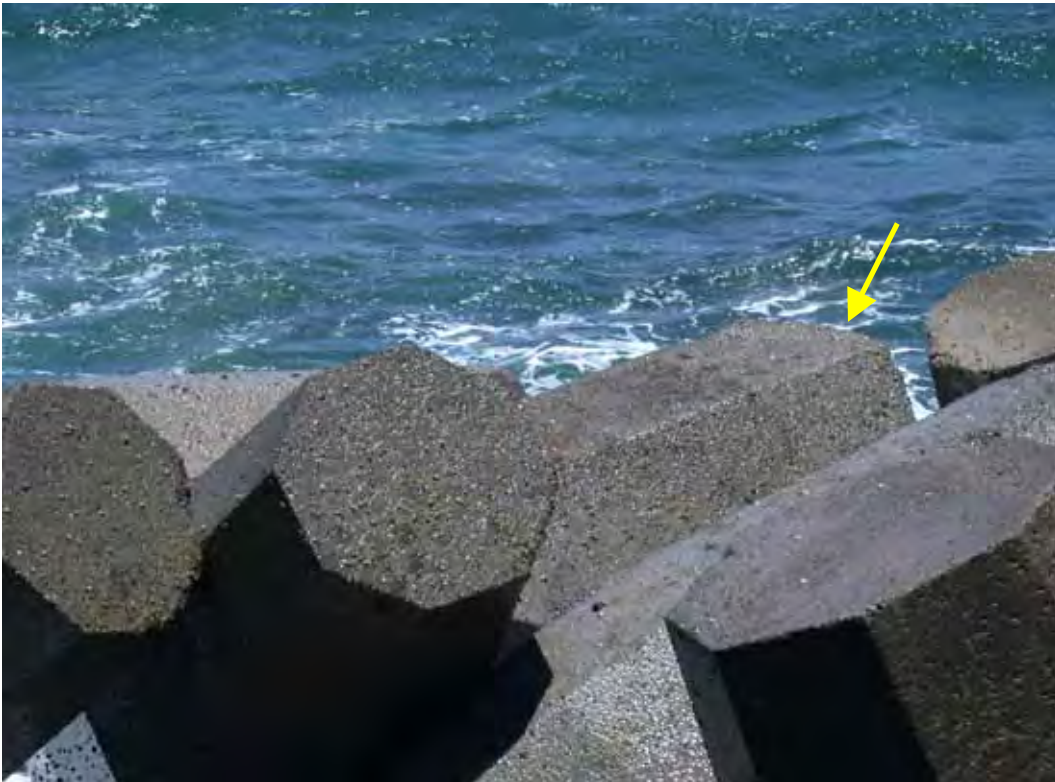
Figure D77. 0 deg is straight through centerline of head, end of crest is sta 20+45.

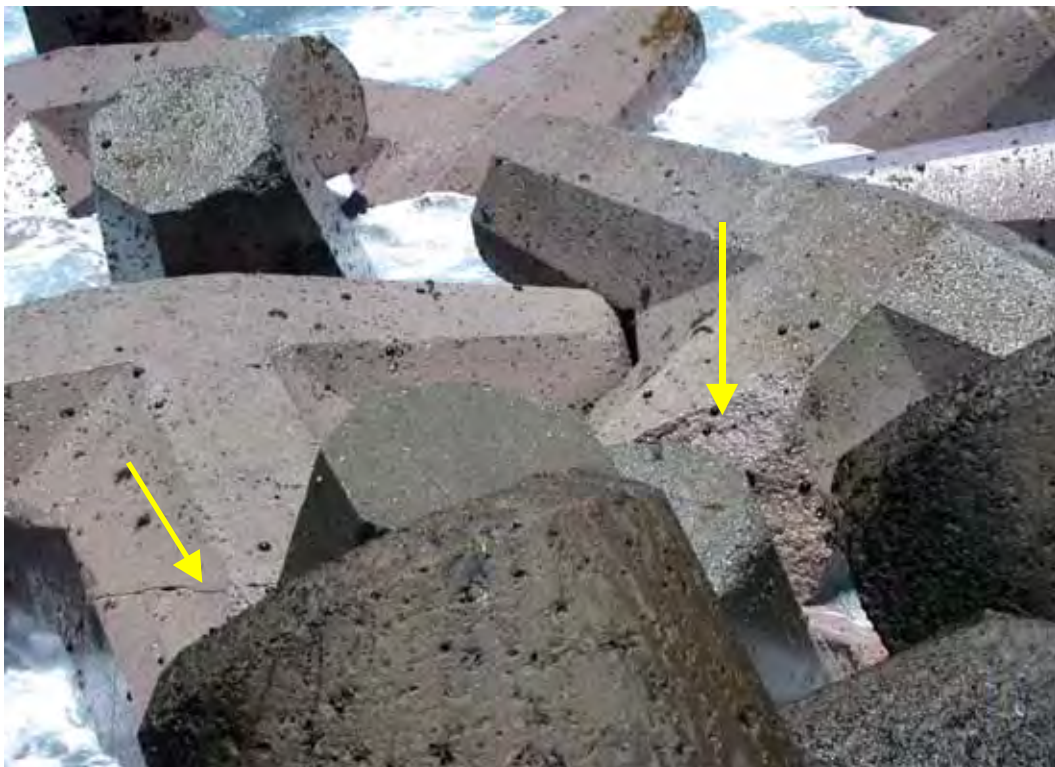
Figure D78. Damage location 108, 70 deg ocean side of head, dolosse with shank-fluke break at waterline.

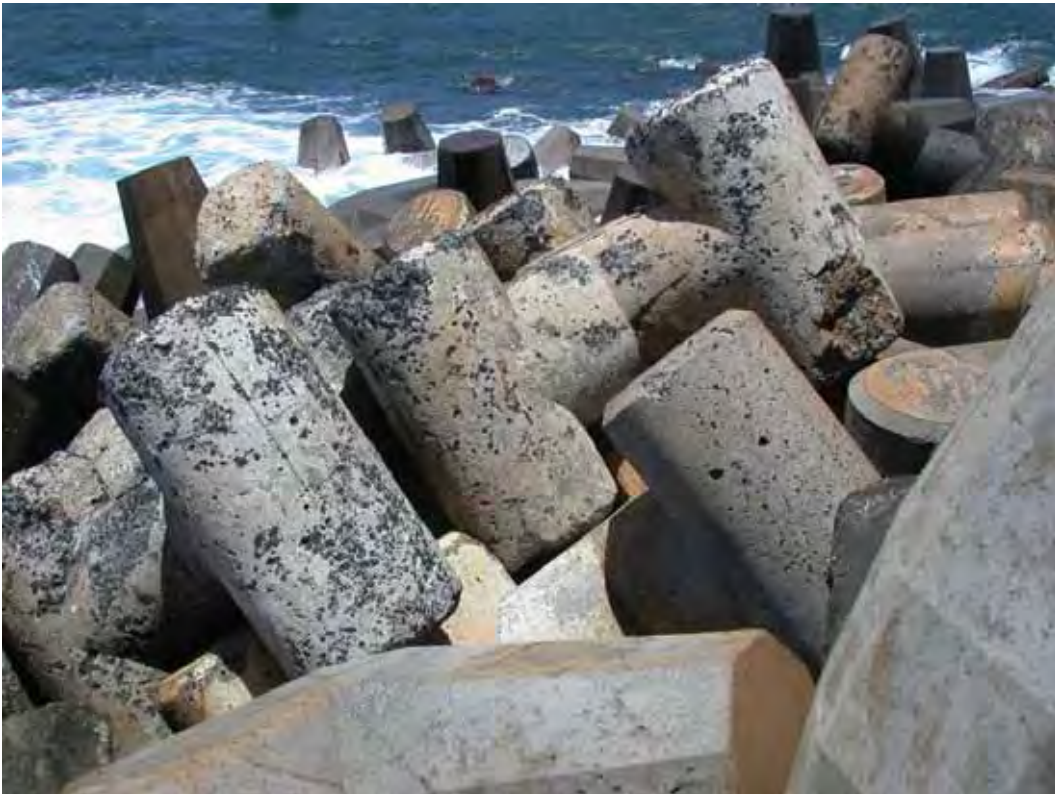
Figure D79. Damage locations 109 & 110, 25 deg harbor side of head, dolosse with shank crack and dolosse with shank break.
