In Situ Corrosion and Heat Loss Assessment of Two Nonstandard Underground Heat Distribution System Piping Designs

Final Report on Project F07-AR01

June 2011

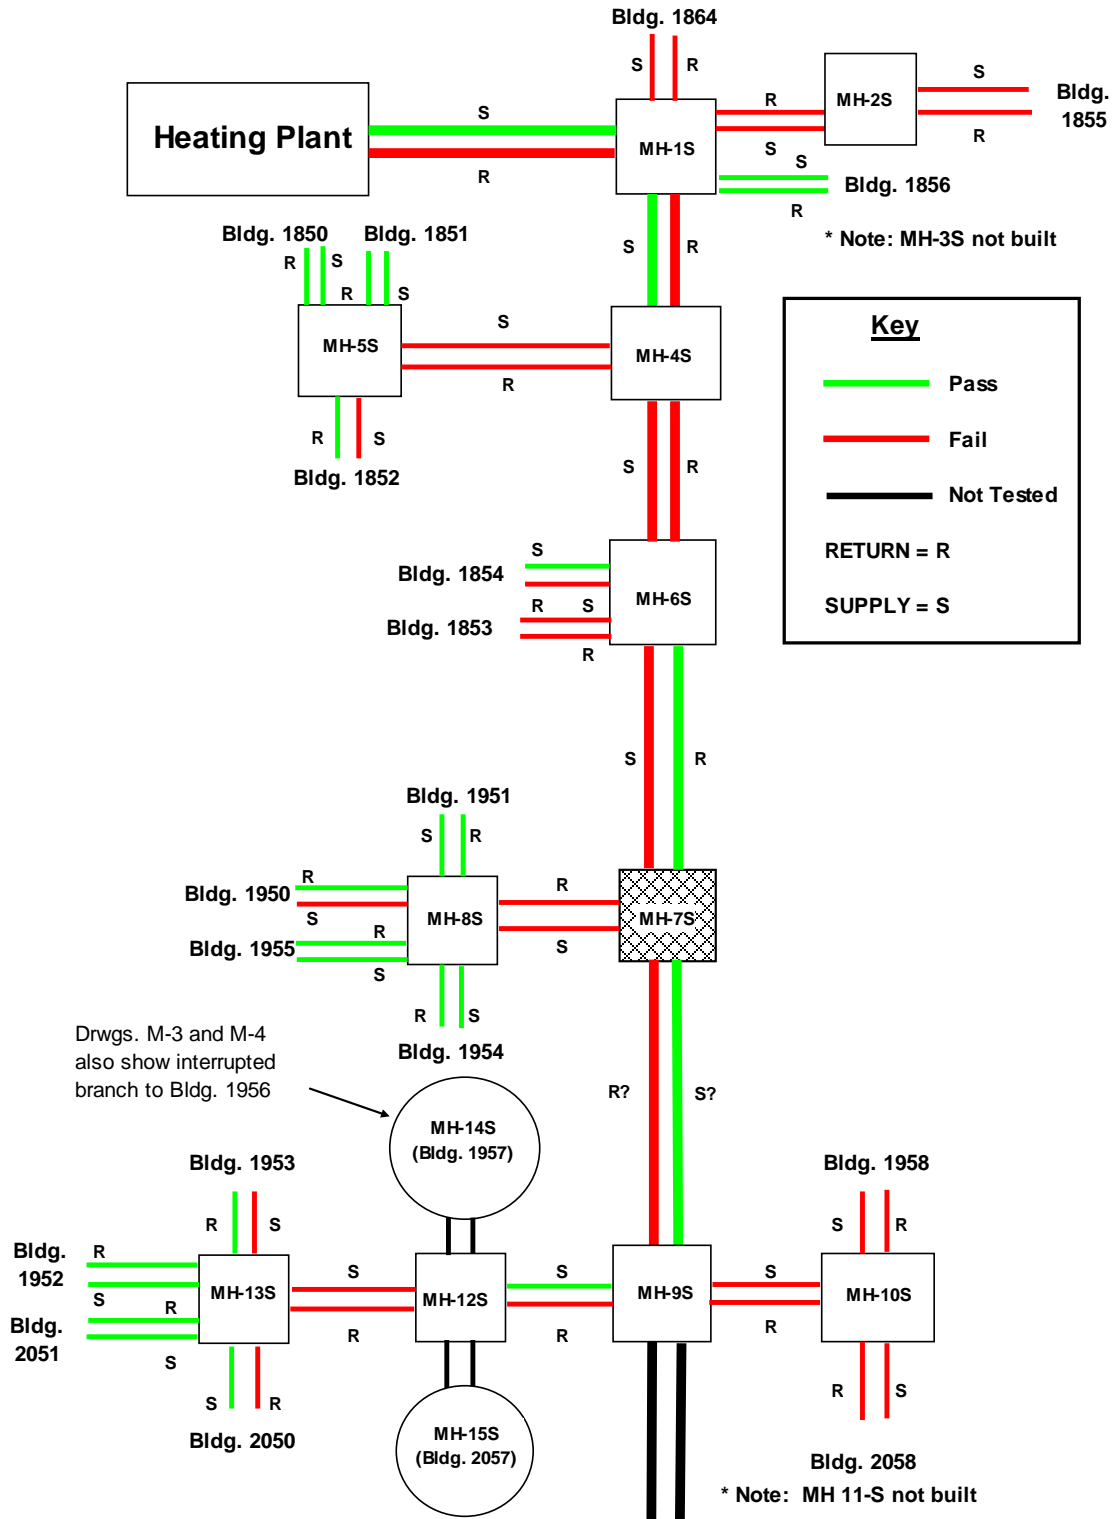
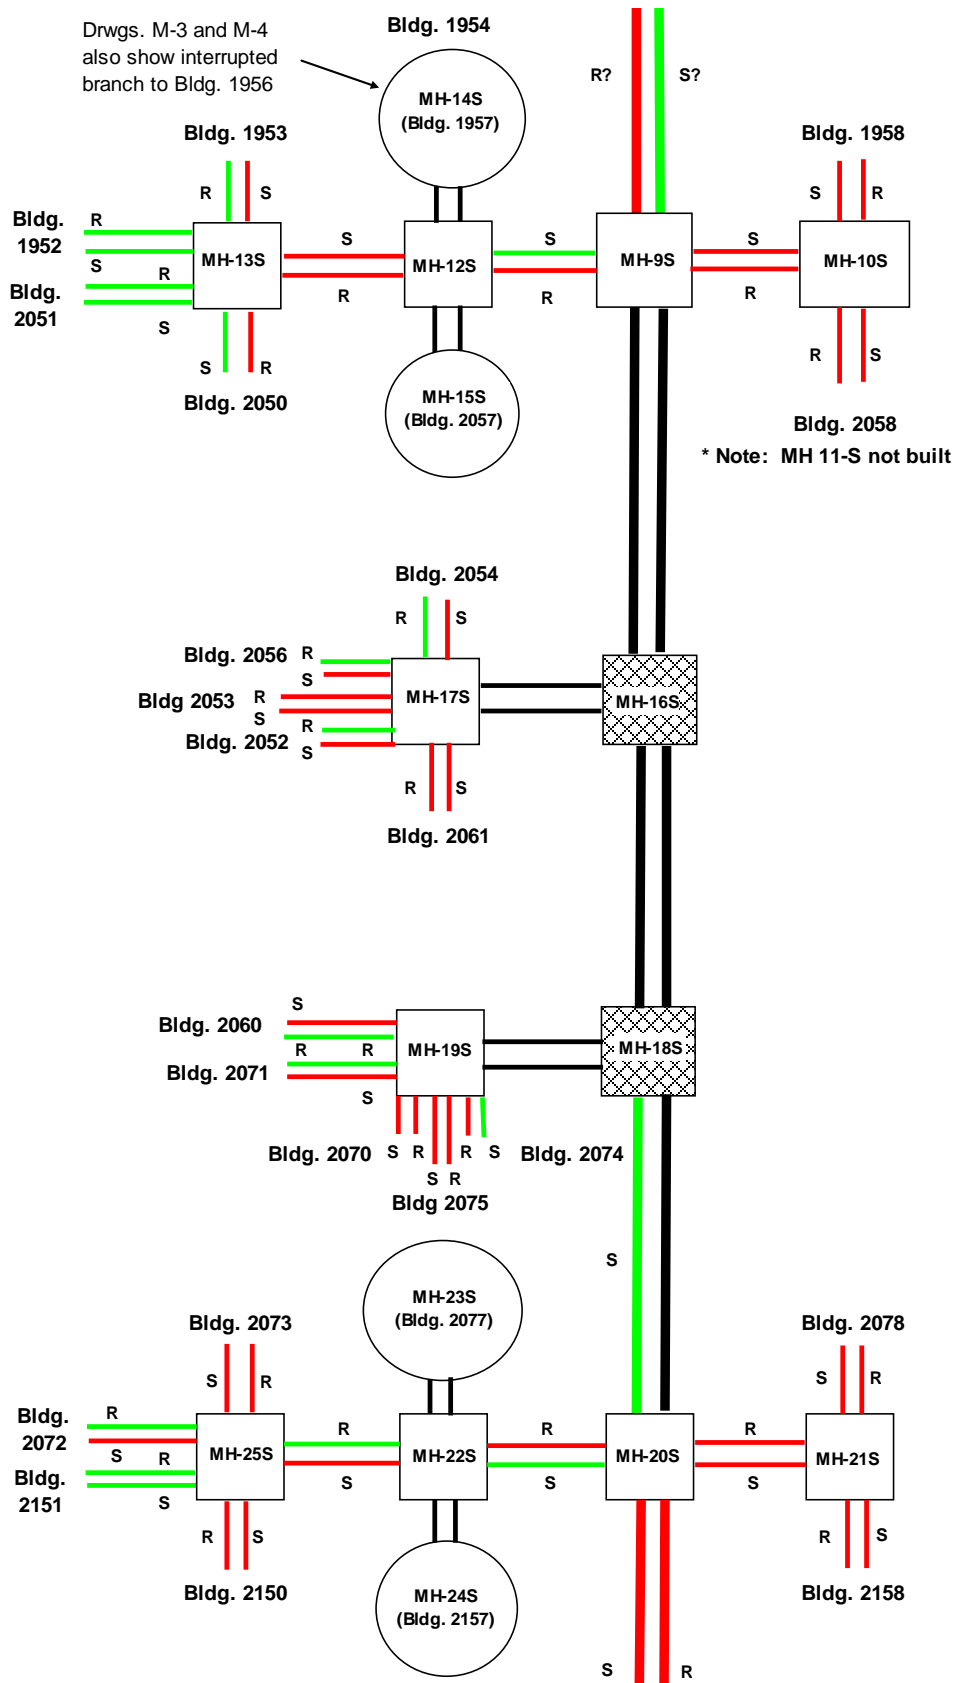
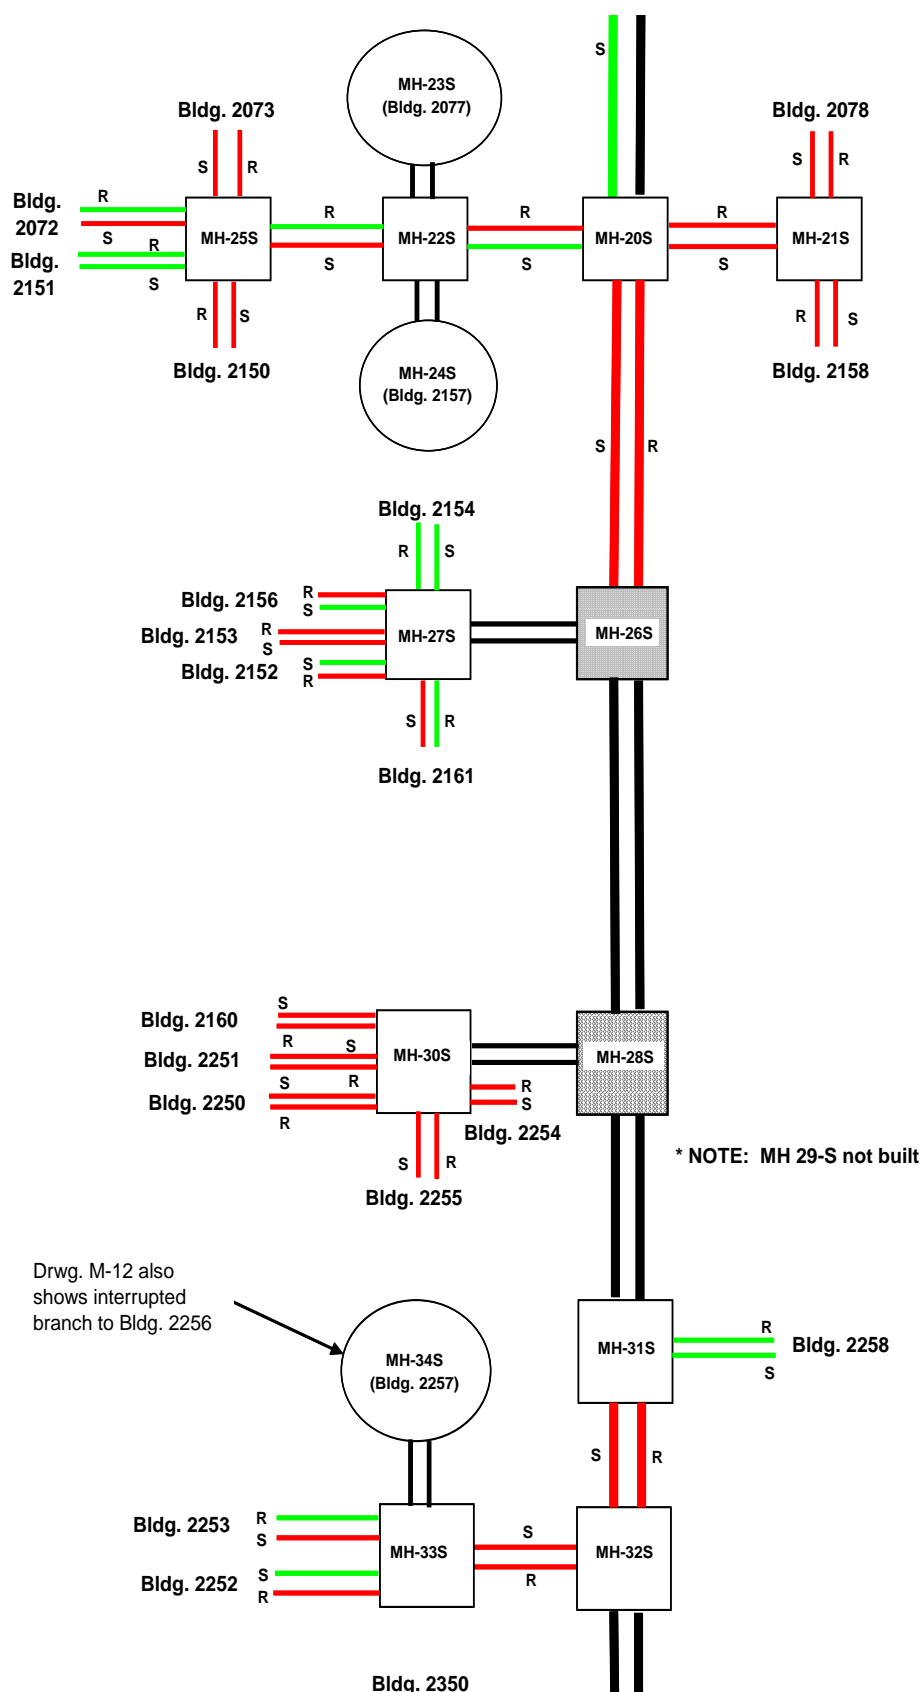
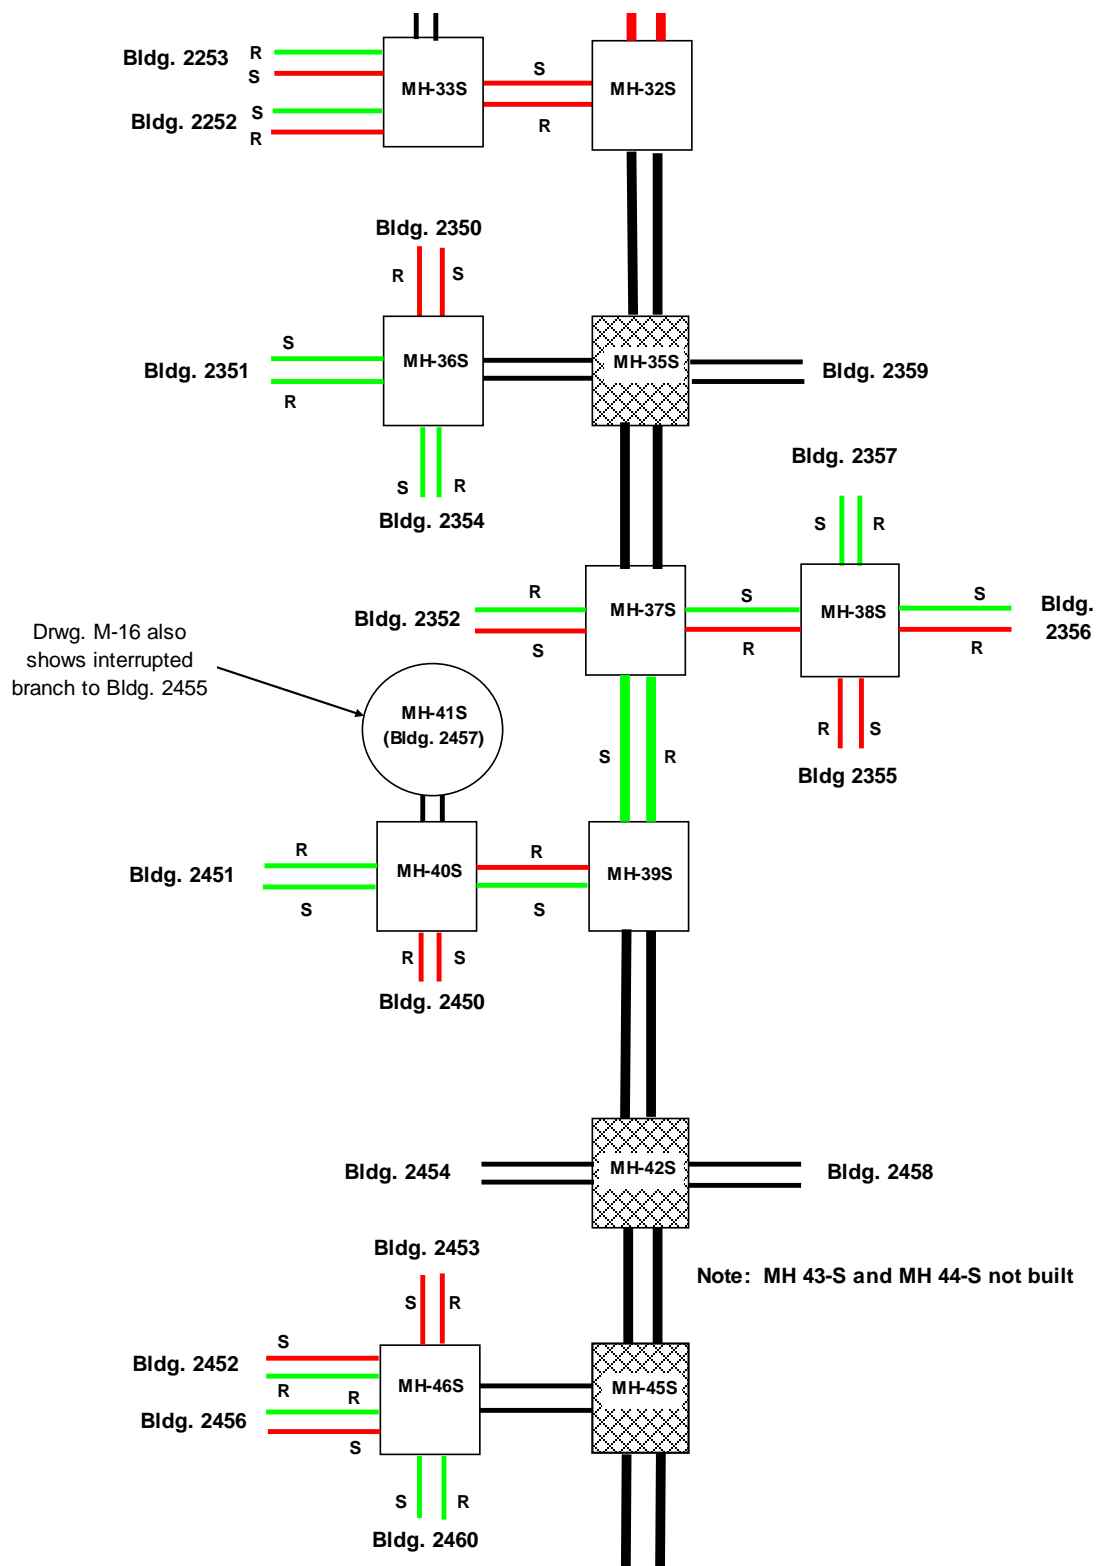
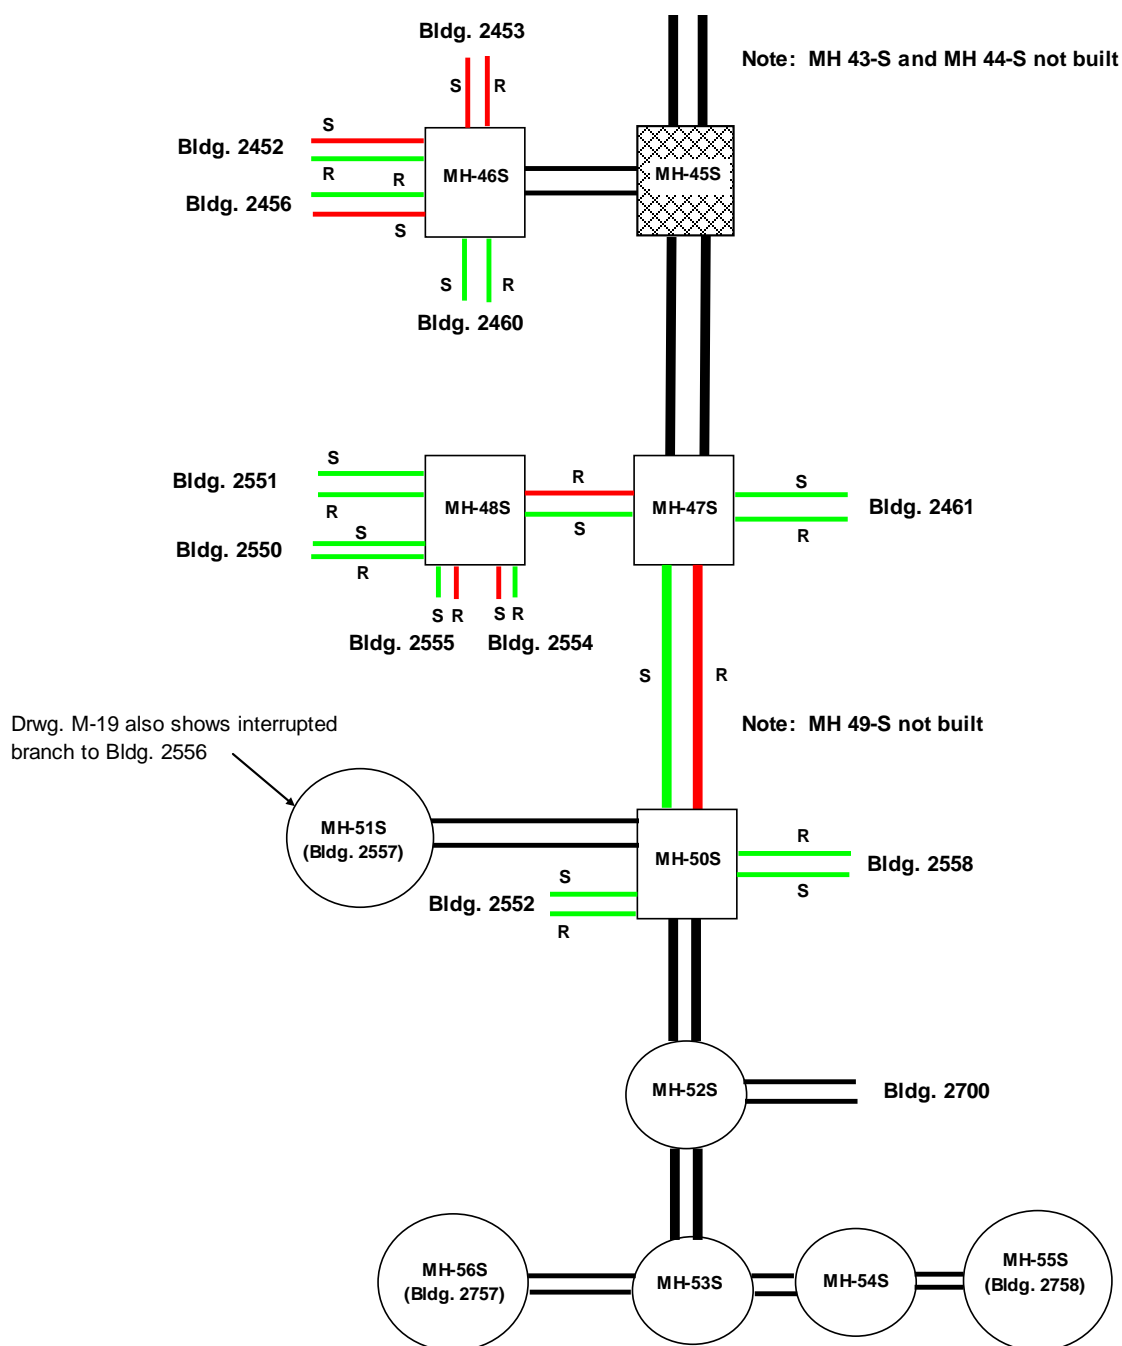
Figure 9 summarizes the test results for the South Loop, indicating a failure rate of 55.9%. It also provides a legend for structures shown in Figure 10, the South Loop schematic diagrams. (Note that Figure 10 extends across five pages.) Detailed test results for each valve pit and conduit segment test data are provided in Appendix I.

Figure 10a. Fort Carson south loop pressure test results in schematic form (network continues from bottom of Figure 10a to top of Figure 10b, and so on).

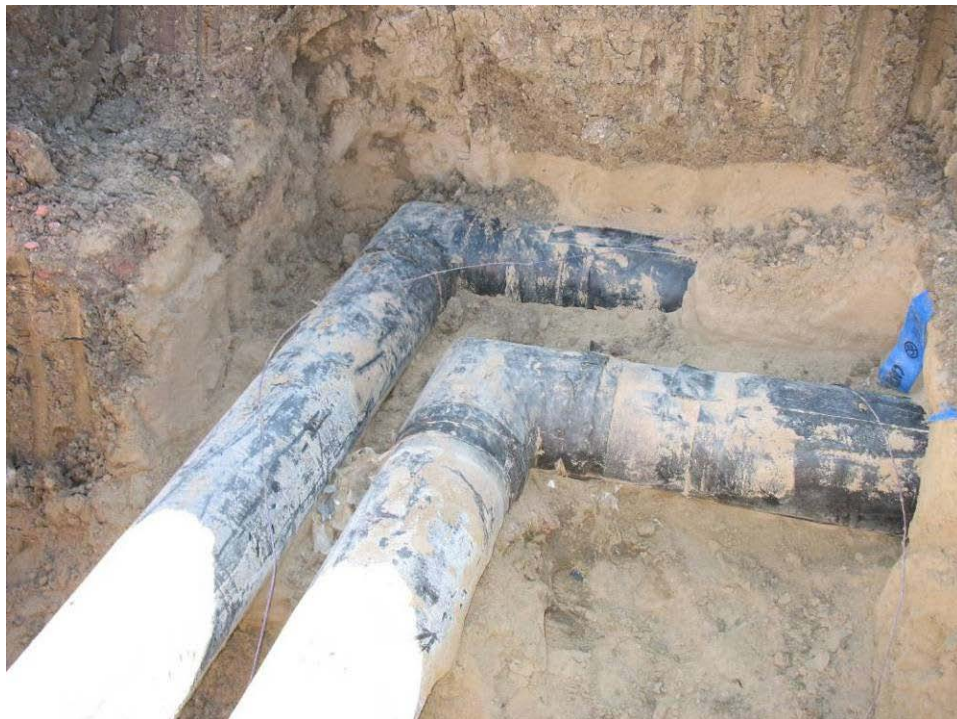
Figure 29. Site 6 excavation, facing west.

5. Damage Observation (Abrasion, wear, damage, workmanship): No significant damage, wear or abrasion; construction workmanship is good.
6. Nature of "Select Backfill": Pea gravel and native earth used for backfill after system installation.
7. Inclusions, if any: Small-medium rocks, occasional construction debris
8. Depth of Burial: 42" below grade to conduit top.
9. Conduit Separation: 15" (east-west run), 20" (north-south run) center-line to centerline
10. Native soil type at burial depth (@ ASHRAE Site 6):
 - a. Sandy Lean Clay
 - b. Grain: Fine-Coarse
 - c. Consistency: Very Stiff
 - d. Moisture: Low-Moderate
 - e. Clay: Moderate-High
 - f. Plasticity: Moderate
 - g. Color: Brown
11. Soil Resistivity at burial depth: 2,000. ohms/cm²
12. Photo Documentation: See Figure 29 and Figure 30.
13. Any other data that would influence the system: N/A. Elbow inspection site.

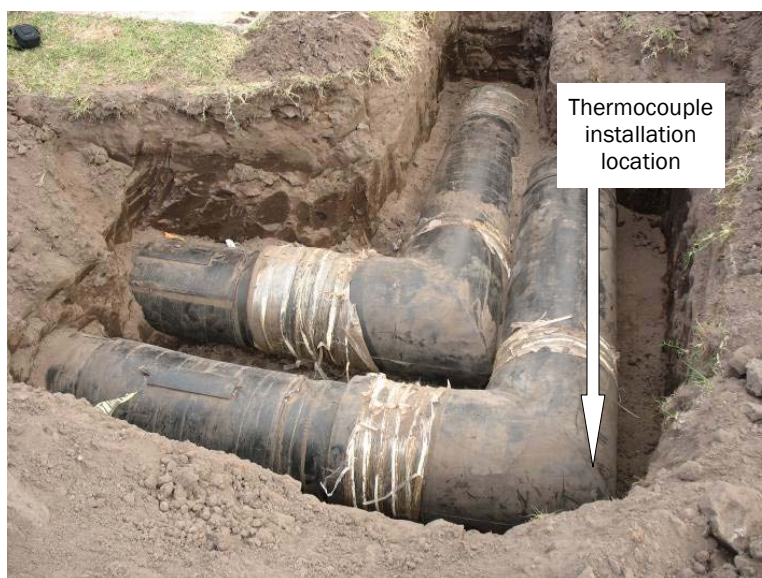
Figure 41. Site 2 excavation for elbow detail inspection.

12. Photo Documentation: See Figure 41 – Figure 43.
13. Any other data that would influence the system: Conduit spacing is much closer than commonly installed making excavation/inspection/maintenance/repair very difficult. This site exhibits a number of unusual features for comparable high temperature water distribution systems:

- d. The sharpness of the elbow. This was a mitered, zero-radius jacket elbow (poor installation practice)
 - e. High surface temperature (to the touch) was noted on the flawed elbow. This likely reflects internal damage caused by poor construction practices. For instance, if the carrier pipe is not centered with the steel casing elbow, it may cause the carrier pipe insulation to butt against the inside of the steel casing and then crush when the carrier pipe heats and expands in service. When the carrier pipe in-

sulation crushes, its thermal conductivity increases resulting in higher heat loss from the carrier and higher conduit outer jacket temperatures. Thermocouples were mounted on the inside and outside radii of the damaged elbow to document performance in service.

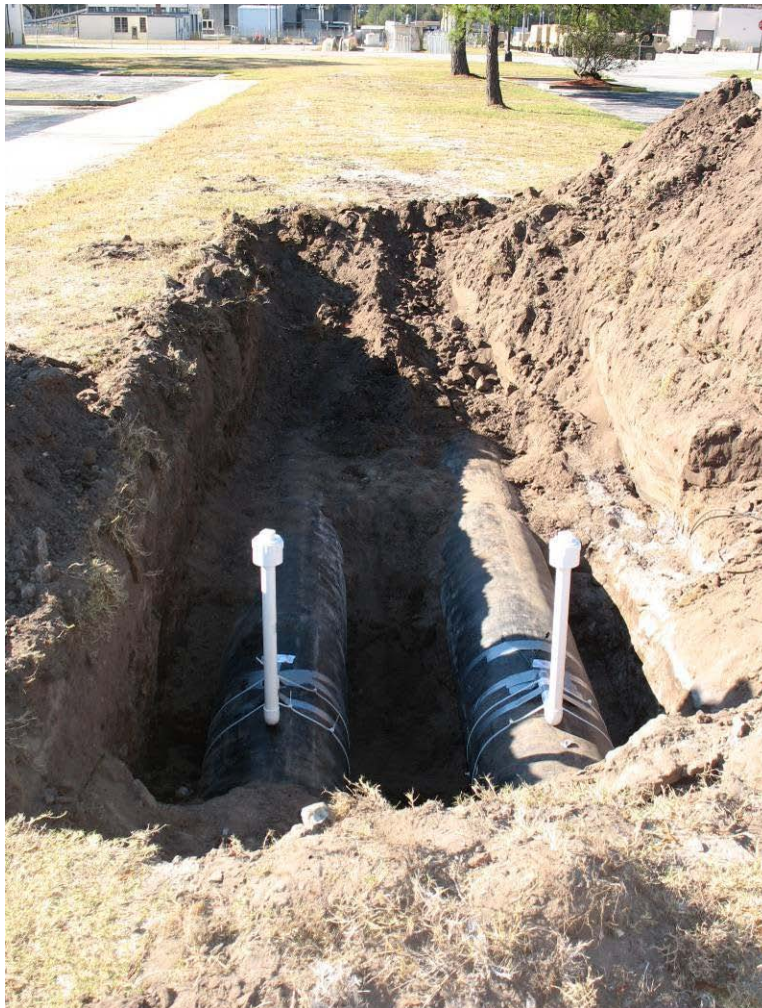
Figure 44. Site 3 excavation with installed instrumentation, facing west.

12. Soil Resistivity at burial depth: 150,000 ohms/cm²
13. Photo Documentation: See Figure 44 and Figure 45.
14. Any other data that would influence the system: 12" dia. (estimated) cement-like conduit located directly beneath and along UHDS supply line (1/2" vertical separation, approx.). The conduit was observed to be at ambient temperature. This asbestos cement pipe will affect the heat loss of the UHDS supply conduit. The influence on the supply conduit is likely to be significant if chilled water is being circulated in the lower conduit.

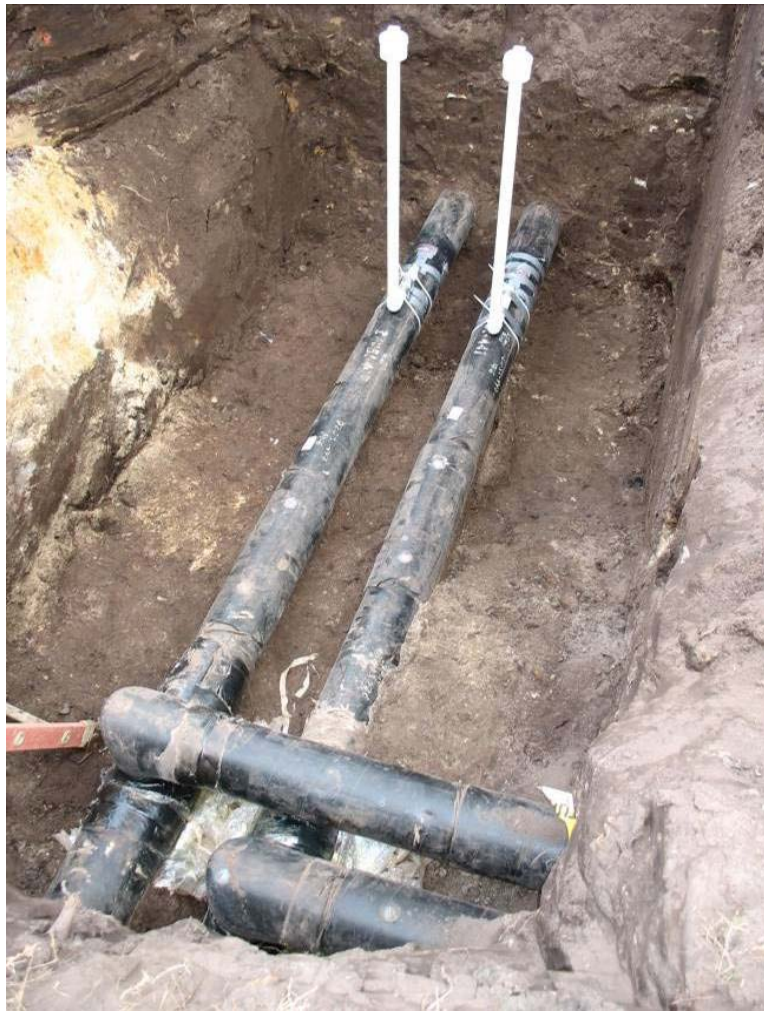
Figure 46. Site 4 excavation (looking south toward Bldg. 646).

11. Soil Resistivity at burial depth: 56,000 ohms/cm²
12. Photo Documentation: See Figure 46 – Figure 48.
13. Any other data that would influence the system: This excavation exposed tee from conduit to Bldg. 646 (See photo below). Tee line runs to Bldg. 649 and is same size as run to Bldg. 646 (except 15" centerline to centerline). There were many obstructions less than 50 feet from this site that are likely to influence the heat loss:
