Organic Finishing Technologies

B-52 Paint Life Cycle Extension

Steve Finley, CTC
Support Contractor to
Mr. Tom Naguy
Air Force Research Laboratory

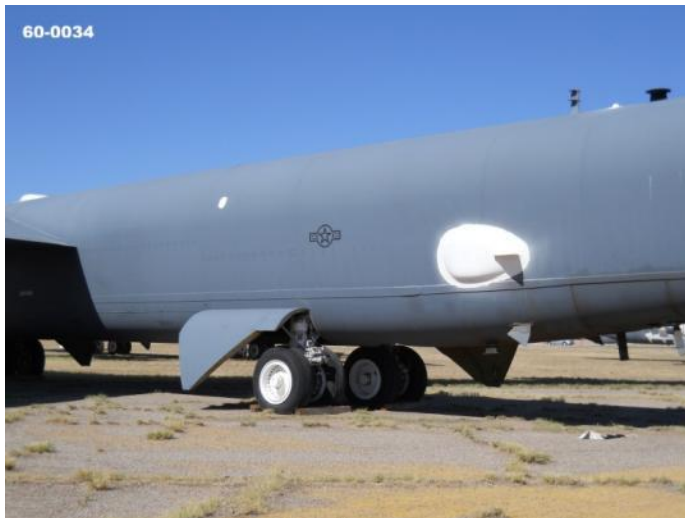
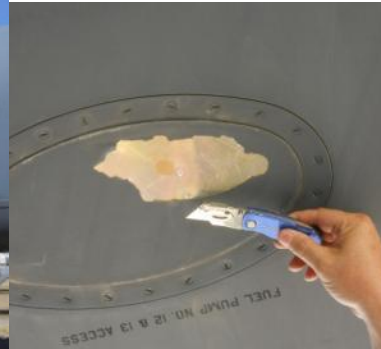
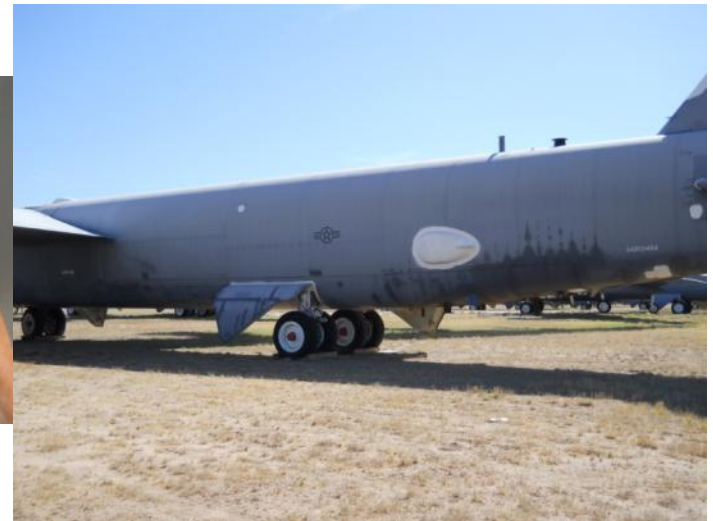
- One adhesion failure noted on the inboard fuel access panel on the bottom of the right wing aircraft 60-0014
- Aircraft from Barksdale showed higher degree of coating degradation
- Minot aircraft showed little signs of degradation
- No corrosion noted on any of the aircraft observed

- **Barksdale Inspection Results**
 - **Several adhesion failures noted on multiple aircraft**
 - **No corrosion was detected during the visual inspection**
 - **No facility to accomplish maintenance touch up**
 - **Color, gloss, and film thickness readings taken on the two aircraft with advanced performance coating (APC)**

- Several adhesion failures noted on multiple aircraft; some as large as 20 ft²
- No corrosion was detected during the visual inspection
- No facility to accomplish maintenance touch up
- Color, gloss, and film thickness readings taken on three APC aircraft
