# ESTCP Cost and Performance Report

(WP-200620)

## Cold Spray for Repair of Magnesium Components

November 2011

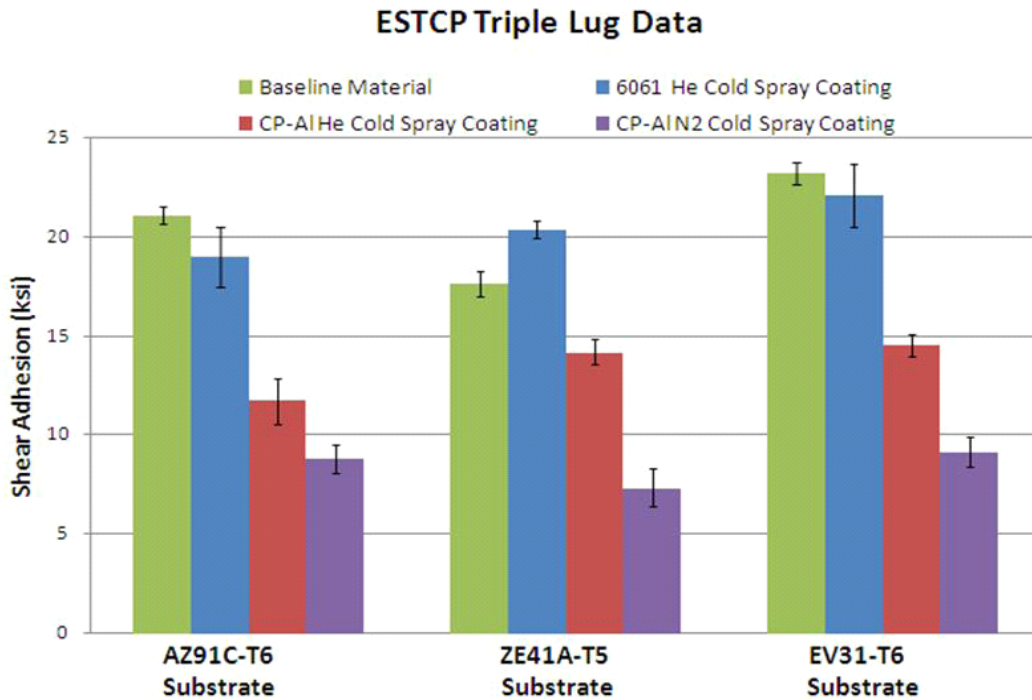
**Figure 7. Triple lug shear adhesion data.**

All JTP laboratory tests were completed with the optimized coating parameters. All the coating systems exceed adhesion strength of 8000 PSI. The Triple Lug Shear test results are graphed in Figure 7. All the coating and substrate combinations tested achieved the 8.0 ksi minimum adhesion except for the CP-Al N<sub>2</sub> coating on ZE41A-T5 (Table 10). This coating had an average adhesion of 7.4 ksi. It is suggested that component specific adhesion requirements first be identified before implementing a repair of ZE41A-T5 with CP-Al N<sub>2</sub>. It should be noted, however, that a shear adhesion value of 7.4 ksi represents a fairly robust coating-substrate bond.

All the 6061 He coatings showed very high adhesion on the Mg alloys. The average adhesive strength of the 6061 He coating on ZE41A-T5 actually exceeded the average strength of the base line ZE41A-T5 samples. Correspondingly, seven of the 12 6061 lugs on the ZE41A-T5 broke off by fracturing material well beneath the coating-substrate interface. This is a positive indication that structural repair could be possible with the 6061 He coating since the weakest point is no longer at the coating interface. All other coating lugs failed by shearing cleanly off at the substrate interface.

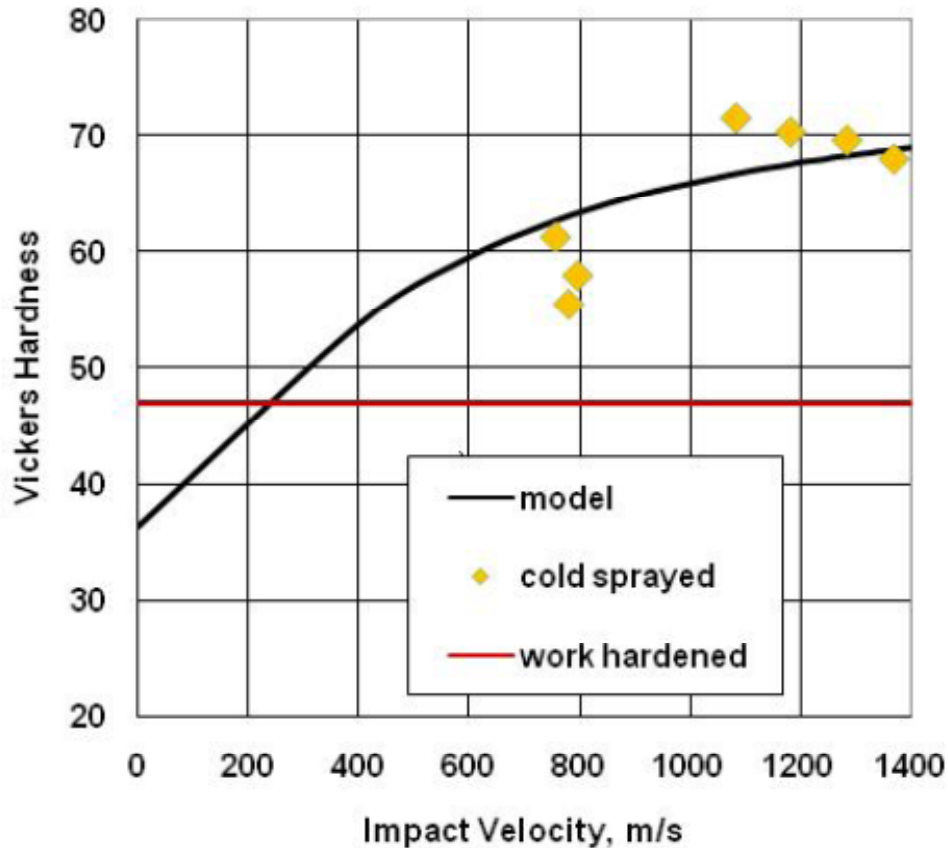
**Figure 8. Model of VHN versus impact velocity for CP-Al Cold Spray coatings [12].**

The microhardness results for all three coatings exceeded the minimum hardness requirement of 50 VHN (Table 9). Additionally, the difference in the hardness of the CP-Al N<sub>2</sub> and CP-Al He is attributed to the greater degree of work hardening in the CP-Al He coating caused by higher particle impact velocities. A model relating particle velocity to work hardening was developed (Figure 8). The model correlated well with the measured VHN. The results are published in Modeling and Simulation in Materials Science and Engineering [12].

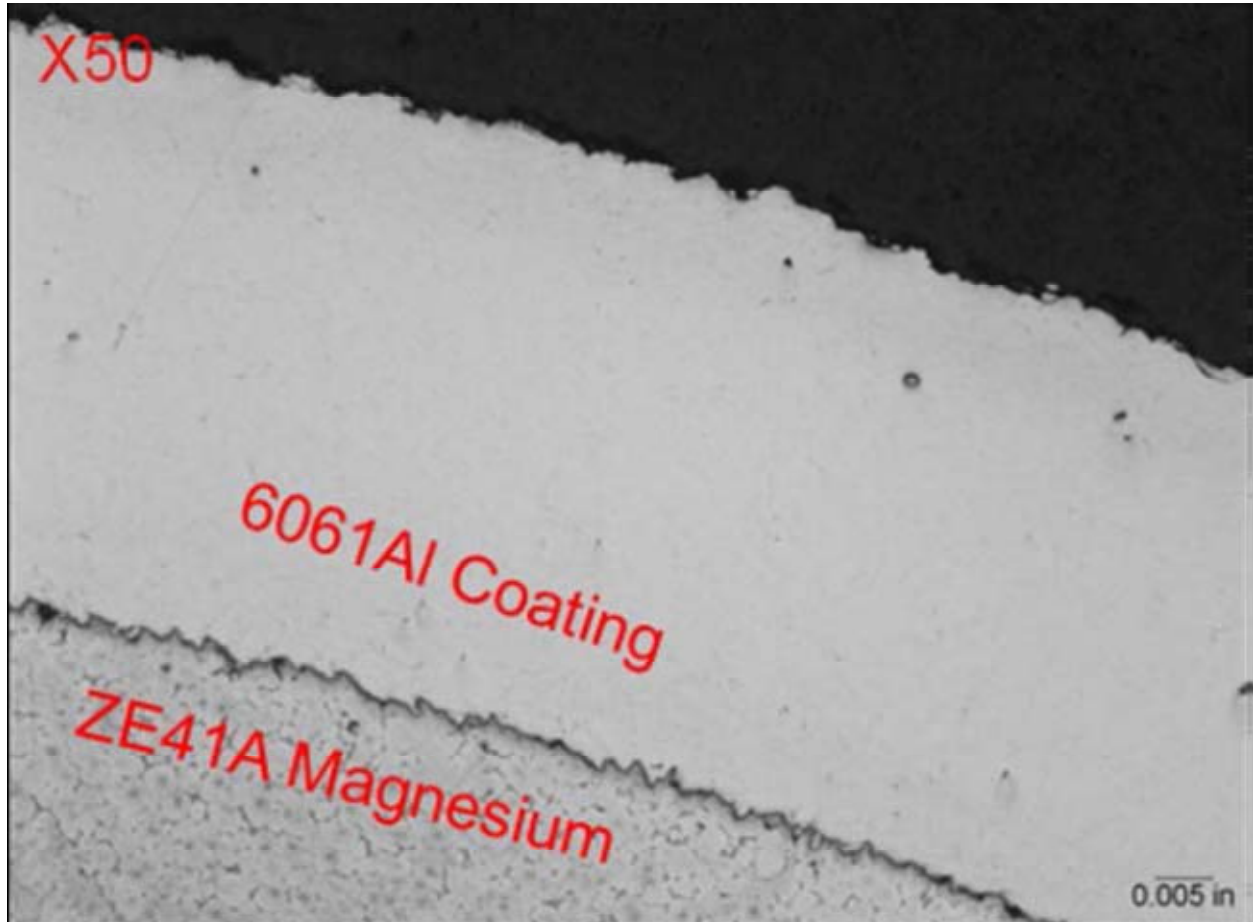
**Figure 9. Optical micrograph showing a 6061 He coating on a ZE41A-T5 rod.**  
(Micrograph courtesy of SAC)

The results from the machining evaluation rod study are qualitative. Feedback from SAC as well as ARL’s own machinist indicated the 6061 coating was much easier to machine than either CP-Al or HP-Al. This is attributed primarily to the hardness of the coatings. The micrograph in Figure 9 shows a 6061 He coating on a ZE41A-T5 rod.

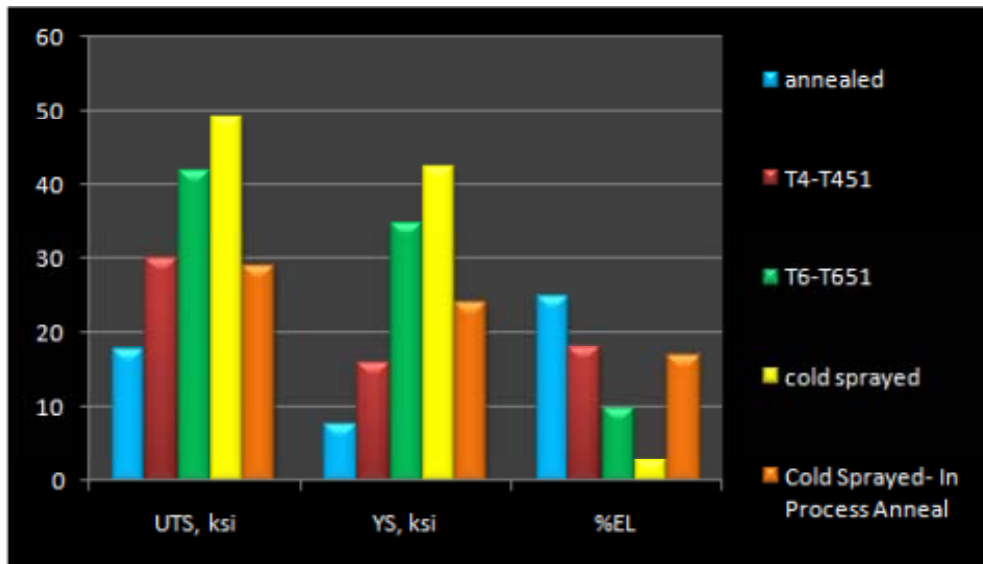
**Figure 10. UTS, YS, and percent elongation at failure for as deposited 6061 He Cold Spray (yellow), in-process annealed 6061 He Cold Spray (orange) versus wrought 6061.**

The 6061 He micro-tensile testing showed that this coating system has very high strength in the as-Cold Sprayed condition (Figure 10). The YS and the UTS of the Cold Spray deposit actually exceed the properties of wrought 6061-T6 [11]. The primary strengthening mechanism is most likely work hardening since the elongation at failure (%EL) is only 3%. However, 3%EL is in line with cast Mg alloys [10-11]. The %EL increased to approximately 17% after the in process annealing. The YS and UTS dropped to values typical of wrought 6061 with T4 tempering. Both the as-deposited and in-process annealed data indicate that there is potential for structurally repairing these Mg alloys with this Cold Spray coating.

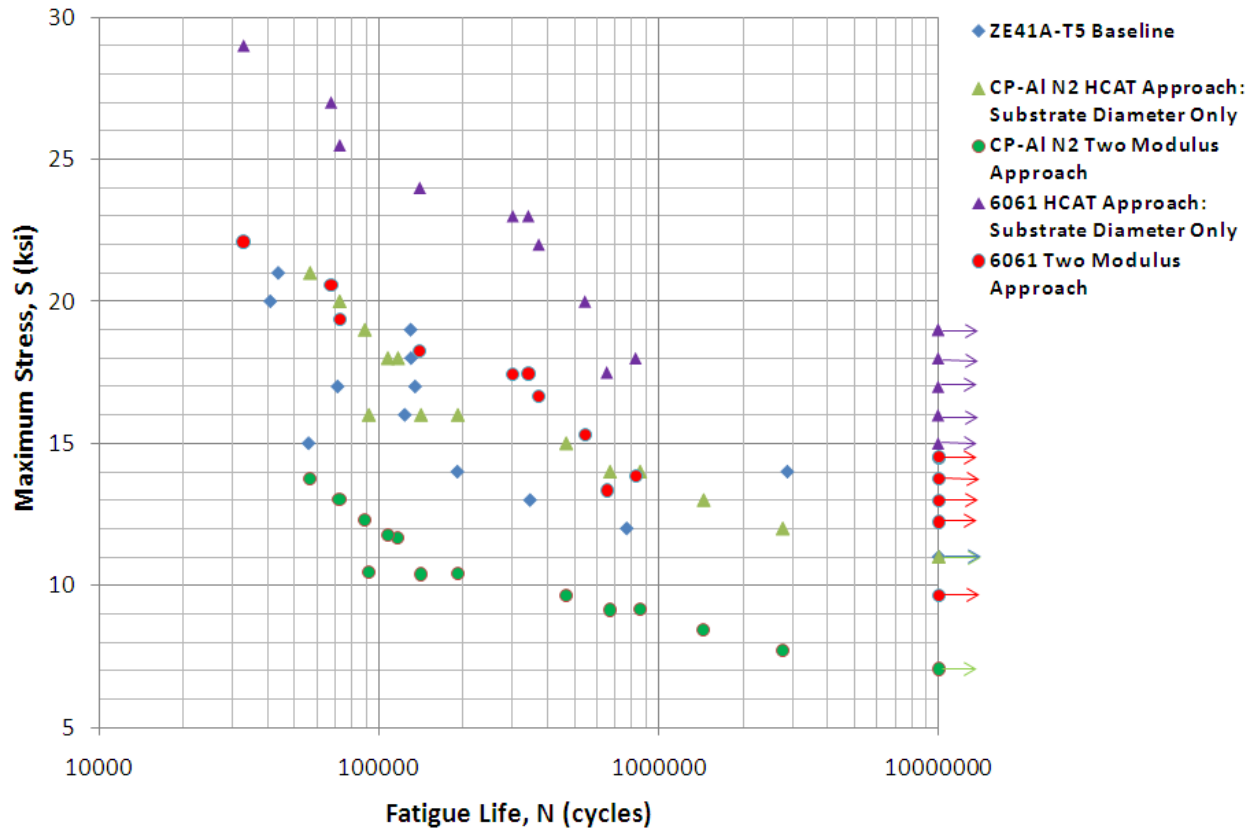
**Figure 11. S-N plots for 6061 He and CP-Al N<sub>2</sub> Cold Spray Coatings on ZE41A-T5.**

There was a significant difference in the rotating beam fatigue performance for samples coated with CP-Al N<sub>2</sub> versus the 6061 He. The stress to number of cycles to failure (S-N) plot for the coatings on ZE41A-T5 is provided in Figure 11. It should be noted that not all specimens failed exactly in the gage. Failure location as well as the cycles, stresses, and gage thickness for all data points for all alloy and substrate combination are provided in the Final Report.

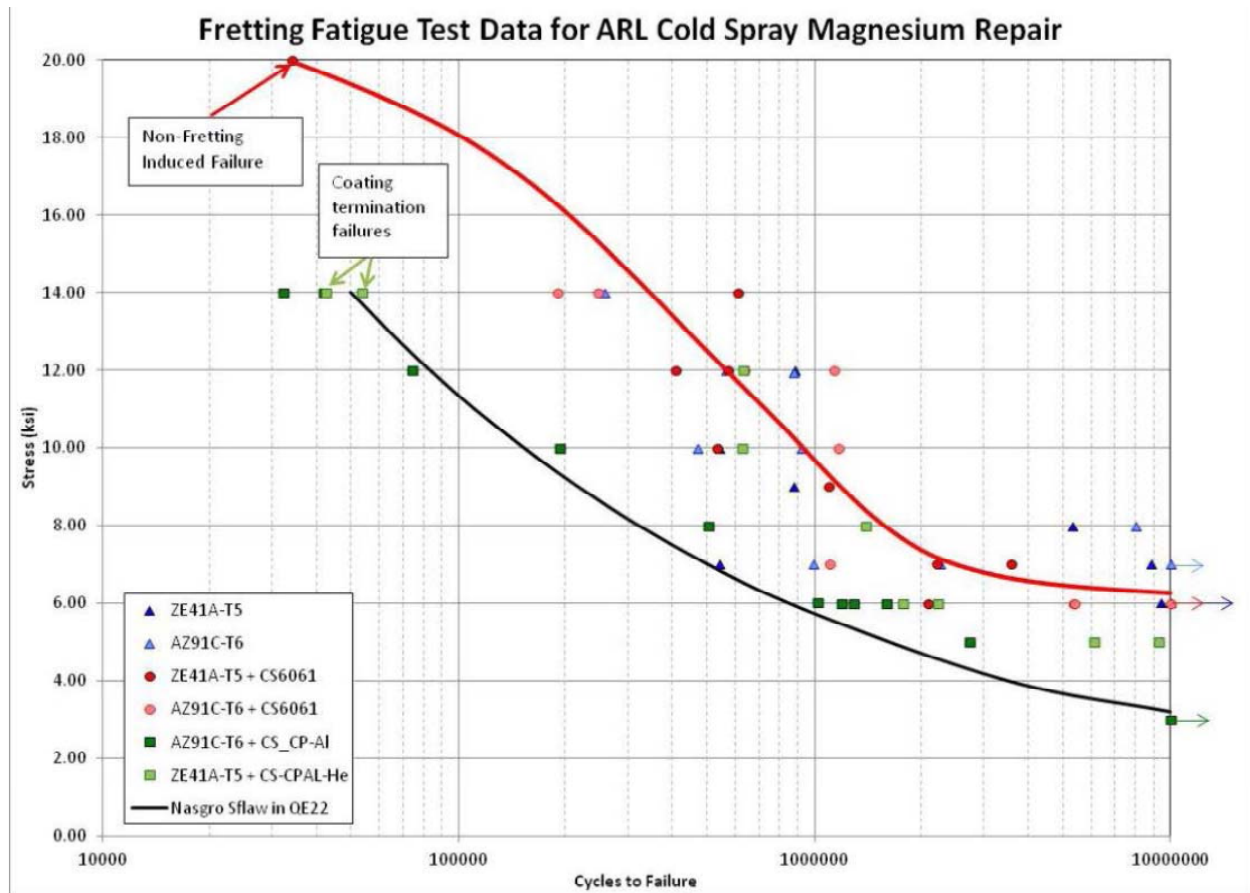
**Figure 12. S-N plot for fretting fatigue.**

A plot of the fretting fatigue results are provided as Figure 12. The 6061 He coating on the ZE41A-T5 caused a very slight debit. The CP-Al He coating caused no noticeable debit in performance. The CP-Al N<sub>2</sub> sample, on the other hand, caused a significant debit to the fretting resistance. A curve for the CP-Al N<sub>2</sub> is shown in black on Figure 12. UTRC cited low ductility of the CP-Al N<sub>2</sub> system as one of the primary reasons for poor fretting performance. Therefore, CP-Al N<sub>2</sub> coatings should not be used in contact scenarios where fretting could be an issue. The slight debit observed for the 6061 coating is also attributed to the low ductility of the coatings.
