**ALTERNATIVE FUELS COMPATIBILITY WITH
ARMY EQUIPMENT TESTING – AGED NIEDNER
RIFTS CONDUIT TESTING**

**INTERIM REPORT
TFLRF No. 426**

**by
Oliver P. Harrison
Southwest Research Institute[®]
Structural Engineering Department**

**Contract No. W56HZV-09-C-0100 (WD15-Task 5)
SwRI® Project No. 08.14734.15.501**

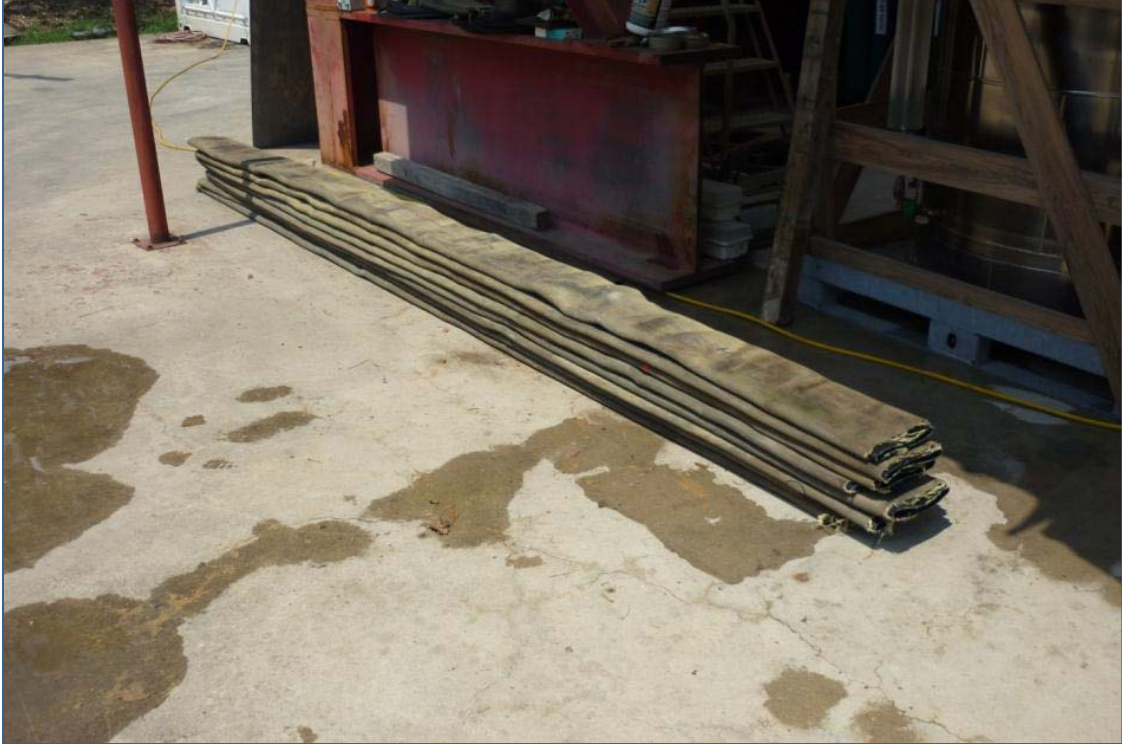
The eight specimens cut from the hose reel were measured and inspected for damage. When measuring the specimens approximately 3 hours after the specimens had been cut, it was noted that the outer jacket and the inner liner were no longer even. For this reason, measurements of both the jacket and liner were recorded for each specimen. These measurements are provided below in Table 1, along with notes of any damage present. It would appear, based on the original cut length of 15 feet, that the liners expanded. Figure 5 shows the specimens just after inspection. Figure 6 shows the ends of the stacked specimens, where the difference in length of the jackets and liners is clearly visible.

Hose Specimen	Length of Jacket (inches)	Length of Liner (inches)	Notes
A	180 ¹ / ₄	181 ¹ / ₂	Tear in outer layer of jacket
B	180	181	No damage noted
C	179 ¹ / ₂	181 ¹ / ₄	Abrasion in outer layer of jacket
D	180	181 ¹ / ₂	No damage noted
E	180 ¹ / ₄	182	No damage noted
F	180 ¹ / ₂	181 ³ / ₄	No damage noted
G	180 ¹ / ₄	181 ¹ / ₂	No damage noted
H	180 ¹ / ₂	182 ¹ / ₄	No damage noted
All hoses had a nominal diameter of 6 inches.

Figure 5. Hose Specimens After Inspection

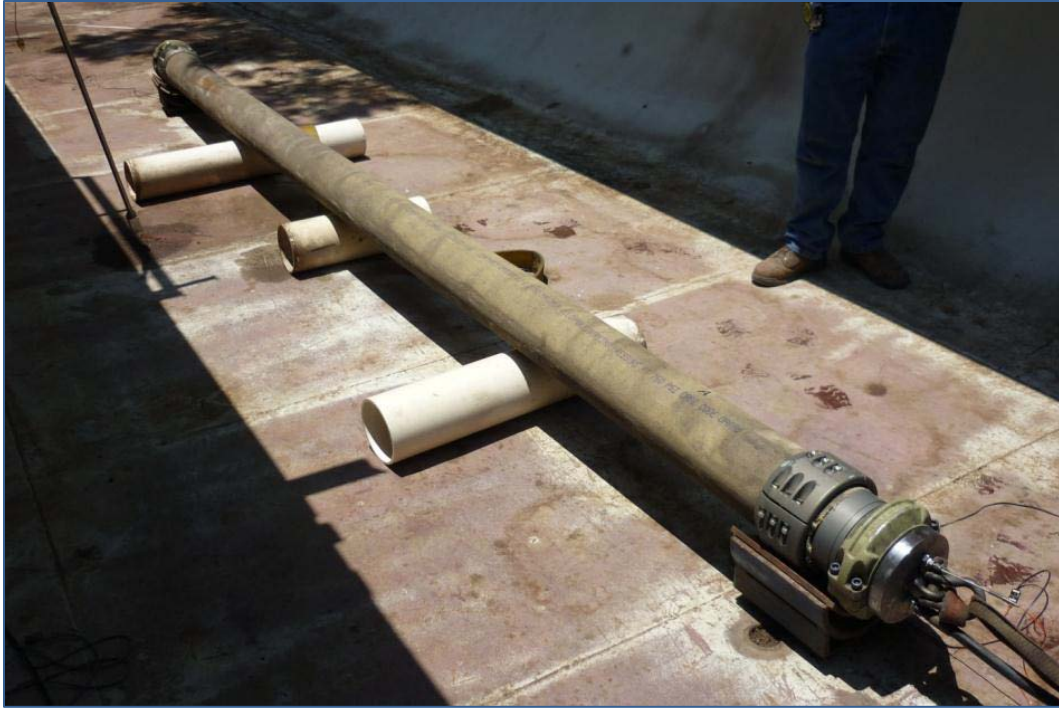
Figure 13. Specimen A Burst Testing Setup

Specimen	Length (inches) ¹	Burst Pressure (psig)	Failure Mode	Underwent Cyclic Testing
A	182 1/2	1504	Longitudinal tear of jacket and liner	No
B	180	1610	Longitudinal tear of jacket and liner	No
C	181 1/2	1886	Longitudinal tear of jacket and liner, small transverse tear of liner	No
D	181 1/2	1767	Longitudinal tear of jacket and liner	No
E	186 1/16	1324	Longitudinal tear of jacket and liner	Yes
F	184 1/2	1712	Longitudinal tear of jacket and liner	Yes
G	184 3/4	1680	Longitudinal tear of jacket and liner	Yes
H	187	1534	Longitudinal tear of jacket, blowout of liner	Yes

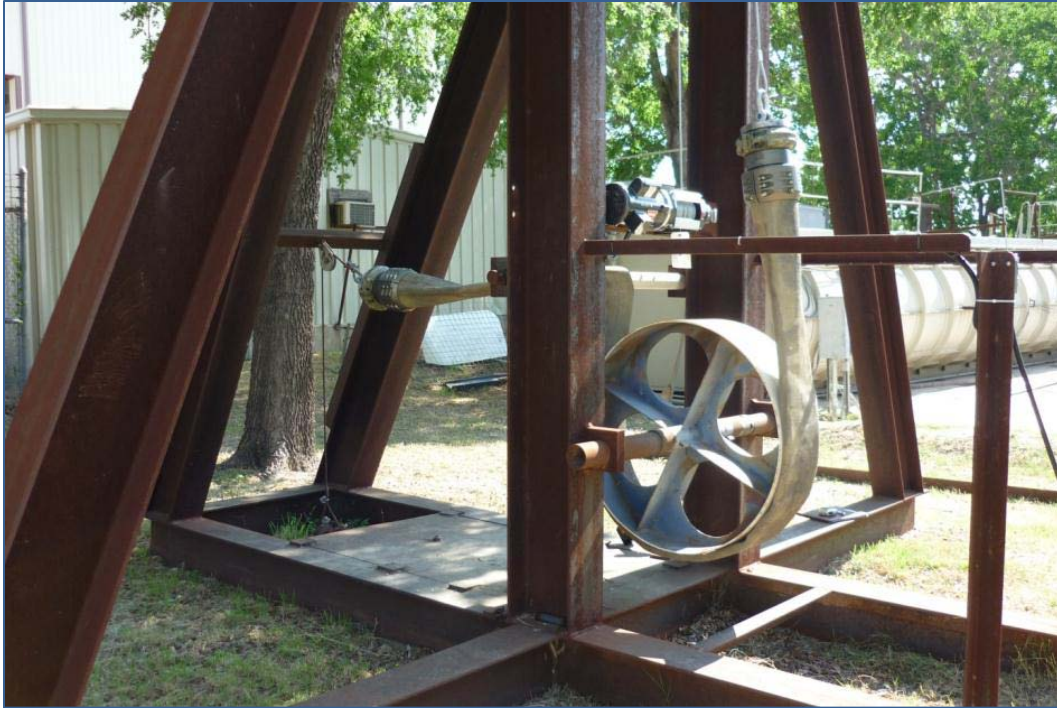
Figure 39. Specimen E Bending Cycles Setup

Specimens E, F, G, and H underwent bending and pressurization cyclic testing without sustaining any considerable damage or failures; however, some effects were noted as a result of the testing. The bending cycles introduced additional creases on the specimens caused by the small (3-inch) roller, and three of these specimens failed in this region when burst. This effect is shown below in Figure 38. The pressurization cycles brought about a notable change in length for each specimen. These results are presented in Table 6. As with the previous measurements, these lengths are of the conduit (as if the end fittings were not there) pressurized to approximately 60 psig. The data sheets from the cyclic testing are provided in Appendix C.
