# **Thule Air Base Airfield White Painting and Permafrost Investigation**

Phases I-IV

June 2013

Final report

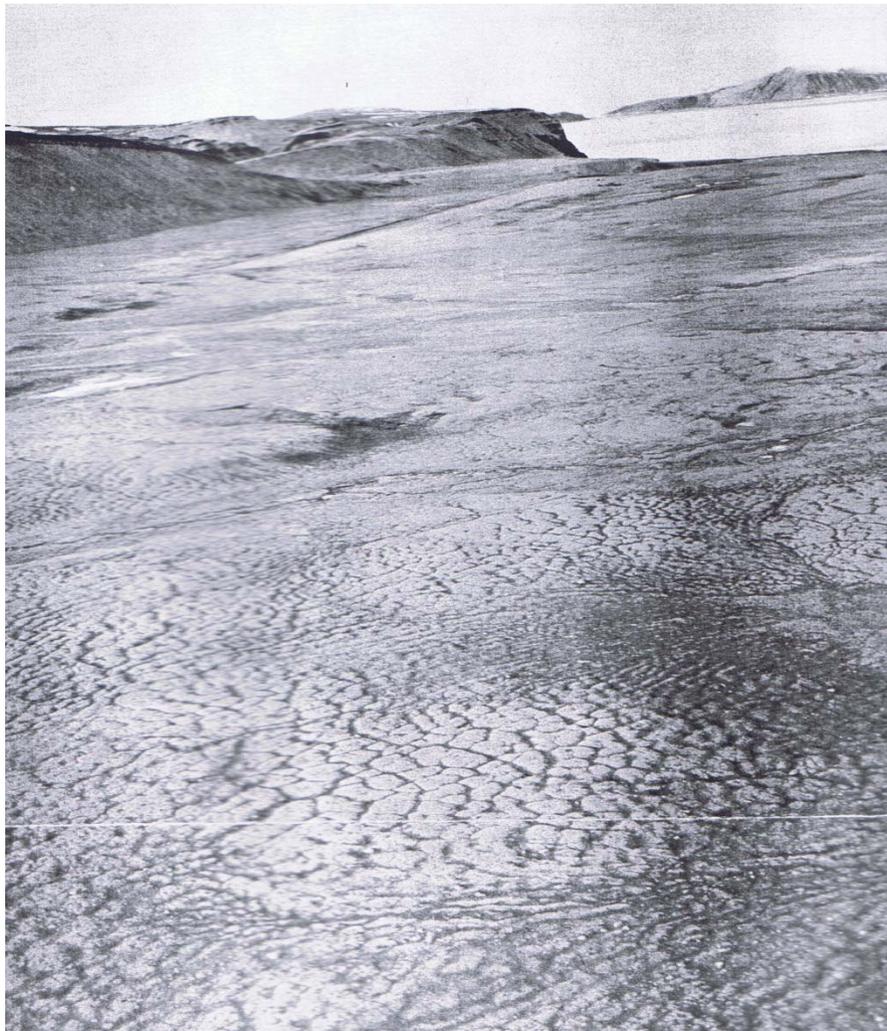
Figure 6. Aerial photo prior to Air Base construction looking southwest. The polygonal ice wedge networks are seen to extensively cover much of the valley.

With the base level topology understood, the surface and near-surface frozen sediment section could be constructed in the model. We know that a layer of glacio-fluvial sediment overlies the bedrock in the Pituffik Valley, and that these are host to the massive ice, mostly in the form of wedge ice. Historical aerial photographs were reviewed to get an idea of how the terrain appeared prior to construction, and one image in particular shows that a moderately dense ice wedge network (20 to 30%) was extensive across the valley (Fig. 6). Because the sediments are of relatively young age

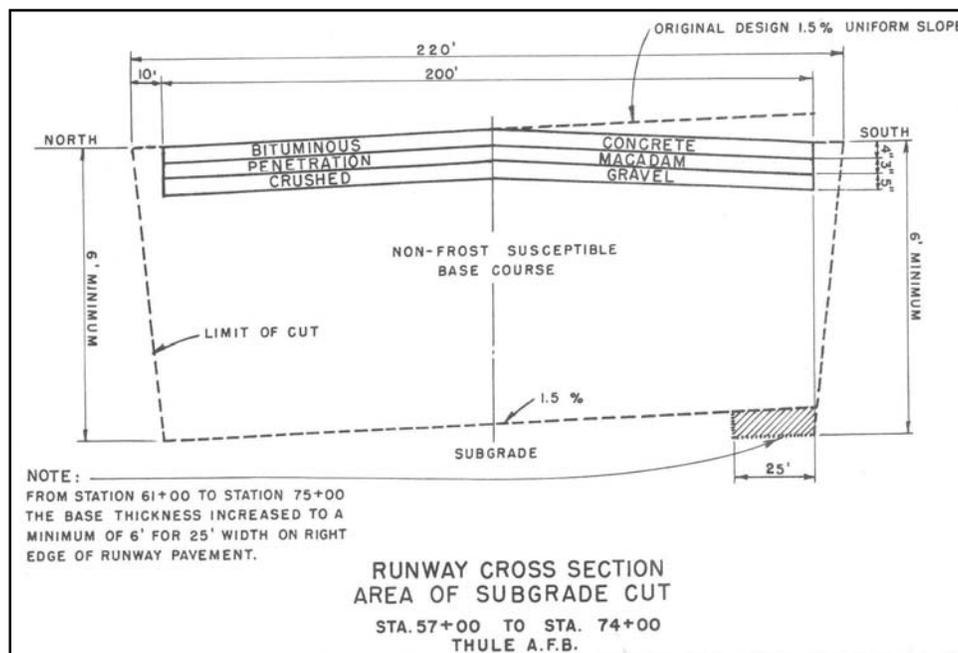
ing the permafrost table and inducing thaw was determined to be 6 ft (Metcalf & Eddy 1956). The 10,000-ft runway was constructed entirely on fill material, with the extreme ends of the runway requiring the greatest amounts, up to 30 ft. A portion of the runway, 1800 ft long, starting at station 50+50 and ending at 70+30, required excavation of a topographic high, resulting in a maximum cut at one location of 13 ft. The mid-point of the topographic high required excavation of diorite bedrock, and the rest of the cut section was excavated in frozen glacial till. The cut portion incorporated the 6 ft of thaw preventative fill as mentioned previously. However, because of design changes in the runway surface during construction, from a transverse slope to a crowned cross section, the resulting thickness from top of runway to bottom of excavation along the southern edge of the cut was reduced to only 3 ft (Fig. 7).

Figure 7. Cross section of the runway cut section from 57+00 to 74+00 showing initial design and mid-construction design change. The box excavation is also shown which was installed from 61+00 to 75+00 along the runway south limit (ACFEL 1955).

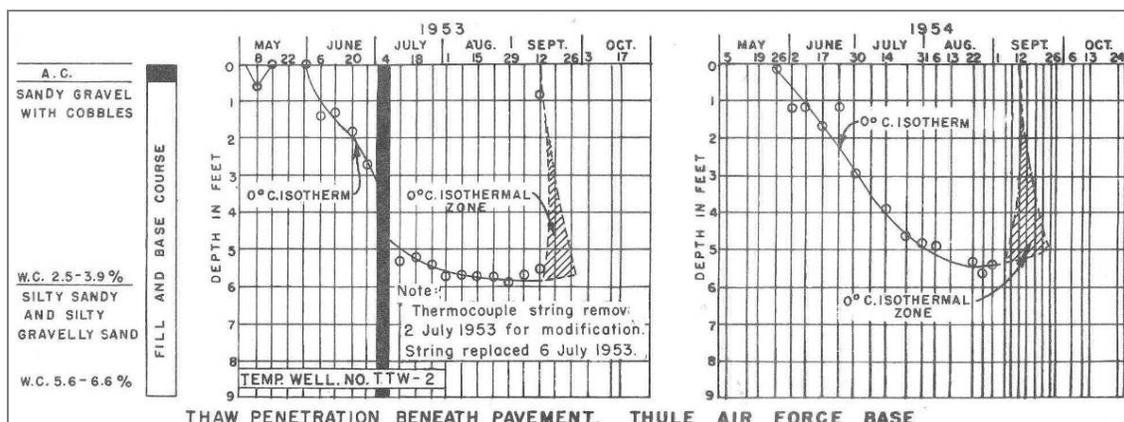
Plots of the depth of thaw under these two areas are compared for two seasons in Figures 9 and 10; the thaw depth was reduced by approximately 2 ft where the pavement was painted white. The thawing index for 1954 was greater than in 1953, but the deeper thaw in 1953 is attributed to heat introduction during excavation of the thermocouple strings, which were replaced in July 1953. Other investigators have confirmed these results (Berg and Aitken 1973). In a more recent study conducted at Kangerlussuaq, Greenland, Jorgensen and Ingeman-Nielsen (2008) used ground-penetrating radar to measure 2.6 ft of decreased thaw depth under white painted asphalt

Figure 9. Temperature profile for two seasons under a white painted asphalt surface (ACFEL 1955). Although 1954 had a higher thaw index, the 1953 thaw depth is deeper owing to excavation for a new temperature measurement string.

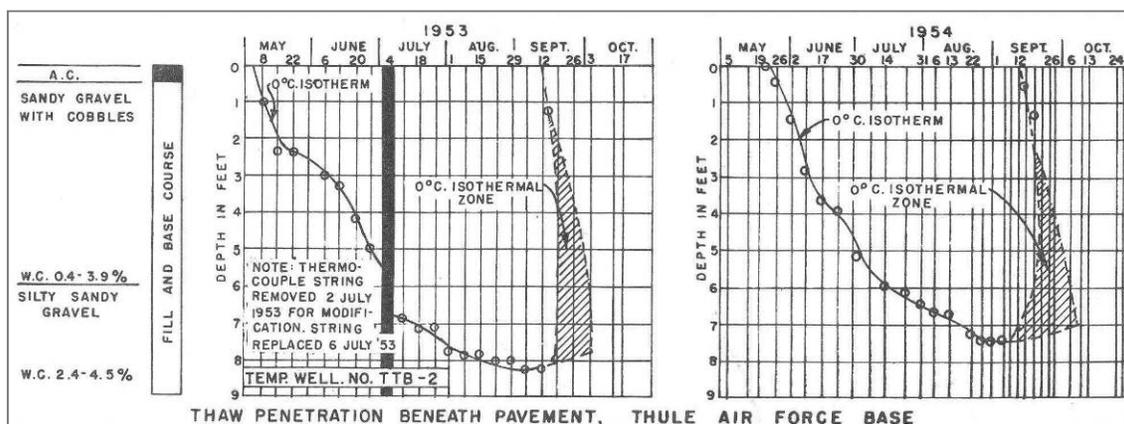
Figure 10. Temperature profile for two seasons under a non-painted asphalt surface (ACFEL 1955).

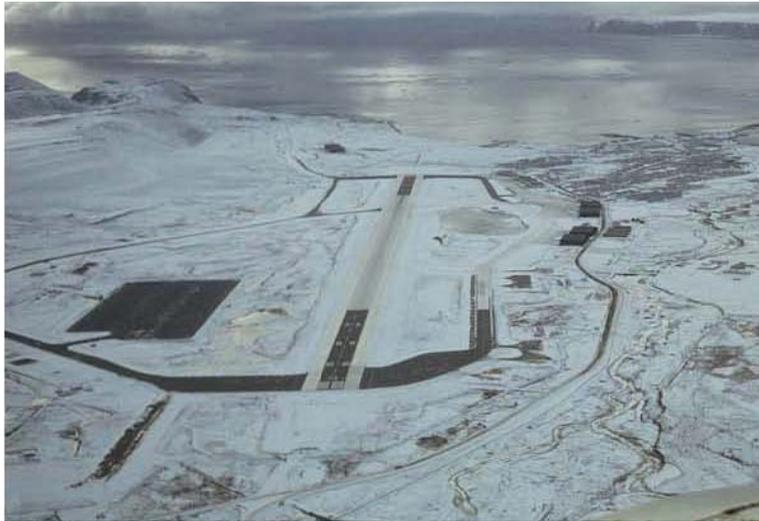
Figure 12. Airfield in September 1975 showing the extent of painting up to that time. The landing zones, 2000 ft from either end of the runway, are not painted nor is the 26 or 08 ends of Taxiway Alpha. This study found there was no information anecdotally, or in the literature, suggesting past thaw depression problems in these areas (Funder 1990).

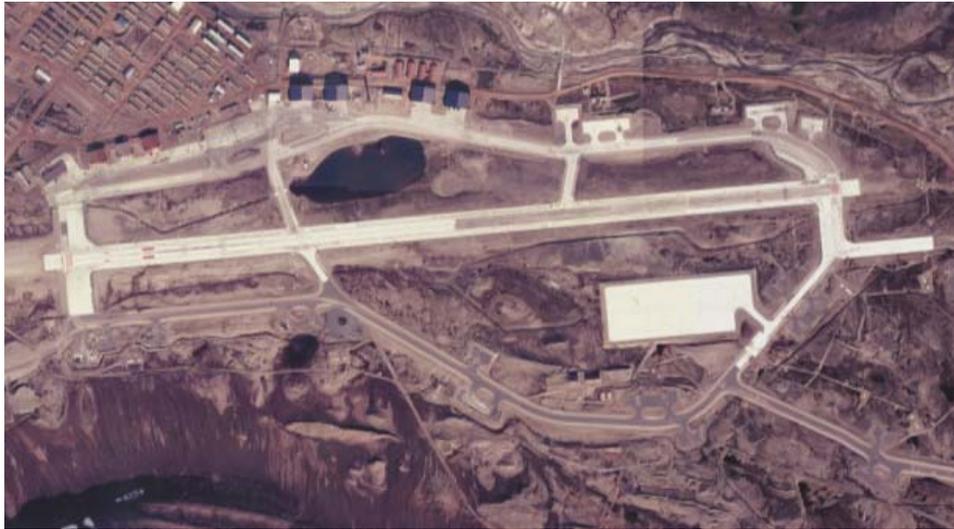
Figure 14. Undated photo of the airfield obtained from Thule personnel. The painting is in process during this photo. It is unknown if the dark pavement from approx. 50+00 to 100+00 is from wear or if milling or some other program is being conducted.

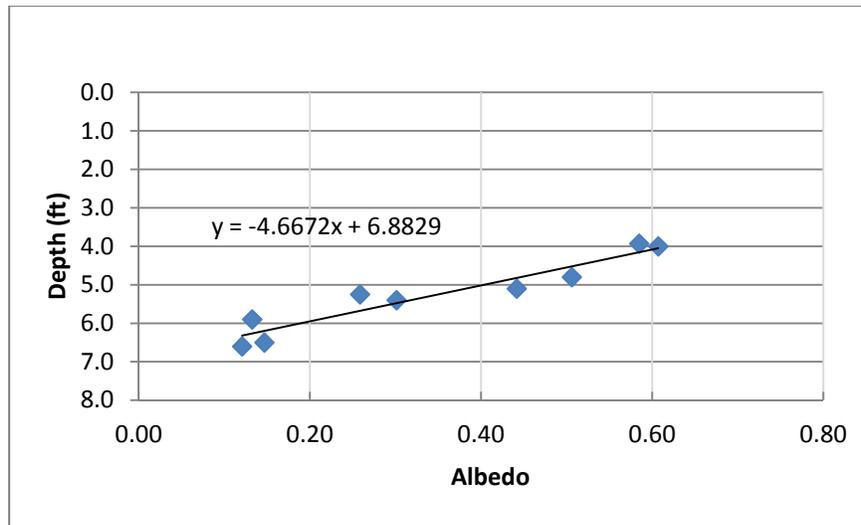
Location	Thaw depth (ft)	Albedo	Paint description
91+00	3.9	0.58	Fresh paint bright keel
Txwy B Ext	5.1	0.44	Old nearly intact white paint
Vortac Calib	5.3	0.26	Newer paint now brushed and faded
Txwy B Ext	6.5	0.15	Never painted
Txwy A at Txwy C	5.3	0.32	Faded due to brushing
Txwy A-08 end	4.0	0.61	East side of Txwy A—bright but older
Txwy A-08 end	4.8	0.51	West Bright (but old with some missing spots)
Txwy A-08 end	5.4	0.30	Faded white with much missing
Txwy A-08 end	5.9	0.13	Milled to black
Txwy A-08 end	6.6	0.12	Dirt

Figure 19. Albedo vs. thaw depth.

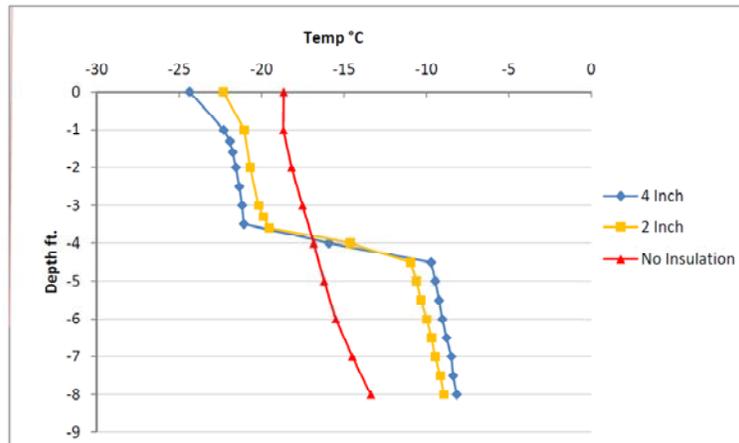
Figure 27. Insulation test measurement 1 April 2011. This plot demonstrates the thermal offset provided by 2- and 4-in. XPS insulation when the air is colder than the deeper subsurface.

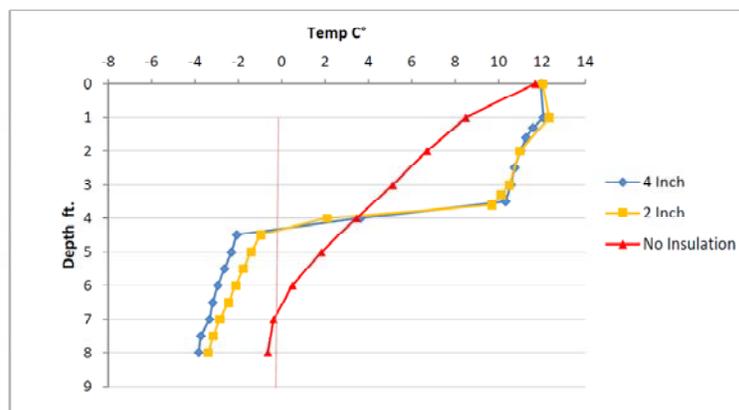
Figure 28. Insulation test measurement on 6 August 2011. This plot demonstrates the thermal offset provided by 2- and 4-in. XPS insulation when the air is warmer than the subsurface. The ultimate frost depth was held at the depth of the insulation. The summer of 2011 was the fourth warmest average air temperature recorded at the Air Base.

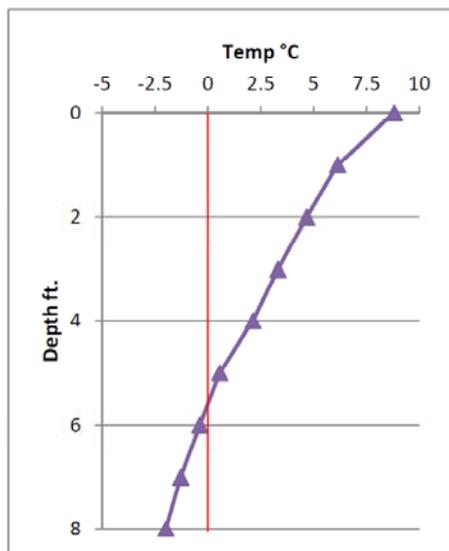
Figure 29. Subsurface temperatures measured at the “White Pavement” site. Measurement taken 11 August 2011 is the deepest thaw obtained for that summer. The albedo was 0.32 and the depth is almost 5.5 ft. This is consistent with the albedo vs. thaw depth presented in this report.

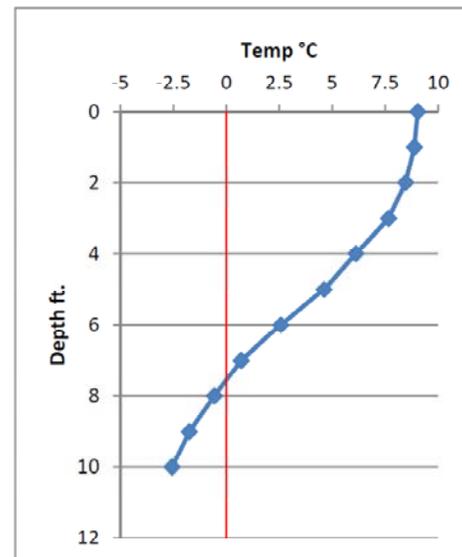
Figure 30. Subsurface temperatures measured at “Black Pavement” site. Measurement taken 11 August 2011 and is deepest thaw obtained for that summer, almost 7.5 ft, which is approximately 1 ft deeper than other measurements in natural colored pavement.

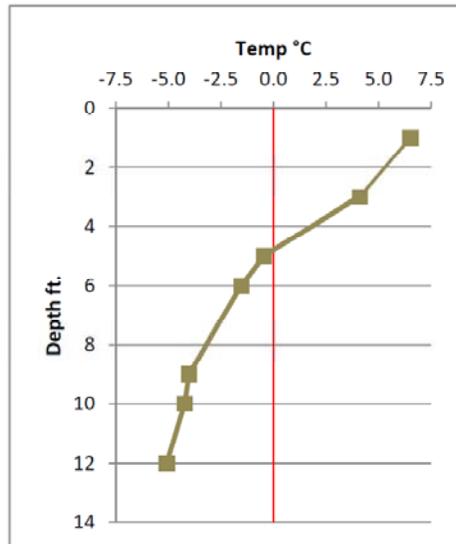
Figure 31. Subsurface temperatures at a permanent station in fill material near the Terminal Operations Building. Measurement was 1 August 2011 and is deepest the thaw obtained for that summer, almost 5 ft, which is consistent with borehole and test pit investigations, and the albedo vs. thaw depth measurements in fill material.

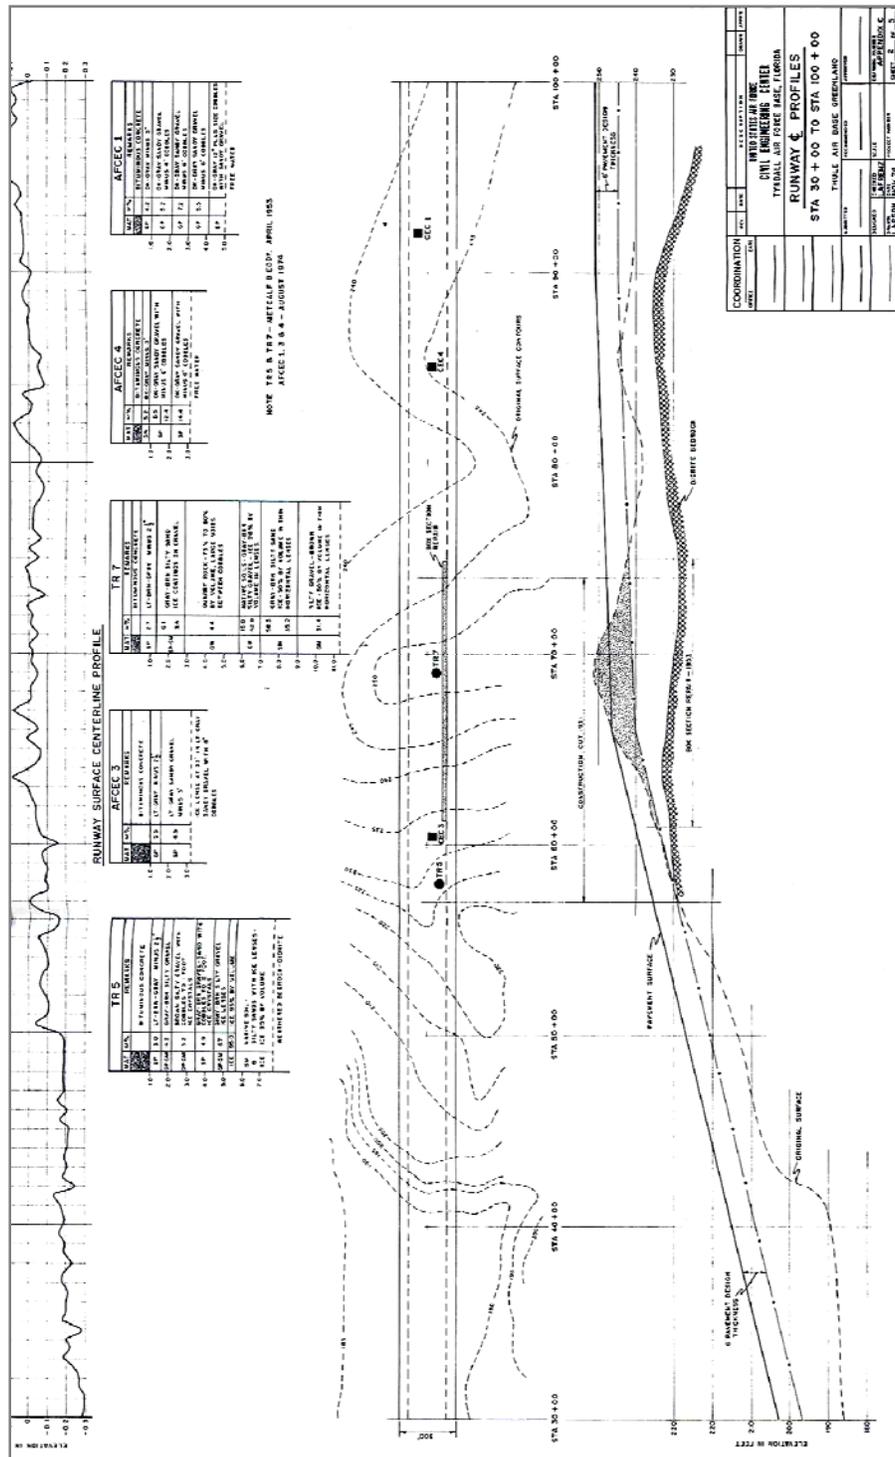
Figure 33. As-built plan provided in the AFCEC (1974) *Pavement Evaluation* report. The original surface before airfield construction is shown and is similar to the ACFEL (1955) report. These differ from the Metcalf & Eddy 1958 drainage report, which shows six cut sections.

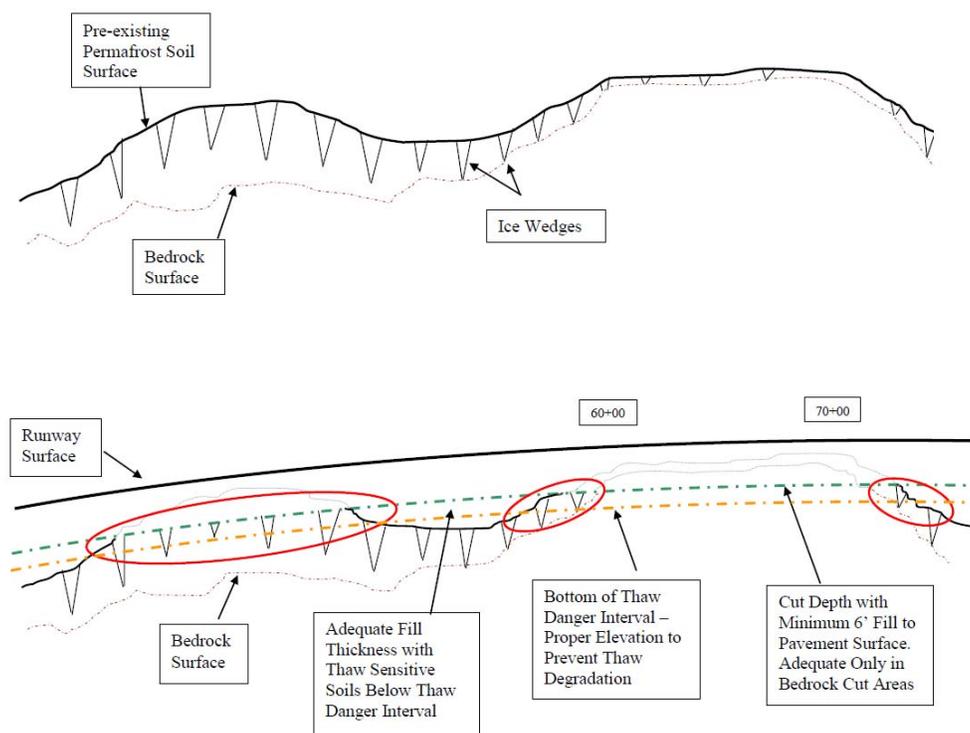
The model is completed with the addition of the accurate cut-and-fill thicknesses over the top of the ice rich native soils. The cut and fill locations indicate where the massive ice and ice-rich soils may be close to the surface and in danger of thaw. As the fill thickness decreases, the native ice-rich terrain surface becomes closer to the man-made surface, within the thaw critical interval. Figure 36 illustrates this general concept. Therefore, if the cut was not substantially deep enough to excavate the entire near surface wedge ice, thaw danger is possible at the margins and surface of the cut areas. However, it is possible that, in some of the cut areas, where shallow bedrock existed, the massive ice was completely removed.

Figure 36. Permafrost terrain conceptual model created for the airfield.

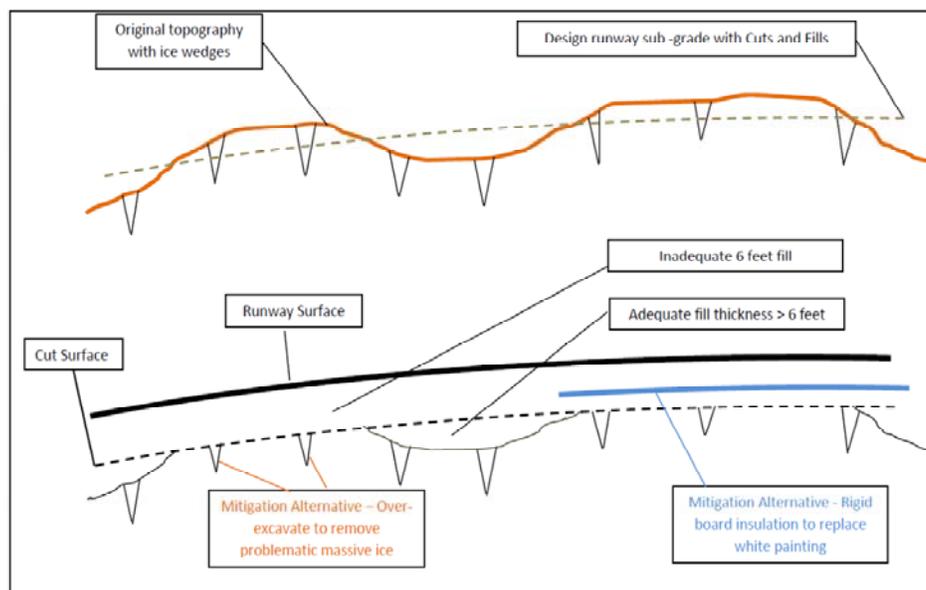
The insulation would be installed at the specified locations for thaw mitigation and at the depth of 4 ft below the finished subgrade. This depth is optimal for ensuring that subsurface groundwater does not flow at a shallower depth than it is now. It also eliminates the possible issues with differential heaving between the insulated section and the adjacent uninsulated sections. Preferably, 4- × 8-ft sheets would be used and each sheet must firmly abut the adjoining sheet. The following layers should be staggered to overlap the previous layer's joints by at least 1/3. Care must be taken with the size of the earth-moving equipment used to minimize fill material lift thickness so as to not shift or damage the XPS. The 4-ft-deep excavation for installing the insulation should not encounter massive ice.

However, if this were to happen, the opportunity should be taken to over-excavate the massive ice to the fullest extent possible to ensure problem areas are mitigated.

Figure 38. Thaw mitigation alternatives, over-excavation and insulation.

Removal of the massive ice in known areas can nearly eliminate the possibility of thaw degradation. Excavation of the subgrade soils to the bottom depth of the thaw critical interval, or 9 ft, would allow for visible identification of massive ice that then can be surgically removed to beyond the depth of the thaw critical interval. If over-excavation is prescribed for a localized area with known massive ice, the entire subgrade to the full depth of the excavation should be removed and replaced with clean, compacted fill material. The only known locations for shallow ice in the active runway are 58+00 to 64+00 (Table 2). Figure 38 also illustrates the concept of over-excavation.

The effectiveness of installing XPS rigid board insulation at depth was discussed in section 4.5. The field test and computer thermal modeling demonstrated that this alternative will perform as required. Extruded polystyrene (XPS) is a closed cell material and will not be adversely affected by water. High compressive and flexural strength insulation, up to 100 psi and above, is available specifically for direct bury in a structural embankment. It has been shown to perform well under these conditions. A minimum installed thickness of 4 in. is adequate for the current climate and soil conditions, and will perform as needed if the mean annual air temperature (MAAT) increases by 2 to 3°C. For an anticipated climate change of up to 6 to 8°C, 6 in. of EXP will be required. Figure 38 illustrates the concept and installation of the XPS.

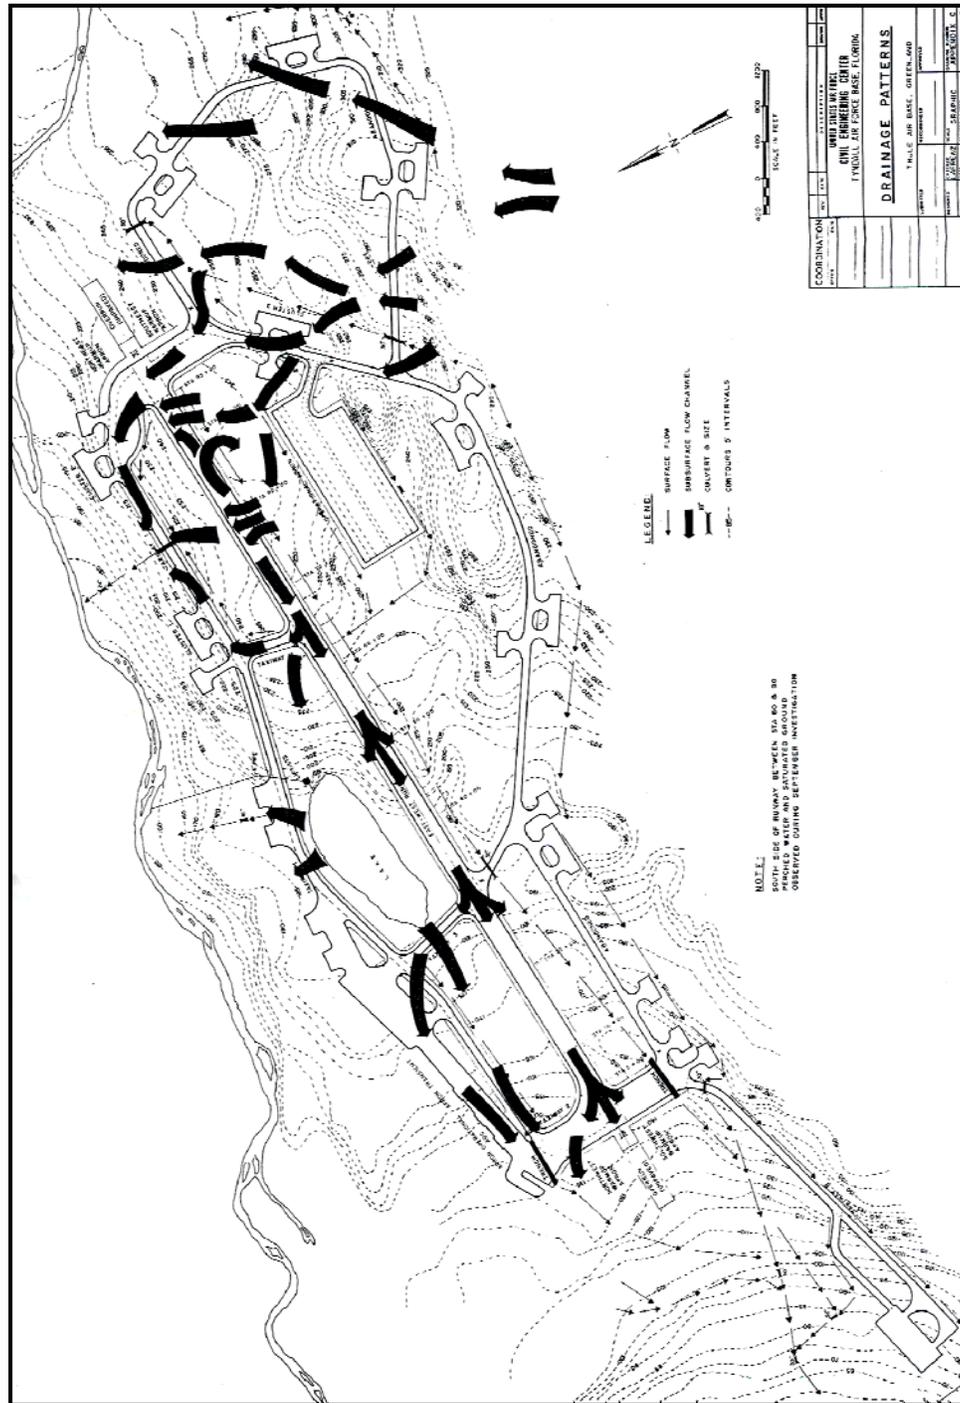
Previous dedicated drainage studies for the airfield (Metcalf & Eddy 1958; Berg 1976) have been conducted. These studies suggest that flow originates from the slopes of South Mountain, with contributions from the area in the direction of DET-1, and then enters the southeast area of the airfield, flowing across the South Loop Taxiway into the runway area. Both studies suggest that the runway and taxiway embankments act as preferential flow paths, and when flow encounters an embankment it migrates longitudinally under its centerline. The studies suggest that a majority of the flow eventually discharges out of the north side of the runway embankment at approximately 80+00 to flow through the culvert under Taxiway Alpha east of Taxiway Charlie (Fig. 39).

Figure 39. Surface water drainage paths and inferred subsurface drainage paths (AFCEC 1974).

Some flow continues to the west into Lake Eddy, under Taxiway Bravo and out under culverts to the west. In 1975, “bird baths” that had developed from 80+00 to 100+00 were suspected to be from groundwater weakened soils. Berg (1976) suggested white painting of this section of the runway; it

was done in 1977. Pavement overlay was done in 1977 and repaving in 1993 and this problem has not returned. The Metcalf & Eddy (1958) study suggests that a spring exists under station 85+00 of the runway with no explanation. A spring migrating through cold, continuous permafrost is very unlikely.

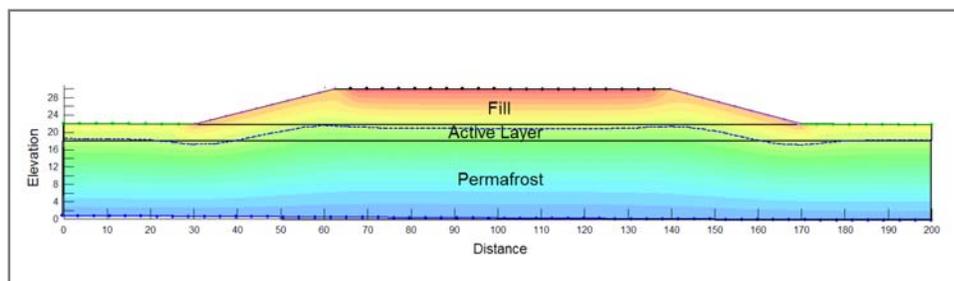
A finite element computer analysis was performed to see if subsurface water could possibly flow down the center of the airfield embankments. An idealized embankment was constructed with a 6-ft gravel fill section overlying a 4-ft active layer, these both in turn overlying an 18-ft thick permanently frozen till. Figure 40 shows that the swales at the transition from the embankment to the native soil grade would be the lowest elevation along the cross section. The top of the permafrost in the embankment will be at a higher elevation than the top of the permafrost in the native material adjacent to it, creating a damming effect that resists groundwater movement from one side of the embankment to the other. Therefore, a more realistic scenario than that suggested by the previous drainage reports is that lateral flow of groundwater under the runways and taxiways is altered or blocked, diverting the groundwater in complicated ways.

Figure 40. Numerical analysis of thaw depth in a 6-ft fill embankment constructed on natural grade. The colors represent end-of-analysis temperatures, with blue the coldest, and red the warmest. The depth of thaw after one season is represented by the blue dotted line. The raised permafrost table into the fill produces swales at the embankment toe and a damming effect that would prevent lateral flow of groundwater from shoulder to shoulder.
