# **Realistic Safe-Separation Distance Determination for Mass Fire Hazards**

Thomas L. Boggs  
*New Directions Technology, Inc.*  
*Ridgecrest, CA 93555*

Kevin P. Ford  
*Energetics Research Division*  
*Weapons and Energetics Department*  
*Naval Air Warfare Center Weapons Division*  
*China Lake, CA 93555*

**MARCH 2013**

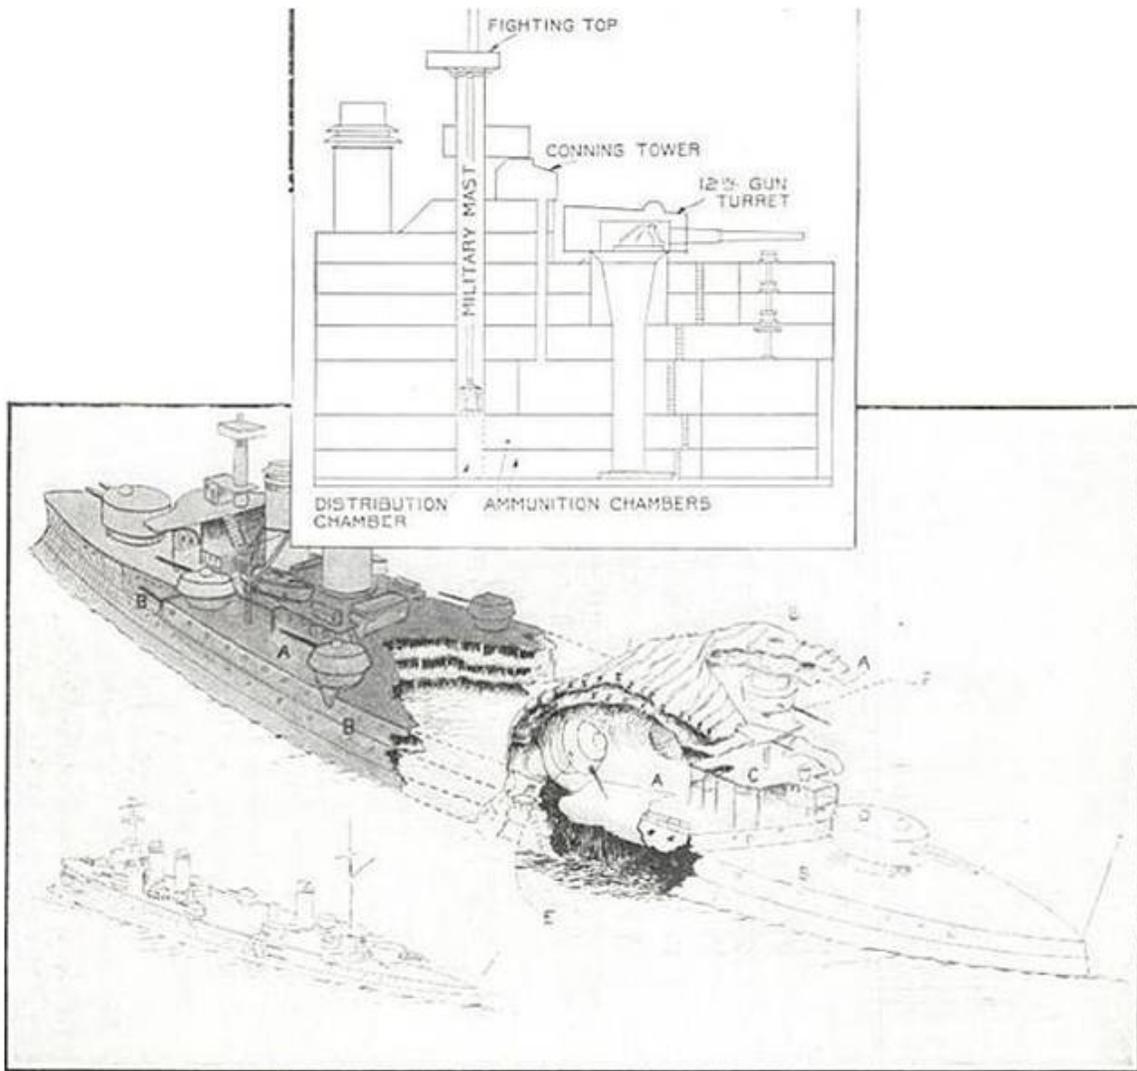
On 25 September 1911 while in the Toulon harbor, the magazines of the *Liberte* exploded. The chain reaction explosions of the magazine followed frantic firefighting after auto-ignition of the nitrocellulose gun propellant in a forward magazine. The violence of the explosion amidships tossed the upper decks back, curled and flattened like a banana peel as indicated in Figure 5.

FIGURE 5. Result of the Explosion Aboard the *Liberte*, 25 September 1911.

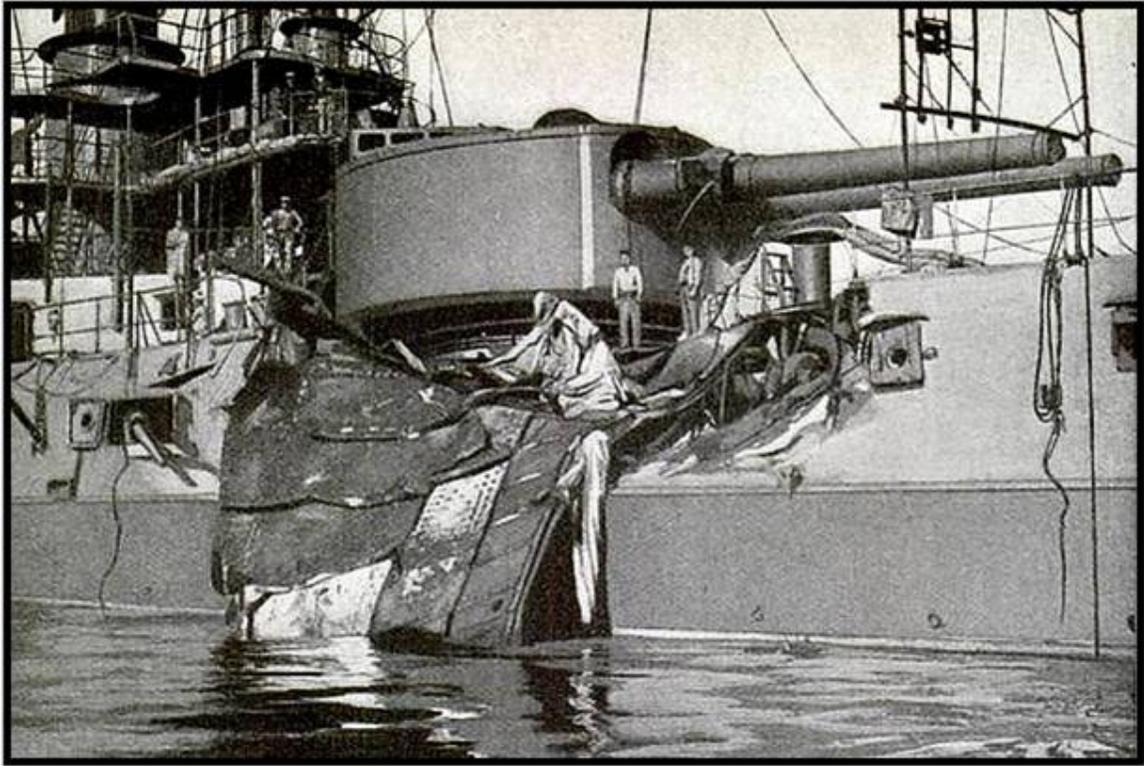
Sections of the *Liberte* were hurled outward with great force. Figure 6 shows a large piece of the *Liberte* embedded in the *Republique*, which was anchored nearby.

FIGURE 6. Sections of the *Liberte's* Armor Plate Embedded in the *Republique*, Which was Anchored Nearby.

The above series of accidents involved auto-ignition of nitrocellulose gunpowder, resulting in fires in high confinement environments allowing significant pressurization leading to explosions. [Magazines below the waterline with associated confinement of the waterline armor belt (see, for example, the armor plate from the *Liberte* embedded in the adjacent *Republique* shown in Figure 6). The waterline armor belt of the *Republique* held up, but the unprotected upper deck crumpled.]

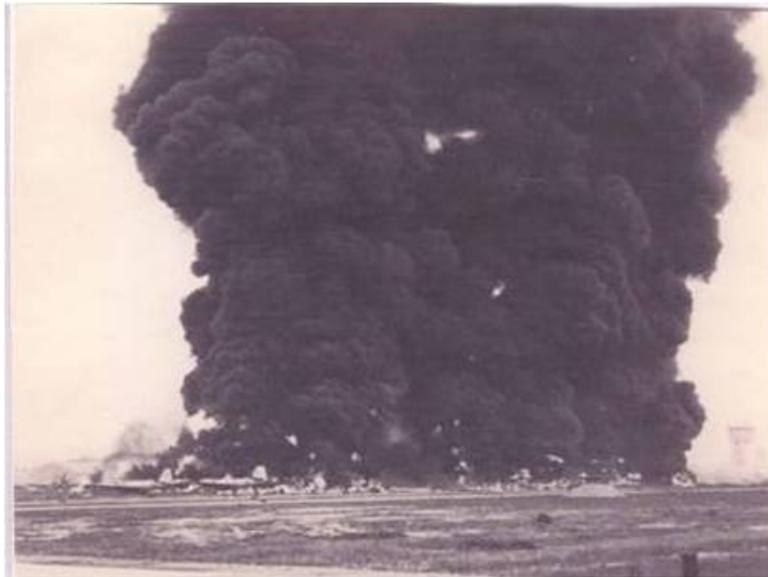
bladders of JP-4 fuel provided additional fire. The video referenced at the end of this section shows movement of the many A-1E Skyraiders with their associated ordnance being moved out of harm's way. When the fire and explosions finally ceased, 27 men had been killed and over 100 injured. Aircraft destroyed included 10 B-57s, one Navy F-8 Crusader, and 15 A-1Es. Figures 14 and 15 present pictures of the conflagration.

FIGURE 14. Conflagration at Bien Hoa AFB, South Vietnam, 16 May 1965, as Seen From the Ground.

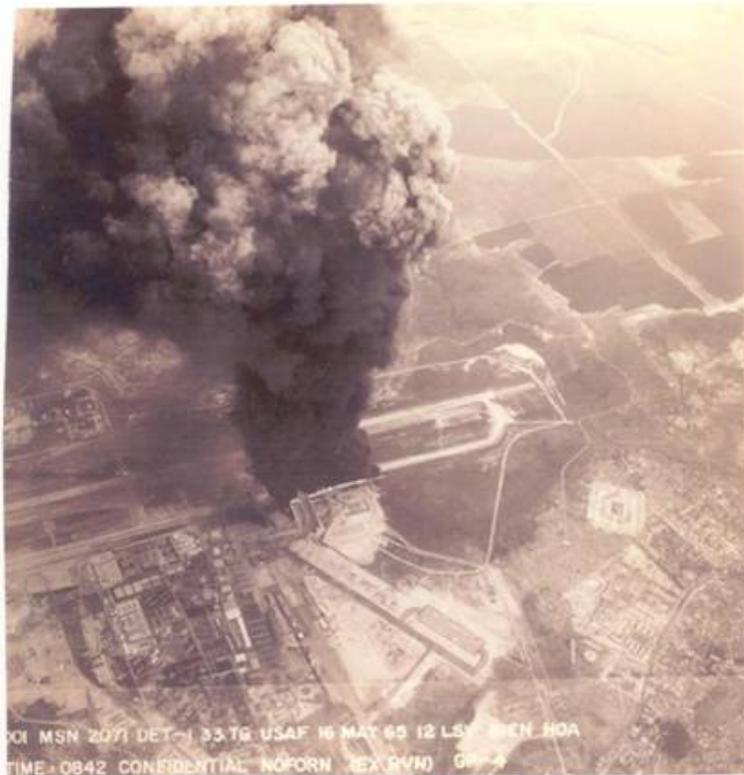
FIGURE 15. Conflagration at Bien Hoa AFB, South Vietnam, 16 May 1965, as Seen From the Air.

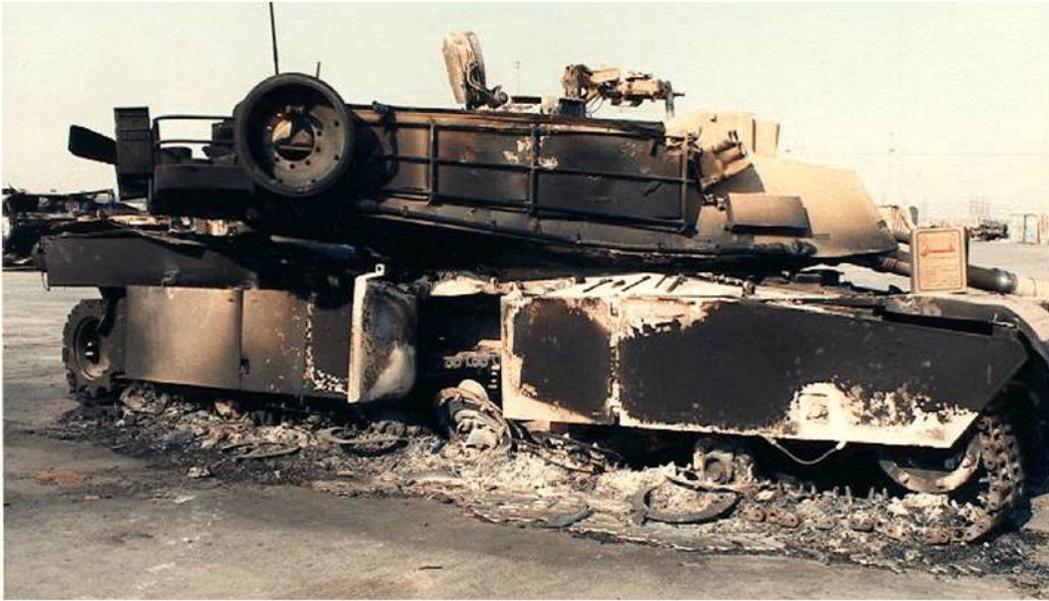
and 6 UK troops. Most of the injuries were relatively minor, such as those suffered when troops climbed over the 15-foot-high perimeter wall (Figure 23), but there were two serious injuries. However, destruction to the camp and equipment was extensive, as shown in Figures 23 through 28.

FIGURE 24. Burned-Out M1A1 Abrams Tank at Camp Doha, July 1991.

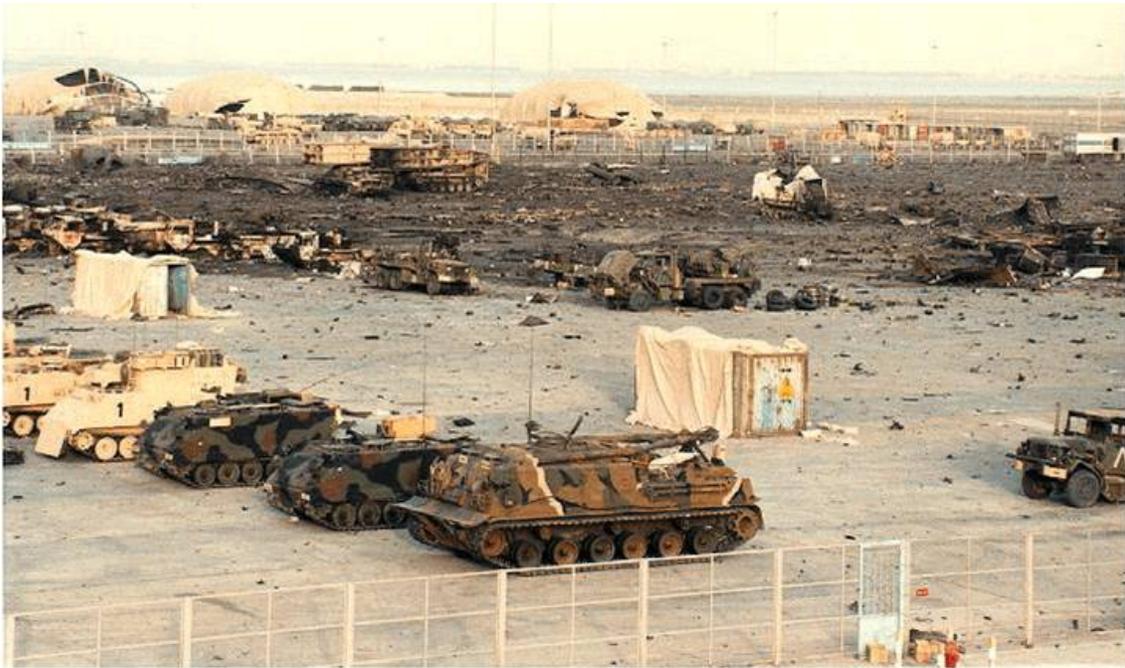
FIGURE 26. Aftermath of Camp Doha Motor Pool Fire.

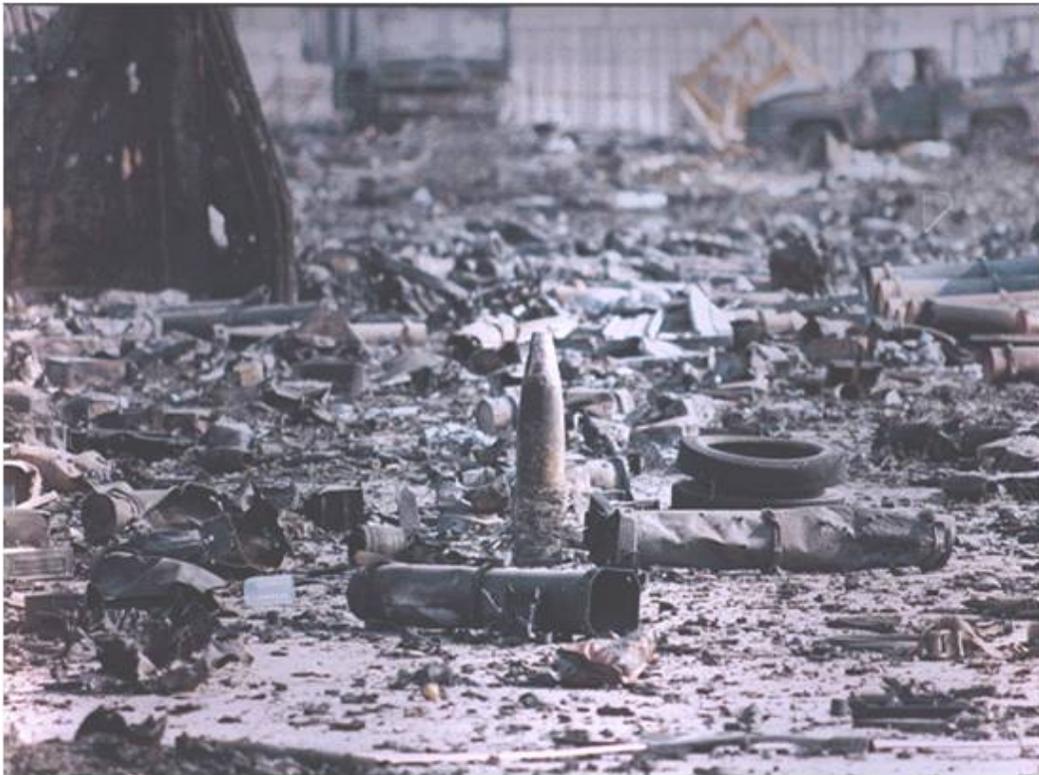
FIGURE 27. Unexploded Ordnance in Camp Doha North Compound.

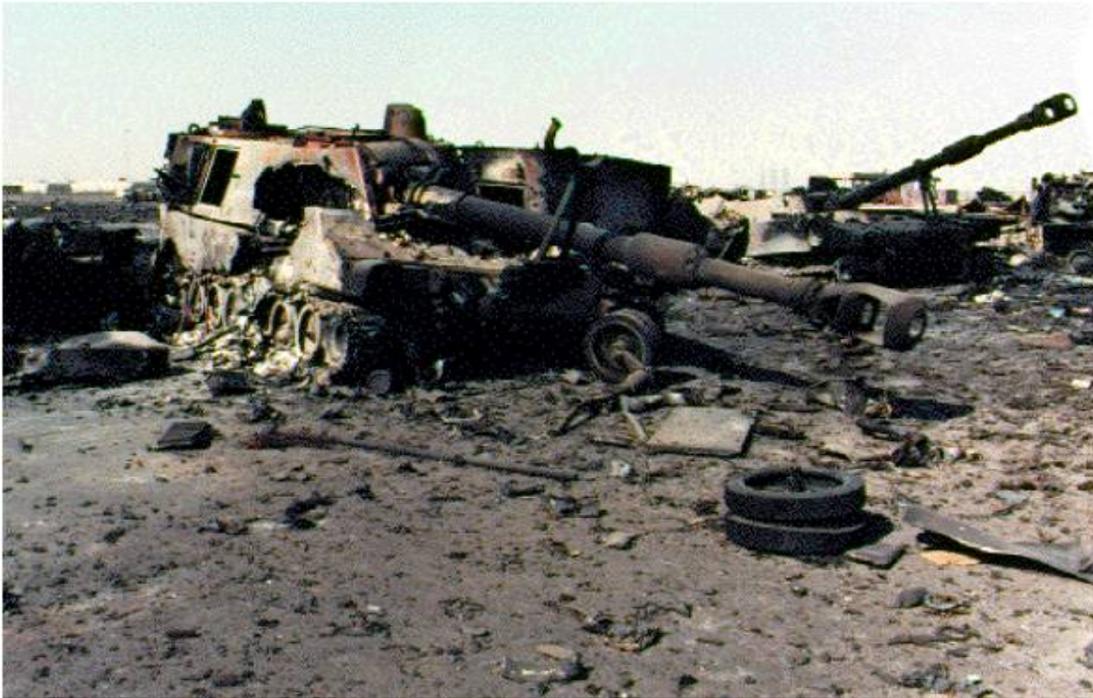
FIGURE 28. Destroyed M109 Howitzers at Camp Doha, Kuwait.

A total of 102 vehicles were destroyed, including four M1A1 Abrams tanks, and seven M109 Howitzers.

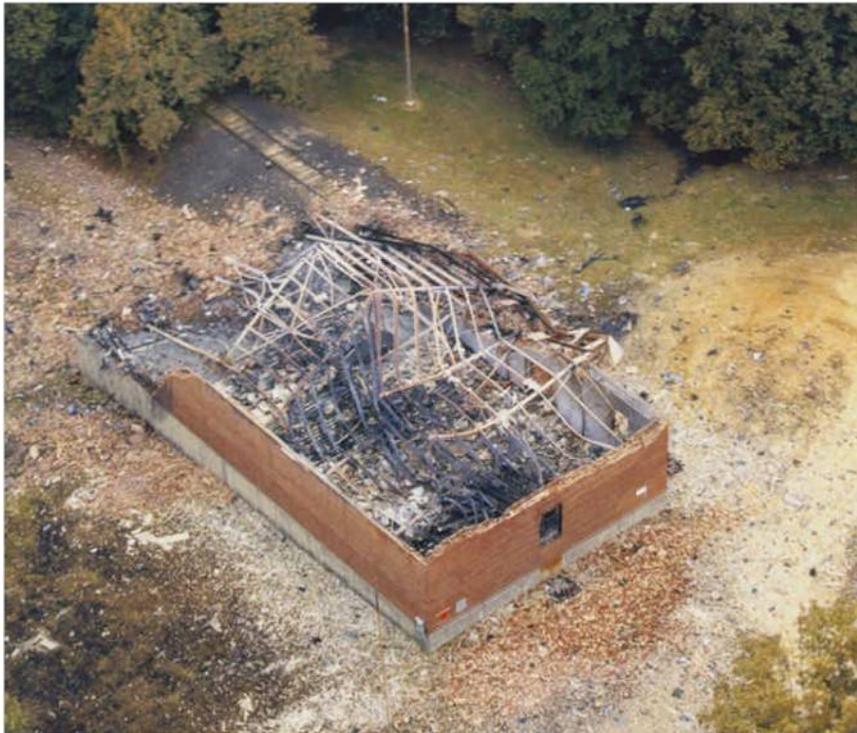
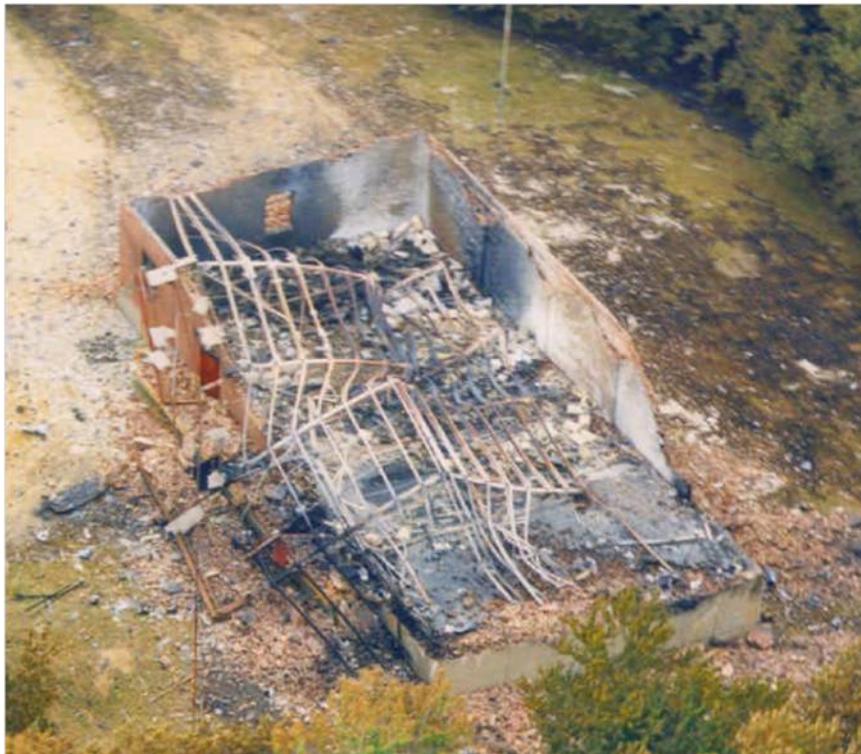
The magazine was damaged beyond economic repair but was not completely destroyed. As shown in Figure 32, the south wall was completely destroyed as was approximately two-thirds of the west wall and one-third of the east wall (the portions that were adjacent to the south wall).

An oblong crater, approximately 7 feet east-to-west and 4 feet north-to south and 3 feet deep at the center, was formed at the southeast corner of the building. In addition, there were smaller craters along the entire width of the south wall. The floor was depressed along the entire width of the south wall.

FIGURE 32. Magazine 518 After the Accident of 1 August 1994.

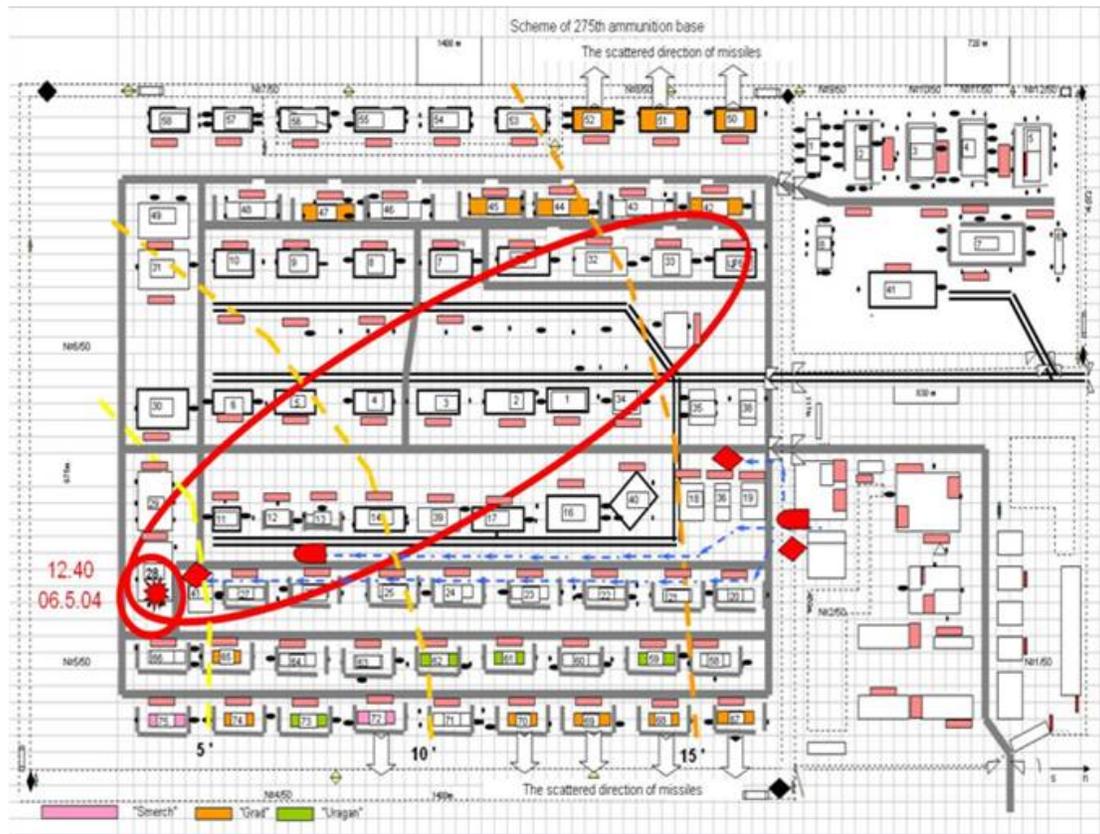
FIGURE 33. Schematic of the 275<sup>th</sup> Ammunition Base Showing the Storage Locations and the Weapon Types Stored in the Various Areas. The fire started in storage area 28, an area for demilitarization operations.

Figure 33 shows the storage locations and the weapons stored in the various locations. The fire started in storage area 28. The “Smerch” refers to 300-mm caliber multiple launcher rocket system having a range of between 20 and 70 kilometers. The “Grad” refers to a 122-mm caliber multiple-launch rocket system having a range between 1.6 and 20.4 kilometers. The “Uragan” refers to a 220-mm caliber multiple-launch rocket system having a range between 8 and 35.8 kilometers.

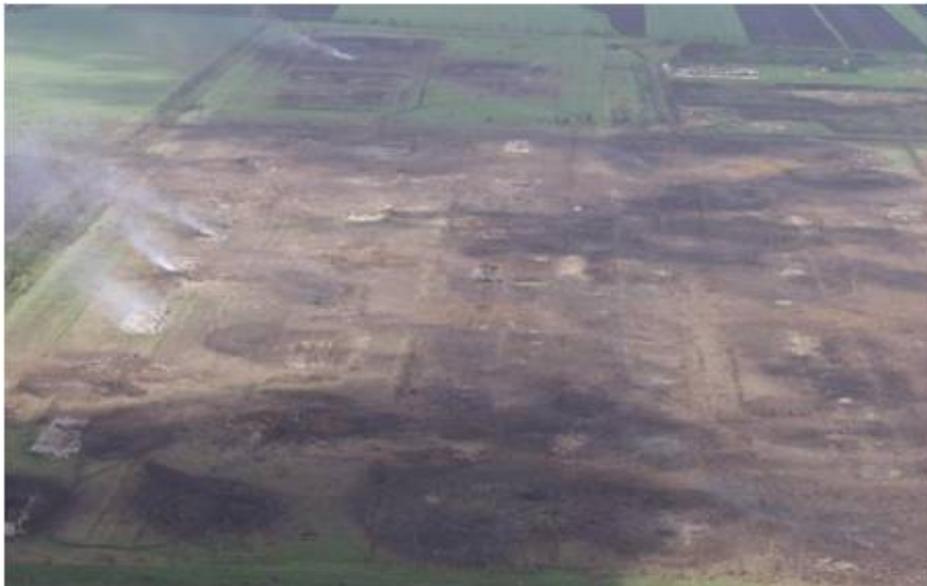
FIGURE 35. Novobogdanovka, Ukraine, After May 2004 Accident.

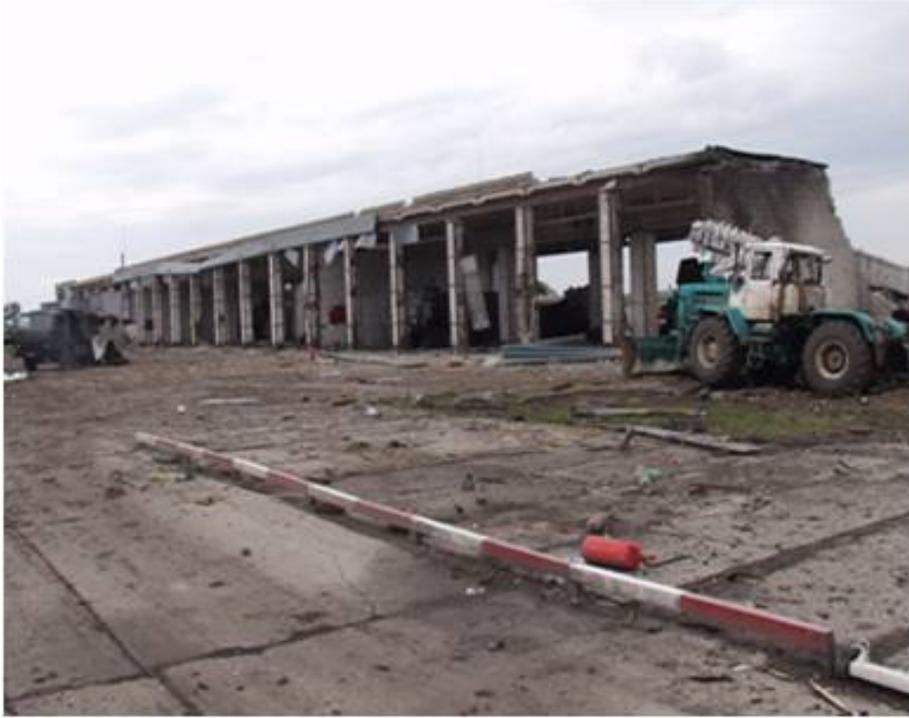
FIGURE 36. Devastation of Facilities and Equipment at the 275<sup>th</sup> Ammunition Base, Novobogdanovka, Ukraine.

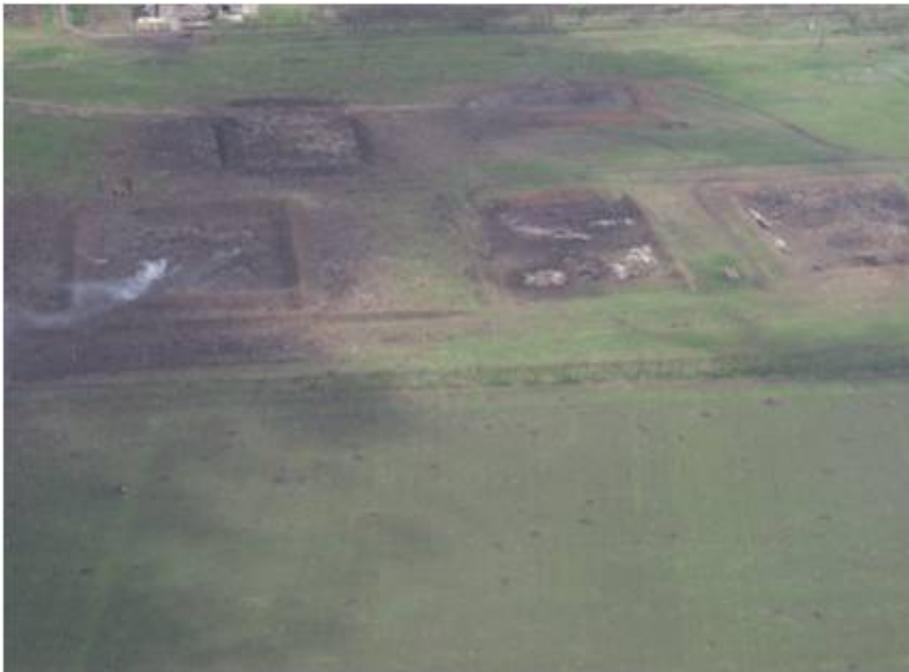
FIGURE 37. Aerial View Showing Some of the Devastation at the 275<sup>th</sup> Ammunition Base, Novobogdanovka, Ukraine.

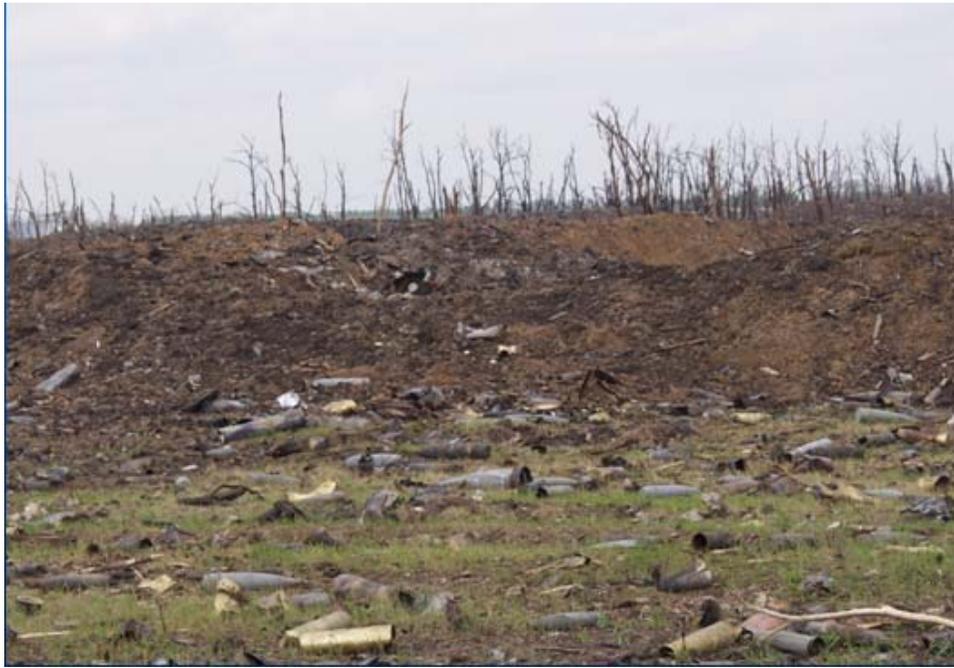
FIGURE 38. View of Devastation and Dispersion of Munitions and Debris at the 275<sup>th</sup> Ammunition Base, Novobogdanovka, Ukraine.

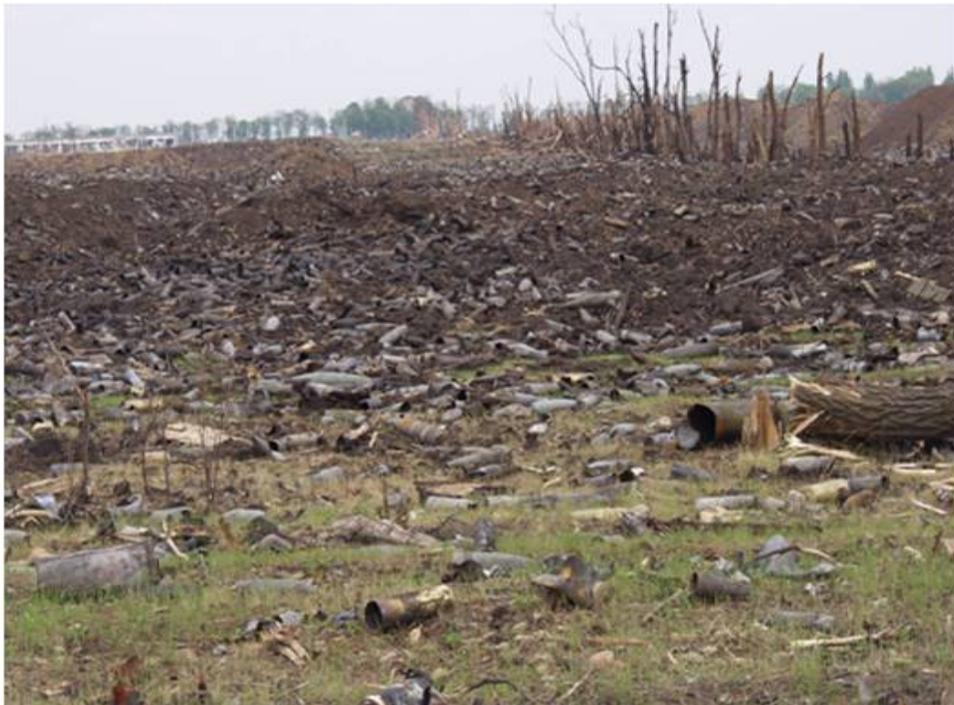
FIGURE 39. View of Devastation and Dispersion of Munitions and Debris at the 275<sup>th</sup> Ammunition Base, Novobogdanovka, Ukraine.

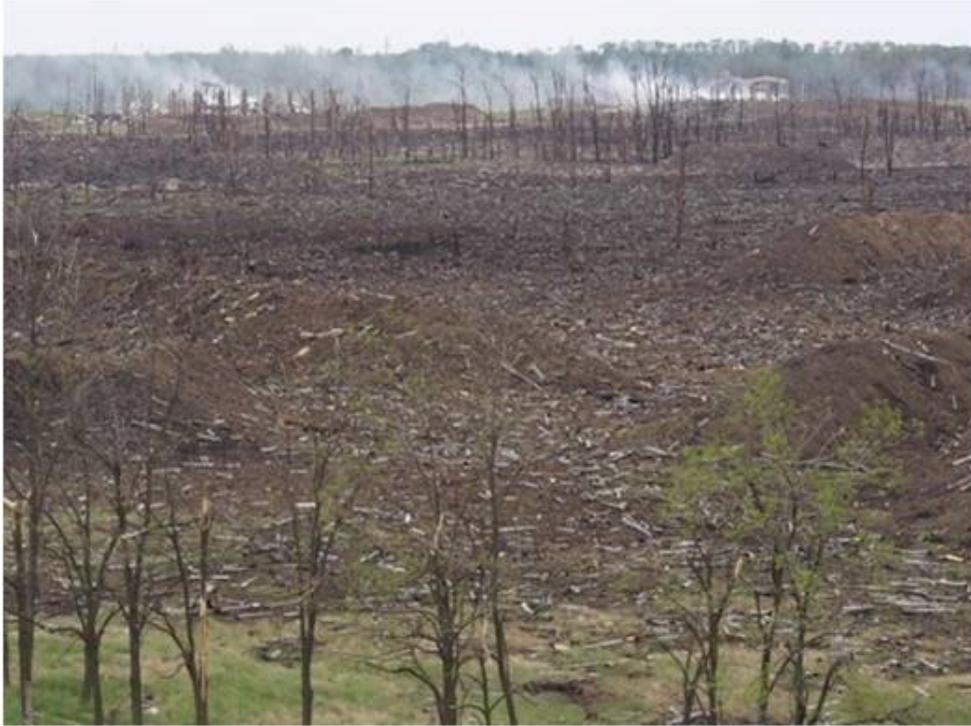
FIGURE 40. Aerial View of Devastation and Dispersion of Munitions and Debris at the 275<sup>th</sup> Ammunition Base, Novobogdanovka, Ukraine.

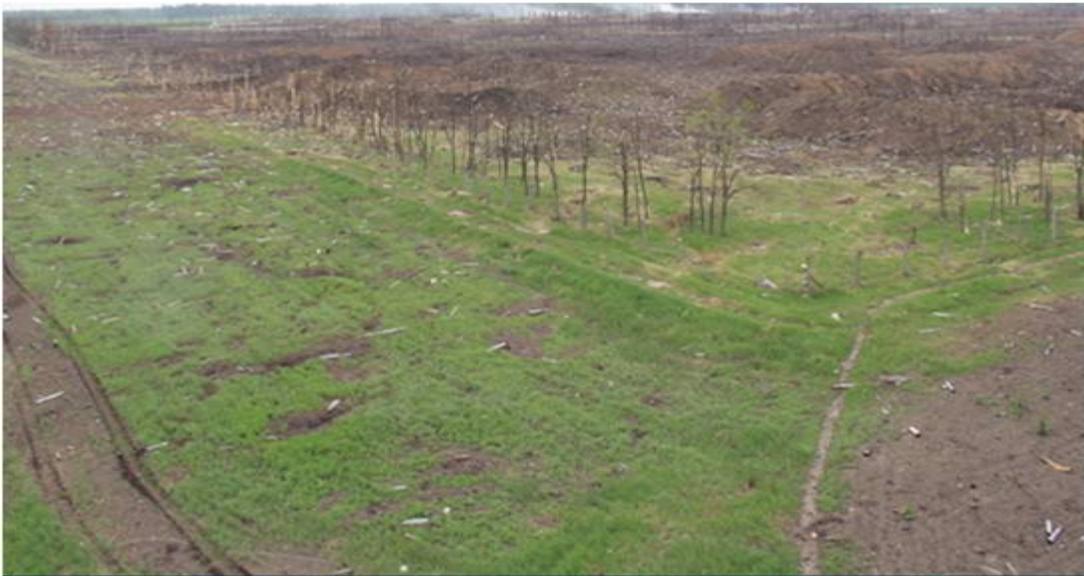
FIGURE 41. Aerial View of Devastation and Dispersion of Munitions and Debris at the 275<sup>th</sup> Ammunition Base, Novobogdanovka, Ukraine.

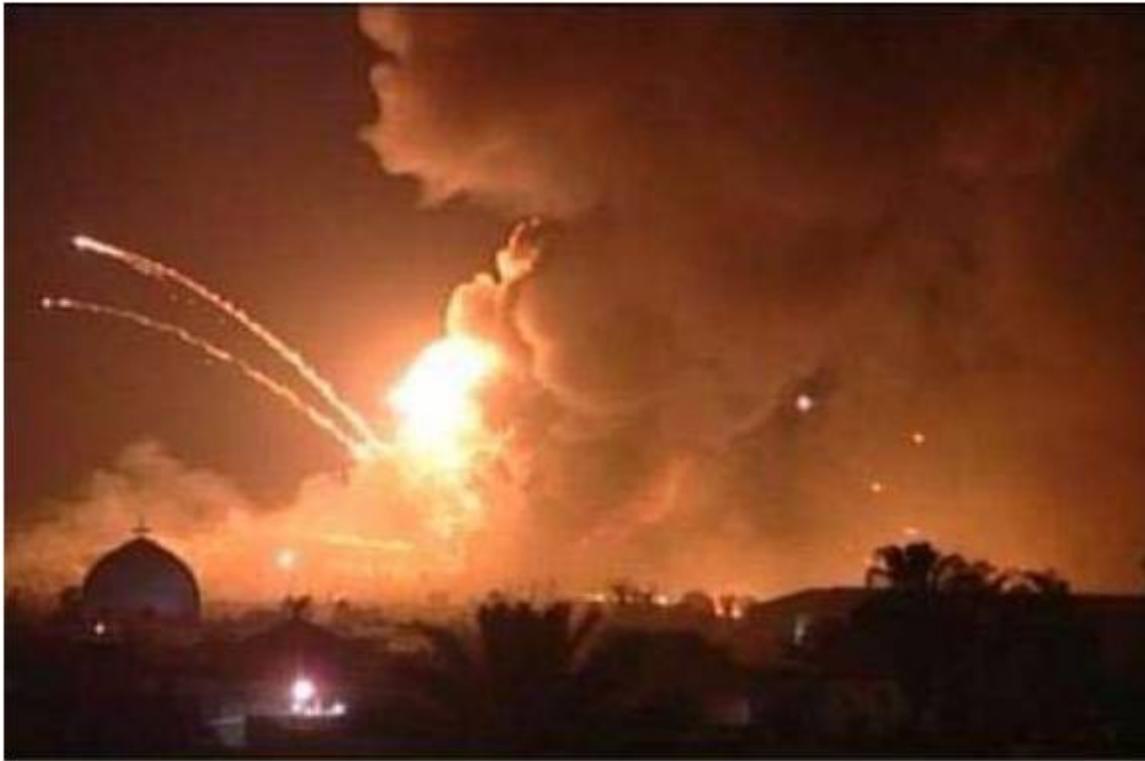
At about 9:00 p.m., a rocket attack caused fires near the ammunition dump at the U.S. air base at Kirkuk, Iraq. The fires spread and caused several explosions over the next few hours. The fires were finally put out at approximately 5:00 a.m. The following morning, there were no casualties on base, but the explosions caused damage over a wide area, including shattered windows and damaged cars. Debris was found 1.5 kilometers from where the munitions were stored. Figure 42 shows the conflagration.

FIGURE 42. Conflagration at Kirkuk U.S. Airbase, Iraq, 2 June 2004.

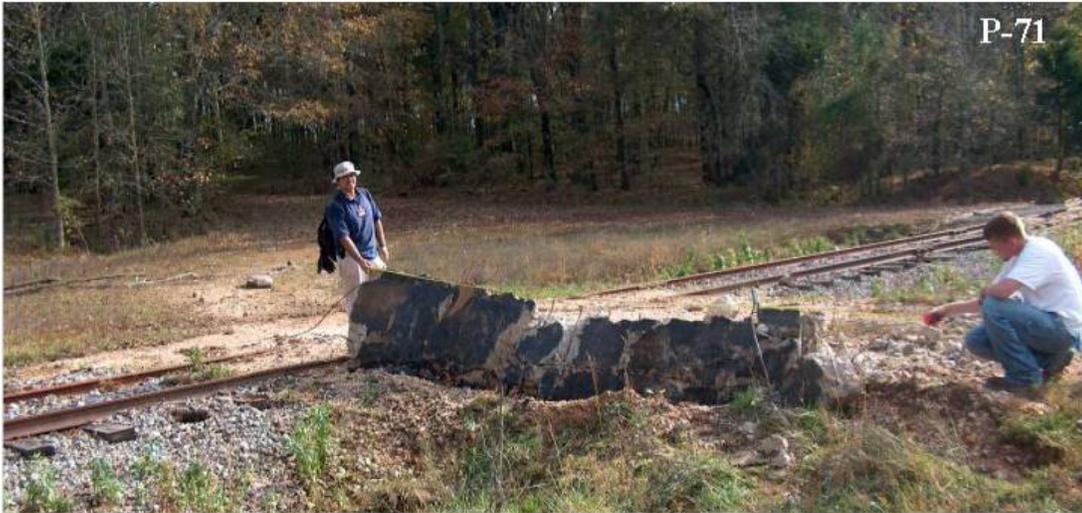
Of particular interest was the size of some of the debris and the distances it was thrown. For example, one fragment was steel reinforced concrete 16 feet in length and 3 to 4 feet in width (Figure 45).

FIGURE 45. Large Fragment That Landed Between Magazines P-70 and P-71.

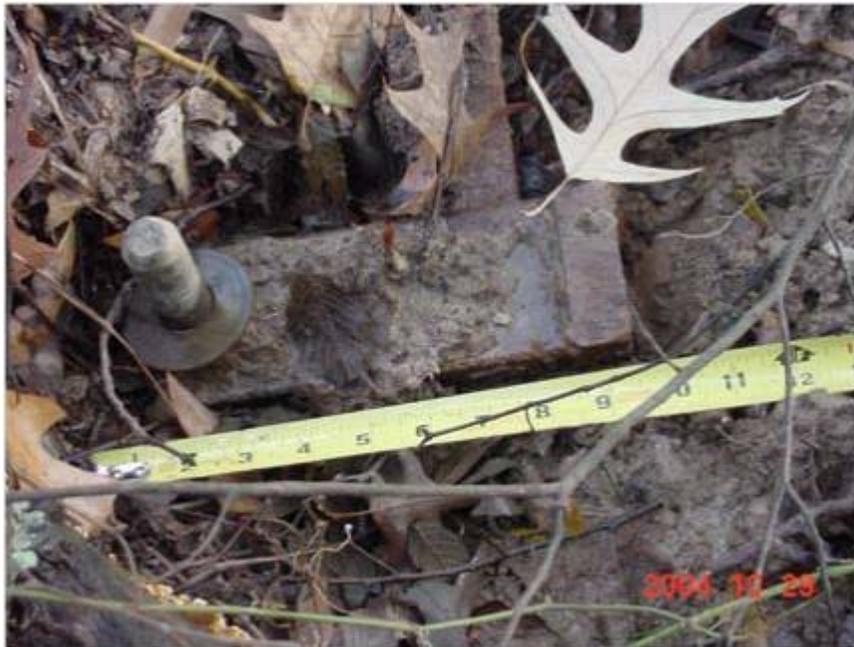
FIGURE 47. (Contd.)

Some of the debris resulted from large fragments breaking up into smaller fragments on impact. There was also evidence of significant fragments traveling distances significantly greater than the 1,250-foot radius IBD arc (Figure 46). For example, there was significant damage to a tree located 2,100 feet in front of ECM-69, as shown in Figure 47 that presents photographs of the tree and the debris found at the base of the tree.

(c) Debris that caused the damage to tree located 2,100 feet to the front of ECM P-69.

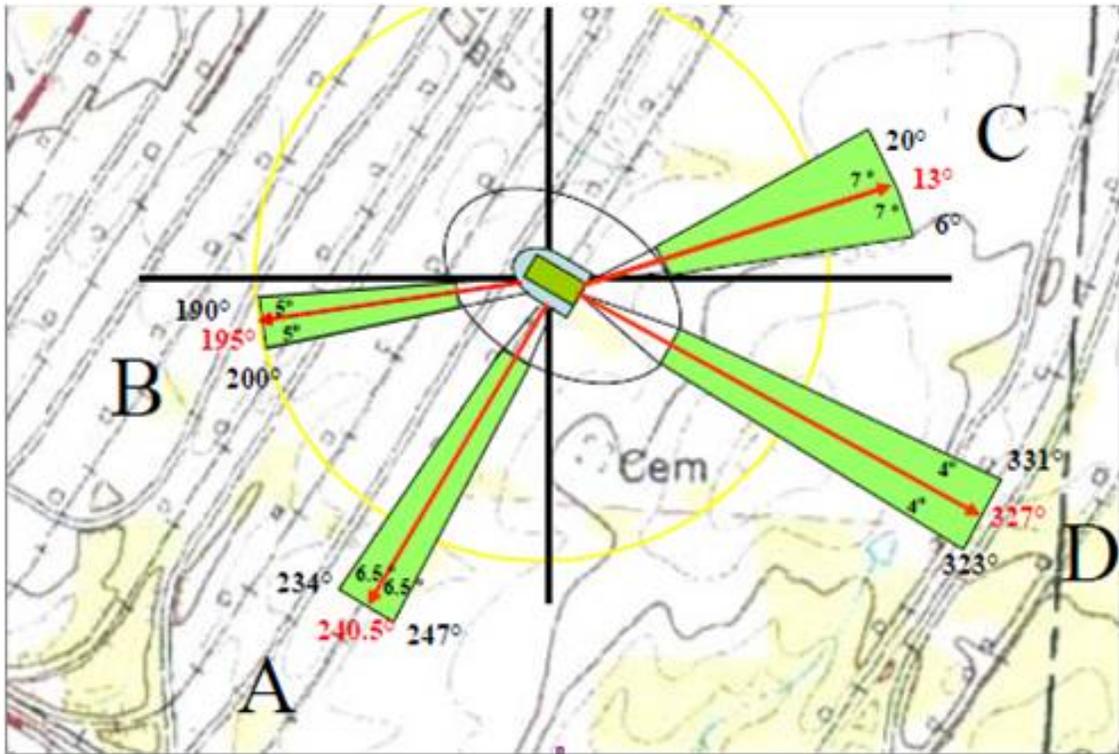
FIGURE 50. Search Sectors.

The U.S. Army Technical Center for Explosives Safety initiated an effort to study the debris fields and dispersion of fragments (Reference 23). Four sectors were defined and fragments were mapped and weighed within the sectors. The sectors were an 8-degree wide sector extended from the center of the front of the magazine (Sector D), a 13-degree wide sector from the side of the magazine (Sector A), a 10-degree wide sector about midway between the side and back of the magazine (Sector B), and a 14-degree wide sector midway between the front and opposite side of the magazine (Sector C) as illustrated in Figure 50.

All fragments were secondary fragments originating from the structural elements of the ECM. No primary fragments (fragments from the HD 1.1 materials) were recovered. Most of the fragments were concrete, rebar, or a combination of both. Emphasis was placed on hazardous fragments having an impact energy of 58 foot-pounds (ft-lb) or greater and/or a weight greater than 6.17 ounces or 175.5 grams. The vast majority of the fragments were hazardous. The fragments were addressed in two fashions: one was simply a unit count, each fragment counted as one item regardless of size and weight, and the other was a weight-equivalent count where each fragment's weight was divided by the minimum weight of a hazardous fragment (6.17 ounces). The results show the following in terms of less than one hazardous fragment per 600 square foot area:

- Sector A. For the unit count method, there is a problem (more than one hazardous fragment/600 square feet) from 1,250- to 1,300-foot radius, and then no problem out to 1,750 feet. However, for the weight-based count, there is a problem from 1,250 to 1,350 feet and then again at about 1,550 feet.
- Sector B. There are essentially no problems for either the unit or weight-based count within a 1,250- to 2,400-foot radius.
- Sector C. There are essentially no problems for the unit count method within the 1,250- to 1,841-foot radius, but there are problems with the weight count over this

- The use of unit count indicates excessive hazardous fragment density beyond the 1,250-foot IBD arc in one sector (A).
- The use of weight-equivalent count indicates excessive hazardous fragment density beyond the 1,250-foot IBD arc in three sectors (A, C, and D).

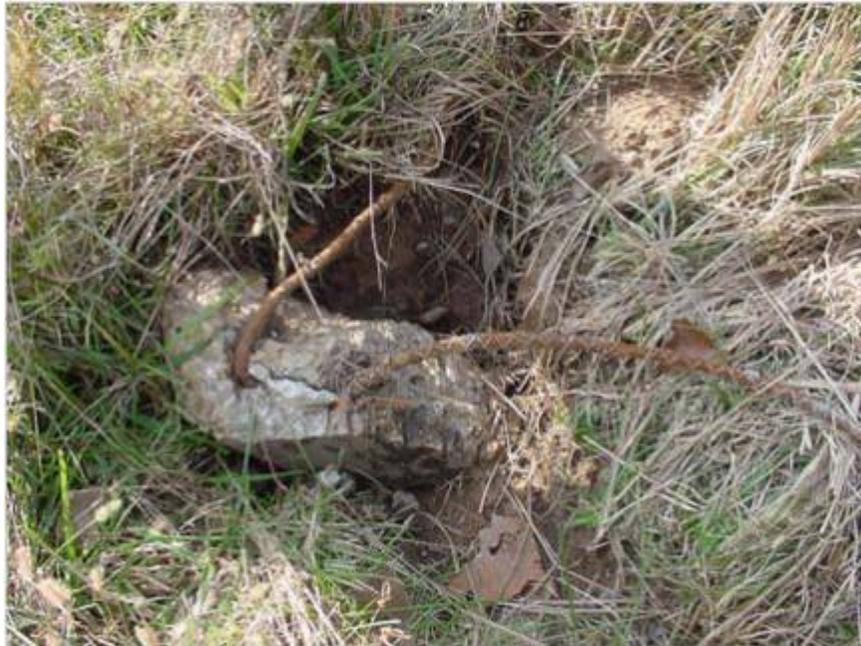
In addition to the sectors previously described, the investigators recorded notable fragments outside of the search sectors. These included especially large fragments and/or fragments that traveled unexpectedly long distances. For example, significant debris was found on top of and in front of magazine P-6, which is approximately 2,050 feet away from P-69 (Figure 51).

FIGURE 51. Fragment Found in Close Proximity to ECM P-6, Approximately 2,050 Feet Away From ECM P-69.

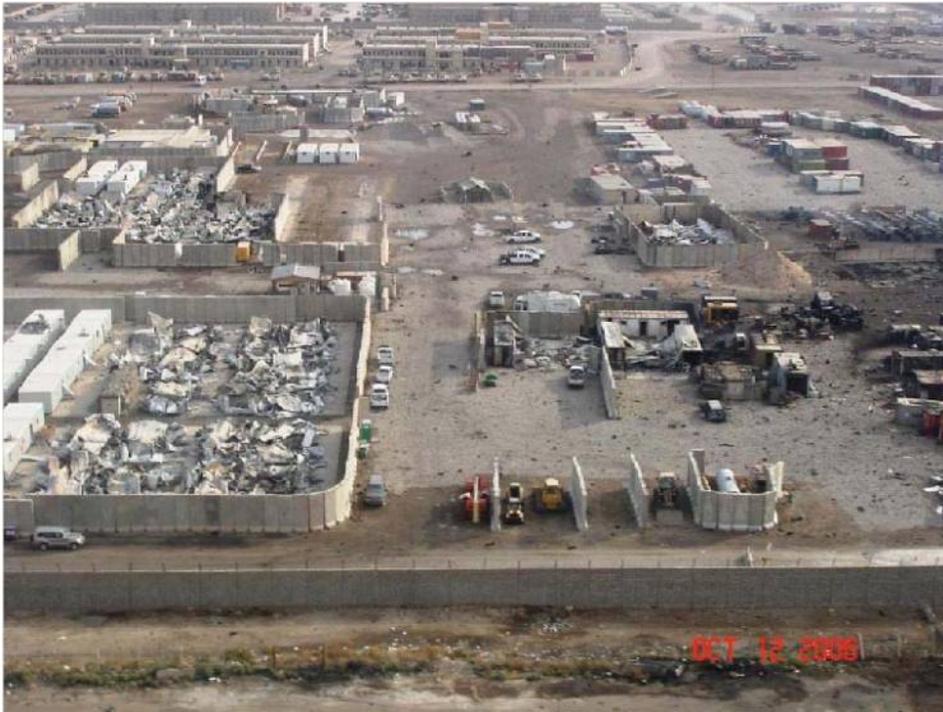
A fire started by an 82-mm mortar round fired by insurgents occurred at Forward Operating Base (FOB) Falcon near Baghdad at around 10:40 p.m. on 10 October 2006. Falcon is located in a former commercial trucking depot in a sprawling industrial area at the southern entrance to Baghdad. There were no injuries reported, but the fire spread and caused fires and explosions in surrounding tank and artillery ordnance and small arm ammunition. These fires and explosions went on for 12 hours after the original fire. The flames, smoke, and flashes from the explosions could be seen in central Baghdad, which was several miles away. There was significant damage as shown in Figures 52 and 53.

FIGURE 52. Damage at FOB Falcon Near Baghdad, Iraq, 10 October 2006.

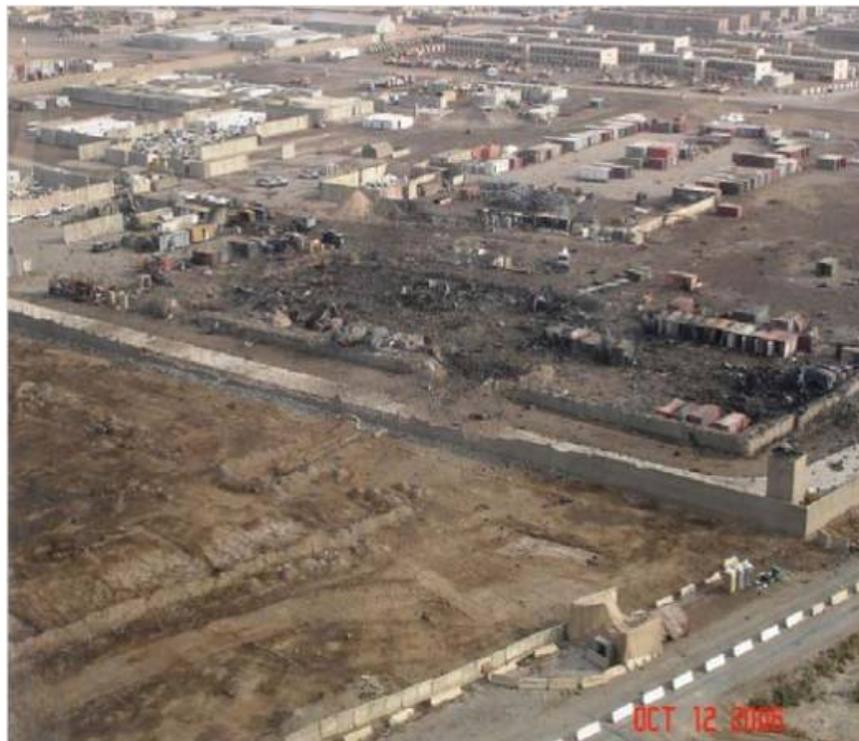
FIGURE 53. Damage at FOB Falcon, Near Baghdad, Iraq, 10 October 2006.

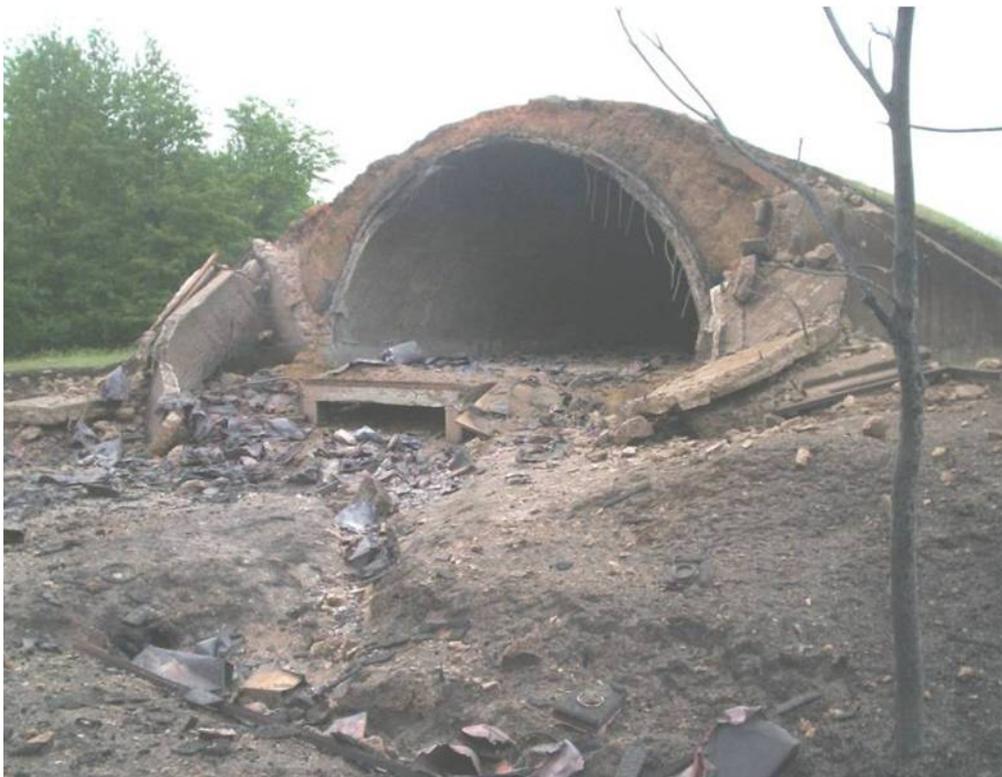
The postmortem photographs clearly show that the fire blew out the head wall and scattered debris over an area as shown in Figures 54 through 56. The remaining portion of the ECM was relatively intact as shown in the pictures. There was no evidence of cratering to indicate a detonation occurred. This is in direct contrast to description in the MSIAC accident report that had a base spokesperson saying, "At approximately 5:00 a.m., one of our storage magazines internally detonated. Something happened that caused the detonation to result in a fire." Again, there was no detonation. The fire was likely due to auto-ignition of the M-10 propellant. The fire resulted in pressurization of the magazine. Fortunately, the pressure blew out the front wall resulting in un-choked flow. The un-choked flow resulted in some material dispersed outside the magazine and burning outside as indicated in the photographs.

FIGURE 55. ECM With Head Wall Blown Out.

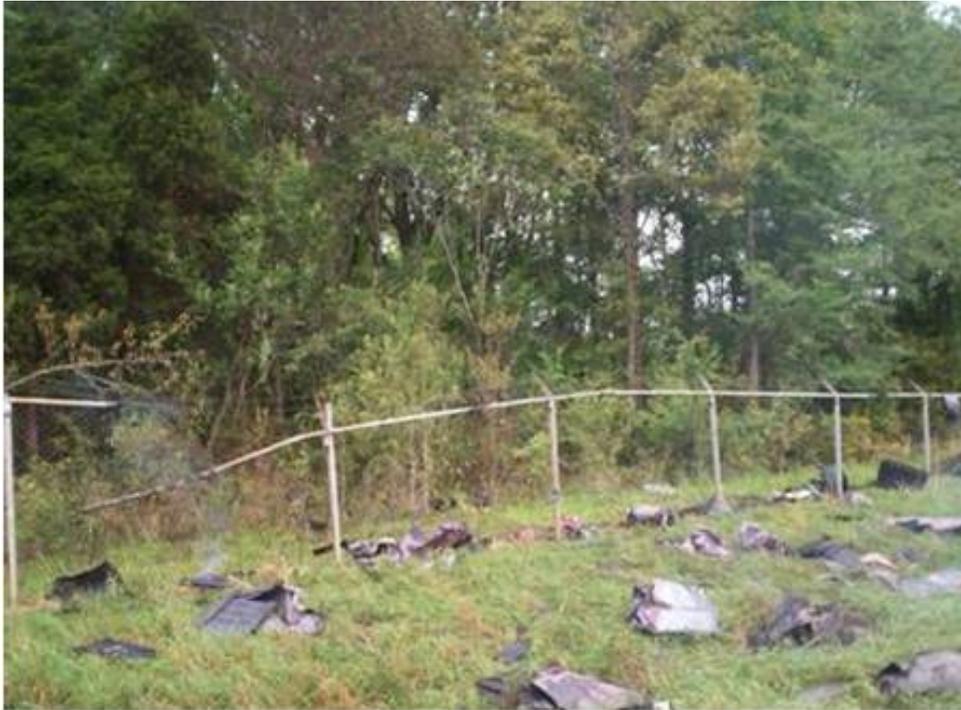
FIGURE 56. Debris Thrown From Magazine Toward Fence.

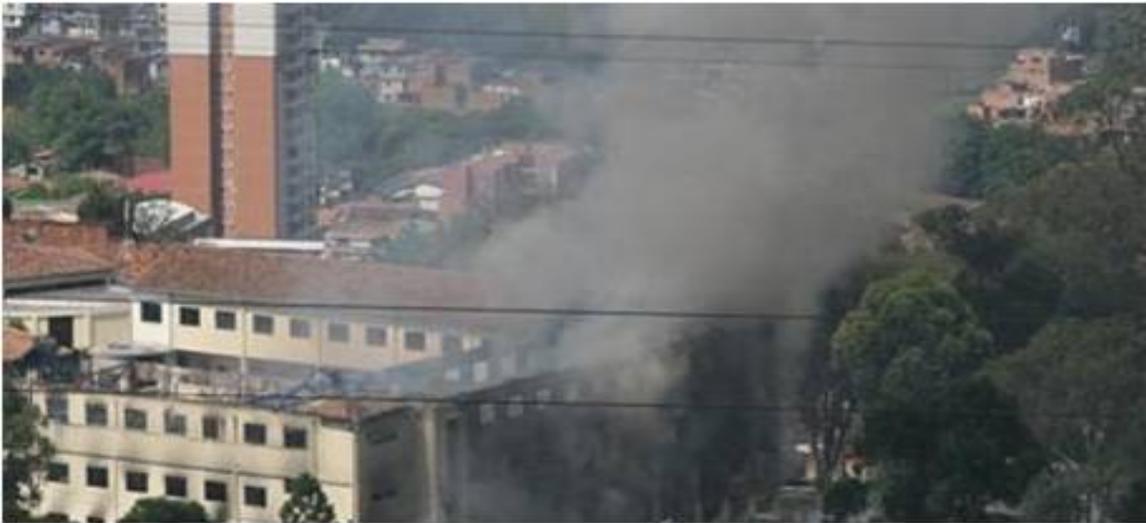
FIGURE 57. Fire at the Bombona Battalion Arsenal, Medellin, Colombia, 29 December 2007.

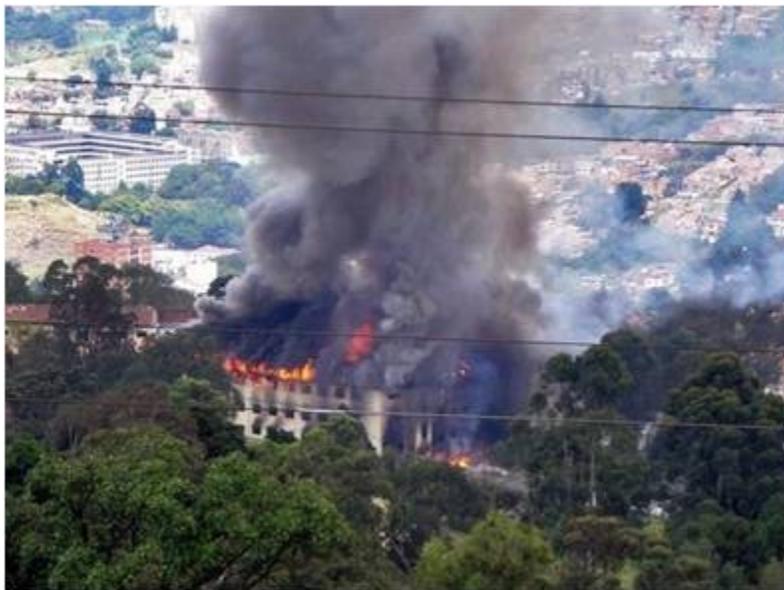
FIGURE 58. Fire at the Bombona Battalion Arsenal, Medellin Colombia, 29 December 2007.
