# **Realistic Safe-Separation Distance Determination for Mass Fire Hazards**

Thomas L. Boggs  
*New Directions Technology, Inc.*  
*Ridgecrest, CA 93555*

Kevin P. Ford  
*Energetics Research Division*  
*Weapons and Energetics Department*  
*Naval Air Warfare Center Weapons Division*  
*China Lake, CA 93555*

**MARCH 2013**

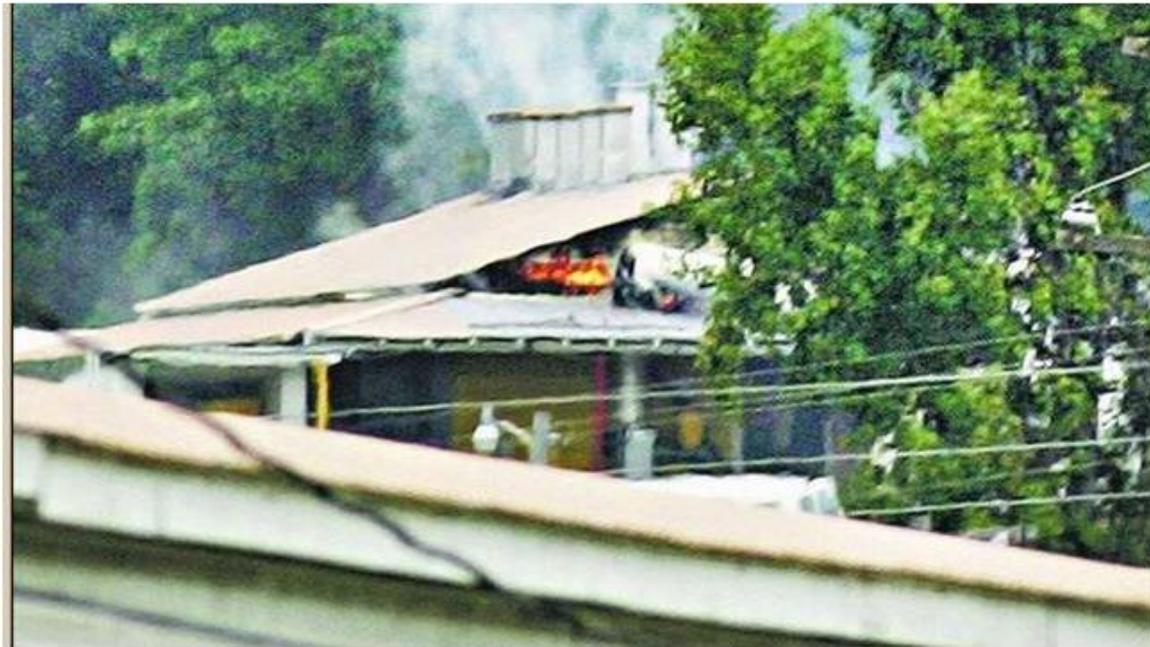
The company said that it had amassed over 4.5 million production-related hours without a work-related injury before the fire. Figure 62 shows a photograph of the fire in Building 35.

FIGURE 62. Fire in Building 35, Kilgore Flares Company, 14 September 2010.

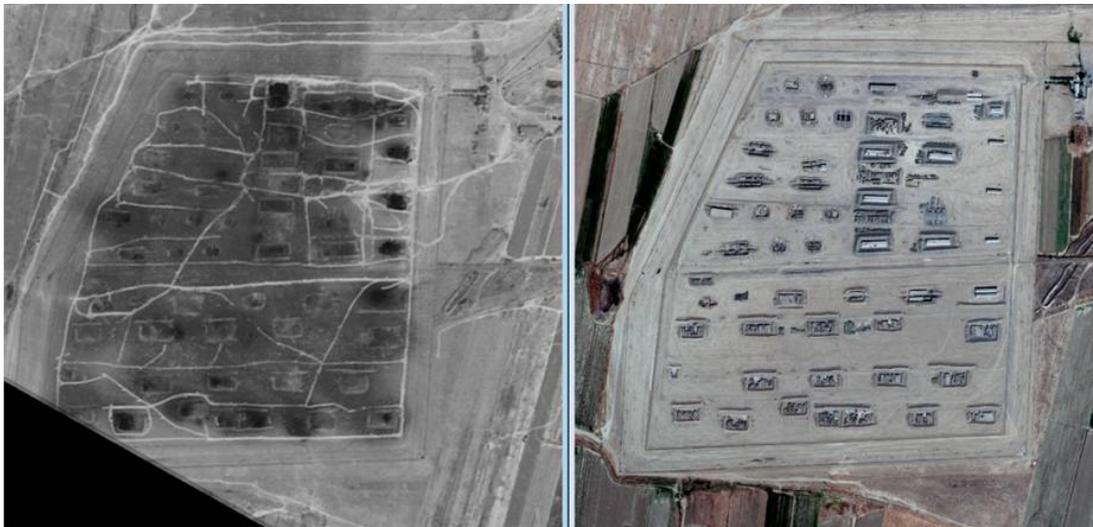
ScanEx, a Russian satellite company, published the before and after images of the military depot where fires and explosions occurred shown in Figure 63. The photograph on the right clearly shows the buildings within the depot before the accident, while the photograph on the left shows the craters and charred areas after the fires and explosions. Figure 64 shows a still photograph of the fire. Figure 65 show a series of still frames taken from a video of the fire and explosions.

FIGURE 63. Photographs Taken from Scanex Satellite Showing After and Before Views of the Military Depot.

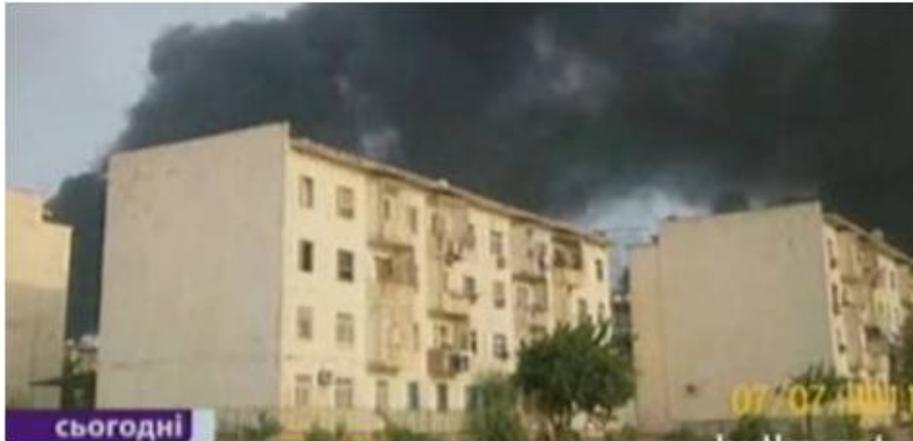
FIGURE 64. Fire at Abadan, Turkmenistan, 7 July 2011.

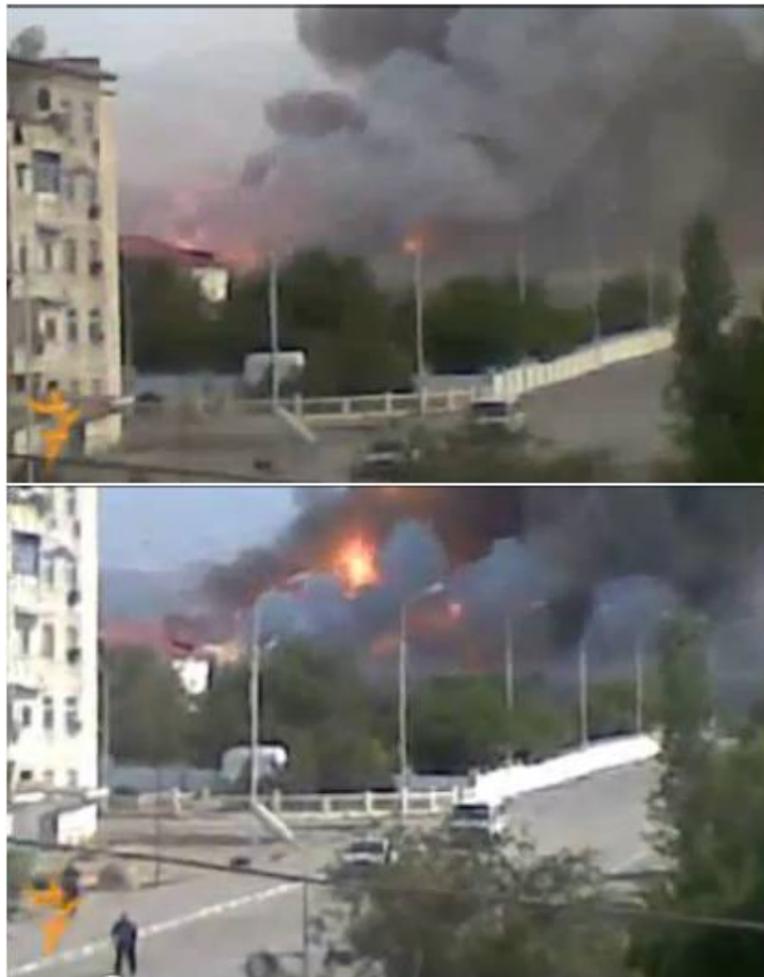
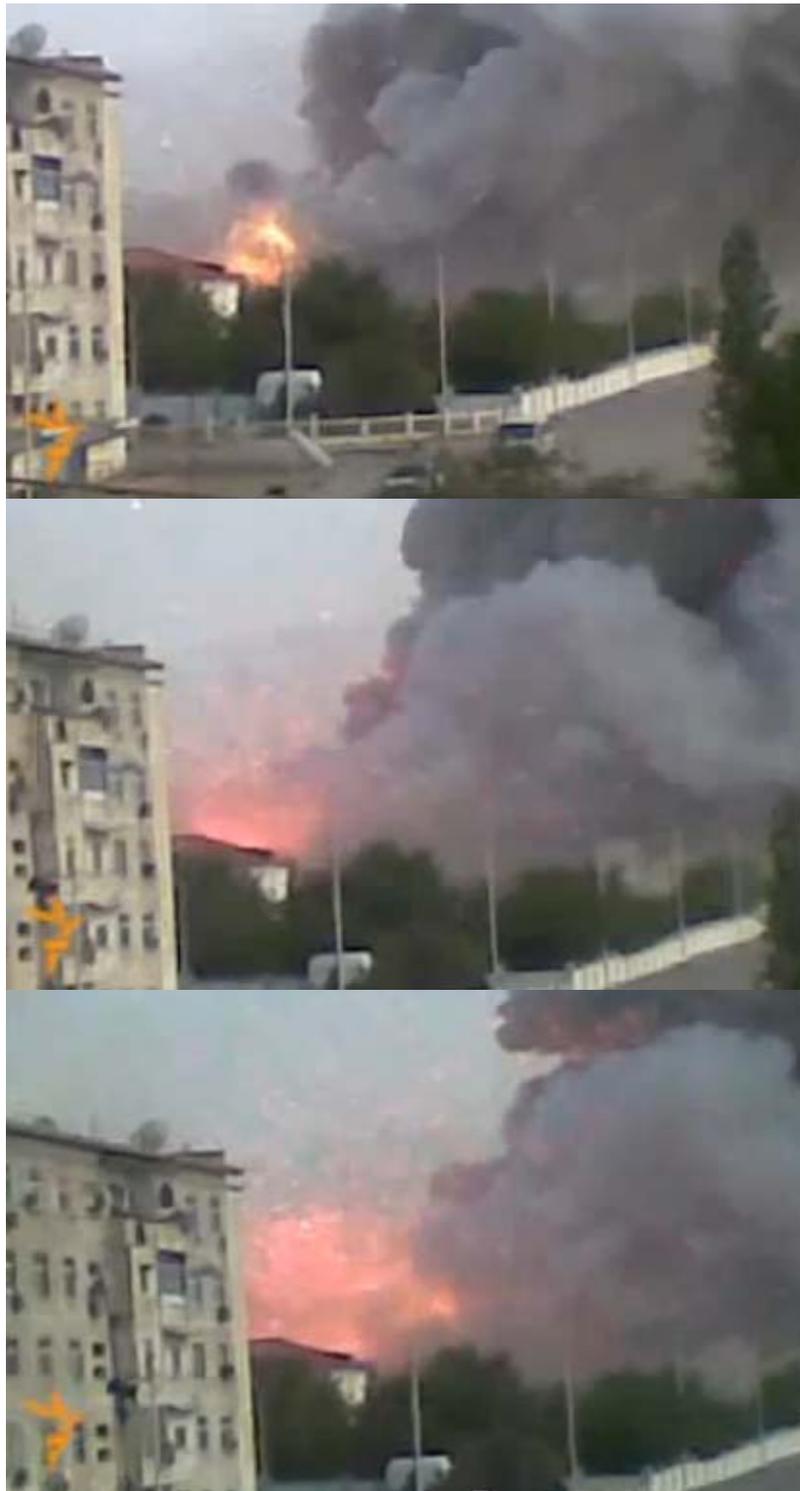
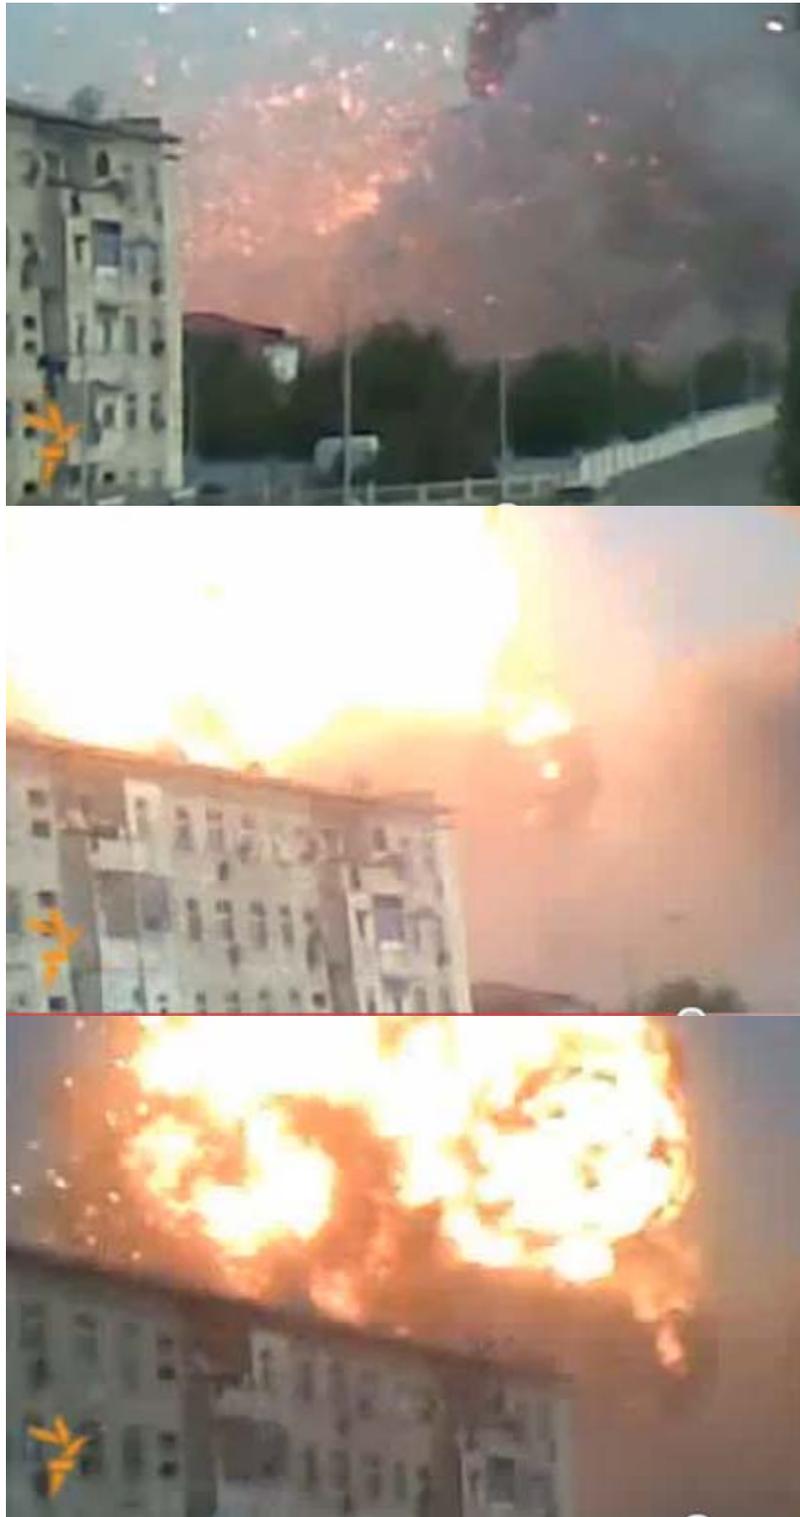
FIGURE 65. A Series of Still Frames Taken From a Video of the Accident in Abadan, Turkmenistan, on 7 July 2011.

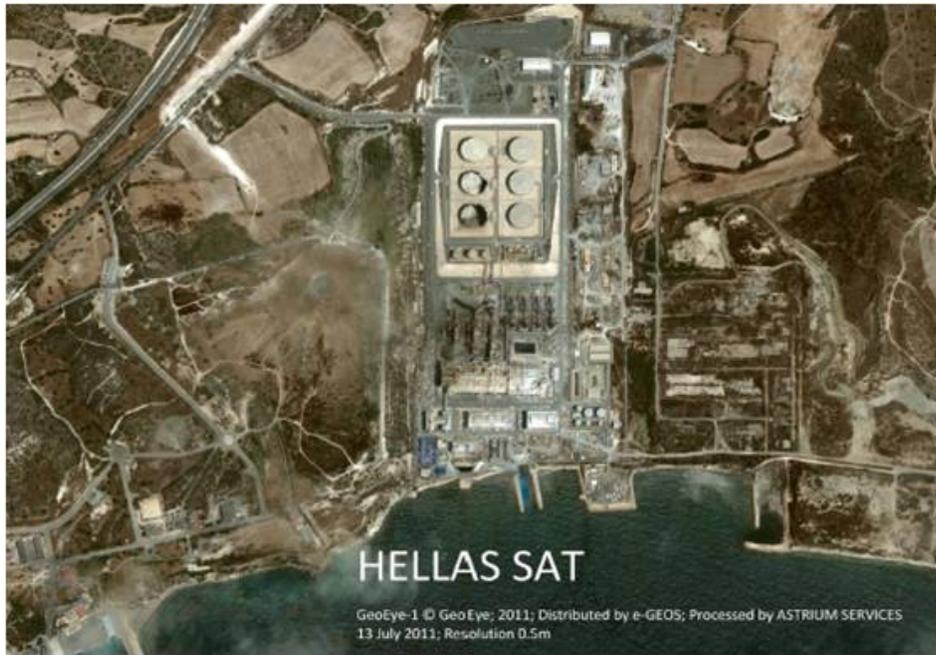
Figure 70 shows the same view as Figure 68 but after the detonations.

FIGURE 70. Aerial View of the Evangelos Florakis Navy Base and the Vassilikou Power Plant After the Detonations.

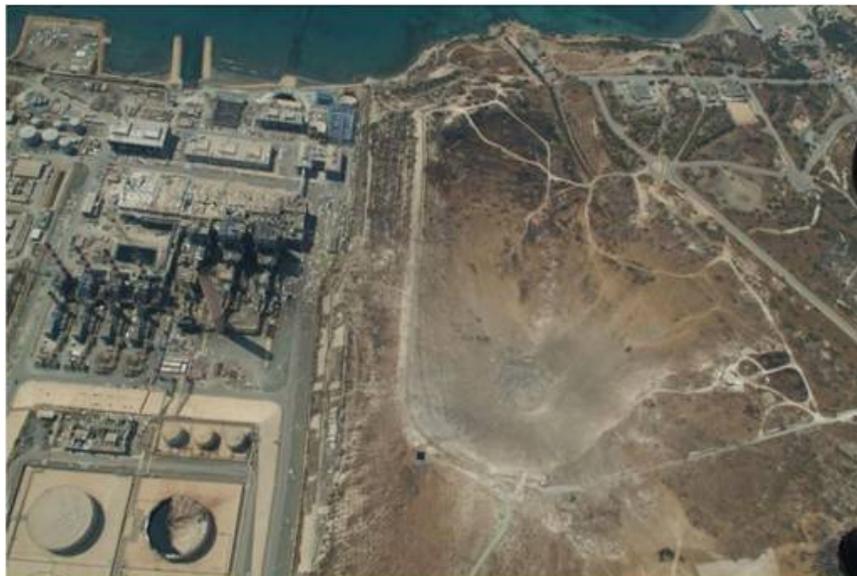
Figure 71 presents a higher resolution view of the crater and damage to power plant.

FIGURE 71. High Resolution Aerial View of the Crater Left after the Detonation, and the Resultant Damage to the Adjacent Power Plant.

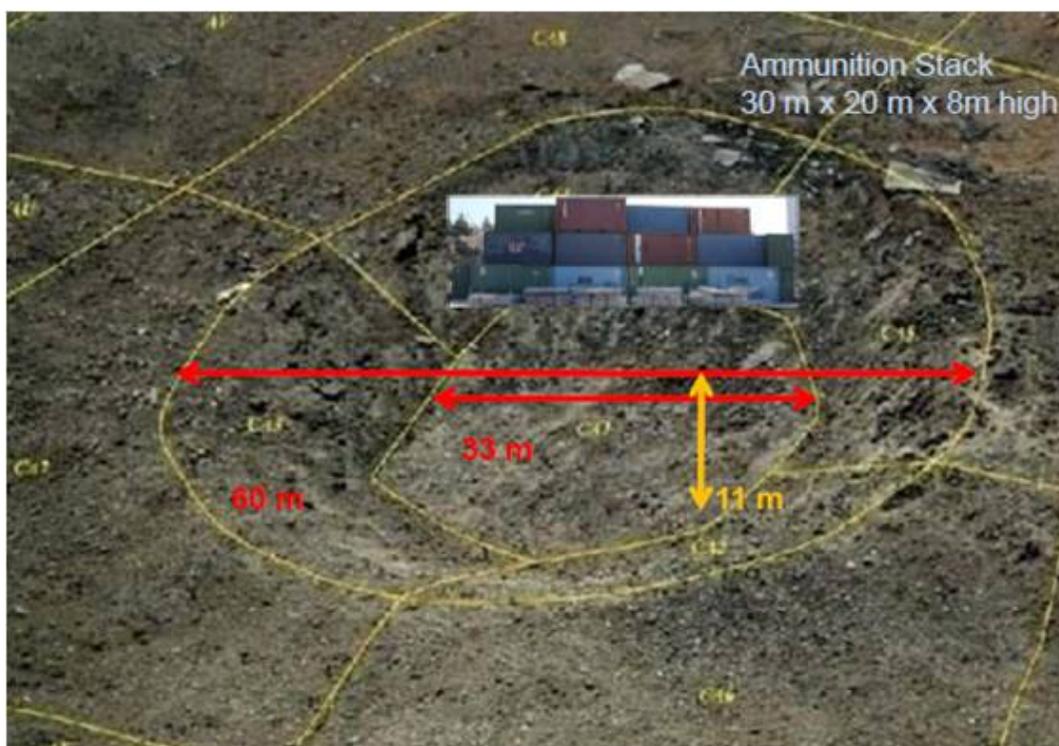
The crater was formed when the gunpowder in 80 of the 98 ISO containers depicted in Figure 67 detonated after the fire had burned more than 2 hours. [Note: In the following discussion, both 80 and 81 are used as the number of ISO containers containing gunpowder. This is because there were 81 containers containing gunpowder when the ISO containers were placed at the Navy base. The contents of one of the containers reacted on 4 July 2011, and the other 80 reacted on 11 July 2011.]

FIGURE 72. Dimensions of the Crater, and Comparison to the Original Stack of ISO Containers.

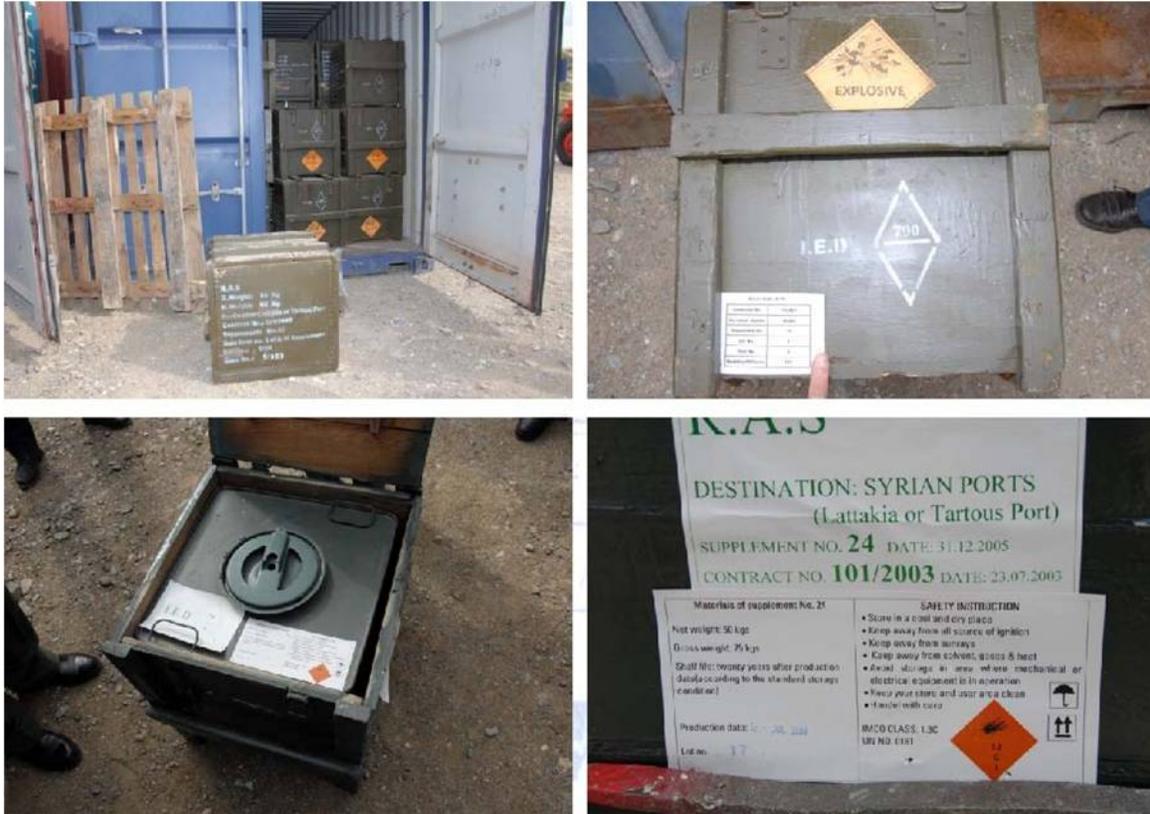
What caused the fire that burned for about 2 hours before the mass detonations? Part of the answer to that question is the answer to the question “What was in the ISO containers?” The material involved in the fire and detonations was primarily gun propellant that had been cargo on the Cypriot flagged *MV Monchegorsk*. The ship carried 481,000 kg of gunpowder plus other cargo from the Iranian port Bandar Abbas and destined for Latakia or Tartous, Syria. The manifest listed the materials as being mostly HD 1.3 and HD 1.3C1 gun propellants. [Page 156 of the Polyviou report lists the materials and some of the hazards classifications, but it does not give the quantities of each. It also presents “Of the 98 containers, 81 contained various types of gunpowder...”. Then on page 629 and 630, it lists 208,320 kg of Class 1.3 propellants, 122,440 kg of Class 1.3C1 propellants, and 150,637 kg Class 1 propellant, for a total of 481,397 kg of propellant.

FIGURE 73. Containers of Gun Propellant Contained in ISO Containers.

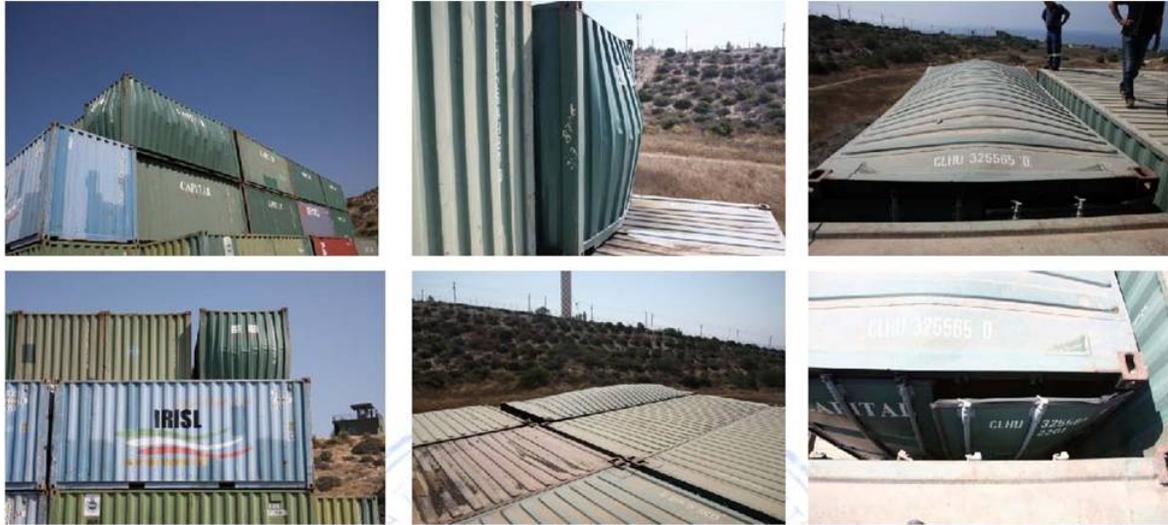
The 98 ISO containers, 81 of which contained gun propellant, were confiscated in January 2009; and on 14 February 2009, the ISO containers were stored on a concrete slab in the open at the naval base. During the day, especially during the summer, the gun propellant in the ISO containers stored in the open got hot. Temperatures in Mari in July typically reach 32 to 33°C. On 11 July 2011, the temperature between 1:00 and 6:00 a.m. in Zygi, adjacent to the Evangelos Florakis Navy Base, was 21.5 to 23.2°C, and the humidity was between 91 and 97%. As discussed earlier in this report in the section on stabilizer depletion and auto-ignition, gun propellants, especially single- or double-based gun propellants, start to decompose when they get hot. As they decompose, the stabilizer gets depleted. Eventually enough stabilizer is depleted so that the decomposition reactions accelerate and ignition of the gun propellant can occur. Once gunpowder starts to burn, the pressure within a closed container rapidly rises and the container may come apart violently, and form and accelerate debris from the container. [The section on tests presents ECMs rupturing producing large pieces of debris one second after ignition of gun propellant.] Could that have happened at Evangelos Florakis Navy Base, Cyprus? Yes. As mentioned above, one week before the 11 July 2011 detonations, on 4 July 2011, one ISO container was discovered with evidence of reaction and fire. Figure 74 shows the ISO container with

bulged walls and roof, and the doors blown partially open. The force of the reaction was sufficient to move the 10.5-ton ISO container approximately 30 cm in two directions as shown in Figure 74.

FIGURE 74. ISO Container in the Stack Showing Evidence of Reaction and Fire by the Bulging Walls and Roof and the Door That Has Been Blown Partially Open. The force of reaction moved the ISO container approximately 30 cm in two directions.

When propellant decomposes porosity is produced in the propellant. Propellant with porosity or voids is usually significantly more sensitive to mechanical shock to detonation transition than undamaged material. That is, it does not take as much input shock level to initiate detonation in the damaged material as it does in undamaged material. While the undamaged gun propellant originally may have truly been HD 1.3 as per UN tests, the damaged material that had been in ISO containers sitting in the hot sun for 2+ years may not have been HD 1.3 any longer. The storage of gun propellant in a stack of ISO containers in the hot sun may have been a recipe for disaster.

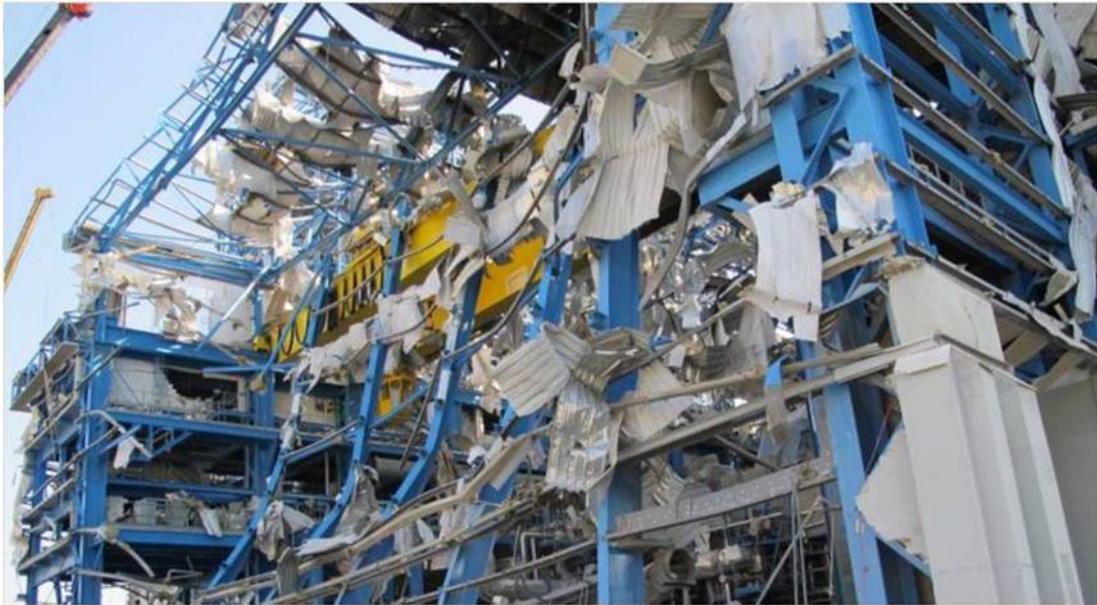
The disaster was not limited to the Navy base. As shown in the aerial view of Figures 68 and 69, the Vassilikou Power Plant was immediately adjacent to the Navy base. Figures 75 through 79 show the considerable damage to the power plant.

FIGURE 78. Damage to Vassilikou Power Plant.

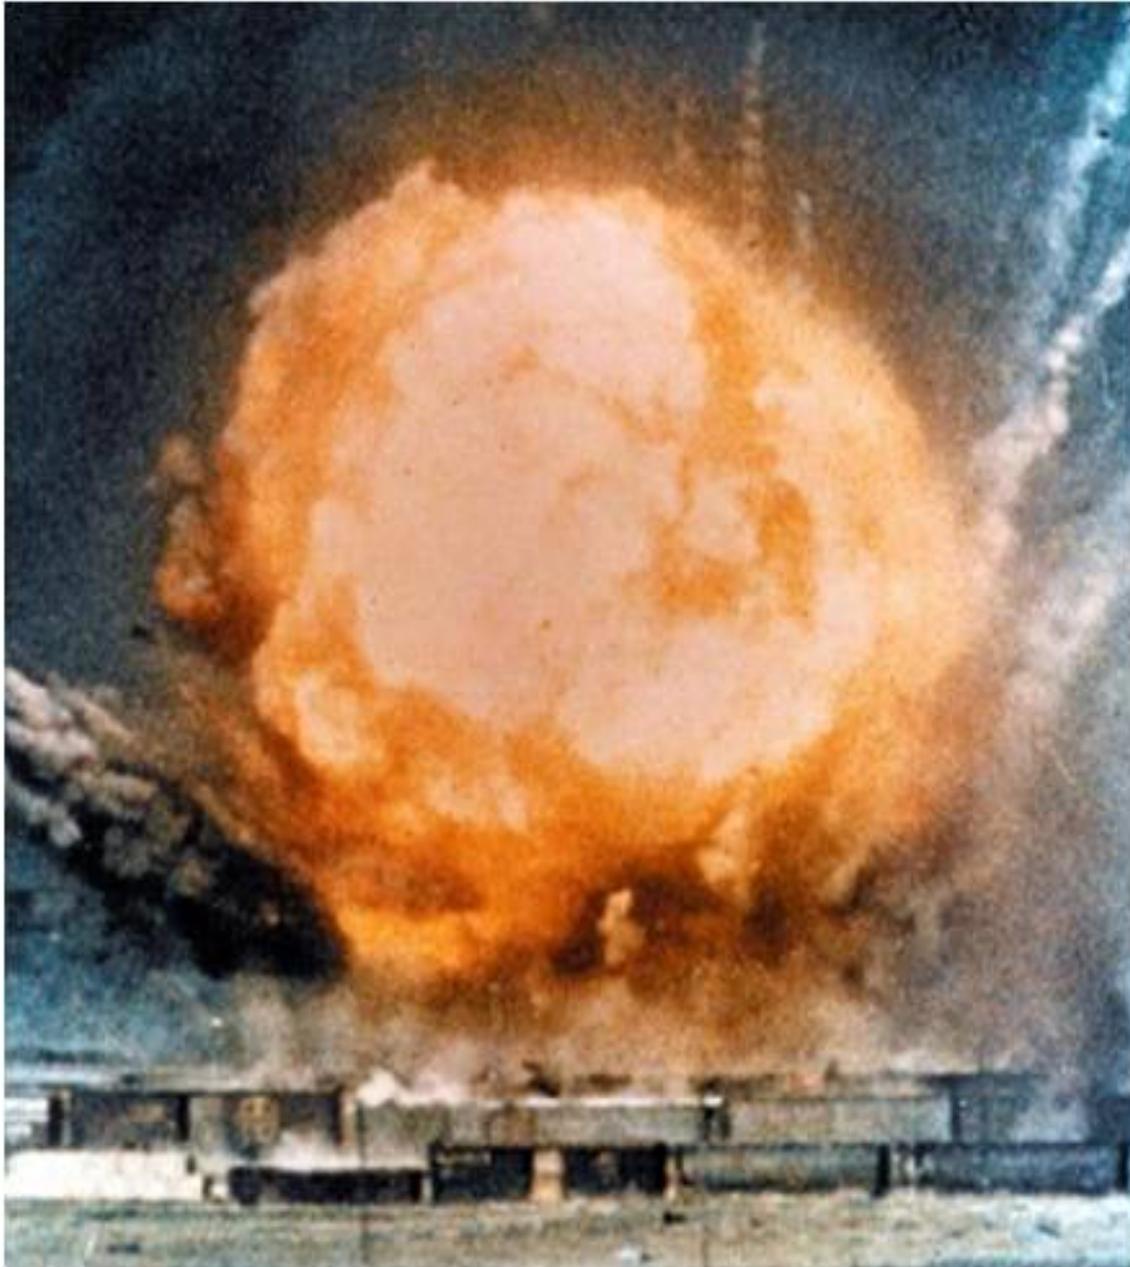
The other 17 cars at the west end of track 7 exploded at various intervals until approximately 10:30 a.m. Bombs strewn in burning debris exploded intermittently until 4:05 p.m. the following day. Figures 81 through 85 present photographs taken of the events and the aftermath of the accident.

FIGURE 81. Accident at Roseville Railyards, 28 April 1973.

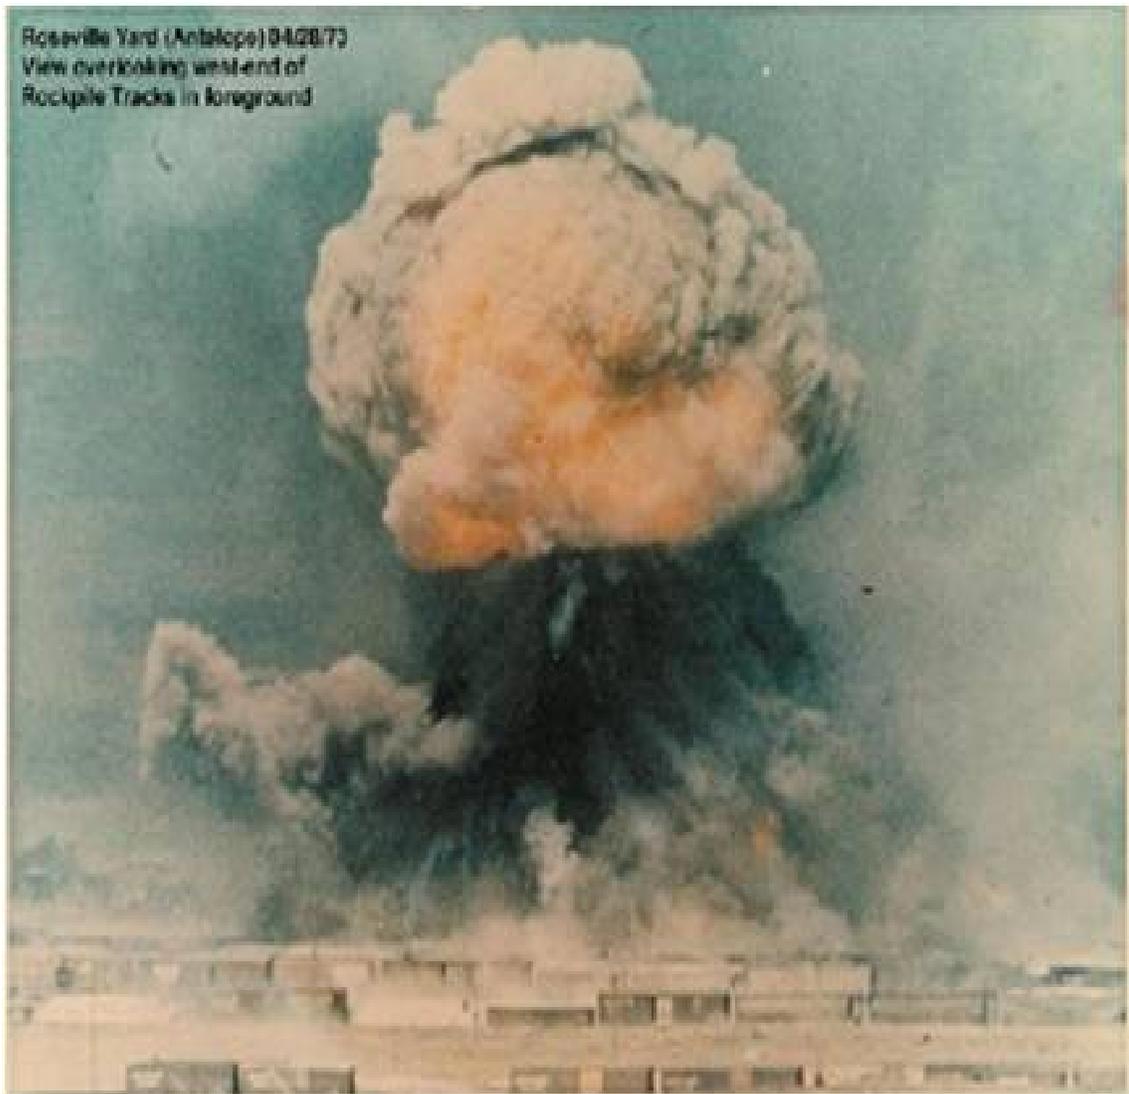
FIGURE 82. Accident at Roseville Railyards, 28 April 1973.

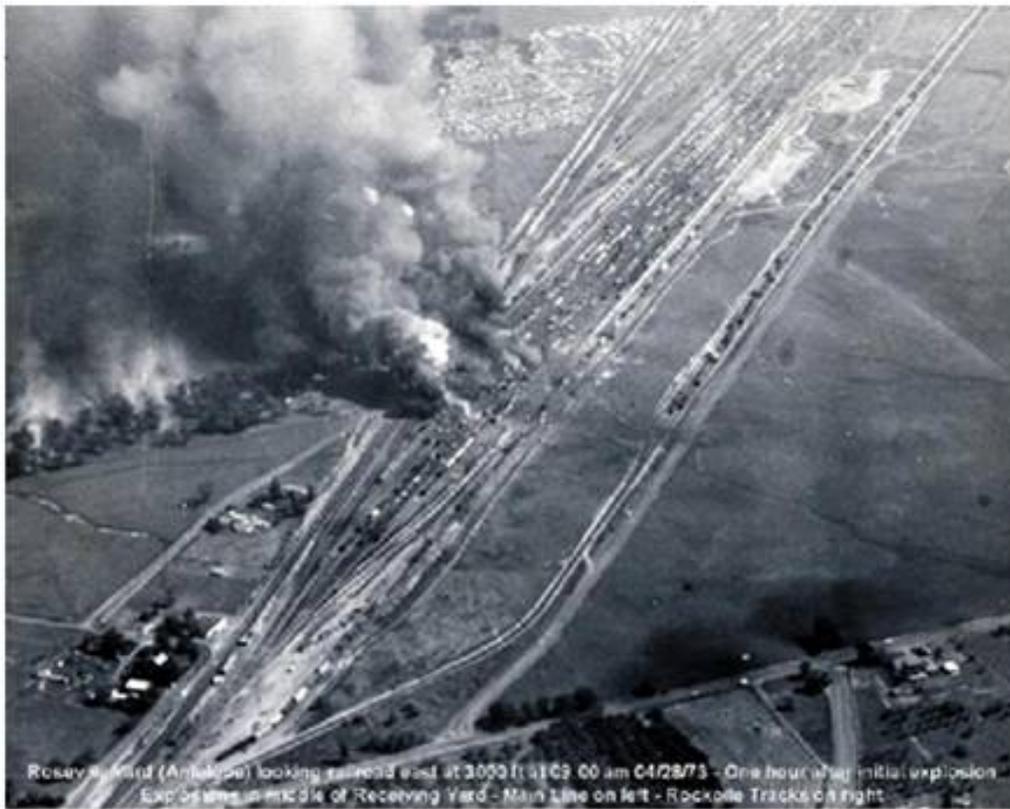
FIGURE 83. Aerial View of Accident at Roseville Railyards, 28 April 1973.

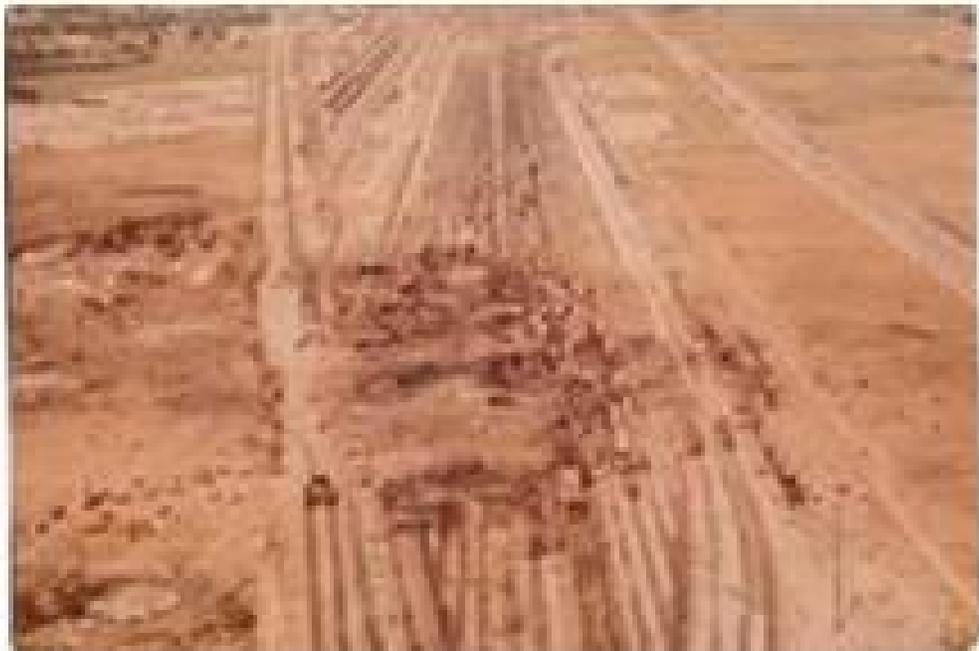
FIGURE 84. Aerial View Showing Damage at Roseville Railyards, 28 April 1973.

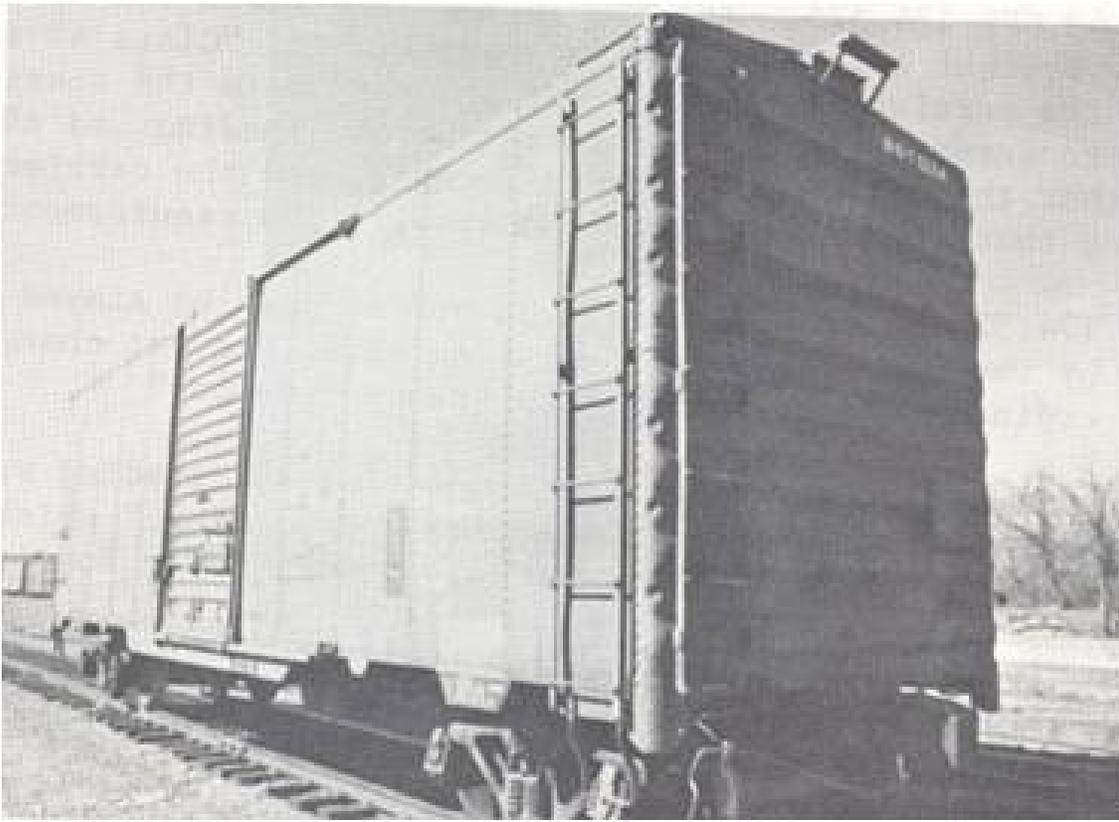
Figure 86 shows a railcar very similar to boxcar 38. Note that the car has truck assemblies (a swiveling frame with two or more axles with pairs of wheels) at front and rear of the boxcar. Later discussions will focus on sparks from the brakeshoes acting on the wheels causing the fire.

FIGURE 86. Railcar Very Similar to Boxcar 38 Involved in Accident Near Benson, Arizona, 24 May 1973.

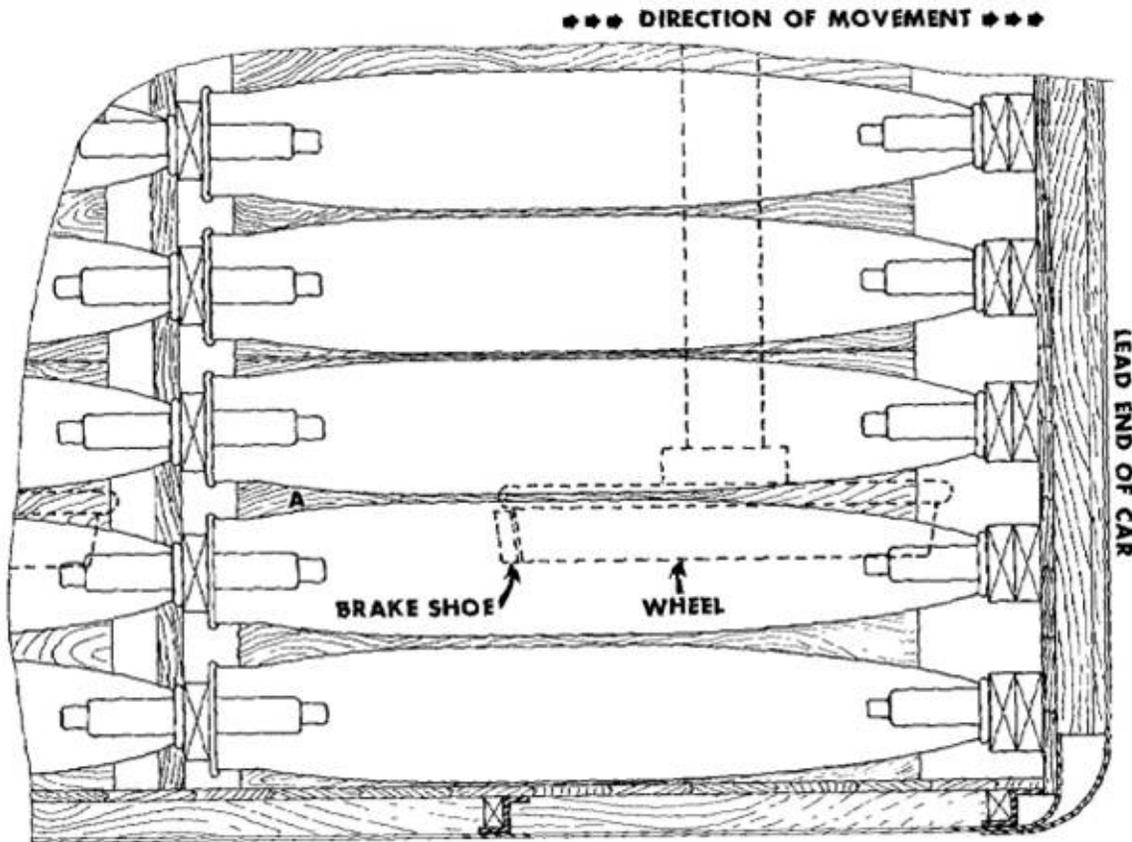
FIGURE 88. Schematic Showing Location of Bombs Over the Brake Shoe/Wheel of the Railcar for Railcar 38.

The cause of the accident was attributed to fire in car 38. It was estimated that part of the flooring below a pallet that contained bombs was exposed to fire of 1,500°F for 25 minutes. The fire was located almost directly above an area where sparks from the brake shoes could impinge on the floorboards. There were no spark shields on this car. The location of bombs and the location of the front wheel on the front truck are shown in Figure 88.

The ignition of the floorboards was facilitated by the presence of sodium nitrate. Records show that car 38 had carried 400 100-pound bags of sodium nitrate on 28 April 1972. During transit, 21 bags had broken open. On 12 June 1972, an inspection of this car at Ray, Texas, revealed that it had been damaged by fire. It was not repaired until April 1973. The interior of the car had been washed with water before it left M-K-T shops on 5 May 1973. Analysis of some of the burned boards from boxcar 38 showed sodium nitrate levels from 3% at the surface to 0.10% a half inch into the board. The floorboards also were impregnated with oil. Once the floorboards were ignited, the sodium nitrate and oil sustained the burning of the floorboards.

Additional support for fire caused by brake shoe sparks impinging on the wooden floor of the railcar enabled by the absence of spark shield, and abetted by contamination of the wooden floor boards by sodium nitrate and oil, was provided by a review of the history of car fires experienced by Southern Pacific in this district. Of the 237 car fires reported in the previous five years, 77% resulted from brake shoe sparks. The reports included a 16 December 1972 accident where a car transporting Mk 82, 500-pound bombs caught fire at Hughson, California, as a result of “dragging brakes.”

- Because of the possibility of wooden floors igniting and burning, later cars were constructed with steel flooring.
- Instead of all of the cars carrying munitions being consecutive, “spacer” cars not carrying munitions, should be inserted between cars carrying munitions.

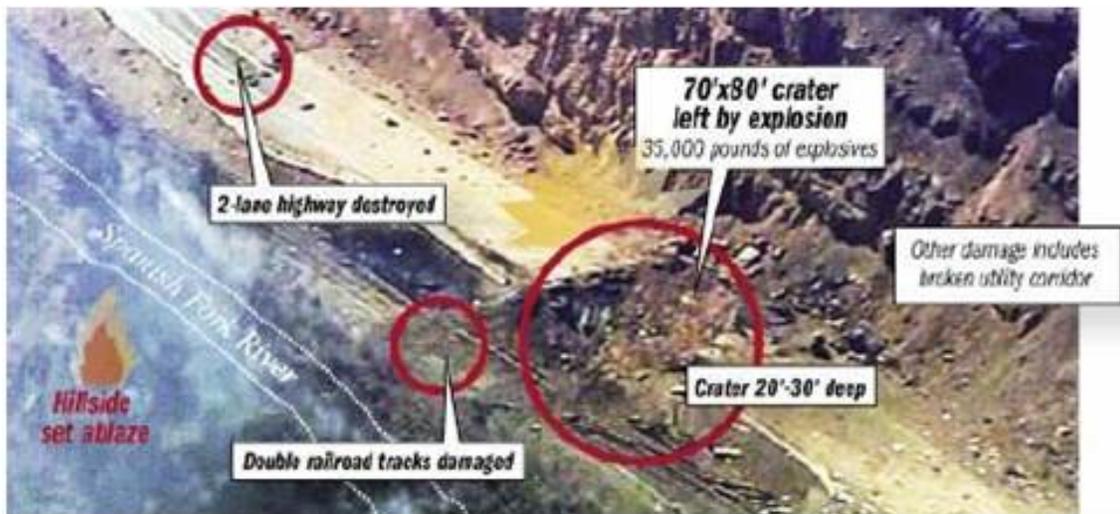
FIGURE 89. Aerial View of Accident Site in Spanish Fork Canyon, Utah.

An accident occurred on Route 6 in Spanish Fork Canyon near Thistle, Utah, on 9 August 2005. A tractor-trailer carrying 35,500 pounds of HD 1.1 commercial booster explosives went off the road, overturned, and caught fire. Rescuers were able to free the driver and his passenger. The dazed driver told rescuers that the trailer was carrying explosives. People were in the process of evacuating when the boosters exploded/detonated. Figure 89 shows an aerial view of the accident site. The crater that was produced (Figure 90) was 21 meters (70 feet) wide and 9 meters (30 feet) deep. There were no fatalities and 11 were injured.

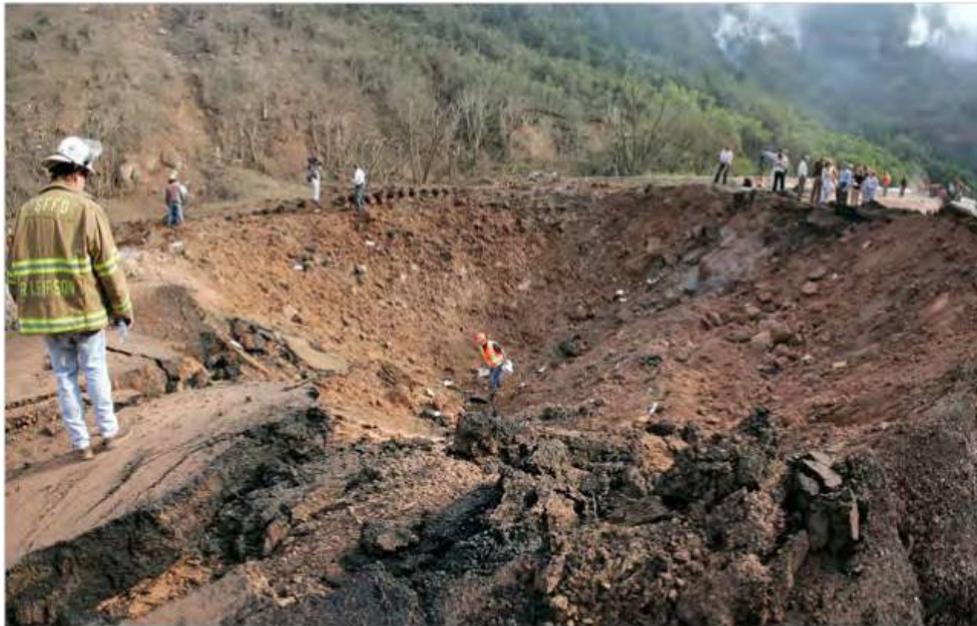
**Crater, 20-35 feet deep**

**FIGURE 90. Accident Involving 35,500 Pounds of HD 1.1 Commercial Booster Explosives That Occurred in Spanish Fork Canyon Near Thistle, Utah, on 9 August 2005.**

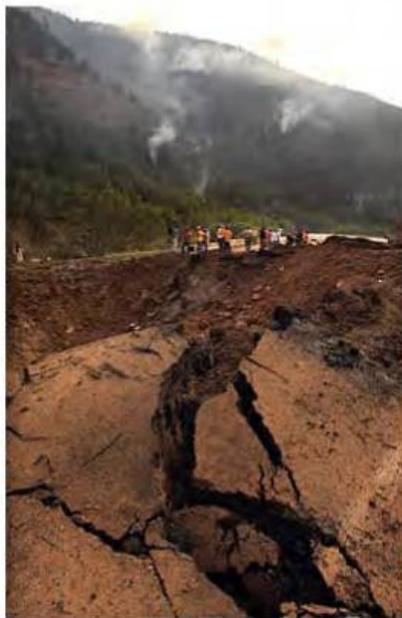
**Crater and damaged roadway**

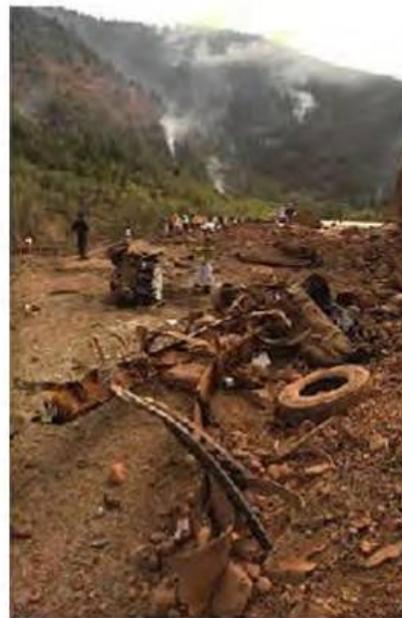
**Remains of truck**

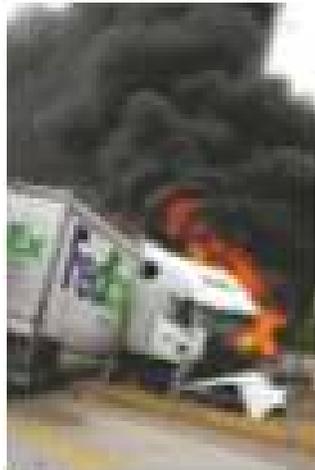
A fiery crash on Interstate 80 near the Tooele County-Salt Lake County line, Utah, killed one person, injured one, and closed the highway for several hours. The crash occurred at about 11:00 a.m. when an eastbound Dodge Dakota crossed the median and hit a westbound FedEx triple semitrailer head on. Part of the truck was loaded with ammunition. The collision started a fire that engulfed the truck and part of the semi. Some of the ammunition exploded as emergency crews worked to clean up the crash scene depicted in Figures 91 and 92.

FIGURE 91. Crash Scene on Interstate 80, 13 June 2009.

FIGURE 92. Crash Scene on Interstate 80, 13 June 2009.

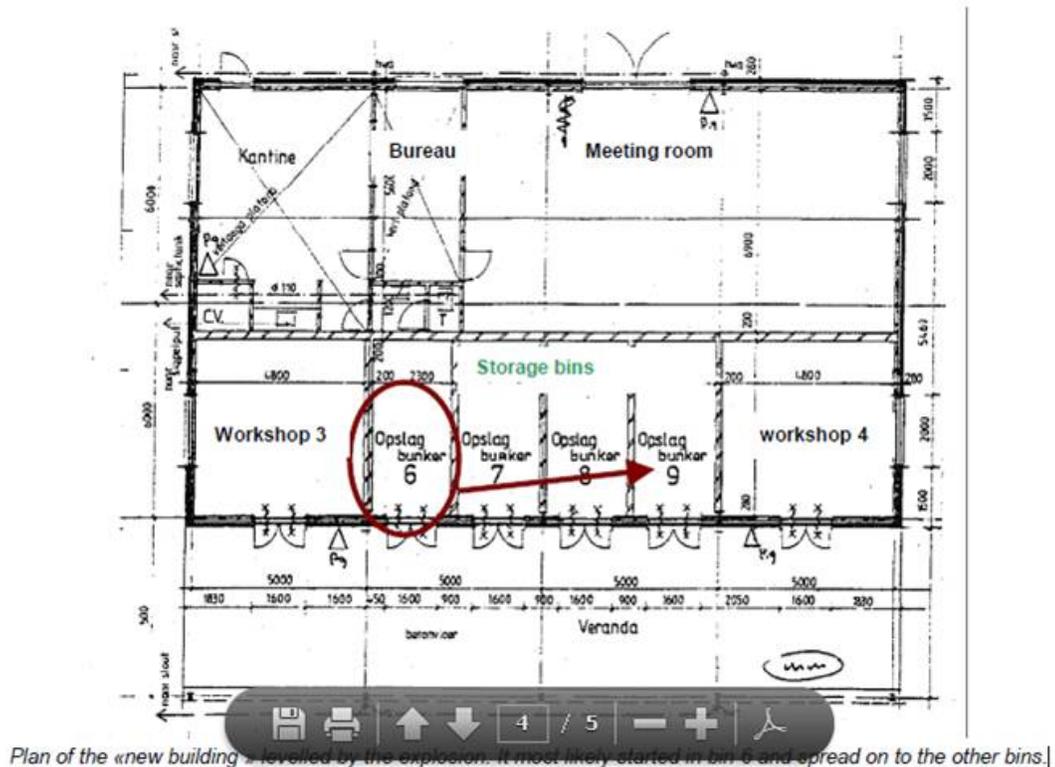
FIGURE 93. Schematic of the New Building, Culemborg, the Netherlands as it Existed Before Accident.

At about 11:50 a.m. on the morning of 14 February 1991, a big bang was heard by farmers and inhabitants of Culemborg. About 20 seconds later a much stronger explosion occurred. The second explosion caused concrete and wood debris to “fall from the sky.” The new building was completely gone and a large crater of 10 by 5 meters with a depth of more than 2 meters was left. The old bunker was set on fire, and fire and minor explosions occurred during the rest of the day.

In the investigation, definitive indications for the direct cause of the explosion were not found. However, a reasonable explanation was that the explosion probably started in storage room 6, immediately followed by explosions in storage rooms 7, 8, and 9.

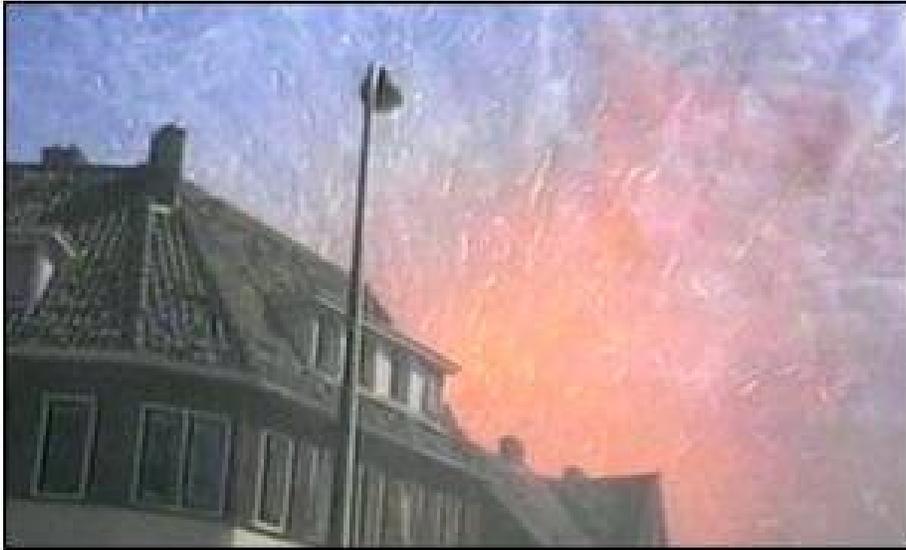
At about 3:00 p.m., a fire broke out in one of the workshops used for working on the fireworks. The doors were blown outwards due to the pressure associated with the fire. The fire spread via ignited firework rockets to containers located opposite the original fire. The fire, and ensuing projections of rockets, caused many people who were in the town center to approach the site. At about 3:30 p.m., the heat produced by the fire caused a container of fireworks having a large explosive charge to explode. The fireworks stored in the MAVO boxes then exploded. Other explosions then occurred and the resulting shock waves destroyed doors in the various storage facilities. The central bunker caught fire and then exploded violently, generating an enormous plume of smoke and devastating damage to the surrounding areas (Figures 95 through 99).

FIGURE 95. Fireworks Explode at Enschede and  
Flames Extend 40 Meters Into the Air.

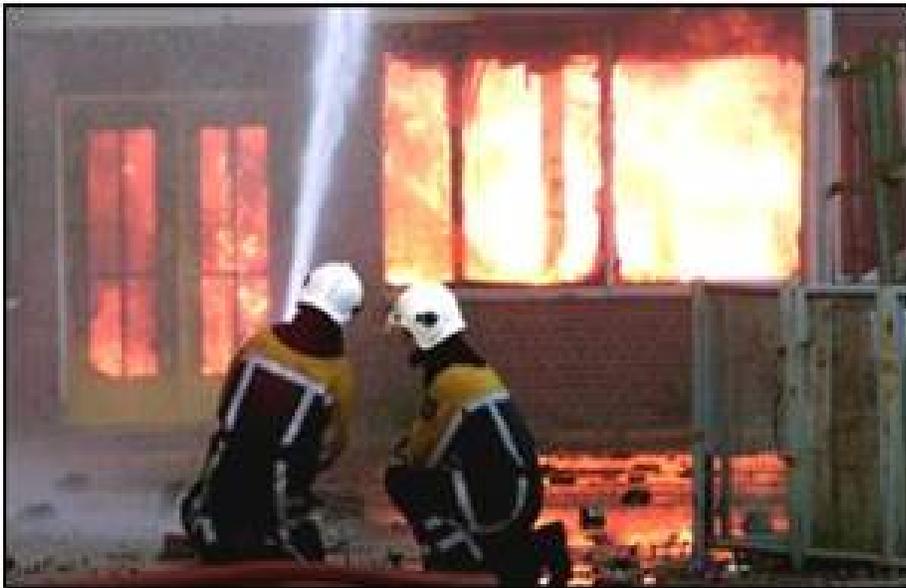
FIGURE 96. Fire Crews Battle to Bring the  
SE Firework Blaze Under Control.

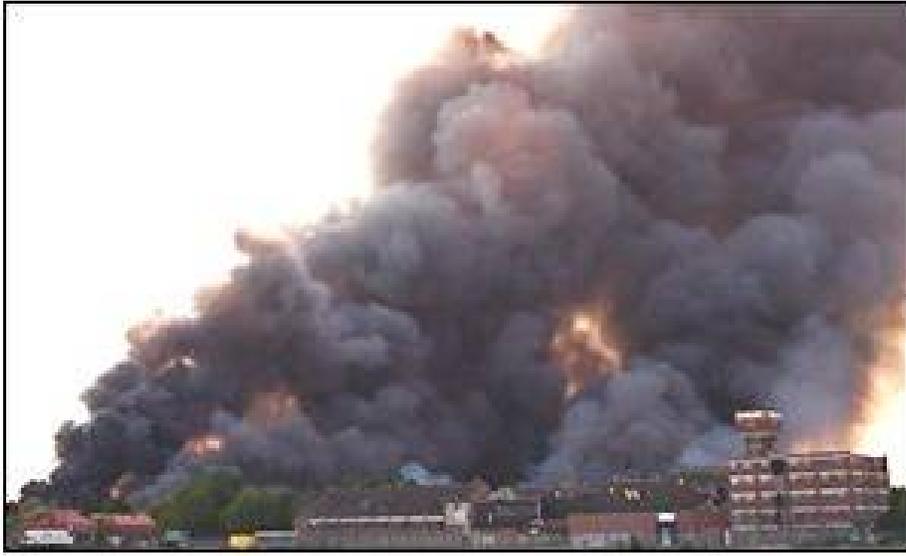
FIGURE 97. Plumes of Smoke Cover Enschede.
