# **Realistic Safe-Separation Distance Determination for Mass Fire Hazards**

Thomas L. Boggs  
*New Directions Technology, Inc.*  
*Ridgecrest, CA 93555*

Kevin P. Ford  
*Energetics Research Division*  
*Weapons and Energetics Department*  
*Naval Air Warfare Center Weapons Division*  
*China Lake, CA 93555*

**MARCH 2013**

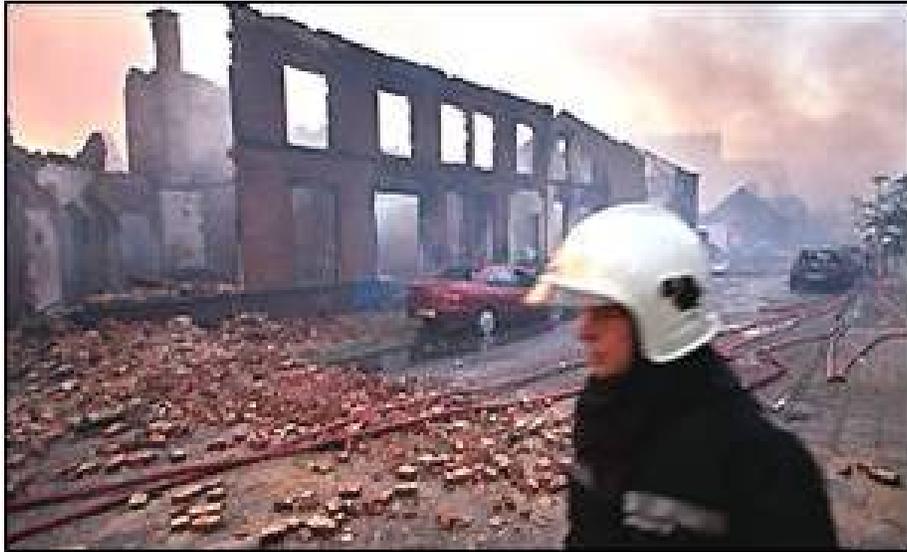
- 22 deaths (including four firefighters) with three people missing. [Subsequent reports did not indicate if the missing were ever found or simply assumed to have perished.]
- 1,000 injuries with 50 being seriously injured (hospitalized at least 5 days).
- Total destruction of homes and other structures within a radius of 250 meters.
- Extensive damage to buildings within a 750-meter radius. The city of Enschede decided to demolish everything in this zone. In all, about 500 homes or businesses were destroyed or severely damaged.
- Property damage was estimated at 500 million euros.

FIGURE 98. Aftermath of the Blaze Looked Like a Bomb Site.

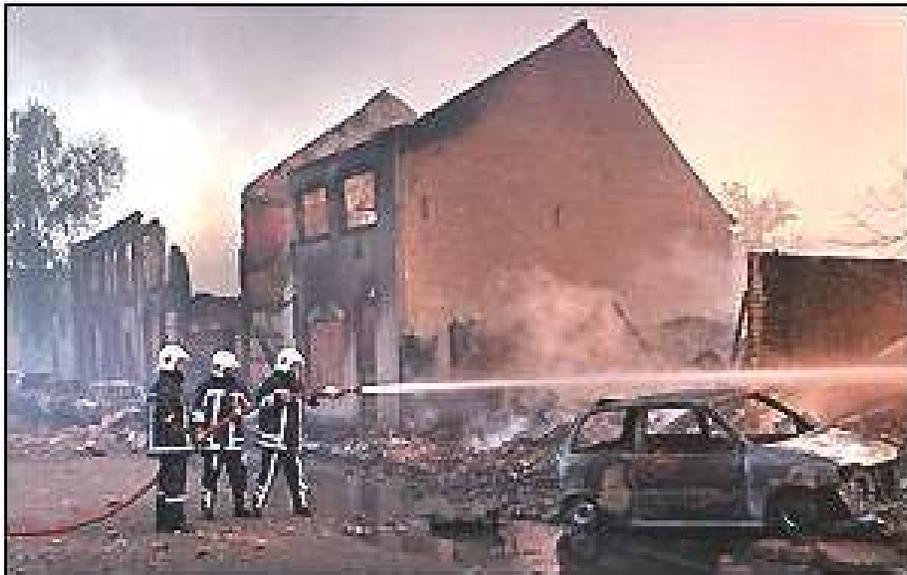
FIGURE 99. Cars and Homes Destroyed in the Explosion at Enschede.

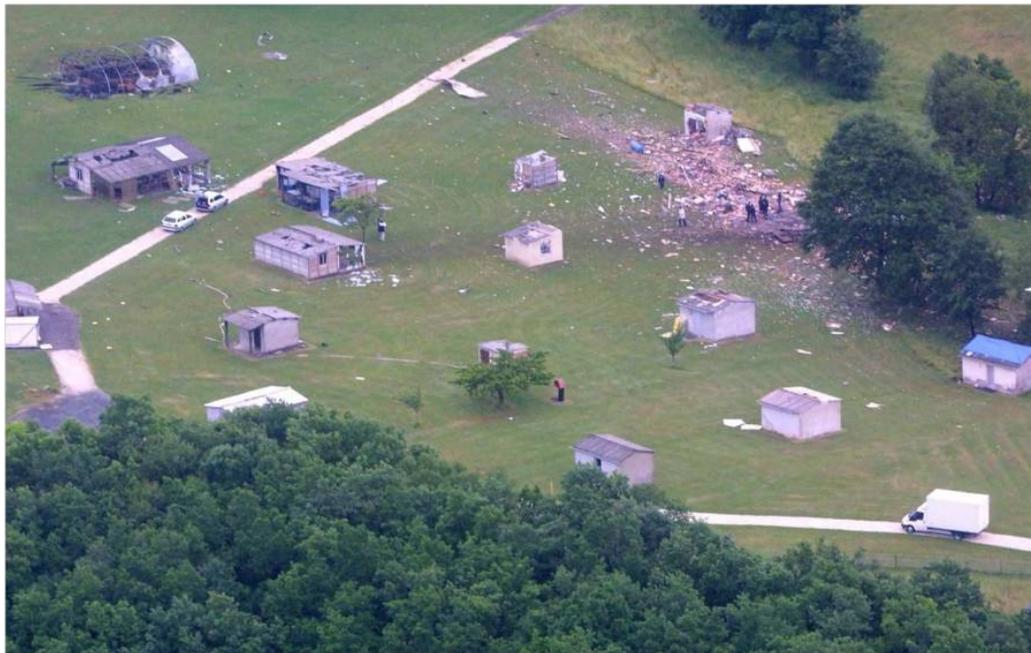
FIGURE 104. Aerial View Showing Where Building 9 Had Been Located Before the Accident.

As shown in Figures 103 and 104, building 9 was completely destroyed. The walls were completely blown out and there was a 3- by 1.5-meter by more than 50-centimeter deep crater near the outside wall in the shell store room (9A).

Figure 104 also shows that the explosion caused damage to the neighboring buildings due to overpressure and fragments. Wall and roof debris from Building 9 was found up to 160 meters away.

- Even though the candles were classified as HD 1.3, a detonation occurred, as evidenced by the crater and shock wave.
- The first event was not a detonation as the only evidence was a mark on the concrete. But the first explosion caused the detonation that produced the crater and shock wave, and scattered debris.

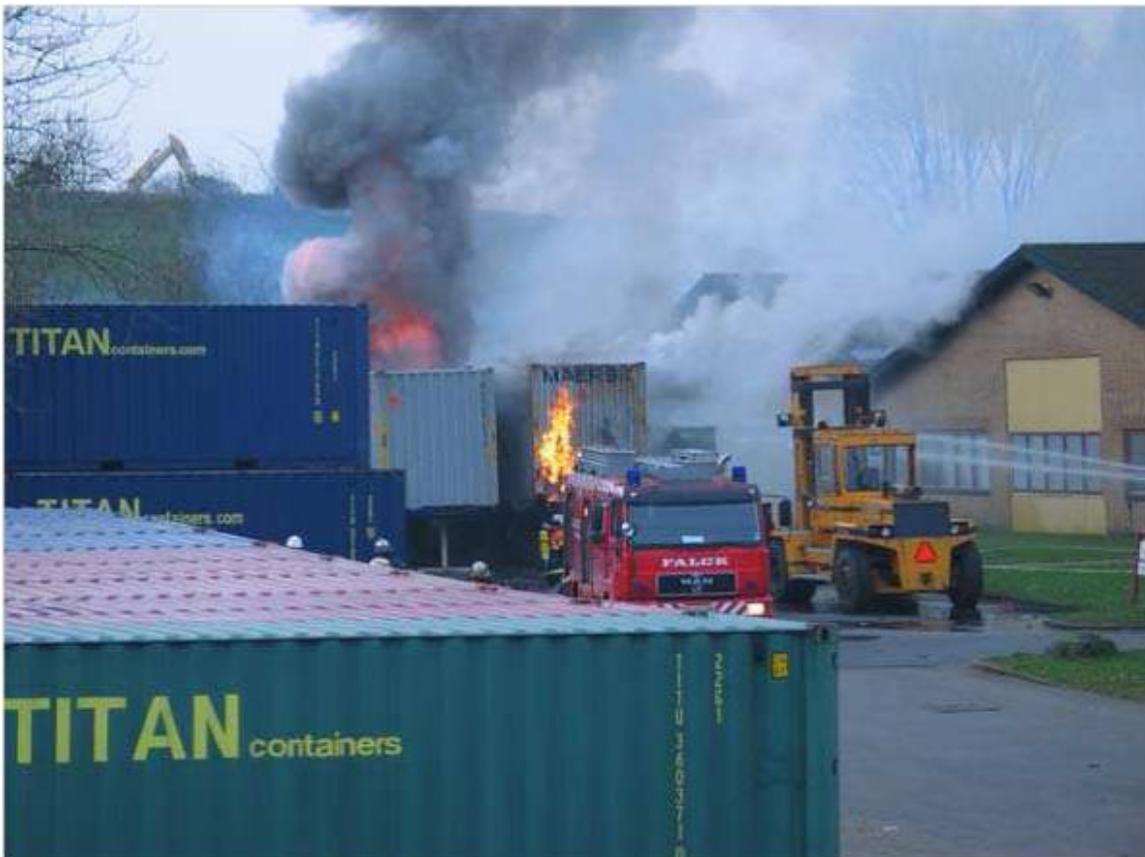
The accident started on 3 November 2004 just before 2:00 p.m. when three employees were unloading ISO containers 1 and 2 that are shown in Figure 107. The containers were being manually unloaded. An employee took a stacked box in the container and handed it down to another employee who placed the box on a pallet. The third employee operated a forklift and took the filled pallets away. An employee accidentally dropped a carton of rockets that ignited in container 1, and quickly spread to the other fireworks in the container. The fire quickly spread to the fireworks on the pallets outside the container and into container 2. The company triggered its internal plan and evacuated the staff. The fire alarm was sounded at 2:02 p.m., and the first unit of eight firefighters soon arrived. Efforts were focused on cooling the two containers and protecting the nearest buildings to keep the fire from spreading. Additional aid was requested. Police evacuated residents within a 500-meter radius.

FIGURE 107. Attempts to Put Out the Fire in the Containers.

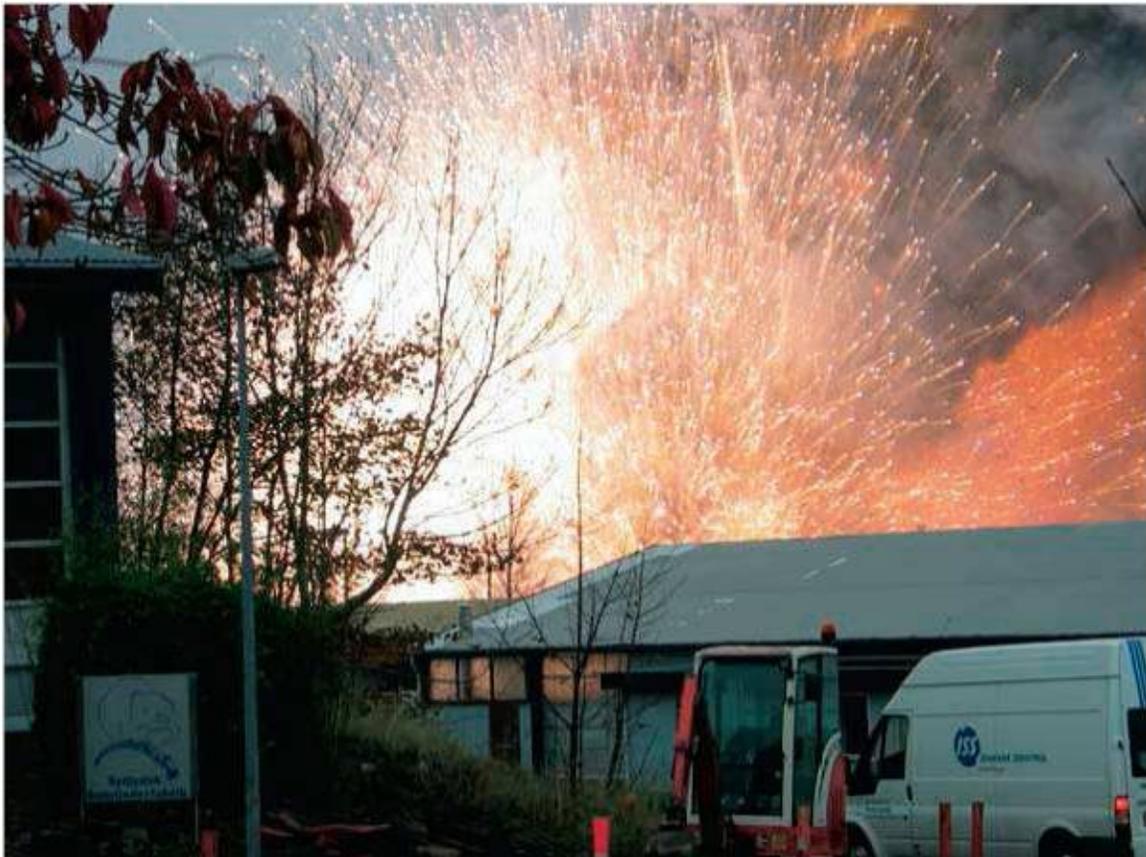
At 3:25 p.m. a major explosion occurred in the area of the burning containers with results shown in Figure 108. The explosion occurred much to the surprise of the rescue workers because there were no signs of an increase in the intensity of the fire immediately preceding the explosion. There were contradicting versions of what happened at 3:25 p.m. Some reports said that container 2 exploded. However, that was also questioned because container 2 was two-thirds empty at the start of the accident (2:00 p.m.) and was on fire for about 90 minutes by 3:25 p.m. It is hard to imagine that any material still on fire in container 2 at 3:25 p.m. could have reacted so violently and caused so much damage. It is more likely that during the 90 minutes between the initial fire and the explosion, one of the 20-foot ISO containers between containers 1 and 2 and buildings 1 and 2 were heated and then exploded at 3:25 p.m. Post accident analysis showed no crater at the location of the containers.

FIGURE 108. Explosion Occurred at 3:25 p.m.; Approximately 1 Hour 25 Minutes After the Initial Fires Broke Out.

The explosion destroyed the doors and windows of warehouses 1, 2, and 4. Ignited fireworks (or firebrands) were projected into these buildings. At 3:33 p.m., the fireworks in buildings 1 and 2 exploded.

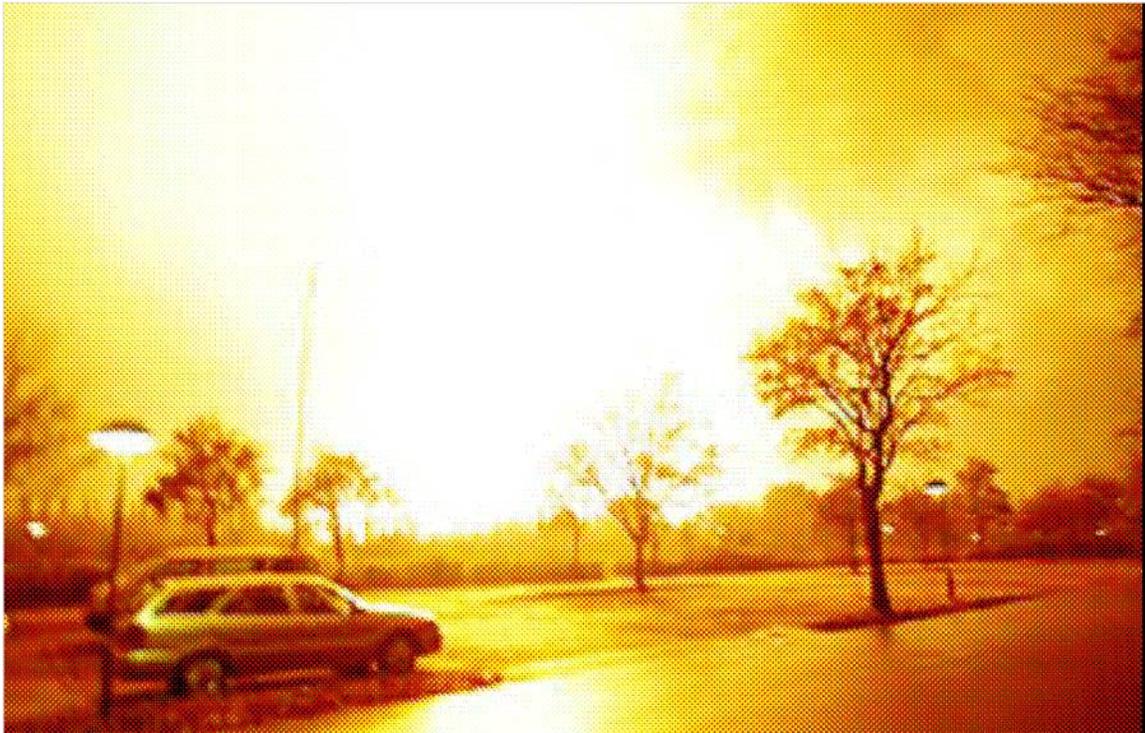
Three major explosions that resulted in a spectacular fireball (Figure 109) of several meters in diameter occurred at 5:45 p.m. These explosions were presumed to have occurred in buildings 6 and 7. These buildings contained 150 tonnes of fireworks.

FIGURE 109. Explosions That Occurred at 5:45 p.m.

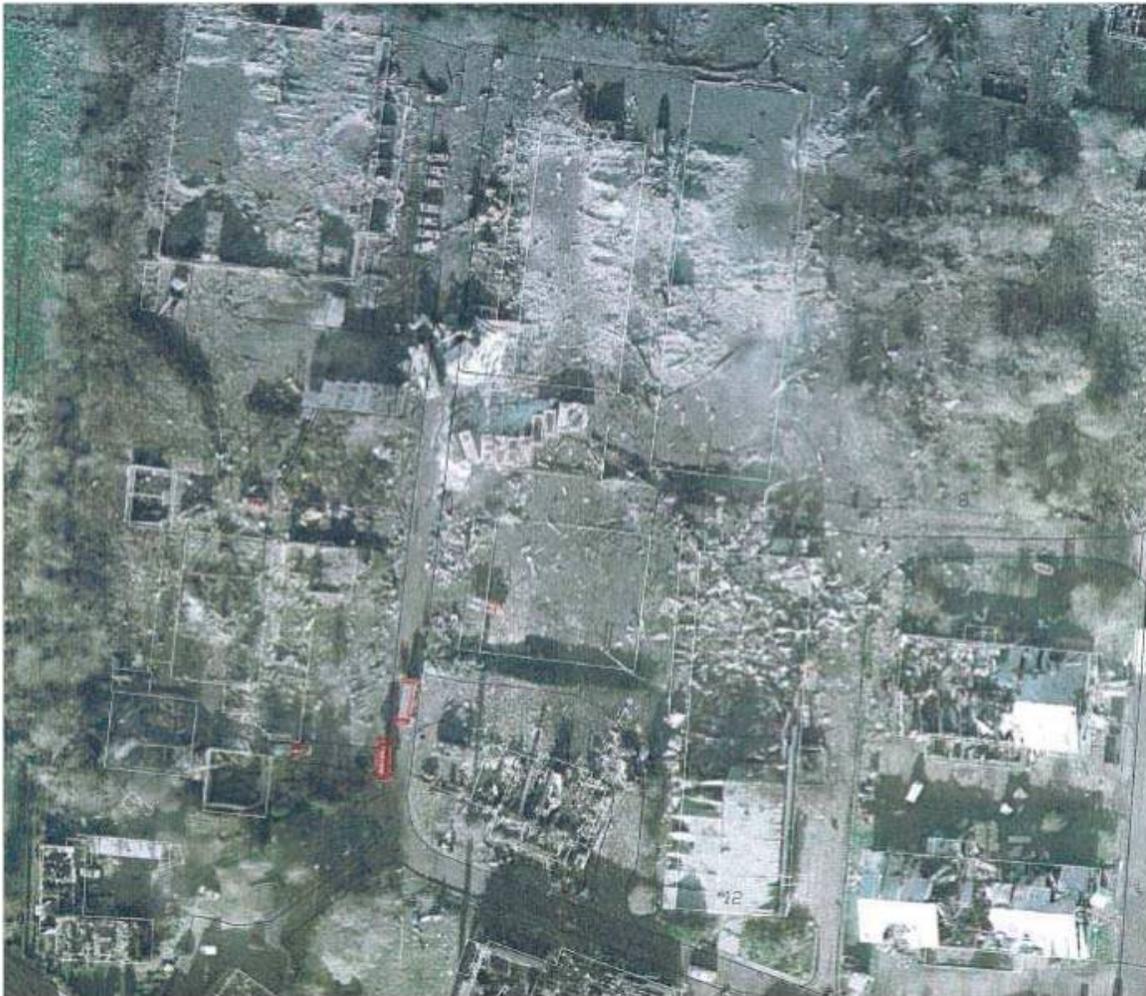
FIGURE 110. Aerial View of the Site at Fireworks Site Near Kolding After the Accident.

Figure 110 shows an aerial view of the site after the accident, and can be compared to Figure 105 that showed the site before the accident.

A 2 meters squared by 15 centimeters thick fragment of a concrete wall, weighing approximately 1 tonne, was found 150 meters from building 6. Debris of the buildings was found over 1,000 meters from the disaster. The damage to buildings was approximately 100 million euros.

The post accident investigation found 10 craters where buildings 1, 4, 6, 7, and 8 had been located. These are described in Table 8.

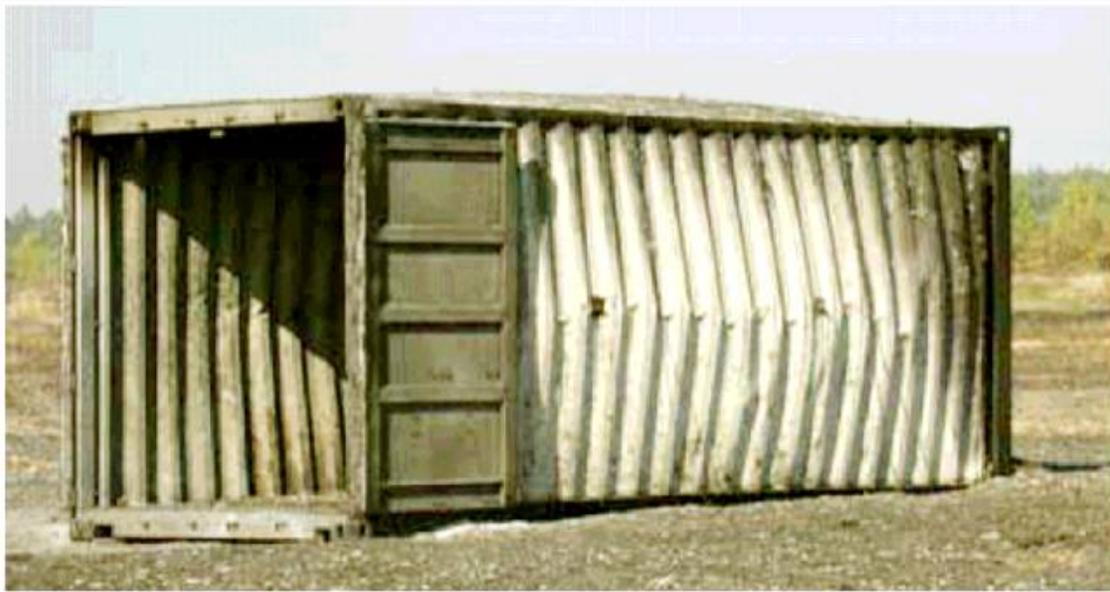
The damage to the containers varied from simple bulging of container walls to destruction of the container to fragmentation of the container and projection of fragments, as shown in Figures 117 through 119.

FIGURE 117. Damage to ISO Container From the 75-mm Shell Test.

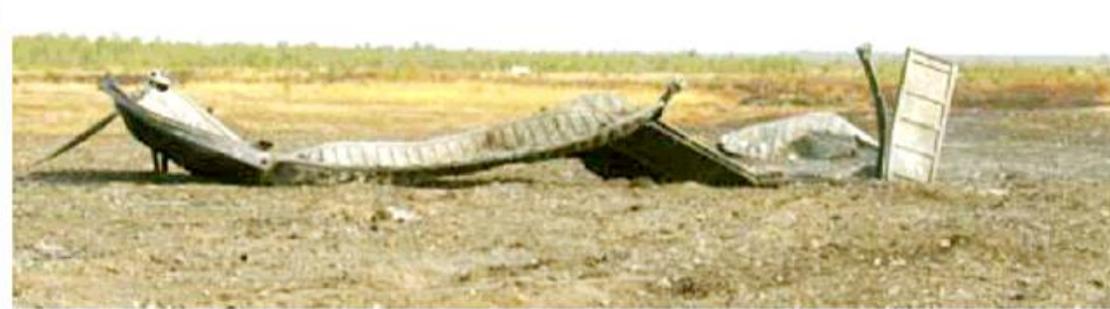
FIGURE 118. Damage to ISO Container From the 150-mm Shell Test.

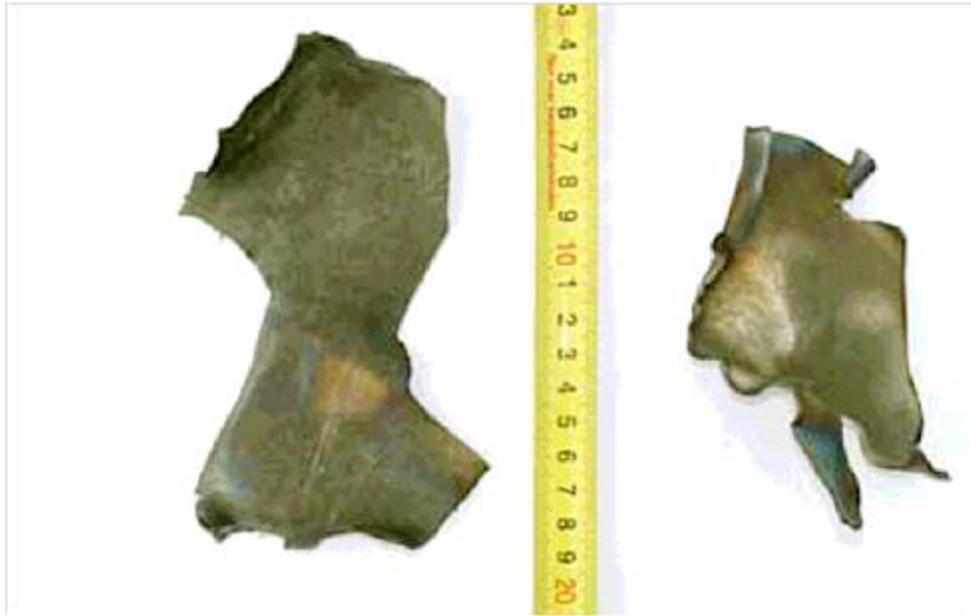
FIGURE 119. Fragments From the ISO Container From the Waterfalls Test.

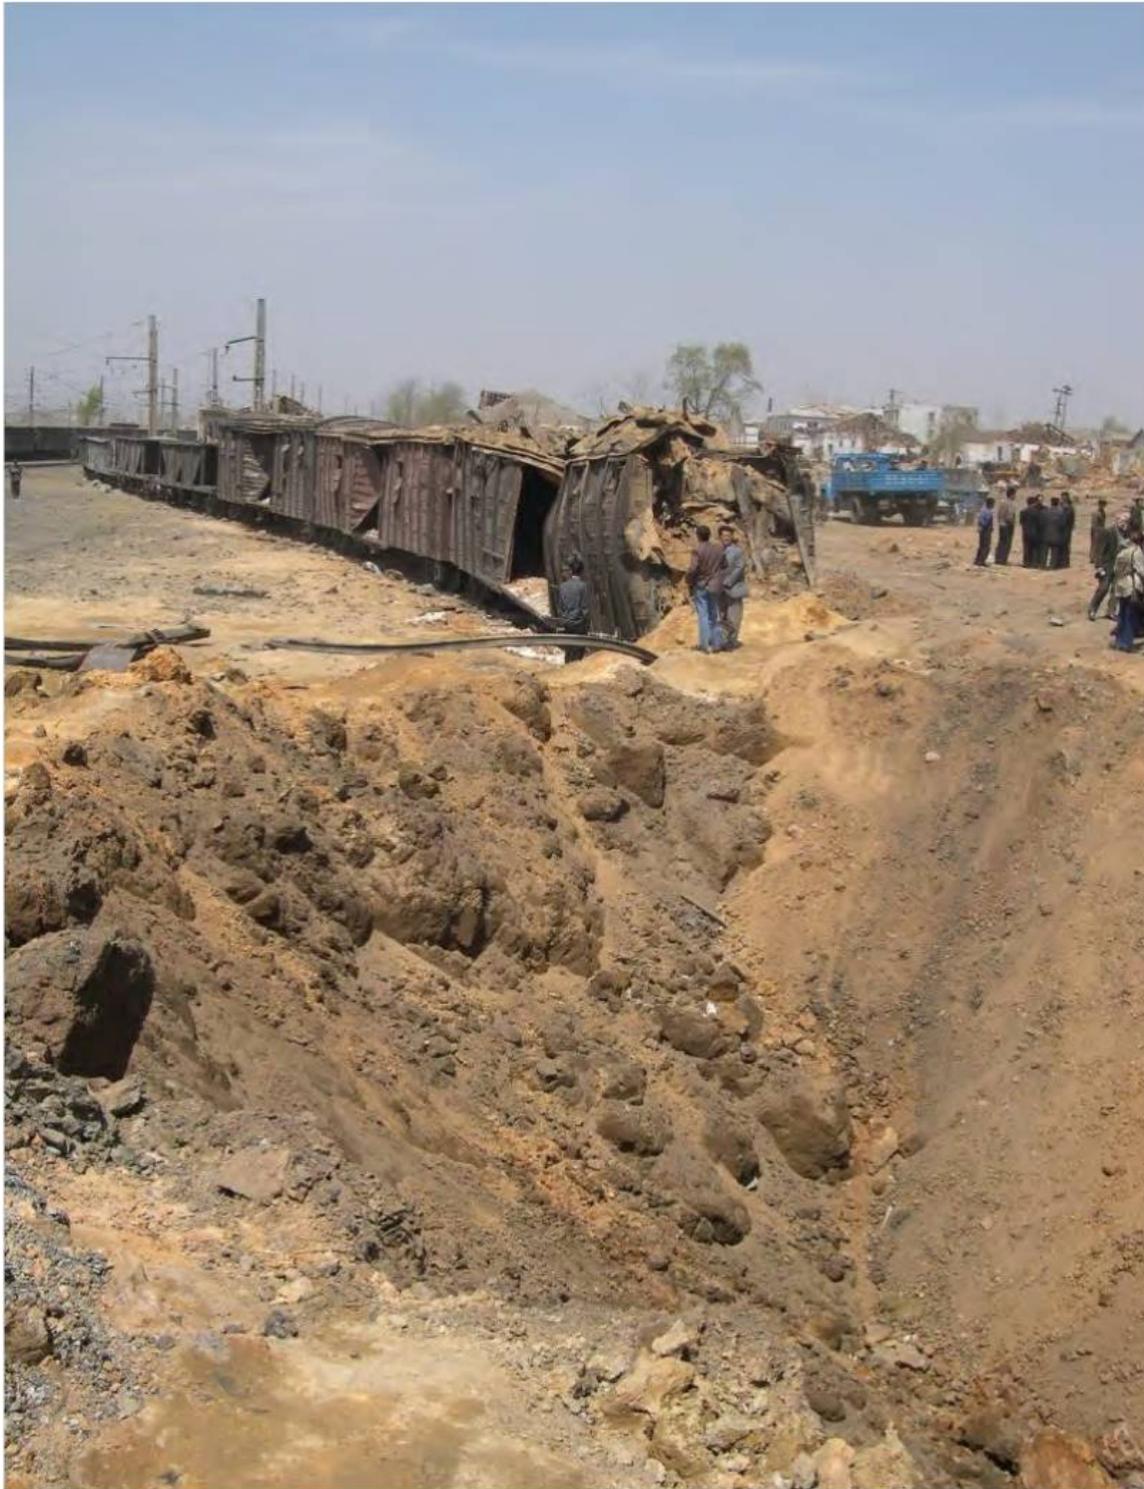
- **Ryongchon, North, Korea, 22 April 2004, 162 fatalities.** On 22 April 2004, there was a large explosion at the train station in the town of Ryongchon, North Korea. A freight train carrying AN exploded in this important railway town near the Chinese border. The explosion occurred during shunting operations at the railyard. Two cars each containing 40 tonnes (44 tons) of AN came into contact with a car containing fuel oil. The massive explosion created a large crater 15 meters (49 feet) deep and leveled everything in a 500-meter (1,640-foot) radius. The cause of the accident was unclear but may have been initiated when the railcars came in contact with a live electrical wire. There were 162 fatalities, including 76 school children and 3,000 others were injured. The station was destroyed, as were most buildings within 500 meters (1,625 feet), and nearly 8,000 homes were destroyed or damaged. Damages have been estimated at 300 million euros. Another report said that there were two craters of about 10 meters (33 feet) in depth were seen at the site of the explosion. Figure 120 shows the crater, while Figure 121 shows the damage to the primary school.

FIGURE 120. Crater at the Ryongchon, North Korea  
Railyard Following Explosion.

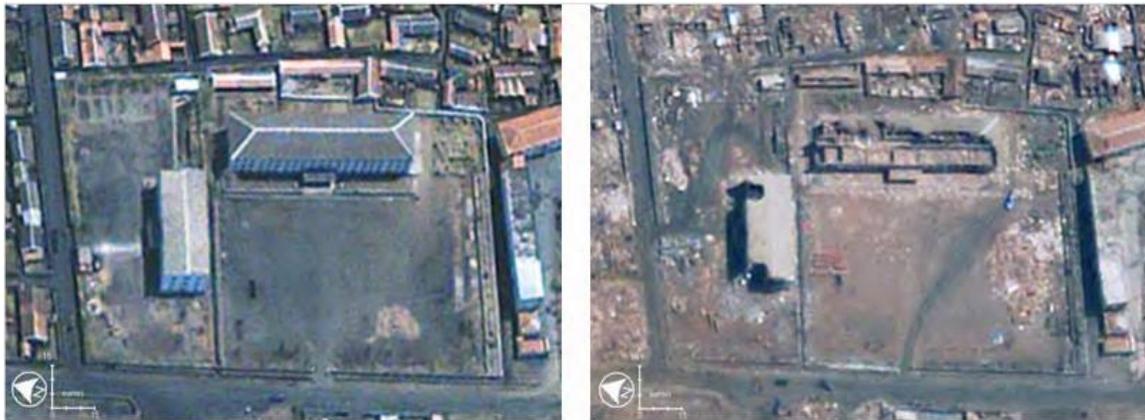
FIGURE 121. Damage to the Ryongchon Primary School.  
<http://www.cdc.gov/niosh/mining/pubs/pdfs/arorai.pdf>

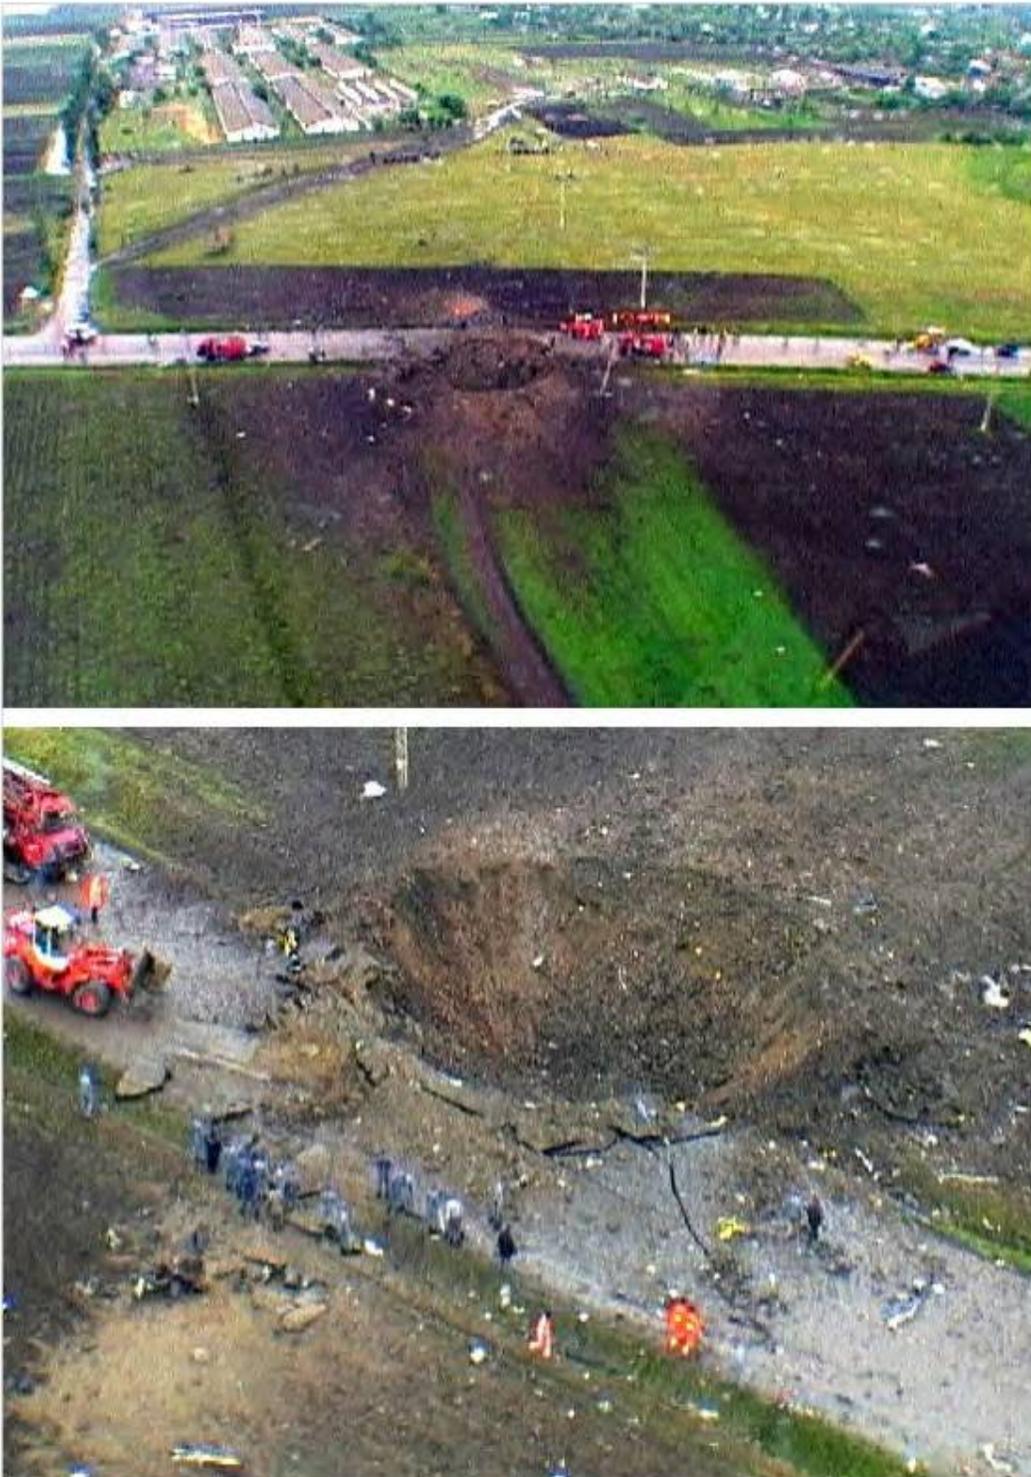
- **Mihăilești, Buzău, Romania, 24 May 2004, 20 fatalities.** A truck carrying more than 20 tonnes (22 tons) of AN tipped over and caught fire on the European road E85 near Mihăilești (50 kilometers (31 miles) northeast of Bucharest, Romania) at 4:57 a.m. on 24 May 2004. The driver tried to fight the fire. A few cars stopped and watched the fire. Two reporters got to the site of the accident and started filming the fire. Firefighters arrived and started to fight the fire. The last mistake of untrained Romanian firemen occurred when water was used in an attempt to extinguish burning chemicals (all firefighting instructions indicate not to use water but carbon dioxide (CO<sub>2</sub>) in case of burning chemicals and/or fuel). Around 5:50 a.m., the truck blew up, killing 20 and wounding 13 people. A crater 6.5 meters (21 feet) deep and 42 meters (137 feet) in diameter was formed by the explosion. Once again, the fire burned a significant time (enough time to get television film crews to the site) before the explosion took place. Figure 122 presents the scene after the accident.

FIGURE 122. Accident in Romania in Which 20 Tonnes (22 Tons) of “Nitrous Fertilizer” Caught Fire and Later Exploded, Killing 20 People.  
<http://www.cdc.gov/niosh/mining/UserFiles/works/pdfs/arorai.pdf>

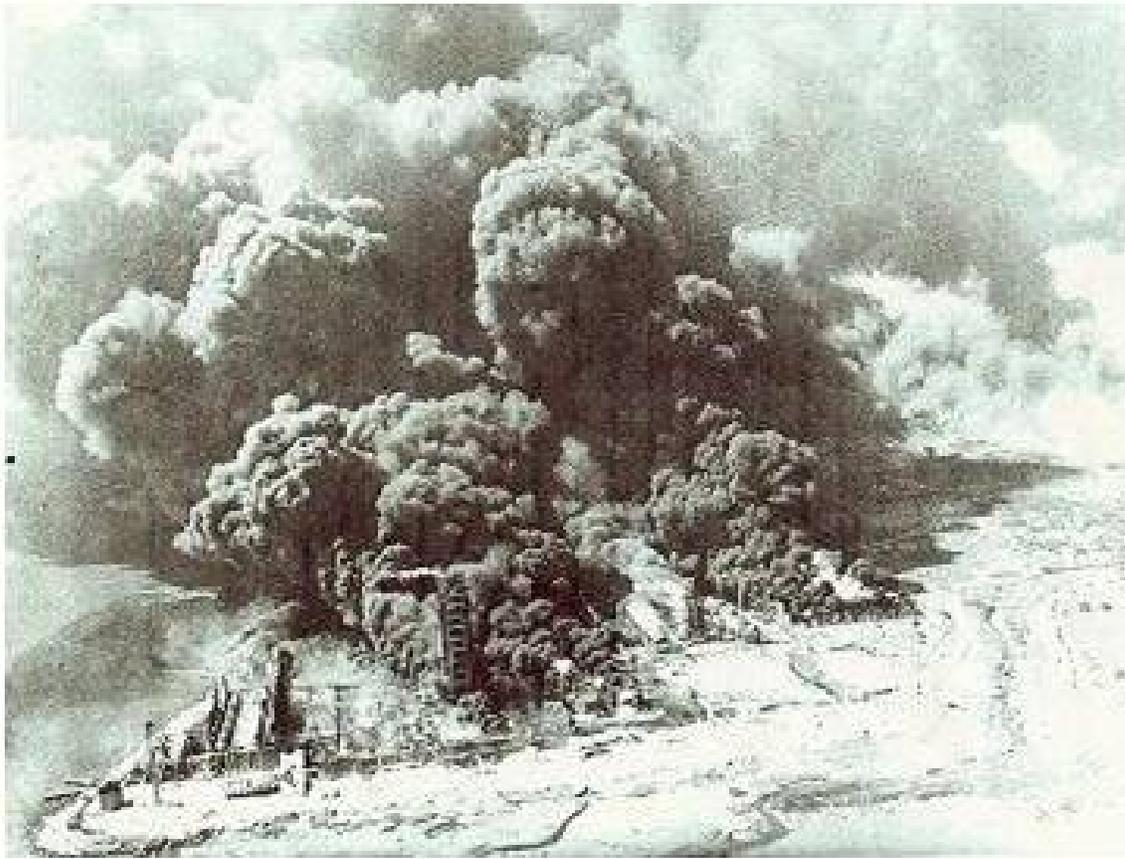
Flames quickly spread, helped by the burning bales of sisal and cotton, to the Monsanto plant and the nearby refineries (Figure 126).

FIGURE 126. Burning Following the Detonation  
on the *Grandcamp* at Texas City.

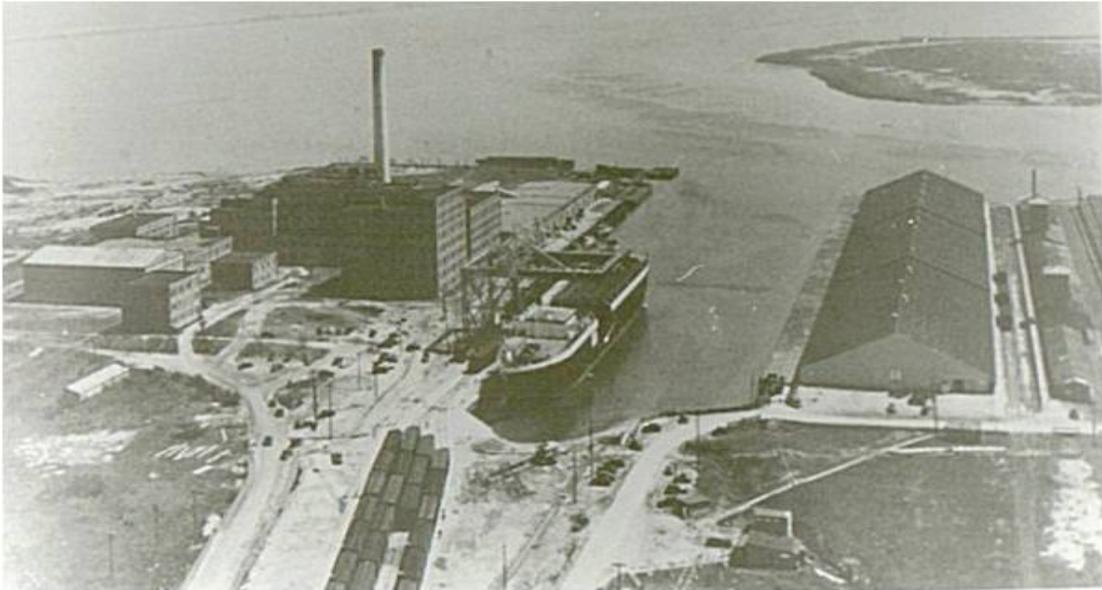
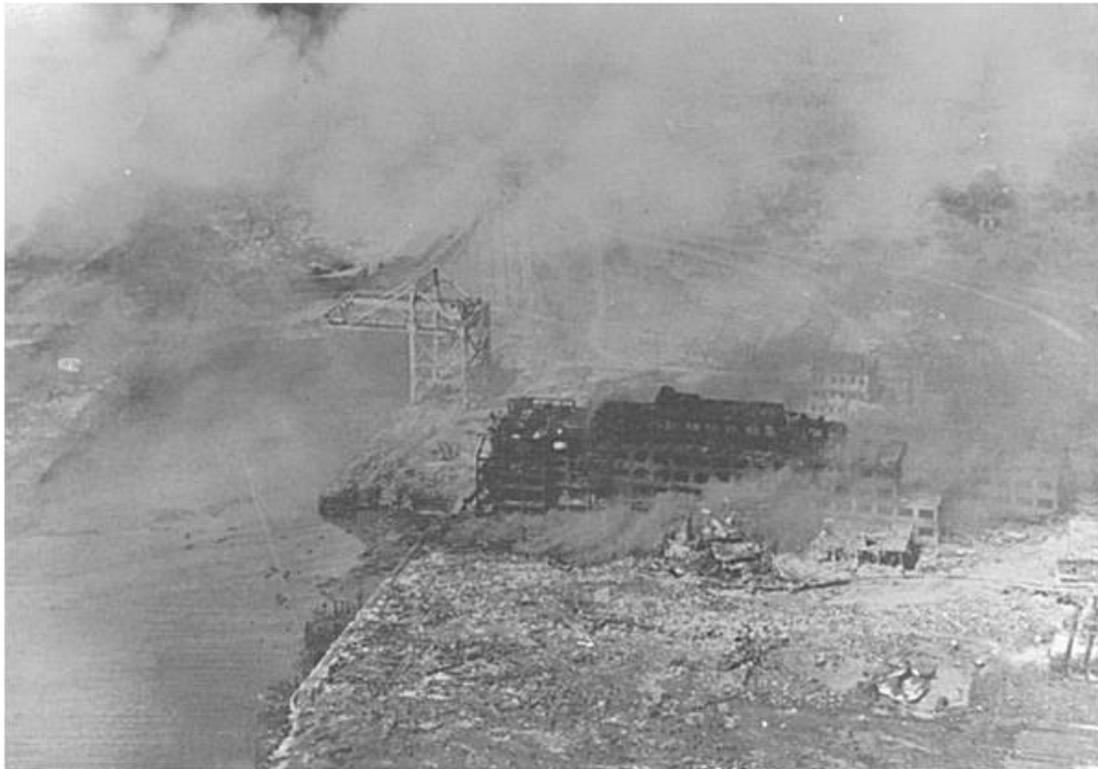
Another indication of the damage caused by this disaster is shown in Figure 128, which shows the adjacent Monsanto plant before and after the disaster.

FIGURE 128. Monsanto Plant.

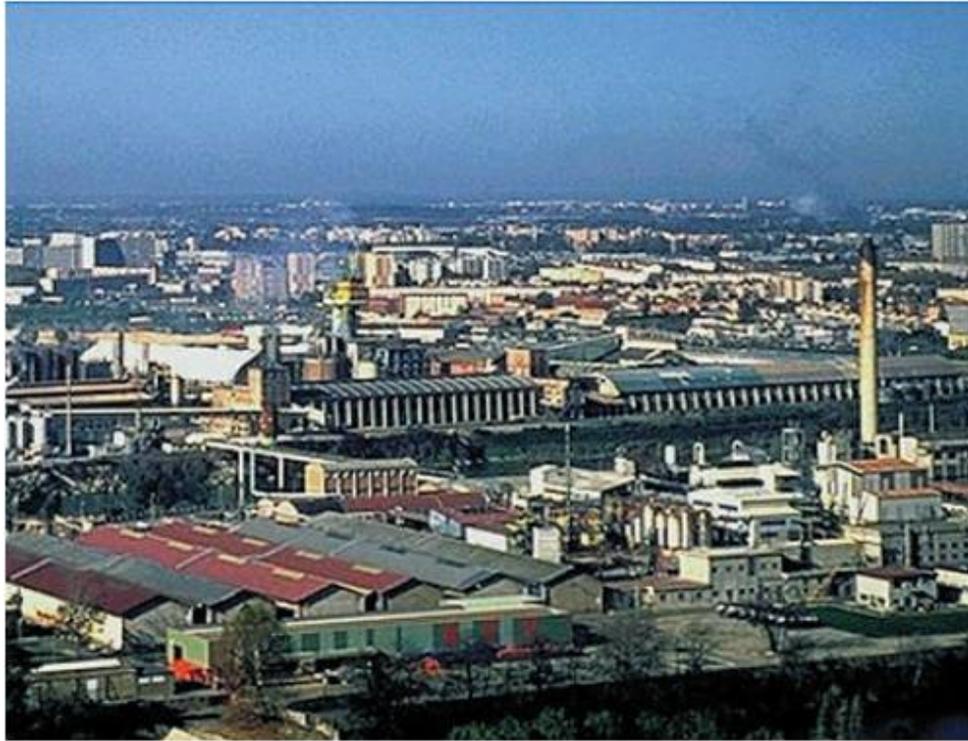
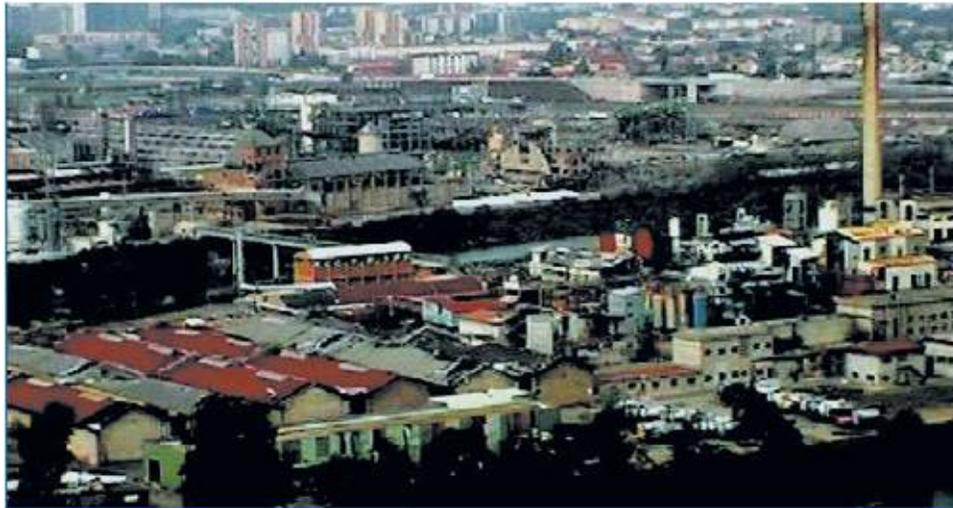
Shed 221 contained about 300 tonnes of AN that did not meet commercial specifications. It was being stored while awaiting shipment to other plants to be used in making compound fertilizers. The explosion left a crater several tens of meters across and was heard more than 40 kilometers from Toulouse. The estimated TNT equivalence was between 20 and 40 tonnes. The explosion registered the equivalent of an earthquake measuring 3.5 on the Richter scale. The explosion caused 30 deaths, including 21 people working in the AZF plant. More than 4,500 people were injured. [Some reports estimated 2,500 seriously injured and the total injured to be as high as 9,000 to 10,000.] Buildings destroyed in the surrounding area totaled approximately 27,000. The cost of damages has been estimated to be 1.5 billion euros. Figure 129 shows the plant before and after the explosions.

FIGURE 129. AZF Plant, Toulouse, France.

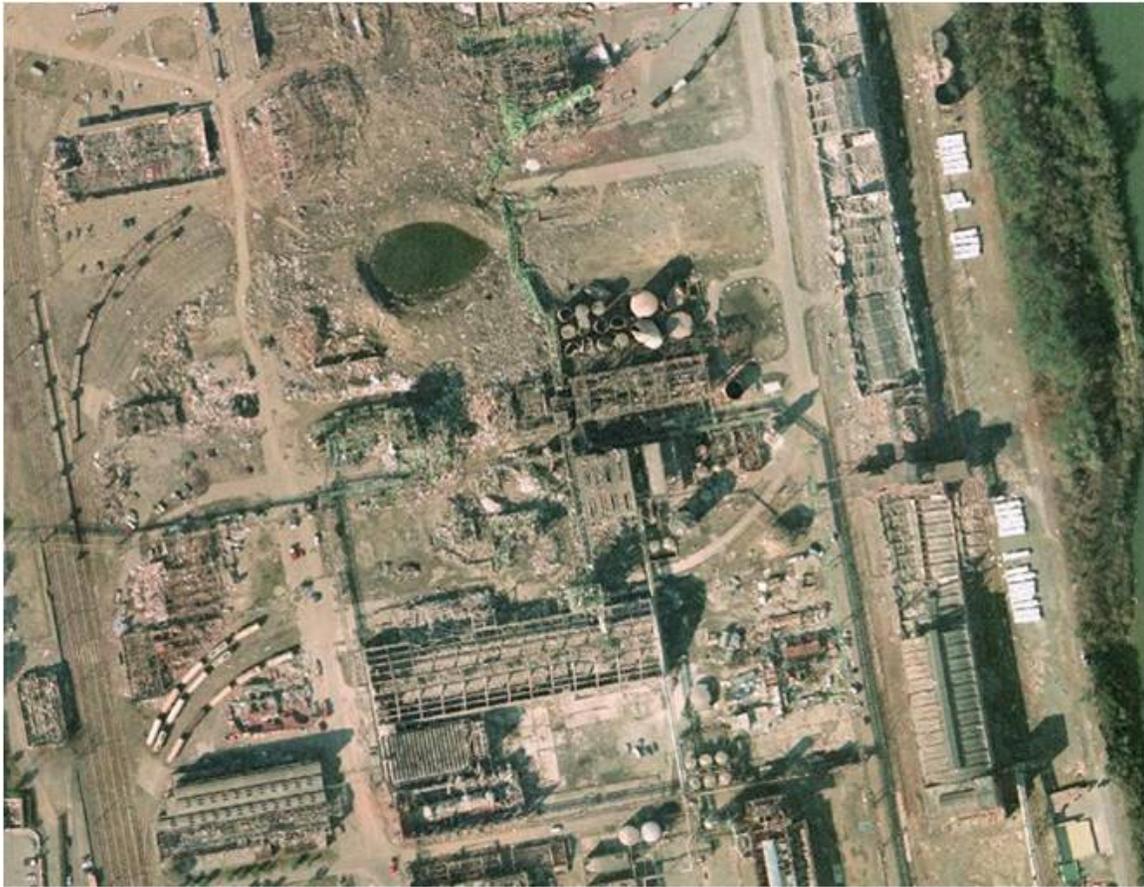
FIGURE 130. Aerial View of the Northern Portion of the AZF, Toulouse, France After the Explosion.

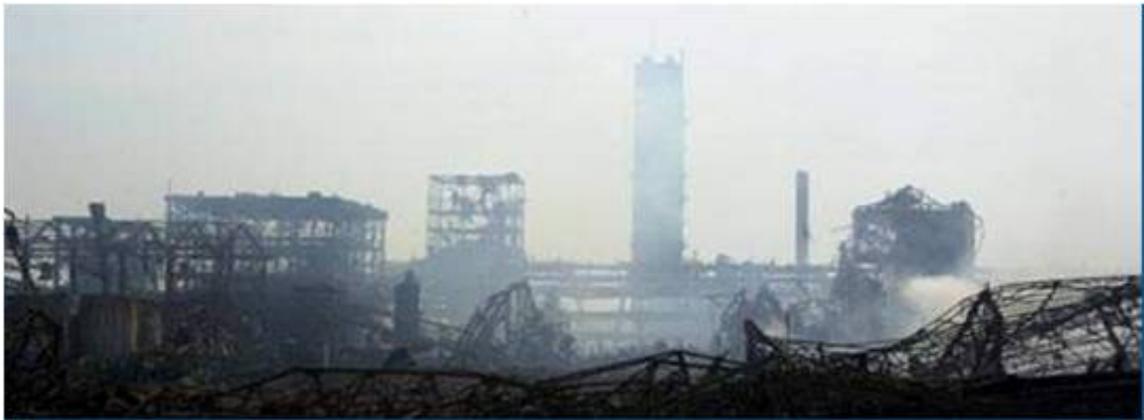
FIGURE 131. Ground Level View Showing the Extent of Destruction Due to the Explosion at the AZF Plant, Toulouse.

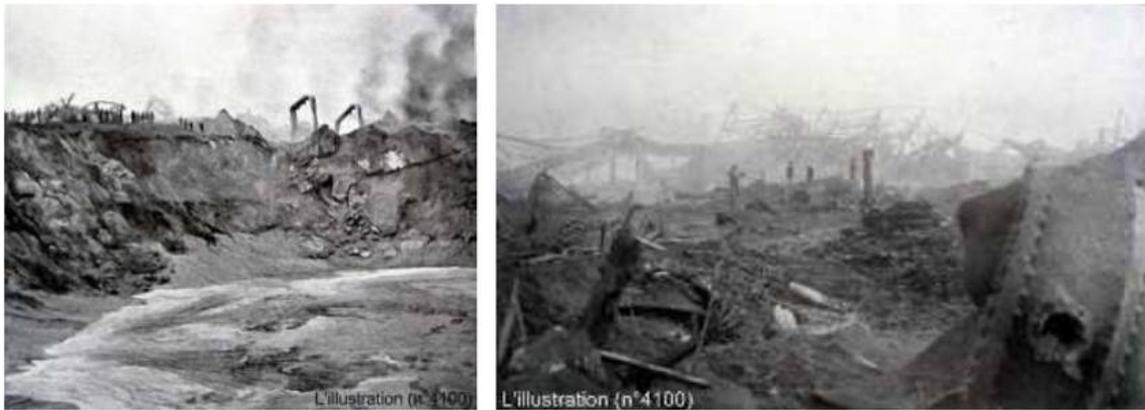
FIGURE 133. Crater and Extent of Damage at Ground Level.

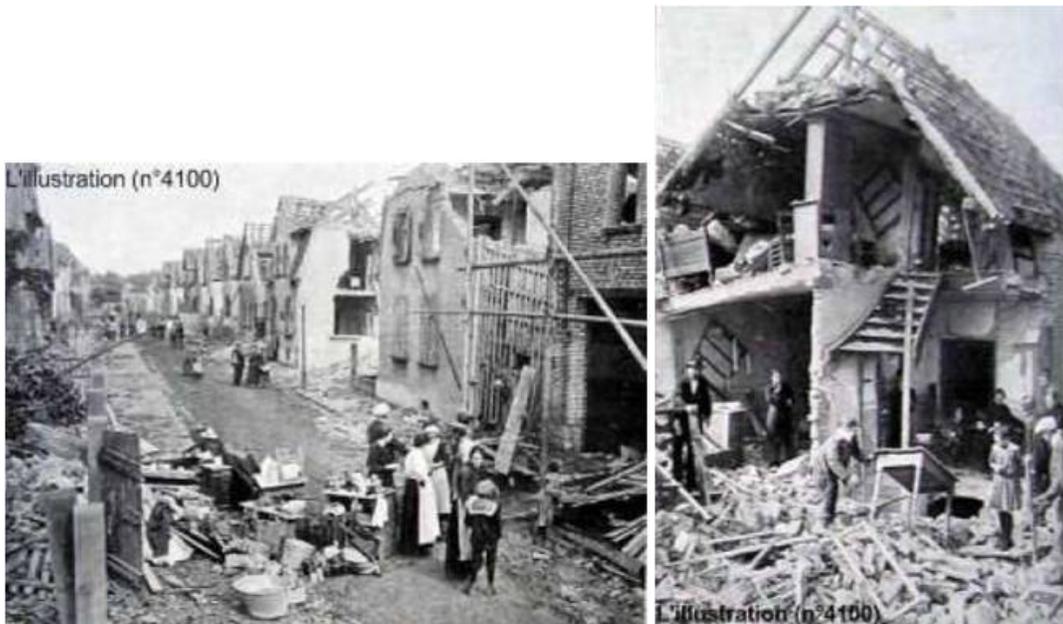
The number of fatalities and injuries reported varied from 430 fatalities in one report to 500 to 600 fatalities and 2,000 injuries in another report to 561 fatalities and 1,952 injuries in two other reports. About 80% of the buildings in Oppau were destroyed. The estimated damage was 321,000,000 marks, or \$1.7 million, at that time. Figure 134 shows some of the damage in the town of Oppau.

FIGURE 134. Damage to Houses in Oppau Caused by the Explosion at the BASF Plant, Oppau.
