SIGAR 14-31 Inspection Report

SALANG HOSPITAL: LACK OF WATER AND POWER SEVERELY LIMITS HOSPITAL SERVICES, AND MAJOR CONSTRUCTION DEFICIENCIES RAISE SAFETY CONCERNS

**JANUARY
2014**

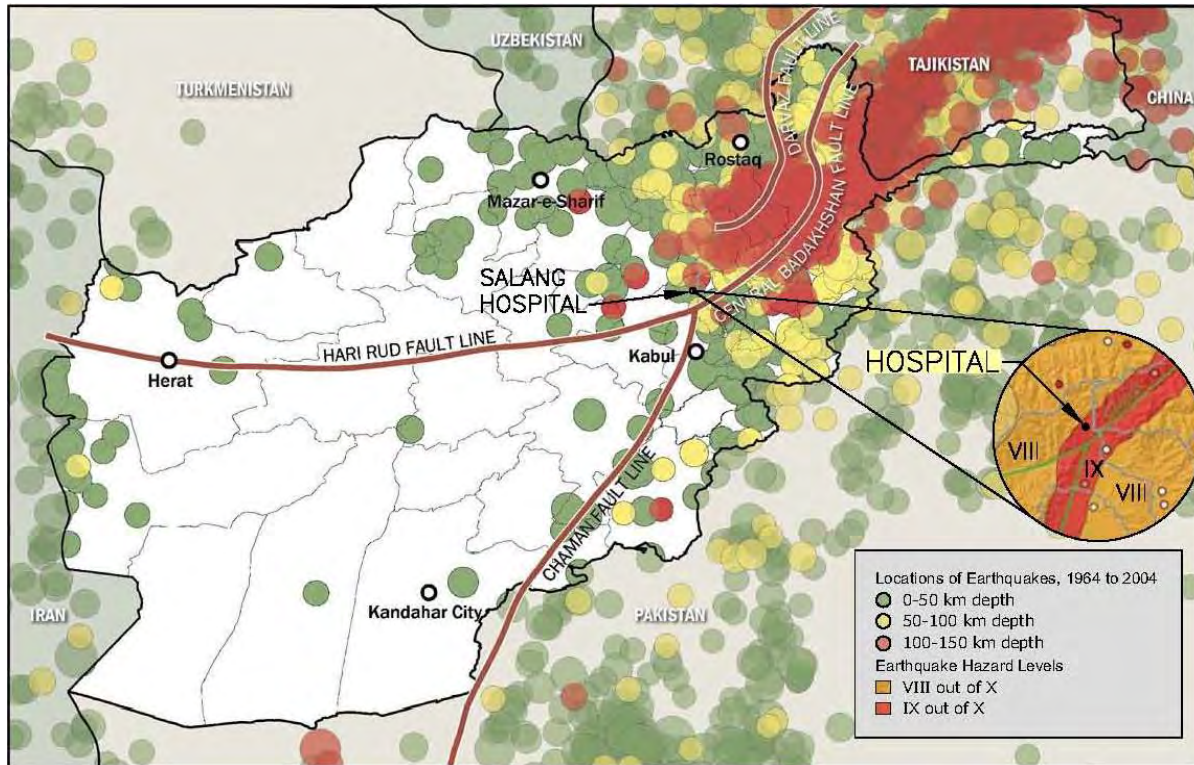
Figure 1 - Location of Earthquakes in Afghanistan from 1964 through 2004

1997 to 2007.⁴ Substandard construction that does not meet industry earthquake standards⁵ exposes the structures involved to increased earthquake vulnerability. Figure 1 shows the proximity of Salang hospital in relationship to the intersection of the Chaman, Hari Rud, and Central Badakhshan fault lines and the location of earthquakes that have occurred in Afghanistan from 1964 through 2004.

According to U.S. Geological Survey data, Salang hospital is located in the second highest seismic intensity zone in Afghanistan. The Chaman and Badakhshan fault lines represent the centerline of a 15 to 25 kilometer wide swath of potential destruction during a seismic event. The U.S. Geological Survey characterizes the seismic activity and potential damage for this zone as Level IX out of X. Level IX activity is described as: “Violent shaking with people forcibly thrown to the ground, monuments and columns fall, and most unreinforced masonry buildings will suffer heavy to very heavy structural damage.”
