## **An Investigation of Concrete Deterioration at South Florida Water Management District Structure S65E**

February 2014

Final report

Under Rapid Assessment of Concrete Deterioration at S65E

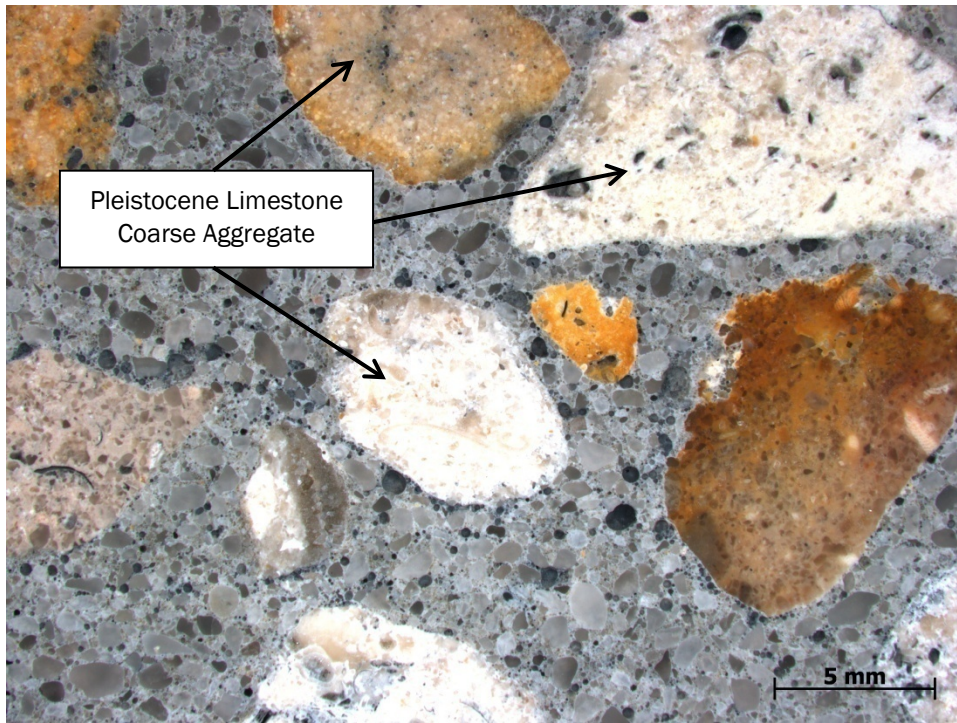
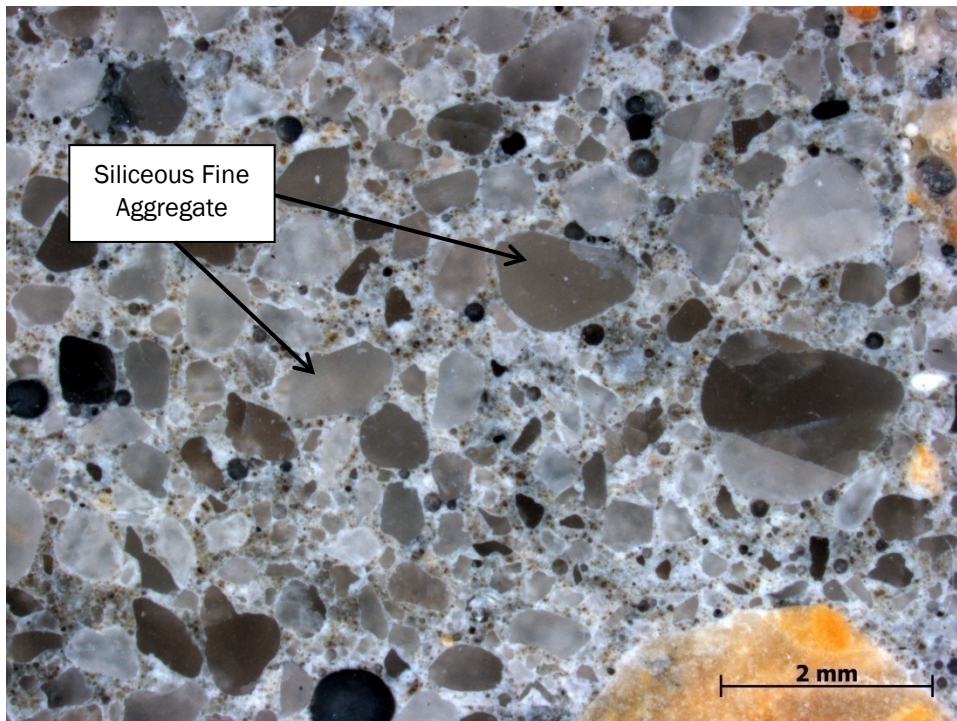
Figure 4. Photomicrographs of typical bulk concrete showing distribution in air voids, coarse aggregates, fine aggregates, and paste.

Prior to examination of non-deteriorated, repaired, and deteriorated concrete from near the exposed surface, an examination of the bulk concrete was made to assess concrete quality and identify coarse and fine aggregates. Typical photomicrographs of the bulk concrete are shown in Figure 4. The concrete appeared to be competent and of high quality. Coarse aggregates were primarily a Pleistocene limestone commonly used in concrete in Florida. Fine aggregates were primarily siliceous. No evidence of deterioration was observed in the bulk concrete that was isolated from any surface deterioration present in the as-received concrete cores.

a. Low magnification photomicrograph.

b. High magnification photomicrograph.

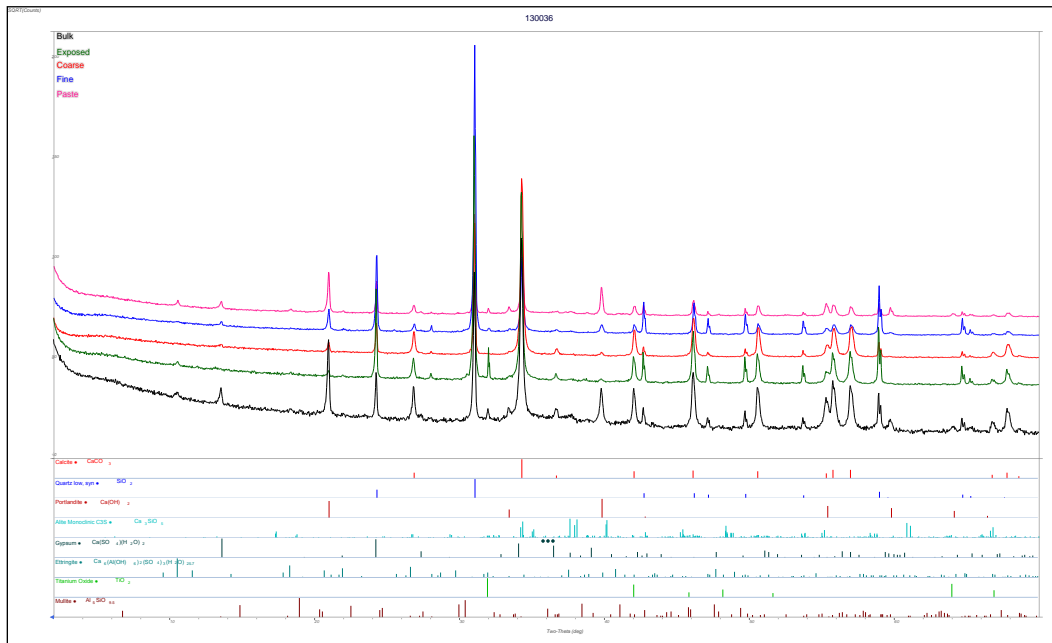
Figure 15. XRD patterns for non-deteriorated bulk concrete, exposed deteriorated concrete, coarse aggregates, fine aggregates, and hydrated cement paste with phases qualitatively identified as shown at the bottom of the plot and corresponding to the peak location in XRD pattern.

XRD measurements were performed to determine the mineralogy of various phases present in the concrete and the differences between non-deteriorated bulk concrete and deteriorated surface concrete. Figure 15 shows typical XRD patterns of various constituents and regions investigated: coarse aggregate, fine aggregate, hydrated cement paste, bulk-deteriorated concrete, and deteriorated exposed concrete. Phases qualitatively identified to be present are shown at the bottom of Figure 15.

As anticipated, the coarse aggregate was primarily composed of Pleistocene limestone, containing the calcite polymorph of  $\text{CaCO}_3$ . The fine aggregate was primarily siliceous, containing the quartz polymorph of  $\text{SiO}_2$ . The paste has additional phases resulting from cement hydration, including ettringite and portlandite, along with unreacted gypsum and alite ( $\text{C}_3\text{S}$ ) contributed by portland cement.

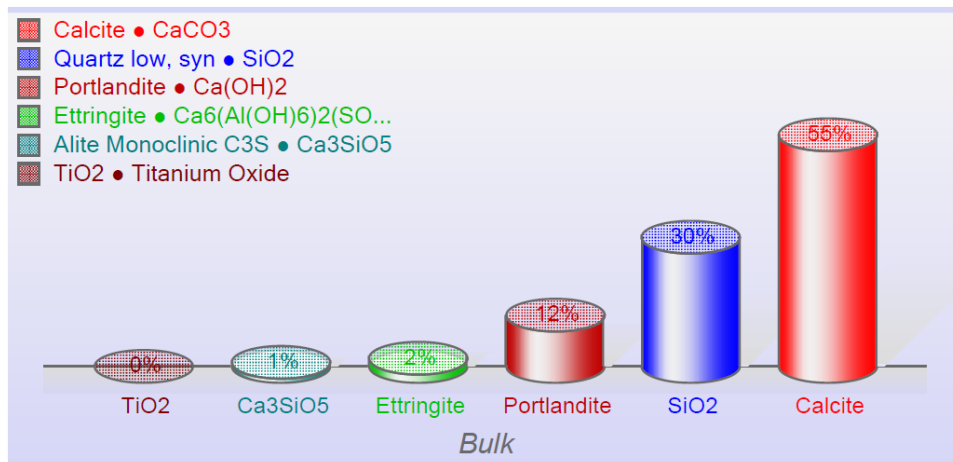
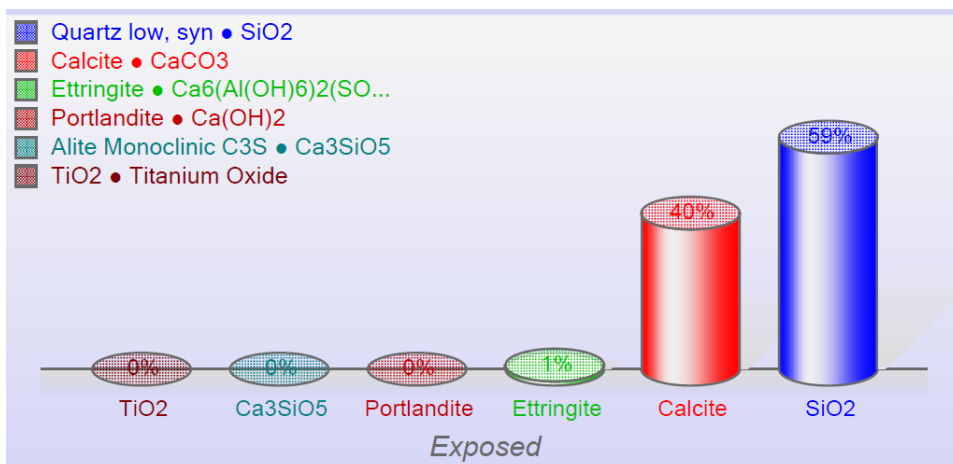
Figure 16. Results from quantitative XRD whole pattern fitting from bulk concrete and surface concrete from exposed areas that exhibited deterioration.

The most useful comparisons can be made between the bulk non-deteriorated concrete and the surface deteriorated concrete. Figure 16 presents the results of quantitative whole pattern fitting of samples from bulk non-deteriorated concrete and surface deteriorated concrete.

a. Quantitative analysis results from bulk non-deteriorated concrete.

b. Quantitative analysis results from surface deteriorated concrete.

In the case of the bulk non-deteriorated concrete, calcite, associated with coarse aggregates, and quartz ( $\text{SiO}_2$ ), associated with fine aggregates, dominated the composition, followed by cement hydration products portlandite ( $\text{Ca}(\text{OH})_2$ ) and ettringite ( $\sim\text{Ca}_6(\text{Al}(\text{OH})_2)_2(\text{SO}_4)_3(\text{H}_2\text{O})_{25}$ ), along with residual unhydrated cement (Alite/ $\text{C}_3\text{S}$ ). In the surface deteriorated concrete, significantly more quartz was present from undamaged fine aggregates, and less calcite was present from the deterioration of Pleistocene coarse aggregates. A reduction in soluble hydrates including portlandite and ettringite occurred. The loss of portlandite and ettringite at the surface is typical for leaching of these highly soluble phases in high-moisture environments. The lack of ettringite or other phases typically present in concrete damaged by sulfate attack such as gypsum supports our hypothesis that sulfate attack is likely not a concern, as  $\text{SO}_4^{2-}$  concentrations are low in the local water at S65E. The reduction in calcite and increase in quartz composition at the surface also supports the hypothesis that biodeterioration may be leading to distress by consumption of limestone coarse aggregates and the paste. However, this finding is highly related to the location of sampling on the concrete core.

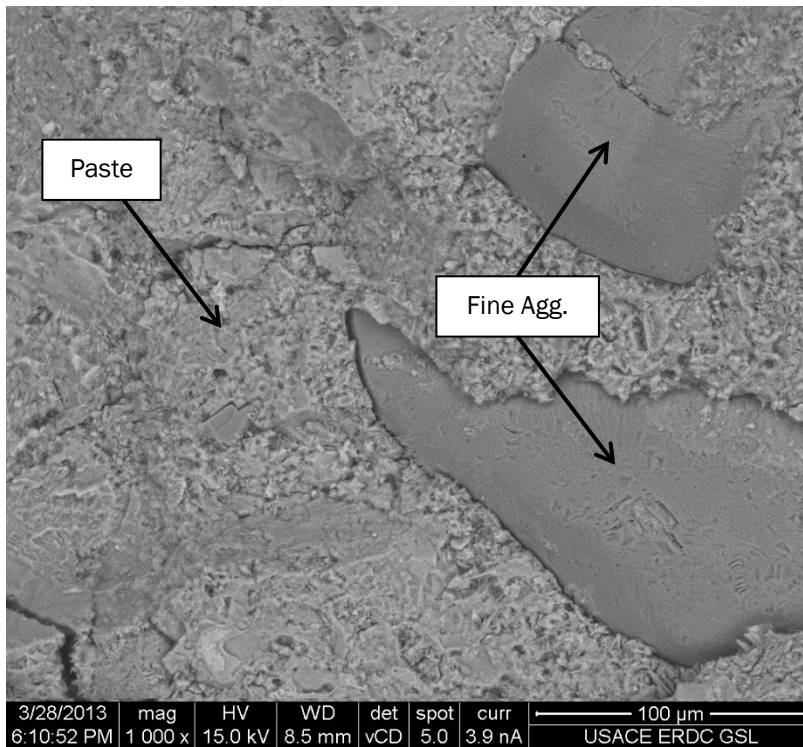
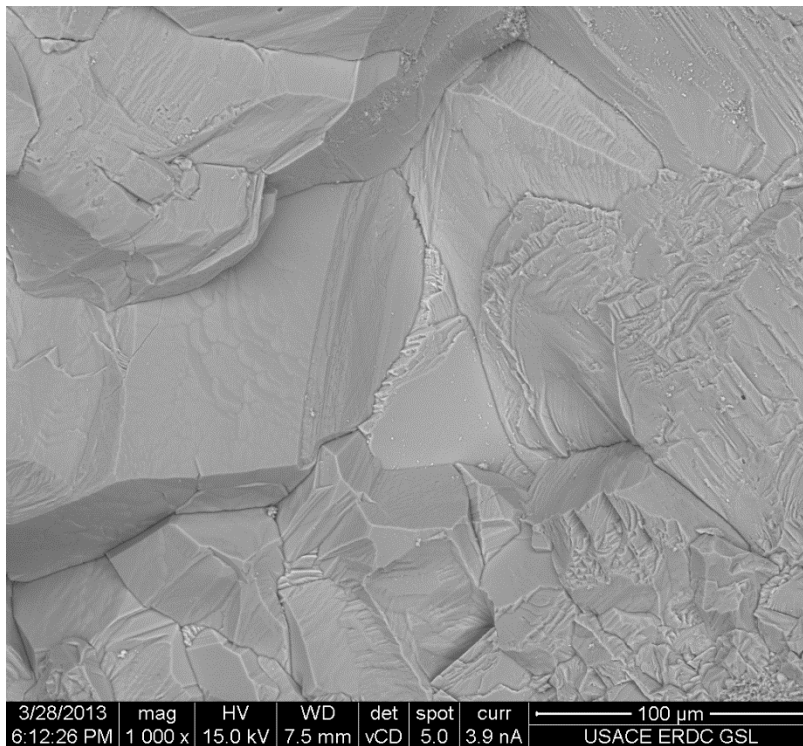
Figure 20. SEM micrographs of inner bulk non-deteriorated concrete showing typical distribution in paste, fine aggregates, and the Pleistocene limestone coarse aggregate.

Further examination of microcores extracted from the surface and split longitudinally was used to investigate damage from the surface in. Figure 19 shows examples of deterioration observed on the fracture surface and the transition between the surface deterioration and the non-deteriorated bulk concrete and unaffected aggregates. The inner bulk concrete appeared typical with no detectable other modes of deterioration (see Figure 20).

a. Fracture surface of bulk concrete showing paste and fine aggregate.

b. Fracture surface of non-deteriorated limestone coarse aggregate.

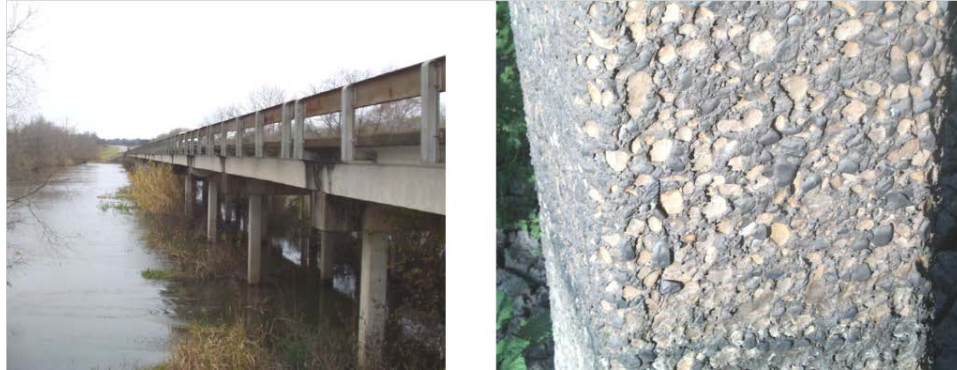
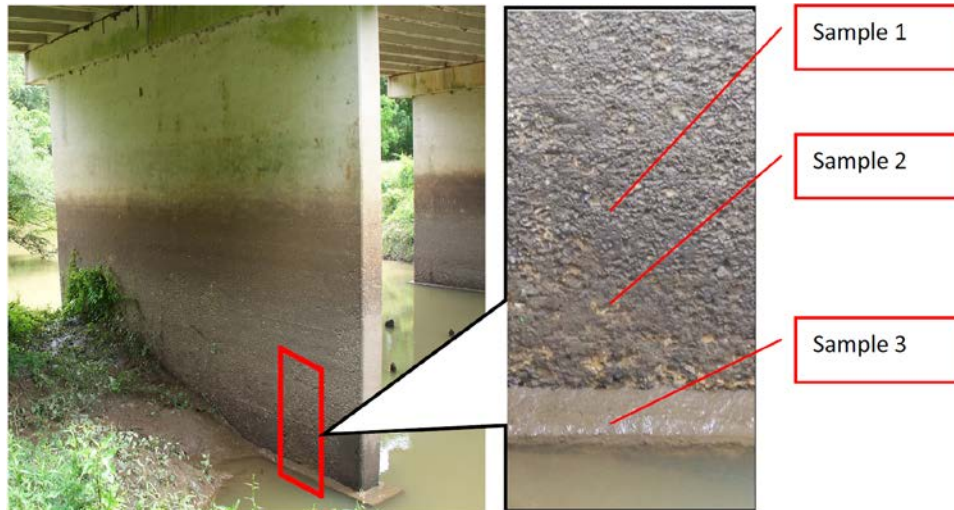
Figure 21. Similar microbial-induced biodeterioration observed in Texas bridge structures exposed to environments similar to those at structure S65E (from Trejo 2008).

Biodeterioration can explain local deterioration at the surface by acidification and direct or chemical consumption of mineral phases present in concrete (e.g., CaCO<sub>3</sub>). Similar modes of deterioration have recently been reported (see Figure 21). However, water-rock reaction simulations have also evidenced the potential for active dissolution of soluble components in the concrete (e.g., calcite and dolomite) based on the typical local water quality at S65E.

a. Example biodeterioration of concrete surface in Texas bridge structure.

cementitious materials) and improve acid resistance (e.g., use of silica fume) would likely improve the durability of the repair material. The use of a high quality repair material that is durable will also serve to better protect the underlying concrete from subsequent deterioration.
