FINAL REPORT

Ultrasonic Guided Wave Technology for Non-Invasive
Assessment of Corrosion-Induced Damage in Piping for Pollution
Prevention in DoD Fuel Storage Facilities

ESTCP Project WP-200819

AUGUST 2011

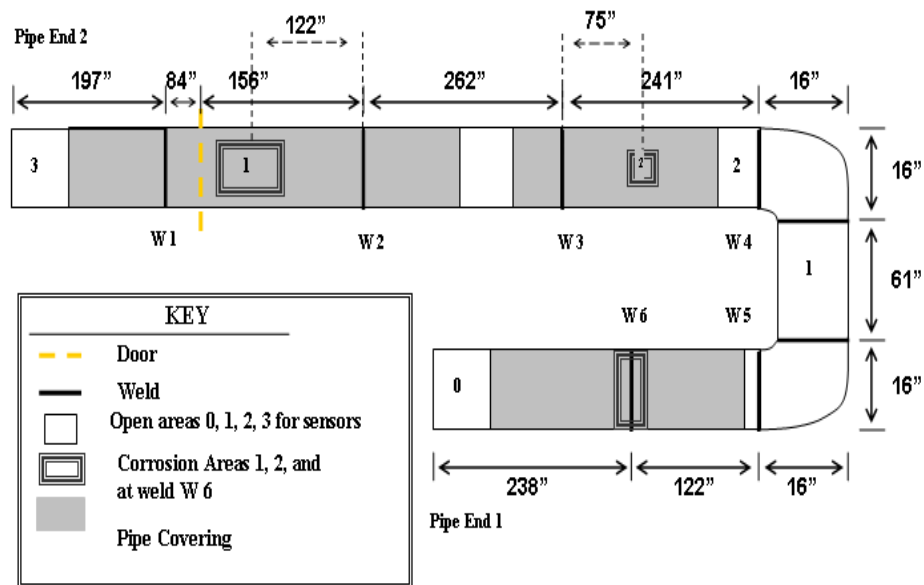
Figure 8. Location of ultrasonic measurement points and corrosion defects in the 8.6 inch diameter pipeline at NSWCCD.

Figure 8 illustrates the locations of the corrosion-induced defects. Two defects (unknown to the inspectors) were placed in the long straight sections of the pipeline. One of the defects not only increased systematically in its depth, but also along the pipe axis and along its circumference as the exposure progressed (Defect 1). The other defect was intended to be a "small" defect (Defect 2) having a fixed lateral dimension of approximately 3 inch x 3 inch, but with increasing material loss in the thickness direction. The goal was to achieve a wall thickness loss exceeding 50% in this defect by the end of Phase I. The third defect (Defect W6) was at one of the welds,

approximately 20 feet from one end of the pipeline. There has not been any report in the literature on ultrasonic guided wave responses for corrosion at a weld, even though welds are not immune to corrosion in the field. As stated earlier, the approach was to increase the severity of the corrosion defect, as measured by the change in thickness and area loss, over time.

In Figure 8 regions 0, 1, 2, and 3 shows where transducers were mounted. We see that waves excited by Sensor 3 propagating in the negative direction should reach Defects 1 and 2 before reaching an elbow. Waves excited by Sensor 2 propagating in the positive direction should reach Defects 2 and 1 before it reaches the pipe end. Waves excited by Sensor 1 should see Defects 2 and 1 after crossing an elbow in the positive direction, and see the Defect W6 in the negative direction after crossing an elbow. Waves excited by Sensor 0 and propagating in the positive direction sees Defect W6 before reaching either elbow and beyond.

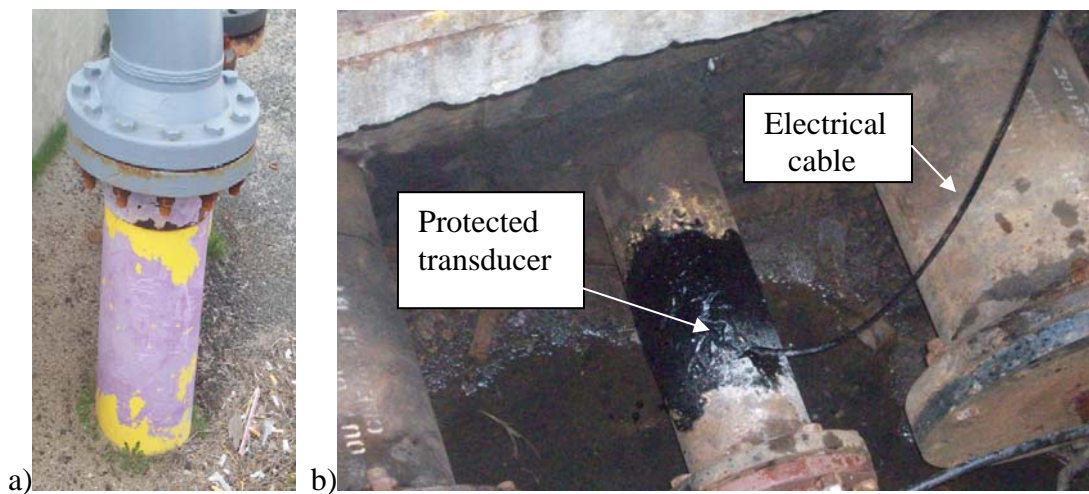
Figure 14. Surface conditions of tested pipe.

14a) Protective paint on a section of pipe to be removed prior to transducer mounting.

14b) Protective tar coating and lead wires for a transducer in the underground pipeline.

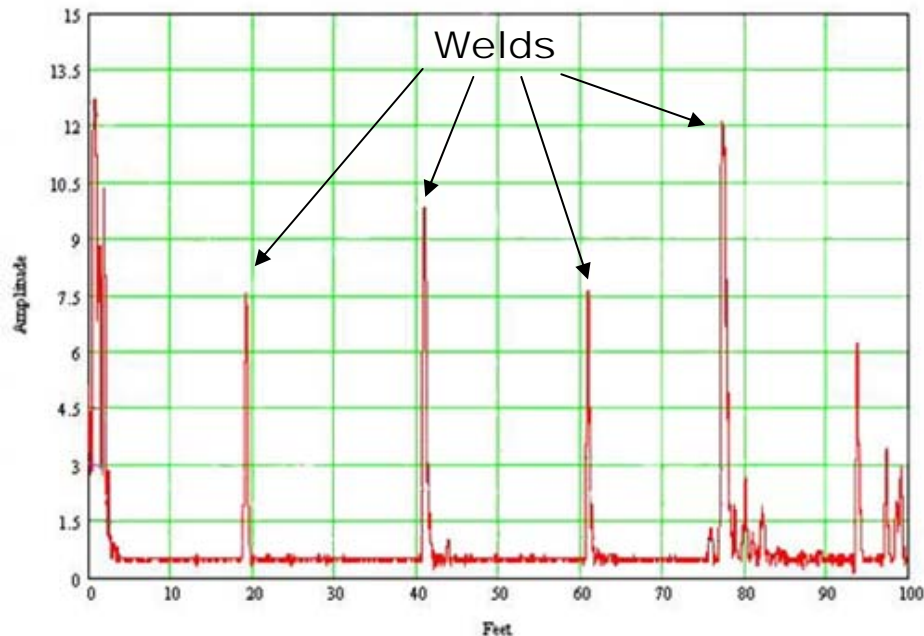
An example of ultrasonic guided wave data showing peak height versus distance along the pipeline (see Figure 8) is shown in Figure 17. Wave propagation speed has been utilized to convert time of flight information to distance information along the pipe. In this figure, the large peaks are reflections from the welds. We note the existence of some small signal peaks with unknown origin before the initiation of corrosion that are not associated with welds. They could be caused by pipe stands, as-manufactured material anomalies, or other unknown conditions. We will come back to these points later in this report.

Figure 17. Example of plotted ultrasonic guided wave baseline data for the above-ground coating system pipeline at NSWCCD before corrosion was initiated. The plot shows peaks originating from welds, approximately 20 feet apart, as sensed by a transducer mounted in location 2.

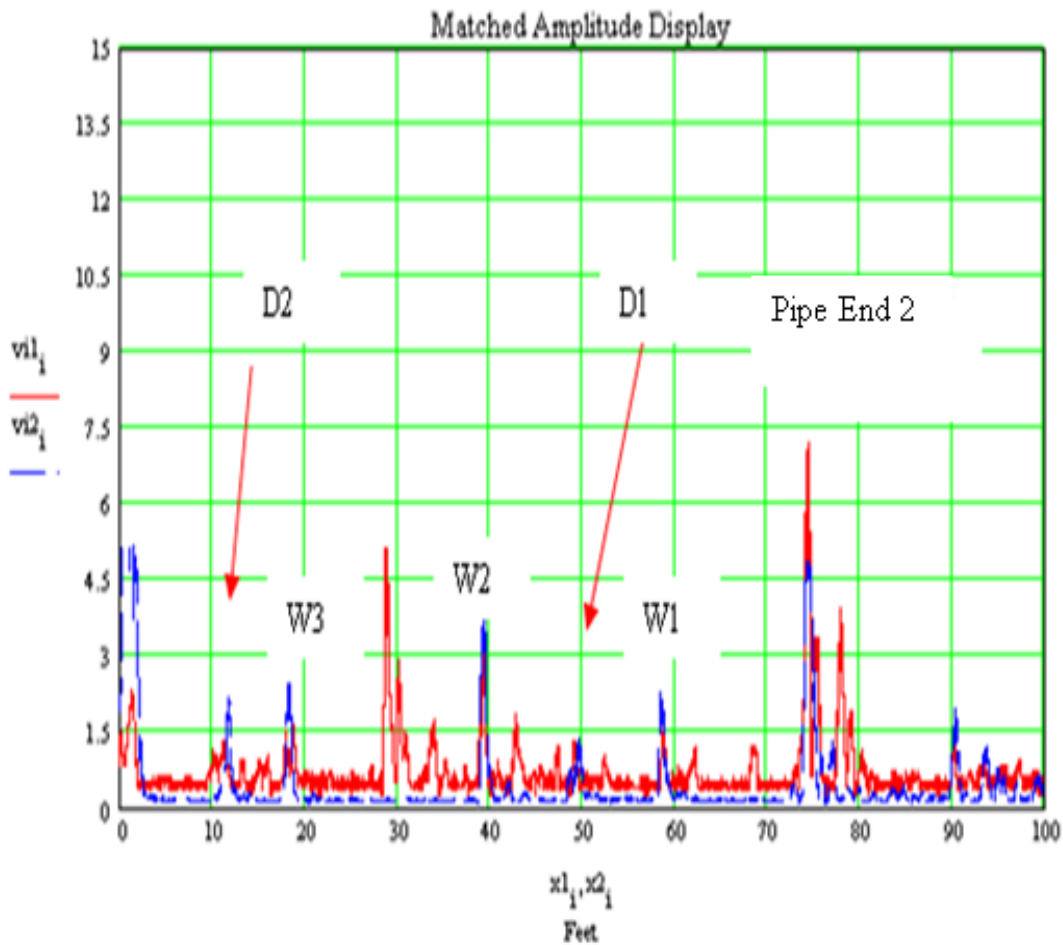
Shown in Figure 20 is an example of Defects 1 and 2, sensed by two sensors located in locations 1 and 2 separated by an elbow, with wave propagation in the same direction as used shown in Figure 18. The origins of the traces are shifted to match the peaks from the defects. We note that the presence of an elbow increased the noise level, but remained less than 0.2 of the weld signal height at 50 to 80 feet.

Figure 20. An example of data obtained by dual sensors generating waves propagating towards Pipe End #2 shown in Figure 8.

The red trace is from the transducer at location 1 and the blue trace is from the transducer at location 2. The origin of the trace for the sensor at location 1 is shifted to account for the sensor separation. The red arrows indicate the locations of Defects 1 & 2. The other matching peaks are from the welds in the pipeline. The large signal at ~30 feet originated from the reflection of the unwanted wave propagating from the transducer at location 1 in the reverse direction towards Pipe End #1.

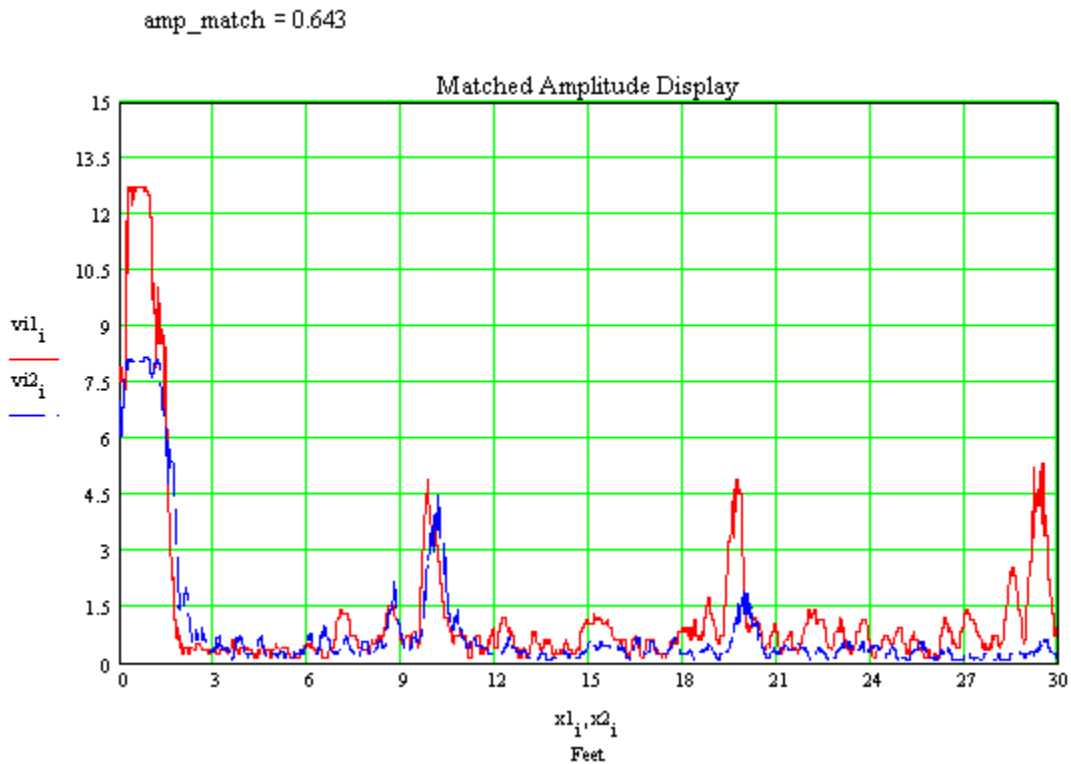
The experiments on the wrapped pipes in Phase I was intended to provide some information on the signal attenuation in the presence of protective wrapping, typically used for underground pipes. Shown in Figure 21 are two traces, the red colored one represents data before and the blue colored one after the coating was applied. The signal for the wrapped pipe has been amplified by ten before plotting. The peaks at approximately 10, 20, and 30 feet represent the first, second, and third round trip signals returned to the transducer from the end of pipe where wrap was applied. The peaks at 7 to 8.5 feet were due to reflections from the uncoated end of the pipe where the transducer was located. In general, data on the wrapped pipes indicated that the coating introduces a signal attenuation factor of ten, and the signal to noise ratio was approximately unity after a distance of travel approached about 30 feet. The uncoated pipe had a signal to noise ratio of at least 5 at the same distance.

Figure 21. Signal traces for a steel pipe, 4.5 inches in diameter before (red) and after (blue) the wrap coating was applied.

The signal for wrap pipe was amplified by factor of 10 before plotting.

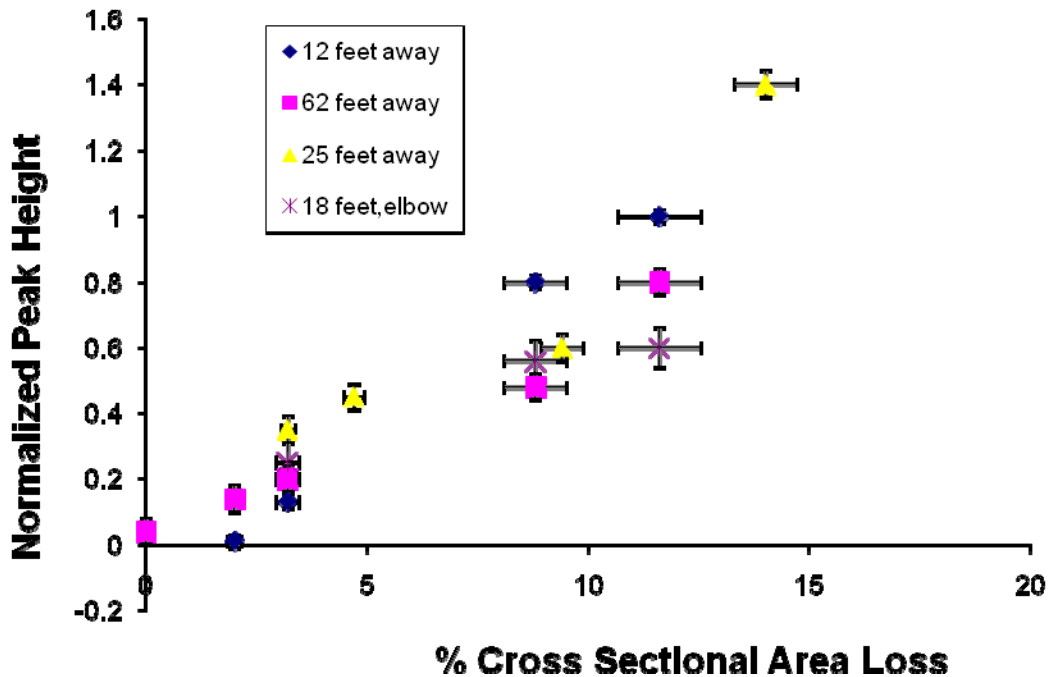
defects varying from approximately 3 inch x 3 inch to 12 inch x 14 inch in surface area, and from 10% to 50% in loss of wall thickness. The signal returned from these two defects was sensed by 3 different transducers, mounted at 3 different distances. The blue symbols represent the signals for a defect (3 inch x 3 inch in area) measured by transducer #2, mounted at 12 feet away from the defect. The pink symbols represent the signals for the same defect measured by transducer #3, mounted 62 feet away, with the wave propagating through several welds before reaching the defect in the opposite direction. The yellow symbols represent the signal for the larger defect (12 inch x 14 inch in area) measured by transducer #3, mounted 25 feet away. The purple symbols represent signals for the same defect measured by transducer #1, mounted 18 feet away with the wave propagating through a 90-degree elbow in the same direction as the wave propagating from transducer #2. Several observations can be made from this plot.

Figure 22. Ultrasonic guided wave signal peak height (relative to a weld signal) plotted against CSAL.

The signal peak height for a defect is influenced by (1) the distance between the defect and the transducer, (2) the number of welds crossed by the propagating waves, (3) the existence of elbows, (4) the asymmetry of a weld or a defect looking from opposite directions, and (5) the size of the defect. As a result of these uncontrollable factors, the peak height values for a defect of 12% CSAL, for example, could range from 0.6 to 1.0 volt, as shown in Figure 22. The same set of data showed that the range of peak heights for a defect of 9% CSAL was approximately 0.5 to 0.8 volt and for a defect of 3% CSAL, the range was 0.12 to 0.35 volt. These variations represent the range of uncertainties for sizing a defect on an absolute basis as a result of the effects of the uncontrolled variables mentioned above. The datum for a defect with 5% CSAL resulted in a signal peak height of approximately 0.4 volts.

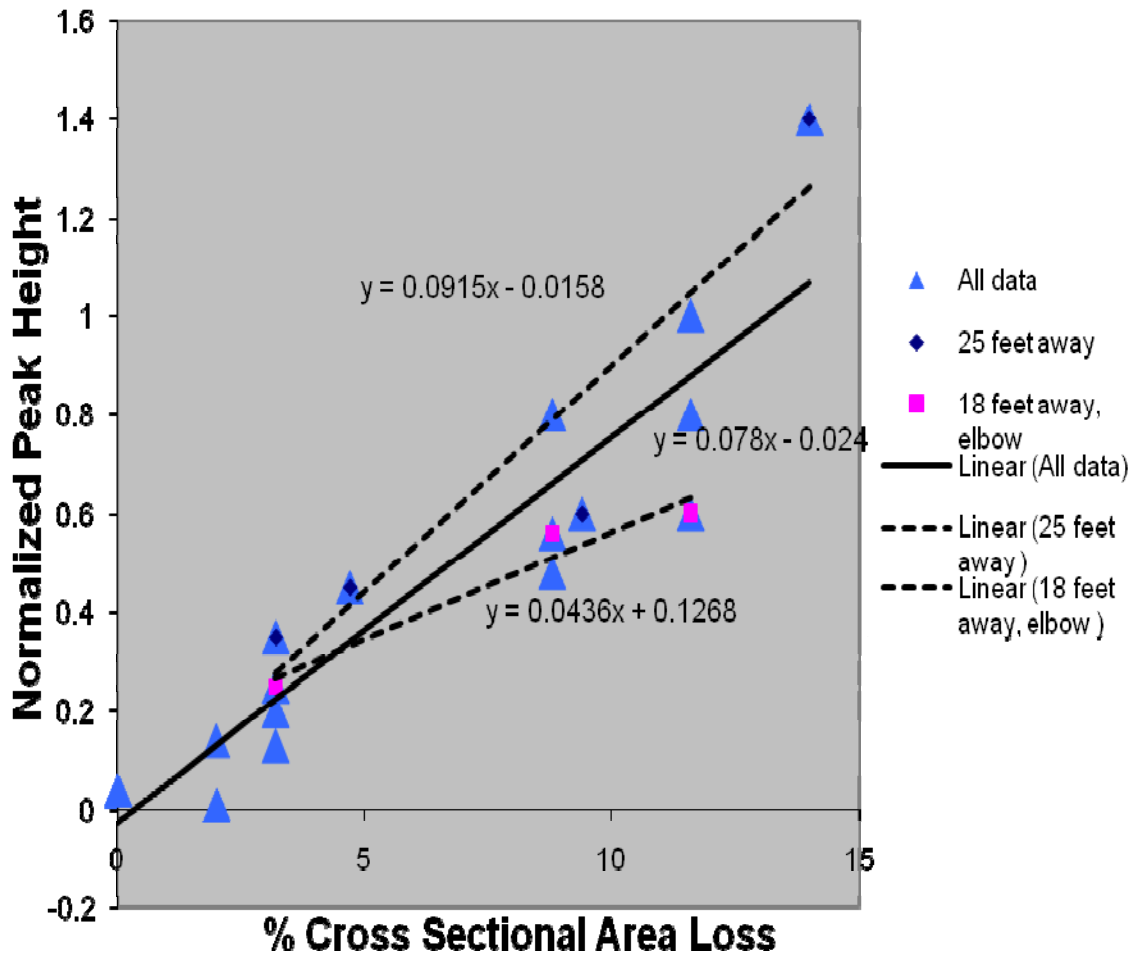
Three trend lines are shown in Figure 24. The solid line is based on the data shown in Figure 22. It represents an averaged trend that provides an empirical “calibration” curve converting relative signal peak height to percentage CSAL for defects. The other two trend lines (dotted) were generated using the two subsets of data including the effects of an elbow (labeled “18 feet away” in the legend) and the ones representing the largest defects (labeled “25 feet away” in the legend). These two dotted trend lines provide the upper and lower bounds for the slope of the average trend line. Defects with 5% and 10% CSAL produced signal peak height of 0.35 and 0.65 volts, respectively, on the average trend line with uncertainties of approximately 25%. These uncertainties are the results of combining all the data obtained from different transducers, located at distances from 12 to 62 feet from the defect, the existence of a variable number of welds and an elbow, as well as defects of different area, volume, and shape.

Figure 24. Trend lines for the increase in signal height as the CSAL increases for data obtained in Phase I.

If we focus our attention on the signals associated with a single transducer, as would be appropriate if we are only interested in measuring the changes of the system from a baseline condition, we realize that the slope of the trend line is mainly controlled by the variations of electronic noise and defect shape change over time. The details of the wave propagation across welds and elbows, as well as, scattering mechanisms affecting the absolute signal peak heights are less important when only signal changes are considered, since the effects of these variables (except for the size of the defect) are constant as a function of time. As shown in Figure 23, the uncertainties associated with electronic noise and defect shape were represented by the vertical (approximately 0.1 volt) and horizontal (less than 2% CSAL) error bar at each datum. For the purpose of tracking defect growth, we observed in Figure 24 that the slope of the average trend line departs from those represented by the two extremes by no more or less than a factor of 2. Additional discussions of the Phase I results can be found in a recently published paper [4].

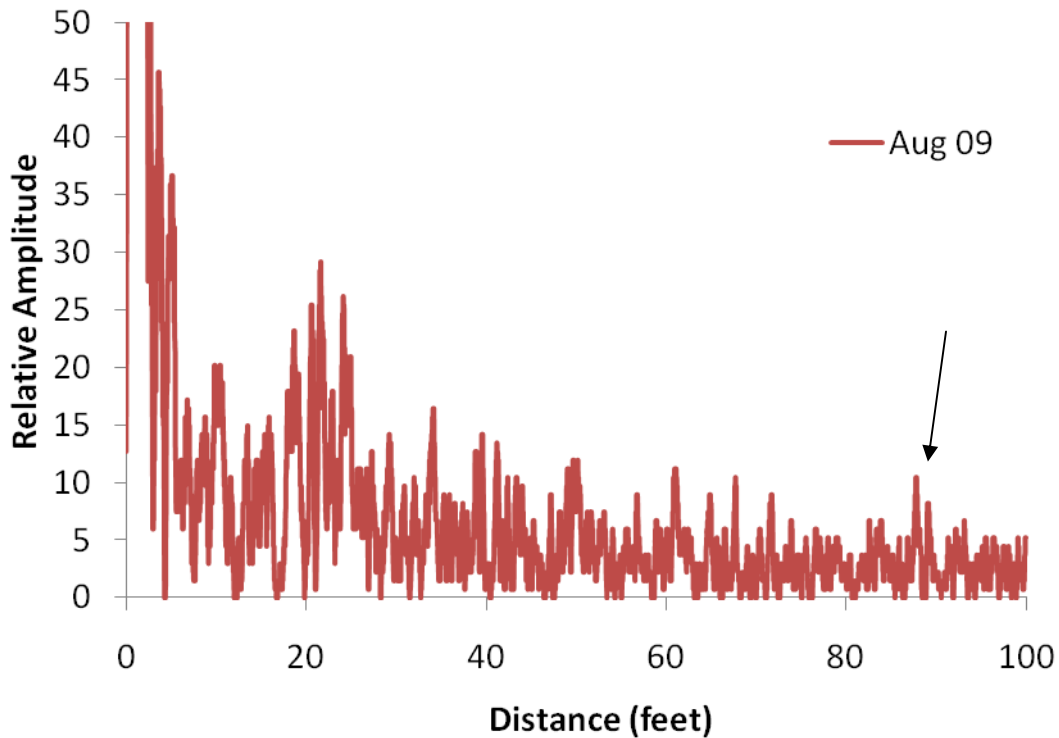
Figure 25. Signal trace at baseline obtained by sensor #22532 inside VP 21 propagating guided waves towards BL 20.

Shown in Figure 25 is the baseline trace for wave propagation from VP 21 towards BL 20. The peaks located up to 20 feet represent signals, first from the leakage of the transducer excitation, followed successively by the signals at the wall interface, and from welds and reducers along the pipeline. Of note is the pair of peaks above noise level at about 90 feet, which could be identified to originate from the region on the ground where pipe repair and replacement were made a few years back. The height of these two peaks was approximately twice as large as the noise level, which was 4 times as large as that typically observed in the laboratory tests in Phase I. We will discuss these signals further in the next section.

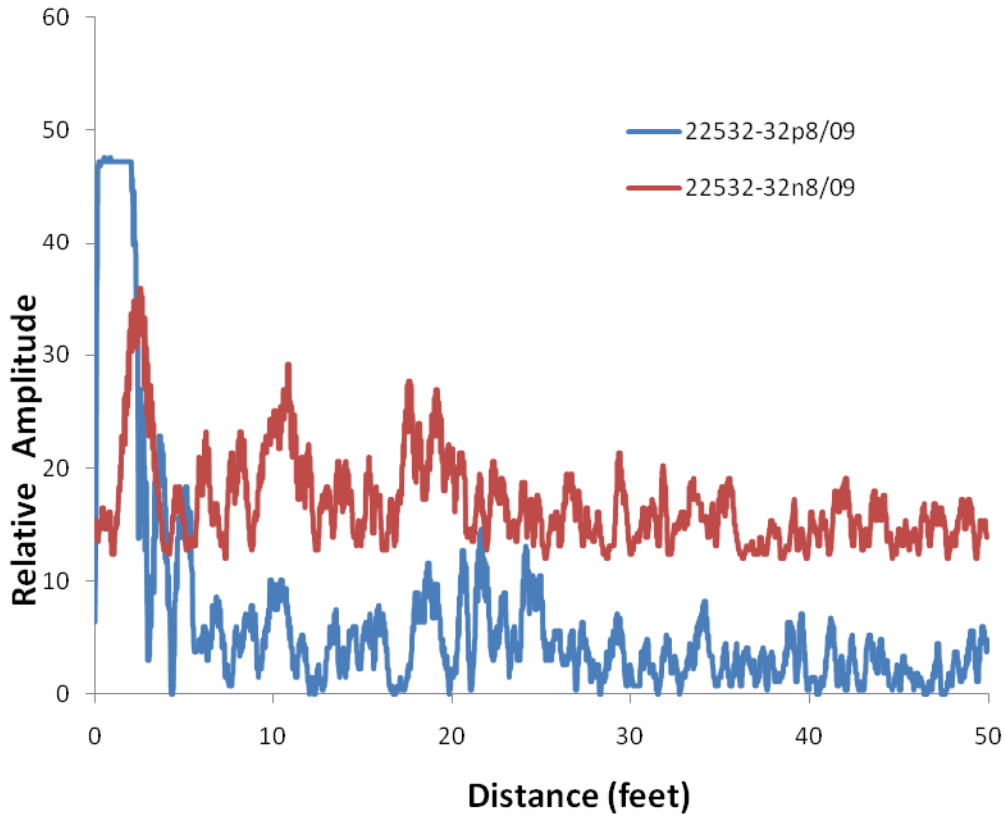
Figure 26. Comparison of forward to backward propagating waves for sensor #22532 at the baseline.

Shown in Figure 26 is the the same data set as in Figure 25, but in Figure 26, both records of the forward propagating (blue) and the backward propagating (red) waves are shown. The latter was time/distance shifted to facilitate the matching of peaks. It is seen that moderately good “matching” of the peak locations from one trace to another is limited only to about 40 feet for this below-ground sensor (#22532) inside VP 21.

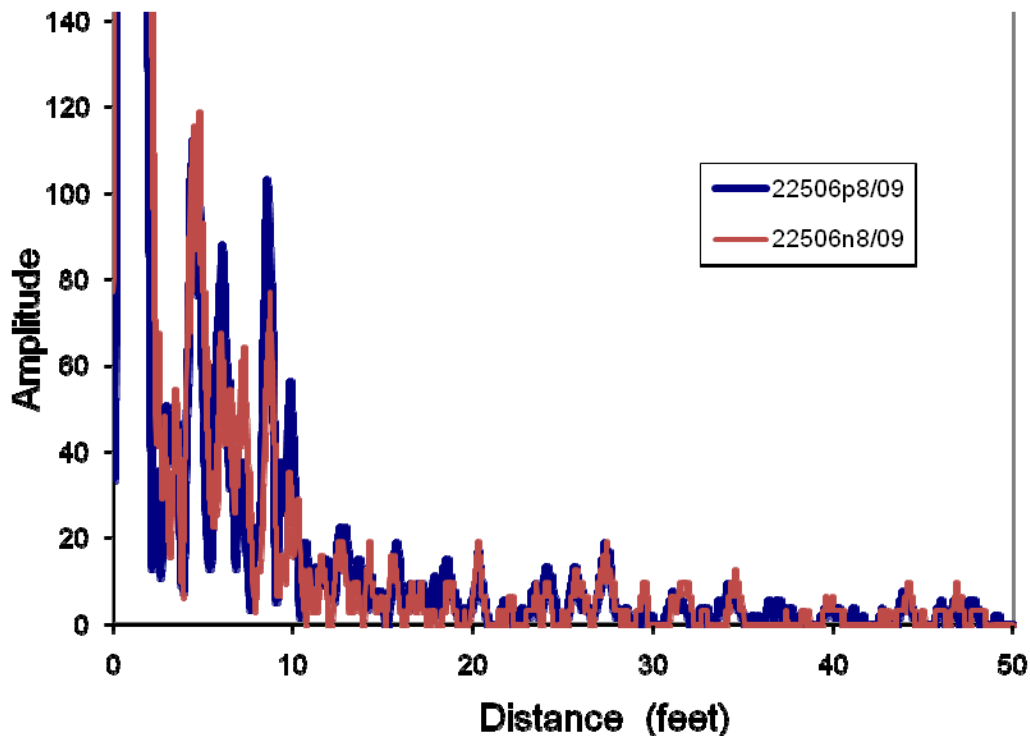
Figure 27. The matching of forward and reverse traces over a distance of 50 feet for above ground sensor #22506 in baseline testing.

In Figure 27 we display a superposition of the traces for the forward and the reverse propagating waves for an above-ground sensor #22506 after time/distance shifting to achieve peak matching. Over the distance of 50 feet, the matching appears to be very good, which gives some confidence that the peaks did not arise from superfluous multiple reflections. The two pairs of peaks up to 10 feet were associated with reflections from two 90 degree bends, which existed to allow the alignment of the pipeline between VP 5 and VP 20, as shown by the pipeline layout in Figure 3.

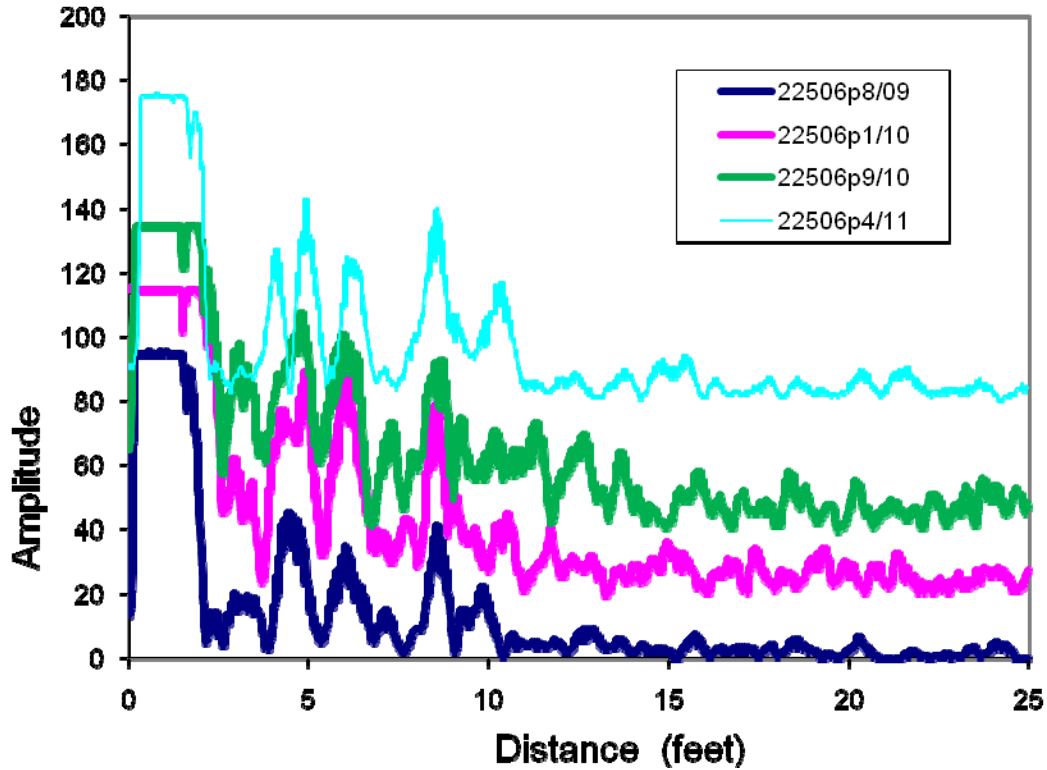
Figure 29. Monitoring changes in data sets obtained by above-ground sensor #22506 at the baseline and successive months at VP5.

In Figure 29, we stack up (with an off-set of 20 units along the vertical axis) the traces obtained from above-ground sensor #22506 over successive monitoring intervals starting with the baseline trace (blue) in August 2009 at the bottom and ending with the April 2011 trace (light blue) at the top. Because of the existence of two or more 90 degree bents in this section of the pipeline between VP 5 and VP 20, identifiable by the pairs of peaks between the origin and 15 feet on the x- axis, the signal to noise ratio rapidly decreased beyond 20-25 feet. It appeared that the stability of the peaks in this section of the pipeline was limited to 15 feet or less over the course of the 20 months of monitoring period.

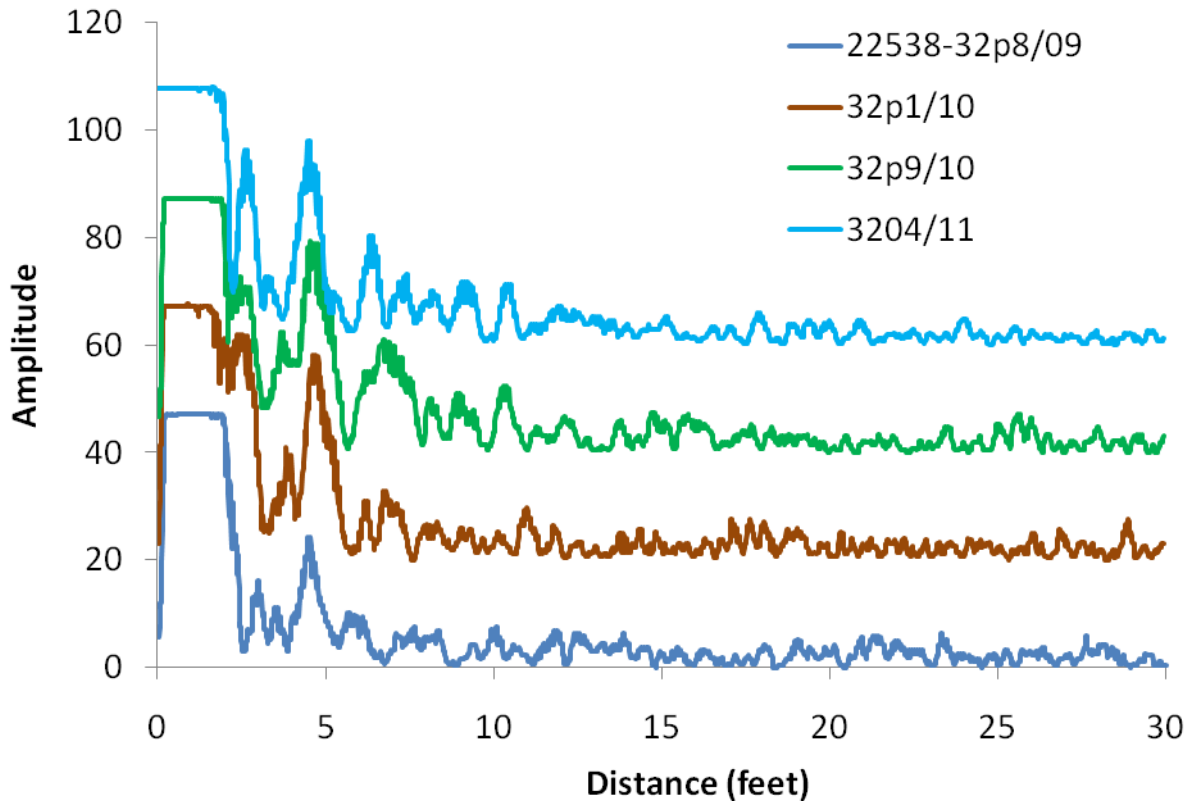
Figure 30. Monitoring changes in data sets obtained by above-ground sensor #22538 at Chambers Field over a period of 20 months. An offset of twenty units along the vertical axis has been added to each successive trace before plotting.

In Figure 30, the traces obtained by above-ground sensor #22538 over the 4 monitoring periods (August 2009 in dark blue, January 2010 in red, September 2010 in green, and April 2011 in light blue) are stacked up (with a vertical off-set of 20 units) to facilitate a comparison. It appeared that the existence of 90 degree elbows again reduced the signal to noise ratio, so that the reproducibility of peak locations was limited to approximately 15-20 feet. The lack of detailed mechanical drawing did not allow a definitive identification for the structural components giving rise to these peaks.

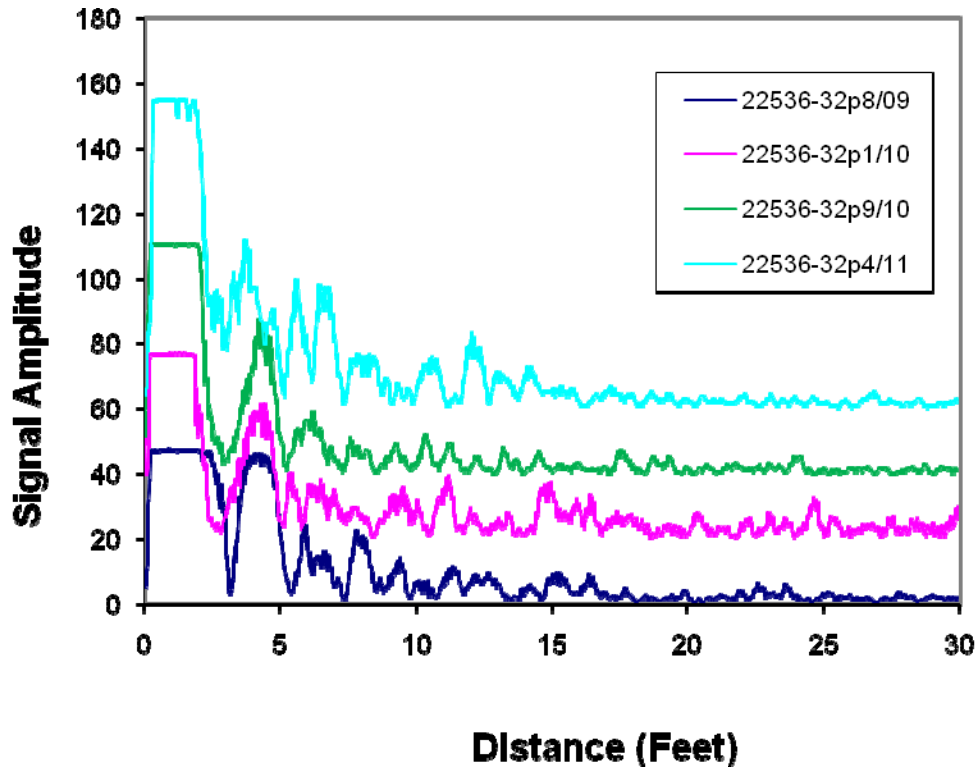
Figure 31. Monitoring changes in data sets obtained by underground sensor #22536. An offset of twenty units along the vertical axis has been added to each successive trace before plotting.

Traces in Figure 31 were obtained for an underground sensor #22536 in VP 7 over the course of the 20 months. Again, the traces (August 2009 in dark blue, January 2010 in pink, September 2010 in green, and April 2011 in light blue) are stacked up with a vertical off-set of 20 units to facilitate a comparison of the stability and reproducibility over time. It appears that the reflections from the pit wall, welds, reducers, and elbows (identifiable by the peaks up to 8 feet) limited the range of signal reproducibility to approximately 15-20 feet with an error of +/- 2 feet.

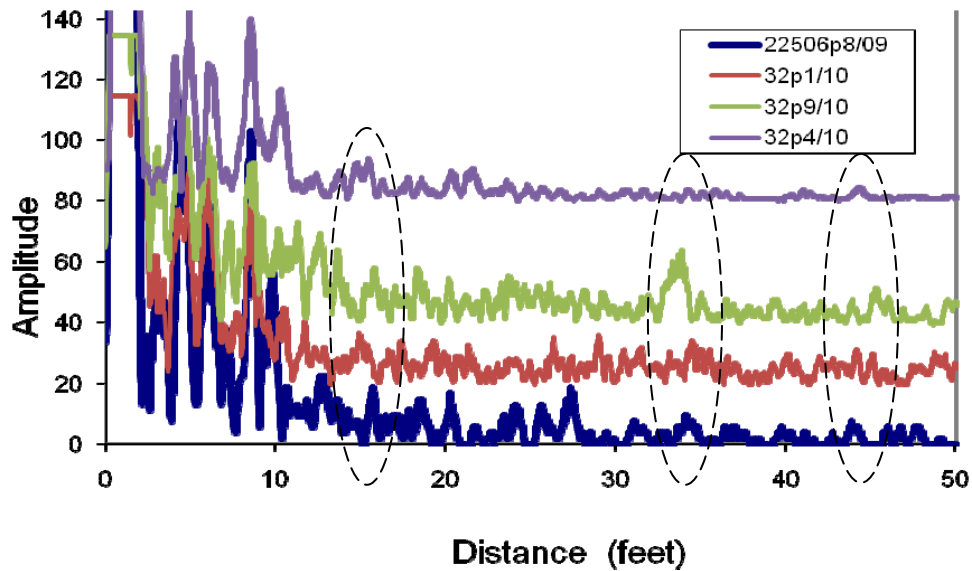
Data traces in Figure 32 are for waves propagating from VP 5 towards VP 20 from sensor #22506. Focusing on the groups of peaks around 16 feet, 35 feet, and 44 feet, we observe that the normalized peak heights at some locations (e.g. 35 feet) have not been increasing consistently or they remained relatively unchanged over the course of the monitoring effort. The locations where peak heights remained constant most likely originated from static structural features such as welds. Inconsistent changes in peak heights could be due to signal noise and/or multiple reflections unrelated to defects.

Figure 32. Monitoring signal changes in data sets obtained by above-ground sensor #22506. An offset of twenty units along the vertical axis has been added to each successive trace before plotting.

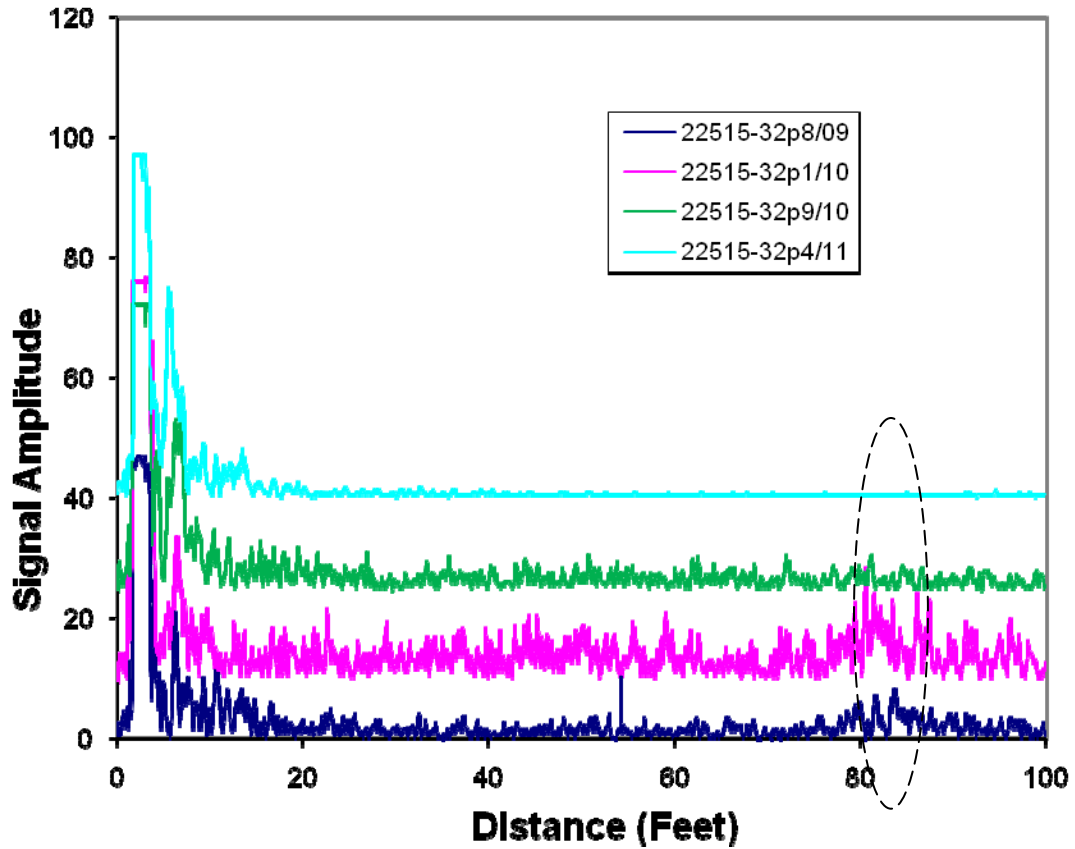
In Figure 33, the inconsistent increases in peak heights obtained by the above-ground sensor #22515 at long distance are also shown. The peak at 82 feet has not yet increased in height consistently over the course of this monitoring effort, and cannot yet be identified as an indication of defect growth at that location without additional monitoring. We also note that the overall signal strength beyond 40 feet in the trace obtained in April 2011 was much reduced from those observed in earlier traces, probably due to a deterioration in the stability of the transducer over time.

Figure 33. Monitoring changes in data sets obtained by above-ground sensor #22515.
 An offset of ten units along the vertical axis has been added to each successive trace before plotting.

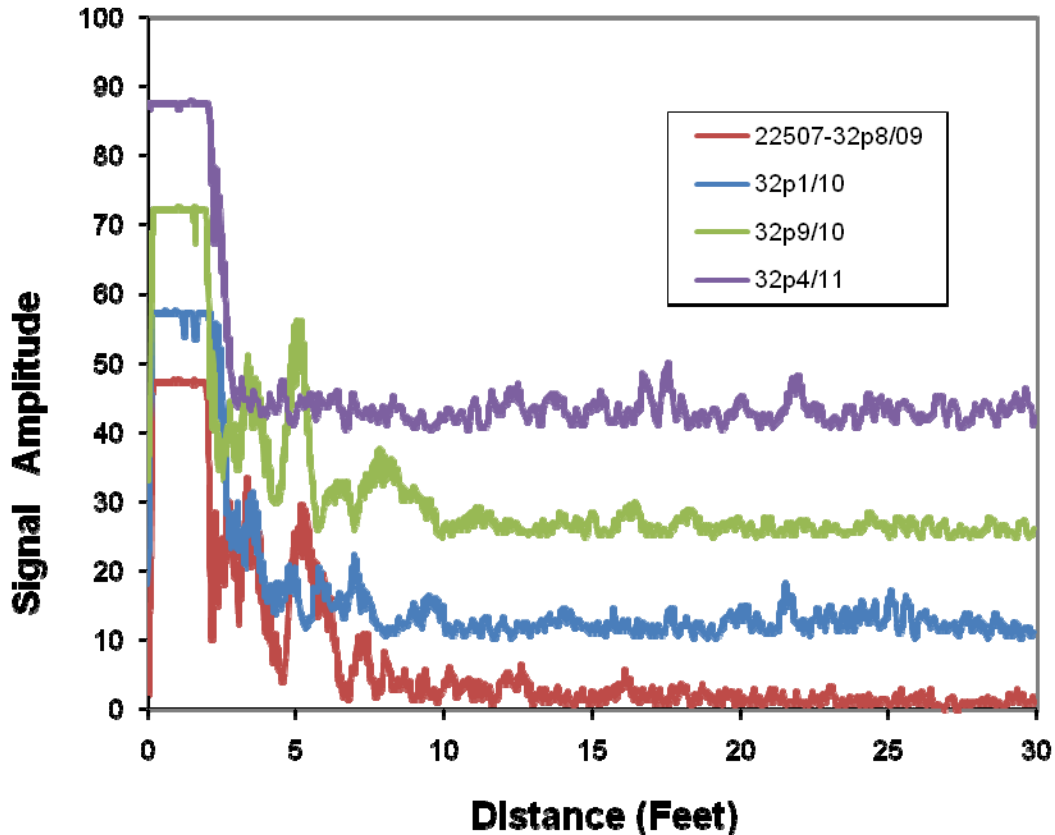
Figure 34. Monitoring changes in data sets obtained by sensor #22507.

In Figure 34, we stack up traces (August 2009 in red, January 2010 in blue, September 2010 in green, and April 2011 in purple) obtained by a sensor #22507 propagating waves from VP 5 towards the water front, over the period of 20 months. The amplitude consistency of the traces was not good. Even though the signal to noise ratio appeared to be good in the April 2011 trace, the matching of peaks over the 4 monitoring periods was not consistent from one period to another. The group of peaks around 20-25 feet should be monitored for additional time before its origin can be identified.

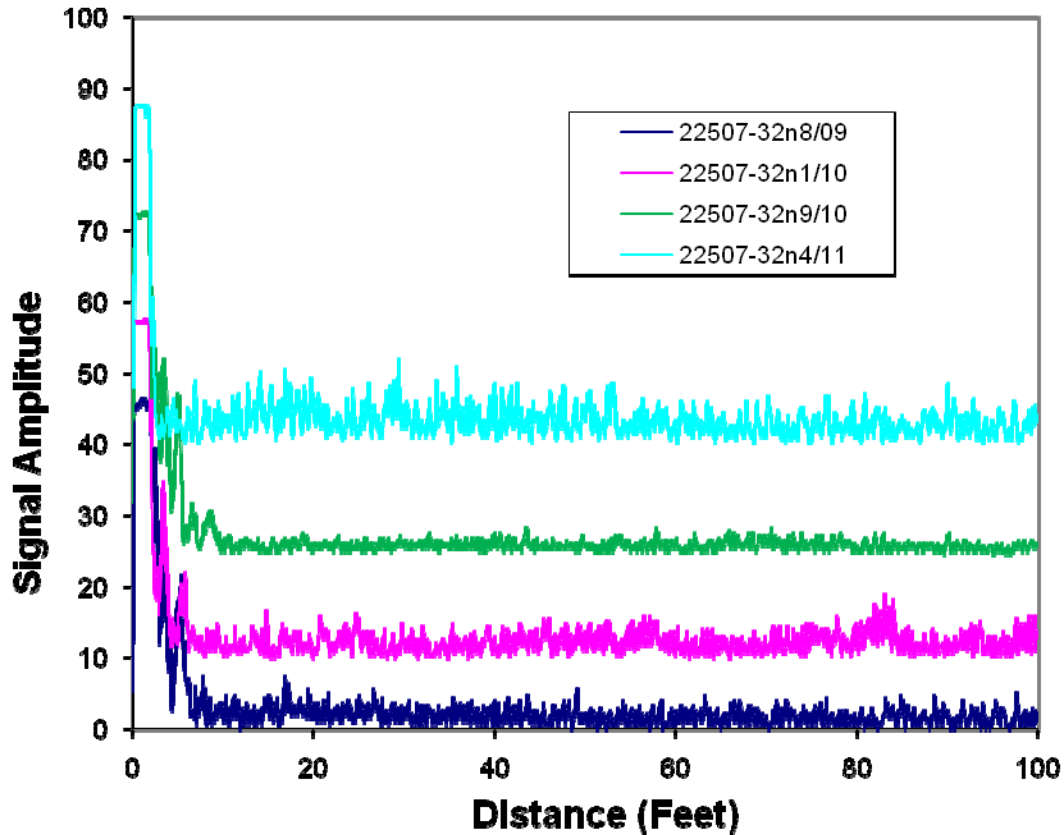
Figure 35. Monitoring changes at long distance in data sets obtained by sensor #22507. An offset of ten units along the vertical axis has been added to each successive trace before plotting.

In Figure 35 are data obtained by the same sensor as in Figure 34, but at a distance up to 100 feet. A peak detected in January 2010 (pink trace) at about 82 feet has not increased consistently in the following months to allow for a definitive identification.

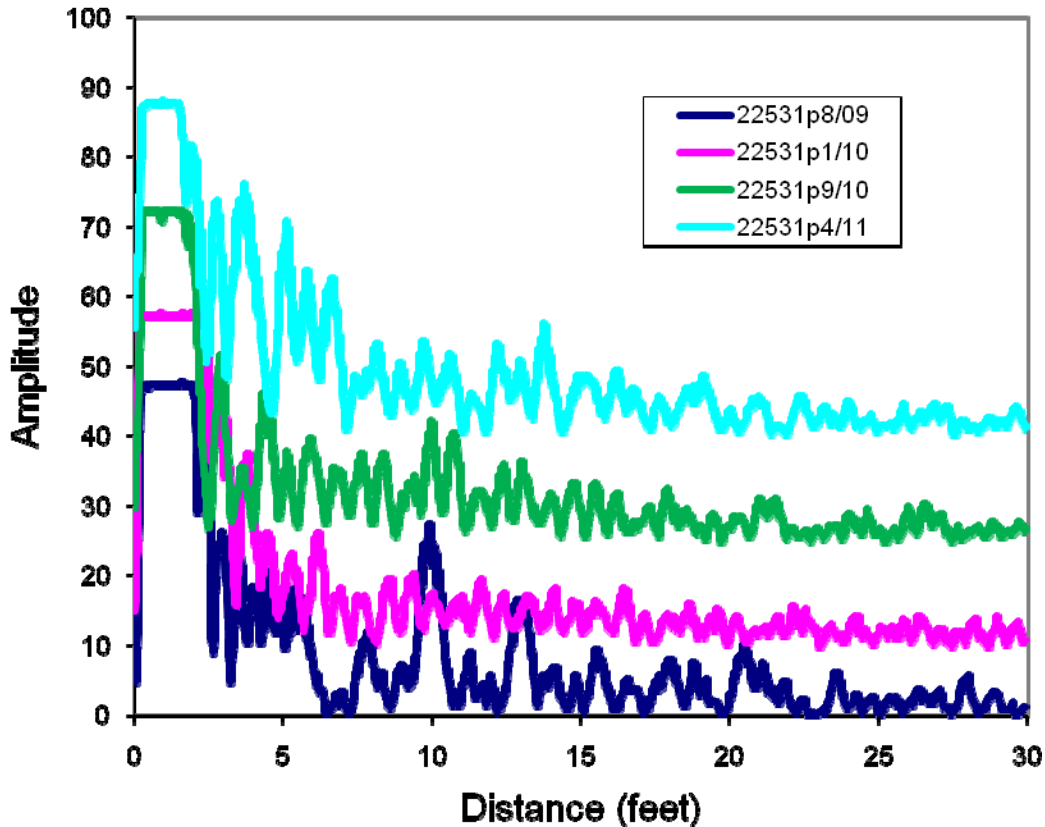
Figure 37. Changes in data sets obtained by under-ground sensor #22531 inside BL 20. An offset of fifteen units along the vertical axis has been added to each successive trace before plotting.

Figure 37 is an example of peak splitting over the course of the monitoring months. The peaks at 10 and 13 feet appeared to split in later months. Our work in Phase I suggested that such splitting was associated with corrosion around a weld. However, there is not yet consistent peak height increase in these split features. Additional monitoring is required to further identify the nature of these signals.

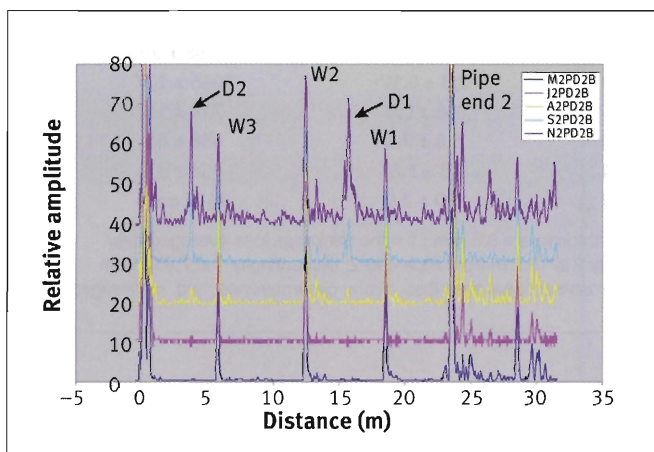
Figure 2. Systematic increases in peak heights for growing D1 and D2 sensed by transducer at Location 2. D1 was located at approximately 15.3 m and D2 was located at approximately 3.7 m. The other large peaks, approximately 6.1 m apart, are from the welds in the pipeline. The baseline signal (May) is blue, the June signal is pink, the August signal is yellow, the September signal is light blue and the November signal is purple. An offset of 10 units along the vertical axis was added to each successive trace before plotting.

Examples of systematic increases in discontinuity peak height as corrosion progressed are shown in Figure 2. Here, traces obtained over the months of May, June, August, September and November were stacked up beginning with the May (baseline) trace shown at the bottom of Figure 2. In order to facilitate the examination of each trace in detail, an offset of 10 units along the vertical axis was added to each successive trace before plotting in Figure 2. The labels for the traces (such as M2PD2B for the month of May), as stated before, indicated that the transducer was at Location 2, propagating guided waves in the positive (P) direction, and the weld signal behind (B) D2 was used to normalize the peak height. It can be seen that the discontinuity signal height depends on the size of the discontinuity, the distance between the transducer and the discontinuity, and the number of welds in the wave propagation path. Note that the weld peaks did not decrease in amplitude following a well-defined exponential decay curve in this welded pipe. As previously mentioned, these measurements of peak height, originated from D2 by the transducer in Location 2, provided the simplest case of discontinuity growth monitoring in a short, straight pipe section without the interference of a weld. In Figure 2, it can be noted that the signal at approximately 13.4 m immediately behind the peak for W2 did not increase systematically throughout the course of the experiment, signifying that it did not originate from a growing corrosion discontinuity.

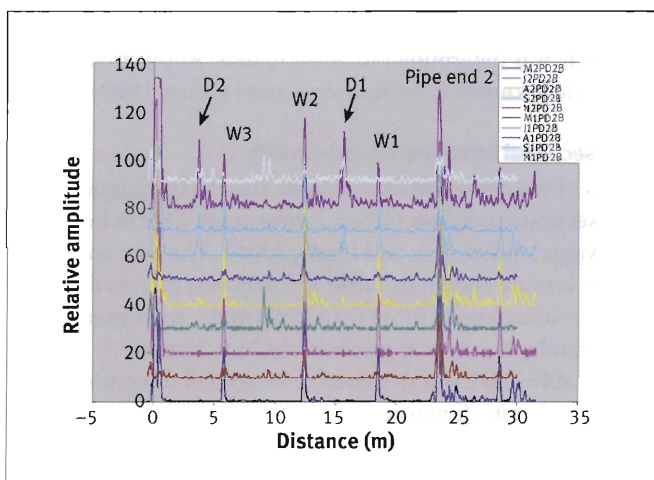
Figure 3. Signal traces for transducers at Locations 2 and 1 (time-shifted), for waves propagating in the same positive direction towards Pipe end 2. The initial portion of the traces for the sensor at Location 1, including the effects of the elbow, was deleted to allow for the matching of peaks in the traces for both sensors. D2 was at 3.7 m and D1 was at 15.5 m. The other matching peaks originated from welds. An offset of 10 units along the vertical axis was added to each successive trace before plotting.

The signals received by the transducer located in Location 1, which was located behind a 90° elbow, were superimposed on the traces displayed in Figure 2 for the same two discontinuities, D2 and D1. The obtained traces are shown in Figure 3. Here, the origin of the traces for the transducer at Location 1 (such as M1PD2B) has been shifted to account for the distance separating the two transducers, in order to match the peaks corresponding to the welds in both sets of traces. Wave propagation was in the same positive direction for both data traces. As in Figure 2, the traces in Figure 3 were stacked upwards starting with the May (baseline) traces measured by the two transducers, followed successively by the June traces for Transducer 2 and Transducer 1, respectively, and then by the traces for the later months.

was reached in the month of August. The spurious signal at approximately 9.1 m originated from the reflection of the unwanted wave propagating from the transducer at Location 1 in the reverse direction towards Pipe end 1.

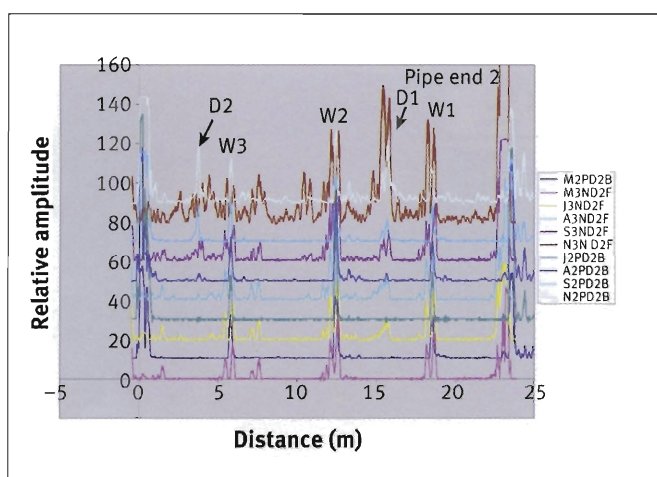
In Figure 4, a comparison is made between the groups of traces obtained by transducers placed in Locations 2 and 3. The origin of the horizontal (distance) axis is defined by the location of the transducer in Location 2. Starting from the bottom, the traces for Transducers 3 and 2 were stacked up alternately, beginning with the May trace for Transducer 3. Because wave propagation was in opposite directions along the pipe, the traces for Transducer 3 are plotted from right to left along the distance axis in order to match the weld peaks. In this way, the peaks originated from D1 and D2 should appear in the same locations (approximately 3.7 and 15.5 m, respectively) among all the traces. The systematic increase in peak heights as corrosion progressed from May (baseline) through November can be seen, except for the trace for the month of June (labeled J3ND2F) obtained by Transducer 3, in which the peak for D2 was below the noise level. This shows that the signal associated with a small discontinuity in the shadow of a large discontinuity was not detectable, as a result of the distortion and energy loss caused by the presence of a large discontinuity in front of it. This distortion also increased the uncertainty in peak height measurements for D2 in the later stages of corrosion, as seen in the November trace labeled N3ND2F. Most of the welds showed a double peak feature in the wave trains detected by the transducer at Location 3. As pointed out earlier, it is believed that these peaks were due to imperfect elimination of the wave propagating in the reverse direction, which was reflected from Pipe end 2, and then superimposed on the main wave train propagating along the negative direction. The signal at 7.6 and 10.7 m, detected by the transducer in Location 3,

Figure 4. Superimposed signal traces obtained by transducers at Locations 3 and 2 with the wave propagating in opposite directions. An offset of 10 units along the vertical axis was added to each successive trace before plotting.

did not systematically increase in amplitude, and was not consistent with the results obtained by the transducer in Location 2. It can be concluded that these were spurious signals unrelated to corrosion.

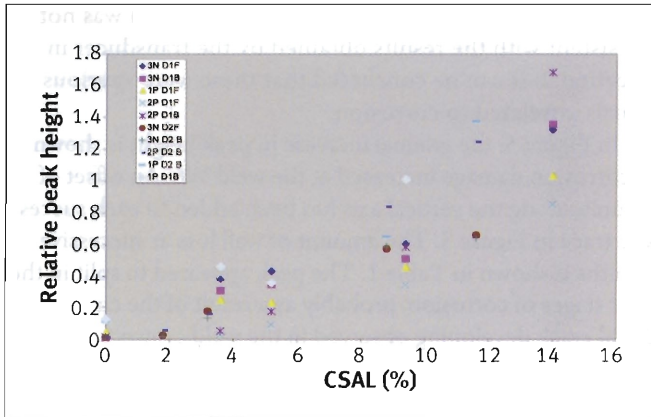
The signal peak height from each data trace was extracted and then plotted versus percent CSAL in Figure 6. The data summarize the results for D1 and D2, varying in size from approximately 76 × 76 mm to 305 × 356 mm in surface area, and from 10 to 50% in loss of wall thickness, as shown previously in Table 1. The signal returned from these two discontinuities was sensed by three different transducers, mounted at distances ranging from 3.7 to 18.9 m, and one was affected by the presence of a 90° elbow. Each of the data sets were labeled with the same system used before, except that the first letter designating the month in which the data were obtained was removed from those used in Figures 2 – 5, since each data set contains peak height information from the month of May through November.

Figure 6. Plot of peak heights for D1 and D2 versus percent CSAL, showing the effects of all variables.

was not influenced by a weld between the transducer and the discontinuity. This data set gave one of the highest values when peak heights were plotted against the discontinuity CSAL.
