FINAL REPORT

Ultrasonic Guided Wave Technology for Non-Invasive
Assessment of Corrosion-Induced Damage in Piping for Pollution
Prevention in DoD Fuel Storage Facilities

ESTCP Project WP-200819

AUGUST 2011

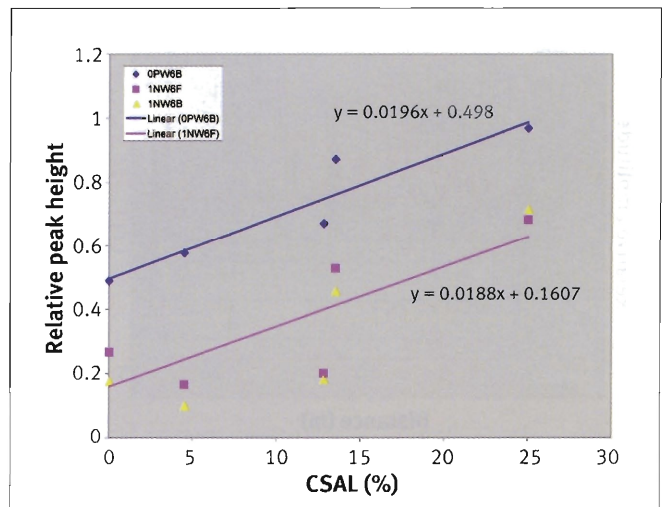
A plot of peak height versus the discontinuity CSAL around the weld, W6, including the influence of a 90° elbow is shown in Figure 8. The relative peak heights were smaller when the effect of the elbow was included (comparing the trace 0PW6B to traces 1NW6F and 1NW6B), and the fitted slope of peak height versus percent CSAL curves was slightly less than that obtained without the presence of the elbow. This is consistent with what was presented previously on the effect of an elbow on signal heights associated with D1 and D2. The large scatter in the data was probably the result of a developing crack in the weld crown midway through this monitoring study.

Figure 8. Increase in signal peak height of the weld signal as corrosion increased in a pipe section with or without a 90° elbow.

This work showed that CSAL as small as 5% was measurable, thereby proving sufficient time to track the discontinuity size before it increased to a size of concern. Similar results were also obtained using measurement systems based on piezoelectric array transducers (Rose et al., 2007). The rate of the signal growth with percent CSAL for localized corrosion in a weld, as shown in Figure 8, is smaller than that for the two isolated discontinuities studied in this work, probably as a result of the existence of extra material in the weld crown. However, the split peak feature of the signal at this corroding weld, probably the result of a crack developing at the weld crown, might have affected the results.
