ERDC/CERL TR-13-11

## **Architectural Survey of Pershing Elementary School, Fort Leonard Wood, Missouri**

August 2013

This document is an architectural survey of Building 6501, Pershing Elementary School, constructed in 1955 at Fort Leonard Wood, Missouri. This survey was initiated for a Section 106 process that satisfies Section 110 of the National Historic Preservation Act of 1966 as amended, and was used to determine the eligibility of the school for inclusion on the National Register of Historic Places (NRHP). This report determined that Pershing Elementary School is not eligible to the NRHP, since it is not individually significant and is not part of a larger historic district.

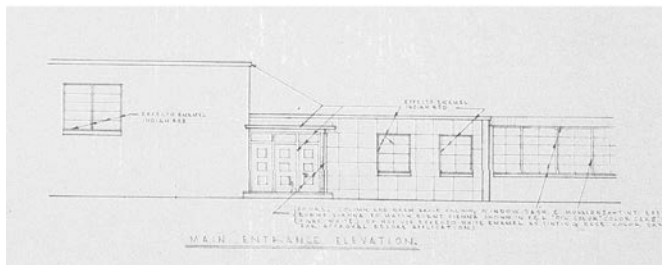
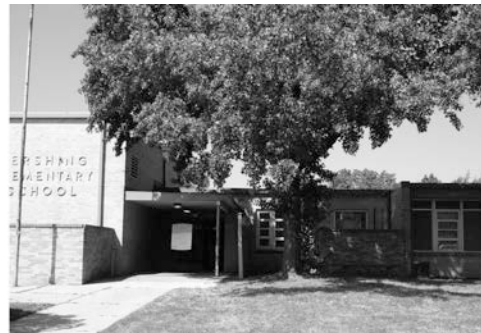
East elevation with main entrance and wall of windows: Original drawing on the left from 1955 with original awning windows compared to the current replacement doors, sidelights, transom, and metal windows.

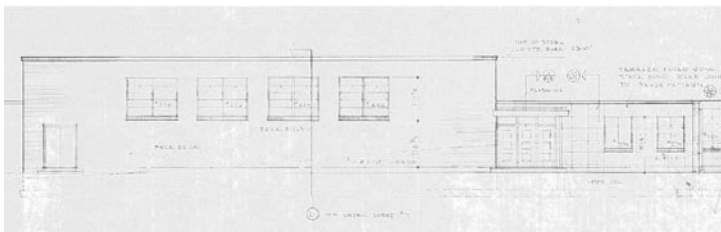
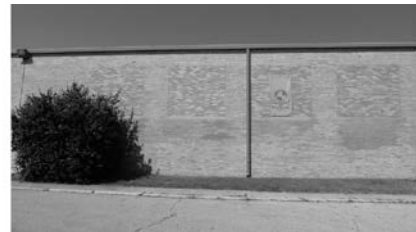
East elevation: Original drawing on the left from 1955 with original multi-pane windows located on the double-height wall of the all-purpose room compared to the current condition of the wall with the removal of the windows and use of infill brick.

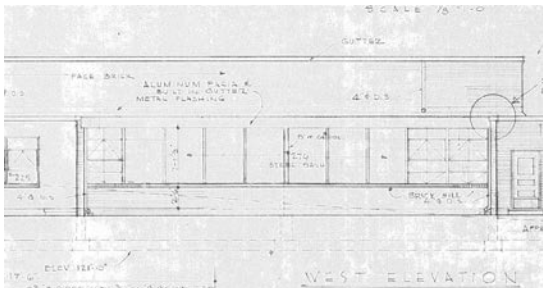
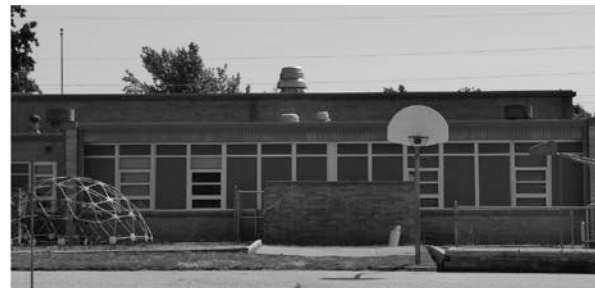
Right side of west elevation: Original 1955 drawing with design of classroom windows compared to the current condition of the elevation with replacement windows and metal panel inserts.

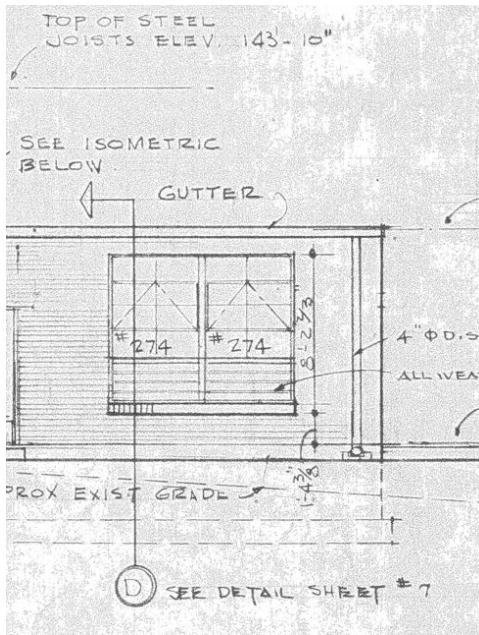
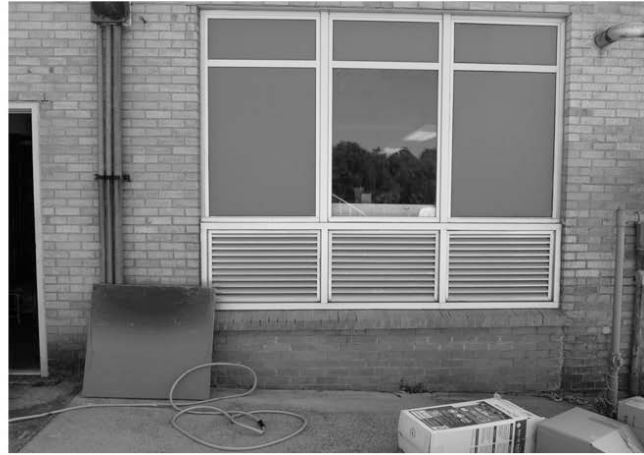
**Window comparison: Original drawing on the left from 1955 showing two original multi-pane awning steel sash windows with two metal louvered vents compared to the current replacement bright aluminum and awning windows with porcelain enamel metal panel inserts and new metal louvered vents.**

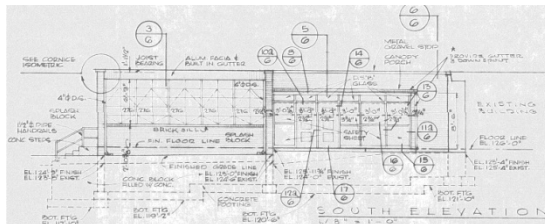
**Window comparison: 1957 addition drawing on the left showing multi-pane awning/hopper steel sash windows compared to the current replacement bright aluminum and awning windows with porcelain enamel metal panel inserts. Also, the original doors have been replaced. The image on the right also shows the 1984 classroom addition on the far left.**

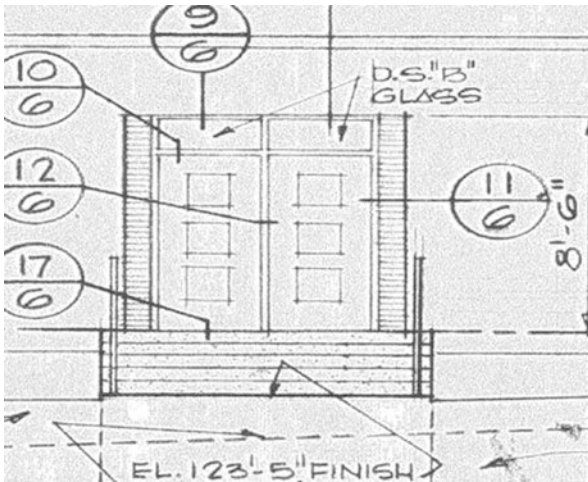
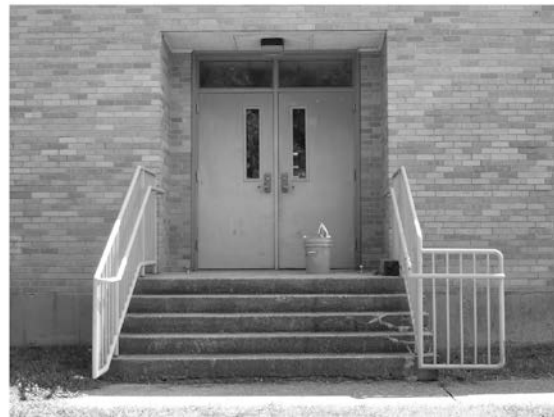
**West elevation: 1984 addition drawing on the left compared to photo on right of the current replacement doors and original transom.**

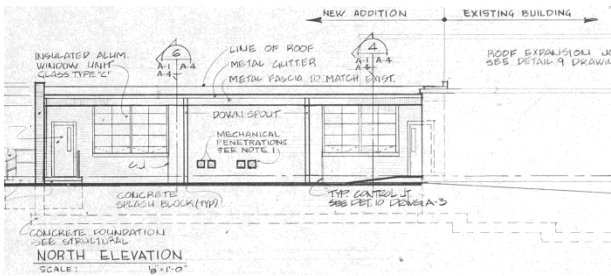
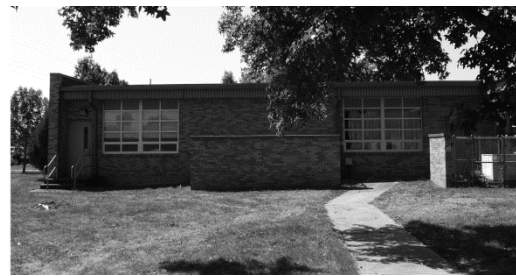
**North elevation: 1984 addition drawing on the left compared to photo on right of the current condition of the left side of the north elevation.**

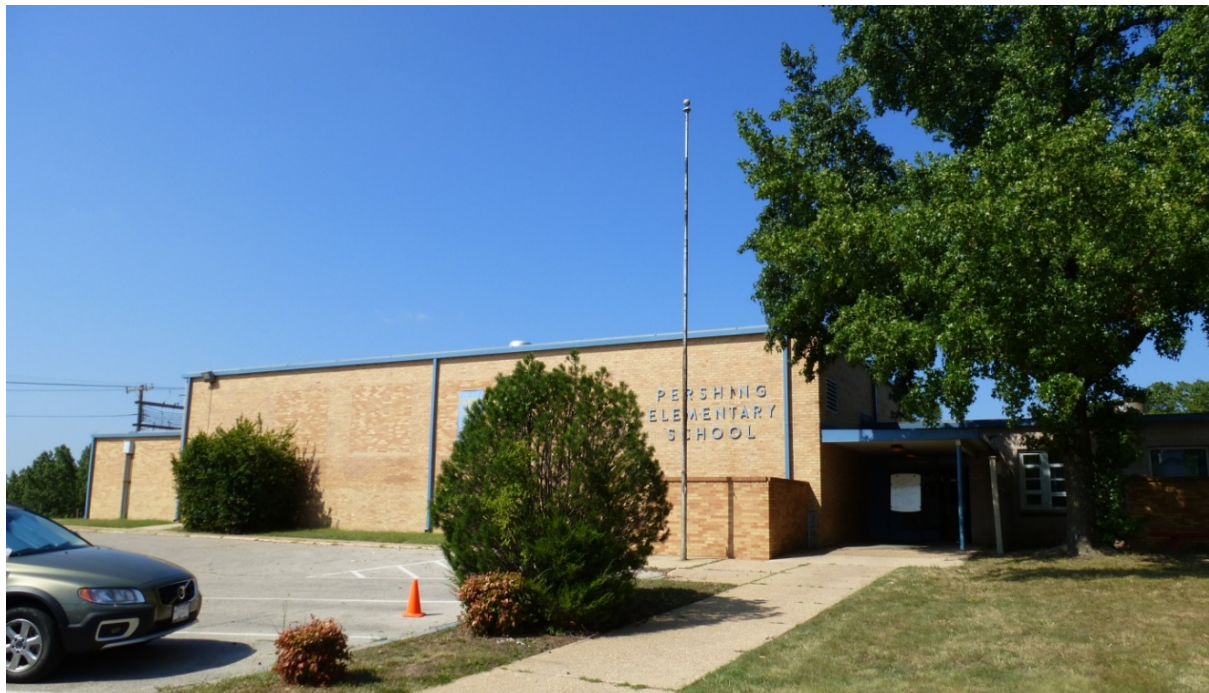
**Photo 3. Left side of the east elevation (ERDC-CERL, 2012).**

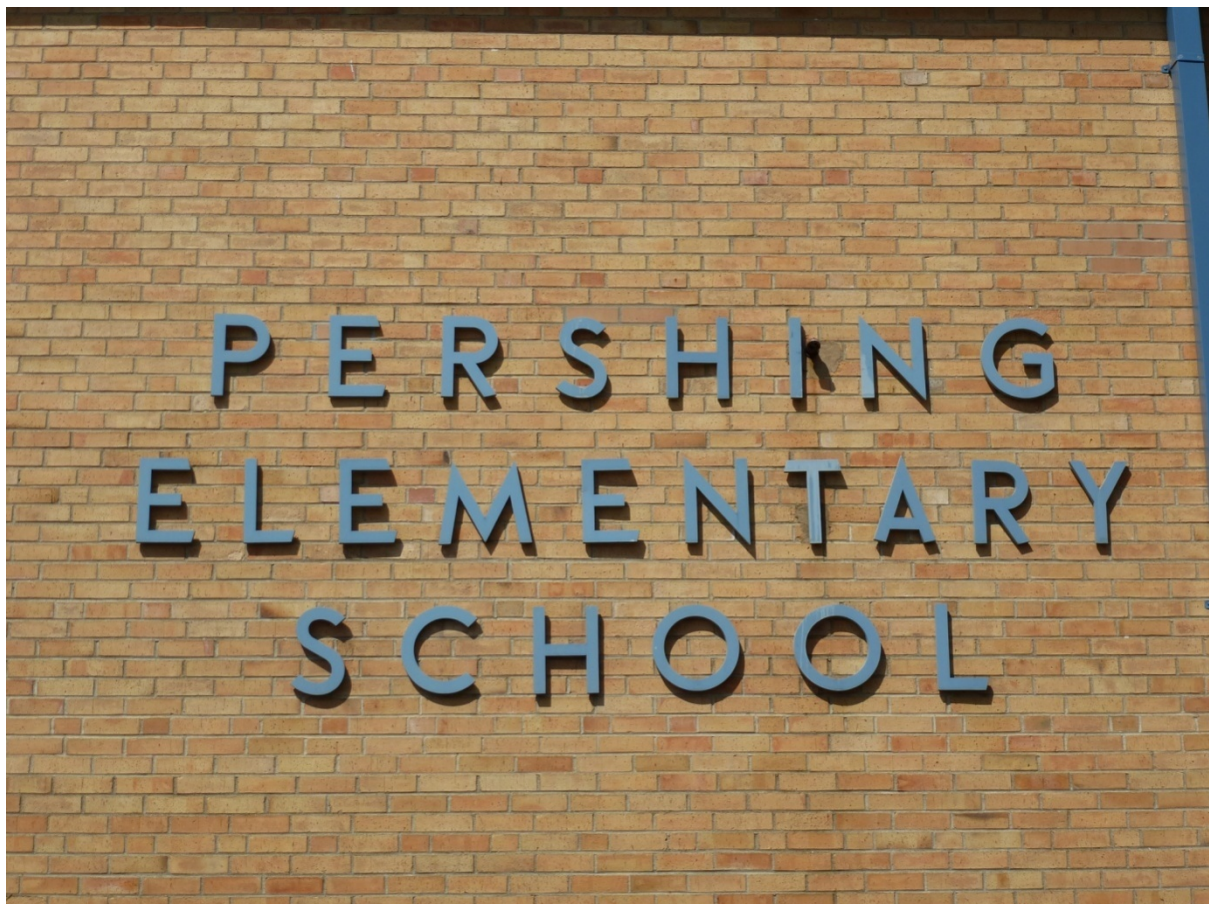
**Photo 4. Original signage on the left side of the east elevation (ERDC-CERL, 2012).**

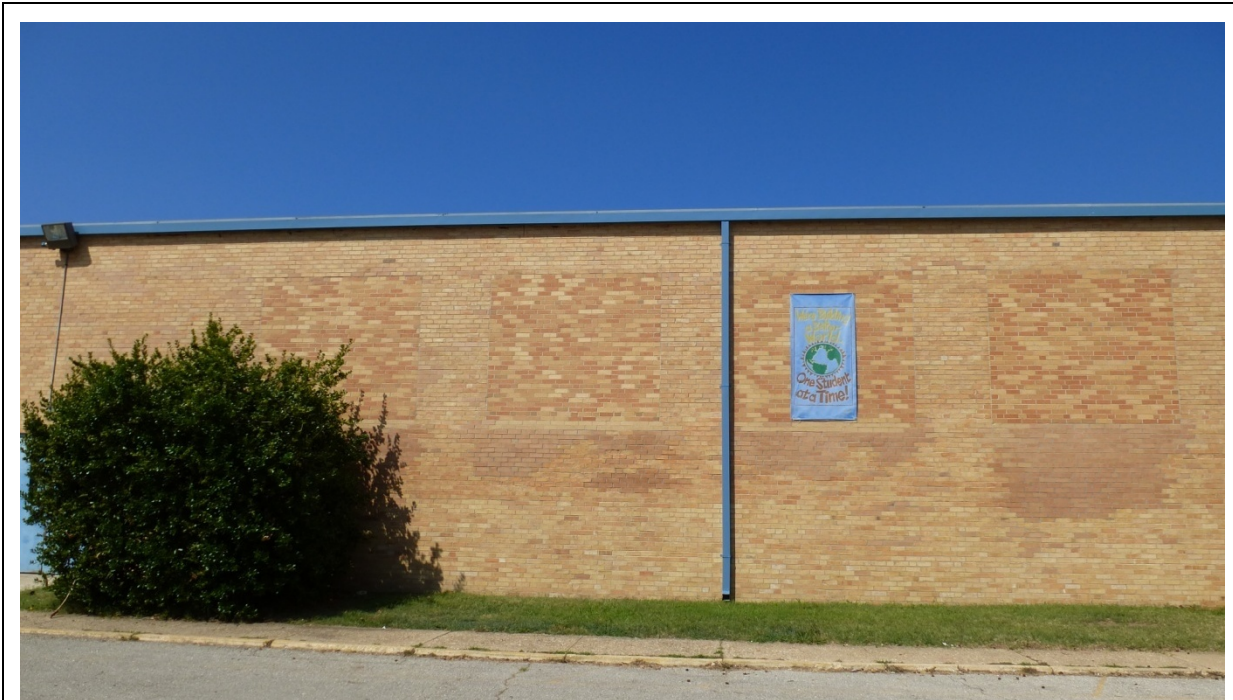
Photo 5. Modified window openings on the left side of the east elevation (ERDC-CERL, 2012).

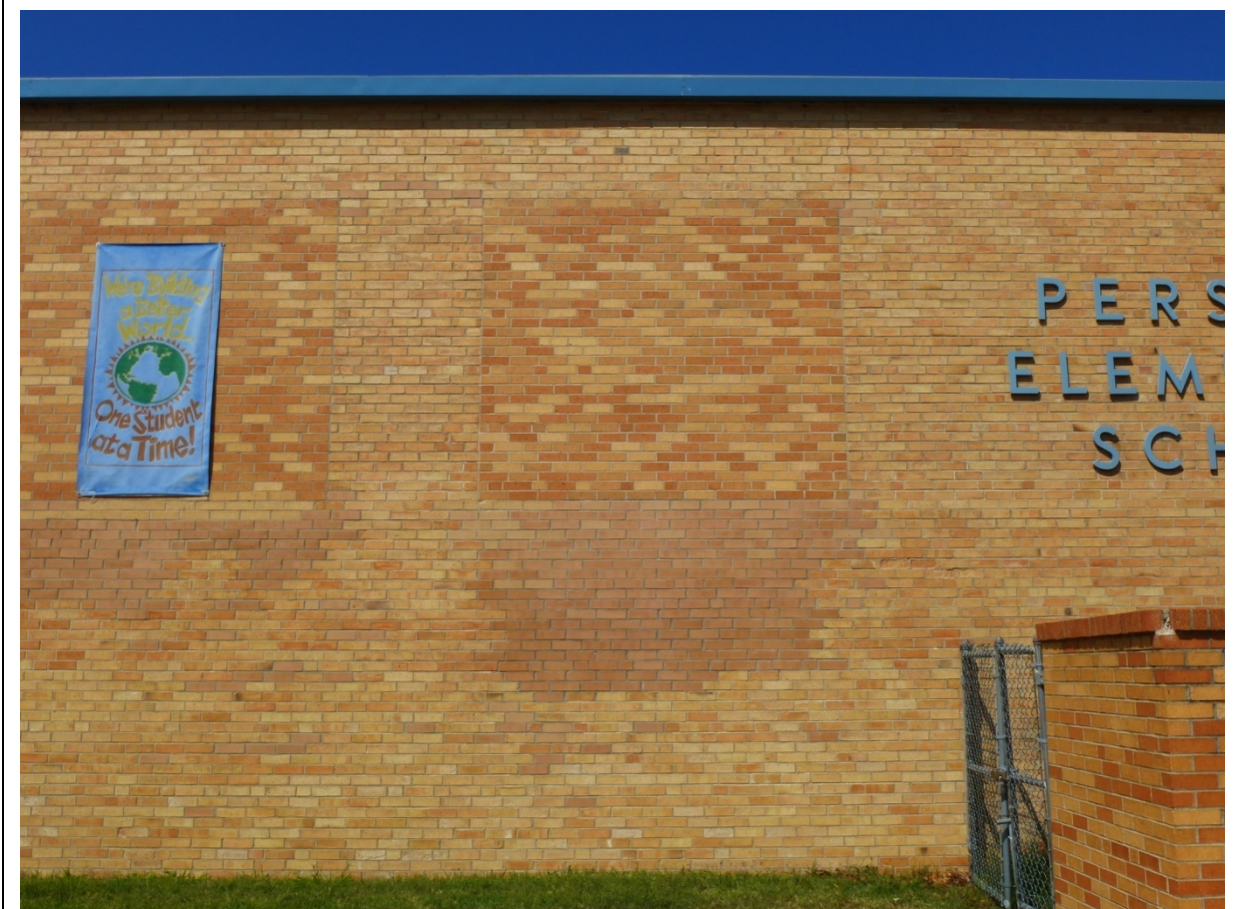
Photo 6. Closeup of the modified window openings on the left side of the east elevation (ERDC-CERL, 2012).
