*Airfield Damage Repair Modernization Program*

## **AM2 3-4 Alternate Lay Pattern Evaluation**

Timothy W. Rushing, Lyan Garcia, Jeb S. Tingle,  
Paul G. Allison, and Craig A. Rutland

September 2014

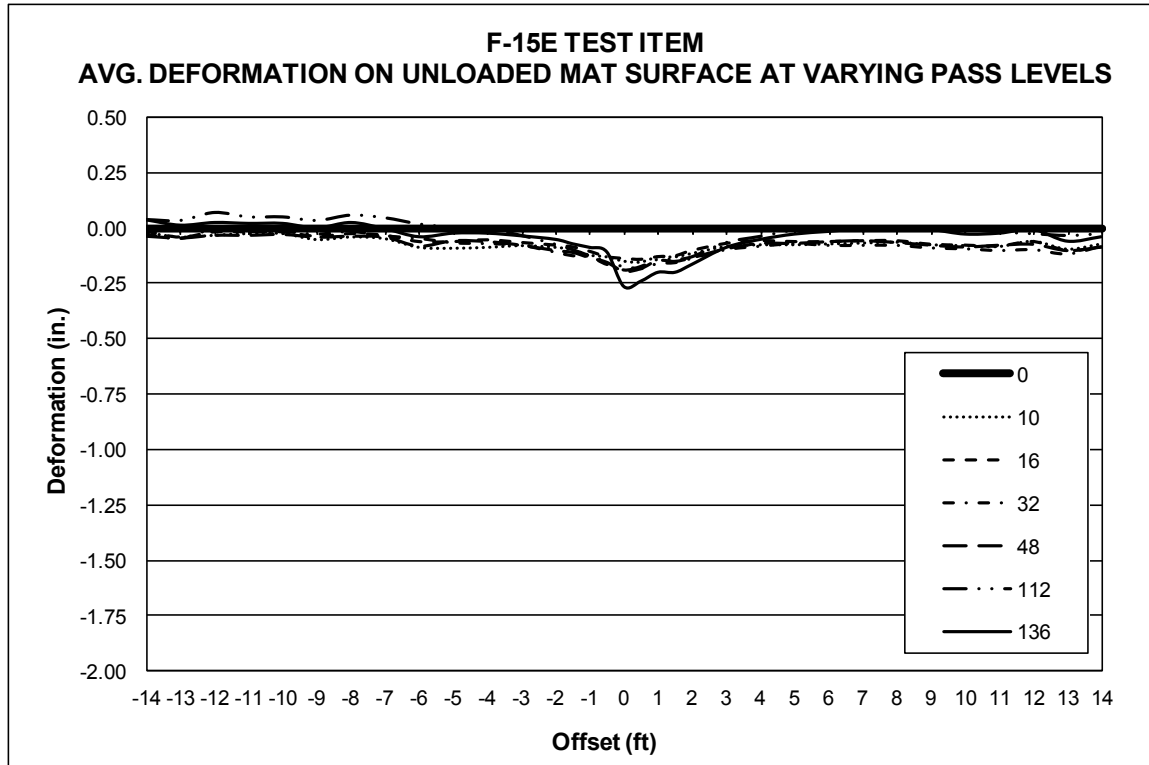
Figure 44. Average deformation on the unloaded mat surface of the F-15E item.

The permanent deformation on the subgrade, the loaded mat surface, and the unloaded mat surface is shown in Figure 40, Figure 42, and Figure 44, respectively. For the F-15E test item, the maximum permanent deformation after 135 passes was 0.74 in., 0.62 in., and 0.26 in. on the subgrade, loaded, and unloaded mat surface, respectively. The failure criterion of 1.25 in. was not exceeded. Therefore, the system performed adequately to prevent excessive roughness from occurring prior to failure by mat breakage. In previous tests over a CBR of 6 using the brickwork pattern, deformation limits were exceeded around 1,500 passes.

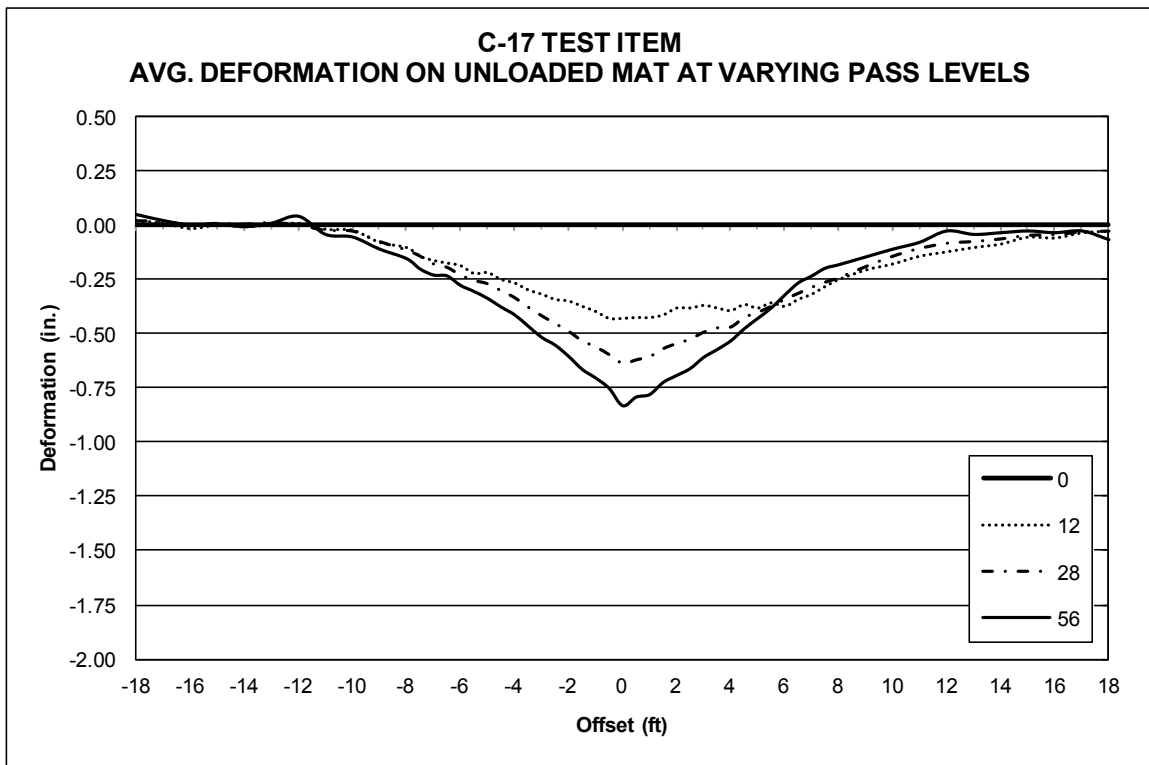
Figure 45. Average deformation on the unloaded mat surface of the C-17 item.

The permanent deformation on the subgrade, the loaded mat surface, and the unloaded mat surface is shown in Figure 41, Figure 43, and Figure 45, respectively. For the C-17 test item, the maximum permanent deformation after 56 passes was 1.11 in., 0.95 in., and 0.85 in. on the subgrade, loaded, and unloaded mat surface, respectively. The failure criterion of 3.0 in. was not exceeded. Therefore, the system performed adequately to prevent excessive roughness from occurring prior to failure by mat breakage. In previous tests over a CBR of 6 using the brickwork pattern, deformation limits were exceeded around 1,500 passes.

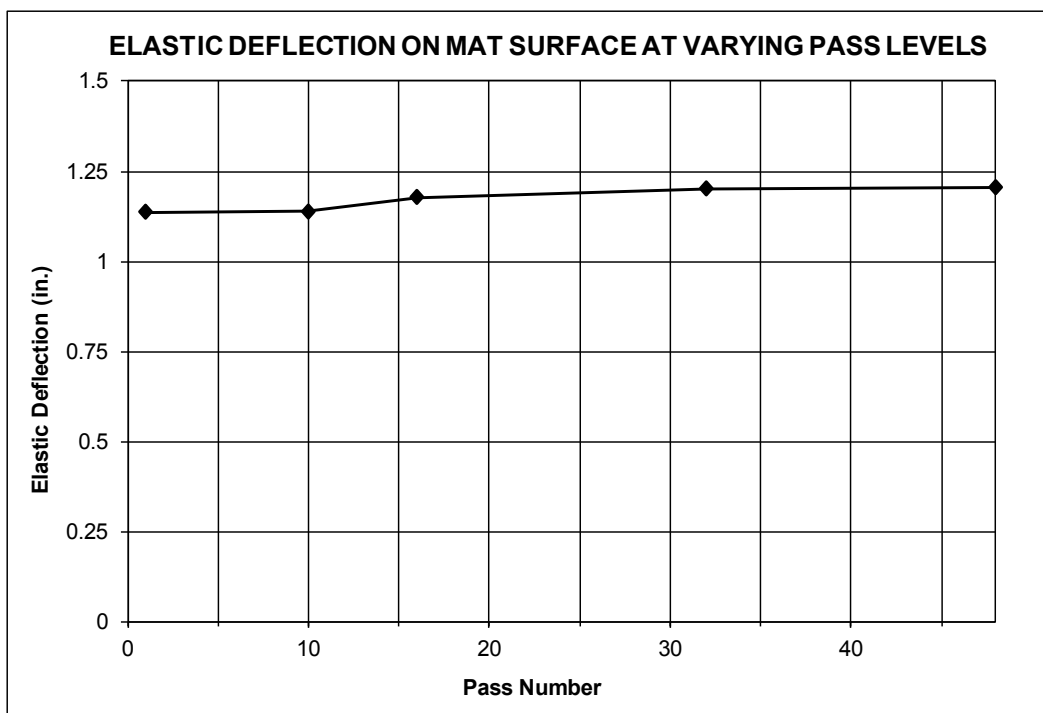
Figure 48. Elastic deflection on F-15 item mat surface at various pass levels.

The elastic deflection measurements shown in Figure 48 were the sum of the gap between the bottom surface of the mat and the top surface of the subgrade when the mat was unloaded (elastic deflection of the mat) and the elastic deflection of the subgrade. The elastic deflection generally remained constant throughout the traffic test at approximately 1.20 in. Previous tests demonstrated an increase in elastic deflection as the test progressed; however, since trafficking was stopped after only 136 passes, the limited number of data ranges evaluated may not have been sufficient for a similar trend to develop. The constant measurement seems to indicate that the distance between the mat and the subgrade stayed relatively constant and that the mat surface moved downward with the permanent deformation in the subgrade. This is reasonable, since the increased number of joints along the wheel path for the 3-4 pattern when compared to the brickwork pattern increases the flexibility and reduces the global stiffness of the test array.

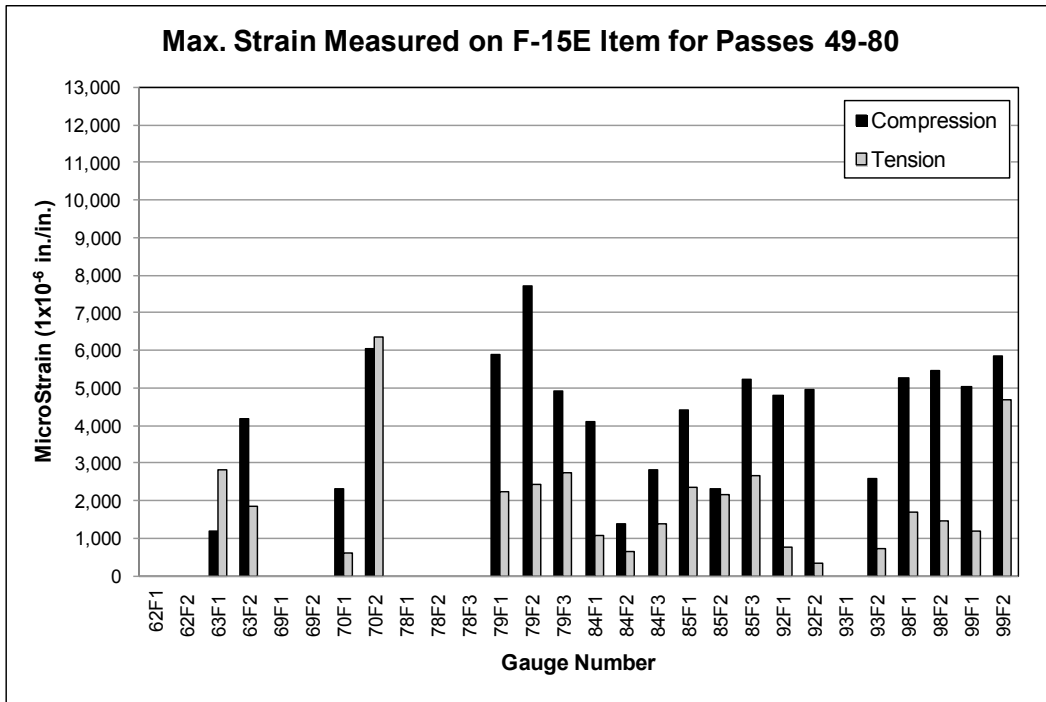
Figure 55. Strain gauge data for F-15E item, passes 49-80.

For the F-15E item, Gauge 93F1 failed to function during the test. From Table 7, Panels 62, 69, and 78 failed in the range of 49 to 80 passes as indicated by their disappearance beginning in Figure 55. After the failures, the strains measured on the opposing panels, 63, 70, and 79, were significantly reduced as shown in Figure 56, validating the stress relief in the lower overlap after the upper underlap broke free from the adjacent panel. Other significant inferences from the F-15E data were that the strain magnitude increased, as shown for gauges on Panels 63 and 98, near the bridging panel boundaries from Panels 57 and 104, and strain values increased because of load transfer to successive panel sets after a failure.

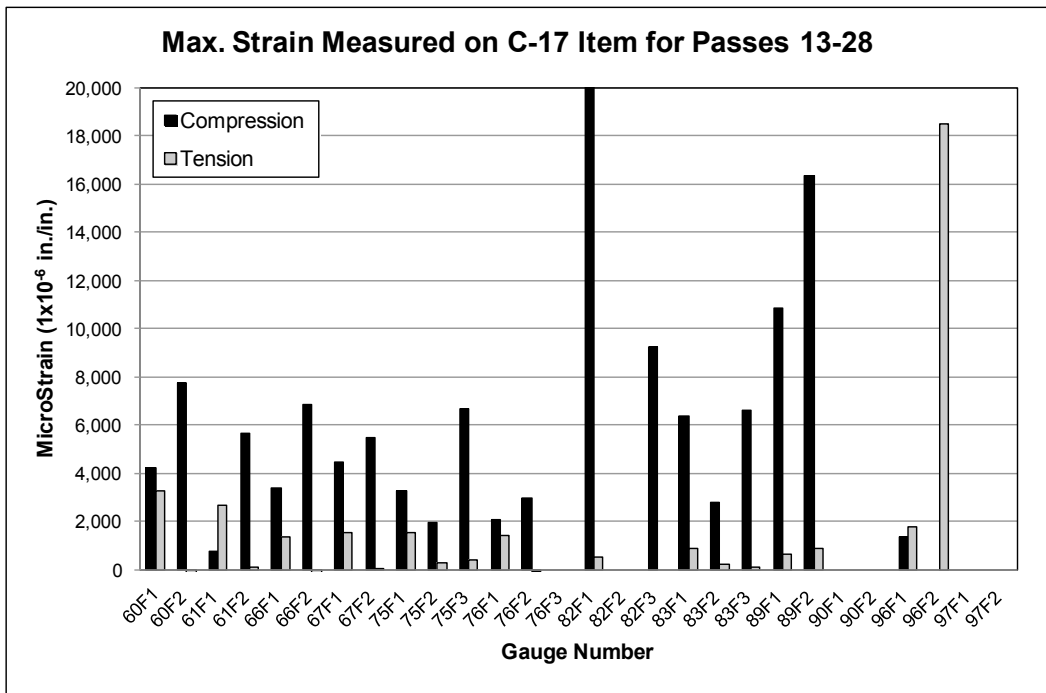
Figure 61. Strain gauge data for C-17 item, passes 13-28.

For the C-17 item, Figure 60 through Figure 62 show that gauges 76F3, 82F2, and 97F2 failed to return any usable data. According to Figure 61,

data indicate Panels 90 and 97 failed between passes 13 and 28, although visual observations reported failures at 28 and 56 passes, respectively. The strain gauge data may be able to show that failure occurred earlier than noted from visual observations or that high strains may have destroyed the gauges prior to failure. Most likely, the gauge failures are directly linked to mat breakage. The raw strain data validated that Panel 83 failed at 46 passes, and Panels 61, 67, and 76 all failed at 50 passes. The values shown in Figure 62 show the strain magnitudes for these four panels prior to failure. Overall, the measured strains in both test items appeared to yield usable results for the DIM and other future modeling efforts.
