Matthew Jones House

Historic Maintenance and Repair Manual

Adam D. Smith and Sunny E. Adams

August 2014

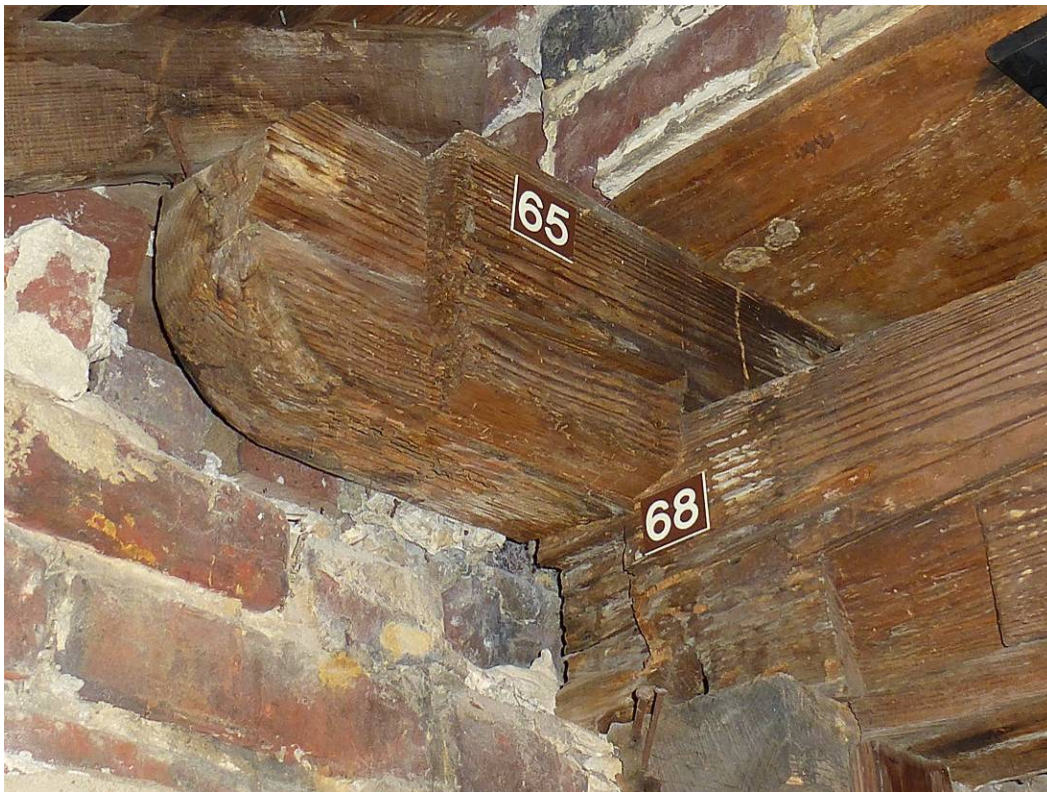
Figure 29. Original end joists (#65) along with other wood structural members in the Matthew Jones House should be maintained and preserved (ERDC-CERL, 2012).

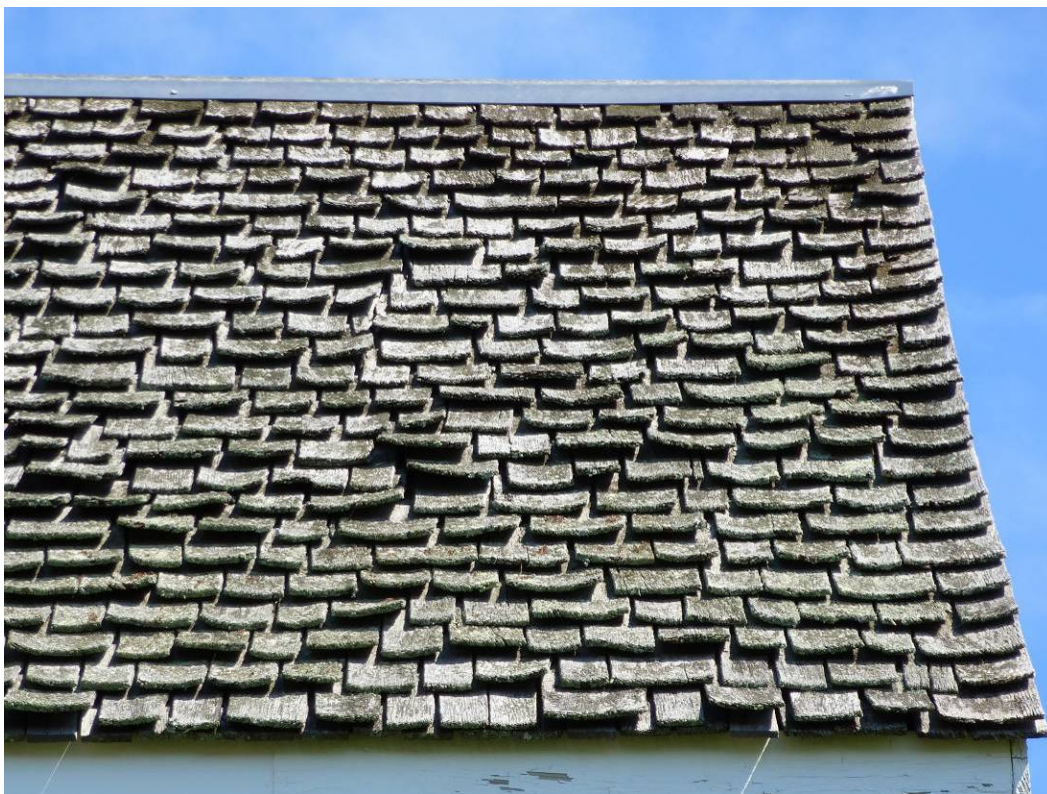
The current wood shingle roof is not original to the Matthew Jones House. It is a replacement roofing system, probably installed during the 1993 preservation efforts. It is however, in-kind to that of the original material and design intent. The condition of the roof is poor (Figure 30).

The failing wood shingles need to be addressed immediately. The system components of the roof are no longer working properly creating gaps in the roof allowing water and exterior elements to penetrate into the structure. The current installation of the shingles is shown that the shingles do not overlap each other therefore creating gaps between the shingles. Replacement of the roofing material may not be an adverse effect depending on the type of replacement material used; however, the roof is such a main character-defining feature that SHPO concurrence is recommended.

Figure 30. Wood shingle roof on main block gable, porch tower gable, and shed room (rear chamber) roof (ERDC-CERL, 2012).

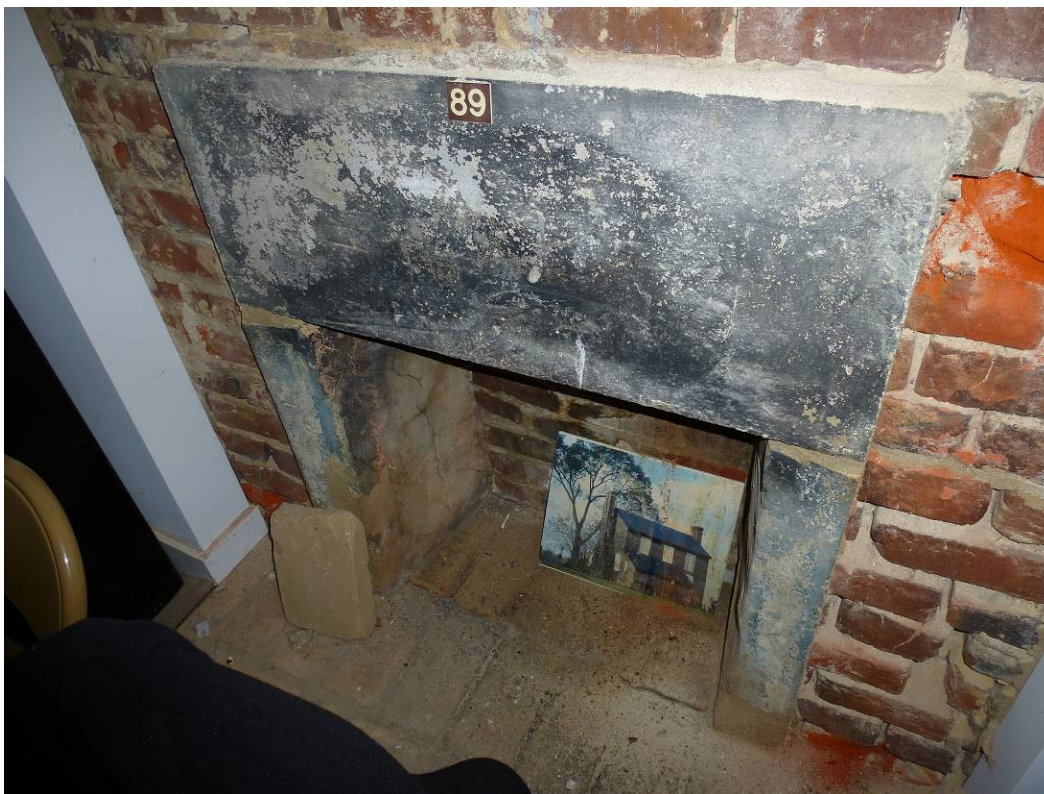
Figure 32. Fireplace on the southeast wall in the second-floor chamber room should be preserved (ERDC-CERL, 2012).

The interior of the cellar is Level 4; however, the original earthfast members visible in the cellar should be preserved. The small closet tucked under the stair passage is Level 4, as well as the second-floor chamber over the dining room. The brick fireplace should be preserved in this room (Figure 32 and Figure 37–Figure 43).

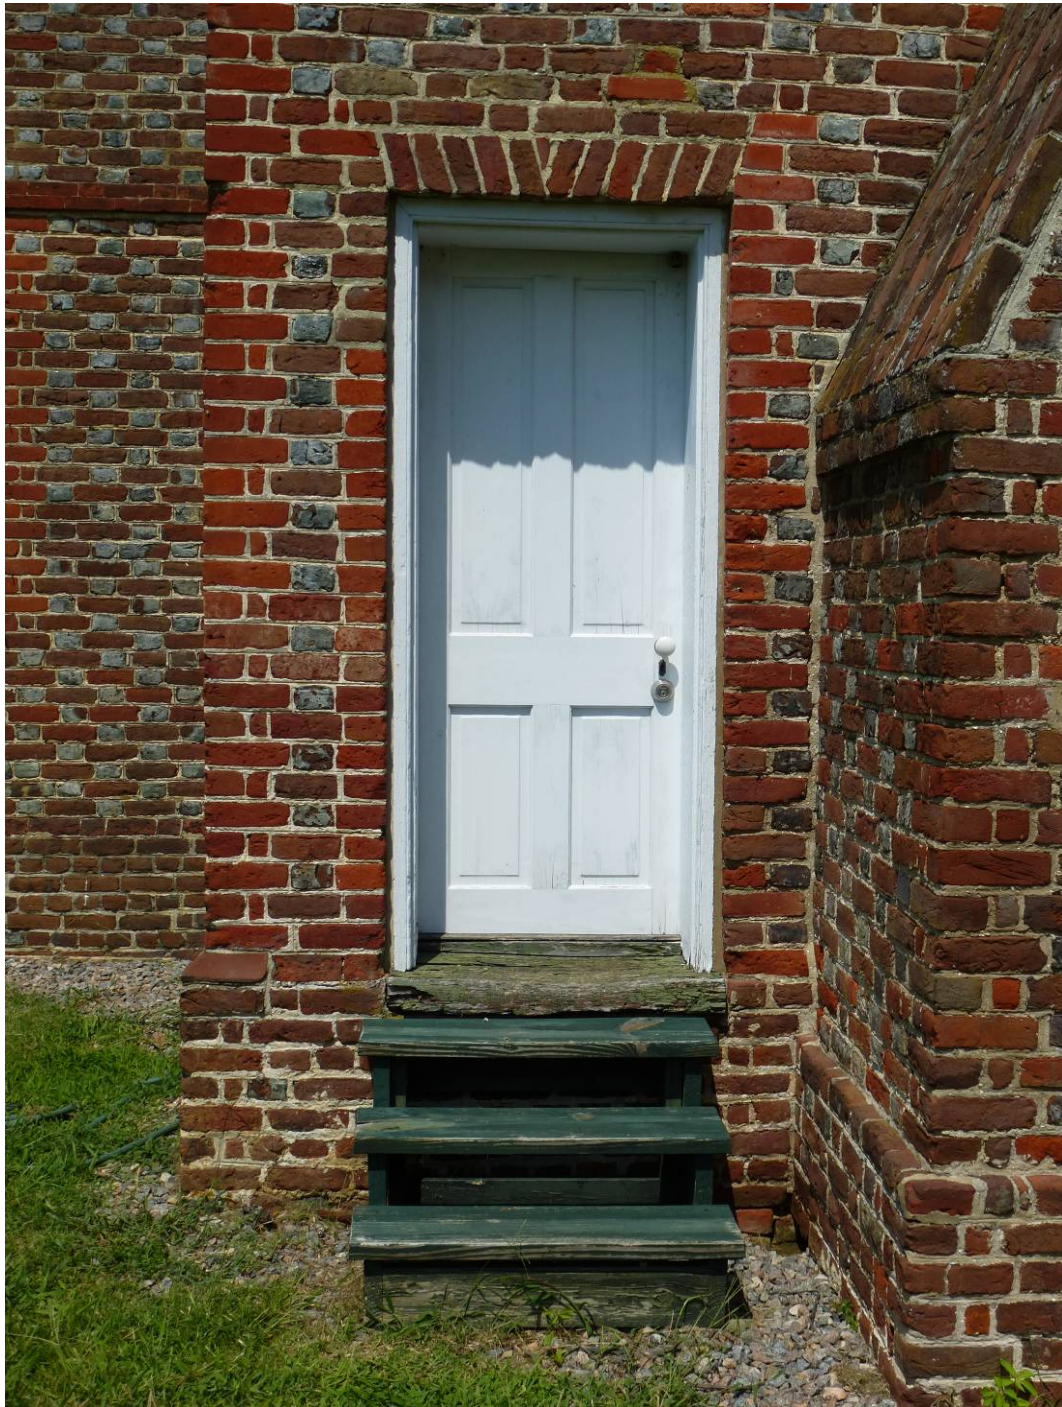
Figure 35. Current wood door on the southeast elevation (ERDC-CERL, 2012).

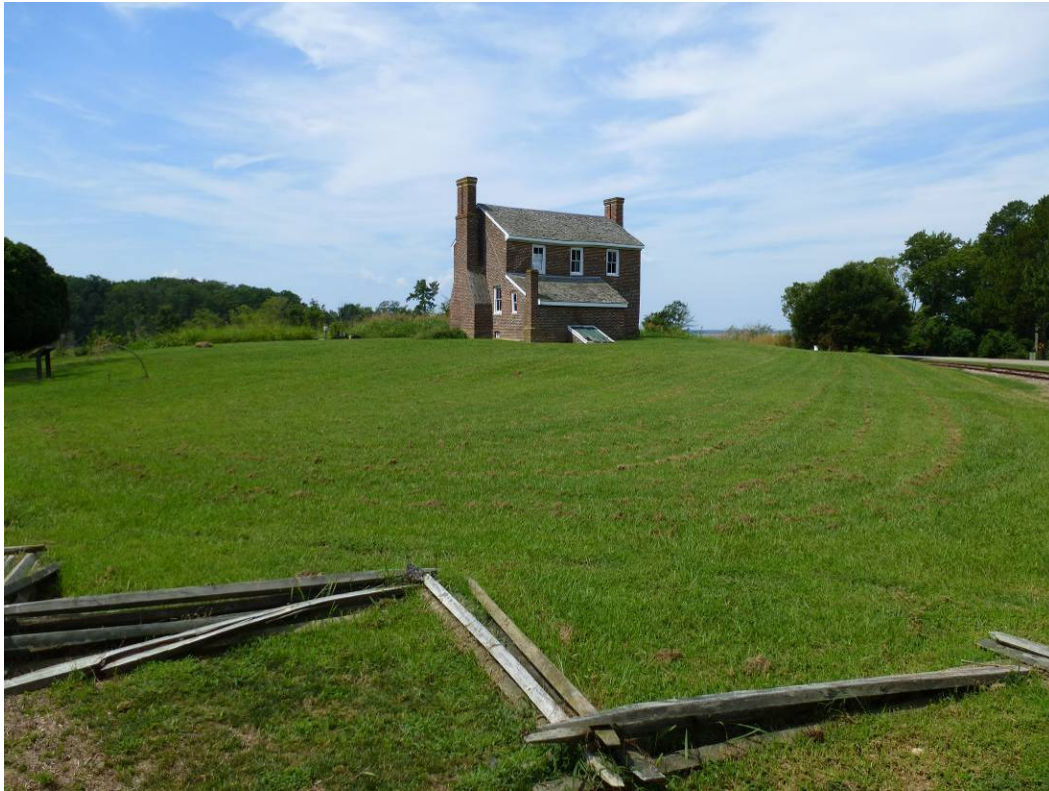
Figure 49. Dismantled wood fence needed to be restructured along the easterly side of the house (ERDC-CERL, 2012). This work was done in 2013 by soldier volunteers (see Figure 50).

It should be noted that since the time of the initial ERDC-CERL site visit in 2012, the pile of timber (which was once a fence that stretched along the

easterly side of the property) has been reconstructed into a fence again by soldiers who volunteered with the 2013 reconstruction efforts (Figure 50).

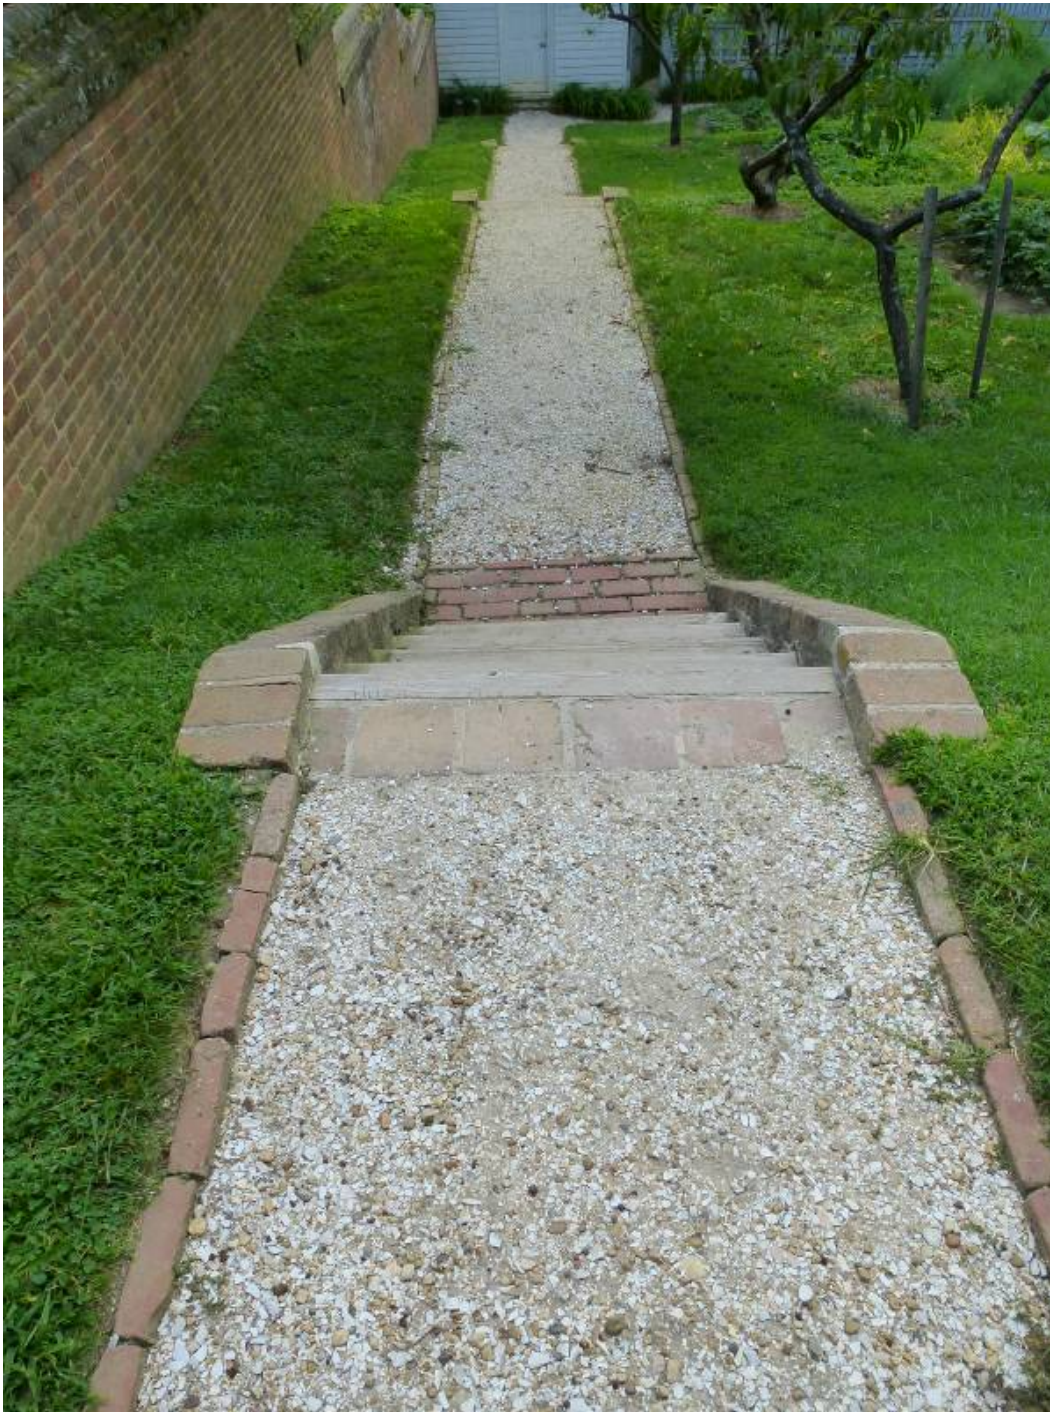
Figure 51. Example of crushed oyster walkway (photo taken at Colonial Williamsburg, Virginia; ERDC-CERL, 2012).

- The grounds are maintained and are on a regular mowing schedule, and
- the path from the paved lot to the front entrance of the house should be more defined by using crushed oyster shell to fill the walk path (Figure 51), and

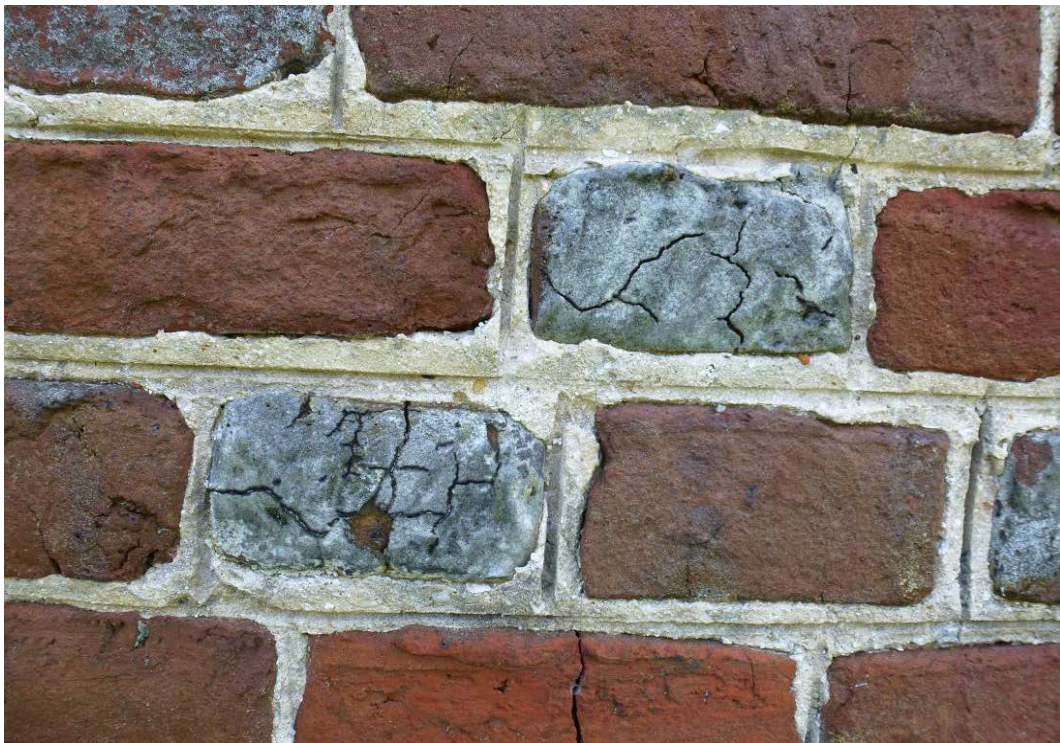
Figure 60. Glazing on header bricks is failing due to the evidence of crazing effects within brick (ERDC-CERL, 2012).

Crazing is the formation of a pattern of tiny cracks or crackles in a glaze (Figure 60 and Figure 61). Unless the cracks visibly extend into the porous tile body beneath the glaze, crazing should not be regarded as highly serious material failure. It does, however, tend to increase the water absorption capability of the glazed unit. To date, no completely effective treatment has been developed for this condition.²⁷

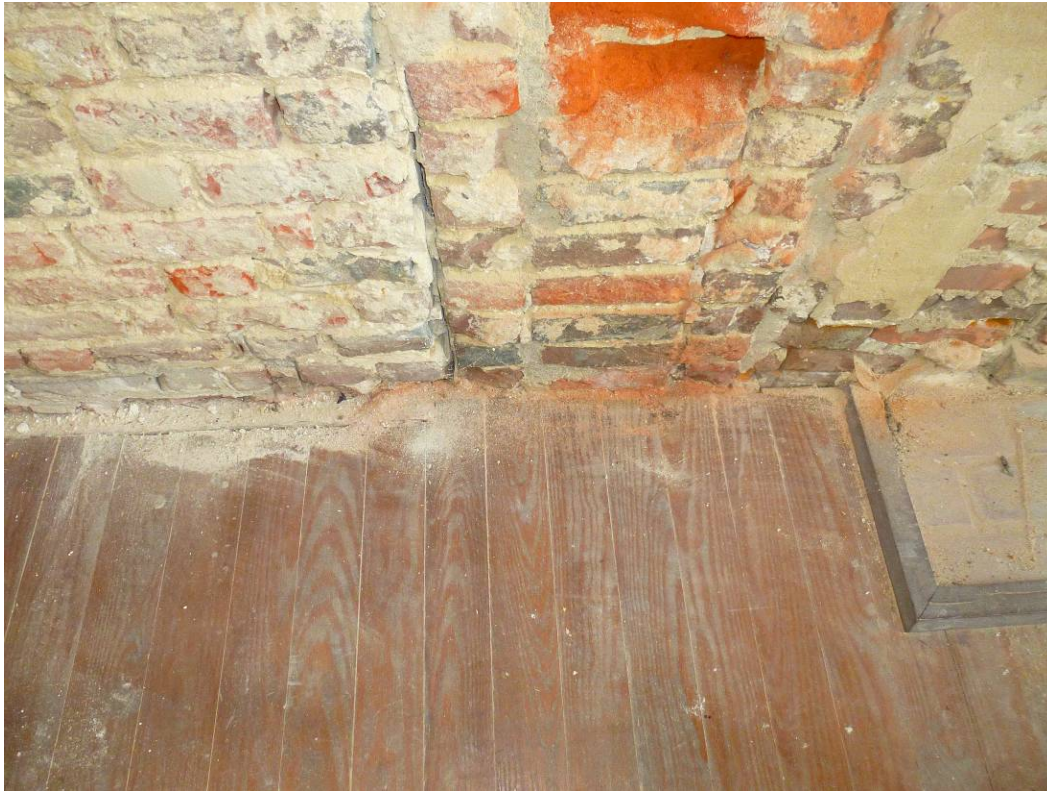
moisture and condensation within the bricks. The bricks are ultimately crumbling to pieces. Evidence of this is seen on the interior with the buildup of “brick dust” at the base of each wall (Figure 88).

Figure 88. Interior of brick wall showing the “brick dust” (ERDC-CERL, 2012).

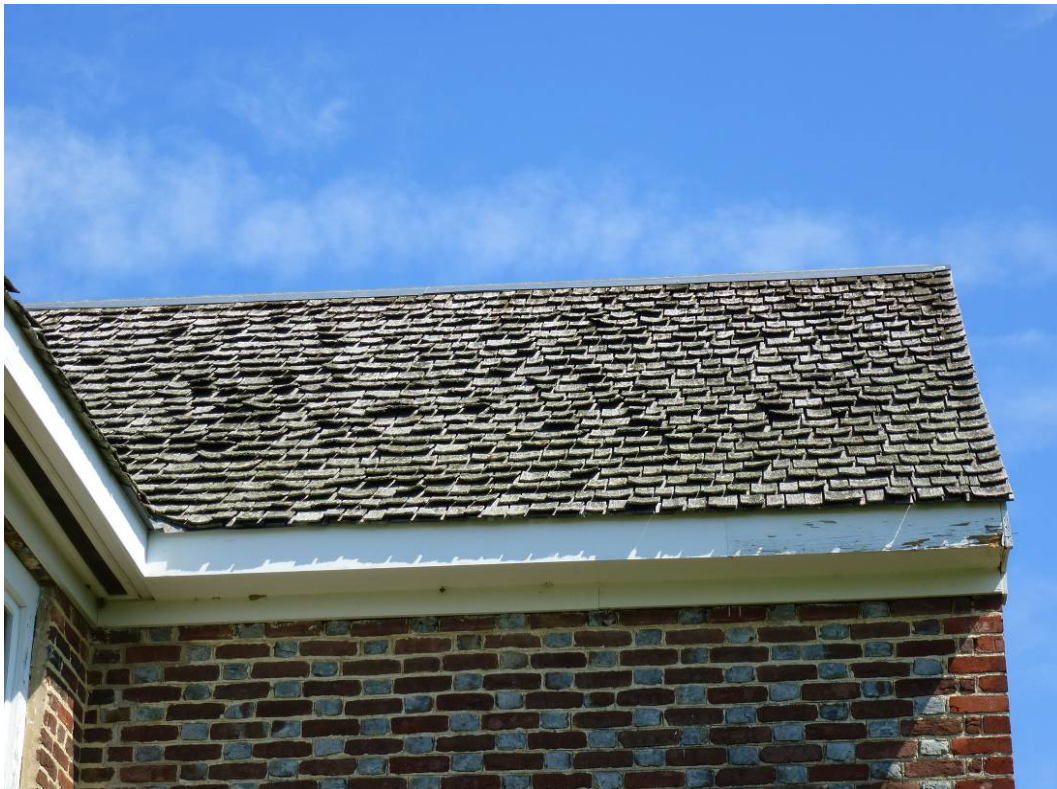
The roof of the Matthew Jones House is in poor condition. The wood shingles have aged beyond maintenance and need to be replaced. Due to improper interior ventilation system and the construction method used to install the current shingles, the wood shingles are cupping; in turn, the cupping is causing gaps in the roof that allow exterior elements to penetrate into the interior of the house.

Figure 92. Wood shingles (ERDC-CERL, 2012).

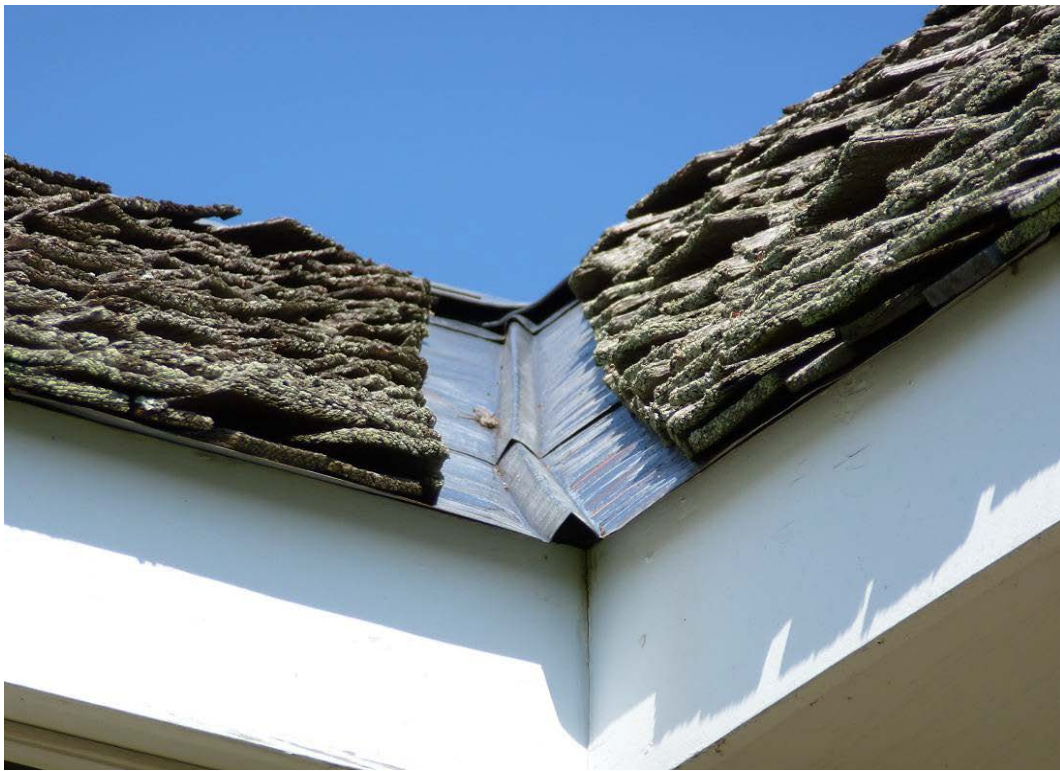
Figure 94. Flashing at the joint of the shed roof and brick wall of main block (ERDC-CERL, 2012).

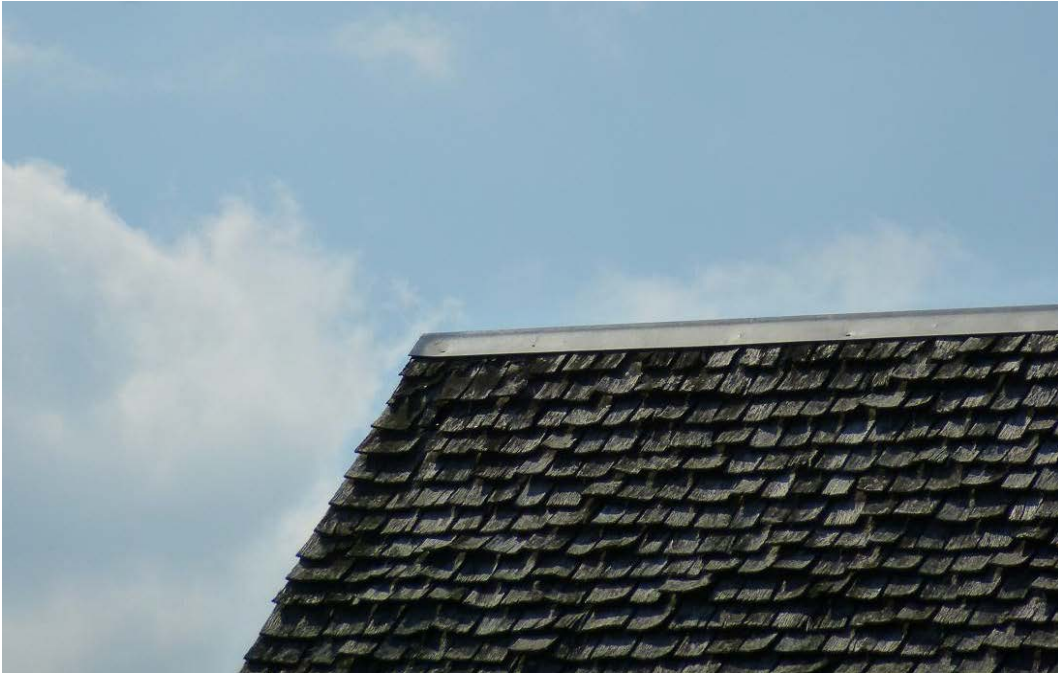
Figure 97. Moisture-soaked roofing members including joists, rafters, and wood shingles (ERDC-CERL, 2012).

Wholesale replacement of the roof is a must in order to preserve the Matthew Jones House. Replacement shingles should match the original shingles in material, size, and shape. Please refer to Figure 99 and Figure 100 for accurate examples of replacement wood shingles.

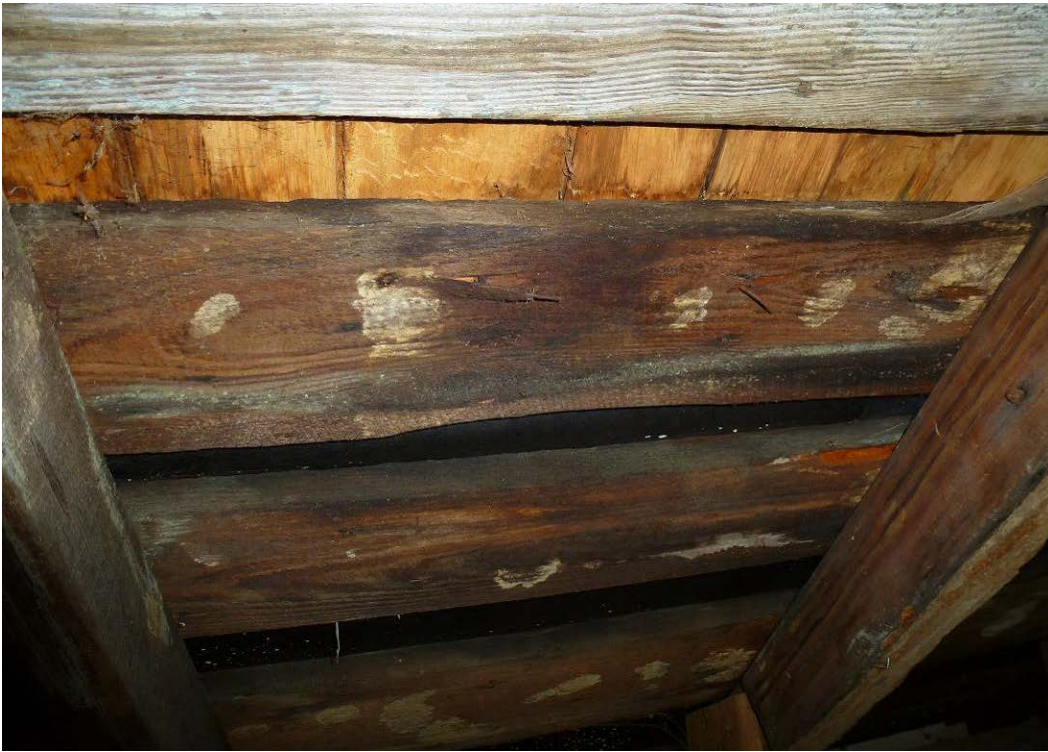
Figure 98. Gaps in the wood shingles where you can see light through, and allowing exterior elements to penetrate into the interior of the house (ERDC-CERL, 2012).

Gaps in the wood roofing shingles allow water, air, and elements into the interior of the structure (Figure 98). Joint Base Langley-Eustis CRM needs to address the various-sized gaps in the roofing material, as well as the type of material being used as a roof covering. The gaps in the roof might be a result of the current installation of the individual cedar shingles. In the current installation of the shingles, the shingles do not overlap each other enough, therefore creating gaps between the shingles allowing air and water to penetrate into the structure.

Remove the existing roofing material down to the existing spaced sheathing. New wood shingles should be applied directly to the space sheathing below. Felts and coverings shall only be used on the overhang areas. Wood decking should be in good repair, and be repaired or replaced as needed. If any decking is replaced, new lumber should match original in lumber type and size. If full-size lumber was used originally, then new should match in size. No plywood or modern composition boards should be used. Generally speaking, it is preferred NOT to install new wood shingle roofs to roofs with solid decking.⁴¹

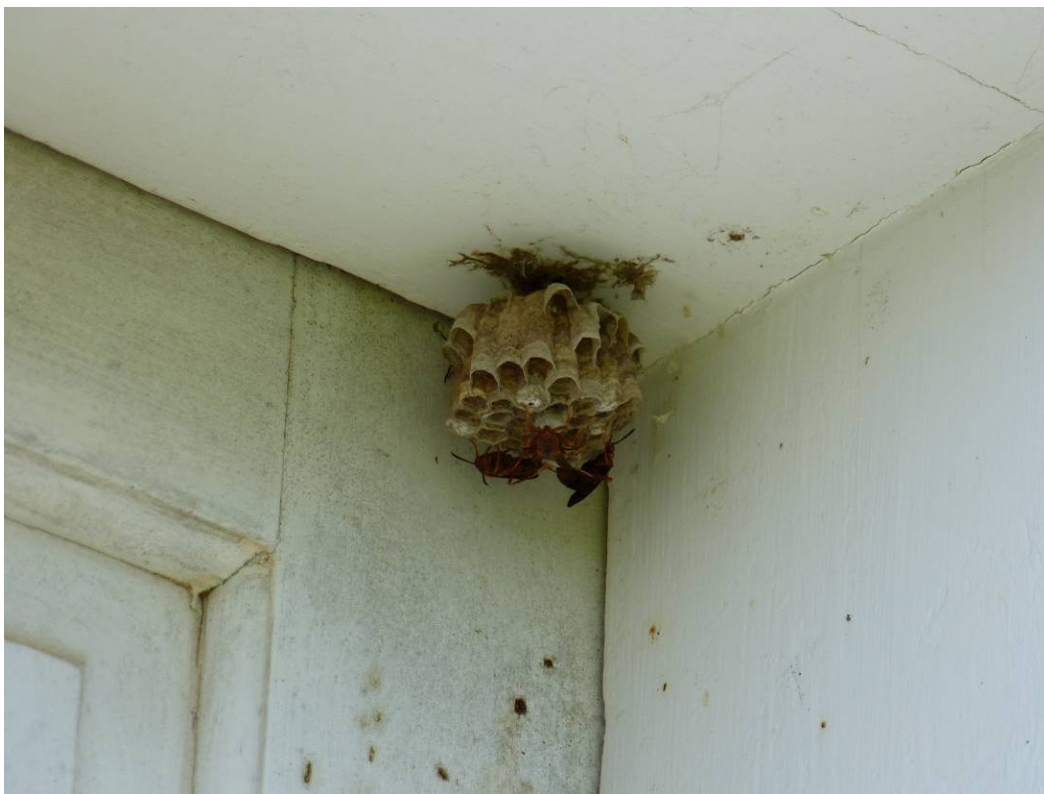
Figure 107. The insect growth/nests should be removed from all wood members (ERDC-CERL, 2012).

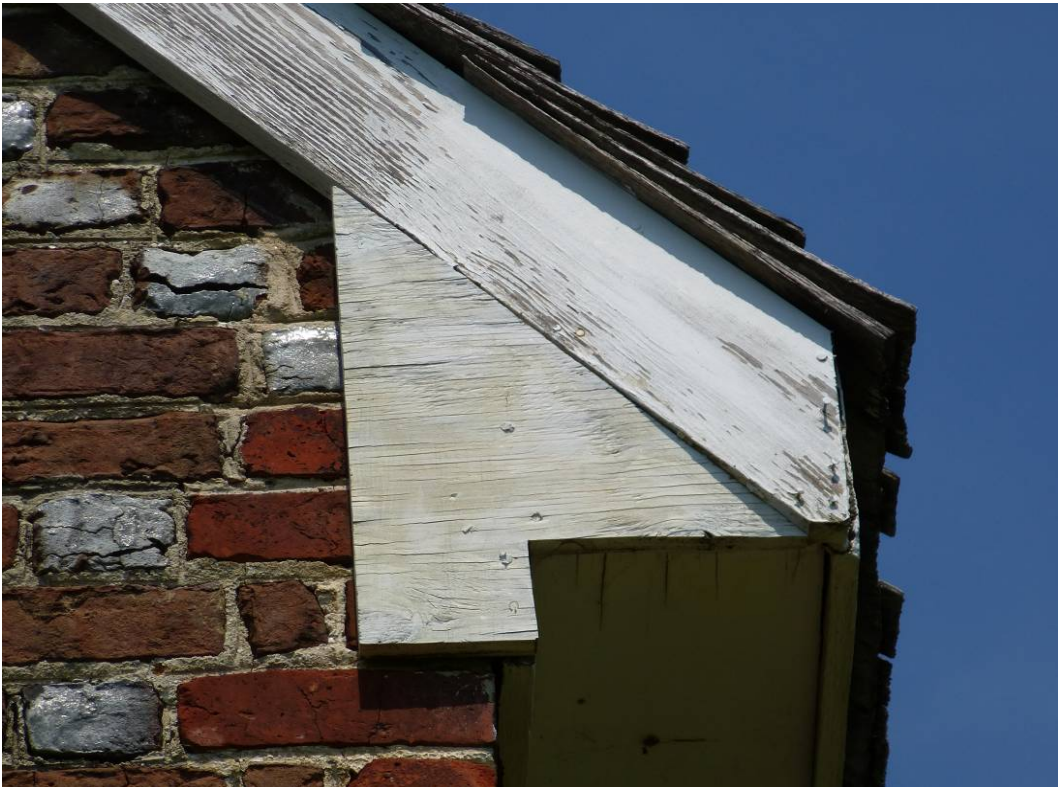
Figure 121. Close-up of weathered rakeboard (ERDC-CERL, 2012).

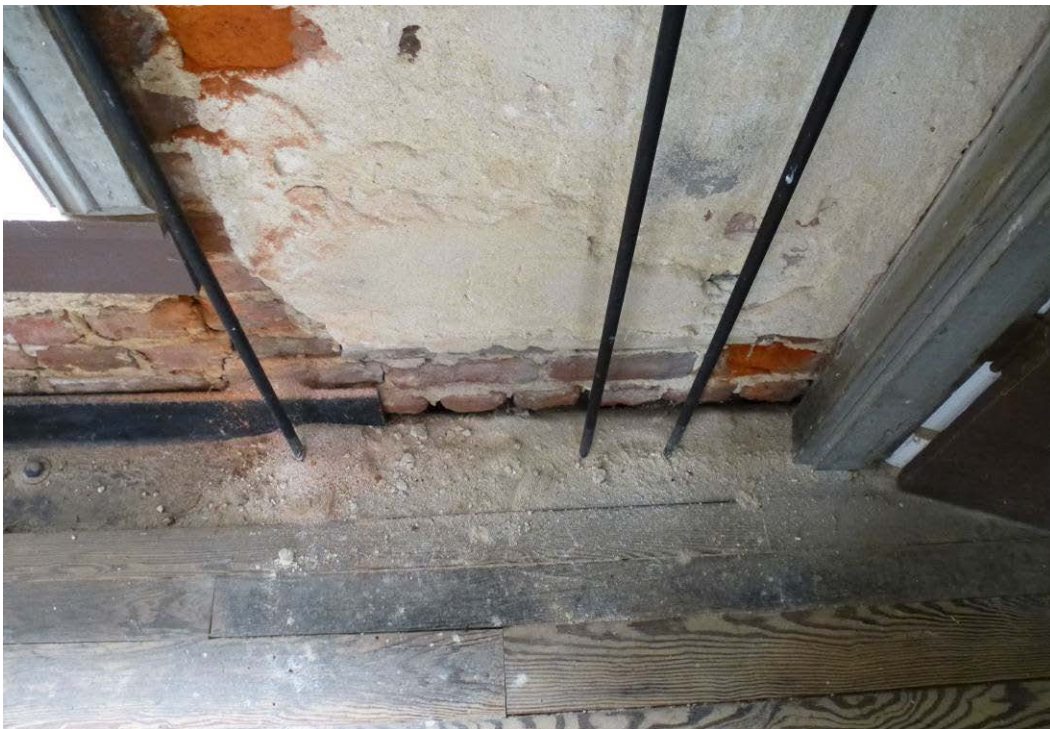
Figure 193. Plaster and brick dust pile around the steel rod enforcement in the upper stair passage on the northeast wall (ERDC-CERL, 2012).

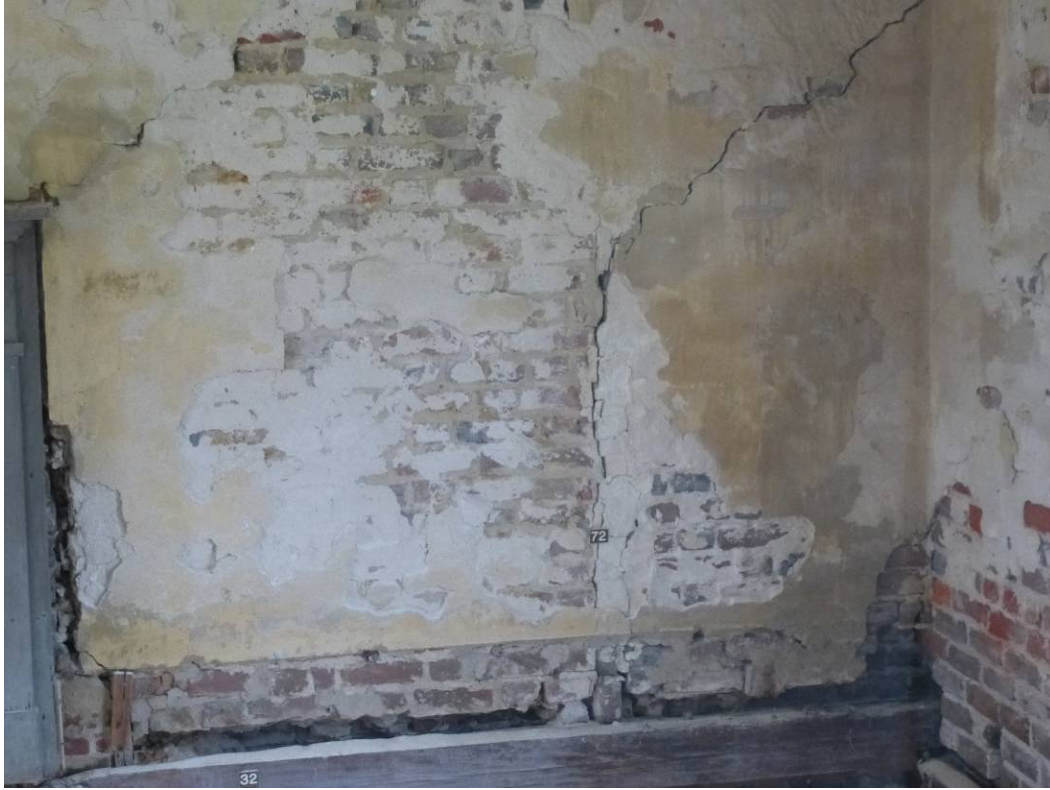
Figure 194. Vertical cracks in the plaster flanking the fireplace are Period I features caused by knee wall studs, left in place during both the ca. 1730 and 1893 renovations. They were plastered over in 1893 and are represented here by cracks in the plaster (ERDC-CERL, 2012).

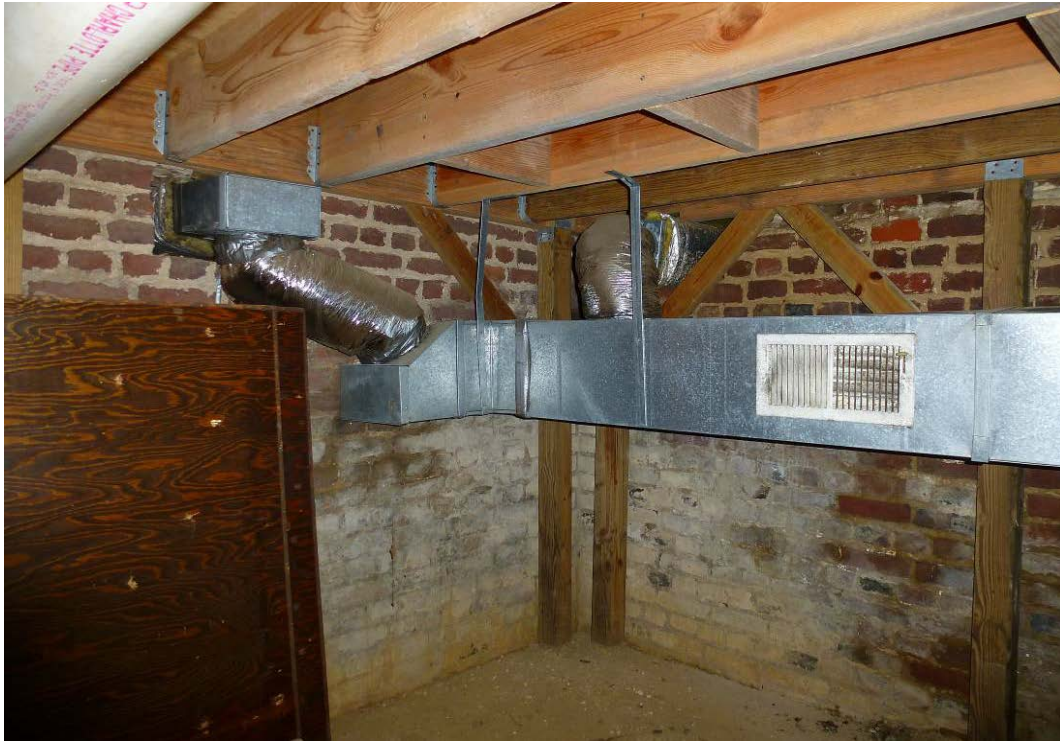
Figure 216. Either water from the ground or condensation from the HVAC system is damaging the brick cellar wall; damage is evident from the white appearance of the brick (ERDC-CERL, 2012).

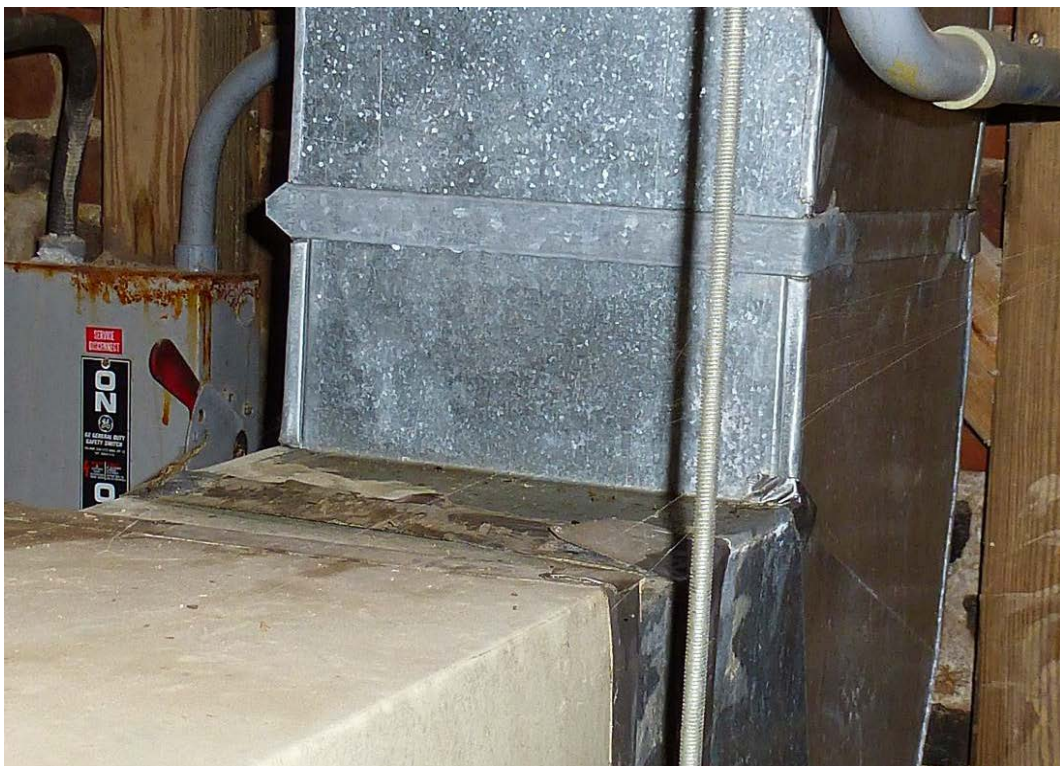
Figure 217. One of the HVAC vents is insulated, but the other is not (ERDC-CERL, 2012).

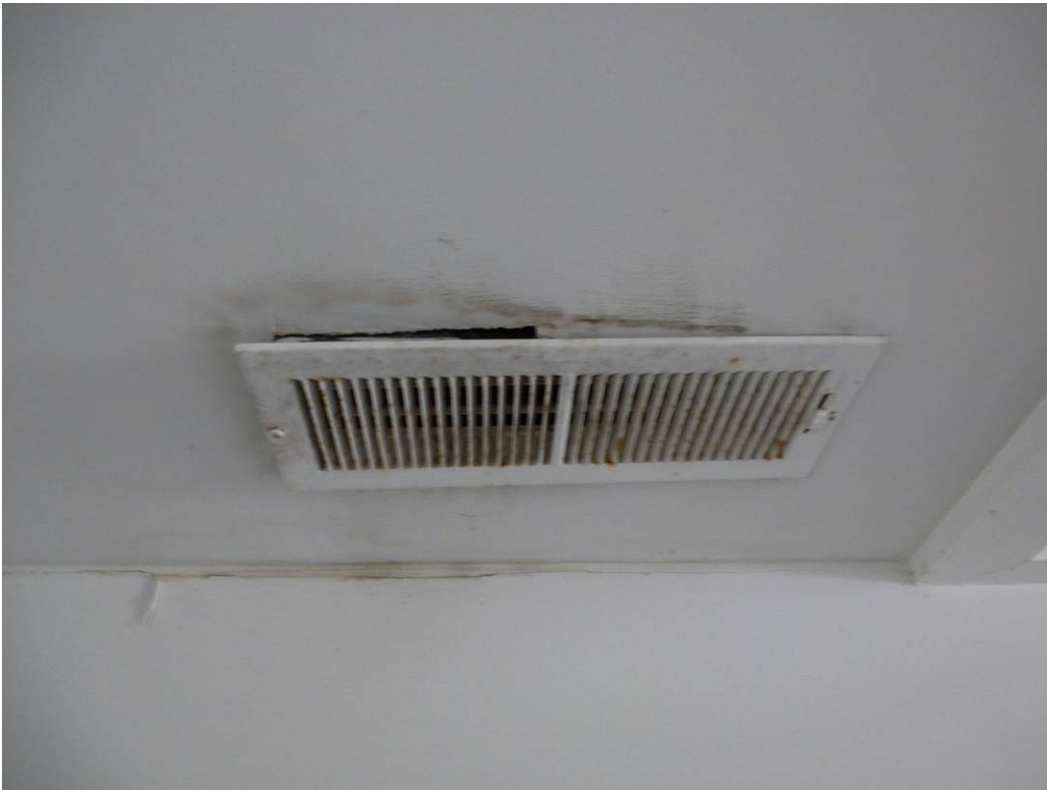
Figure 223. Ceiling vent in the second-floor chamber above the dining room. Vent is not properly attached, and mold is evident (ERDC-CERL, 2012).
