TECHNICAL REPORT
TR-NAVFAC-EXWC-PW-1406
APRIL 2014

**BUILDING INTEGRATED PHOTOVOLTAIC (PV)
ROOFS FOR SUSTAINABILITY AND ENERGY
EFFICIENCY**

BUILDING INTEGRATED PHOTOVOLTAIC (BIPV) ROOFS FOR SUSTAINABILITY AND ENERGY EFFICIENCY COST & PERFORMANCE REPORT

ESTCP Number: EW-200813

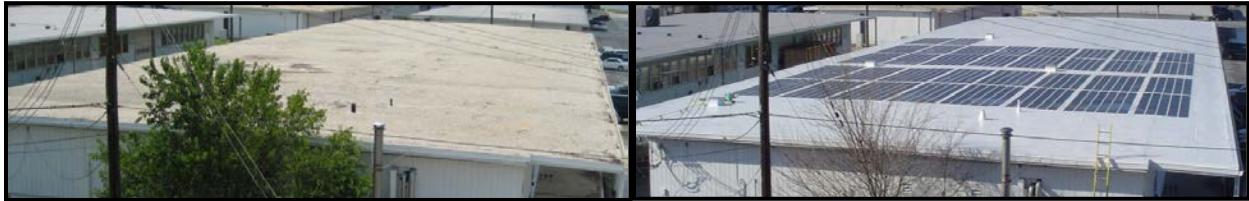
The Building 515 roof at Site II (NAS Patuxent River) is approximately 80 feet wide and 200 feet long and is a four-ply, flat, built-up, asphalt roof (Figure-6, left). The facility was built in 1942 and is a single story warehouse that has been converted to store contract documents. The roof has two small plumbing stack vents and the slope of the roof is 1/8 of an inch to one foot. The heights of the eaves range from 14 to 16 feet. The roof deck and support beams were rotten in up to ten locations. Due to the poor condition, the pre-existing roof material was removed, repairs were made, and the BIPV roof system was installed. The installed PV laminates cover about 27% of the roof, resulting in an installed capacity of 26.9 kW (Figure-6, right).

Figure-6: Before (left) and after (right) photos of Building 515 at NAS Patuxent River.

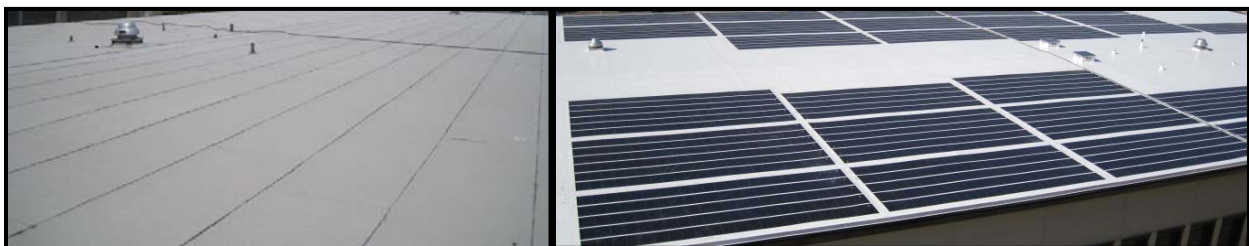
Building 228 at Site III (MCAS Yuma) is a 14-foot, single story, wood-frame building built in 1943 with a 9,270 ft² roof. The roof was in good physical condition and has one large exhaust vent with several small vents around the center (Figure-7, left). There was no indication that the thermal properties of the roof were compromised, so the BIPV roof system was installed on top of the existing roof. The pre-existing antennae cable was re-laid across the BIPV roof and held down by PVC strips so that the cable will not interfere with any of the solar panels or wear out the PVC membrane. The 20.6 kW of PV laminates cover about 36% of the roof (Figure-7, right).

Figure-7: Before (left) and after (right) photos of Building 228 at Site III (MCAS Yuma).

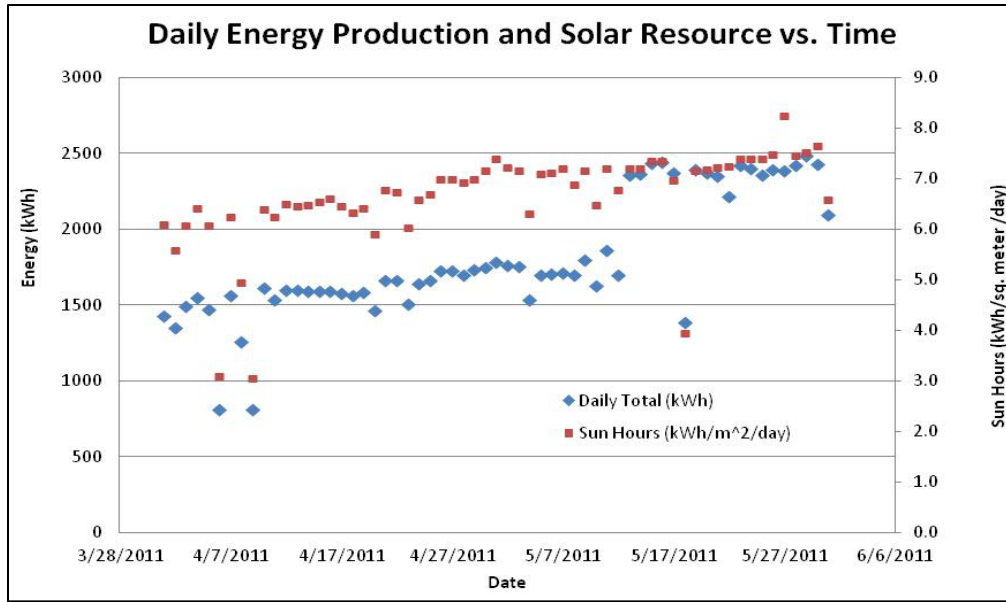
Figure-11: Total daily energy production and solar resource from April to May 2011 at Site I (Luke AFB).

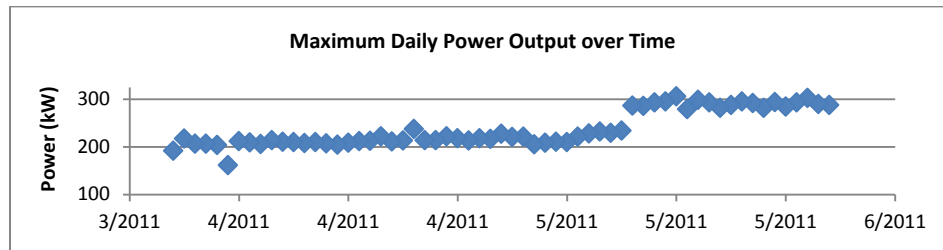
Figure-12: Maximum daily power output for April-May 2011 at Site I (Luke AFB)

Site I (Luke AFB) data shows that the maximum daily output was often between 200 kW and 300 kW (Figure-12). While the installed capacity is rated at 375 kW, recall that the system should only be expected to produce power at that level under STC. To properly assess performance, the output was compared to the available solar insolation and the PV system was determined to be producing only about 80% of what it was expected to. Starting on May 13th,

when the energy production significantly increased, the PV system performed as expected. This was likely due to natural soiling of the PV modules. However, without detailed weather data, it was impossible to correlate actual weather events. While Site I (Luke AFB)'s data was limited, the performance objective was met since the PV system was able to perform to expectations.

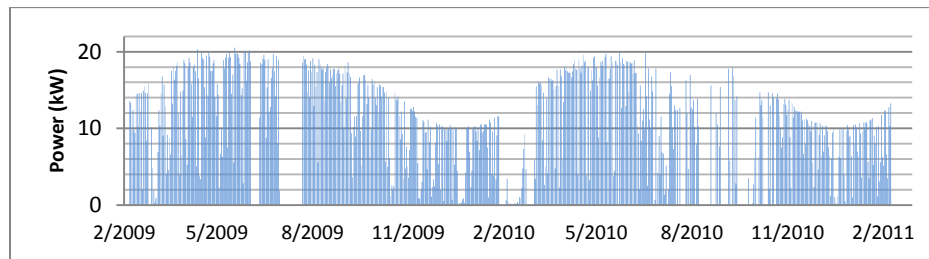
Figure-15: Power output over time at Site II (NAS Patuxent River).

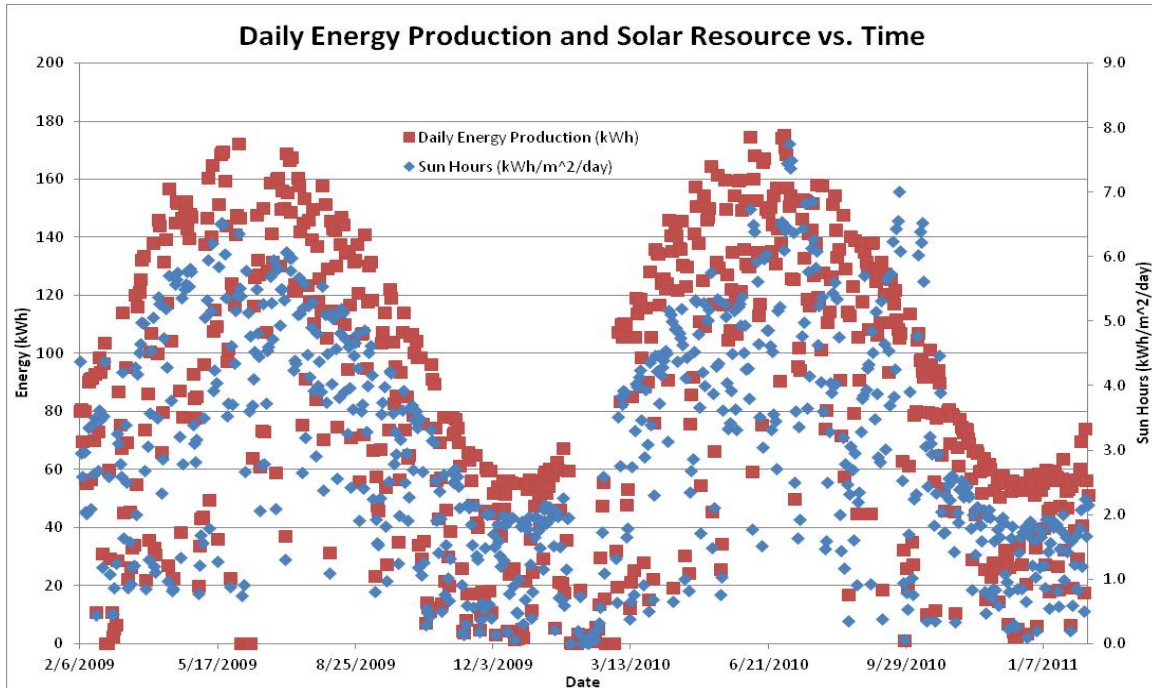
Figure-16: Total daily energy production and solar resource over time for at Site II (NAS Patuxent River).

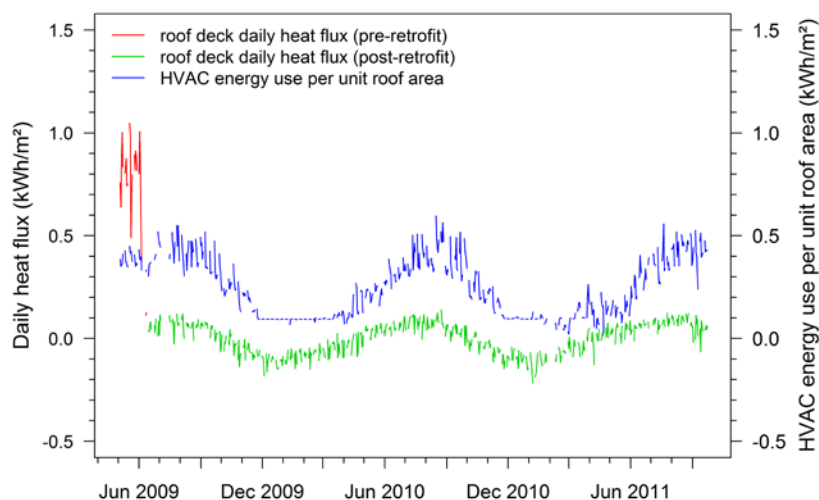
Figure-18: Site III daily, weekday heat flux through roof deck in the pre and post-BIPV roof phases and A/C energy use.

BIPV roof impact on temperature was not clear by just looking at the graphs. However, Figures-18 shows a significant heat flux change after the BIPV roof was installed. For comparison, standard heat transfer equations using spatial average roof temperatures at different locations of the roof assembly, the estimated thermal resistance of the original roof is $0.20 \text{ m}^2\text{-K/W}$ whereas it is $0.47 \text{ m}^2\text{-K/W}$ for the BIPV roof. Note that since the Site III (MCAS Yuma) BIPV roof was installed on top of the original roof, the thermal resistance for the final roof assembly is actually a sum of the two and is estimated to be $0.67 \text{ m}^2\text{-K/W}$. Actual heat transfer dynamics is much more complicated than just comparing the thermal resistance values, but the data shows that a significant reductions in the heat flux through the roof surface and deck occurred as expected. The actual thermal resistance of the ceiling and heat flux through the ceiling are unknown and

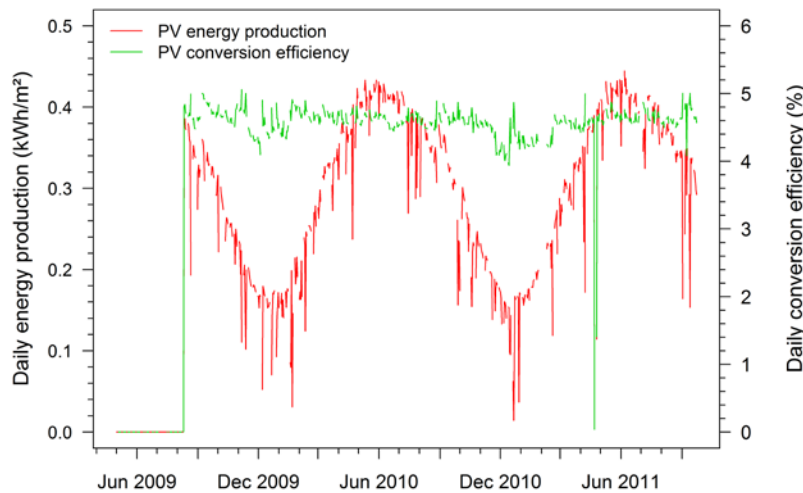
Site III (MCAS Yuma) PV energy production was low during the winter, but conversion efficiency was relatively constant over time (Figure-19).

Figure-19: Site III daily PV energy production per unit PV surface area and mean PV conversion efficiency over time.

Instrumentation at Site III (MCAS Yuma) was the most extensive due to the additional instrumentation for the A/C study. Data shows that the solar irradiance and mean wind speed are slightly synchronized with higher summer values. Figure-19 shows the energy output was lower in the winter, but the PV efficiency was relatively constant throughout the year. Visual inspections of the Site III (MCAS Yuma) BIPV roof showed that desert soiling is a recurring problem, so it was likely that winter rain helped clean the PV system to maintain its efficiency. Weekly data shows that the efficiency does increase temporarily after major rain events, but the size of the benefit varied and was possibly due to the amount of the prior soiling. Analyzing the energy generation and PV efficiency against outside air temperature under a smaller time-scale shows that both are fairly constant, which mean that this type of PV module performs fairly well in hot, desert conditions. For a typical summer day, the data shows that power output increases steadily over time before peaking around noon then decreases almost symmetrically while the PV efficiency was more level throughout the day and had a slight local minimum point around noon. As with most objects exposed to the sun, the PV module is typically at a higher temperature shortly after solar noon, which could explain the drop in efficiency. The data showing that the PV system reached its expected operational efficiency as early as 0700 and maintaining it as late as 1700 confirms the manufacturer's claim that this a-Si PV module works well with diffused sunlight. Occasional power output exceeding the system rating only indicates conditions better than STC. In summary, Site III (MCAS Yuma) met the performance objective.

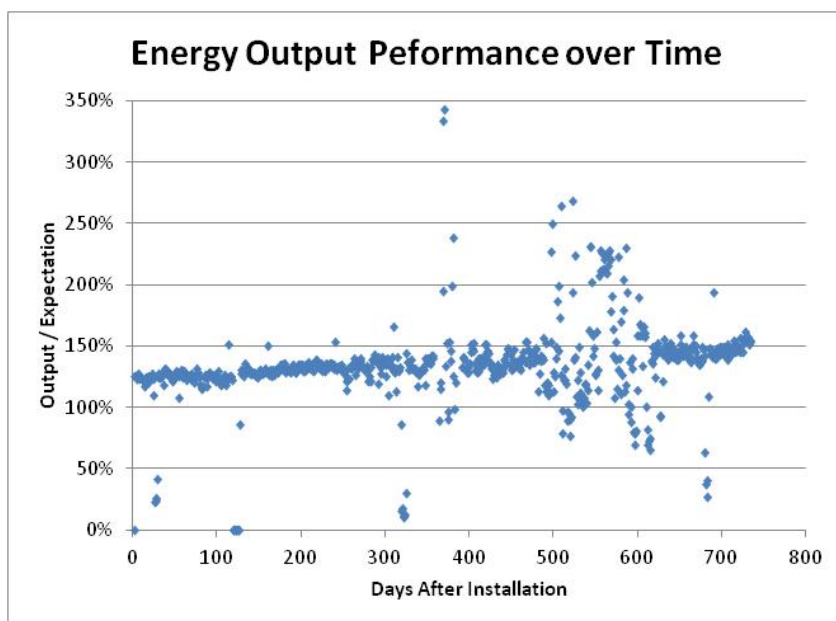
The two years of data for Site II (NAS Patuxent River) was more extensive. As expected, the output was lower in the winter. Furthermore, the site mainly experienced partly to mostly cloudy weather. However, when comparing the energy output against the available solar insolation, the BIPV system performed above expectations, thus, exceeding the performance objective (Figure-22). This can be accredited to the fact that thin film PV material tends to perform relatively well in diffuse sunlight when compared to crystalline PV material and this data provides evidence that the characteristic should be considered when developing future PV systems in similar climates. Note that at times when the performance appeared exceptionally high, such as over 150% of the expectation, this often occurred when the solar insolation was very low, such as early in the day or during heavy rainfall, so it has a very minor impact on the overall energy production.

Figure-22: Site II (NAS Patuxent River) performance compared to estimates based on available solar resource.
