TECHNICAL REPORT REMR-CO-3

**CASE HISTORIES OF CORPS BREAKWATER
AND JETTY STRUCTURES**

Report 2

SOUTH ATLANTIC DIVISION

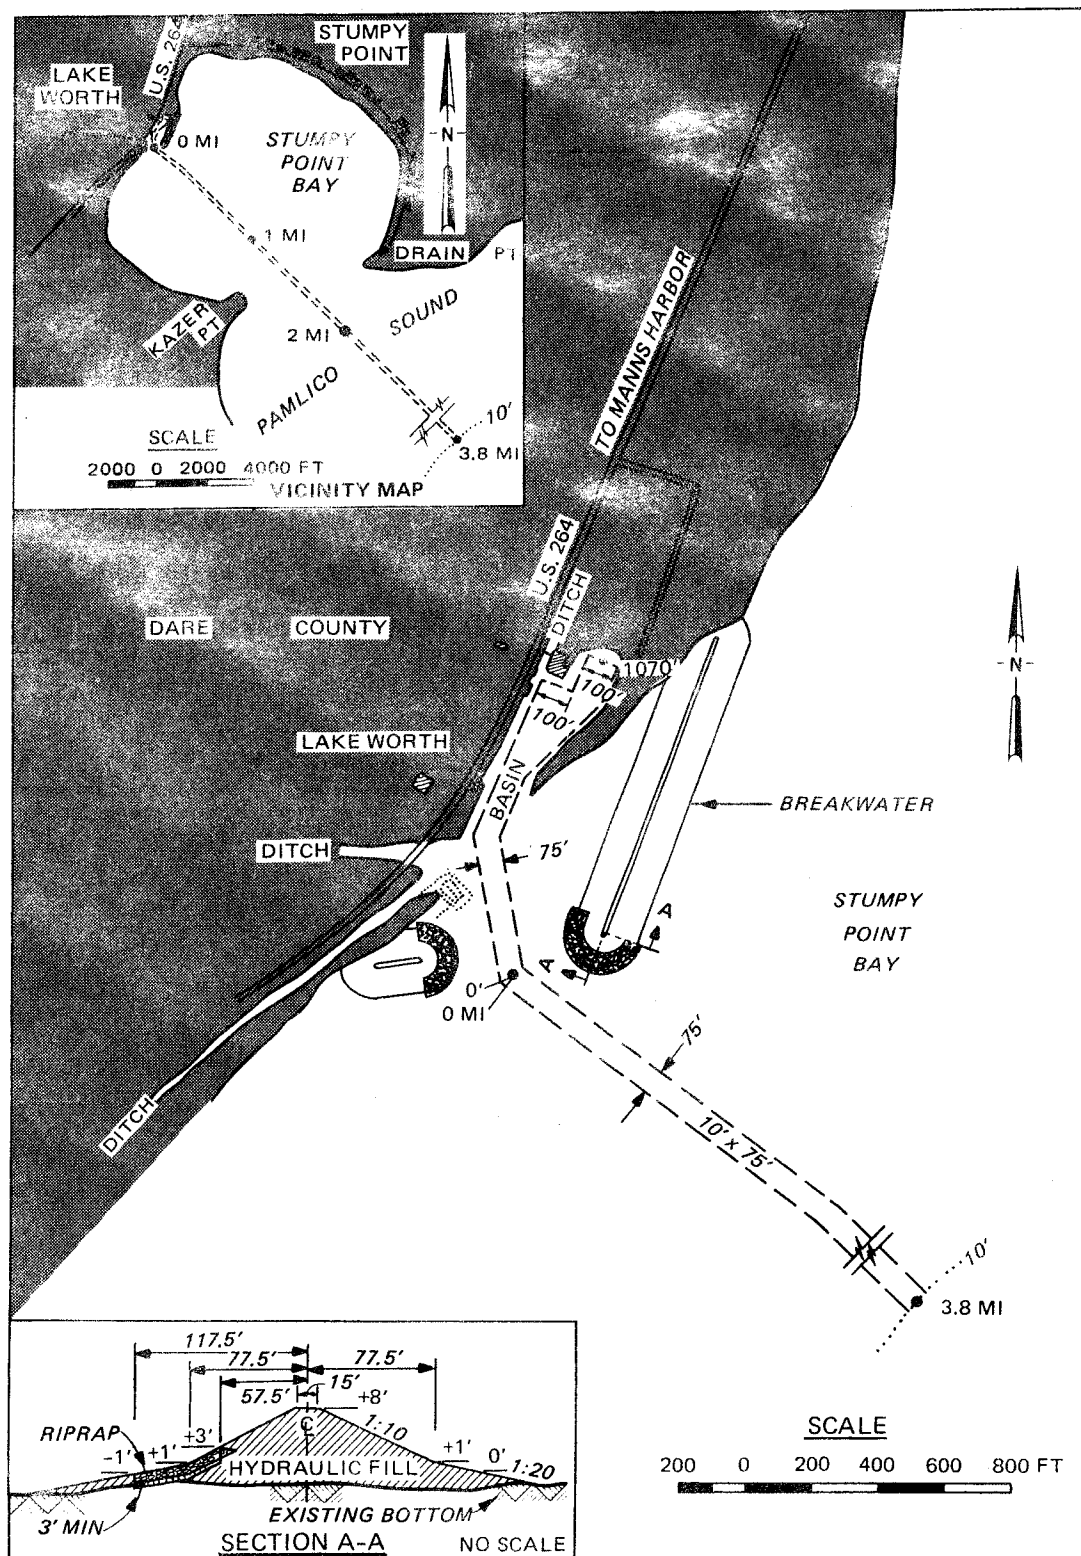
Figure 4. Stumpy Point Bay, North Carolina

1974	A reconnaissance survey was made to determine the severity of erosion to the breakwaters. It was found that the riprap protected sections were functioning satisfactorily but that the fill material adjacent to the riprap sections had substantially eroded. Maximum vertical scarps of 7, 3, and 3 ft, respectively, were noted on the bay and harbor sides of the north breakwater and bay side of the south breakwater. The erosion on the north breakwater was on directly opposite sides of the breakwater with only 30 ft of original material separating the narrowest point. It was felt that "the southeasterly wind with its associated fetch is very erosive to the breakwaters on both sides of the dredged channel."
1985	Neither repairs nor maintenance has been carried out since the breakwaters were originally constructed.

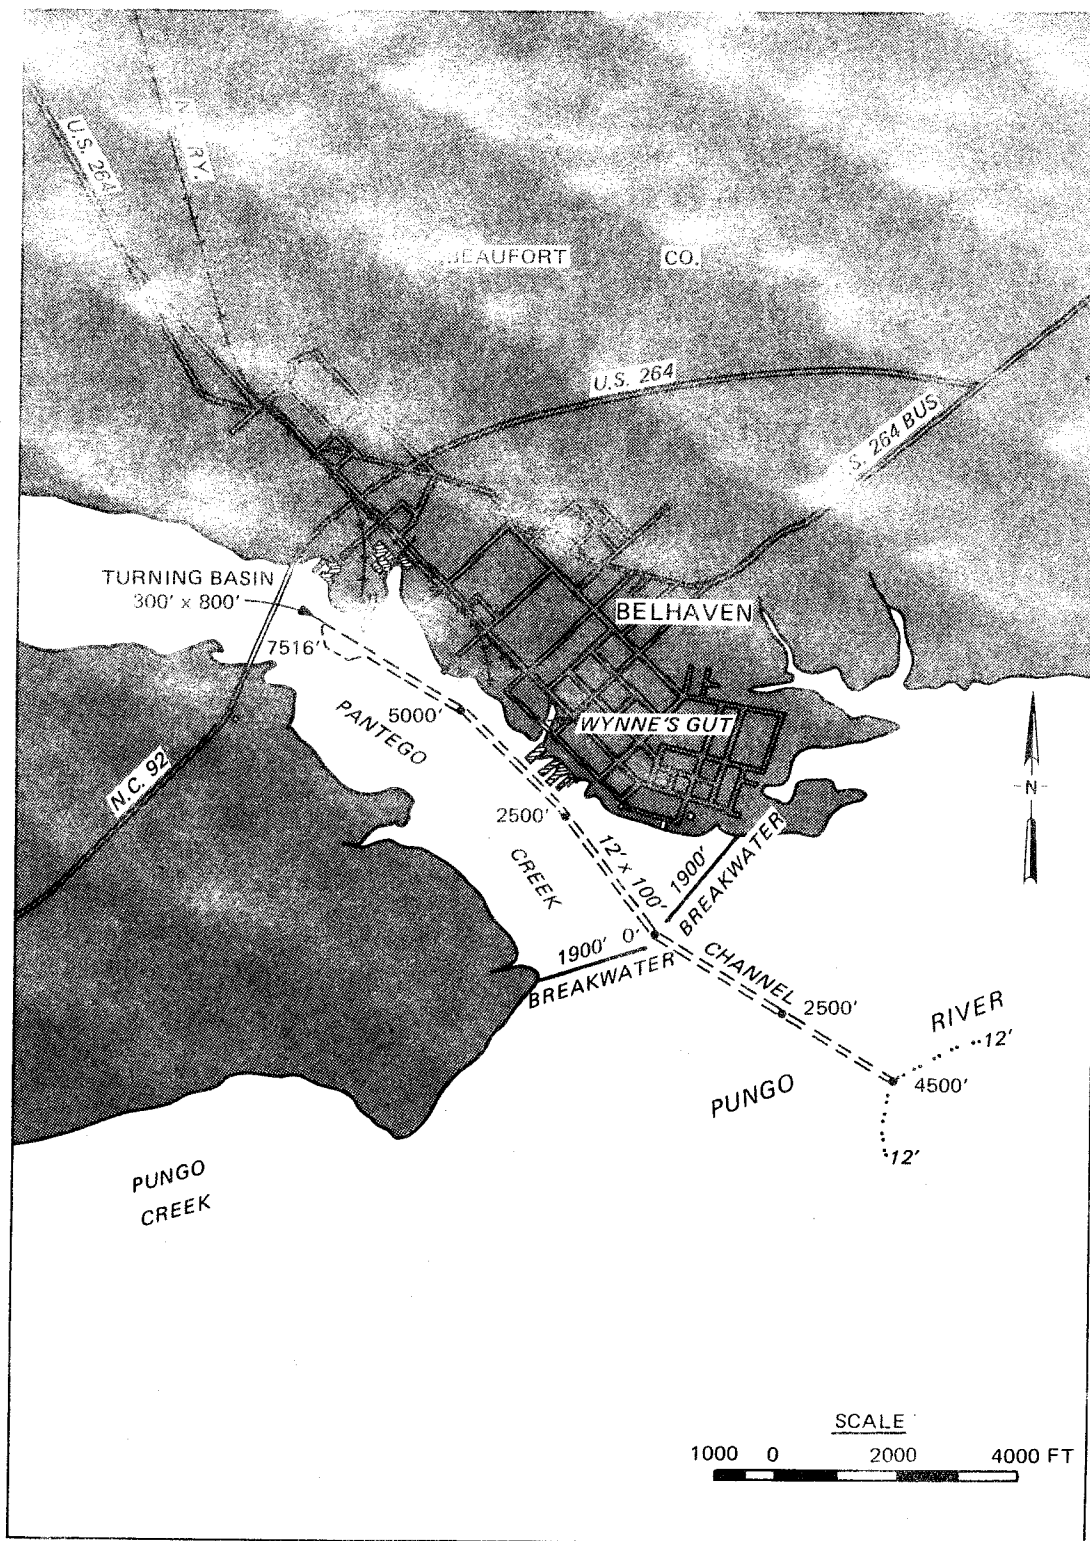
Figure 5. Belhaven Harbor, North Carolina

1982	Visual examination showed that approximately three dozen timbers were missing over the length of the breakwaters. Also, a few pilings were missing. It was thought that the damage resulted from the impact of transient barges tied to the structure.
1985	The structure does not provide its intended wave protection, but at present there are no plans for improvement.

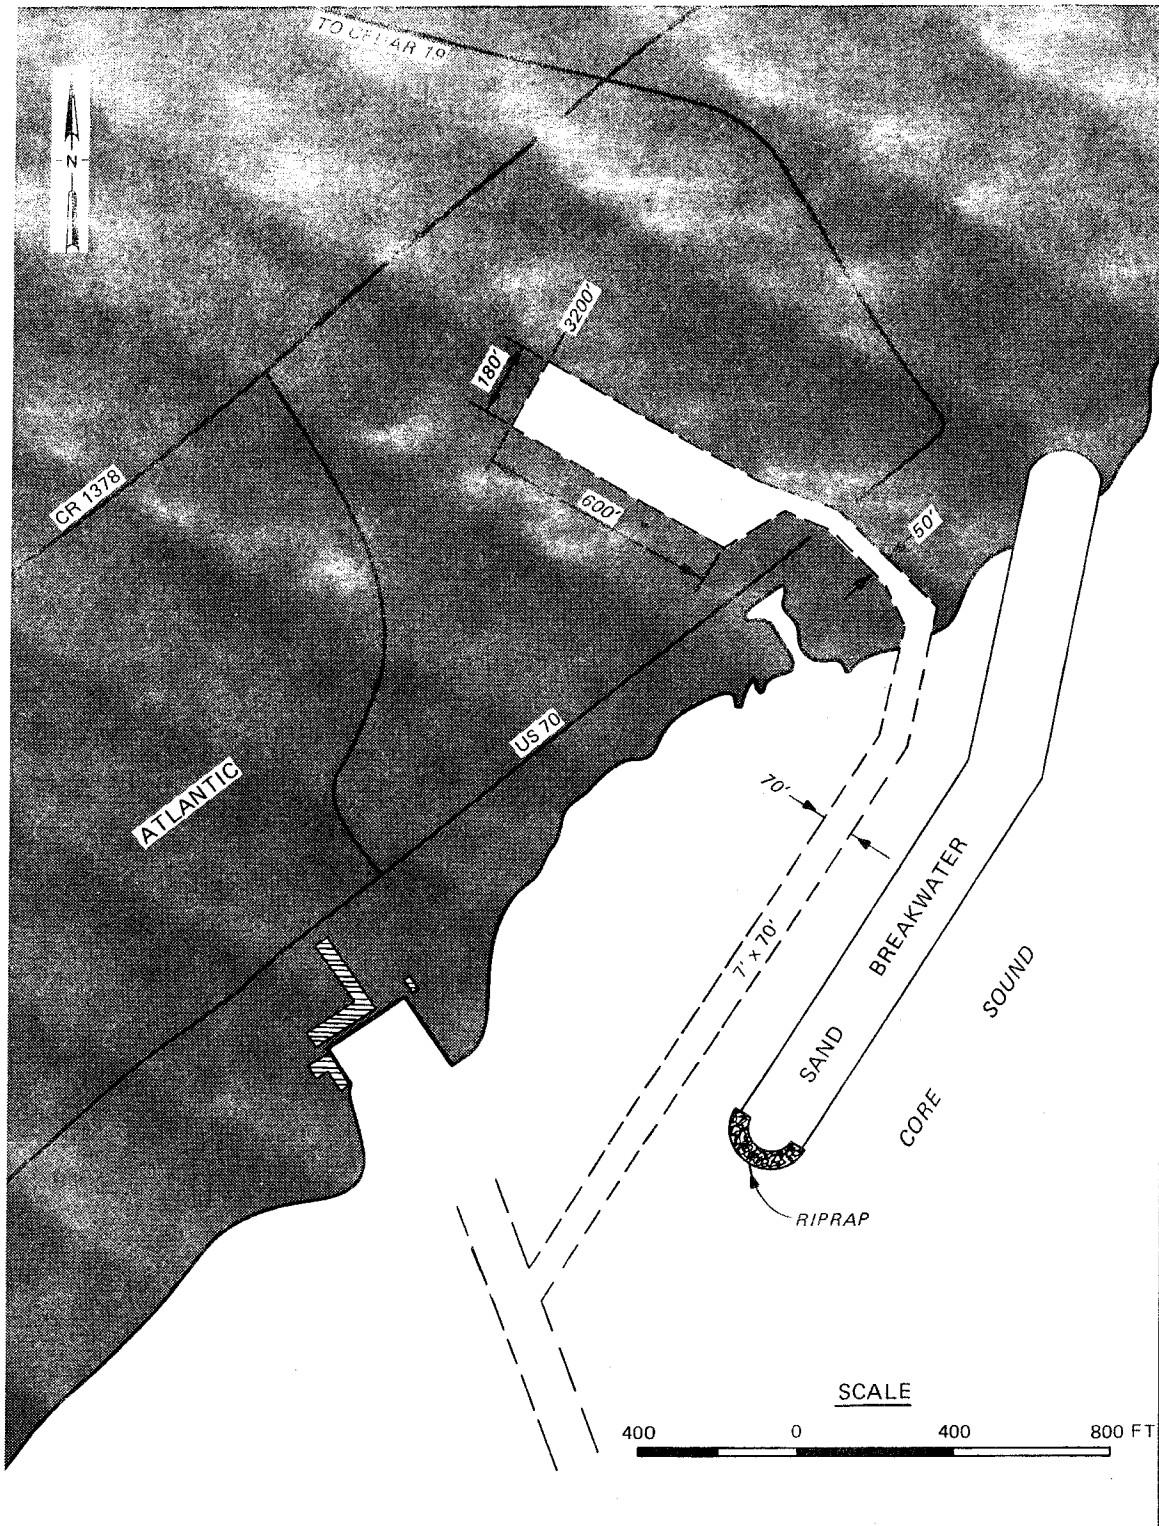
Figure 8. Atlantic Harbor of Refuge, North Carolina

Date (s)	Construction and Rehabilitation History
1971- 1972	A 2,000-ft-long sand breakwater (Figure 8) with a riprap head was constructed in February 1972 as part of the Harbor of Refuge project. Material dredged from the access channel was used for the breakwater. A tentative design section called for a crest width of 15 ft at an elevation of +8 ft mlw, with side slopes of 1V:10H above mlw and 1V:20H below. The head of the breakwater would have a 3-ft-thick riprap section from -1 to +3 ft mlw. This design section was similar to the one used on the Stumpy Point Bay breakwaters. Estimated quantities were 46,500 cu yd of sand, 3,232 tons of stone, and 6.5 acres of grass (to hold the sand in place). The estimated total cost was \$51,400.
1973	Erosion had occurred along a 400-ft section of the southeastern face of the breakwater. The erosion extended from 35 to 60 ft into the embankment, creating an escarpment of about 3 ft, and the planted grass had been destroyed in this area. Also, the stone protection on the south end of the breakwater (previously covered with sand) had become uncovered, displaced, and scattered. The sand fill behind the stone apparently eroded away first, undermining the rock and subsequently displacing it.

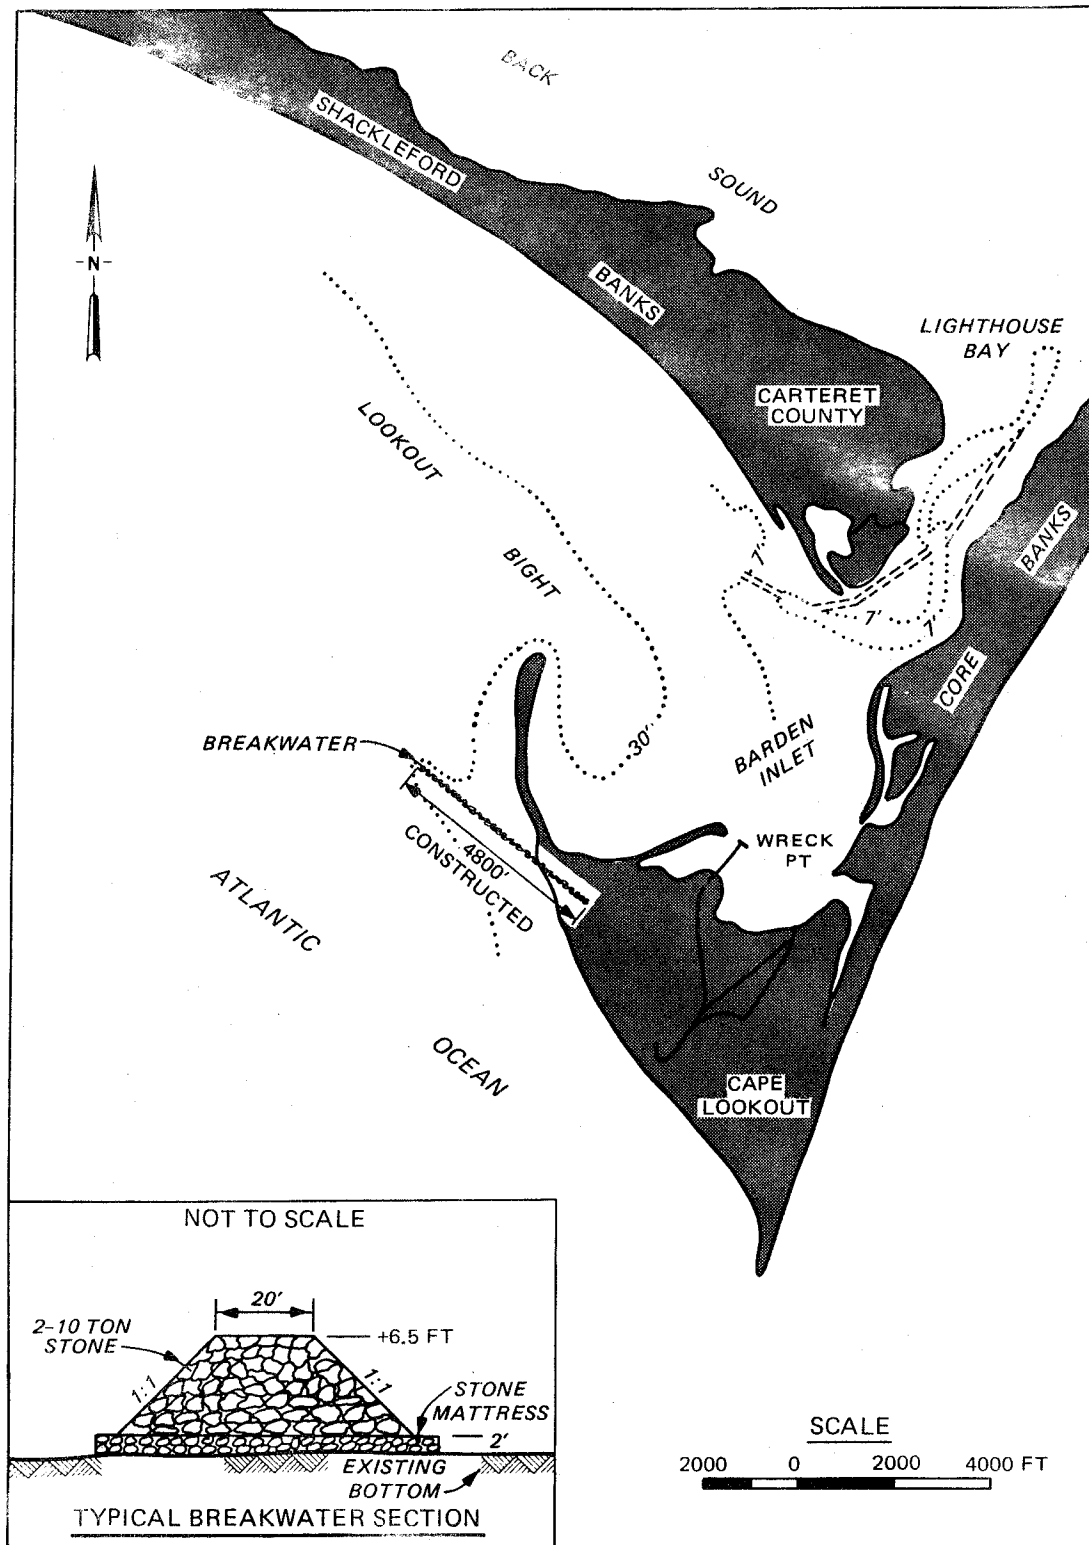
Figure 9. Cape Lookout Harbor of Refuge, North Carolina

Date(s)	Construction and Rehabilitation History
1914- 1917	The landward 4,800 ft of a 7,500-ft-long rubble-mound breakwater (Figure 9), authorized by Congress in 1912, was completed in 1917. Subsequently it was determined that the remaining 2,250 ft of the structure was not needed. The breakwater was constructed on a 2-ft-thick stone mattress. Specifications for the breakwater called for quarry-run stone graded so that at least 10 percent was greater than 10 tons, at least 40 percent greater than 7 tons, and at least 70 percent greater than 2 tons. The design section had a 20-ft crest width at +6.5 ft mlw with 1V:1H side slopes. About 651,400 tons of stone were placed at a total cost of \$1,363,800. (The cost included some other items such as constructing sand fences, a survey boat, and paying for rights-of-way.)
1921	In December cross sections were taken of the breakwater. They showed that the average top elevation of the breakwater was at mlw. The side slopes near the top were fairly flat (about 1V:2H to 1V:3H), and the lower part of the side slopes was fairly steep, generally 1V:1H. At that time the breakwater was visible only in places at extreme low water.

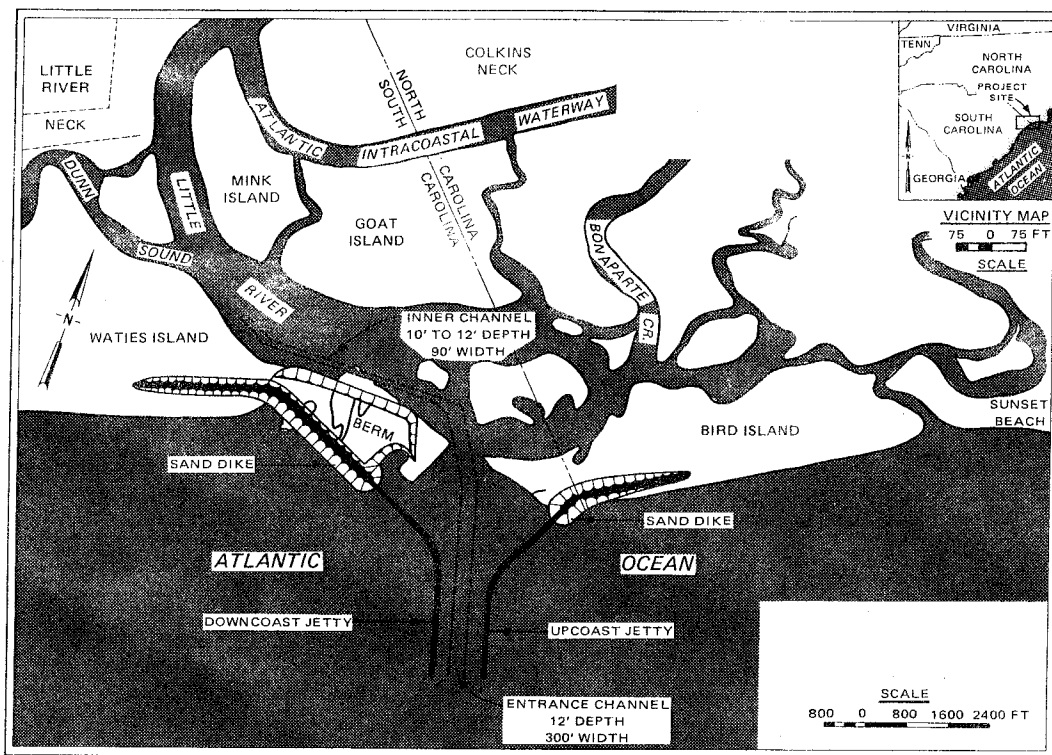
Figure 14. Little River, South Carolina

1986	<p>A visual examination of the structures indicated some displaced stone along the weir section of the north jetty. Surveys also revealed scour holes at the head of the north jetty and along the channel side of the south jetty. No apparent jetty damage was indicated above the water surface. Damage along the toe of the structures, if any, is unknown.</p>

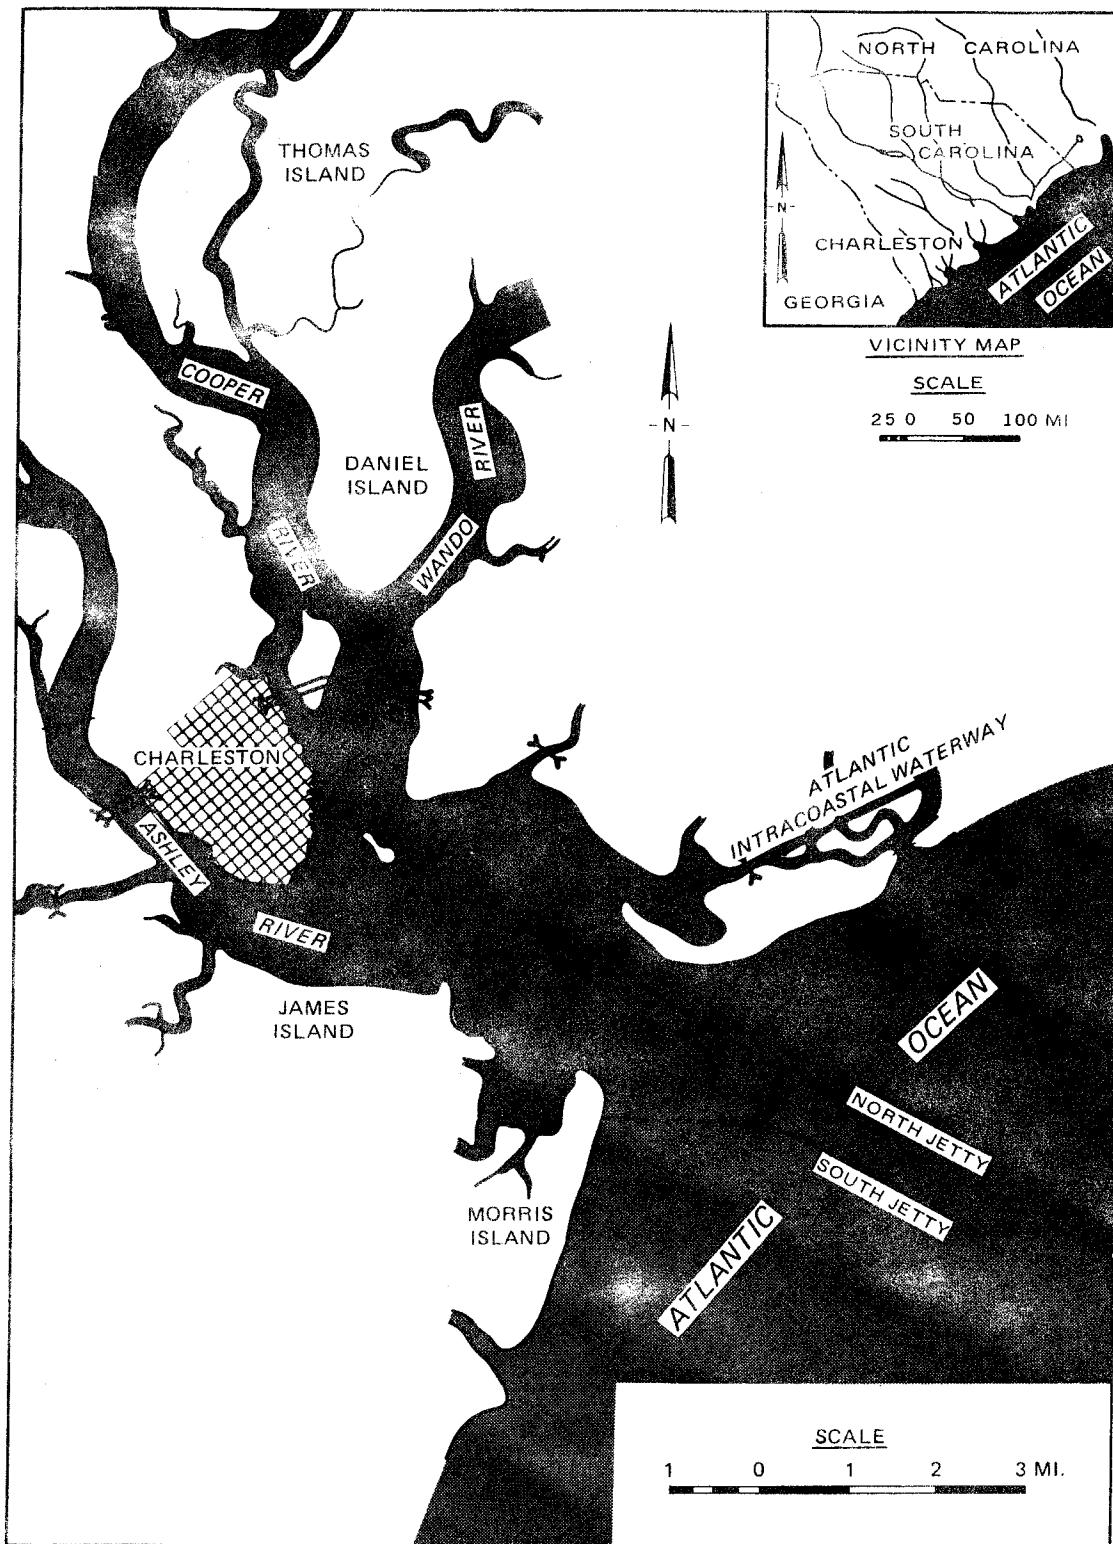
Figure 18. Charleston Harbor jetties, South Carolina

1935	<p>Only minor dredging between the jetties has been required since the project depth was increased in 1917 to -30 ft mlw. Field survey showed very little deterioration to the submerged or raised portion of the jetties.</p>
1966	<p>Present channel depth of -35 ft mlw has been maintained since 1961. An inspection survey in August 1966 indicated a general subsidence of 1.5 to 3.5 ft along the raised portion of the jetties, with maximums of 5 and 6 ft over short sections of the north and south jetties, respectively.</p>
1985	<p>Present channel depth (-35 ft mlw) extends approximately 13,000 ft beyond the end of the jetties. There has been no history of maintenance or repair to the jetties since their completion.</p>

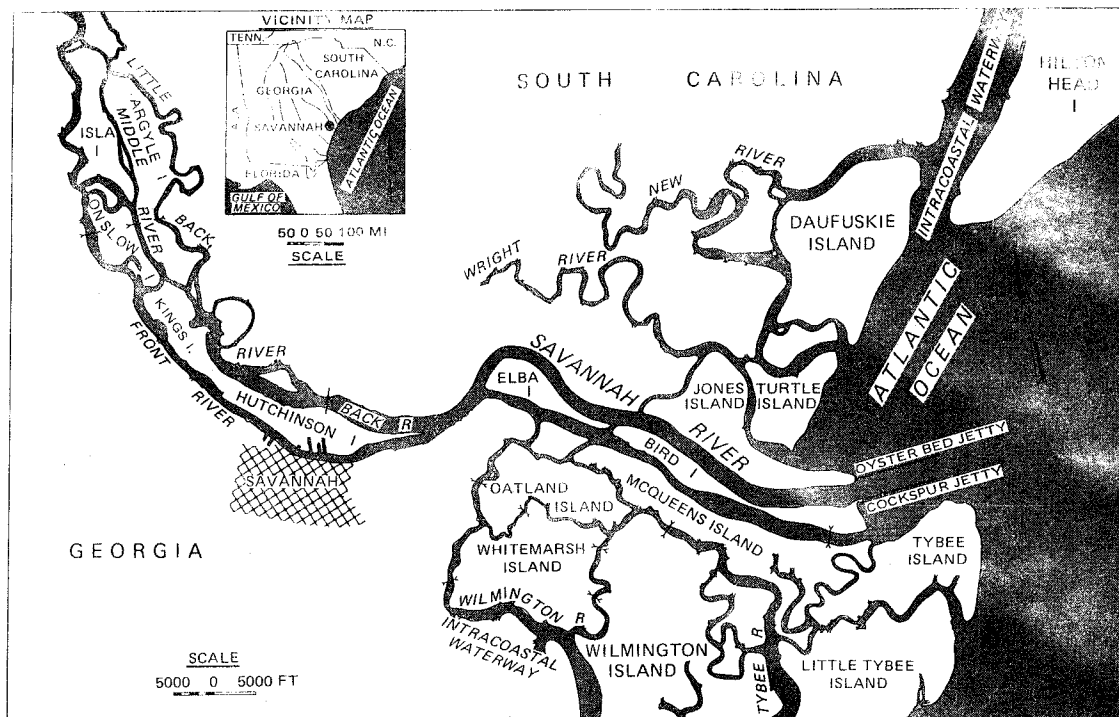
Figure 19. Savannah Harbor jetties, Georgia

1915- 1916	Part of Oyster Bed Jetty was raised to mhw.
1921	A survey of Cockspur Jetty showed the shoreward 2,000 ft at about +6 to +7 ft mlw, the next 9,000 ft from +3 to +5 ft mlw, and the seaward 1,000 ft from -4 to -8 ft mlw. A survey of Oyster Bed Jetty showed the first 6,000 ft of the jetty at +6 to +7 ft mlw. The outer unimproved portion of the jetty composed of small stone had subsided from 1 to 3 ft since the 1914 survey.
1923	The outer portion of Oyster Bed Jetty was raised to mhw. Design improvements consisted of a crest elevation of +6.8 ft mlw, crest width of 8 ft, and side slopes of 1V:1.25H. The cross section consisted of core stone with large cover stone (Figure 20). A post construction survey showed the seaward end of the jetty, with approximately 1V:1H side slopes, was the only section with side slopes exceeding the design value.
1926	During a survey of Oyster Bed Jetty, crest elevations varied from +5 to +7.5 ft mlw over the entire length.

1935	The Oyster Bed and Cockspur Jetties were surveyed. There were no major areas of damage and only negligible subsidence when compared to previous surveys of 1921 and 1926. Between the 1921 and 1935 surveys 500 ft of Cockspur Jetty, 500 ft from the original seaward

Date(s)	Construction and Rehabilitation History
1935 (Cont)	end, appeared to have been raised +3.5 to +4 ft mlw, from about -4 ft mlw. The jetty length at that time was considered to be 11,500 ft.
1962	A survey was taken of Oyster Bed and Cockspur Jetties. There were no major areas of damage. Except for the seaward end of the Cockspur Jetty, the outer 3,000 ft has subsided from 0.5 to 1 ft.
1985	Except for the improvements to the jetties mentioned previously, the jetties have no history of maintenance or repair. The jetties appear to be functioning properly by maintaining a navigable channel with minimal dredging. The present channel depth between the jetties is -38 ft mlw.

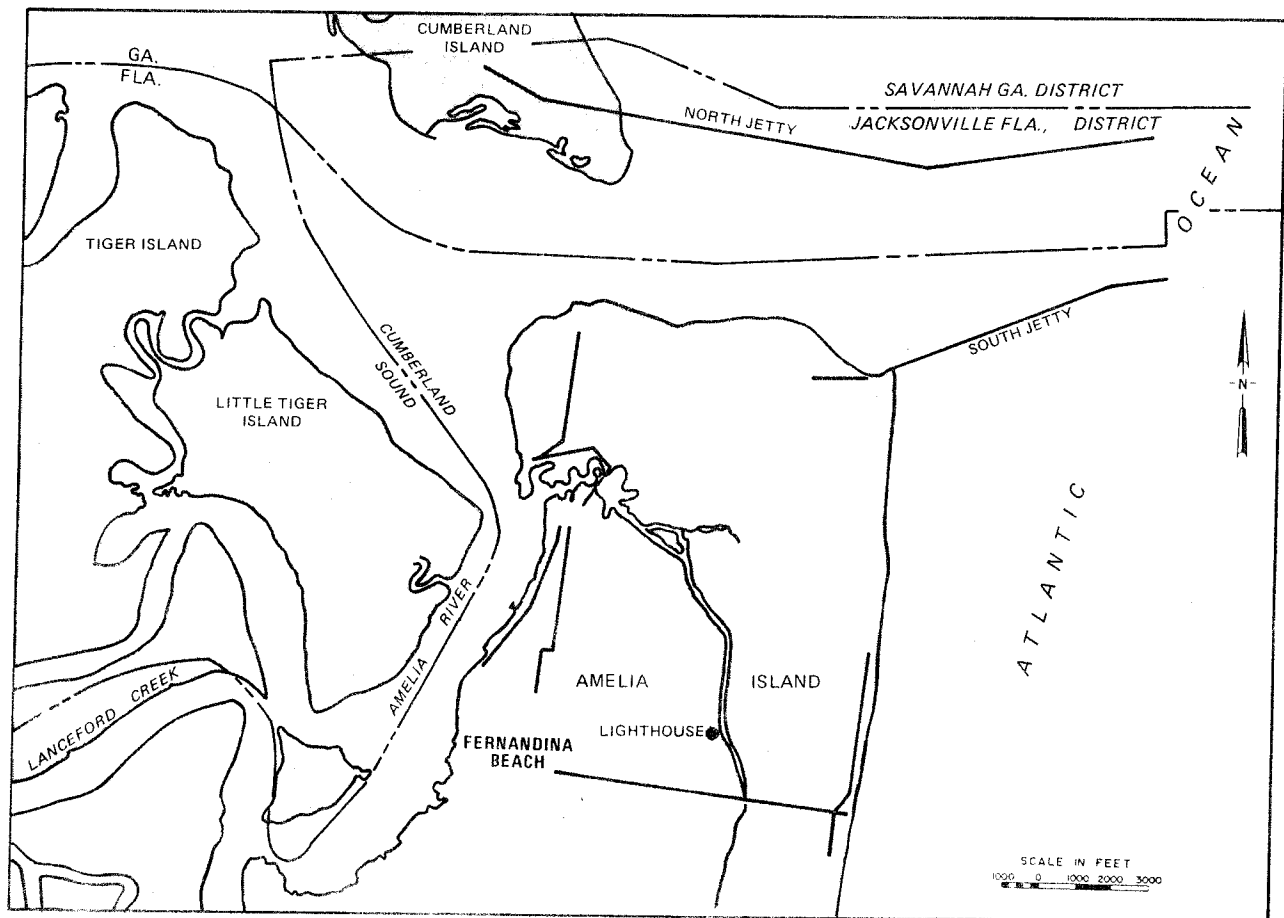
Figure 21. Fernandina Harbor jetties, Florida

Date(s)	Construction and Rehabilitation History
1937	A survey in May showed crest heights of +2.5 to +8.5 ft mlw and +2.0 to +9.0 ft mlw for the north and south jetties, respectively.
1945	A survey of the south jetty in December showed crest heights from +1.5 to +9.0 ft mlw.
1985-1987	At present, a 40-ft-deep by 400-ft-wide channel between the jetties is maintained by the Navy (the Federal project depth is 32 ft). A contract has been awarded to sand-tighten the landward 1,500 ft of the south jetty. (As of 17 Aug 87 the job had not been completed.) Plans call for removal of the existing jetty to -5 ft mlw, placing an impermeable core of precast concrete sections (inverted Y-shape), and rebuilding to a crown elevation of +9 ft mlw using 8-ton (maximum) armor stone.

1926- 1927	<p>Work under contract to repair both jetties began in February and was completed 1 year later. This repair resulted in raising the north jetty to +7 ft mlw and the south jetty to +6 ft mlw. In each case, the crest width was 8 ft.</p>

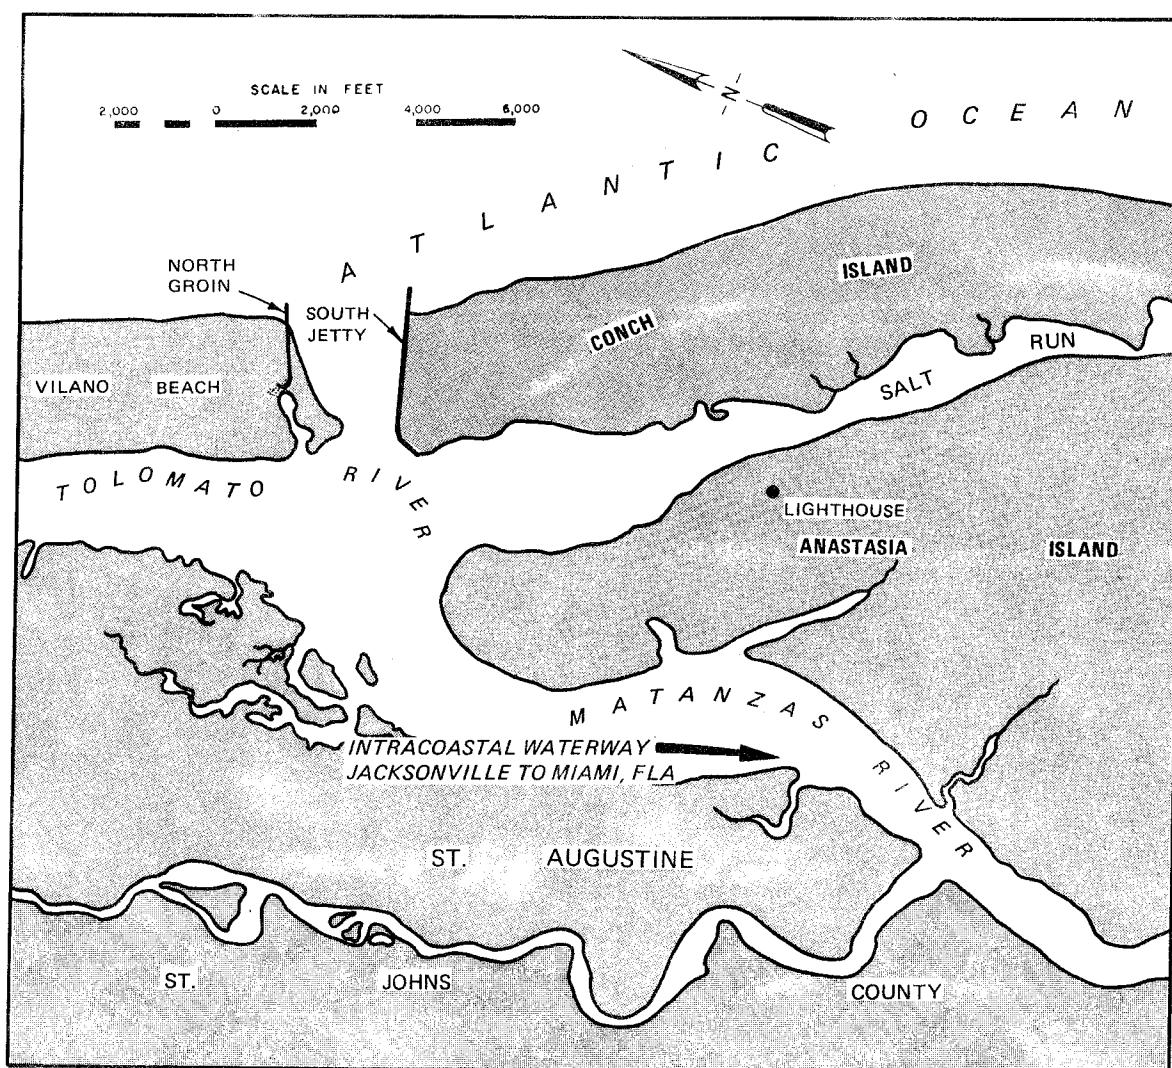
Figure 26. St. Augustine Harbor, Florida

Date(s)	Construction and Rehabilitation History
1985	No repair work has been done since construction of the south jetty (or since 1943 for the north groin). Although no detailed surveys of the jetties (considering the north "groin" as a jetty) have been made, they are functioning properly and appear to be in good condition.

Date(s)	Construction and Rehabilitation History
1941	During 1941 a sand-tight terminal groin of timber wall, native stone, and granite was constructed to a length of 1,580 ft, and 450 lin ft of cresote-treated timber was placed at its shoreward end (Figure 26). The groin (Figure 27) side slopes were 1V:1.5H. Crown widths varied from 6 to 12 ft, and the crown elevation varied from +10 to +6 ft mlw at the shoreward and seaward ends, respectively. A 2-ft-thick mat foundation was placed using 8,000 tons of native stone, and 13,300 tons of mostly 5- to 10-ton stone was used to complete the groin. (The largest stone was to be placed at the seaward end.) The cost of the structure was \$305,000.
1942	Granite stone, weighing 600 tons, was placed on the south side of the north groin at an exposed section of core wall. This placement was necessary since sand had been accreting on the north side and eroding on the south side to the point that the highwater line was 150 ft west of the structure. Cost of the repair was \$4,200.

1943	Repairs were made to 350 ft of the existing north groin, and a 300-ft shoreward extension was completed using 20- to 100-lb core stone and 300- to 1,000-lb cap stone to guard against flanking of the structure by the continued recession of the shoreline south of the groin. The repairs cost \$54,600.
1949	The seaward 100 ft of north groin had gradually subsided below mhw (+4.5 ft).
1956- 1957	A 2,825-ft-long sand-tight south jetty was constructed (Figure 28) approximately 2,400 ft south of the existing north groin, providing protection for a 16-ft-deep channel. The sand-tight section (landward 1,800 ft) was constructed to +10 ft mlw with a 10-ft crown width and 1V:1.5H side slopes. The cover stone was 2 to 8 tons with a core of 200-lb maximum stone placed on a 2.5-ft-thick foundation blanket (the entire length of the jetty) of 1- to 12-in. pieces. Seaward of this section the crown width was 12 ft, the crest elevation was +6 ft (via 300-ft transition), and the side slopes were 1V:1.5H. The core stone was 200 to 4,000 lb, and the cover stone consisted to 6- to 10-ton stone. The outermost 350 ft of the structure had side slopes of 1V:2H and used 10-ton minimum cover stone. The channel side of the jetty was protected by a 3-ft-thick apron, 40 ft wide consisting of a 1-ft-thick filter bed of 1- to 12-in. stone, overlayed with 75- to 1,500-lb riprap stone. The total cost of the jetty plus a shoreward revetment section was \$967,000.

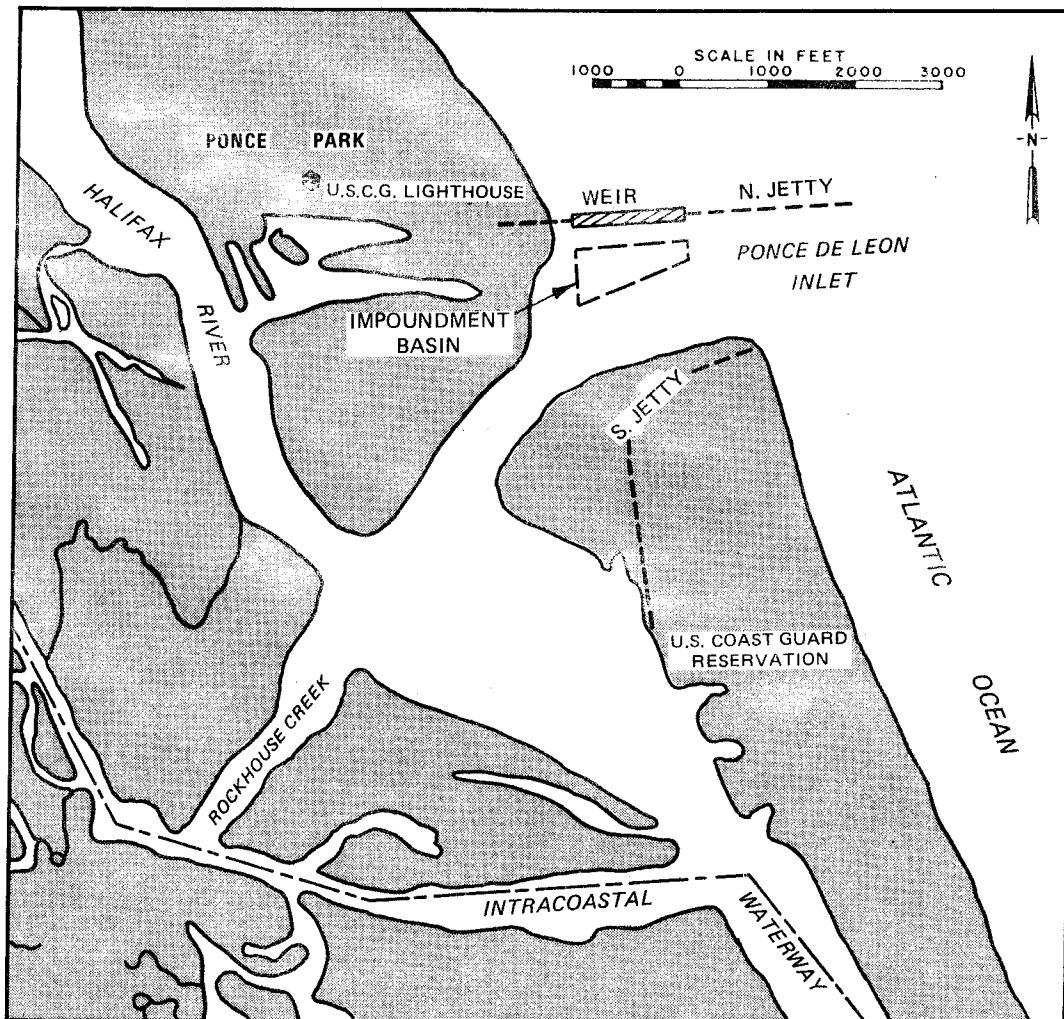
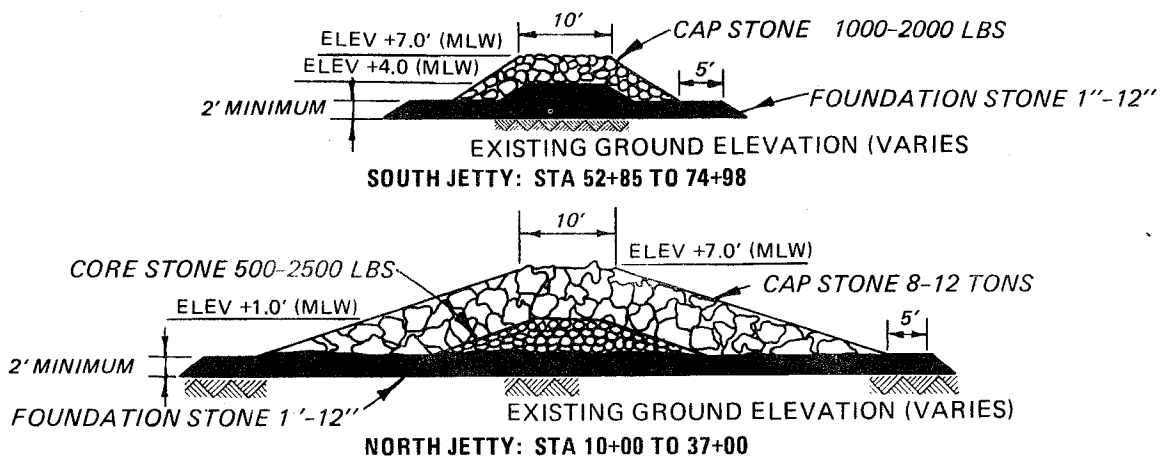
Figure 29. Ponce de Leon Inlet, Florida

Date(s)	Construction and Rehabilitation History
1981	Erosion at the root of the north jetty required placing stone over a 375-ft section of the existing jetty beginning 125 ft from landward end. The repair cross section consisted of a 1.5-ft layer of 1- to 50-lb bedding stone, a core of 30- to 1,000-lb stone, and 0.5- to 2-ton capstone. Side slopes were 1V:2H with a 5-ft crest width and crest elevations varying from +9 to +12 ft mlw. Additionally, 1,150 tons of bedding stone, 1,970 tons of capstone, and rearrangement of stockpiled core stone were used in the repair.
1982- 1983	The north jetty weir section was closed using core and armor stone (no details). Armor stone size and cross-section geometry were similar to those for the existing rubble-mound section at the seaward end of the weir section.
1985	The jetties are presently in good condition except for some damage on the north jetty head because of a recent storm and continued erosion at the root of the jetty.

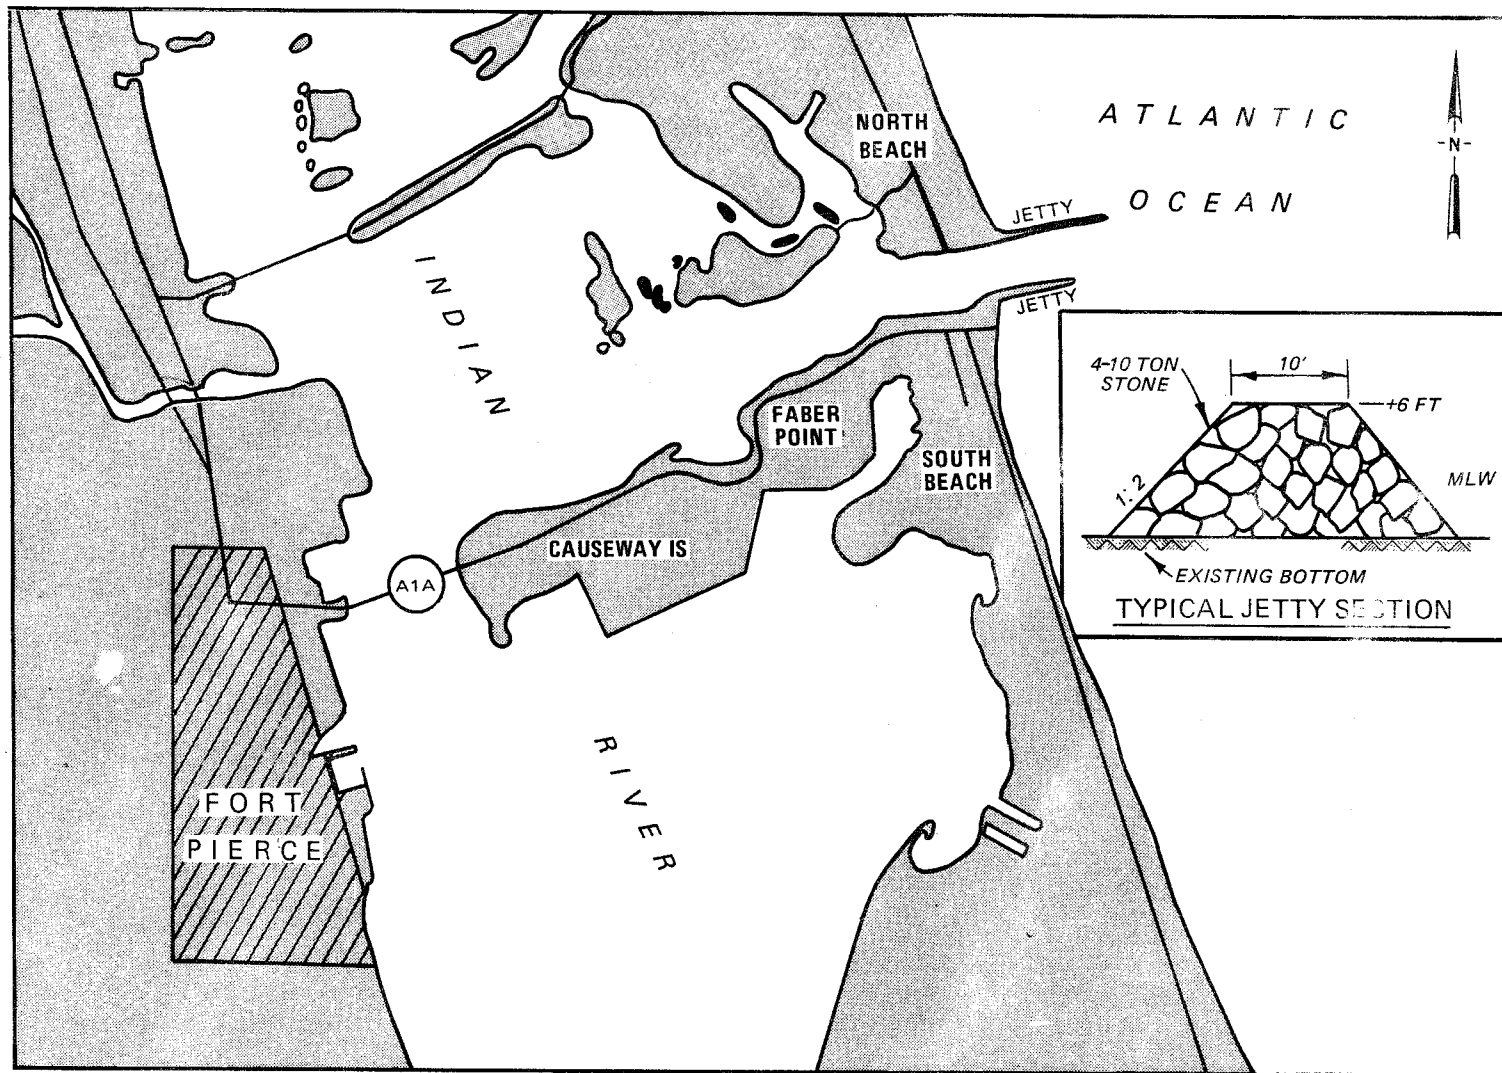
Figure 31. Fort Pierce Harbor, Florida

1949	The annual report of the Chief of Engineers states, "both jetties are in good condition."
1985	Presently a 350-ft-wide by 27-ft-deep channel is maintained, running adjacent to the south jetty. The jetties have not been repaired since 1934 and are considered to be in good condition.

Date(s)	Construction and Rehabilitation History
1922- 1929	Local interests constructed parallel jetties, each 400 ft long and spaced 600 ft apart, to protect a dredged channel 5 ft deep by 90 ft wide. About 1925, seas eroded the north beach and flanked the north jetty, leaving it 200 to 300 ft offshore. In 1926 local interests started construction of another jetty 400 ft north of, and parallel to, the south jetty. At the completion of these improvements in 1929, the north and south jetties were 2,300 ft and 1,600 ft, respectively (Figure 31), and the channel between the jetties was 240 ft wide and had a controlling depth of 20 ft. The structures were constructed of native coquina stone with 1V:1H side slopes below, and 2V:1H slopes above -7 ft mlw.
1931	The district engineer report states that the jetties had settled and that wave action had created numerous gaps.
1933- 1934	The jetties, at that time under Corps jurisdiction, were repaired using 4- to 10-ton granite stone (Figure 31, inset). Prior to the repairs the existing side slopes were irregular but approximately 1V:2H, and the alignment of each jetty was irregular. These irregularities were corrected during the repairs. The existing crown elevation of the jetties ranged from mlw to +6 ft mlw. On the north jetty and outer 400 ft of the south jetty, old stone above -1 ft mlw was removed and placed below this elevation. New stone was placed along both jetties to a crown elevation of +6 ft mlw, a 10-ft crown width, and 1V:2H side slopes. In addition, the south jetty was extended 420 ft, the crown elevation on the inner 320 ft sloped from +6 ft mlw to -5 ft mlw, and the outer 100 ft consisted of a 3-ft-thick by 40-ft-wide stone apron. The estimated quantities of old rehandled stone and new stone were 7,500 cu yd and 38,000 tons, respectively. The water depth at the end of the jetties was approximately -10 ft mlw. The cost of the repair work was \$246,000.

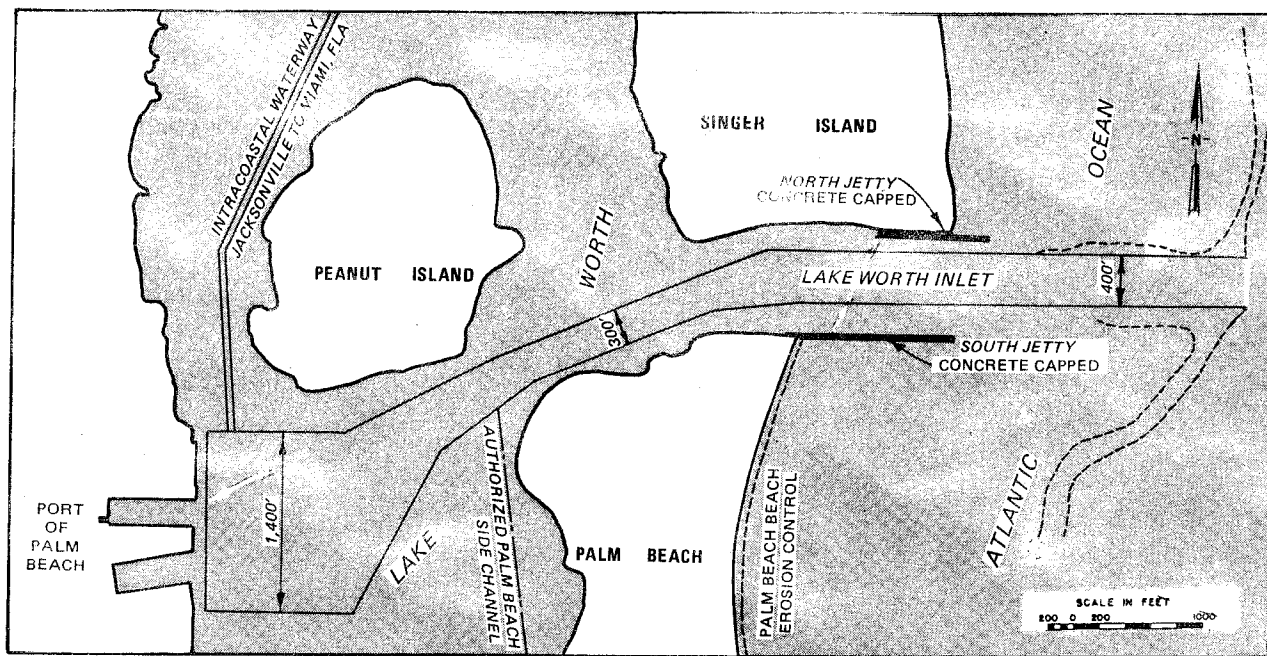
Figure 33. Palm Beach Harbor, Florida

Date(s)	Construction and Rehabilitation History
1920	Local interests constructed two parallel jetties, 600 ft apart, providing for a 16-ft-deep channel entrance. The jetties were constructed of coquina rock and limestone.
1925- 1926	Local interests constructed two new granite stone jetties (Figure 33) 800 ft apart (north jetty constructed along its original alignment). The lengths were 1,700 and 2,150 ft for the north and south jetties, respectively. The design cross section consisted of a 10-ft crest width at +5 ft mlw and side slopes of 1.5V:1H.
1934- 1938	Lake Worth inlet became a Federal project in March 1934. A report of May 1935 stated that the jetties were in poor condition and that revetments were needed. Restoration of the jetties and construction of connecting revetments were accomplished from October 1936 to June 1938. The major features consisted of (a) the placing of new 8- to 10-ton granite stone and resetting of existing stone to elevations of +1 ft mlw (trunk crest width of 30 ft) and +7 ft mlw (head crest width of 10 to 20 ft) with 1V:2H side slopes, and (b) the placing of a solid concrete cap on the trunks above +1 ft mlw with side slopes of 1.5V:1H. The shoreward 850 ft of the 950-ft-long north jetty was capped to an elevation of +8 ft mlw with a top width of 6 ft, and the seaward 100 ft had void spaces filled with asphaltic concrete above -3 ft mlw. The shoreward 1,790 ft of the 1,890-ft-long south jetty was capped similarly, except that the seaward half had a crest elevation of +7 ft mlw and crest width of 9 ft. For comparison purposes, asphaltic concrete was not placed on the 100-ft head section. The jetties were placed on existing grade without a core of smaller stone. The total cost of the project was \$333,000. Shortly after completion of the north jetty/revetment areas, heavy seas caused loss of stone and deterioration of the revetment section immediately adjacent to shoreward end of the concrete cap. During this period the project depth was increased to 20 ft.

1945	A 40-ft section of the concrete cap on the south jetty approximately 420 ft from the shoreward end had settled about 4 in., had longitudinal cracks, and was acting as a beam. These occurrences were brought on by tidal scour through, and settlement of, the underlying armor stone. The cause of the problem was thought to result from the lack of additional armor stone placed in this and adjacent sections of the old jetty during the 1934-38 rehabilitation. The north jetty was in good condition, and its only problem was its ineffectiveness as a barrier to tidally-induced sand motion under the structure. This problem was evidenced in the original jetties and

1950	In January 1950 repairs to the north jetty consisted of (a) placing a filter blanket of 1/4- to 6-in. stone along 200 ft of its shore-side landward junction (to impede sand motion) and (b) placing existing and additional 500- to 2,000-lb armor stone at the revetment/jetty cap interface (30-ft section). In March 1950 repair of the south jetty consisted of placing 2- to 10-ton armor stone as needed. Total cost of the repairs to the south jetty (26,000 tons of stone placed) and revetment was \$227,000. (The jetty portion was roughly 90 percent of the total.) In August 1950 an underwater survey of the asphalt-filled north jetty showed some deterioration on the channel side; otherwise, it continued to function properly.
1955	Repairs were made to the north jetty from the existing shoreline to the landward end of the concrete cap (500 ft). A total of 1,300 tons of 6-ton minimum capstone was placed on the channel side of the repair section. Filter layers were placed on the shoreward side of the cap as follows (Figure 34): (a) 2-ft-thick lower layer of 3- to 6-in. stone placed above, and shoreward of, new/existing armor stone, (b) overlayed with 9 in. of 0.1- to 0.4-in. material, and (c) covered by a layer of 500- to 4,000-lb riprap stone. Total cost of the repairs was \$51,000.
